The former Bee's Knees public house  
(previously the Derby Hotel)  
St James' Street, Accrington, Lancashire:  
Level 2 Historic Building Record

January 2021

STEPHEN HAIGH  
Buildings Archaeologist

### **LEVEL 2 HISTORIC BUILDING RECORD**

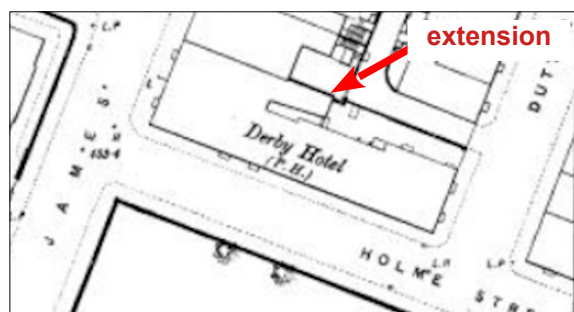
Figure 4: OS 1:500 map, 1892

- 6.7 The 1892 town plan<sup>6</sup> shows the site named as the "Derby Hotel (P.H.)" (figure 4), and having been extended at its rear. Subsequent OS maps show no further changes to the building's outline.

- 8.7 Those parts of the building which face into the back yard are mostly brick-faced, but the rear of the north-west end is random rubble, which matches that of the adjacent property on St James' Street (**21,22**). There are two blocked openings at street level at the south-east end, but these are not shown on the 1862 plan, where a midden, ash-pit and pair of water closets were indicated as adjoining the building. A modern, brick, fire escape has been built alongside the building further back from the street (**23**), perhaps concealing evidence for a large former opening (as shown here in 1862). This is just one of a number of interventions here, which also include a rather haphazard-looking, brick extension to basement and ground floors only, housing WCs above a low storage area (**24,25**). This addition was extant by 1890 (see figure 4 above).

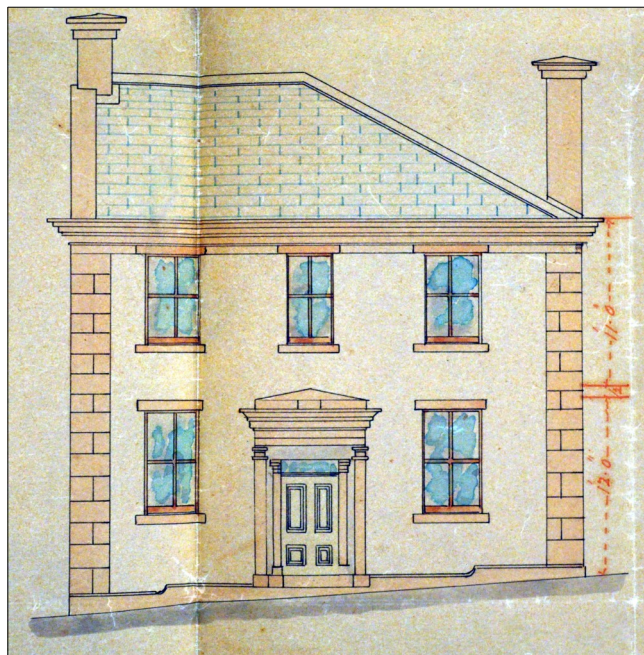
Figure 5: Proposed front elevation, 1862

- 6.3 The proposal drawings include the two elevations to St James' Street and Holme Street, and plans of the basement, ground and first ("chamber") floors, and indicate that the building occupied its present extent from the outset. There are however significant differences between the proposals and the building's present form, most of which appear to reflect the extensive alterations during the building's life, but others suggest that the public house was not constructed exactly as shown on the plans.

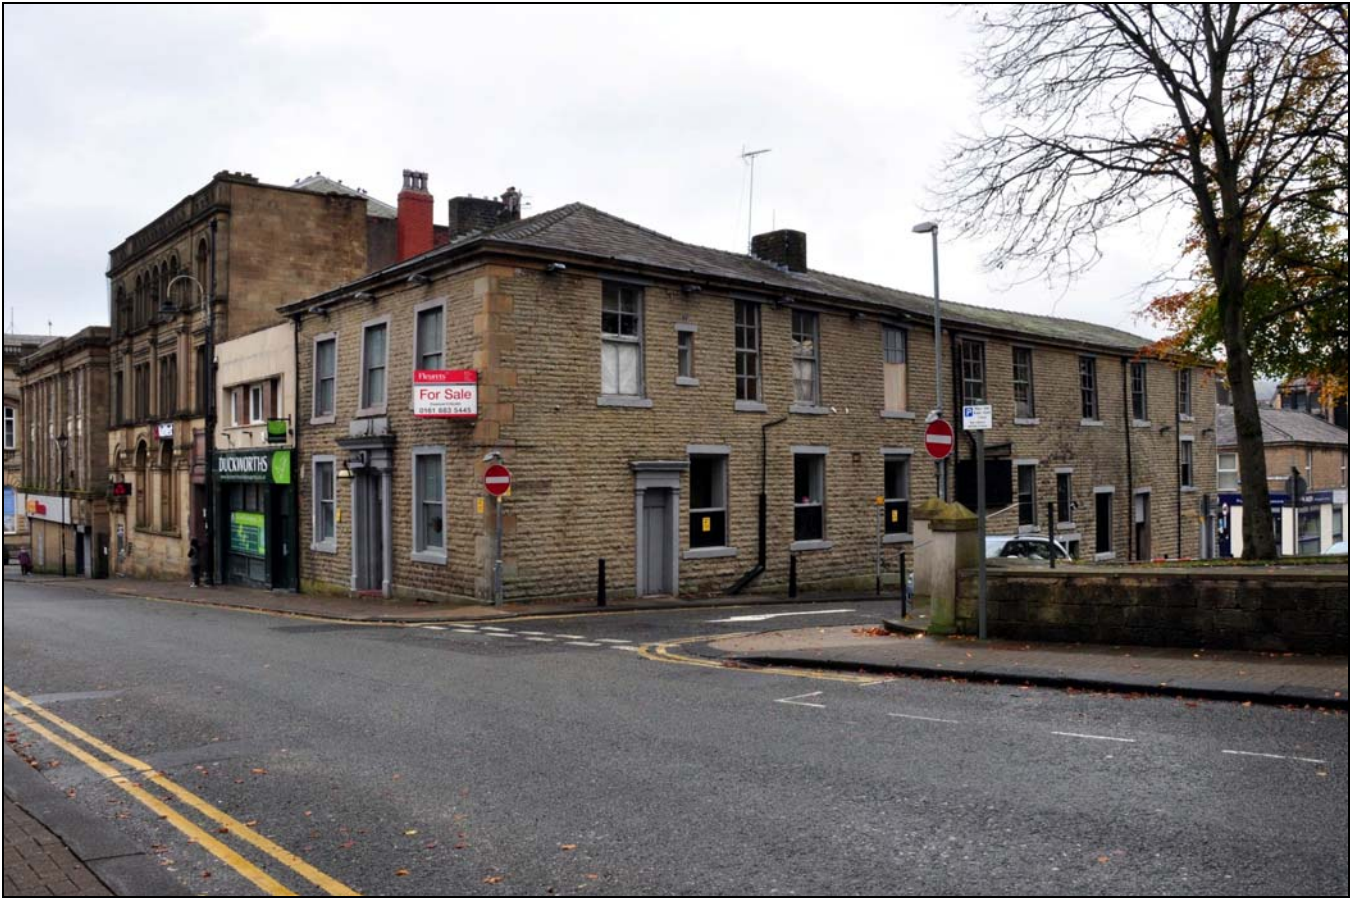
- 8.2 The north-west end forms the front (**1-4**): it has an ashlar plinth with the tops of two cellar light-wells just visible above footpath level, and an ornate ground floor doorway to left of centre (**5**), with moulded stone pilasters beneath a cornice, and blank escutcheon. The fielded panelled door itself appears original, though it formed two leaves originally, and now lacks any original furniture. The windows

Photo 1: General view, from the south-west

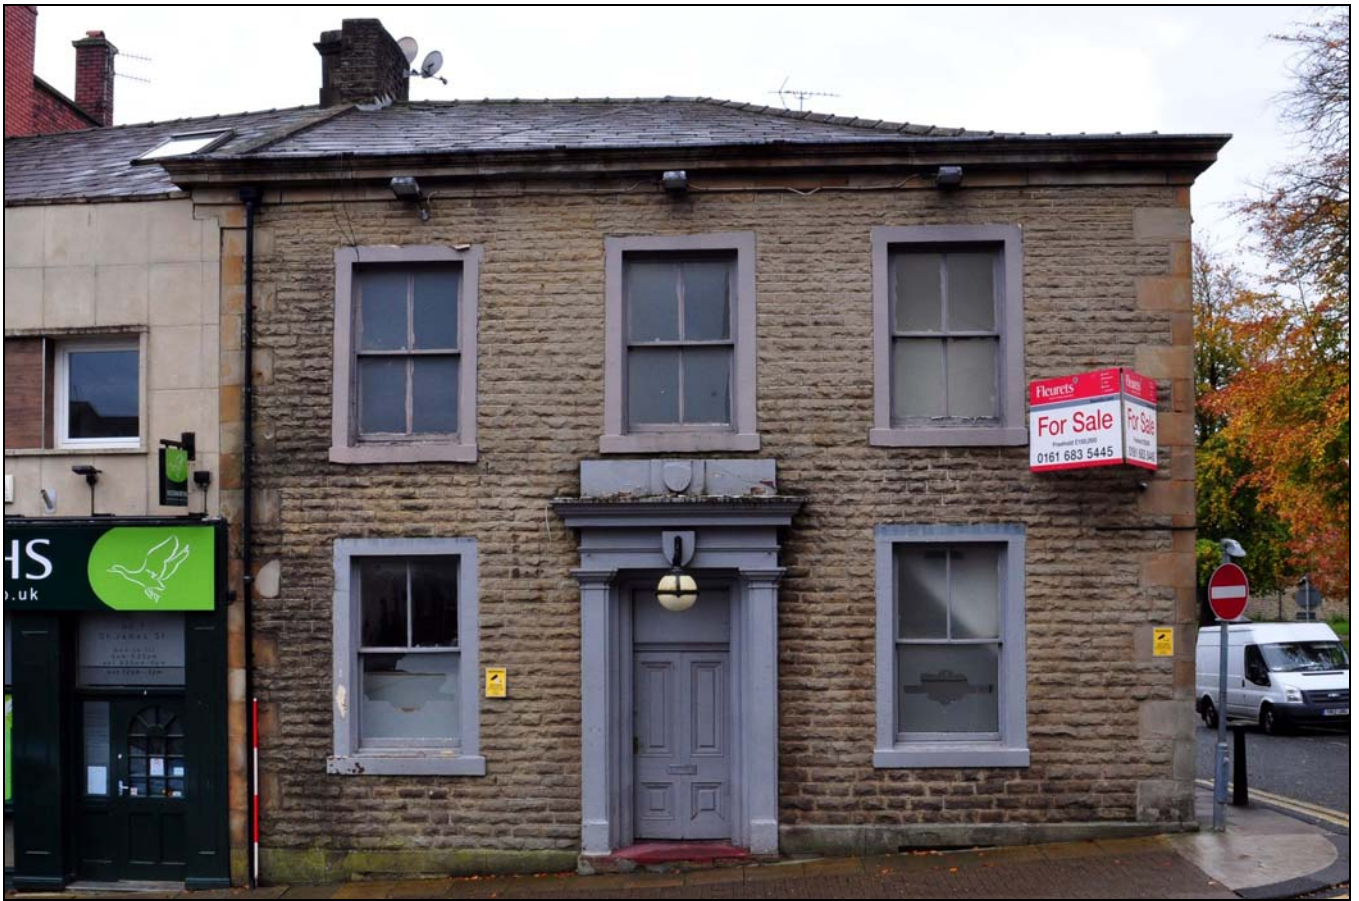
Photo 3: North-west, front elevation to St James' Street

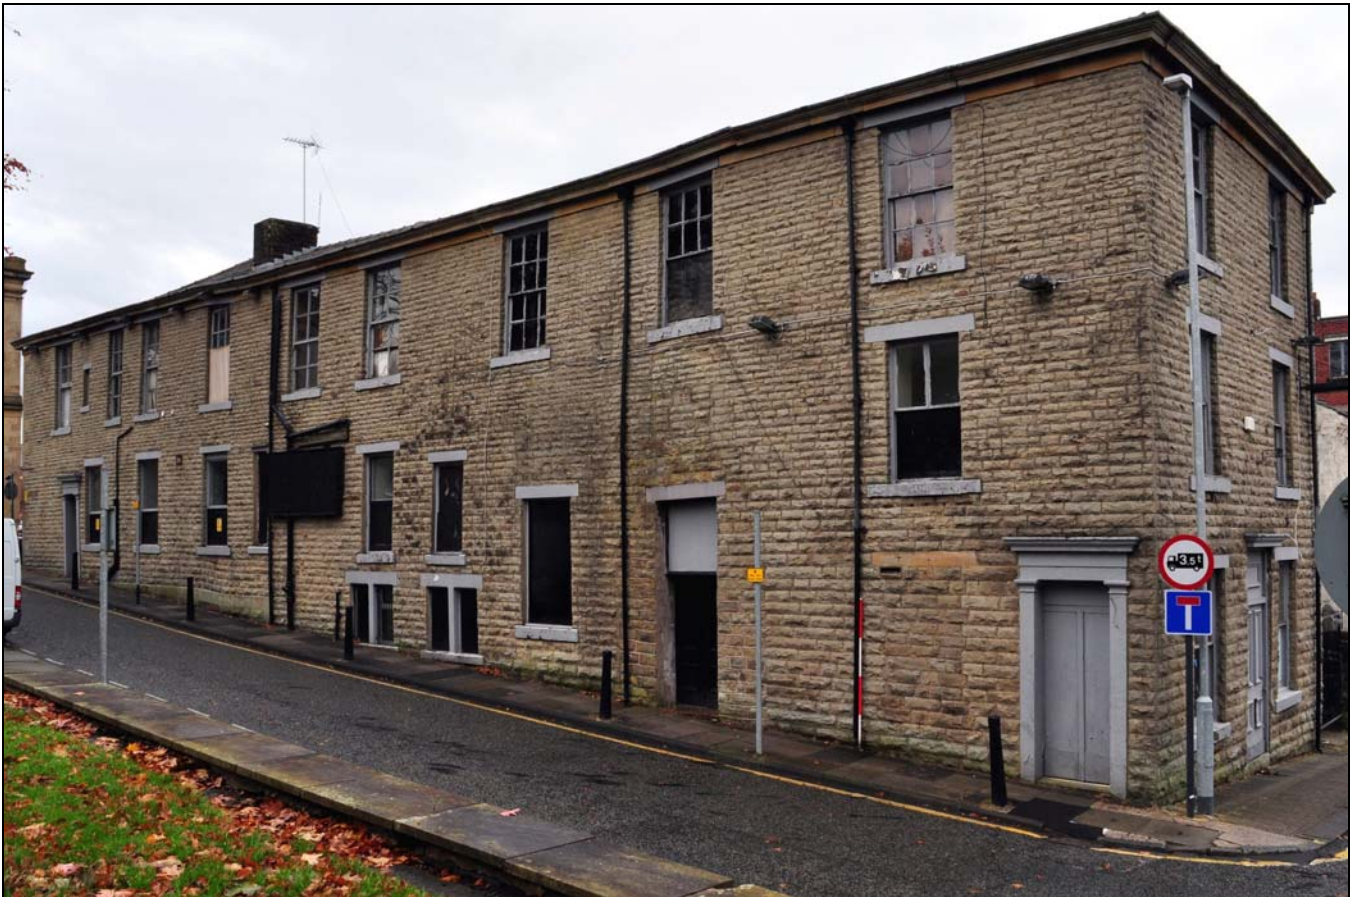
- 8.3 On the Holme Street elevation ground level falls away (**8-10**), and the upper floor levels step up towards the south-east end, so that the cellar at the north-west end becomes contiguous with a full-height basement storey at the Dutton Street end. Comparison of the existing building with the 1862 proposals shows numerous anomalies in this elevation, some of which indicate significant alterations have taken place along this façade, but others suggest there was some variation from the outset.

Photo 10: Holme Street elevation, from the south-east

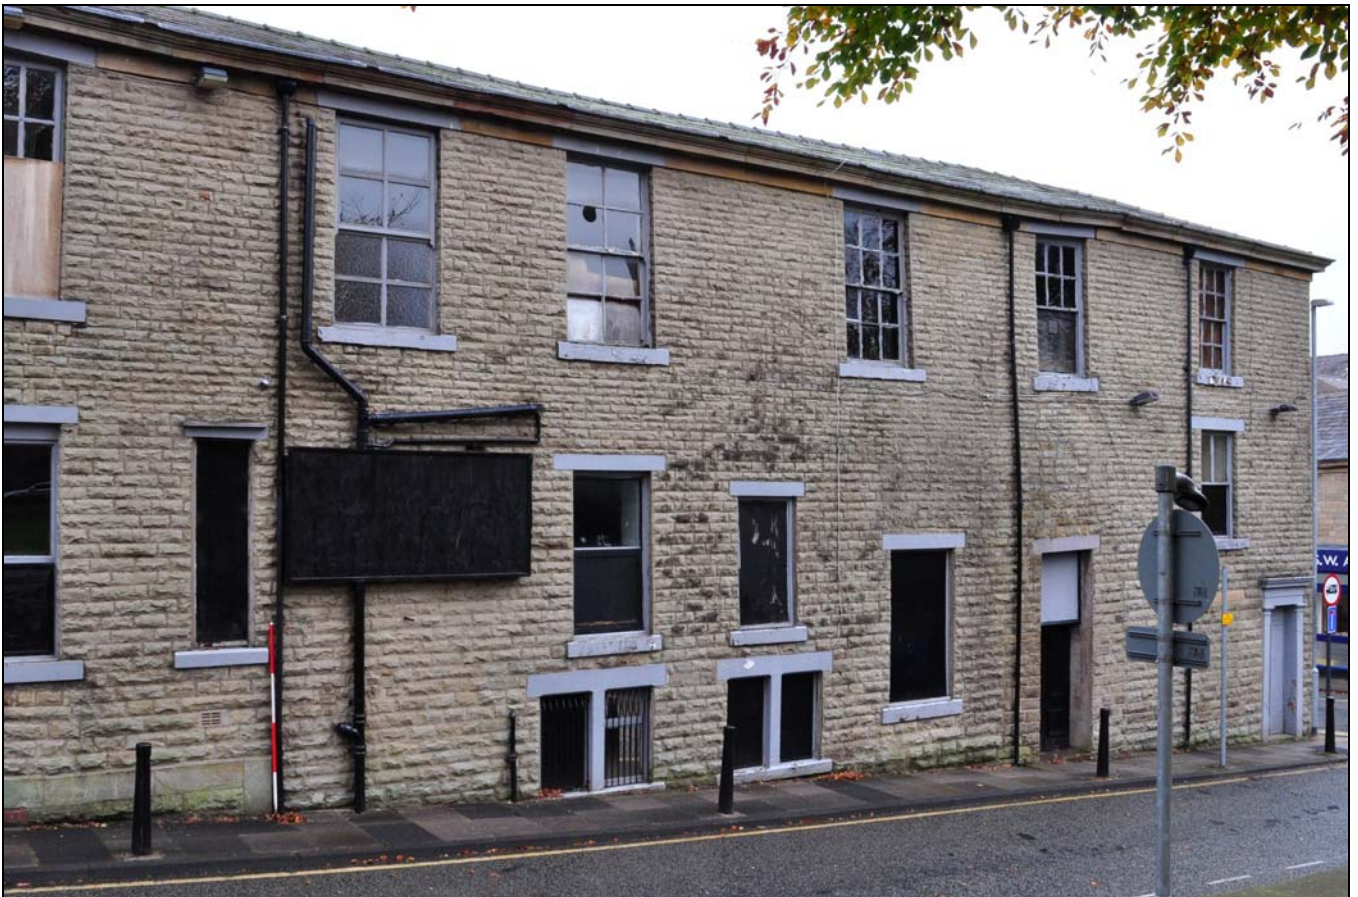
- 8.5 A number of six-over-six sashes survive on the top floor in this elevation, some of them apparently original, to judge from their narrow glazing bars and lack of horns (**16**), but it is notable that these contrast with the larger four-pane sashes shown throughout the building on the 1862 drawings and surviving in many instances; perhaps the twelve-pane windows were cheaper, and relegated to the lower status parts of the building. Also of interest is the step-down of the cornice within the middle part of the elevation, by a single course of stone, for which there is no obvious explanation (**14,17**).

Photo 14: Lower part of Holme Street elevation, from the south-west

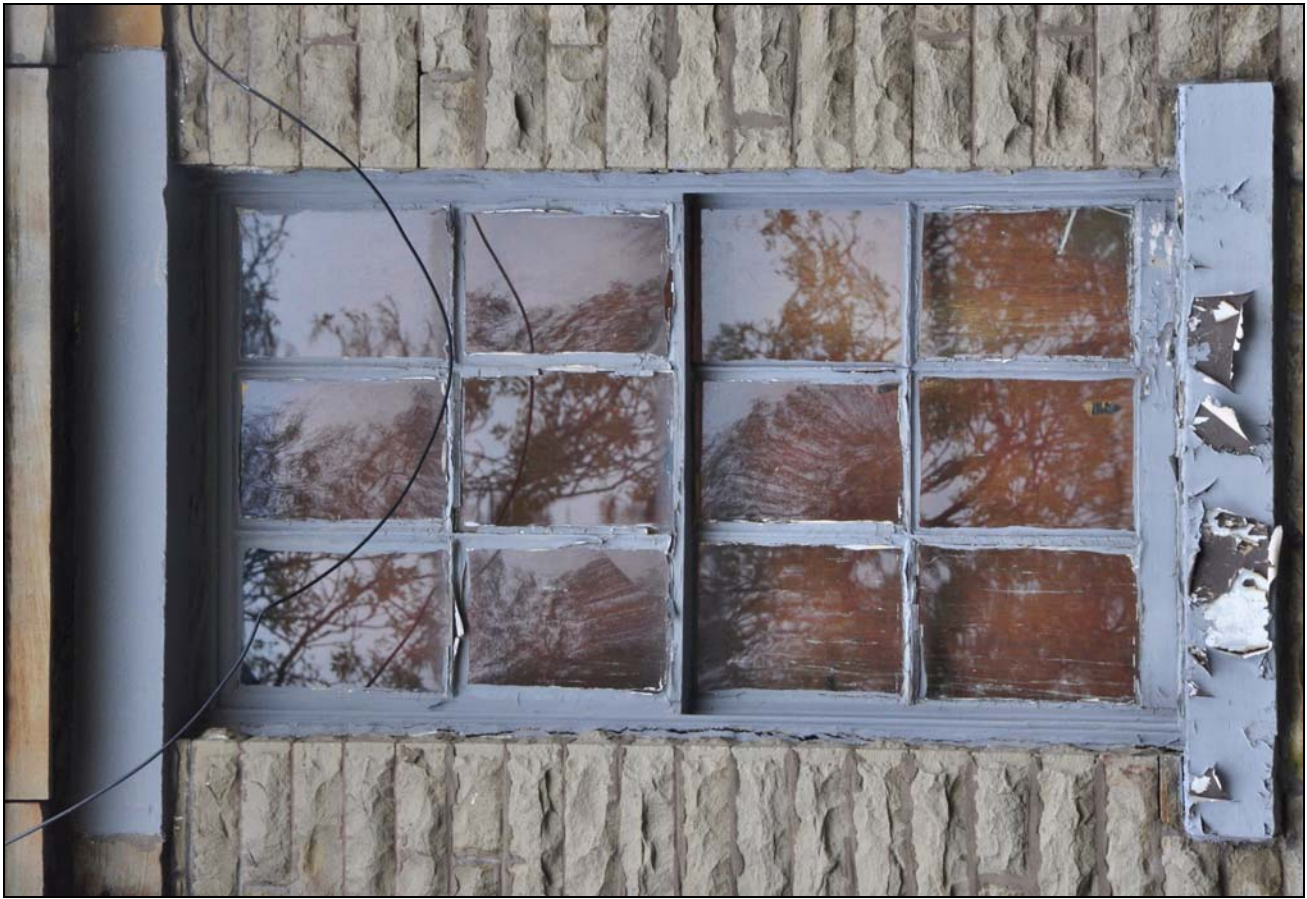
Photo 16: Twelve-pane sash (probably original), top floor, Holme Street elevation

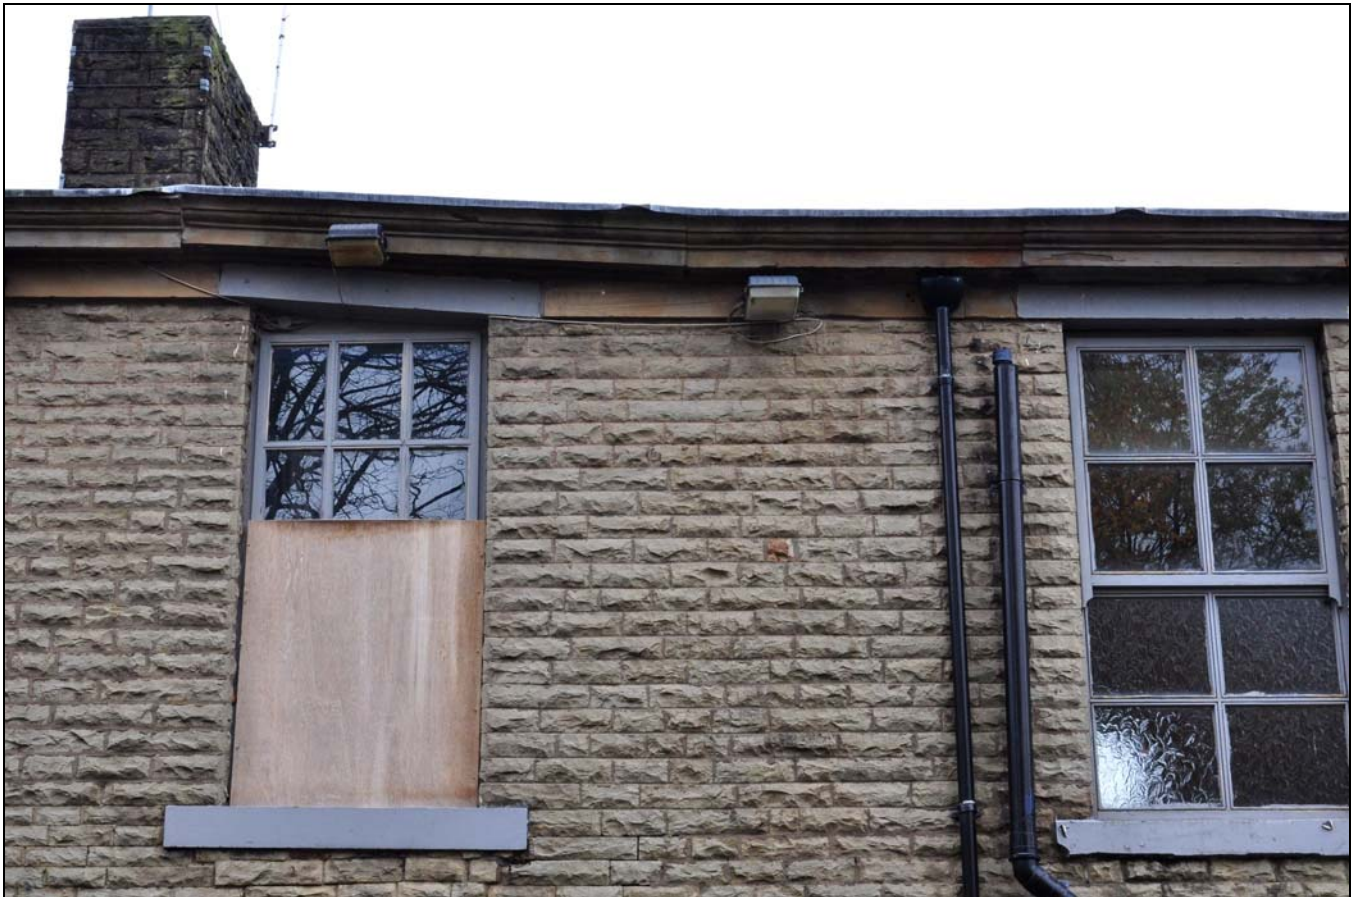
Photo 17: Inconsistent stonework at eaves, Holme Street elevation

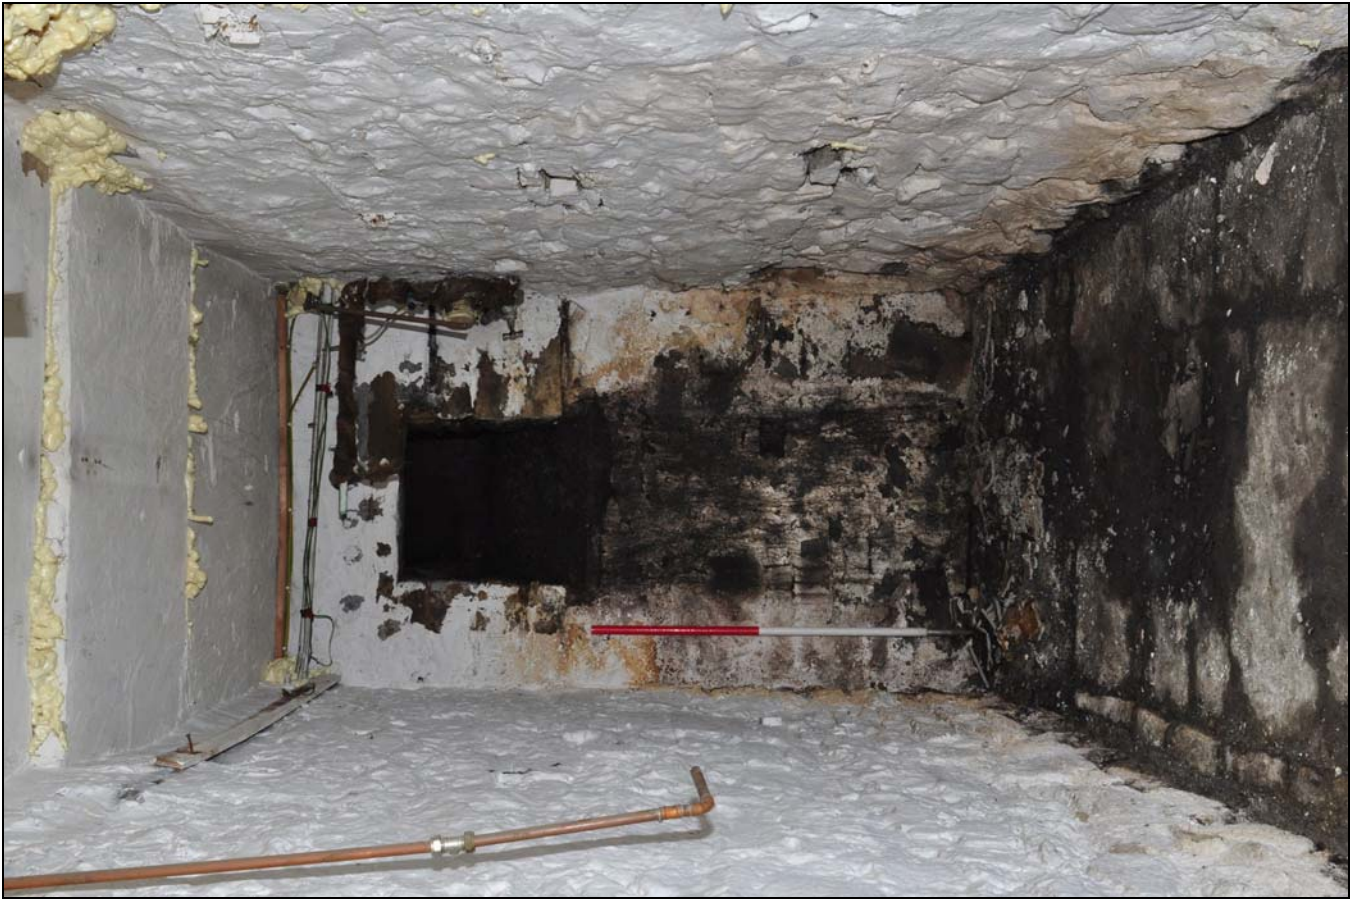
- 8.11 The north-west end of the basement has a central passage which may have doubled as a coal cellar, as there is a chute from St James' Street set at its north-west end (**33**). To either side of the passage are four rooms (**34-36**), and three of them remain recognisable as cellar storage rooms, though the fourth now contains WCs. A passage (not shown on the 1862 plan) now links this area with the south-east end of the building, where this floor becomes a semi-basement, with its own windows rather than light-wells, but modern changes have created a largely open area, from which the historic character and plan-form have been almost entirely lost (**37,38**). There is a fireplace with some glazed tiles attached in the north-east side, but this is in the area shown in 1862 as proposed for stables, so the provision of heating here may have been an early twentieth century adaptation (**39**).

Photo 33: Basement: coal cellar, with chute at end from St James' Street

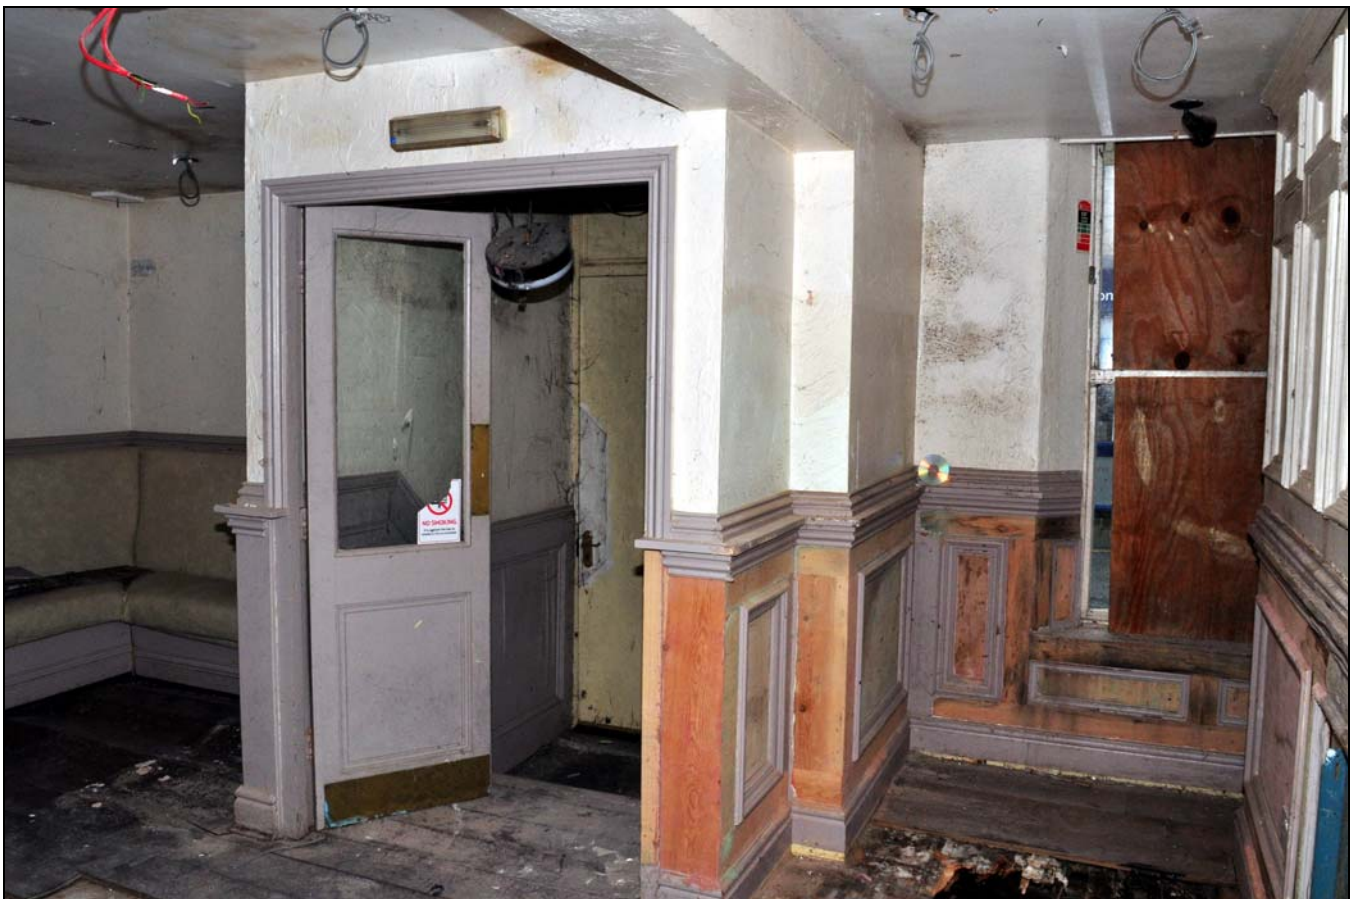
- 8.12 There has evidently been considerable change inside the building at the Dutton Street end, where the entrance is now enclosed within a small vestibule (**40**). Here, the floor level now steps up, but appears formerly to have descended to two basement rooms some 1.5m below, across which the present timber floor now cuts (**41**), sealing off those lower rooms, leaving them without means of access. From the available safe vantage point, they do appear to have been habitable rooms, most likely the kitchen and parlour with stairs between, shown on the 1862 plans. A new staircase has been inserted in the south corner from an original entrance, leading up to the ground floor (**42**).

Photo 40: Basement: lobby to Dutton Street entrance, with altered floor levels, looking east

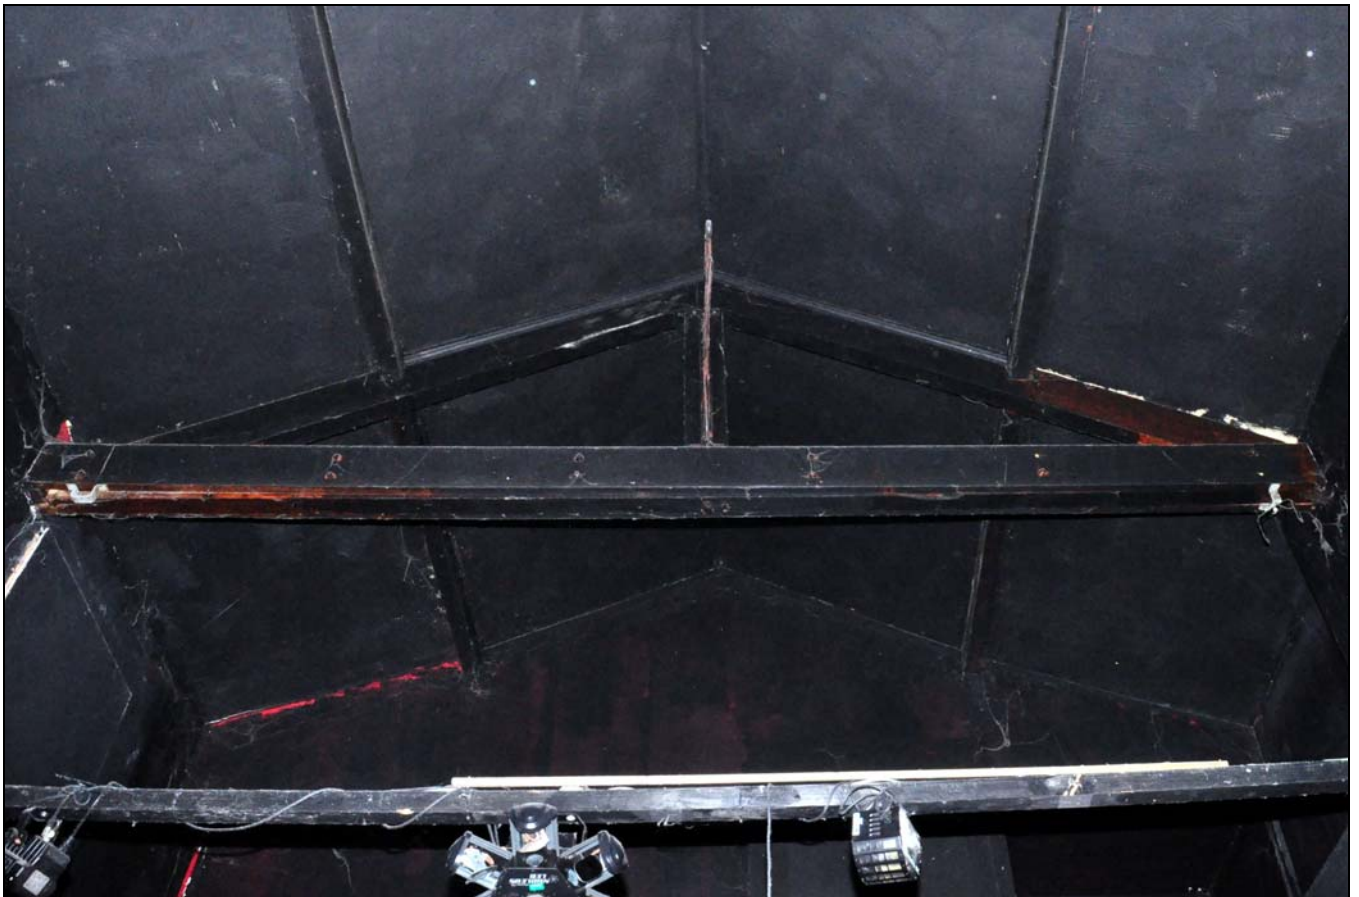
and straw lofts, but this has since been subdivided, partly to provide additional living accommodation, and part of its floor has been removed in the creation of a void over a modern dance-floor below (47). The Club Room, intended for group activities or private functions, was four bays long and heated by two fireplaces in the north-east side, whose chimney breasts survive. Its ceiling originally rose into the roof space, to the level of the lower purlins (48), but where the later bedrooms were created, lower ceilings have been inserted (on two occasions), probably to make the living accommodation more comfortable. Over the dance-floor void the space is now fully open to the ridge, but this is evidently a very recent alteration (49). The visible trusses are typical for the 1860s, being of imported softwood in a king-post arrangement.

Photo 48: First floor: roof truss over former Club Room, now exposed over modern dance-floor

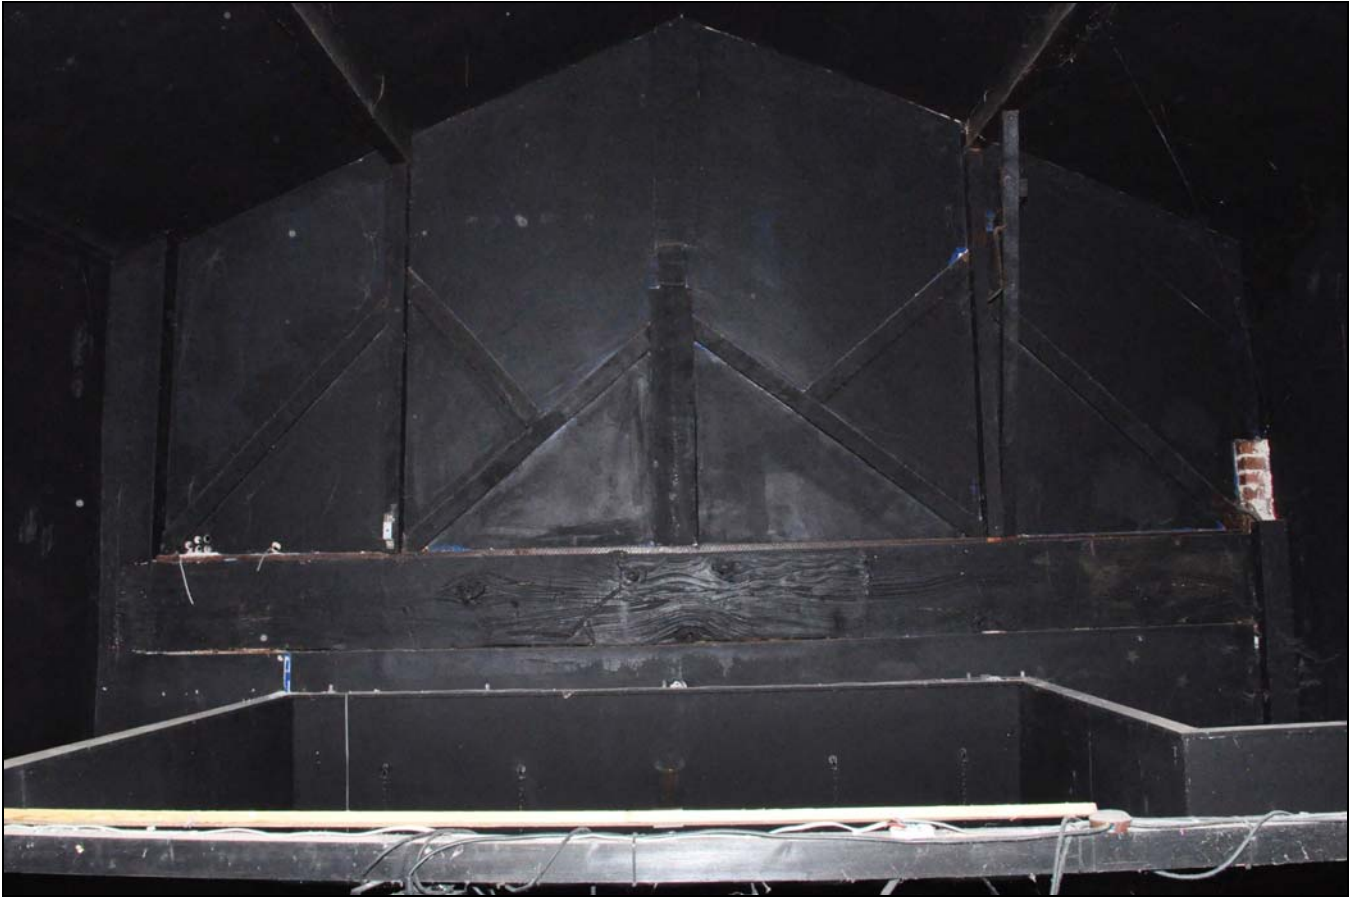
- 8.15 At its south-east end, the former Club Room is separated from the top floor of the dwelling on Dutton Street by a rather enigmatic partition, which incorporates a king-post truss, whose tie-beam is set at about 1.4m above floor level, well below the eaves (50). Additional vertical members above the truss support the longitudinal roof members, but there is no obvious explanation for this peculiar use of a truss. Beyond it, the top floor of the dwelling is now inaccessible, but can be viewed through a small hatch. It has new floor joists and the ceiling has been removed, so the roof structure above is visible (51,52). This probably formed part of the dwelling's living accommodation, although it is worth noting that this floor was omitted from the 1862 plan.

Photo 49: First floor: roof truss forming division between Club Room and Dutton Street dwelling, looking south-east
