Fields House, Grindleton, Lancashire: Historic Buildings Photographic Record

FIELDS HOUSE, GRINDLETON, LANCASHIRE:

HISTORIC BUILDINGS PHOTOGRAPHIC RECORD

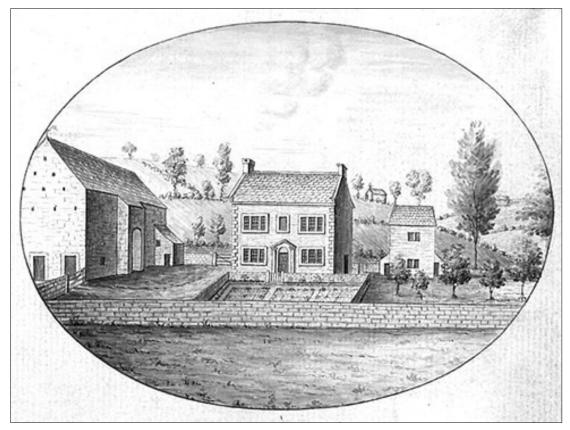
Figure 4: 1783 illustration of the house, with barn to west and outbuildings to east

6.3 The 1783 survey⁴ is very useful in that the title page of the document is illustrated with an image of the buildings at Fields House at that time (figure 4 below), implying that this was George's home and the seat of his estate. It also includes a map of the estate, showing the Fields House buildings in outline. In the illustration, the house itself appears much as it does today, though the windows then still had their mullions. It was also at that time still detached from the two-storey trap-house, which was flanked only by a pair of lean-tos rather than the more extensive group which stands today. Also depicted is the modestly walled front garden and an orchard.

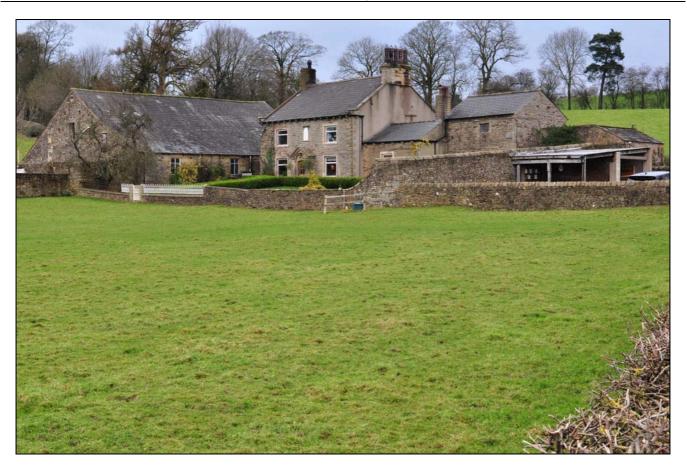
Photo 1: General view of the site, from the south-east

8.1 The group of buildings at Fields House (excluding the separately owned, and detached barn) form a linear group, albeit with an irregular arrangement which arises from its piecemeal development (**1**). The largest component is the house,

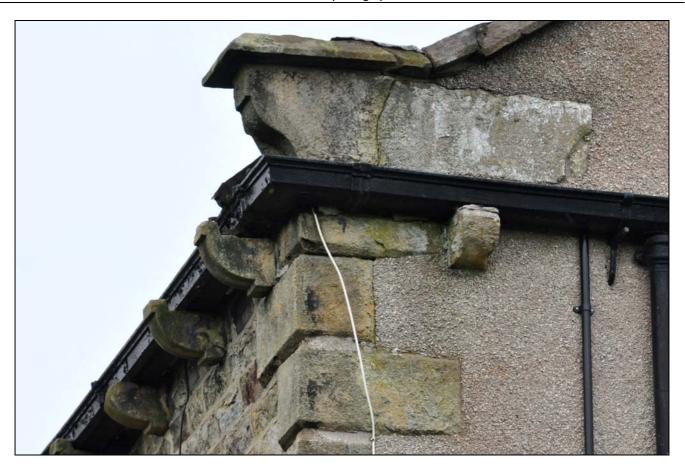
Photo 13: House: detail of quoins, kneeler and corbels at south-east corner

- 8.2 The farmhouse front is of squared, watershot sandstone, and has a symmetrical composition, which comprises a central entrance flanked by a single window of equal size to either side, on both ground and first floors (4-8). The entrance breaks forward in the manner of a porch, but functionally this is actually part of a small lobby, otherwise set mostly inside the house. It is ornamented externally by jambs moulded as Tuscan pilasters, surmounted by an open pediment (10), above which is the elaborate date-stone (11). Other details to the front include the modestly moulded architraves to the windows (from each of which two mullions have been removed, most likely flat-faced) (12), the chamfered quoins, and moulded kneelers and eaves coping (13).

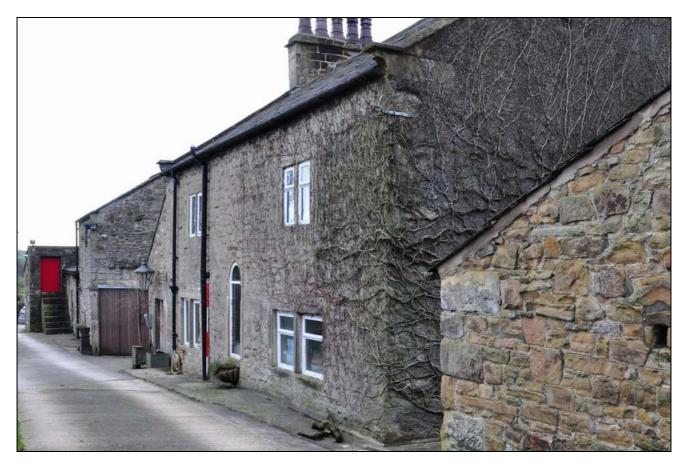
Photo 15: Rear of house and outbuildings, from the north-west

- 8.6 The rear elevation (**14**,**15**) is considerably more modest than the front, being of rubble with slobbered cement pointing, and in a single plane. It is more traditionally vernacular, with most openings being plain and rectangular with flat-faced mullions, and only the narrow, rather low, stair window is different in this

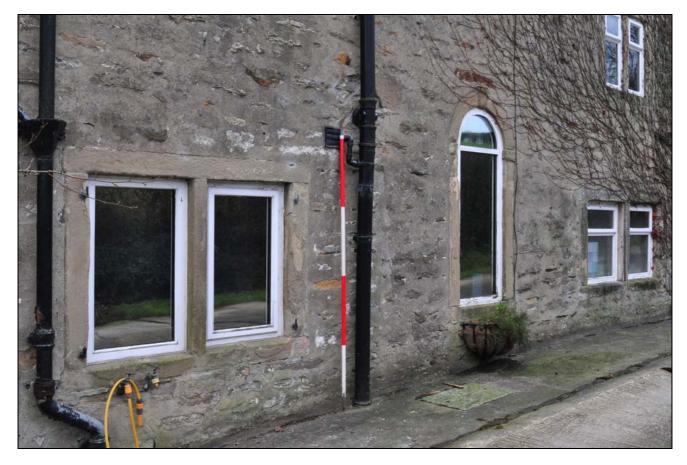
Photo 19: Rear of house, from the north-east

respect (**16-19**). At the east end of the rear, the small lean-to porch appears to have been built around the turn of the 20th century (see figures 7 and 8 above), prior to which the house had a gable entrance here, still in use though now an internal doorway. The porch has been heightened, probably in the late 20th century.

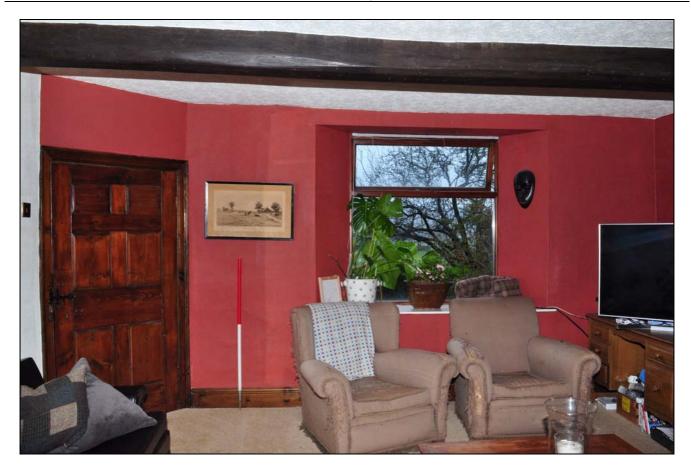
Photo 22: House interior: parlour, looking south

- 8.10 The parlour has its two original chamfered oak ceiling beams (**22-25**), but a modern fireplace. The four-panel oak door to the rear hall (**26**) is also likely to be original (note the marks of L-hinges on the rear face), though it contrasts with those to the front lobby.

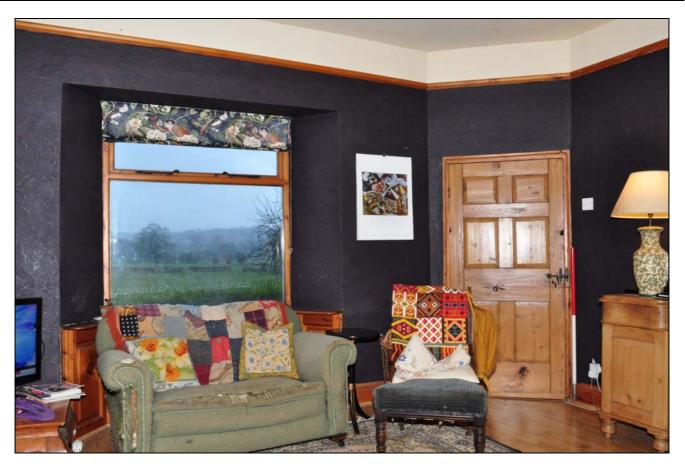
Photo 27: House interior: living room, looking south-west

- 8.11 The living room is almost entirely modern in appearance (the Victorian style fireplace appears to be a reproduction) and its ceiling has been raised by some 450mm, for convenience and modernity, most probably in the 20th century, and accompanied by the removal of its original beams (**27-30**).

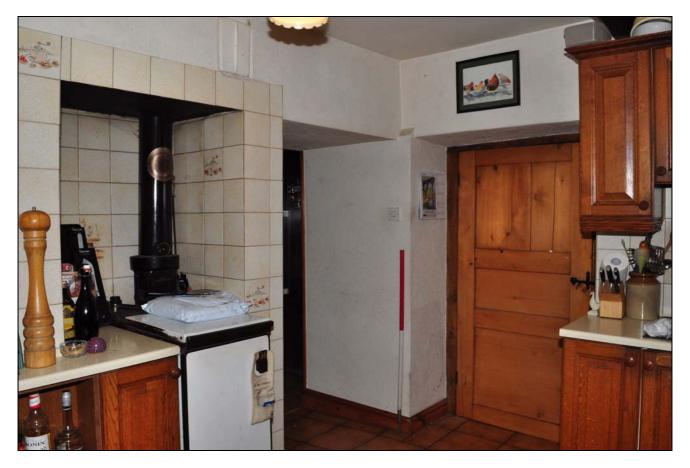
Photo 31: House interior: kitchen, looking south-west

- 8.12 The kitchen is located to the rear of the living room, through a doorway within a thick wall, in which the fireplace was also placed (now occupied by the cooking range) (31). The gable entrance precluded a more typical siting of the fireplace within the east wall.

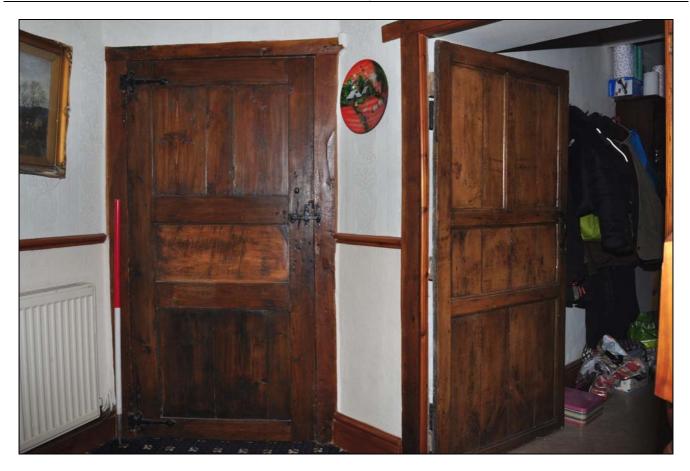
Photo 32: House interior: rear stair hall, looking south-west

- 8.13 A second lobby at the foot of the staircase gives independent access to three rooms off (32), including the unheated former pantry at the north-west corner, now entirely modern in appearance, except for its false panelled door (33-34).

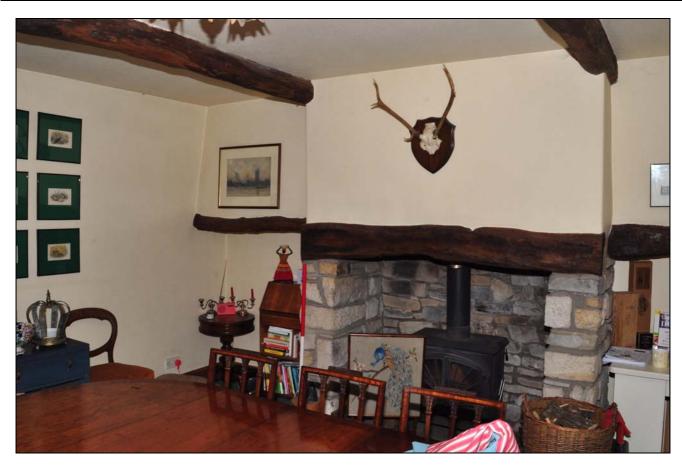
Photo 36: House interior: 19th century extension, looking north-east

- 8.14 The small, early 19th century domestic extension adjoining the present living room now forms part of the ground floor accommodation and its interior appears largely modern, apart from the chimney breast (**35**,**36**). Its original function may have been as a second kitchen or wash-house, as it has a formerly external doorway to the north.

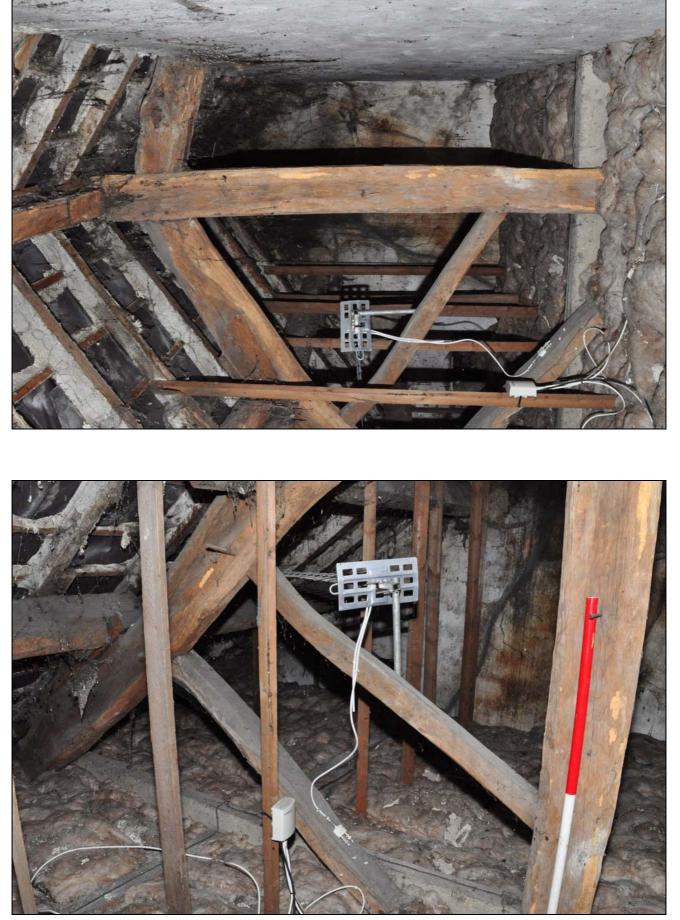
Photo 48: House interior: west roof truss, looking south-west

- 8.19 The stairwell is still discernible within the attic, being enclosed by masonry walls, and having four doorways off it, none of which are fitted with doors or door frames (**43-45**). Each of the four rooms had a small gable window (**46**), and the two larger south rooms held the two roof trusses, with a cross-wall between the two also supporting the roof. The trusses are of pegged oak, with king-posts and raking struts, the posts central to the building, but the northern principal rafters are reduced to very short lengths, their lower ends set within the spine wall (**47**-

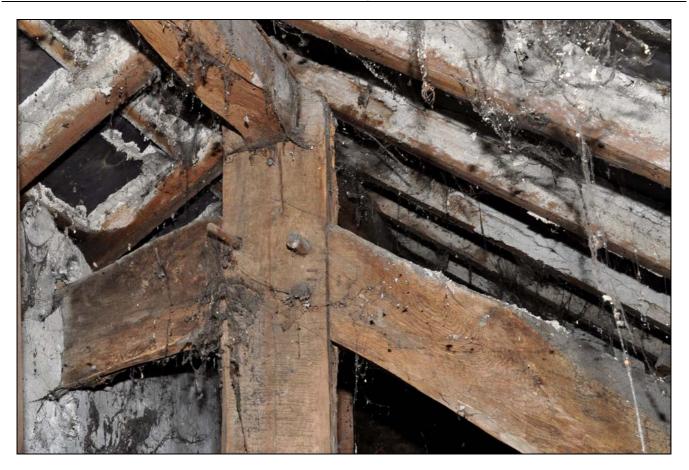
Photo 51: House interior: head of east roof truss

49). Joint numbering, in the form of chiselled Roman numerals, can be seen on the west side of the east truss, with the joints of king-post and upper strut numbered "I", and king-post and principal rafter numbered "II" (**50-52**).

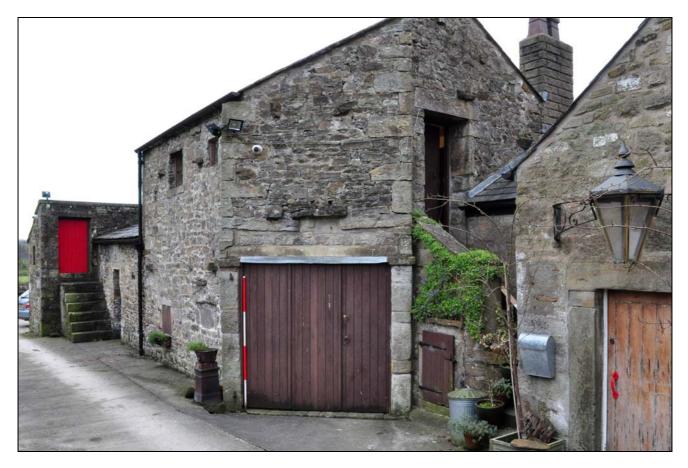
Photo 53: Trap-house, looking south-east

- 8.20 The two-storey building which was formerly detached, but is now linked, was built as a "trap house", for storing a light horse-drawn vehicle, to judge from the canted north-west corner with its wide doorway, positioned thus to allow access from the narrow lane down which the farm is reached (**53**); it possibly also contained stabling for a pony. It is much plainer than the house, being of random or poorly coursed rubble with projecting throughstones, and it has a modern blue slate roof.

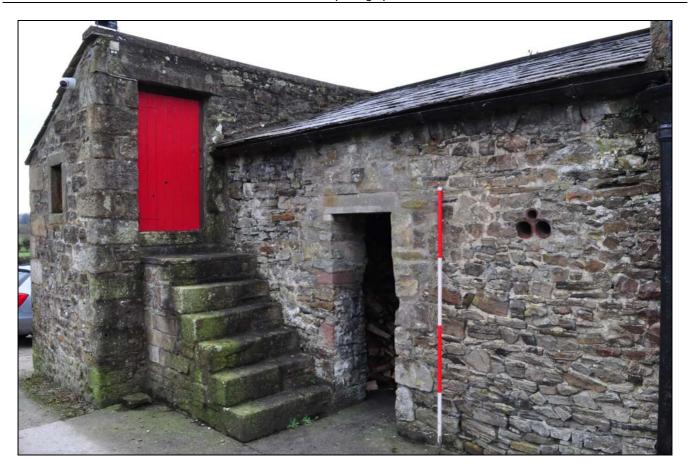
Photo 61: Outbuildings at east end, looking south-east

- 8.23 To the east of the two-storey outbuilding is a small adjoining range of other lesser buildings, likely to be early 19th century (**61-63**). They include an earth closet with arched opening to the south (**64**), and a store (currently filled with logs), which occupies the adjacent space and has a rebuilt or inserted doorway in the rear wall, beyond which is another store (**65**) with poultry loft over (**66**), reached by external steps to the north side.
