Barns at Landskill
Barnacre-with-Bonds, Lancashire:
Historic Buildings Record

Historic Buildings Record

Two barns at Landskill, a farm in Barnacre-with-Bonds civil parish (NGR: SD 53830 45866), appear to date from the early 19th century. The larger, and probably earlier of the two (Barn 1), is a five-bay combination barn with a simple rectangular plan, and was built with a shippon on a lower level at one end, while Barn 2 was added to an existing barn range (now on a neighbouring property), and combines stable with shippon, and large hayloft. The buildings were recorded for the developer, Mr Whitaker, to fulfil a condition of planning consent for conversion.

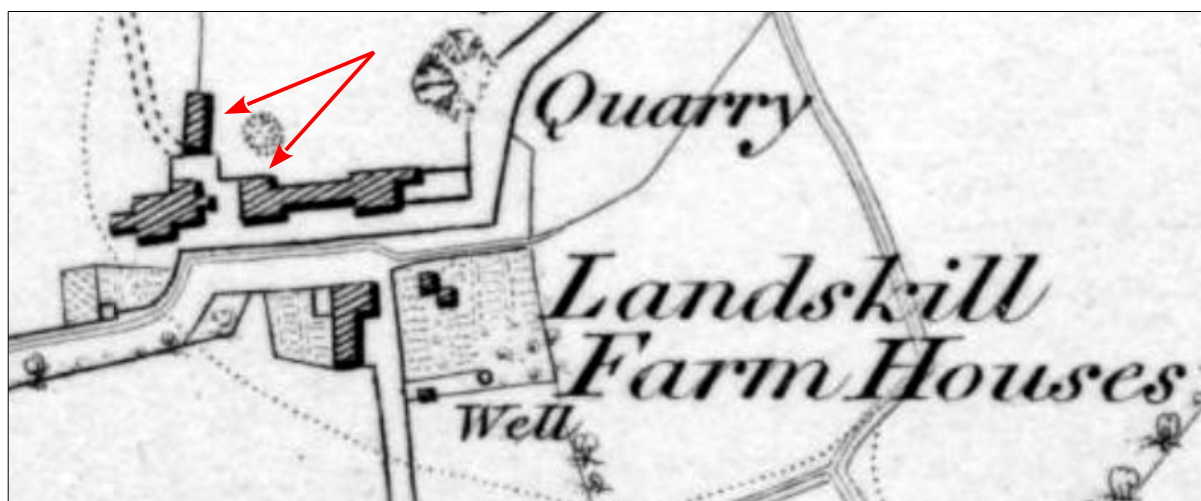
Figure 4: OS 1:10560 map, 1846

- 6.2 Ordnance Survey maps show that the present arrangement of historic buildings at the farm, including Barns 1 and 2, had been established by the mid 1840s³, and remained unchanged in the 1890s⁴ (figures 4 and 5). The Landskill holding may have remained in single ownership during this period. By 1910 (figure 6), a boundary wall had been added to the east of Barn 2 however, implying a division of the property, and Barn 1 had been extended to the west⁵.

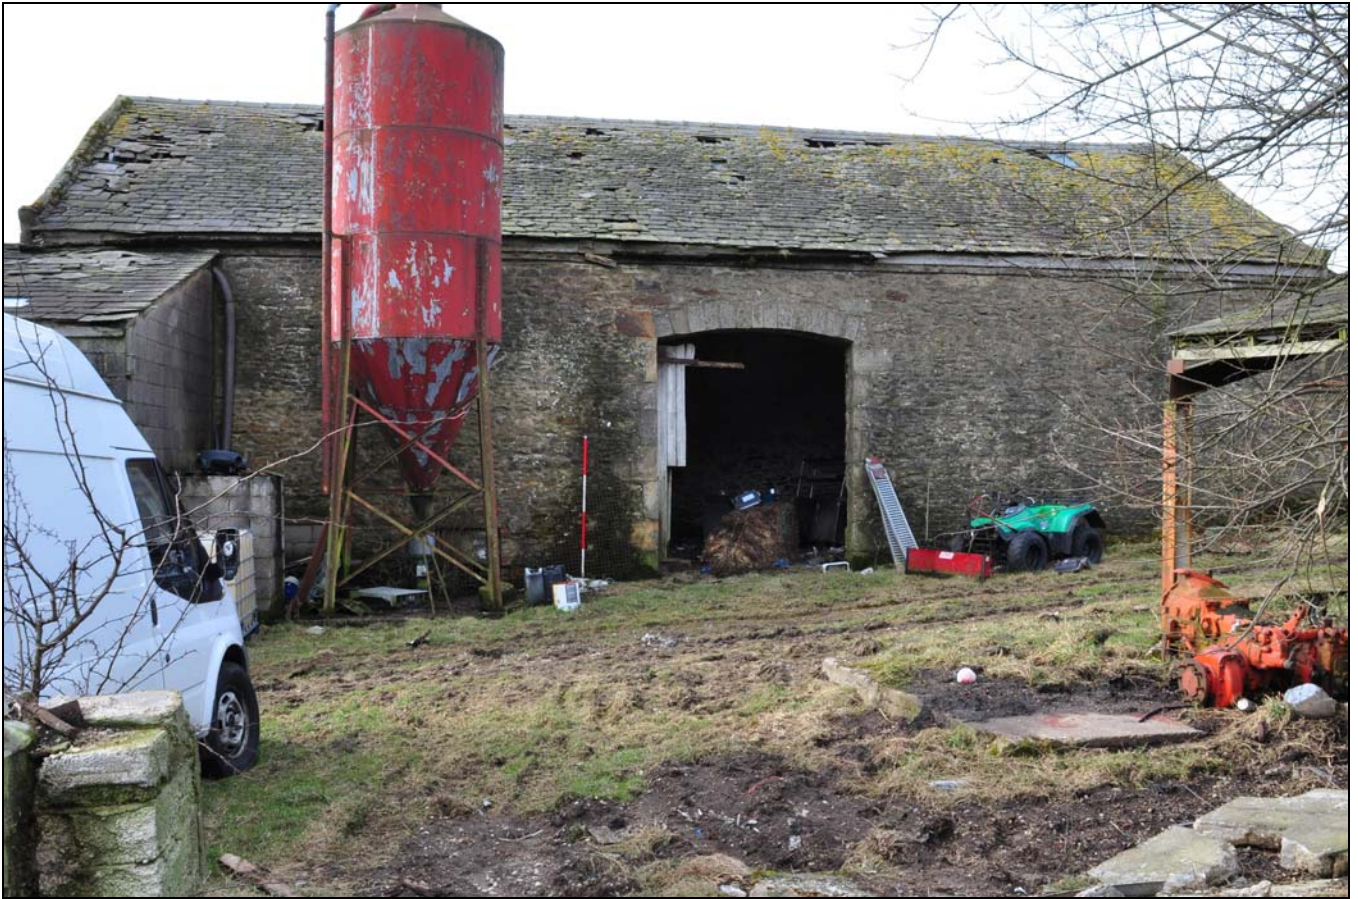
- 8.1 The larger of the two barns measures 18.5m long by 8.8m, and is a five-bay structure with a simple rectangular form, most likely built in the early 19th century (**1-3**). It is sited on a slope which runs up slightly to the north-east, and has its front elevation facing east. The building was extended to the west between 1891 and 1910, by a lean-to along its full length (a common phenomenon), but with the exception of its south end, this lean-to was later demolished and replaced by the existing larger, steel-framed shed in about 1970.

Photo 1: Barn 1: general view, looking west

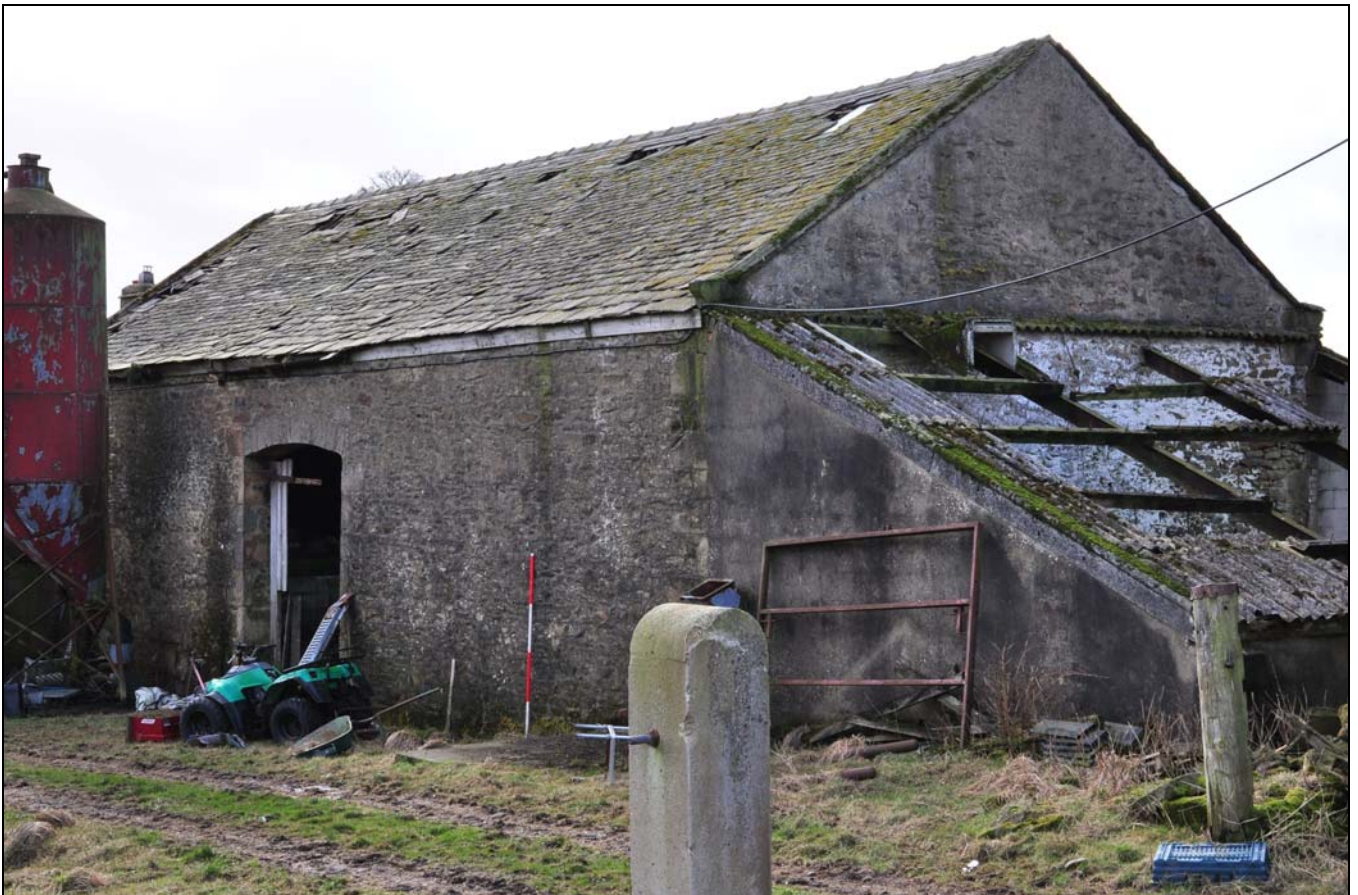
Photo 3: Barn 1: general view, looking south-west

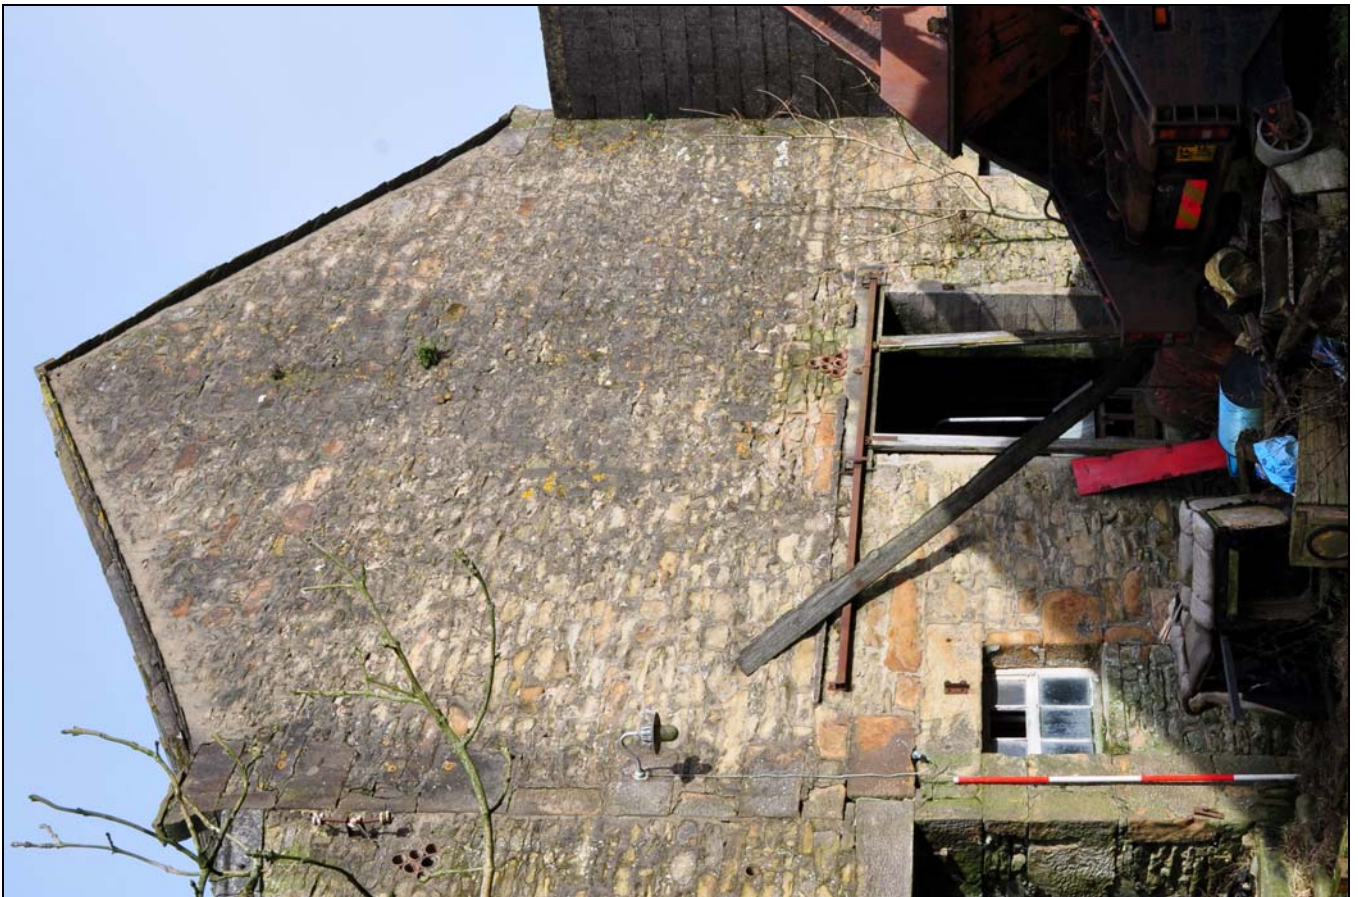
- 8.4 Two former entrances to the shippon exist in the south gable, in a typical arrangement close to the corners (**8,9**), and these would have been the means of access to two rows of stalls, facing onto a central feeding passage. The large doorway which now occupies the centre of the south gable is another 20th century insertion, and quite probably replaced a doorway to the feeding passage.

Photo 8: Barn 1: south gable

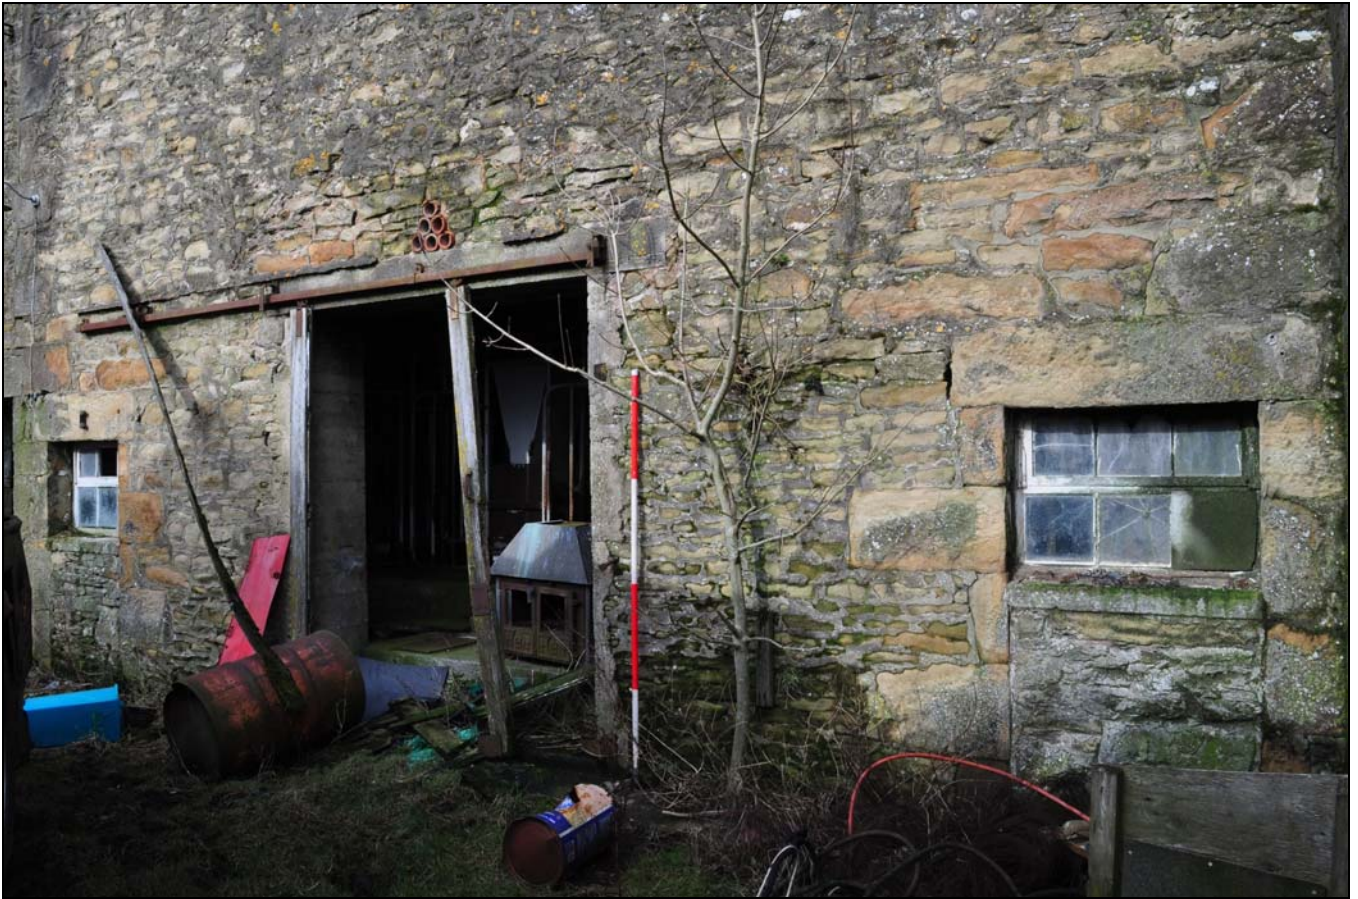
Photo 9: Barn 1: former outer doorways, and modern central doorway, south gable

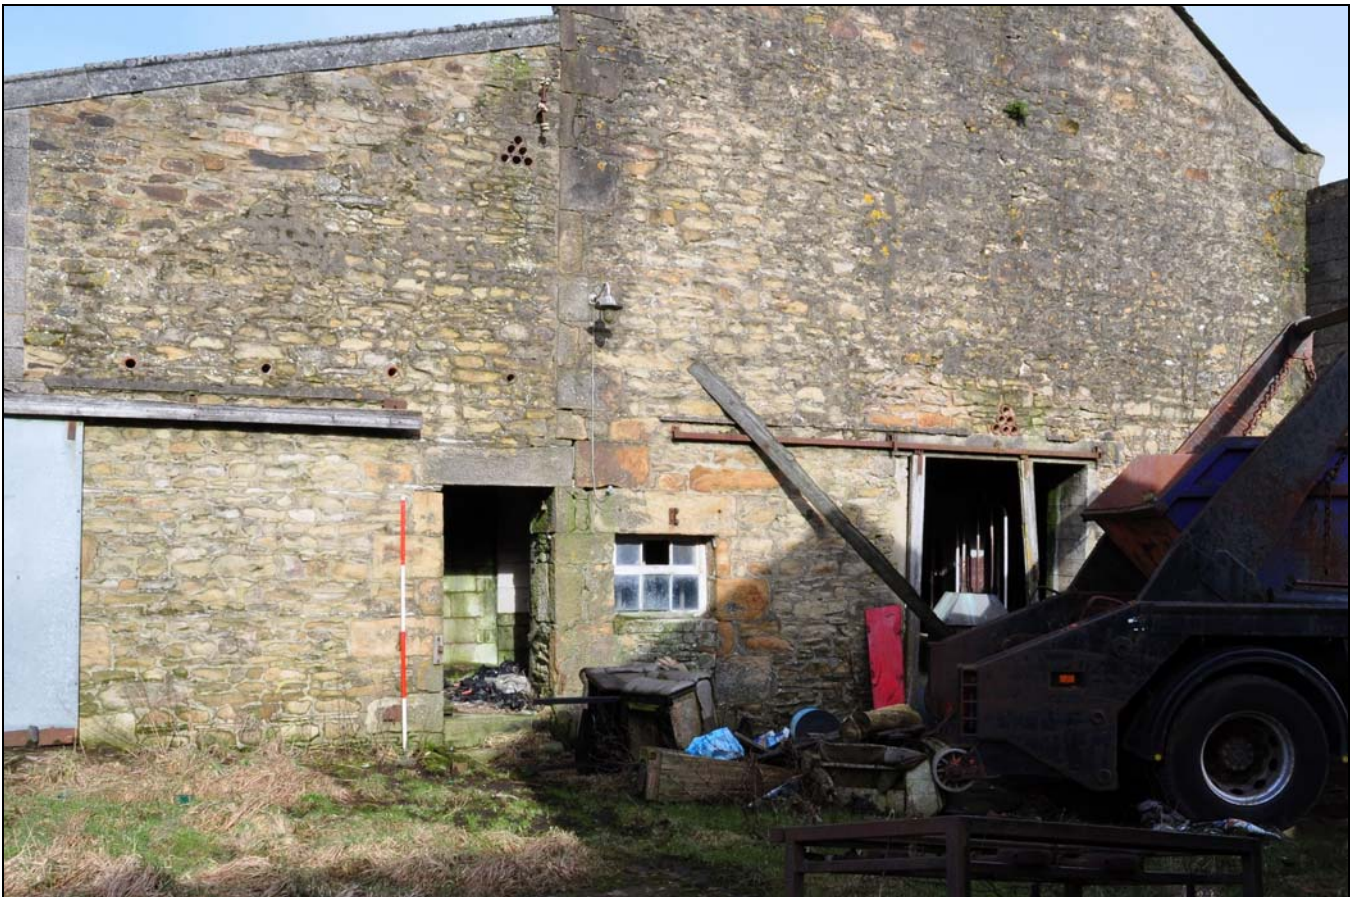
- 8.5 The remnant of the western outshut adjoins this gable, and contains a doorway to its own feeding passage (**10,11**). Although this wall has been heightened, to support the roof over the larger steel-framed shed here (dated to 1970 by a graffito within the pointing), the original, steeper roof-line of about 1900 can be discerned within it.

Photo 10: Barn 1: south gable, with remnant of added outhshut at left

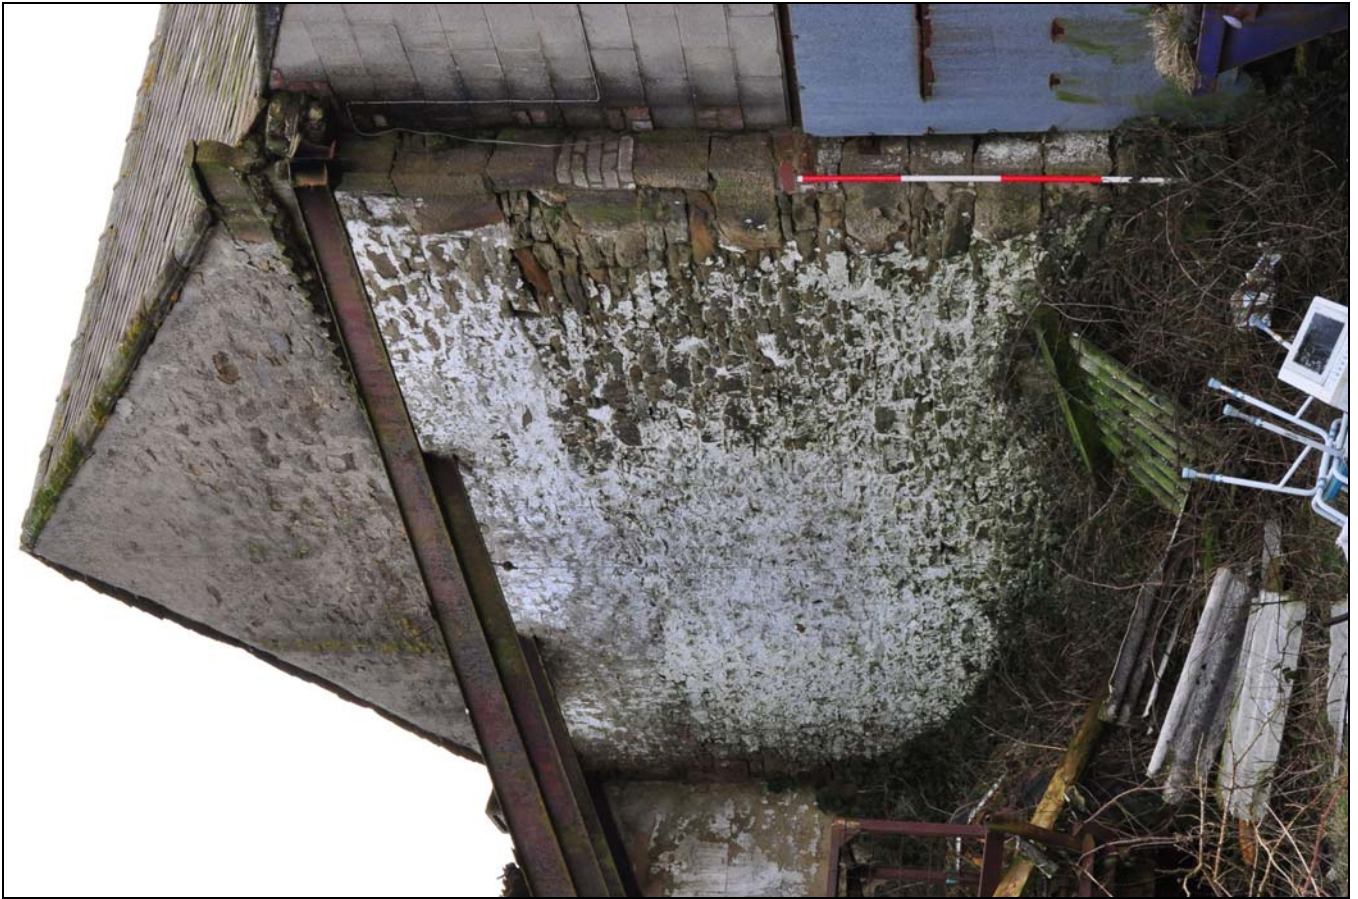
- 8.6 There are no openings in the north gable, where a late 20th century lean-to has also been added (**12**).
- 8.7 Inside the barn, the threshing bay connects the east and west doorways, with a low stone wall on its south side, which enclosed the shippon (**13,14**). As is usually the case, the threshing bay and mewstead to the north are open to the roof, and the latter would have been used for storing crops or hay (**15**). No floor surfaces can be identified within these areas.

Photo 12: Barn 1: north gable

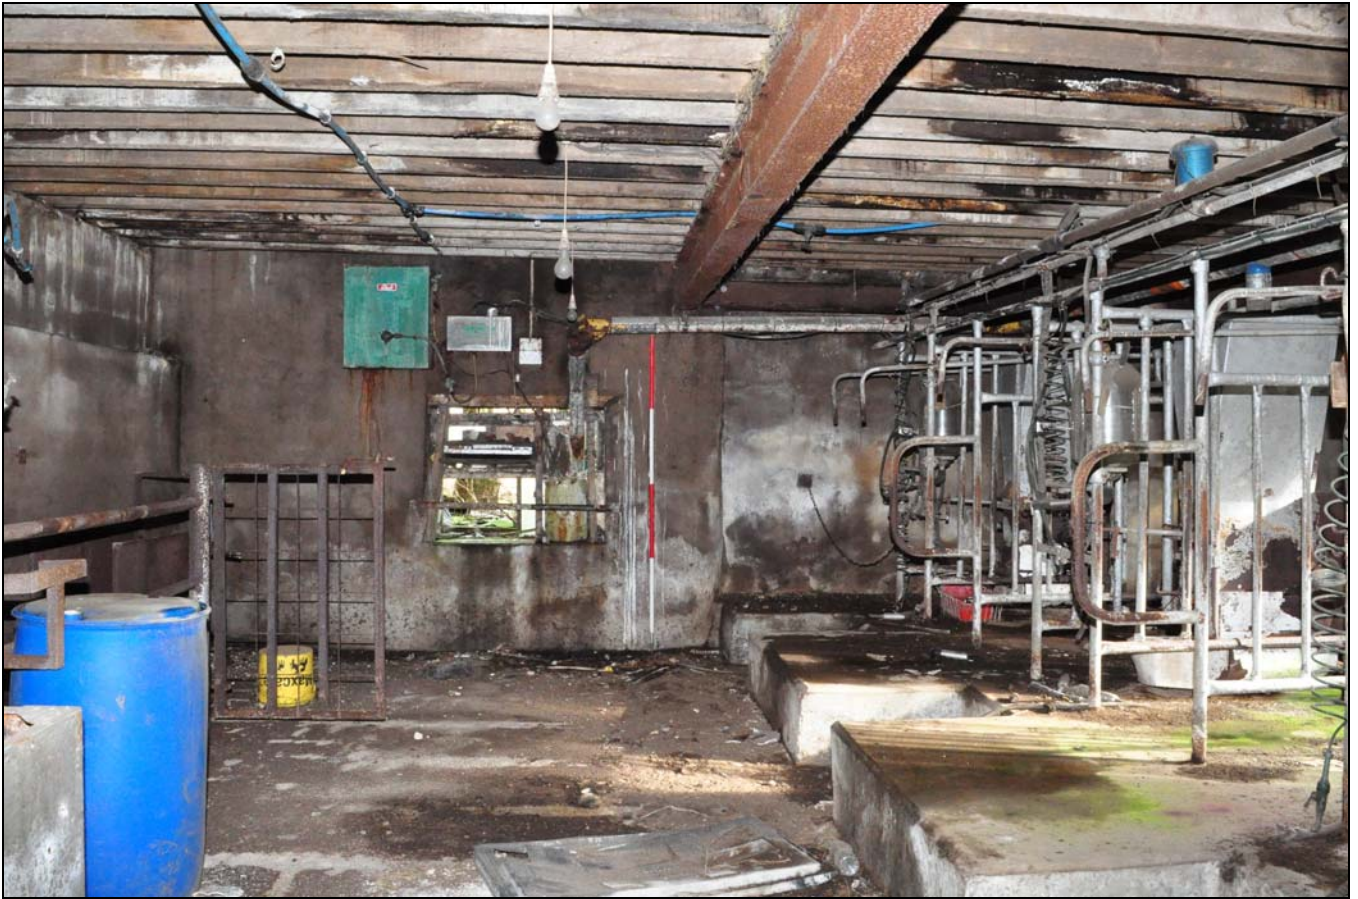
- 8.8 The low stone cross-wall has a good coping, and contains a former entrance in the centre, which would have led down to the shippon's feeding passage, whose floor was at a level approximately 0.6m below the north end of the building (**16**). The wall has also been heightened with concrete blockwork, which supports the modern hayloft over the two south bays; while there would no doubt have been a hayloft here originally, its exact level and means of construction have been lost. The conversion of the shippon to a milking parlour, probably about 1970, has left no original internal arrangements (**17,18**).

Photo 17: Barn 1: modern milking parlour in former shippon, looking east

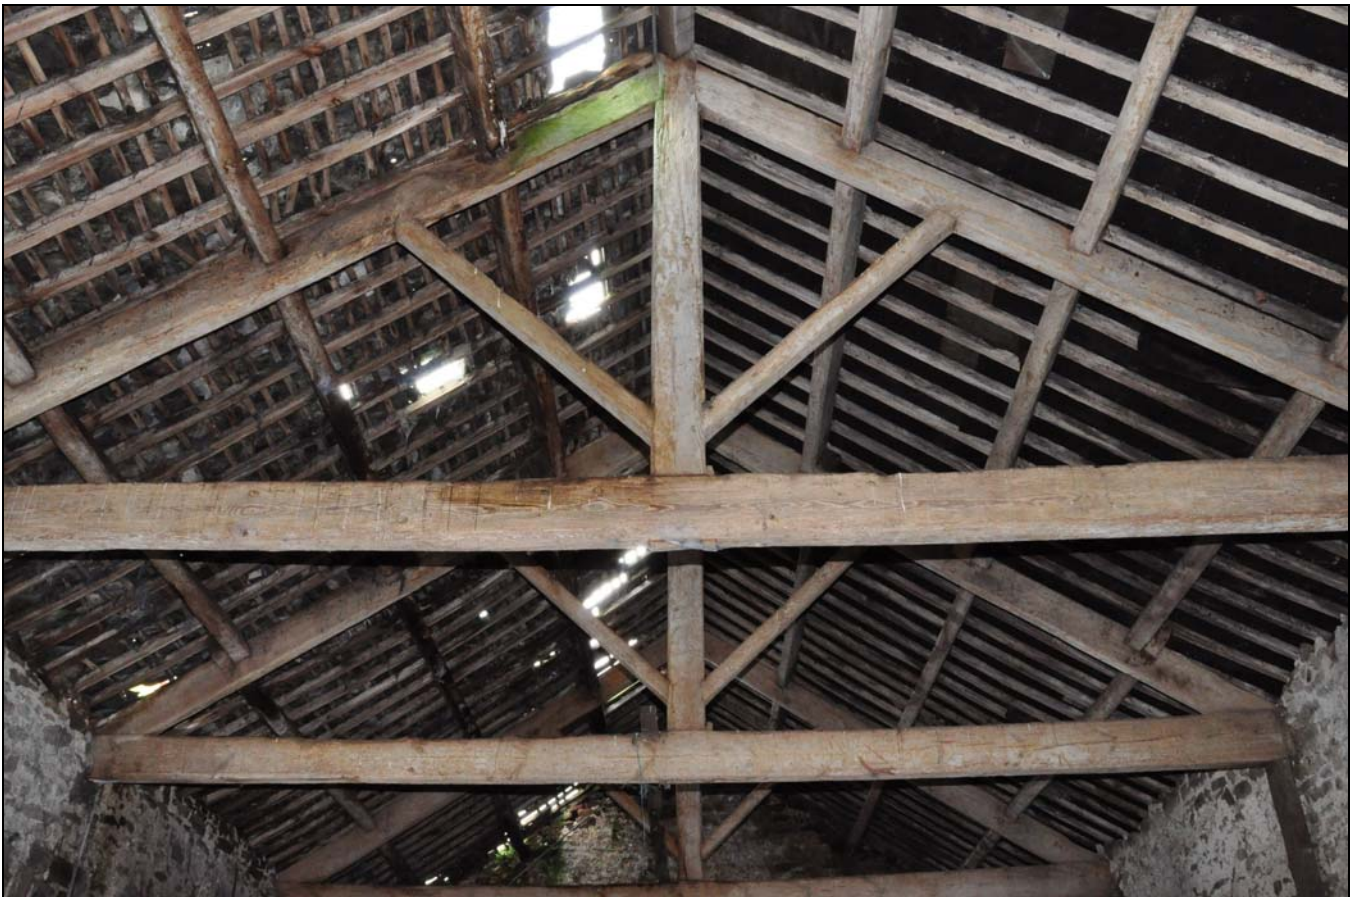
- 8.9 In contrast, the barn's roof structure does appear to be largely original (**19,20**). It consists of four king-post trusses, all of imported softwood. The feet of the king-posts have been morticed through the tie-beams, and there are raking struts to the principal rafters. Notably, the ridge is a substantial, diamond-set timber.

Photo 20: Barn 1: roof trusses, looking south

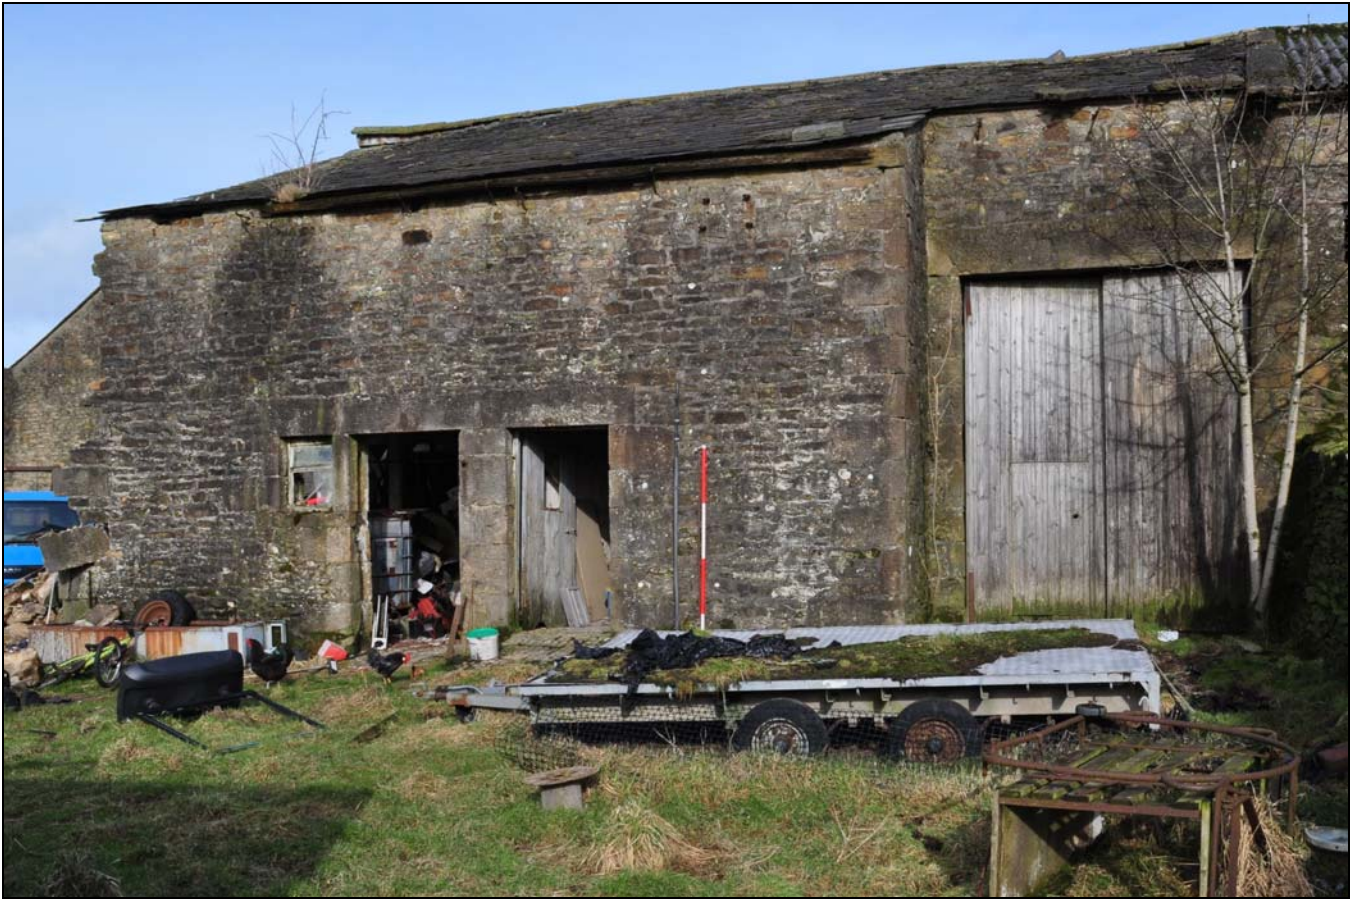
- 8.12 The building faces south, and has a tall, wagon doorway at the east end, under a massive stone lintel (**23,24**); its east jamb is formed by the south-west quoin of the earlier building beyond. To the west of here, the front elevation breaks forward by 1.4m as the building widens, and in this part are a window and pair of doorways, of which the wider, left one serves the stable, and the right one a shippon.

Photo 23: Barn 2: south elevation

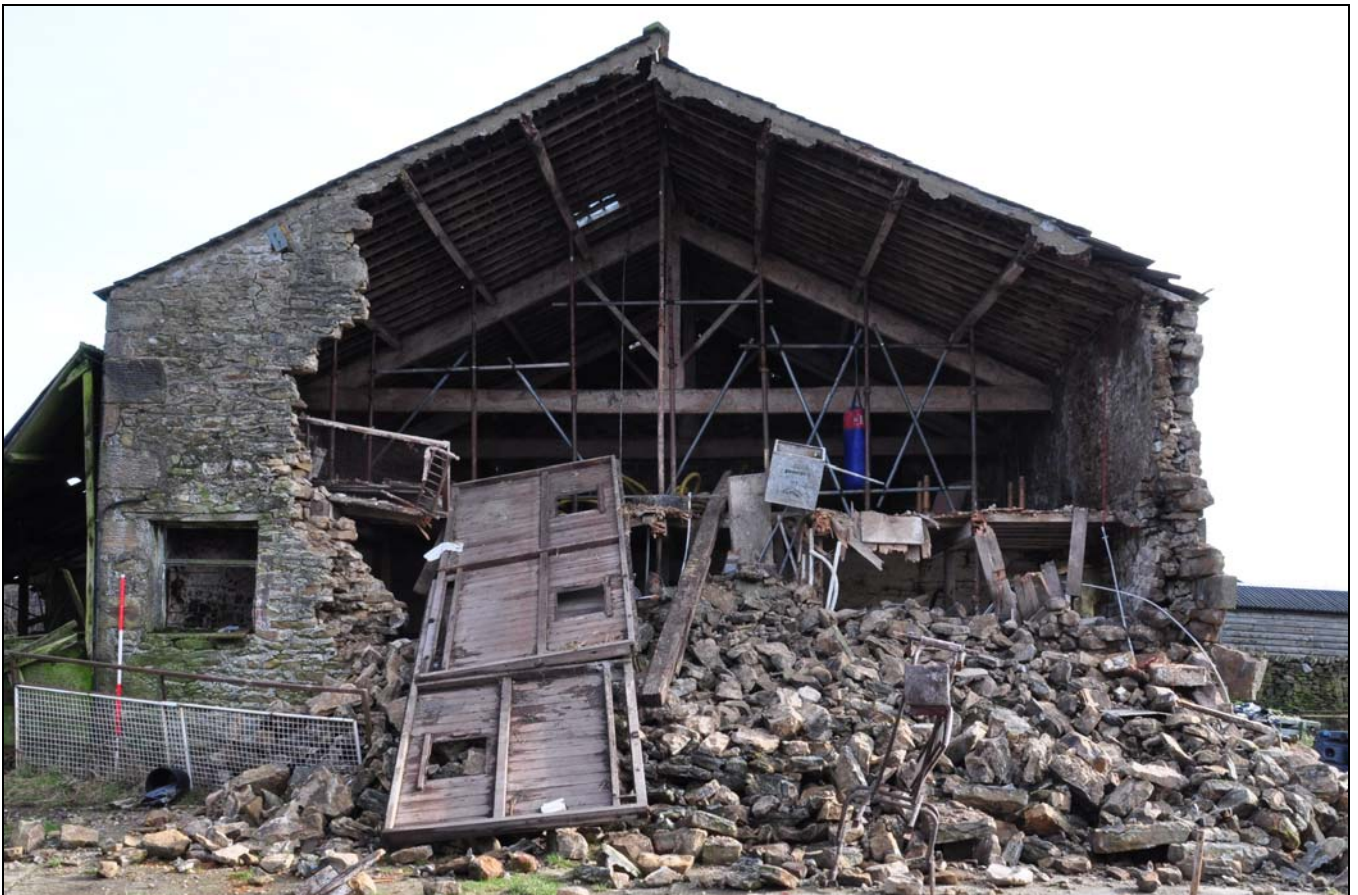
- 3.1 The barns appear not to have been in farming use for a number of years, and show signs of deterioration, to the extent that the west gable of Barn 2 collapsed in early 2021.

- 8.13 The west gable has recently collapsed (**25**), leaving an inserted window with brick jambs intact, but a photograph in the 2017 heritage assessment confirms that there were no other openings. A modern timber-framed lean-to prevents a meaningful view of the rear elevation (**26**), but beneath it, a doorway from the narrower east end emerges (**27**), and a blocked doorway and mucking-out hole can be identified to the rear of the shippon and stable, respectively (**28**).

Photo 25: Barn 2: west gable (recently collapsed)

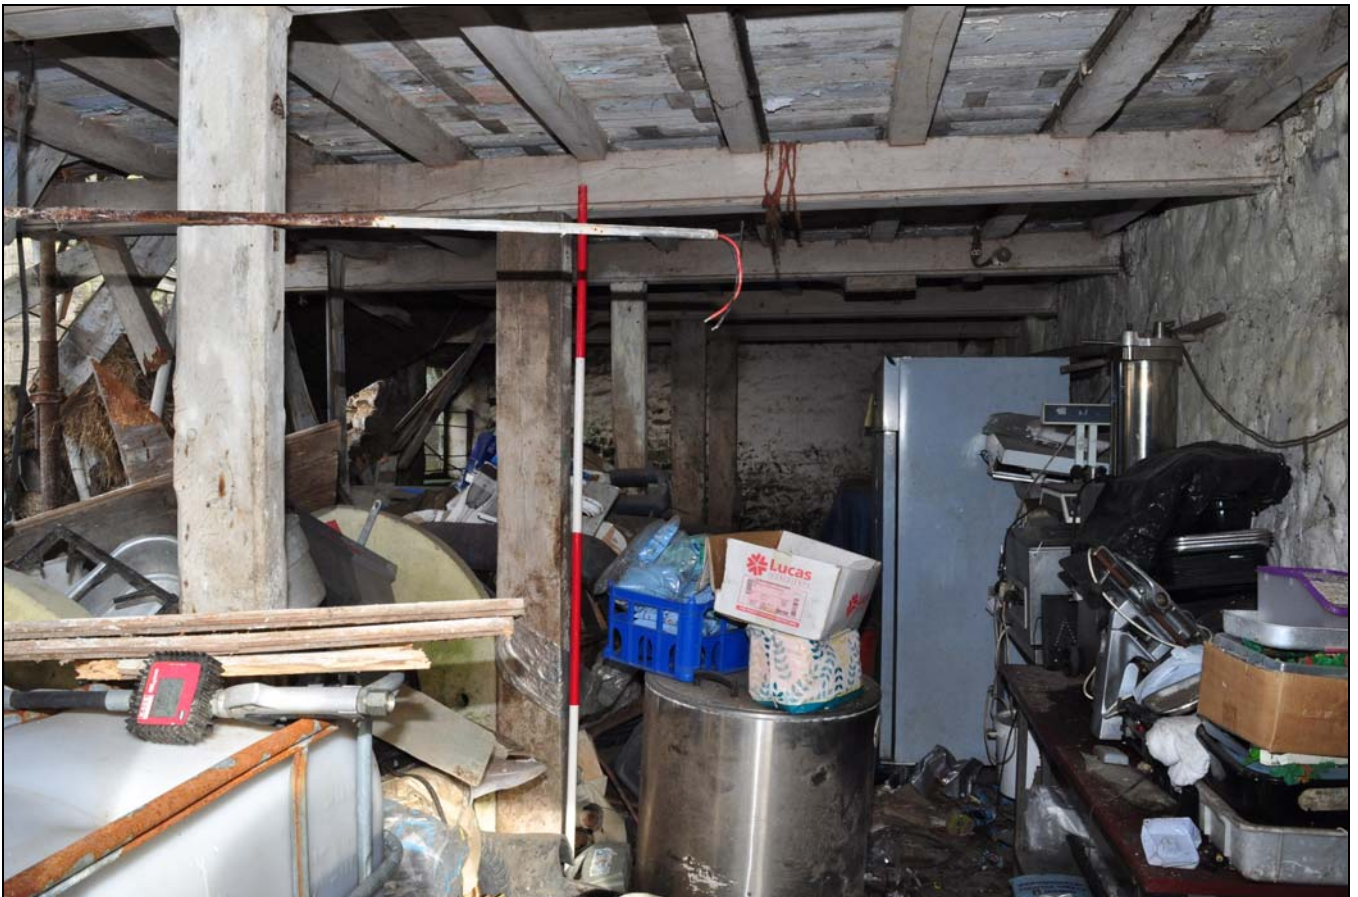
- 8.15 The larger ground floor room to the west would have been a stable for six horses, but has also been adapted in the 20th century, and more latterly served as cow housing (**30**). The individual horse stalls are now separated by concrete boskins, with timber heel-posts still supporting the loft, although some of those have been replaced. Evidence of equestrian occupation, rather than bovine, is found in a row of timber pegs fastened to the east wall to the rear of the stalls, used for hanging harness or tack (**31**).

Photo 30: Barn 2: stable, looking north

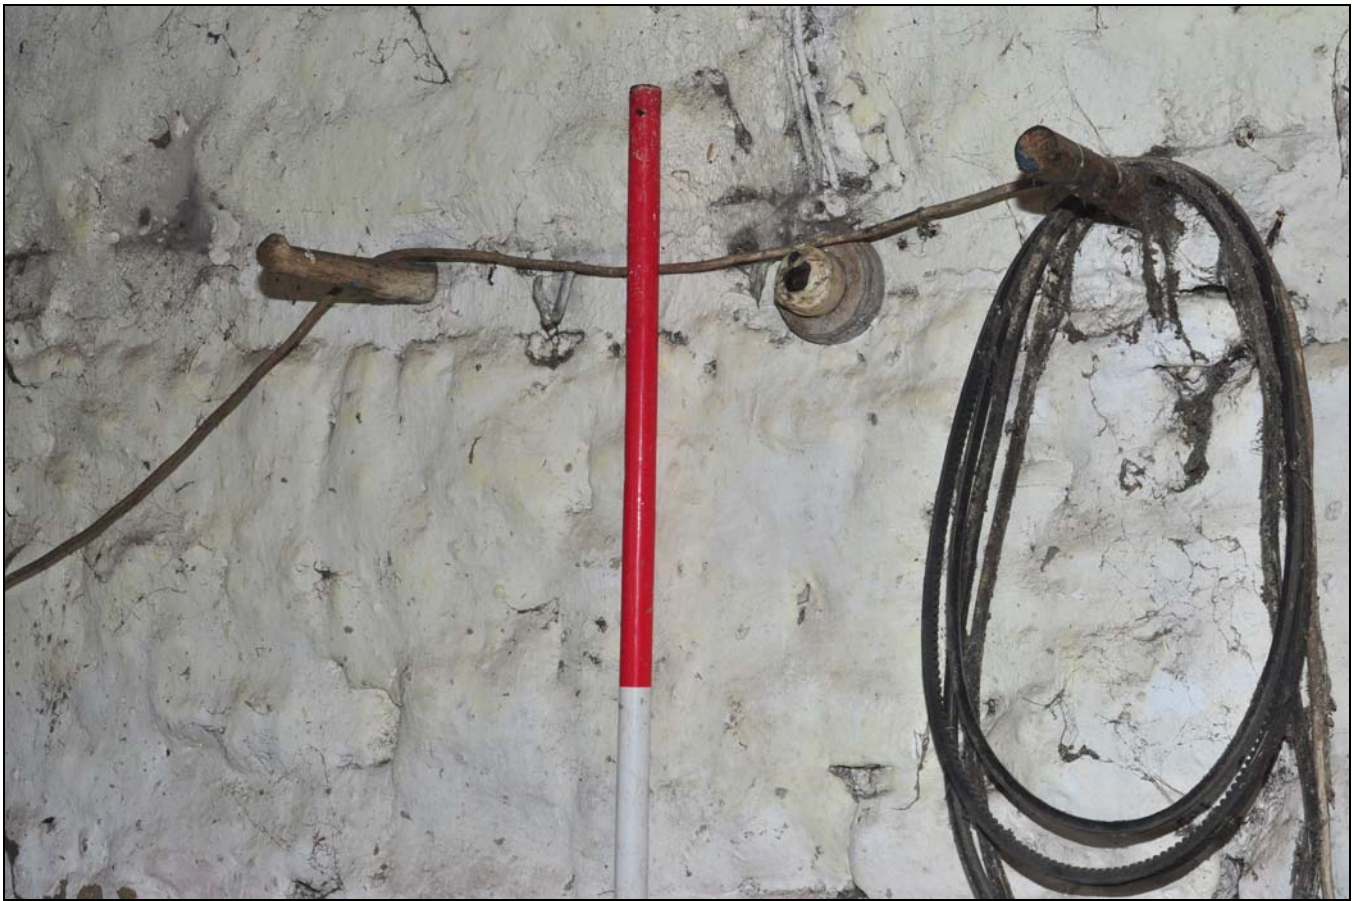
Photo 31: Barn 2: harness pegs in east side of stable

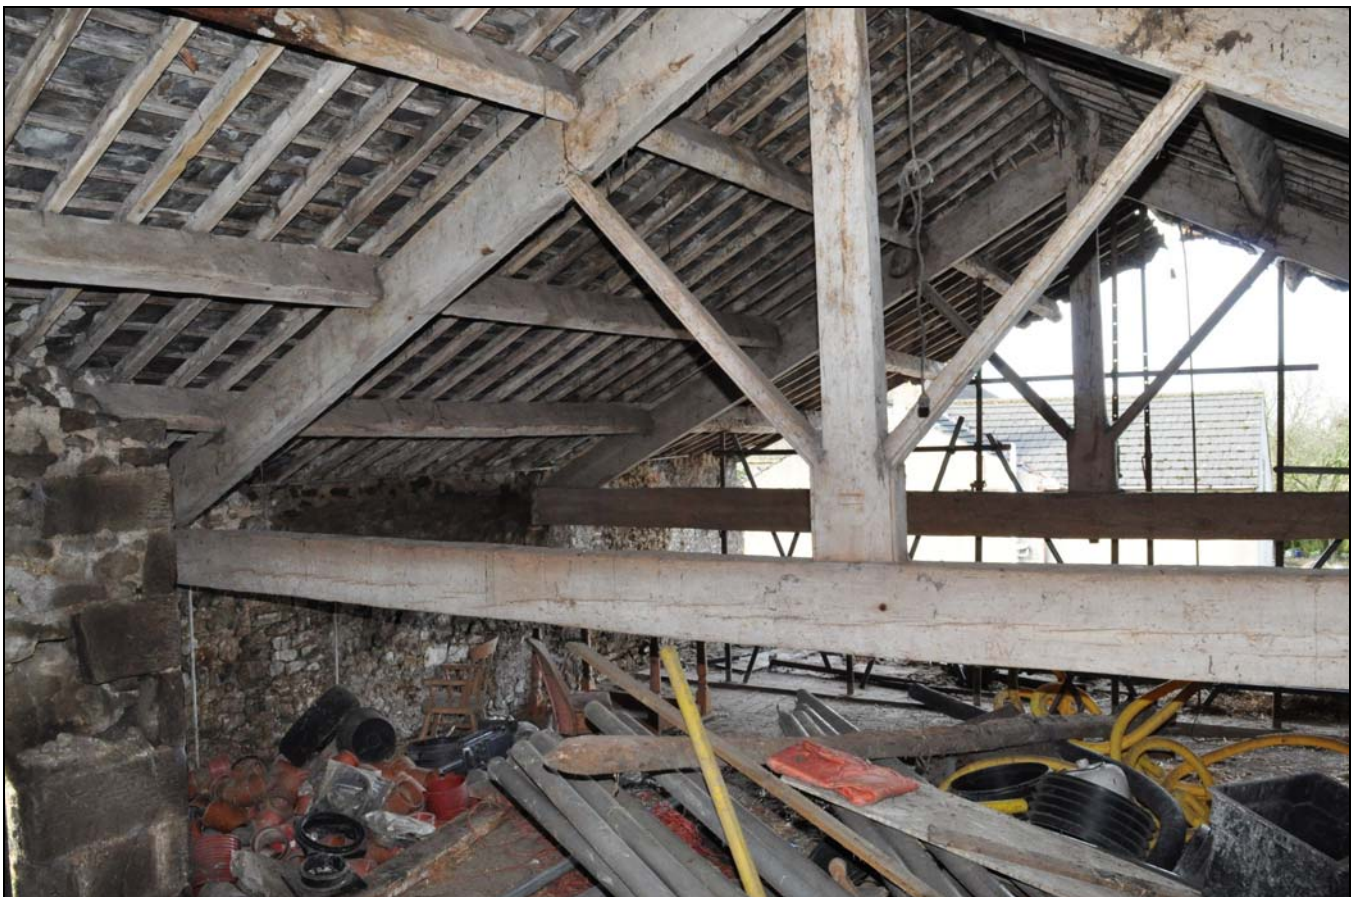
- 8.16 Two trusses carry the roof, set within the wider part of the building. They are of a standard king-post form with raking struts, but differ from those in barn 1 by virtue of the bolts fastening the king-posts' feet (**32,33**). All timbers are machine-sawn, imported softwood, and the ridge piece is set vertically (**34**).

Photo 32: Barn 2: roof trusses and hayloft, looking south-west
