Chimney and detached weaving shed  
at Hollin Bank Mill (Pendle Village Mills)  
Brierfield, Lancashire:  
Archaeological Record

March 2021

STEPHEN HAIGH

## SUMMARY

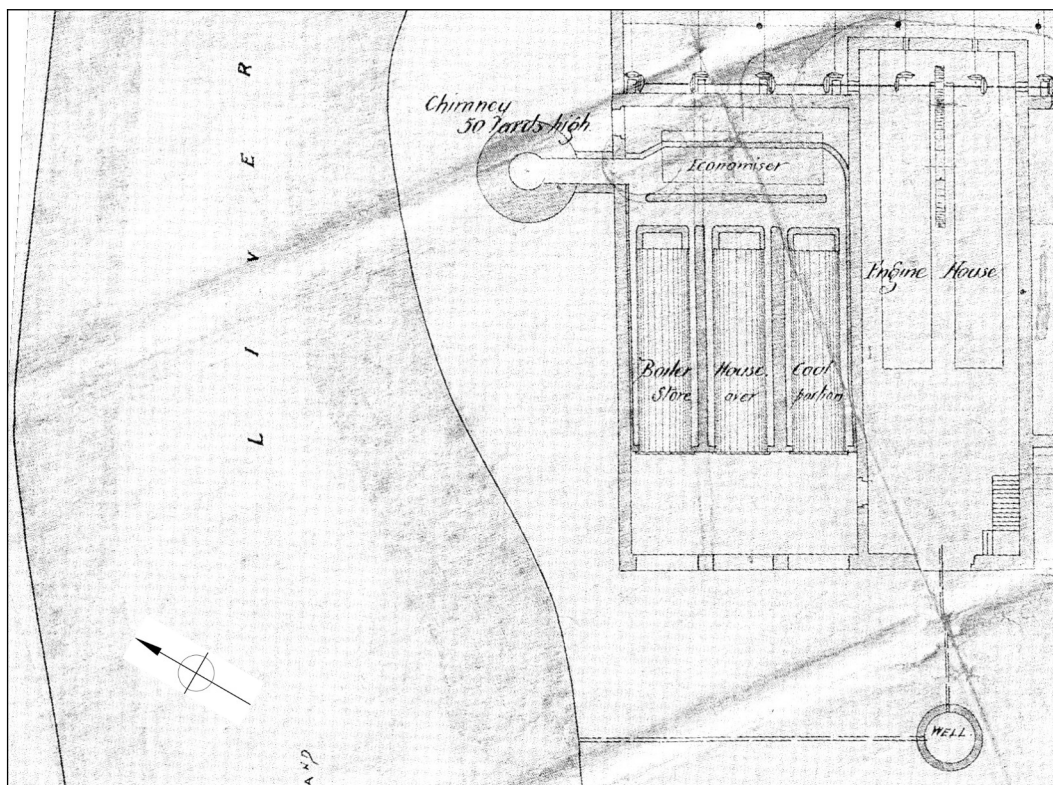
Figure 5: Part of 1891 plan, showing boiler house, engine house, and chimney

- 5.6 The proposed drawings for the mill, of 1891<sup>8</sup>, show that it was intended to comprise a pair of adjoining weaving sheds, each for 1040 looms, with parallel warehouse ranges along the outer sides, to the south-west and north-east. A single engine house was to supply both sheds, located at the canal end of the south-west warehouse, next to the boiler house and chimney (figures 5 and 6). Construction was however undertaken in two phases, and the OS map of 1893<sup>9</sup> shows that the south-west half was put up first (figure 7). Weaving in it began in 1893, by two local firms, but it seems it was not until the end of that decade that the main mill reached its maximum extent.

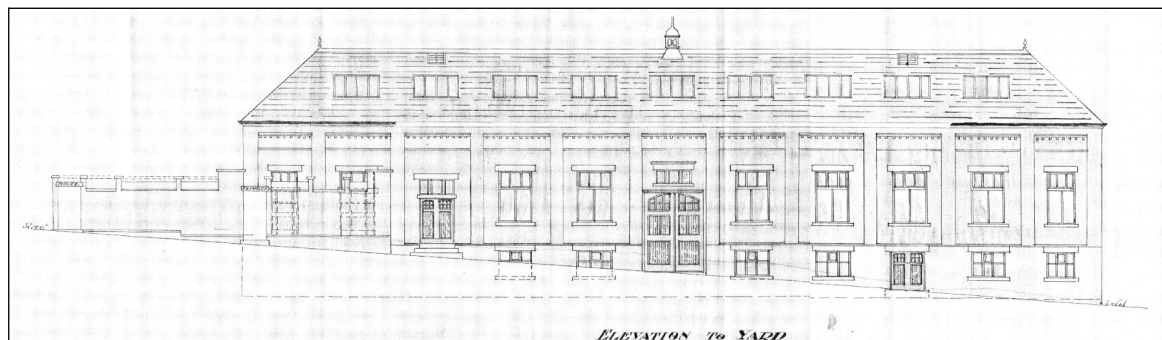
Figure 8: Detached weaving shed: north-east (warehouse) elevation, 1905

5.7 Approval for the later, detached weaving shed was granted in 1905, and the architect was J P Earnshaw of Nelson<sup>10</sup>. It was to contain a warehouse along its north-east side, and an approximately square shed, capable of housing 360 looms, driven by a horizontal shaft from the main mill's engine, carried overhead from across the yard (figures 8 to 12).

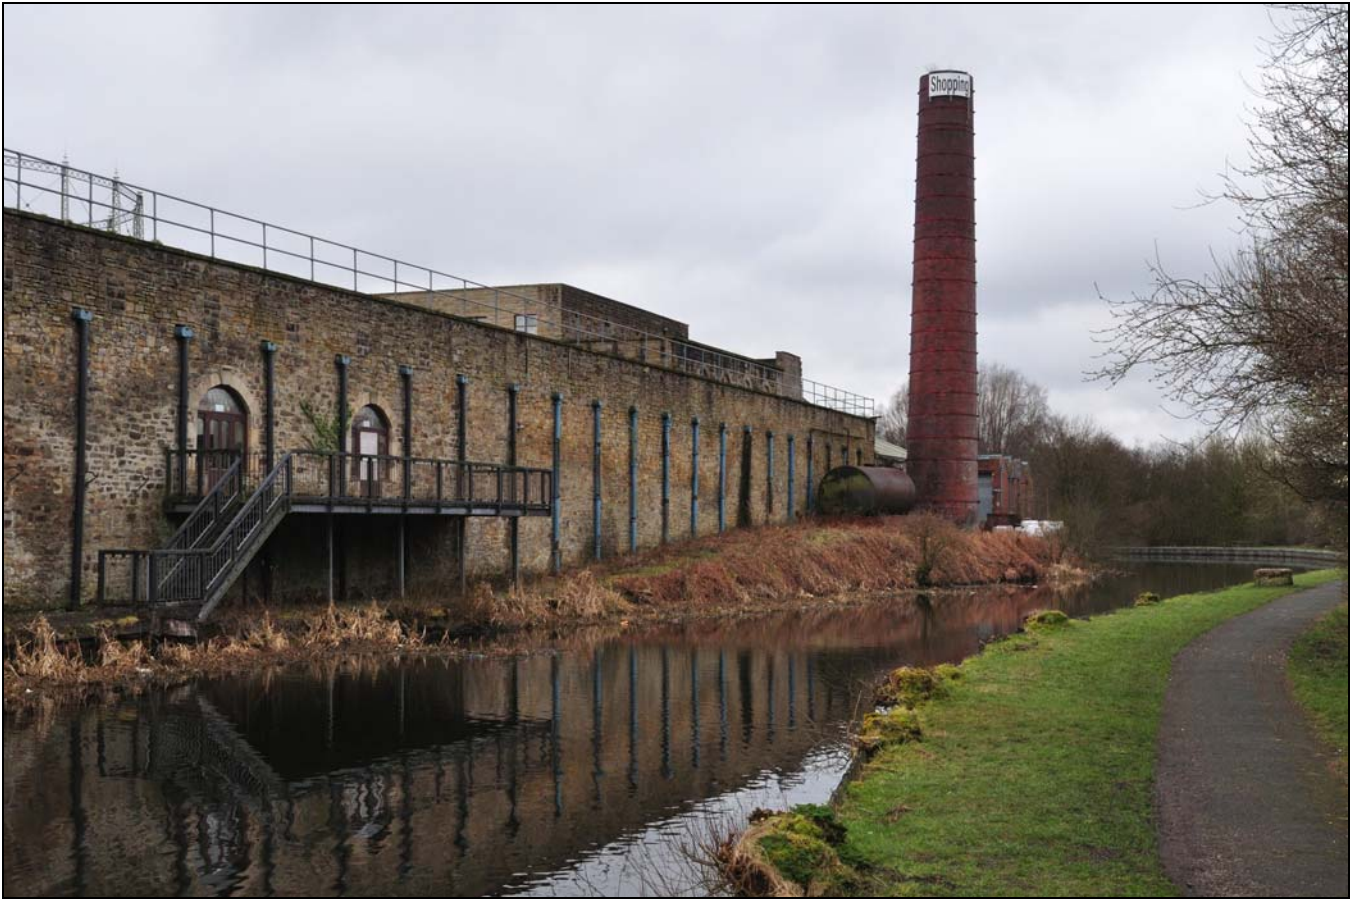
- 7.1 The chimney is entirely brick-built, and was intended to be 50 yards tall with oversailing courses when first built in 1891, but has been reduced in height over recent years. It stands within a few metres of the canal, 1m to the north-west of the stone-built boiler house, to which it is attached by a brick flue, above ground level (**1-7**).

Photo 1: General view of 1891 chimney and mill, from the north-east

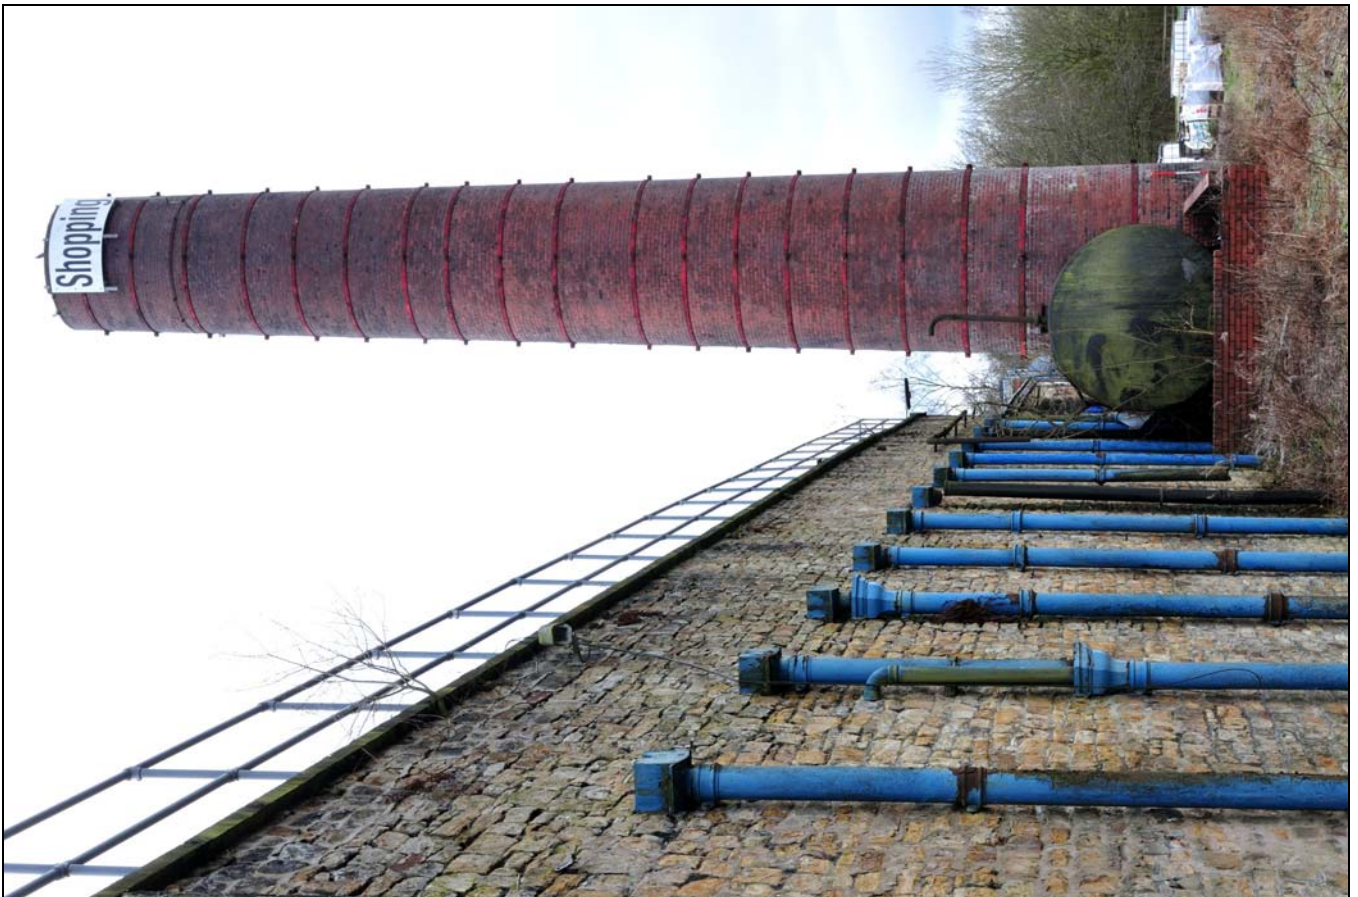
Photo 2: Chimney, from the north-east

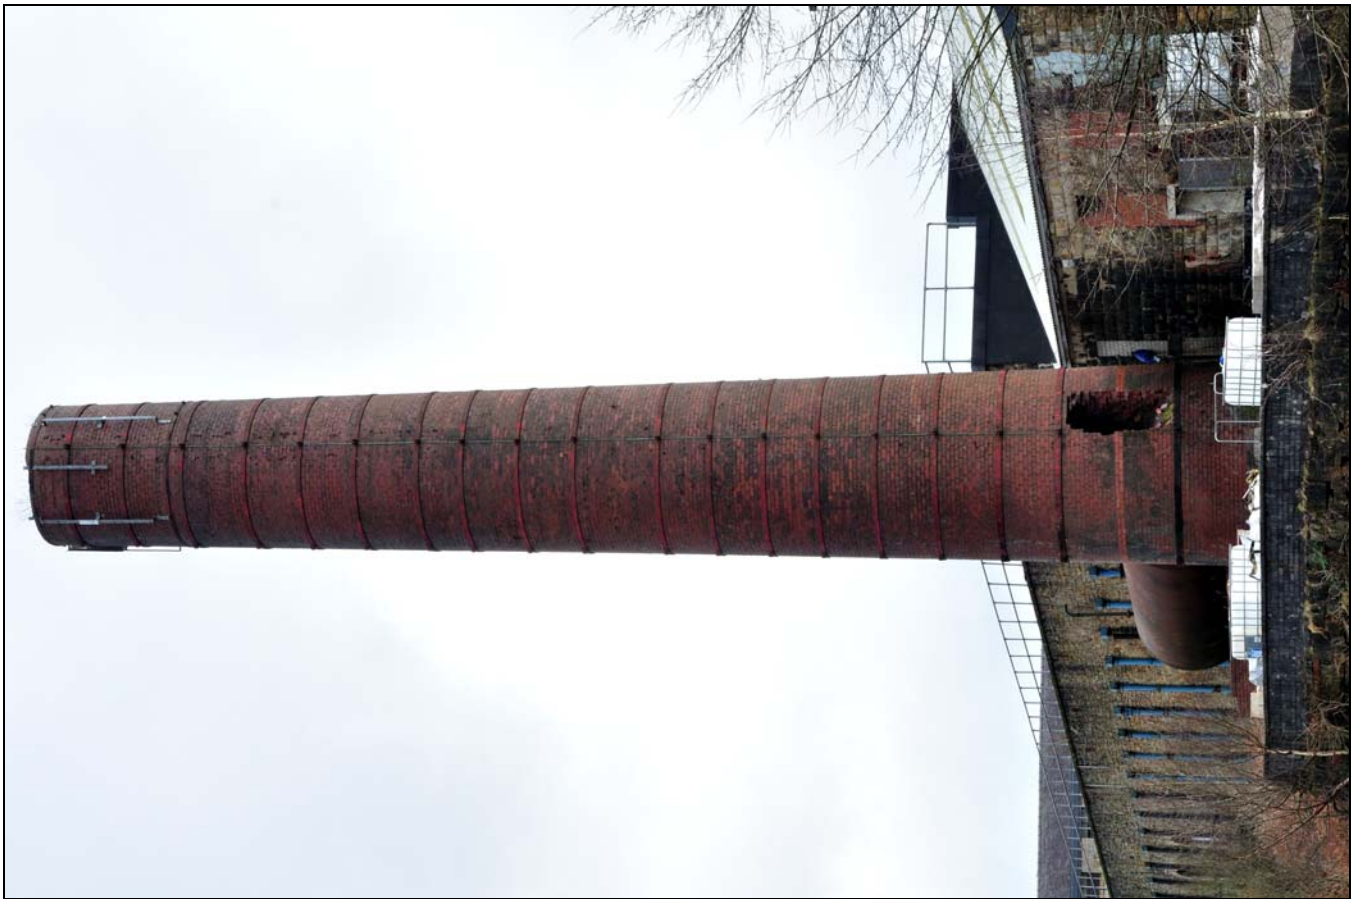
Photo 4: Chimney, from the west

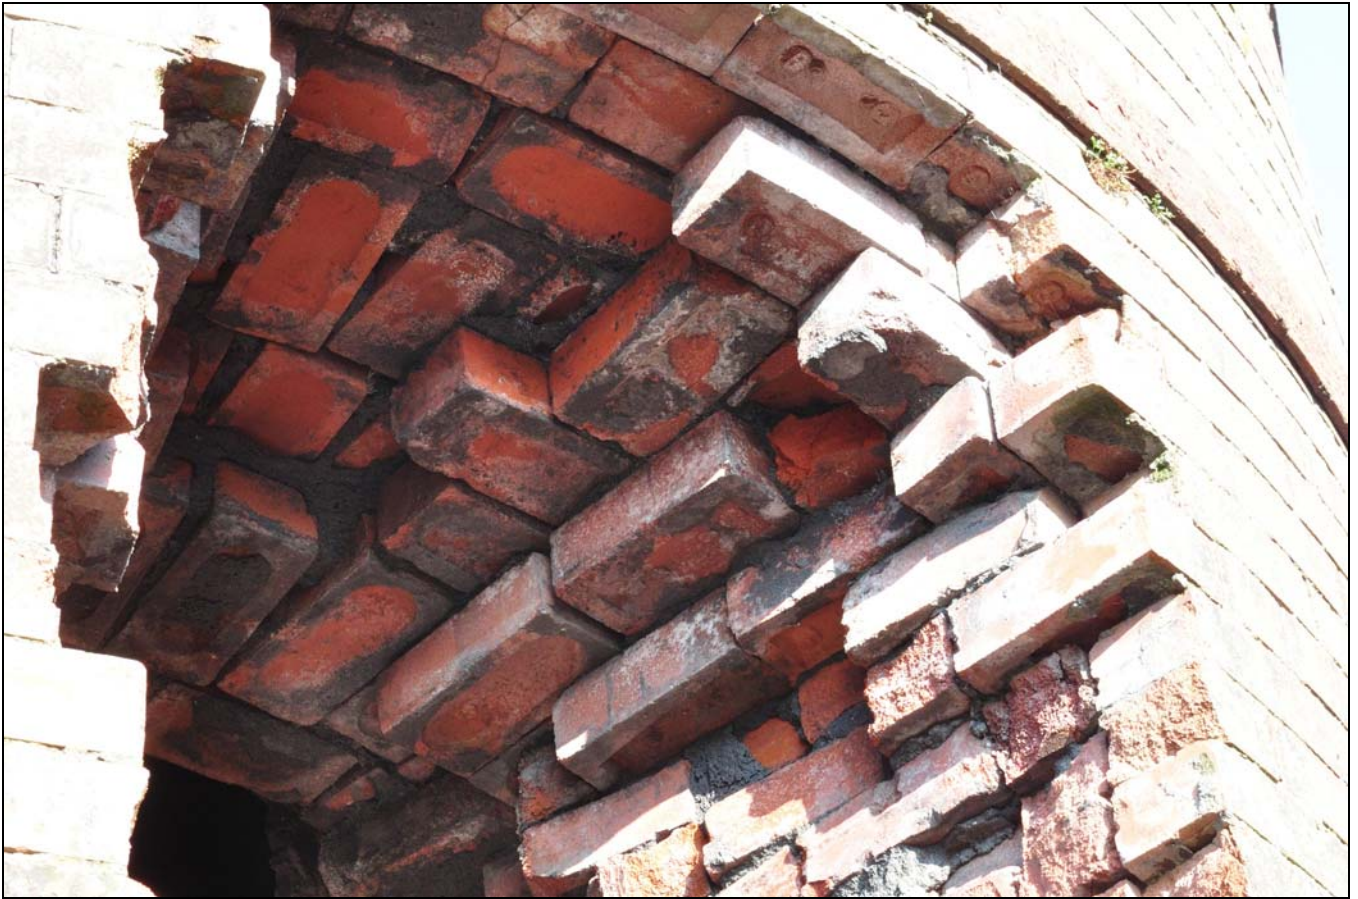
- 7.2 At 1.5m above ground level the structure has an outer diameter of 4.1m, and its brickwork is approximately 1.2m thick (**8**), but it tapers as it rises. The irregular opening in the south-west side is modern, and was made to remove debris from the dismantling at the top, while the steel bands are also a modern remedial feature.

Photo 8: Detail of chimney construction, looking up into modern opening

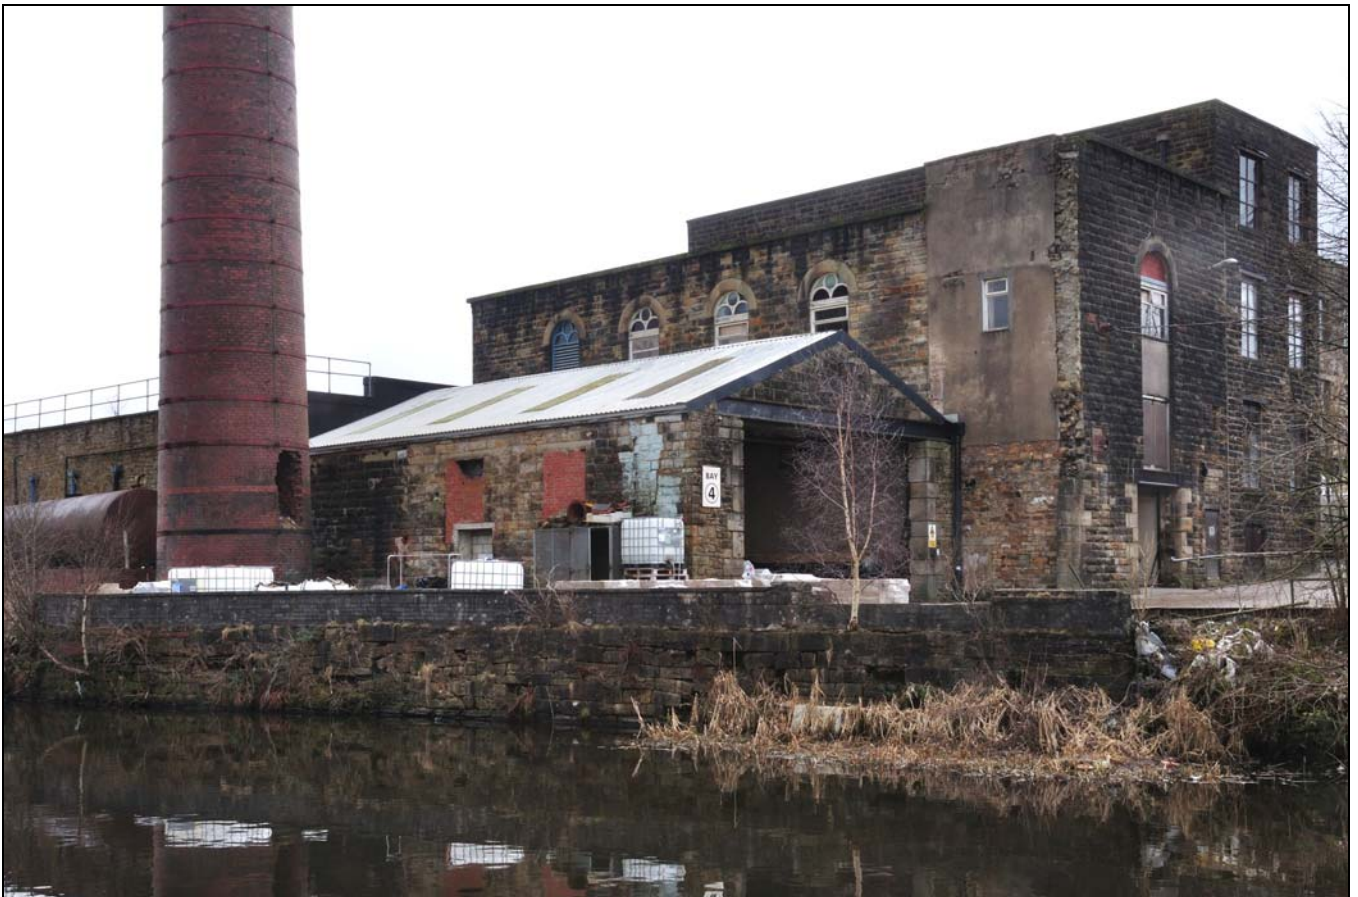
- 7.3 The flue connects the base of the chimney to the adjacent stone building (**9-11**), which housed boilers and economiser, of which the latter recovered some of the waste heat within the gases, by pre-heating the water supply to the boilers. The flue has lost its capping, which seems to have been arched, and in any case it is not certain that the present sides are original. There is an opening in the south-west side of the flue, containing a large cast iron pipe (perhaps inserted to allow waste gases from another source into the flue) (**12-14**), and a smaller, rectangular opening in the north side, with an iron shutter, presumably for maintenance (**15-18**).

Photo 9: Chimney, boiler house, and engine house, from the north-west

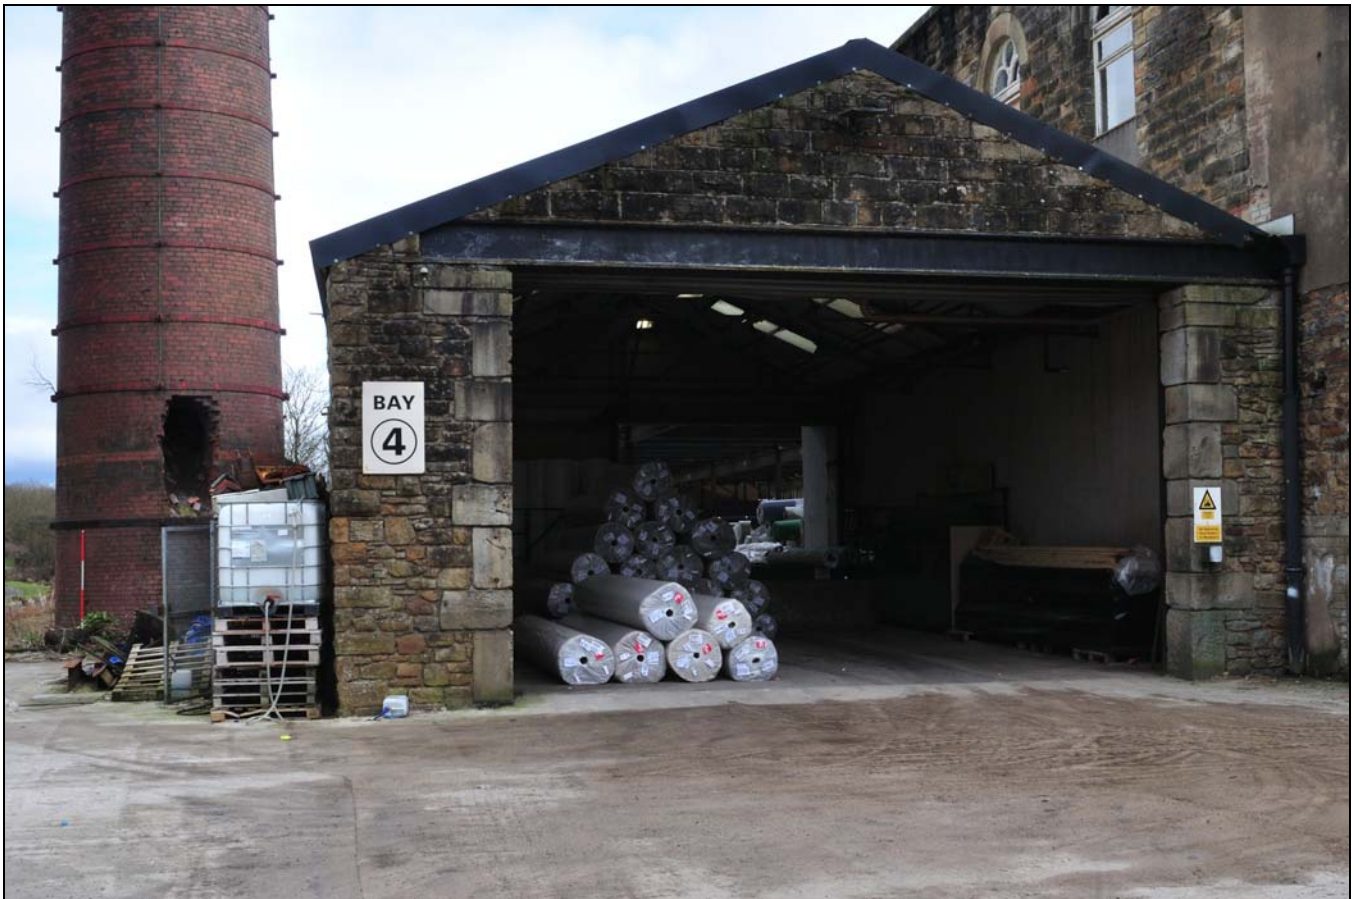
Photo 10: Chimney and boiler house, from the south-west

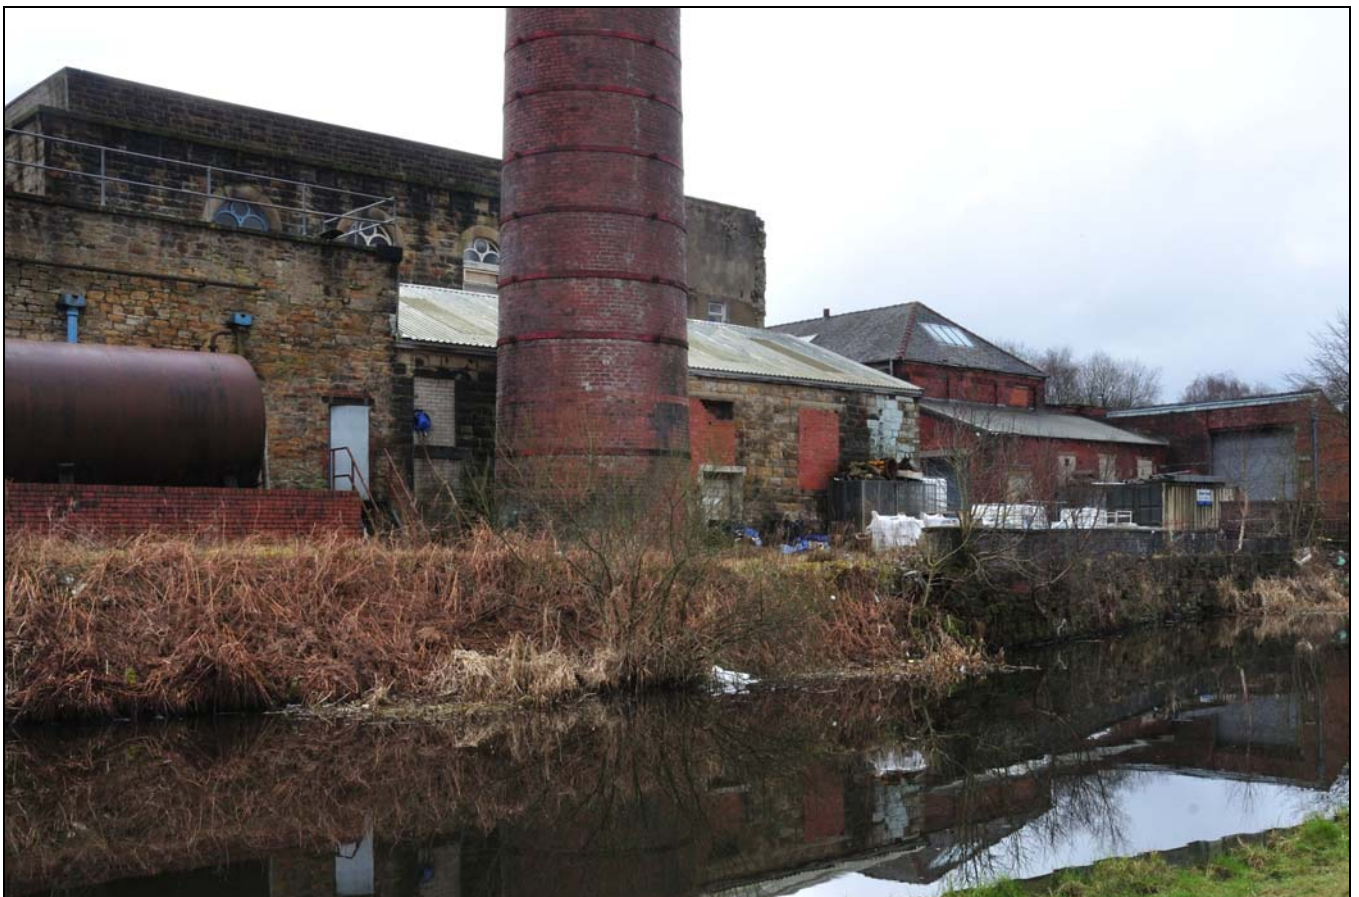
Photo 11: Chimney, boiler house, and engine house, from the north

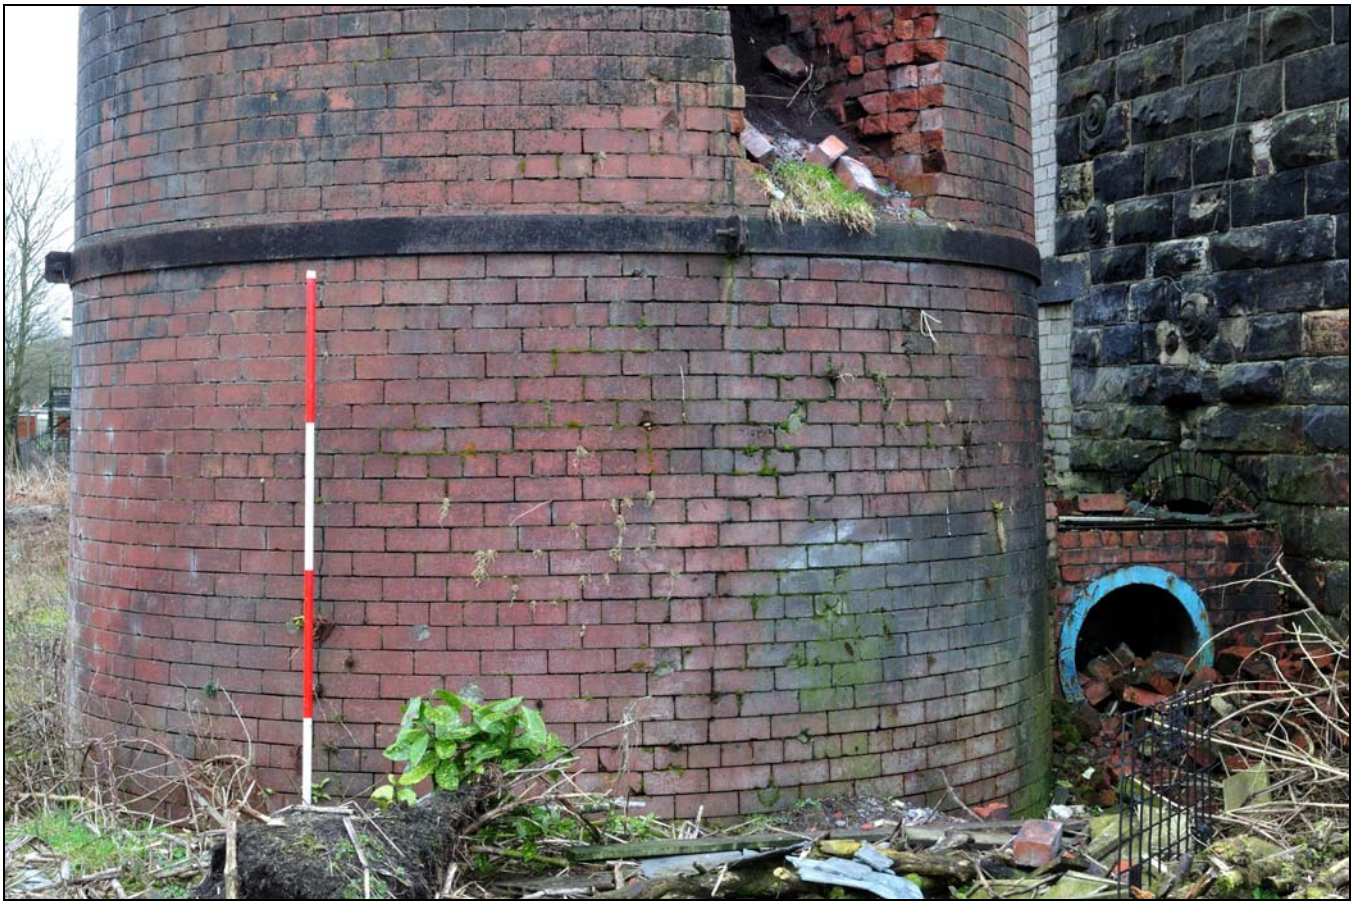
Photo 12: Base of chimney with flue from boiler house, from the west

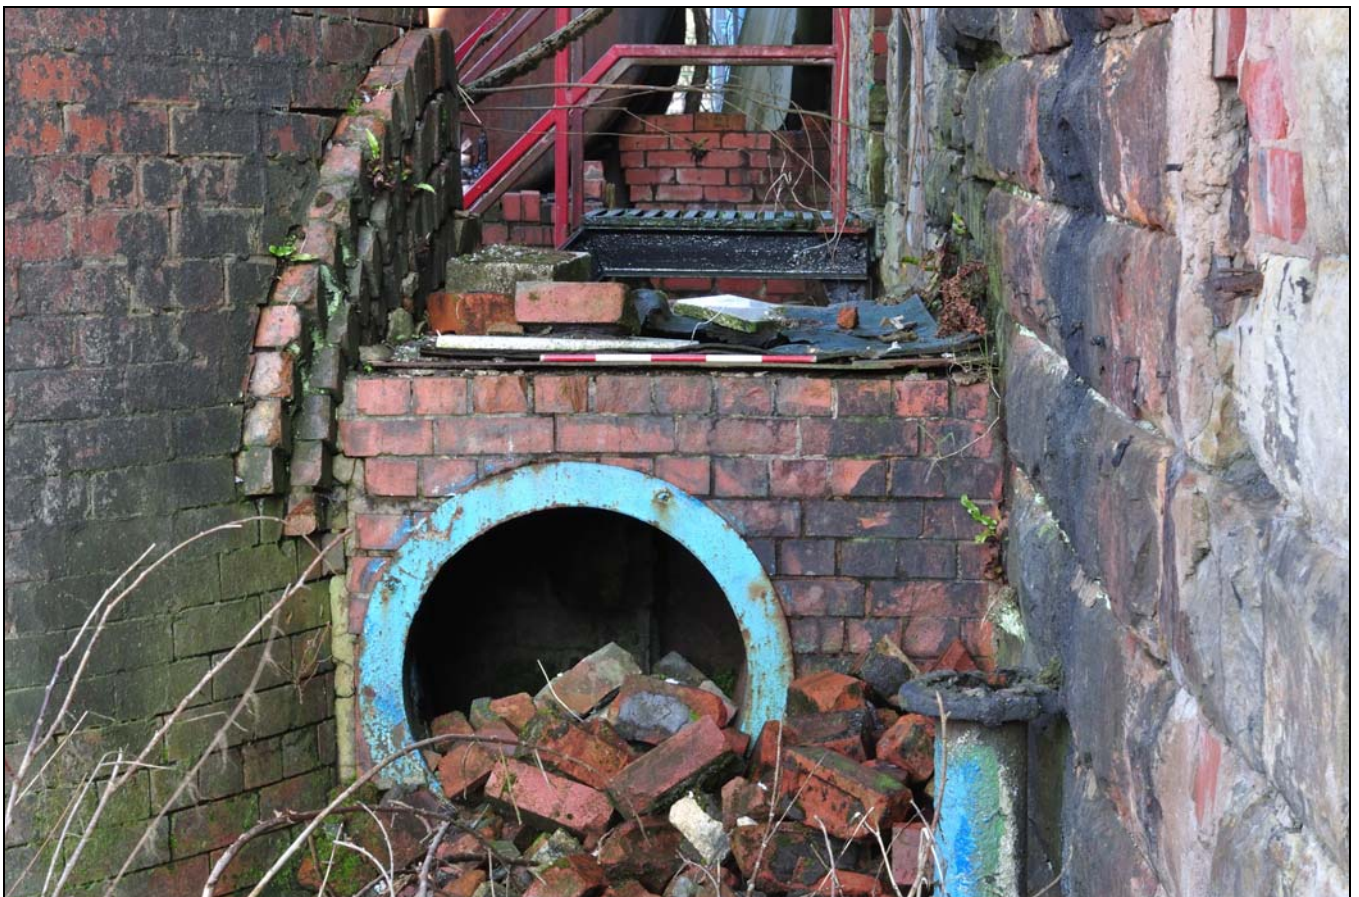
Photo 14: Pipe in west side of flue to chimney

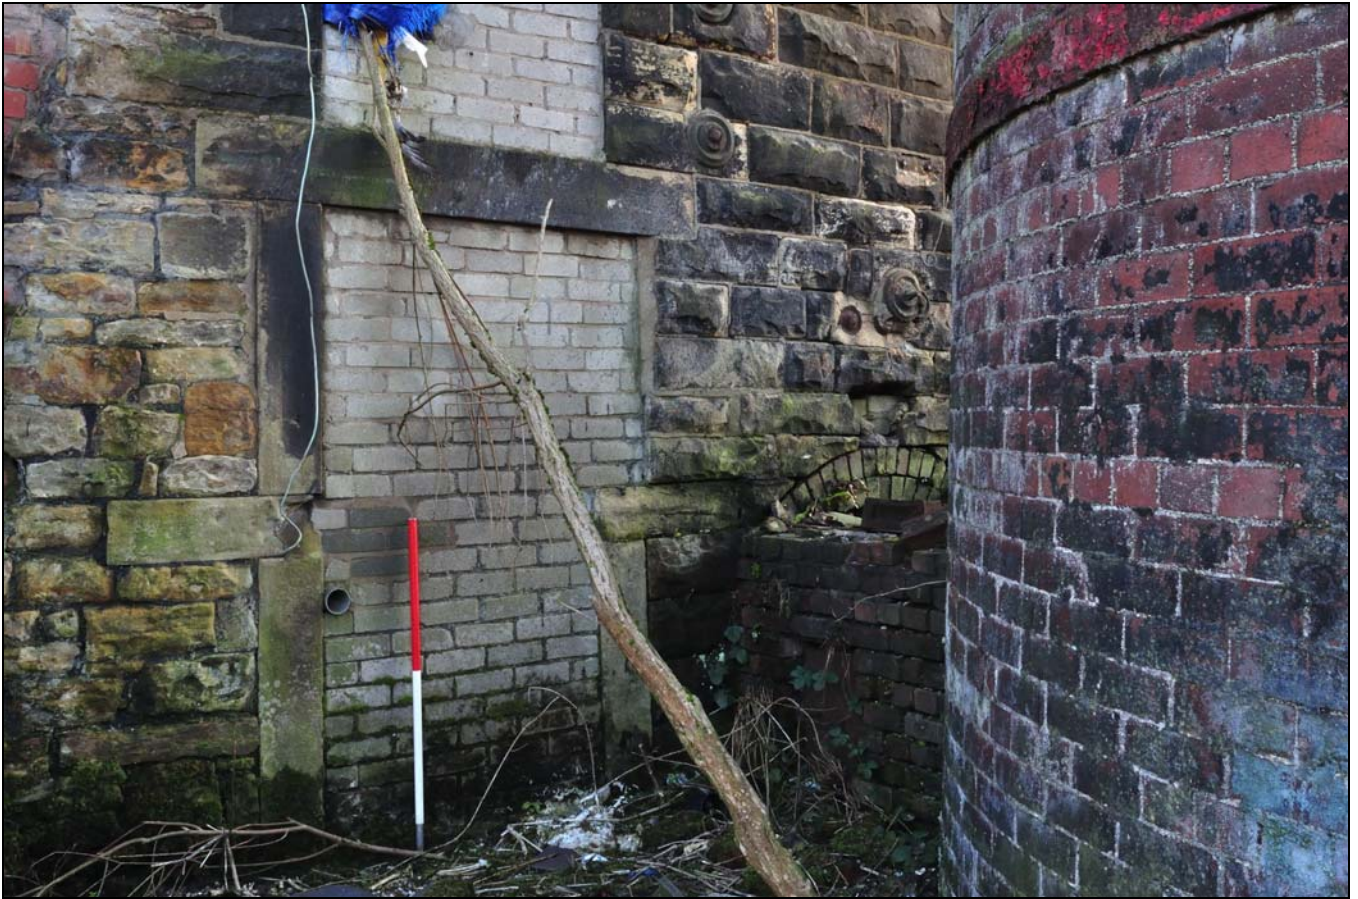
Photo 16: Flue and blocked doorway to boiler house, from the north-east

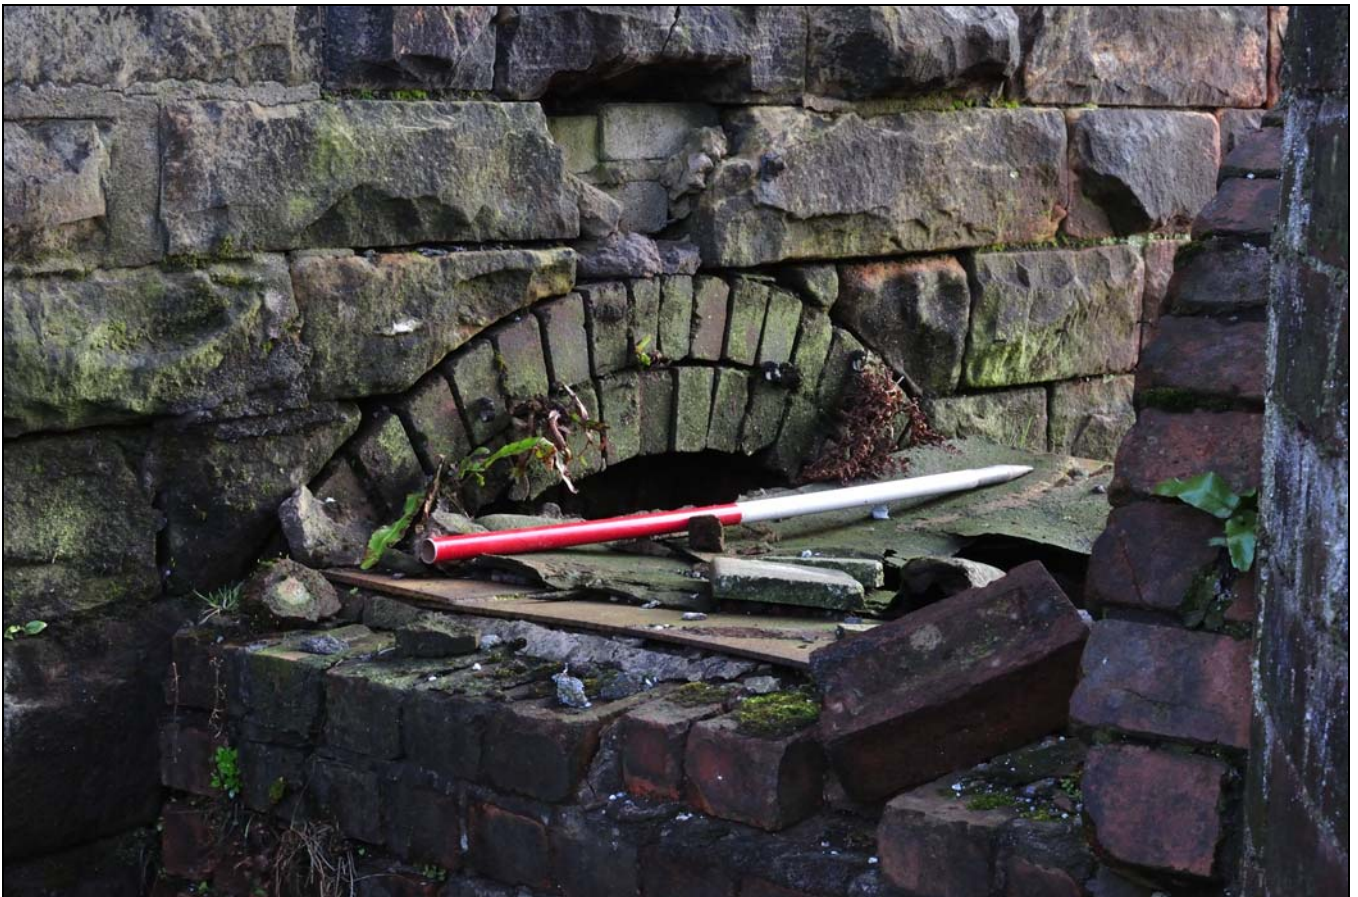
Photo 17: Detail of arched construction to flue, egress from boiler house

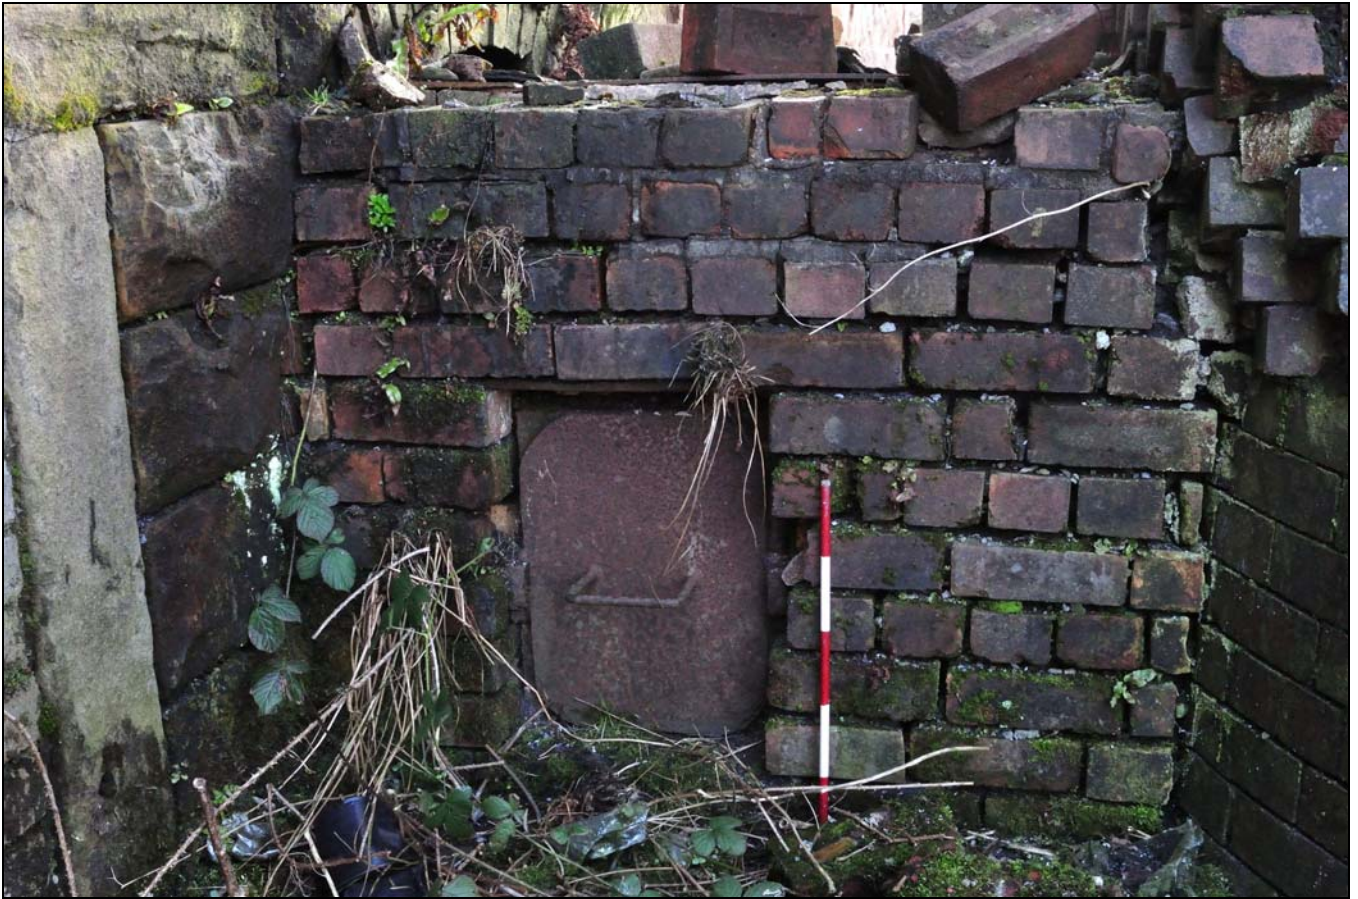
Photo 18: Shutter in north side of flue

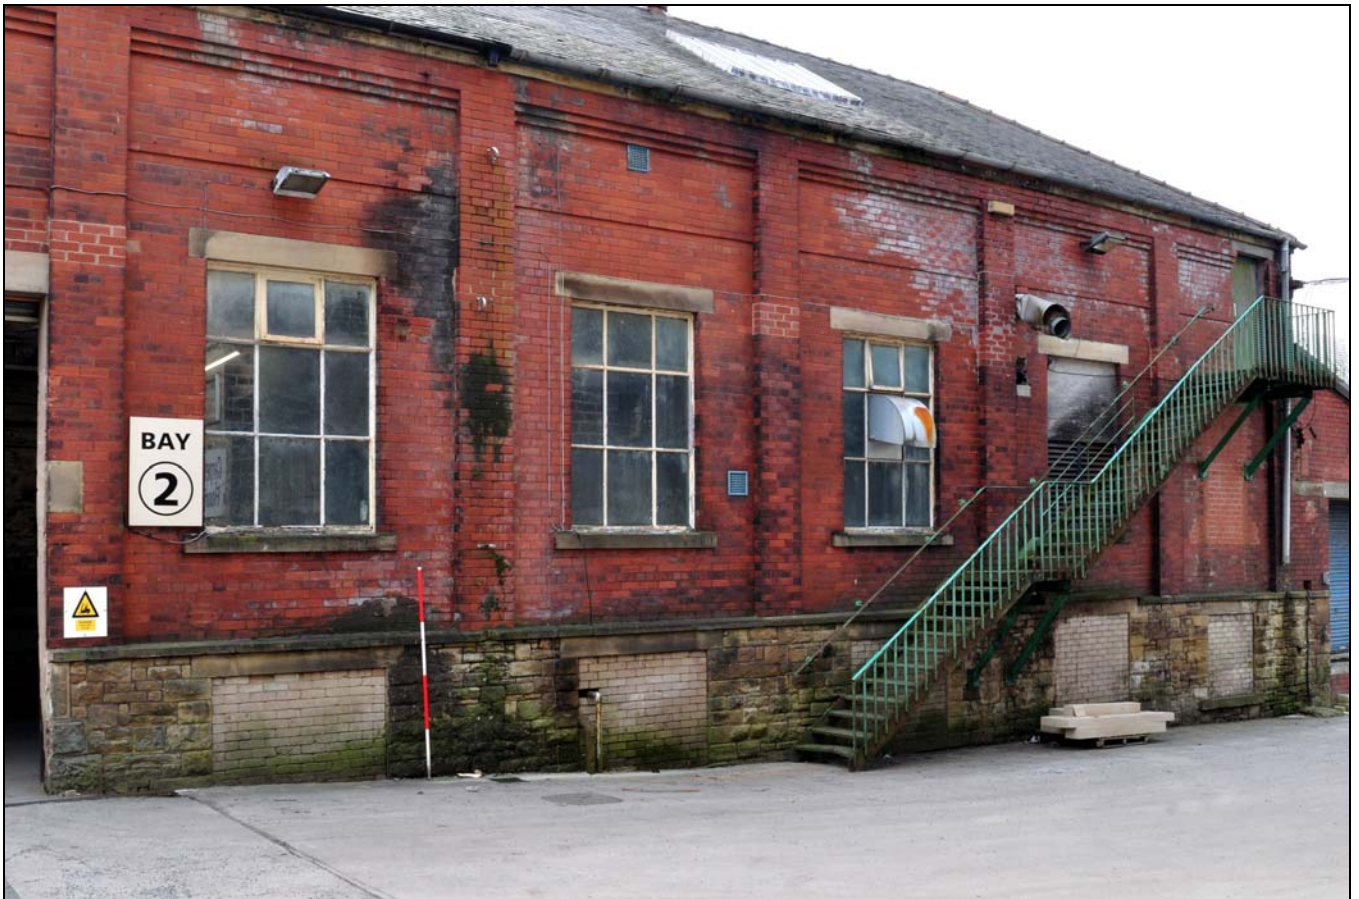
openings to the basement below, but are all now blocked **(27)**. Within bay 3, to the left of the loading doorway, was the personnel entrance, now reduced to a window but distinguished by its lower lintel and brickwork infill **(28)**. Bay 1 also has a former doorway **(29)**, which may have been the means of access to the latrines which previously stood alongside the front, but have been removed in their entirety.

Photo 27: Detached weaving shed: north-east front of warehouse, lower end

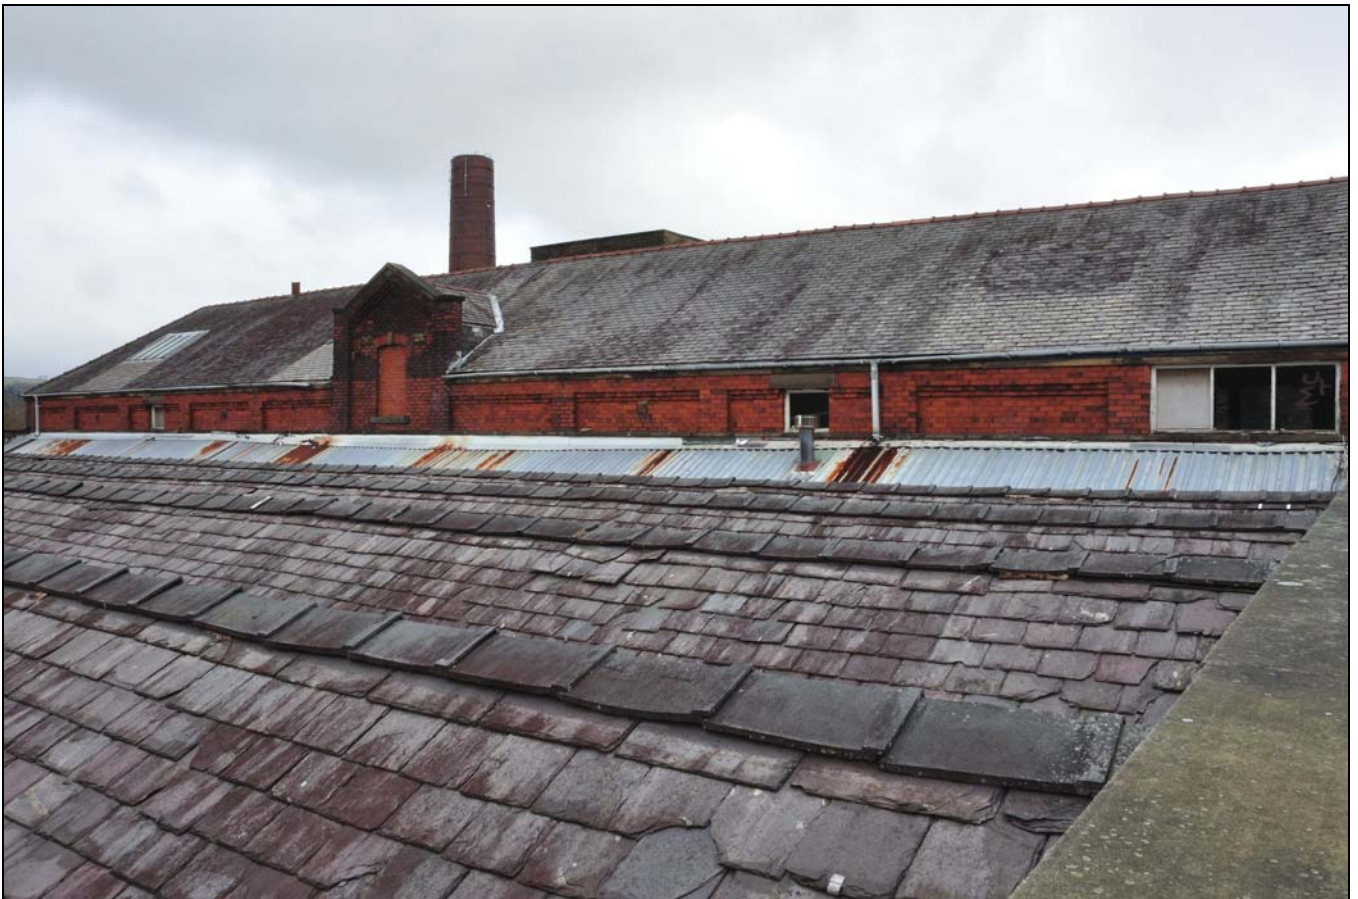
- 8.3 The top storey of the warehouse rises above the loom shop roof **(30)**, where it has a small gabled dormer in the central bay, with blocked window **(31)**; the gable seems intended to have provided space on the attic floor for the hoist mechanism. To either side, most of the bays are blind, but two small windows were incorporated, to light a pair of staircases **(32)**. A larger window at the right-hand of this elevation is a modern insertion.

Photo 30: Detached weaving shed: south-west side of warehouse, above loom shop

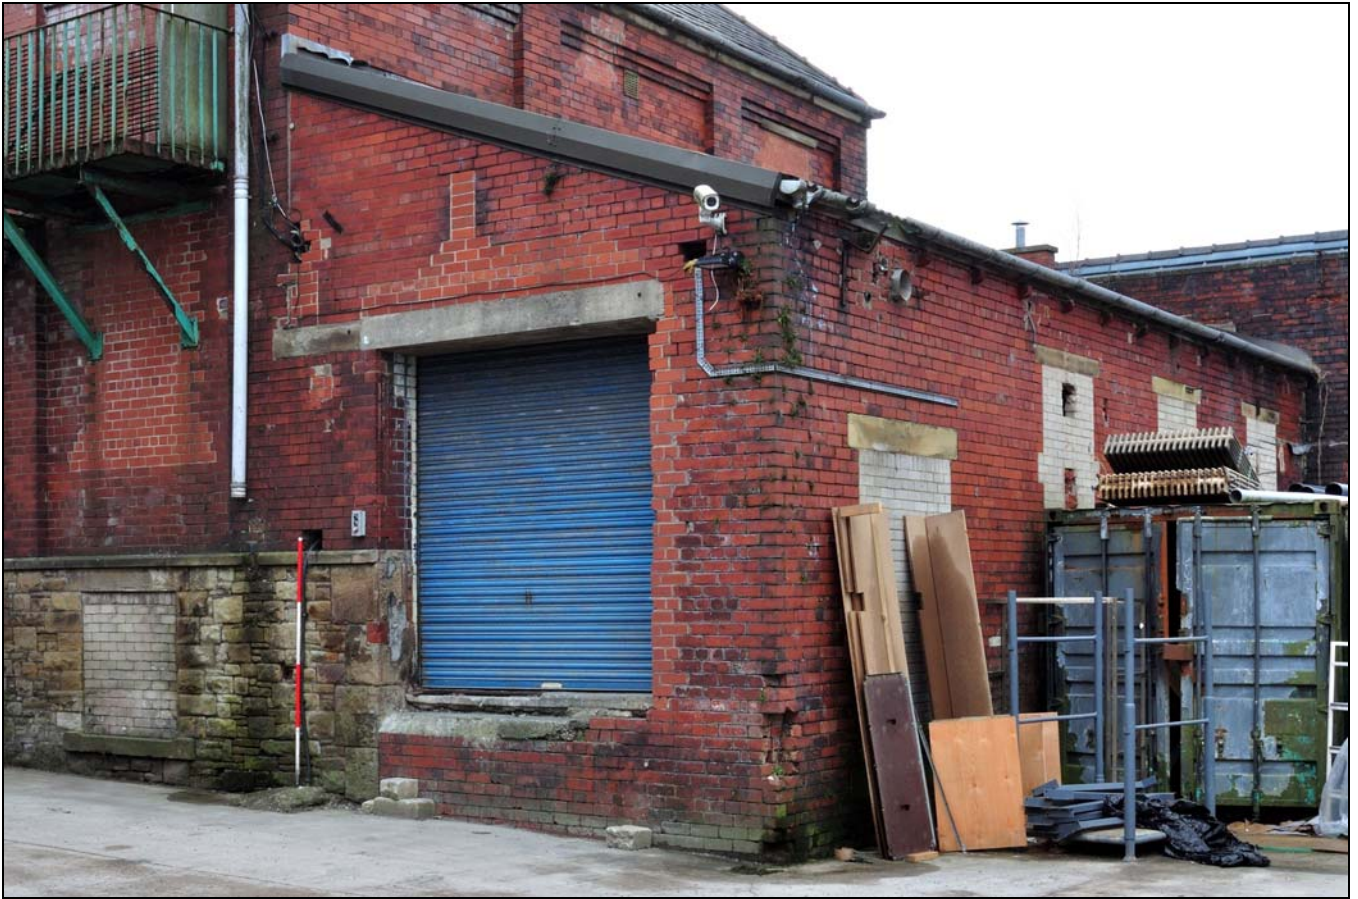
- 8.8 The lean-to extension at the north-west end of the warehouse **(41-42)** is likely to have been built for the additional steam engine, acquired in 1917, and can be

dated to the period between 1910 and 1929, from OS maps. The large front doorway is now a modern loading entrance, but the blocked personnel doorway and windows in the north-west wall remain unchanged in outline. Within the extension, the former windows in the warehouse's end wall are still evident, but there is nothing to indicate any former arrangements relating to the 1917 engine (43). The 1905 plan shows the "driving shaft" passing along the outside of the warehouse here, from the main mill engine across the yard, and then turning 90° into the weaving shed, with what was probably a bevelled gear enclosed within a projecting cavity; again, there are no obvious traces of this power distribution system remaining, and the original shaft was probably removed when the new engine was installed here.

Photo 41: Detached weaving shed: extension to warehouse (1917 engine house?)

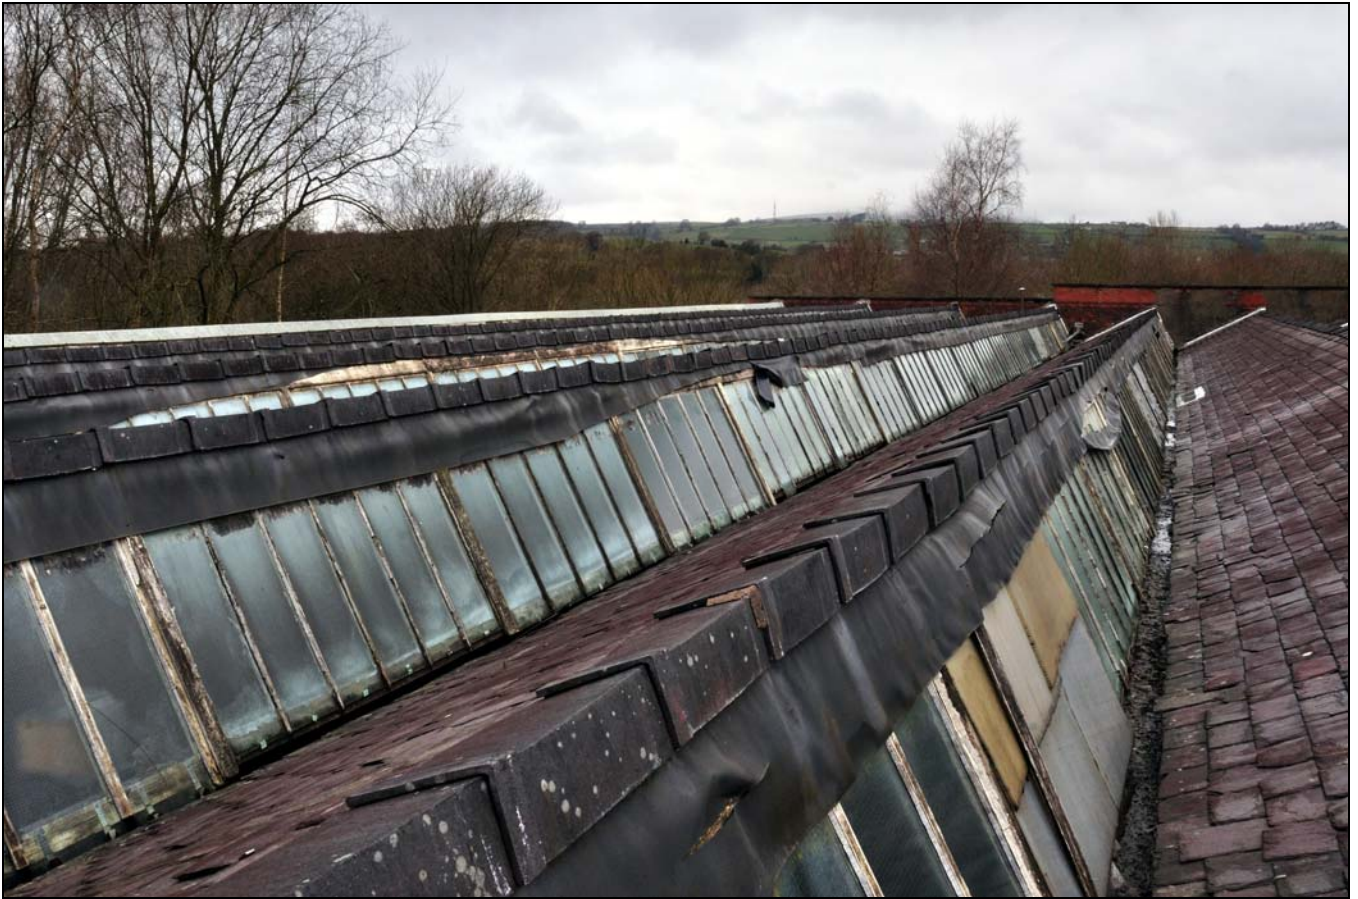
- 8.9 The weaving shed itself is, characteristically, very plain externally, and the only openings are modern fire exits in the north-west and south-east sides; it too has been extended at the north-west side (44). The brick walls rise as parapets to conceal the saw-tooth roof, with its continuous lights to the steeper north-east pitches (45).

Photo 45: Detached weaving shed: saw-tooth roof, looking north-west
