Chimney and detached weaving shed  
at Hollin Bank Mill (Pendle Village Mills)  
Brierfield, Lancashire:  
Archaeological Record

March 2021

STEPHEN HAIGH

## SUMMARY

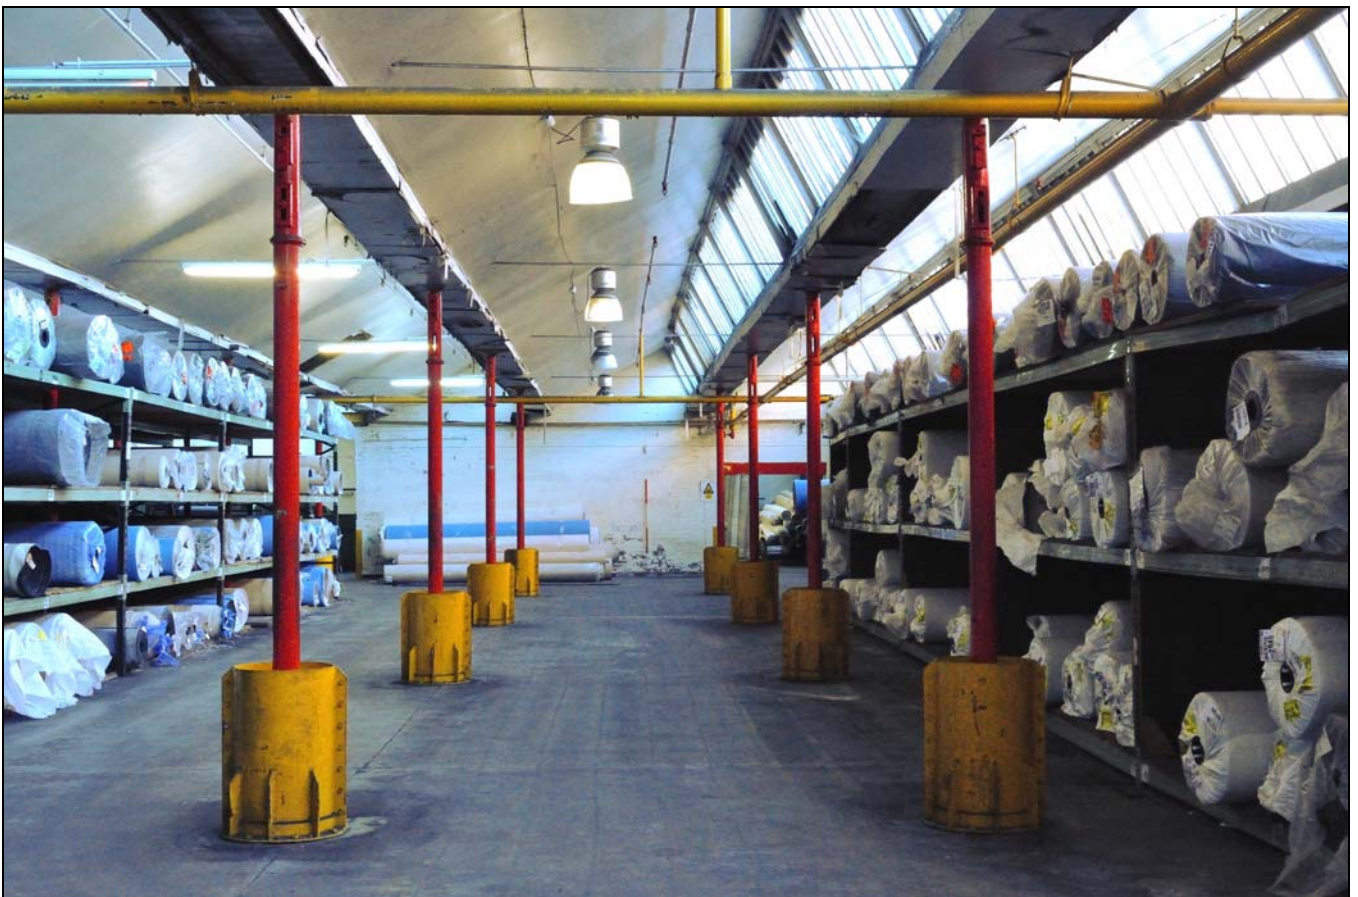
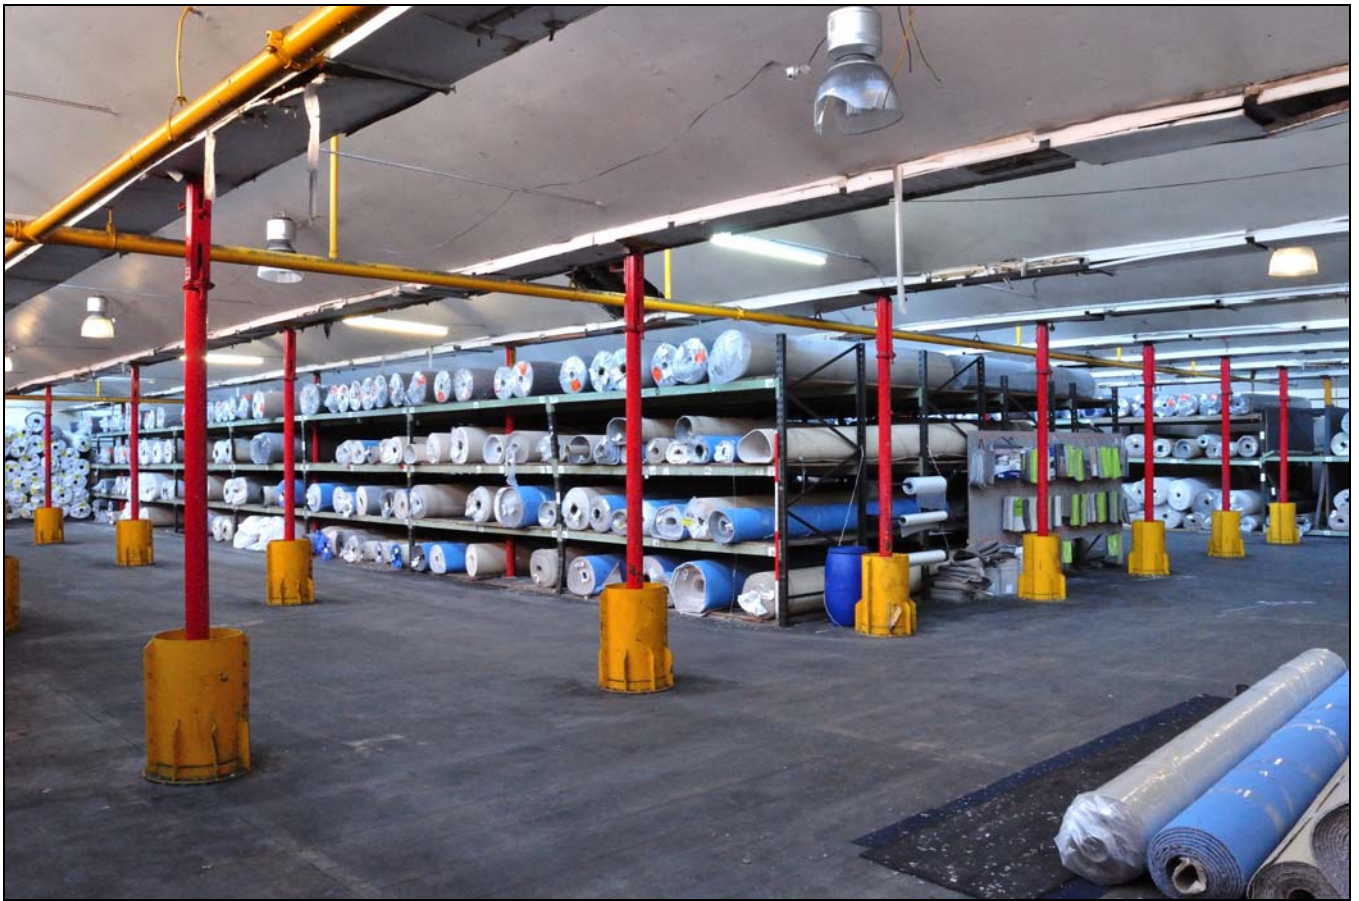
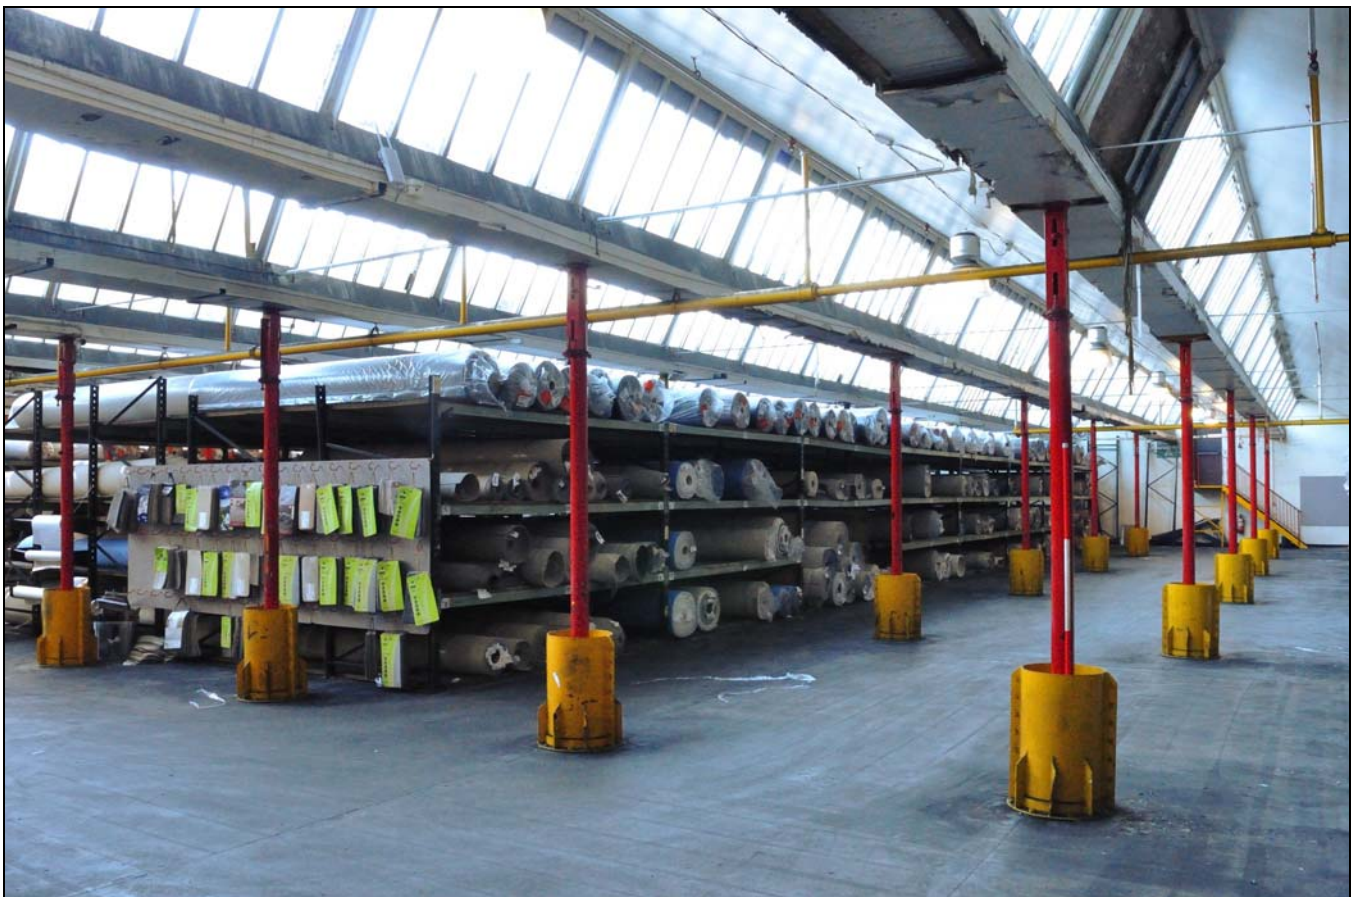
- 8.10 The internal structure is entirely in keeping with the building type, and comprises a regular array of cast iron columns, five along each of the nine roof valleys (46-48). The columns all appear to be original, which is relatively unusual in a building which has otherwise been adapted to alternative uses. They are of a standard design, with flat bolting faces to their north-west sides, but no shaft hangers or brackets have survived (49-51). Similarly, no traces of the means by which the main shaft was attached to the north-east side of the weaving shed (rear of the warehouse) were identified during this survey. Four arched recesses within this wall were noted however, in various states of alteration. They are a common feature within the building type (53).

Photo 46: Detached weaving shed: loom shop, looking north-west

Photo 47: Detached weaving shed: loom shop, looking south

Photo 48: Detached weaving shed: loom shop, looking east

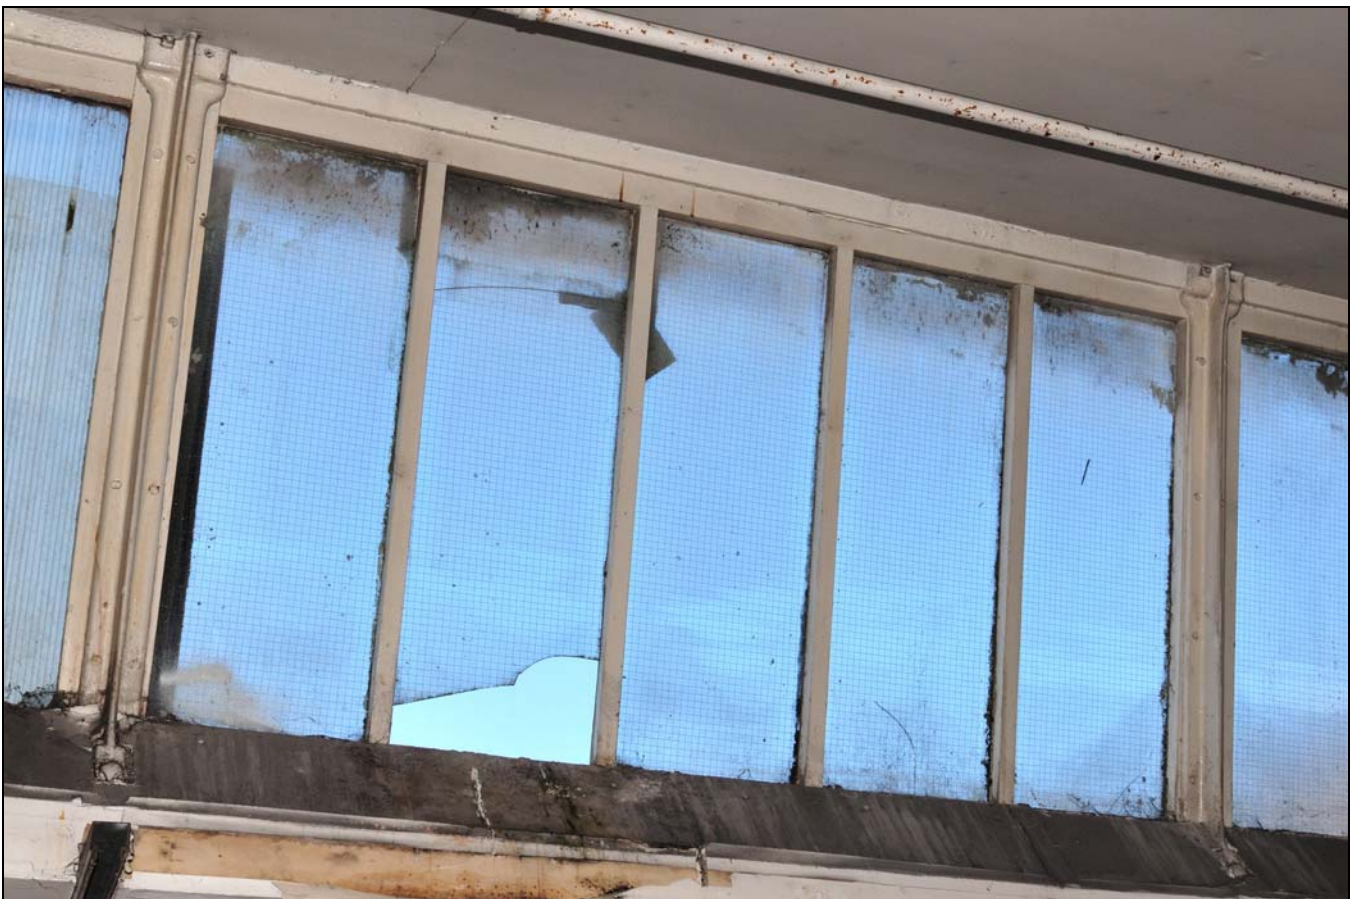
Photo 52: Detached weaving shed: detail of roof light

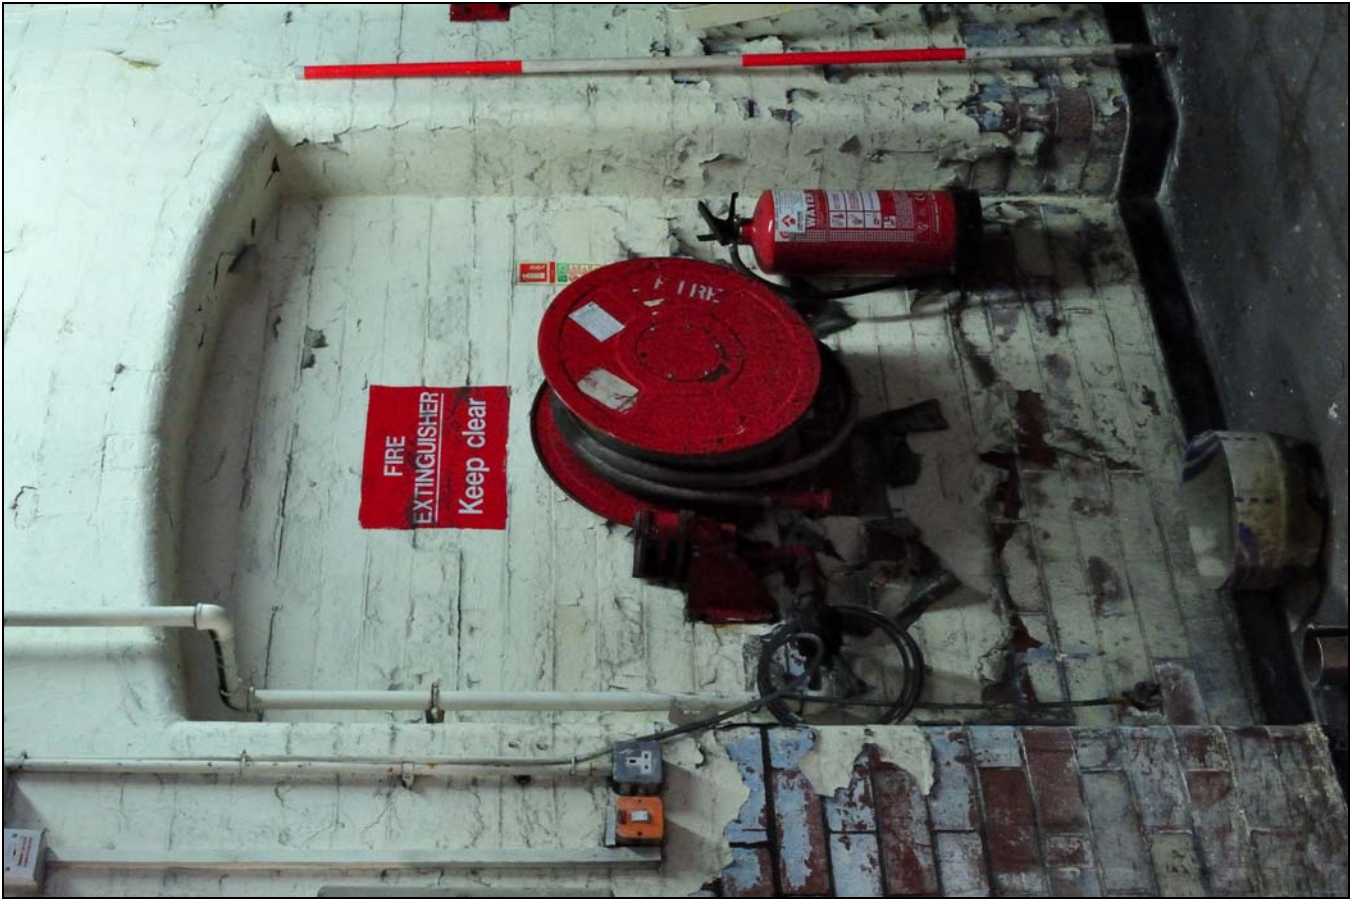
Photo 53: Detached weaving shed: arched recess in north-east side

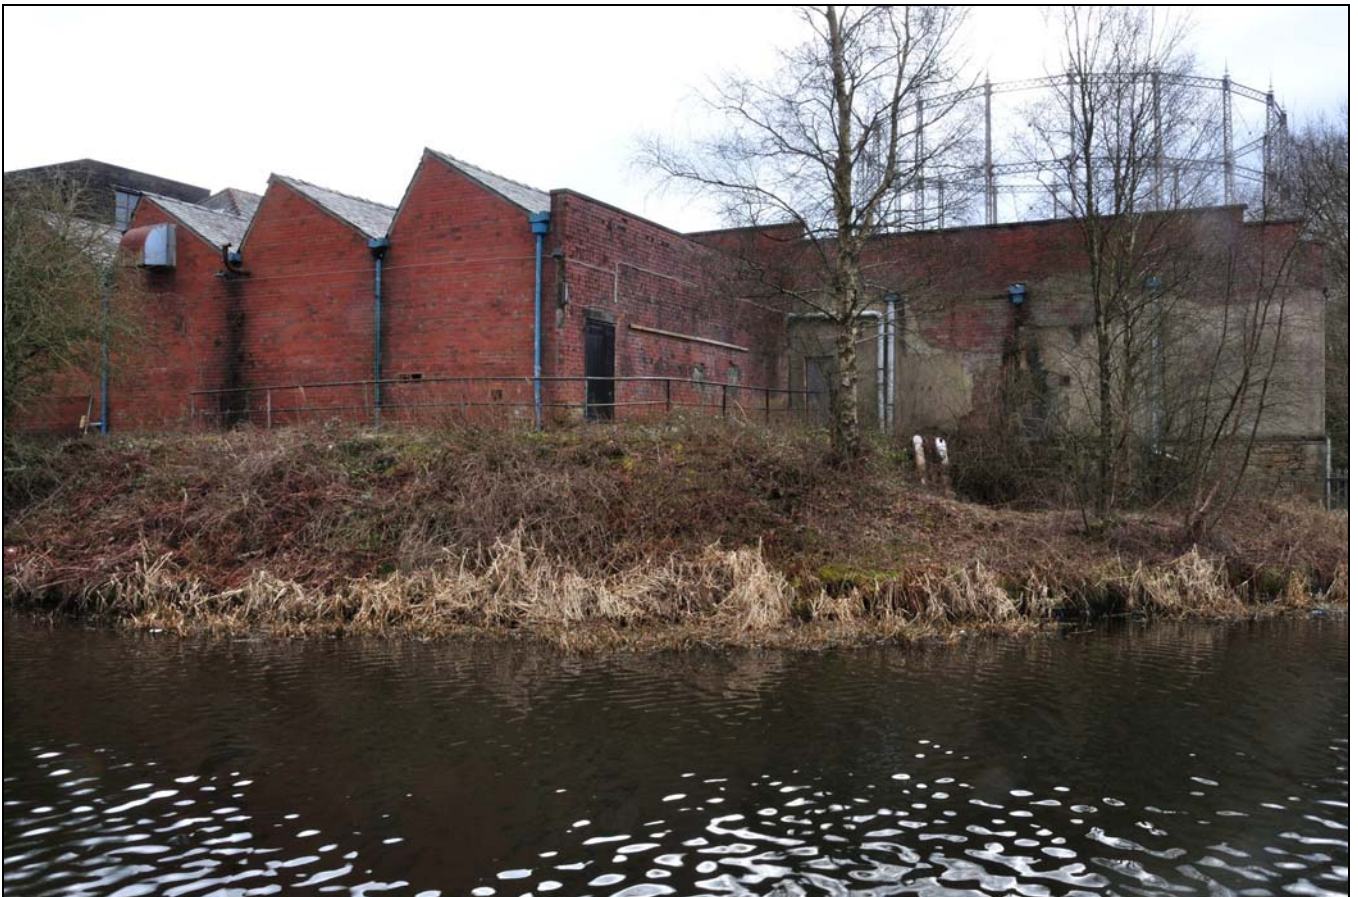
- 8.11 The extension of the weaving shed to the north-west provided an additional 183m<sup>2</sup>, also under a saw-tooth roof (54-57). This was an early addition to the building, as it was recorded by the OS in 1910, and may have been intended to increase the number of looms. The absence of columns, and by extrapolation, mechanical power, is likely to be a consequence of alteration, to accommodate the present machinery.

Photo 56: Detached weaving shed: north-west extension (1905-1910), looking south-east
