Farm Buildings at Barcroft Hall
Cliviger, Lancashire:
Archaeological Building Recording

Farm Buildings at Barcroft Hall Cliviger, Lancashire: Archaeological Building Recording

FARM BUILDINGS AT BARCROFT HALL, CLIVIGER, LANCASHIRE:

ARCHAEOLOGICAL BUILDING RECORDING

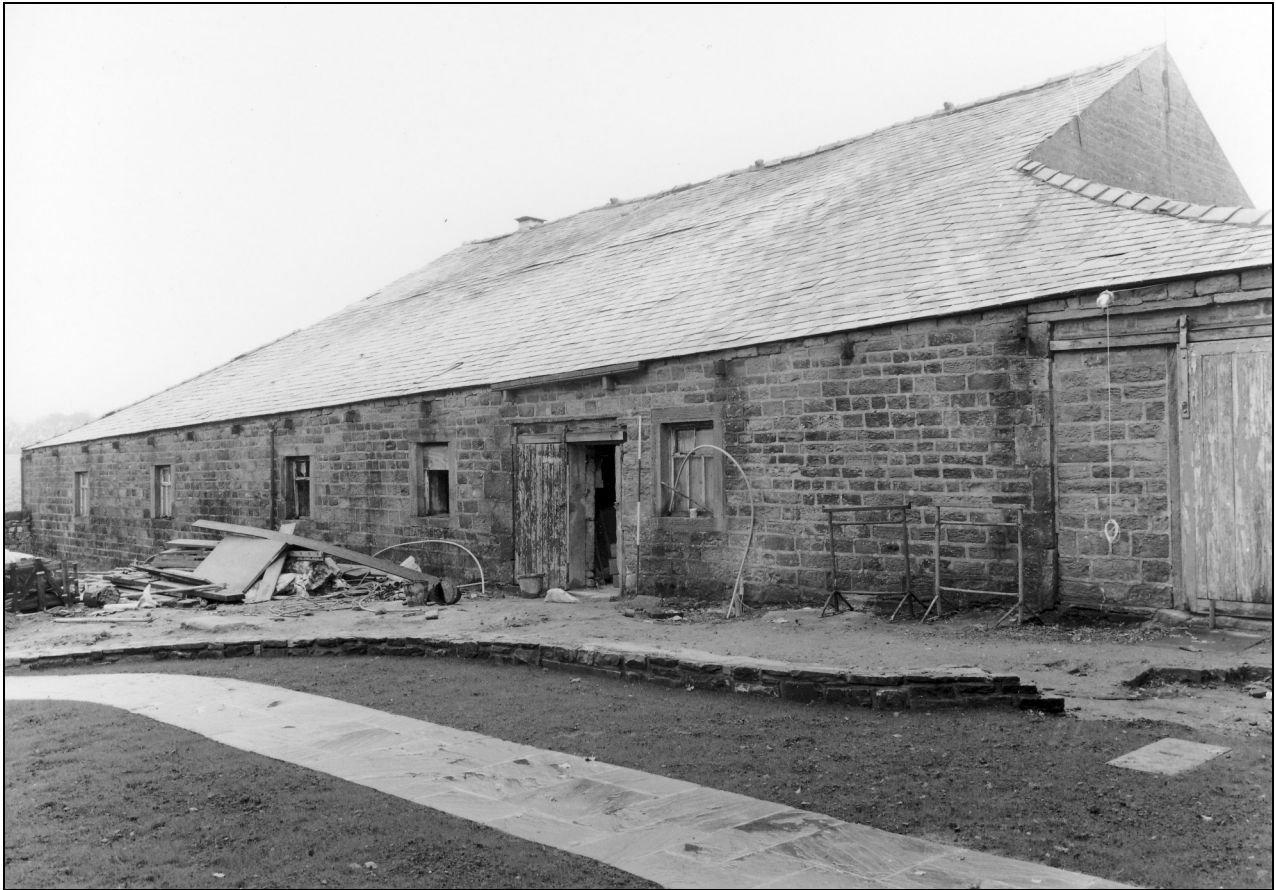
Photo 2: View of the barn, from the south

- 6.2 The barn is faced with sandstone, squared and coursed to the south-west front and the projecting gables (**2**), but with rubble elsewhere which is largely random in character, with few dressings: these include squared quoins, window and doorway surrounds, stone eaves brackets, and two owl holes. The roof is covered with blue slate and an interlocking tile ridge with ventilation cowls, evidently all of 19th century date.

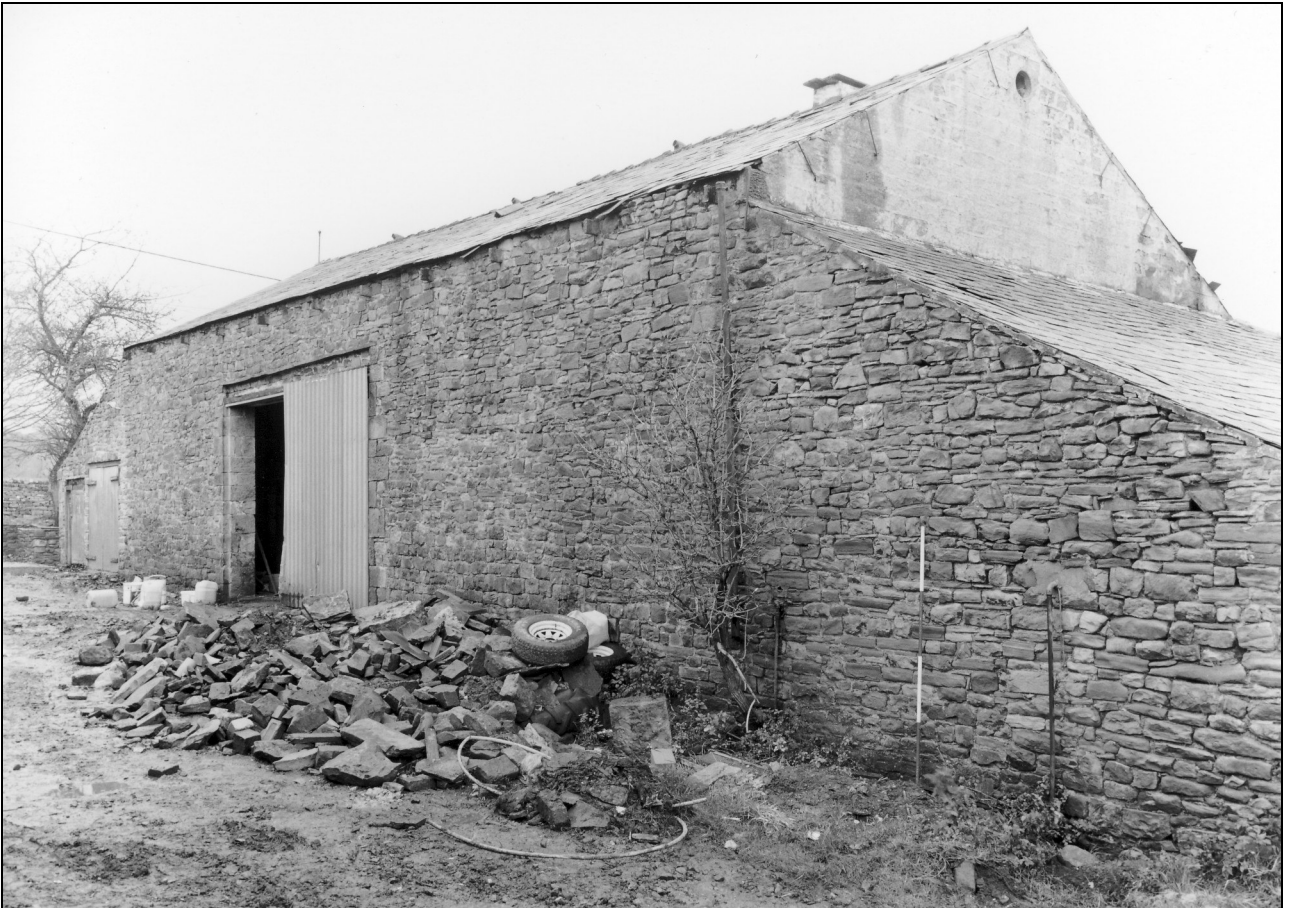
Photo 4: North-east elevation of barn, from the north

- 6.3 The main part of the barn has its entrance in the north-east side (**4**), a tall, wide cart entrance with flat timber lintel and an external rebate to accommodate a sliding door, indicating that the opening must date from the late 19th century (**5**). There are no straight joints in this elevation, which continues beyond the original gables to the end outshots, a feature which implies that this wall has been completely rebuilt, although some coursed stonework in the central area may be

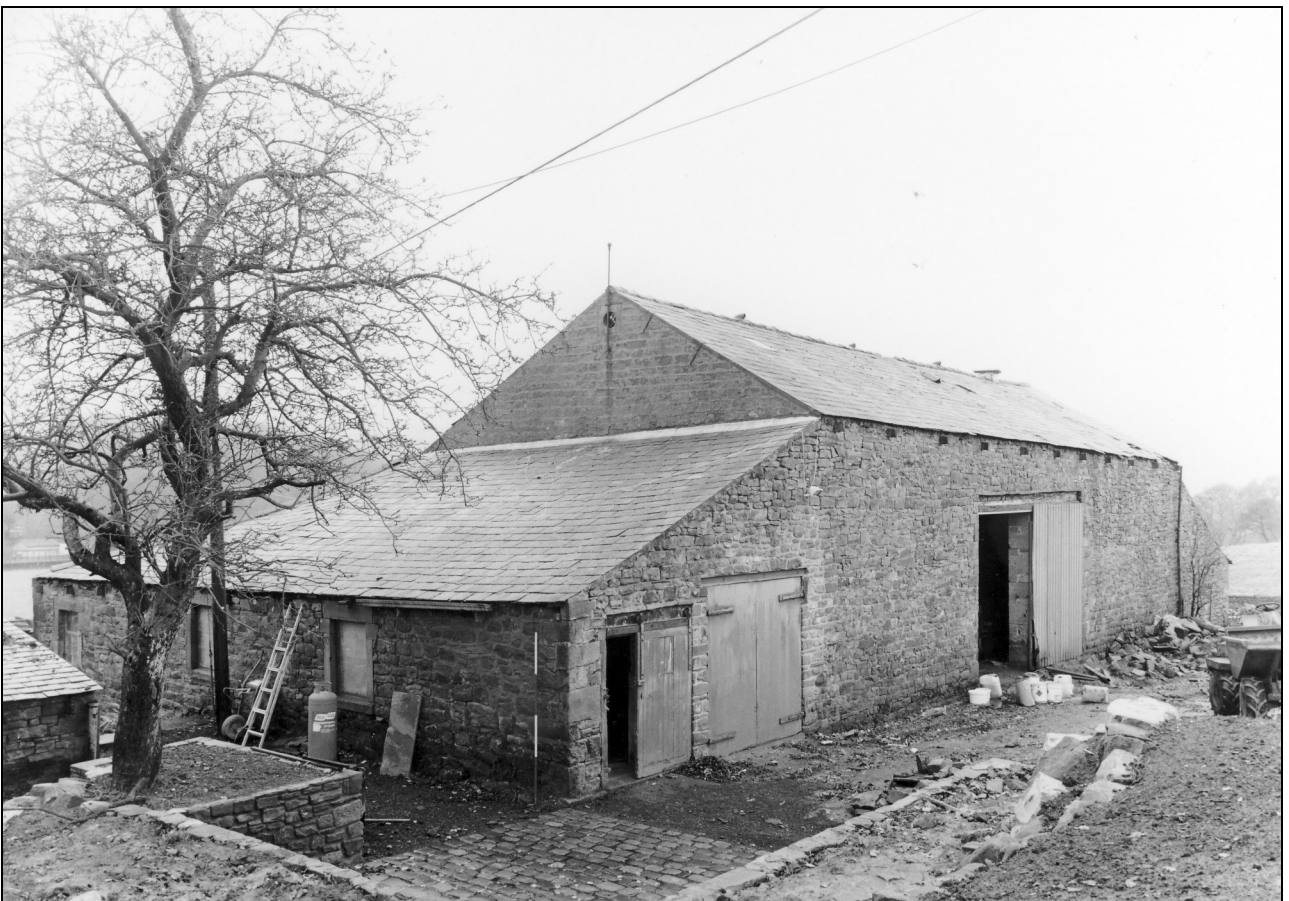
Photo 6: View of the barn, from the east

remnants of the original structure. At the south-east end of the elevation, serving the outshot, is an original pedestrian doorway intended for a sliding door, and a more recent, inserted vehicular door (6).

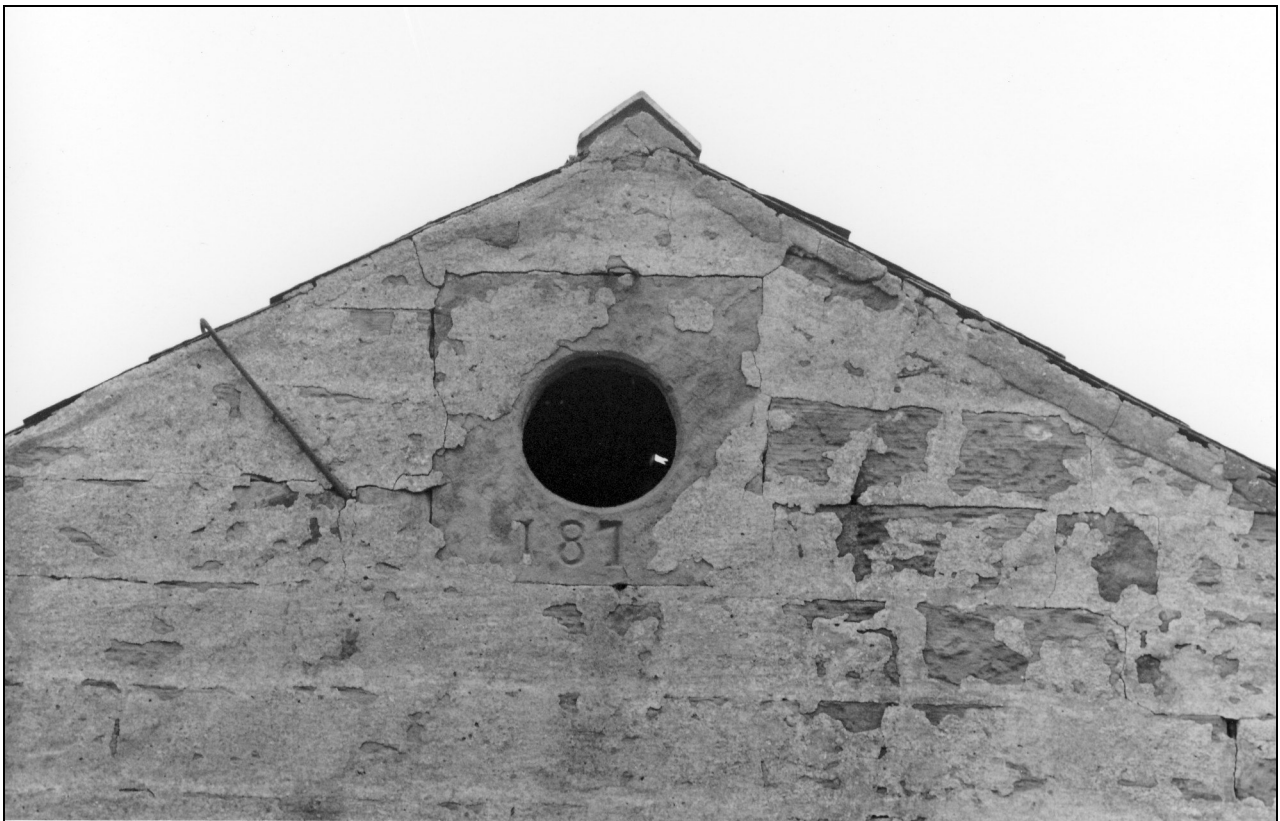
Photo 15: Dated owl hole in north-west gable of barn

- 6.5 The only other external features of note are the owl holes within the gables: that to the north-west with the date carved below the aperture, reading 187_. The figure "7" may have been re-worked, suggesting an original date of 181_, possibly the date when the barn was first built (15).

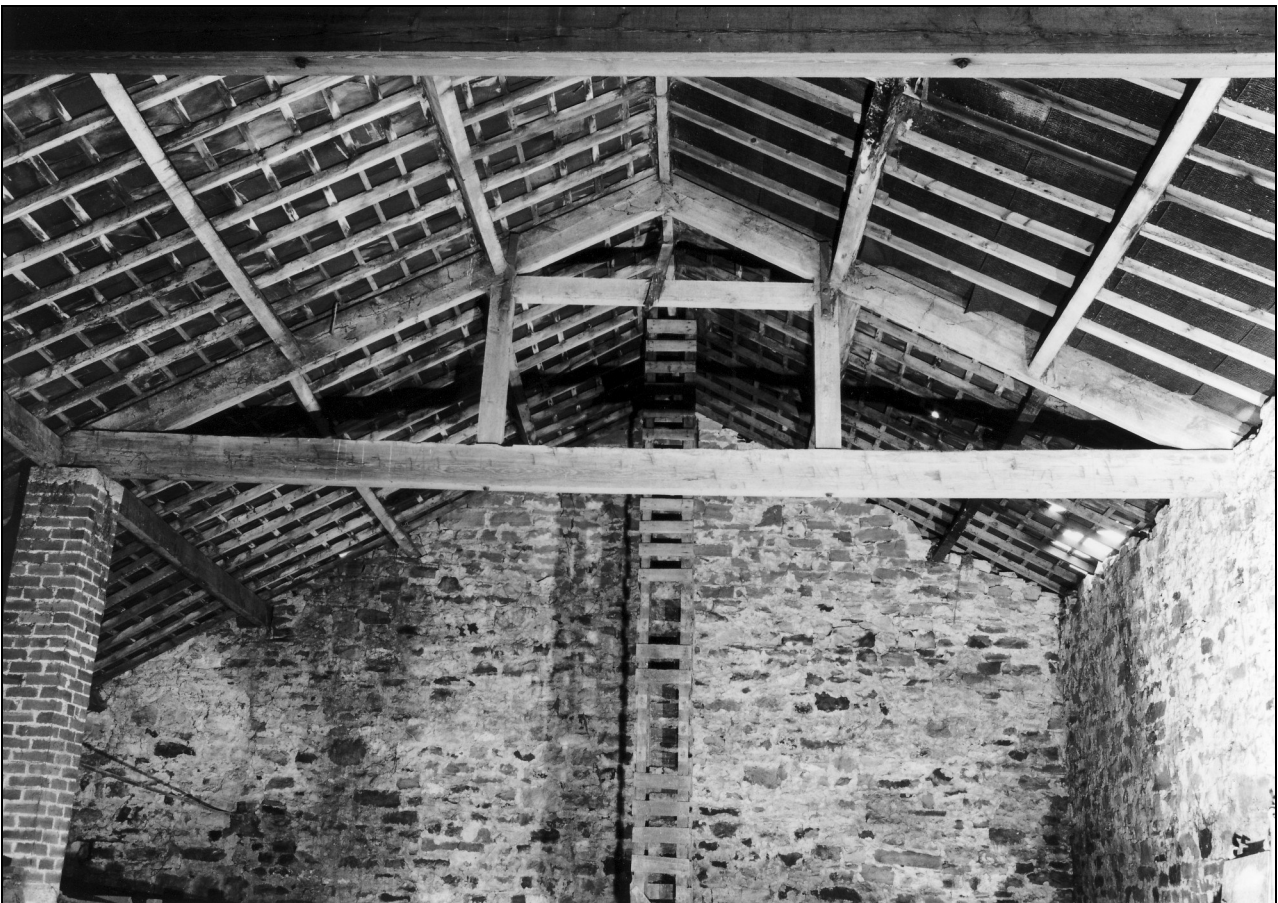
Photo 21: Roof structure over barn, from the south-east

- 6.7 The south-west side of the barn's mewstead comprises a timber partition enclosing the shippon and supporting a hay loft, interspersed by three brick piers carrying the roof trusses (20), and with a masonry wall at the south-east end enclosing a small room, probably a dairy. Nothing of the south-west side of the original building survives, although its position may be indicated by the straight joint in the north-west gable. Likewise, the roof structure is wholly of late 19th century date, the three queen-strut trusses and the purlins being fashioned from sawn imported softwood (21).

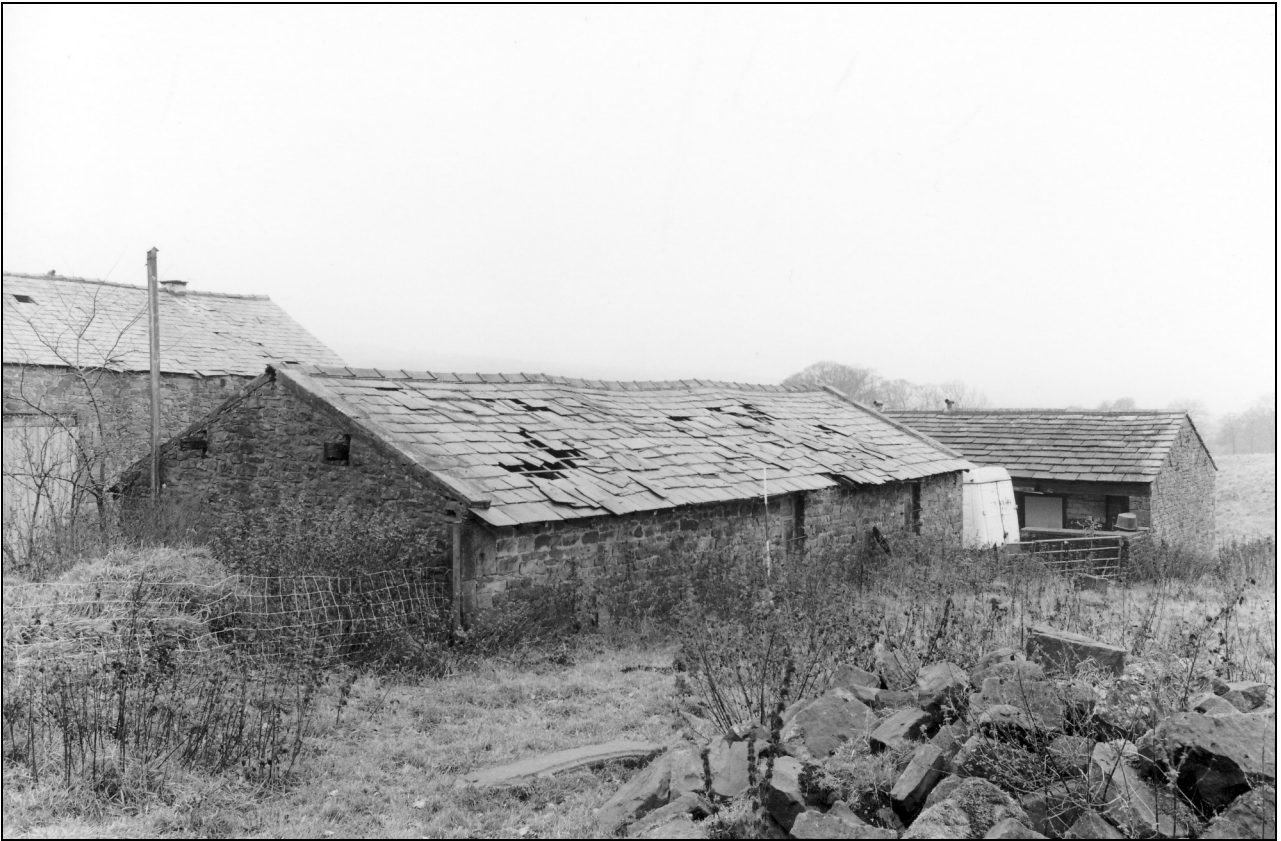
Photo 39: Cart shed, from the east

- 6.10 The cart shed appears to be the earliest of the outbuildings recorded, and was probably built during the second half of the 19th century, but has been much altered during the 20th century. It is a single storey, rectangular building with two wide doorways and two windows in the south-west front, and two windows in the rear elevation (37-39). The walls are of sandstone, coursed to the front but random rubble elsewhere, and the roof is of blue slate with tile ridge. There are no features of interest inside the building.

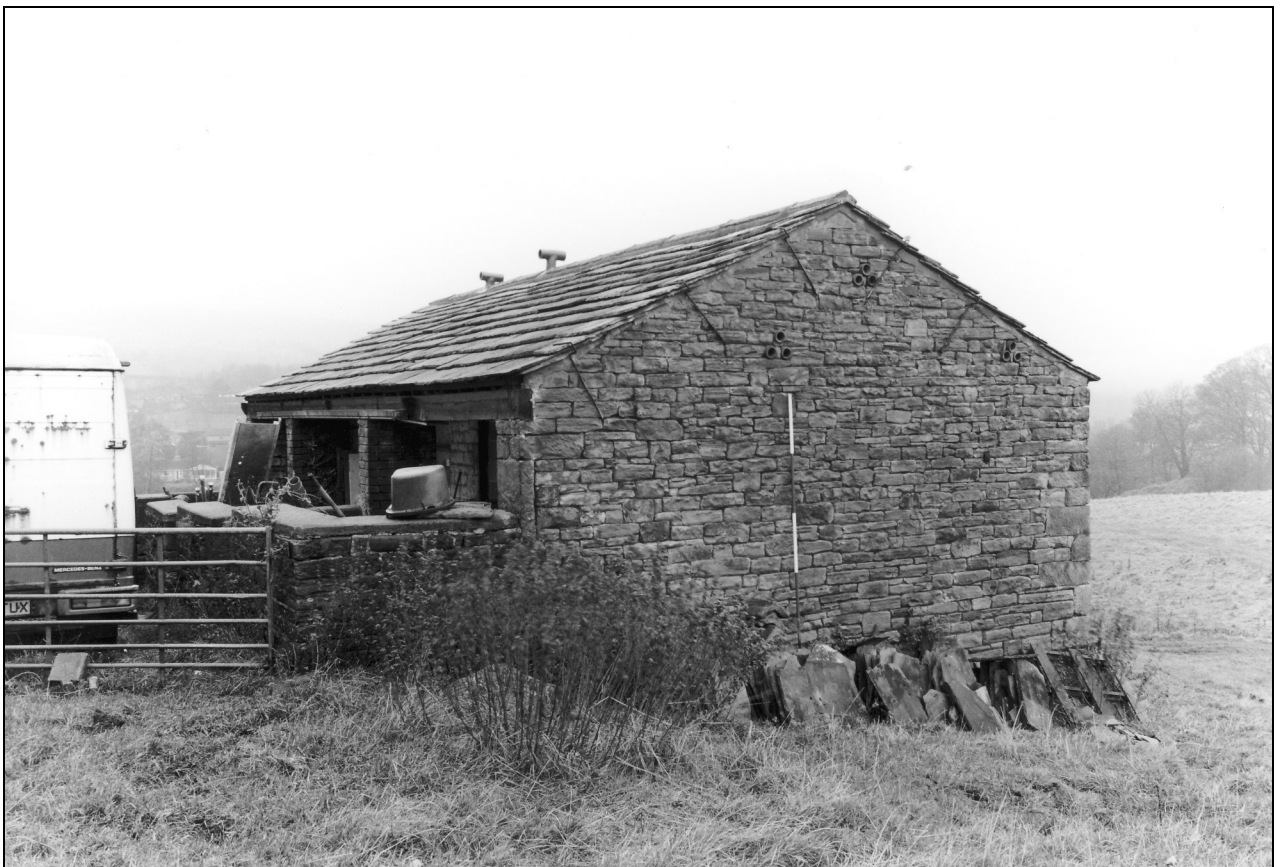
Photo 40: Pig sties, from the east

- 6.11 The pig sties, dated to between 1909 and 1928, form a short building facing south-east, of coursed rubble and brick and with a stone slate roof and tile ridge. There are three sties, each with its own pen enclosed by a yard wall, and each is lit by a high window in the rear (40-42).

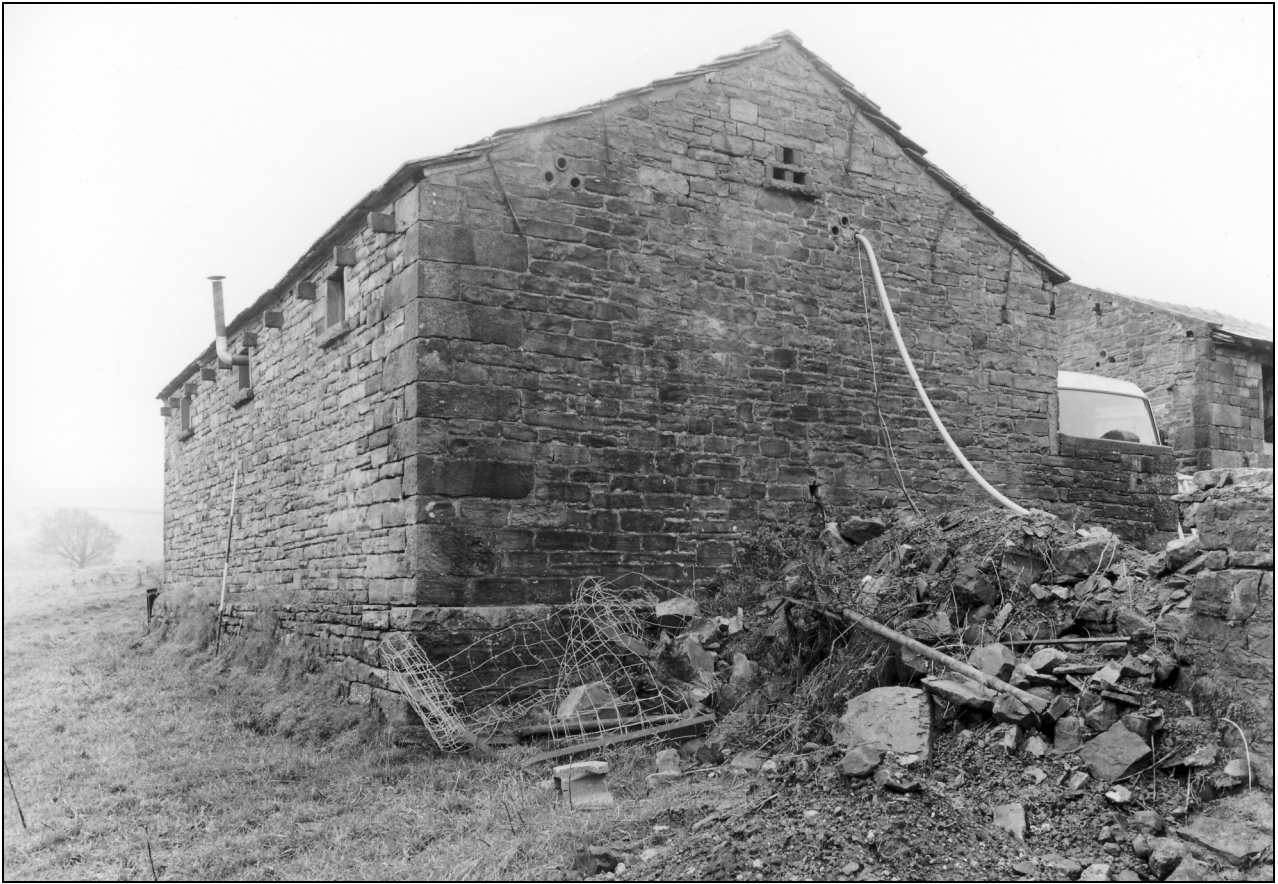
Photo 42: Pig sties, from the west

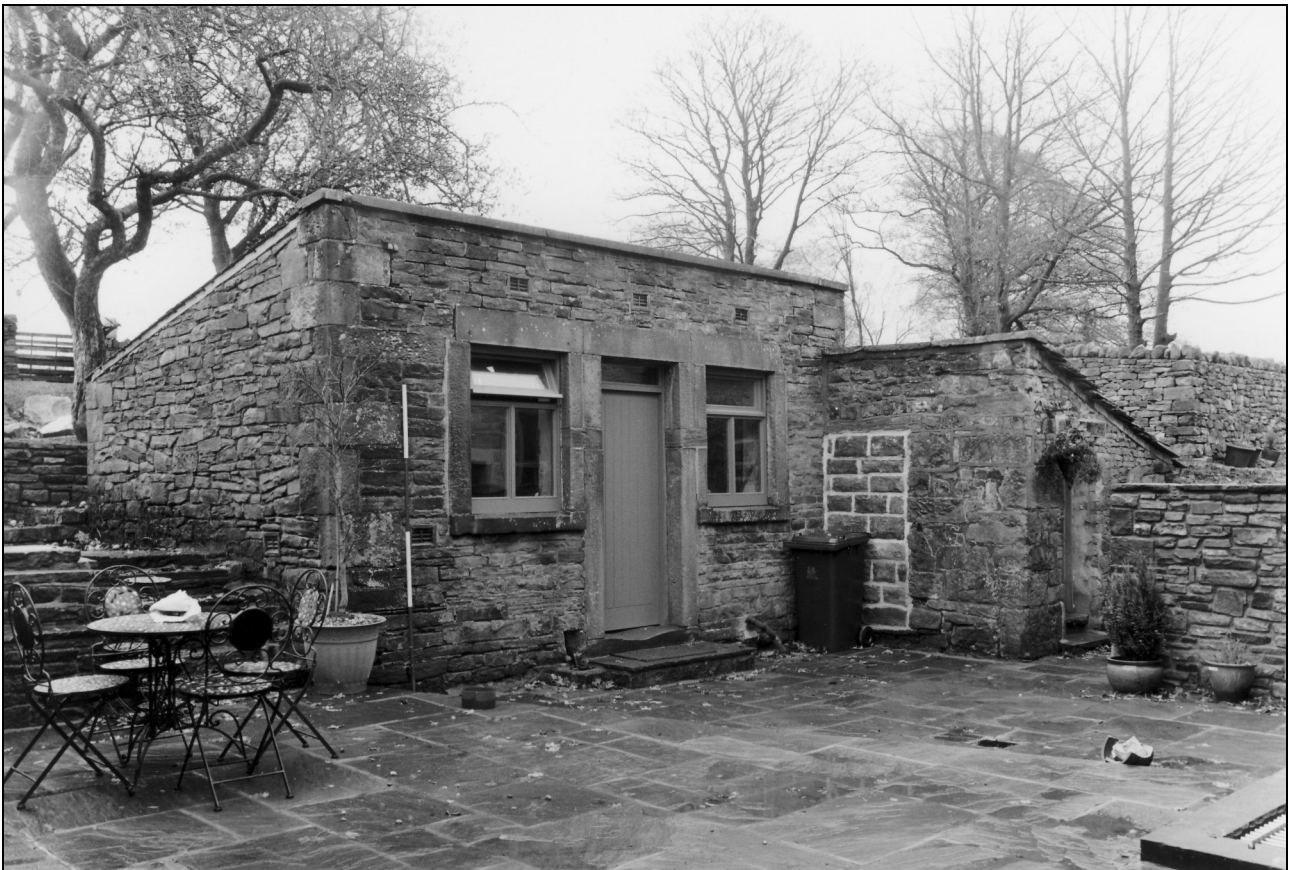
Photo 43: Former wash-house, from the west

- 6.12 The wash-house to the south-east of the barn is mostly of the same period (ie early 20th century), although it adjoins a smaller building which maps show to

have been extant in 1890 – 1892, and was probably an earth closet or privy originally (43).
