Buildings at Old Hall Farm
Kirkby Lonsdale Road, Over Kellet, Lancashire:
Historic Buildings Record (Level 3 Survey)

June 2019

STEPHEN HAIGH

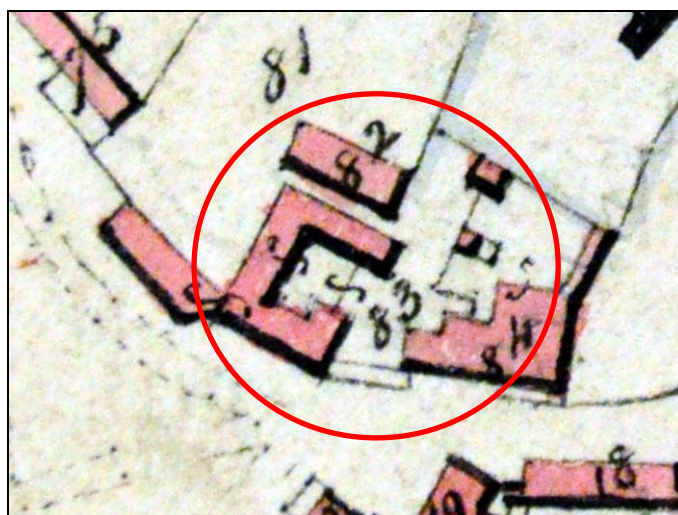
4: Tithe map, 1840⁴

- 6.2 The earliest evidence for the buildings recorded, identified during the present survey, is the tithe map of 1840 (figure 4). On this map, Buildings 1 and 2 are clearly shown, though at that date, the yard they partly enclosed adjoined a north-east range (since demolished), to form three sides of a fold-yard, opening to the south-east. The present Building 10 appears to have formed the outer end of that demolished range. Building 4 was at that time a detached structure (marked as “82”); Building 7 was also extant at that date. There was also a long building to the west of the site, since demolished, but clearly forming part of the farmstead at that time.

- 6.3 The accompanying tithe schedule records that the holding was owned by John Bond Esq, and occupied by John Maudesley. It formed a 240 acre tenancy, which at that date was a substantial one and the largest in the township. (Bond himself owned 1000 acres in Over Kellet.) The farmstead was not named: item 84 was simply noted as “House and garden”; 82 as “Barn”; and 83 as “Barns and fold”.

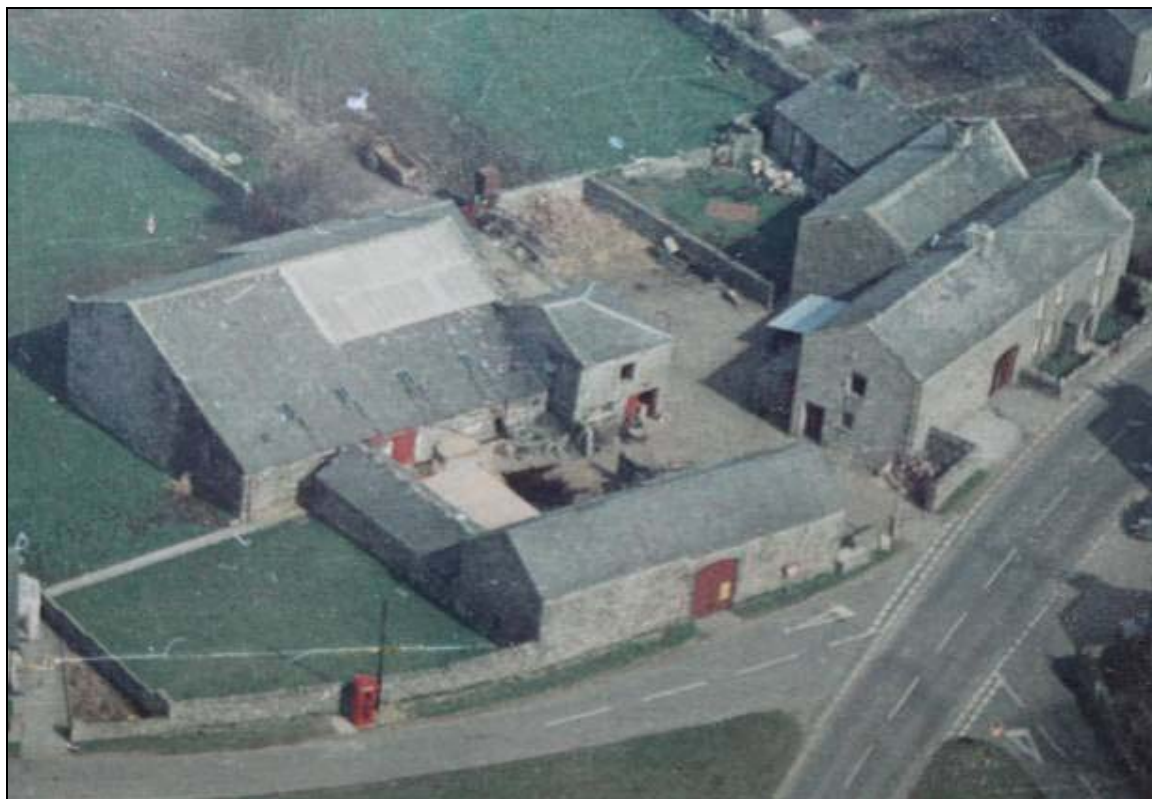
8: Aerial photograph taken from the south-west, 1960s or early 1970s

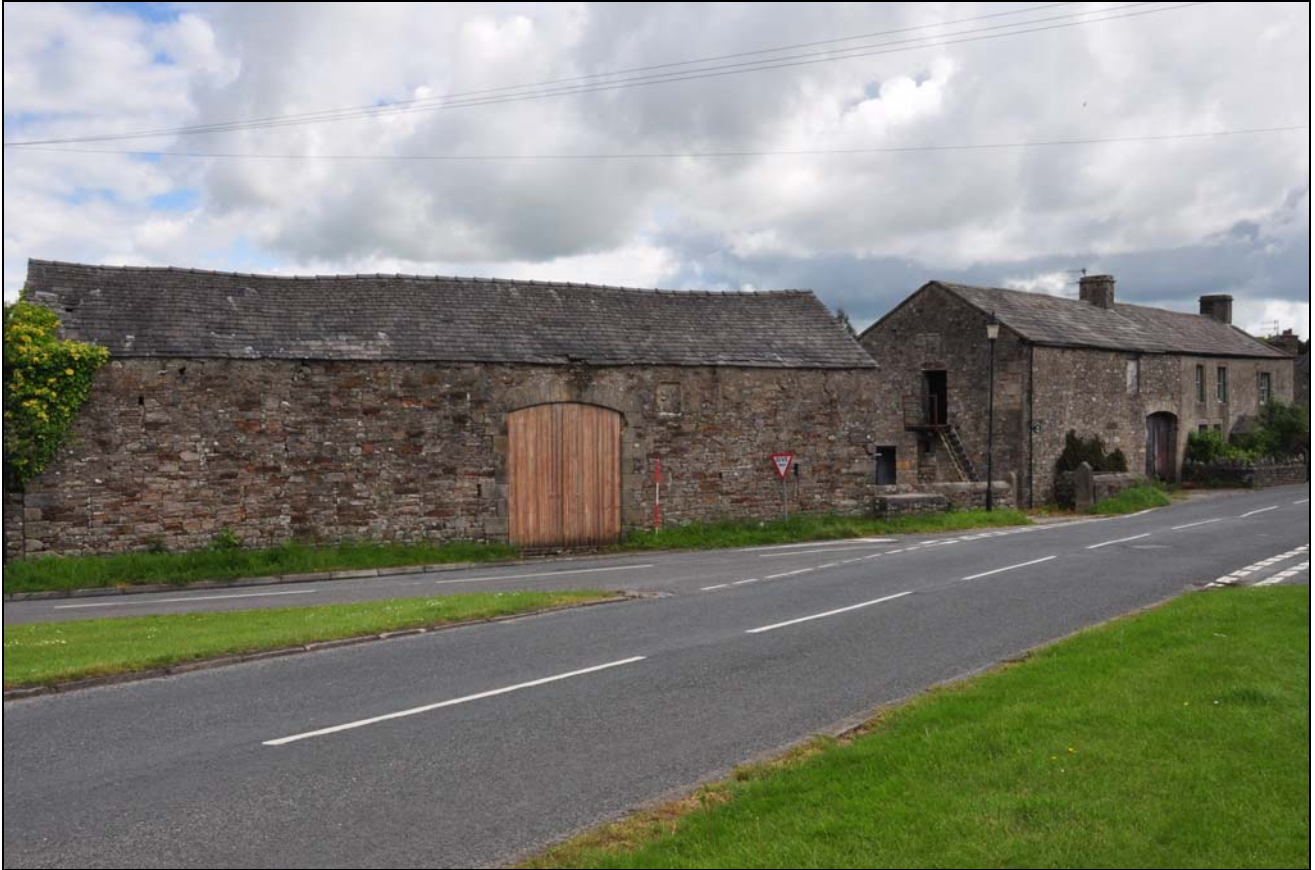
- 8.1 This substantial former combination barn stands alongside the road, at the front of the property, and to the west of the entrance to the farmyard (**1**). It has an L-shaped plan, seven bays long, with the two south-eastern bays being slightly wider than the rest. Walls are of sandstone rubble, with variation in the type used, and the few dressings are generally plain, squared sandstone. The majority of the roof is laid with metamorphic slate (of uncertain origin – either Wales or Cumbria most probably), and a tile ridge, but a small portion of the rear pitch retains stone slates, and this earlier, locally derived material is presumed to have been the original covering throughout the building (**2**). The barn is thought to be 18th century, or possibly late 17th century.

Photo 1: General view of the farm from the green, looking north-east

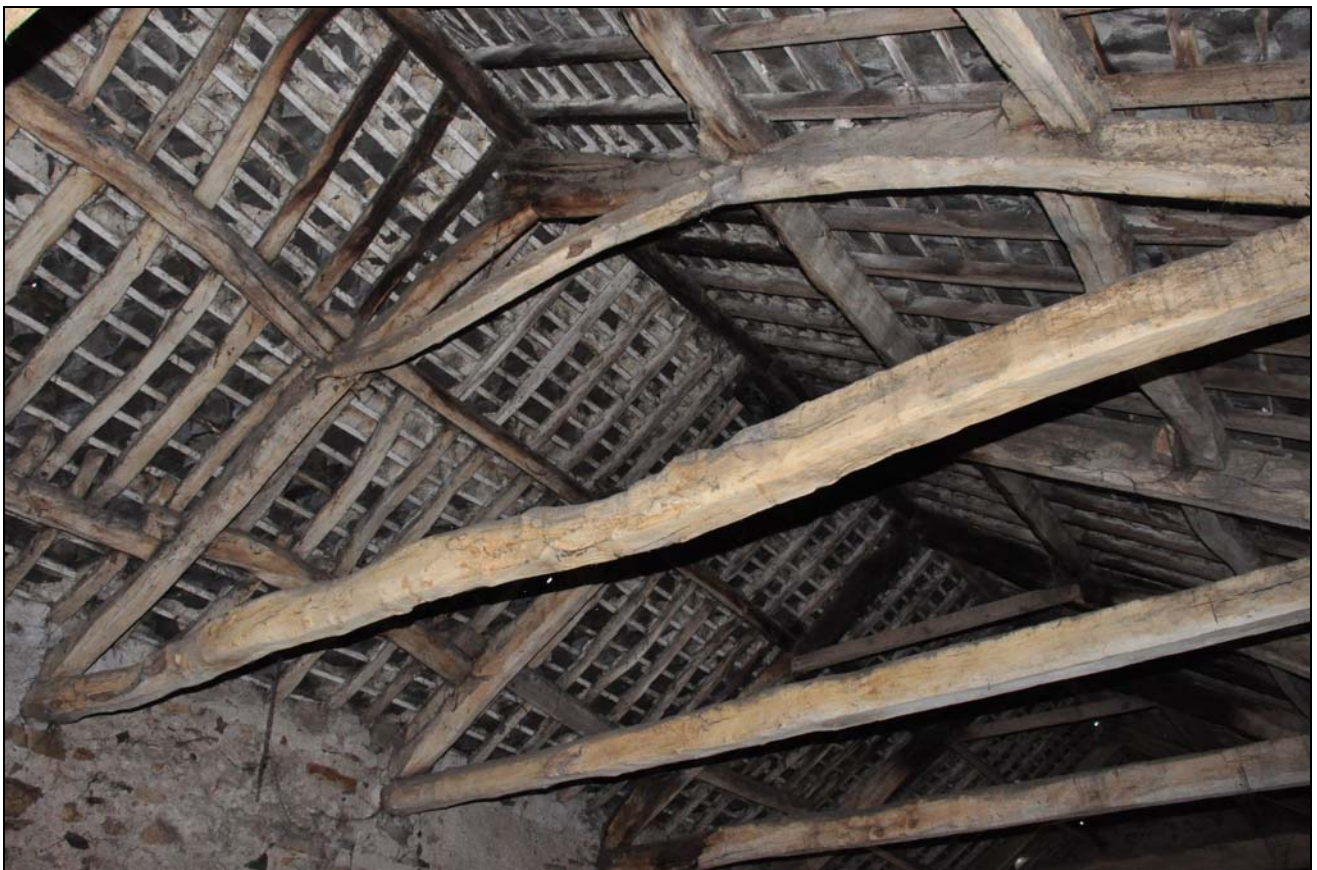
are of principal rafter type, with the members pegged at the ridge, and most have pegged collars (26). The absence of historic collars from some of the trusses may have been intended to facilitate movement of hay through the trusses, though the pattern is not clear, as some of the trusses now have modern collars, which may or may not have replaced earlier ones. The trusses are numbered with simple Roman numerals from I to IIII [5], starting from the north-west end of the building, with the numbers facing north-west (27), although no number was observed on the south-east truss, which is in poor condition. The tie beam and one principal rafter of truss I are constructed from former crucks, to deduce from halvings and peg holes (28-32). Elsewhere, some of the timbers are notable for their irregularity, indicating a scarcity of good oak, as might be expected in a lightly-wooded region at a relatively late date (33). This is particularly true of original rafters within the rear pitch, which are of short length, and only run between one pair of purlins (34).

Photo 26: Building 1: roof trusses, looking east

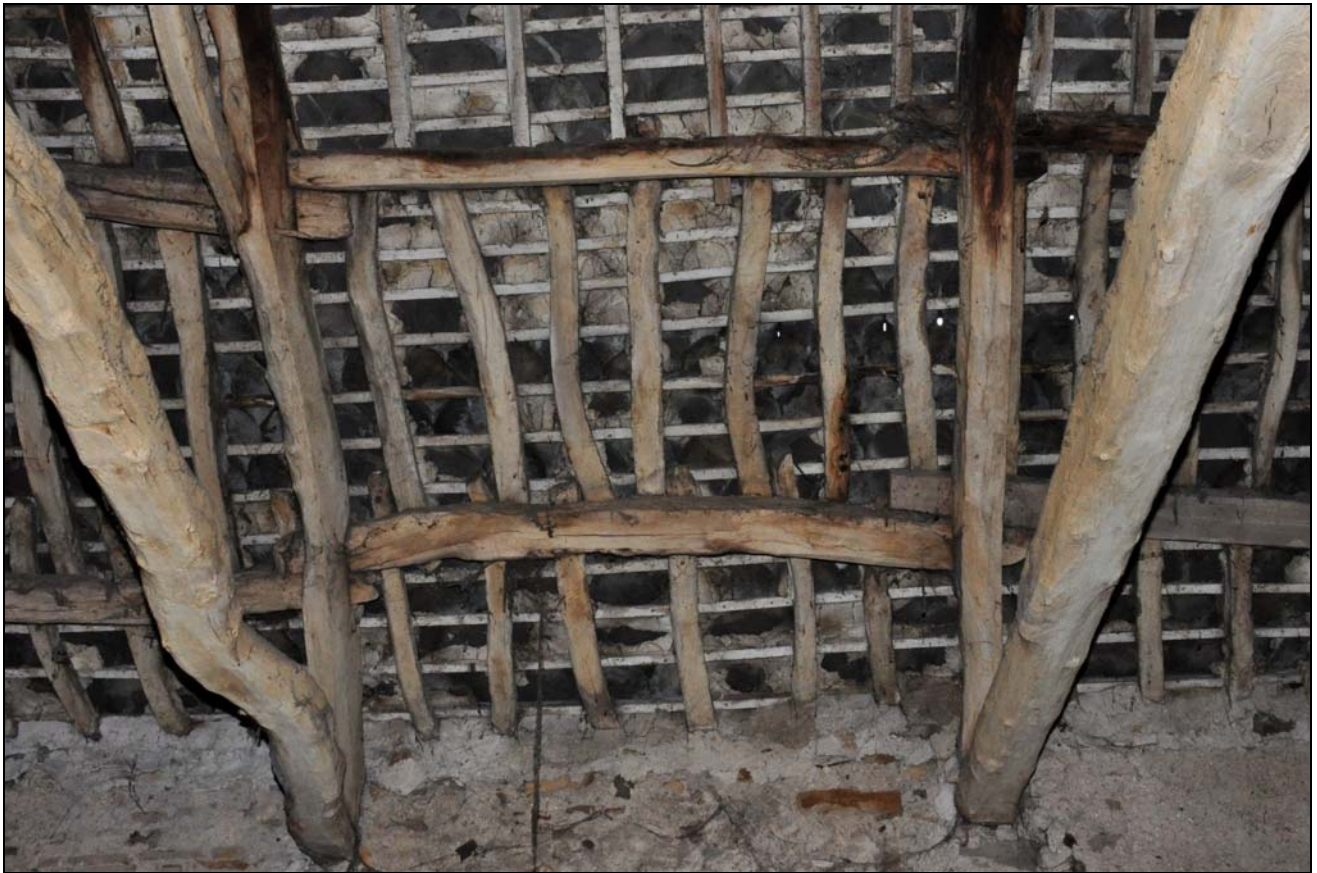
Photo 34: Building 1: underside of rear roof pitch, showing original rafters

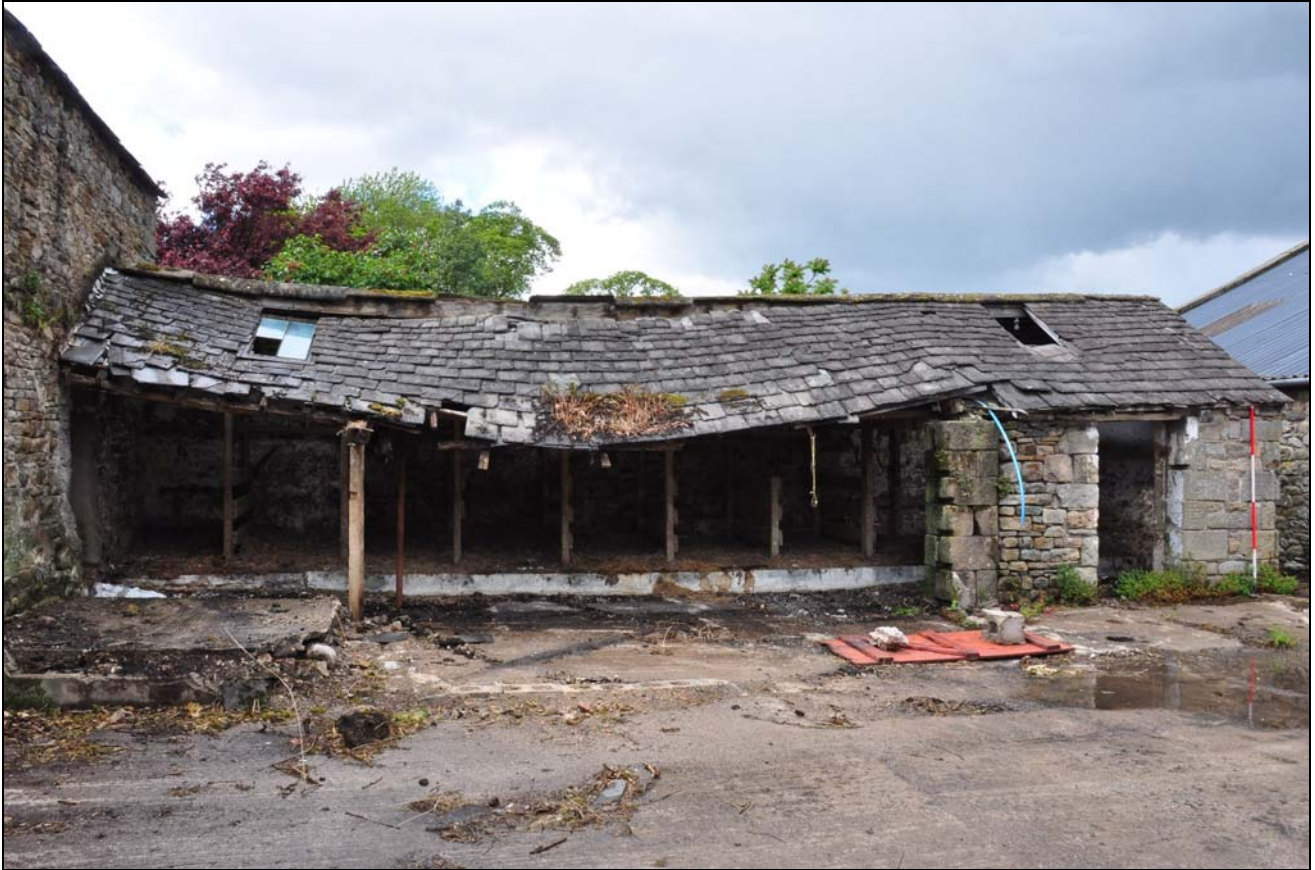
- 8.9 The shed appears to have been fully open-fronted originally⁹ (37), with the roof trusses then supported on this side by a row of piers built up from large blocks of dressed stone, only one of which survives in situ however (38,39). The exposed side of this pier is notable for the L-shaped slots cut into it for horizontal poles, as a means of containing cattle within the building or yard; it can be assumed that there are slots on the other side of the pier, but here a later wall has been built, when the shed was shortened in about 1900. The rear wall is of coursed rubble and contains a blocked doorway (40); the roof is covered with metamorphic slate and a sandstone ridge, but the original covering might have been stone slates.

Photo 37: Building 2: front elevation

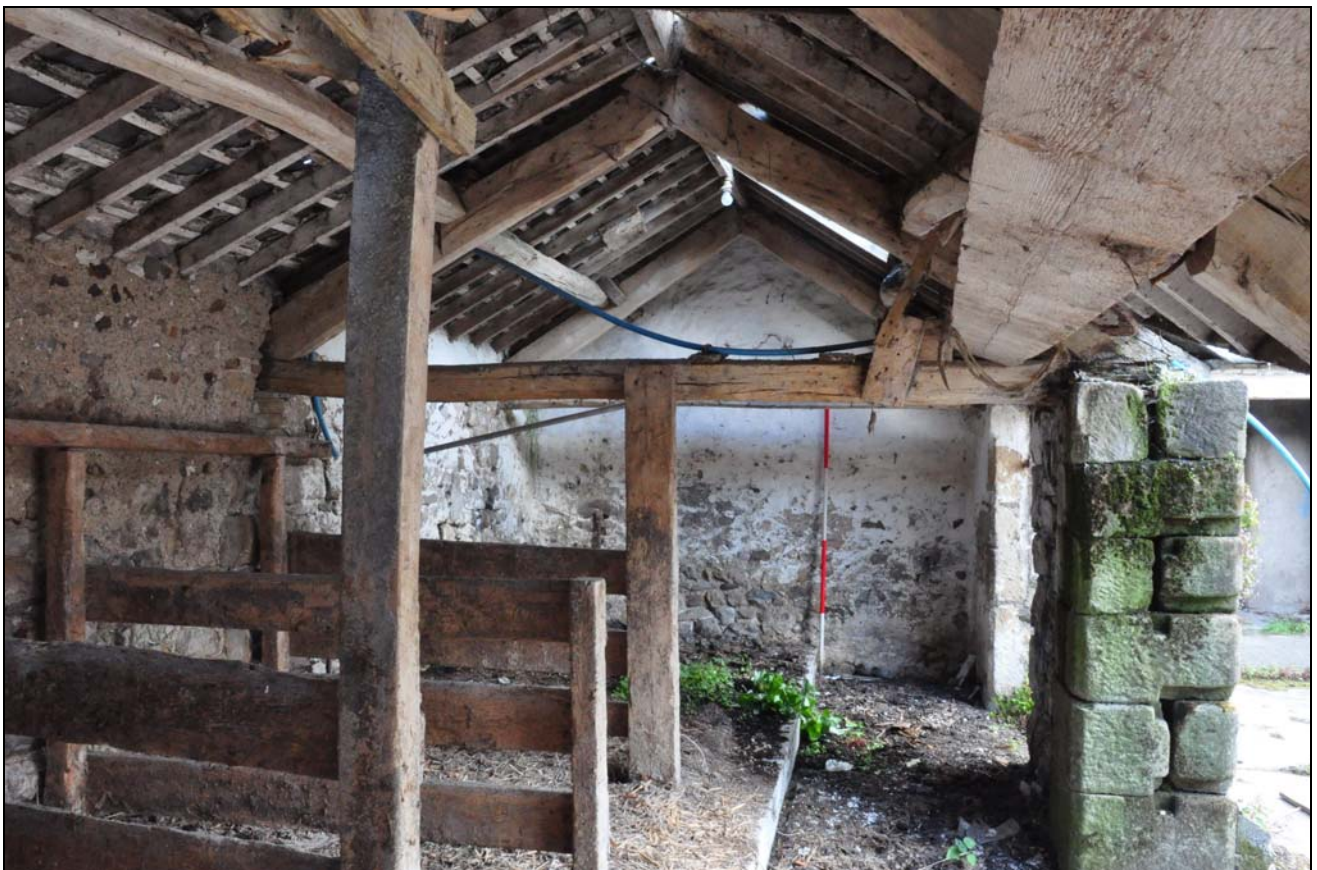
- 8.10 The shelter shed is likely to have been a single, undivided space originally, but in the 20th century it was given a concrete floor and timber stalls or cubicles were inserted (41,42), with a small separate room at the north-east end, perhaps a loose box. The principal rafter roof trusses and purlins are oak, with the former being notched and pegged at the ridge, but the rafters themselves are sawn softwood (43). The proximity of the north-east truss to the end wall indicates how the building has been shortened (44).

Photo 42: Building 2: interior, looking north-east

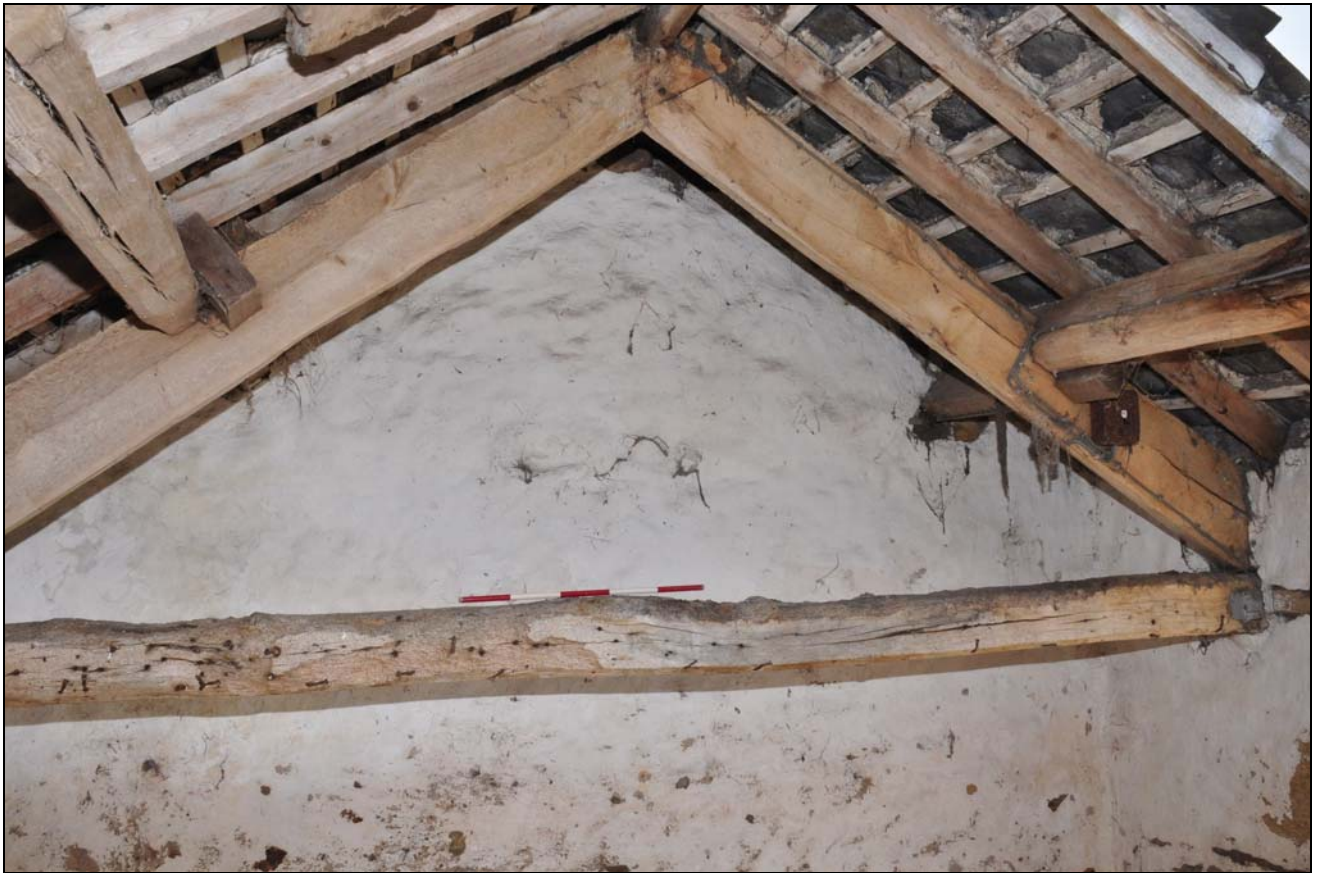
Photo 44: Building 2: end roof truss, looking north-east

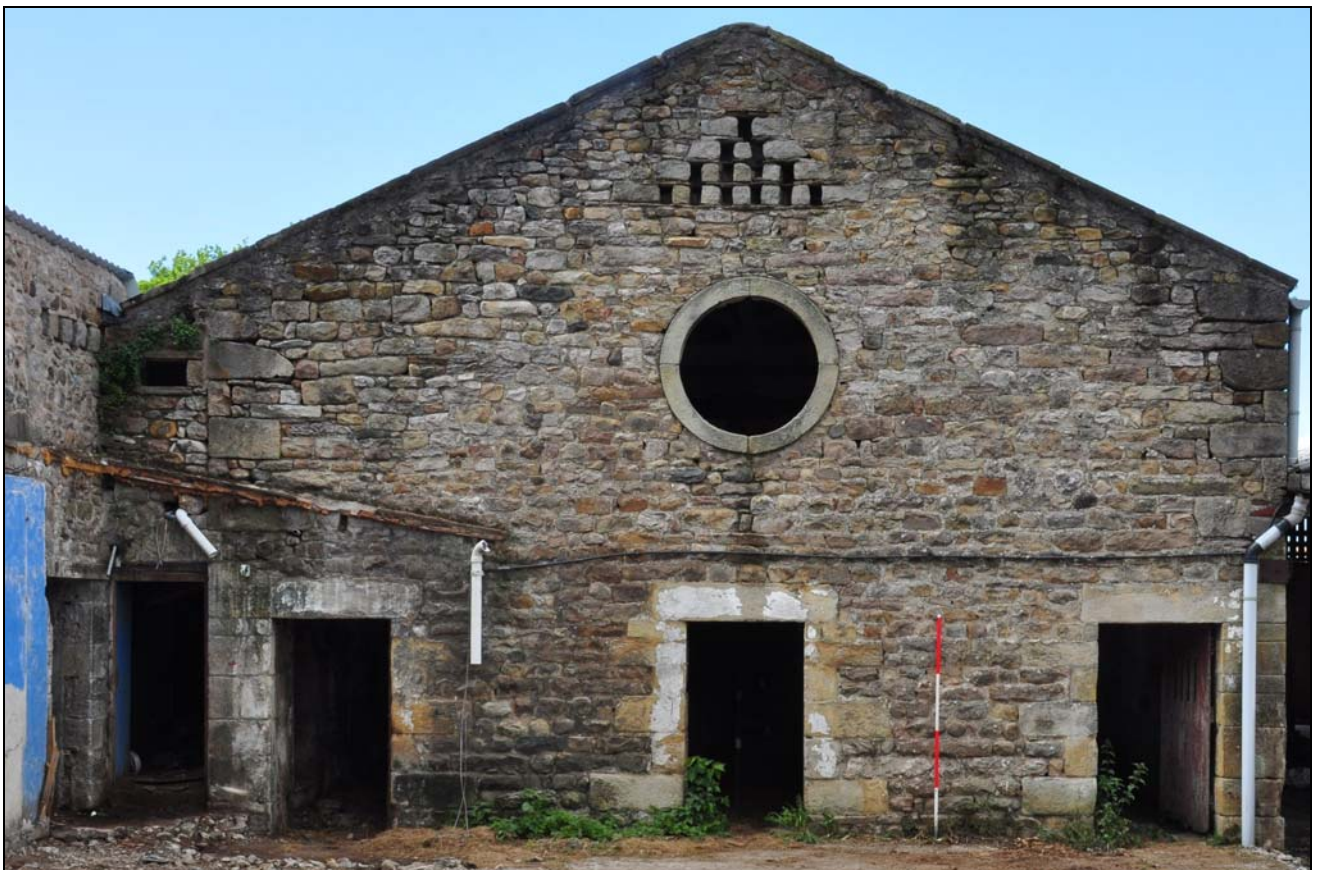
- 8.13 The barn's south-east gable is presently the most prominent of the elevations (46), as the north-east side, which contains the main entrance to the threshing bay, now faces into a portal-framed shed of the 1970s. The gable has an arrangement of three shippon doorways (the central one to the feeding passage) (47), with a central, circular forking hole at loft level (missing its internal shutter), and there is a triangular arrangement of pigeon nesting-holes above (48). Also notable in this gable is the re-use of a shaped kneeler, upside-down, within the left-hand quoins.

Photo 46: Building 4: south-east gable

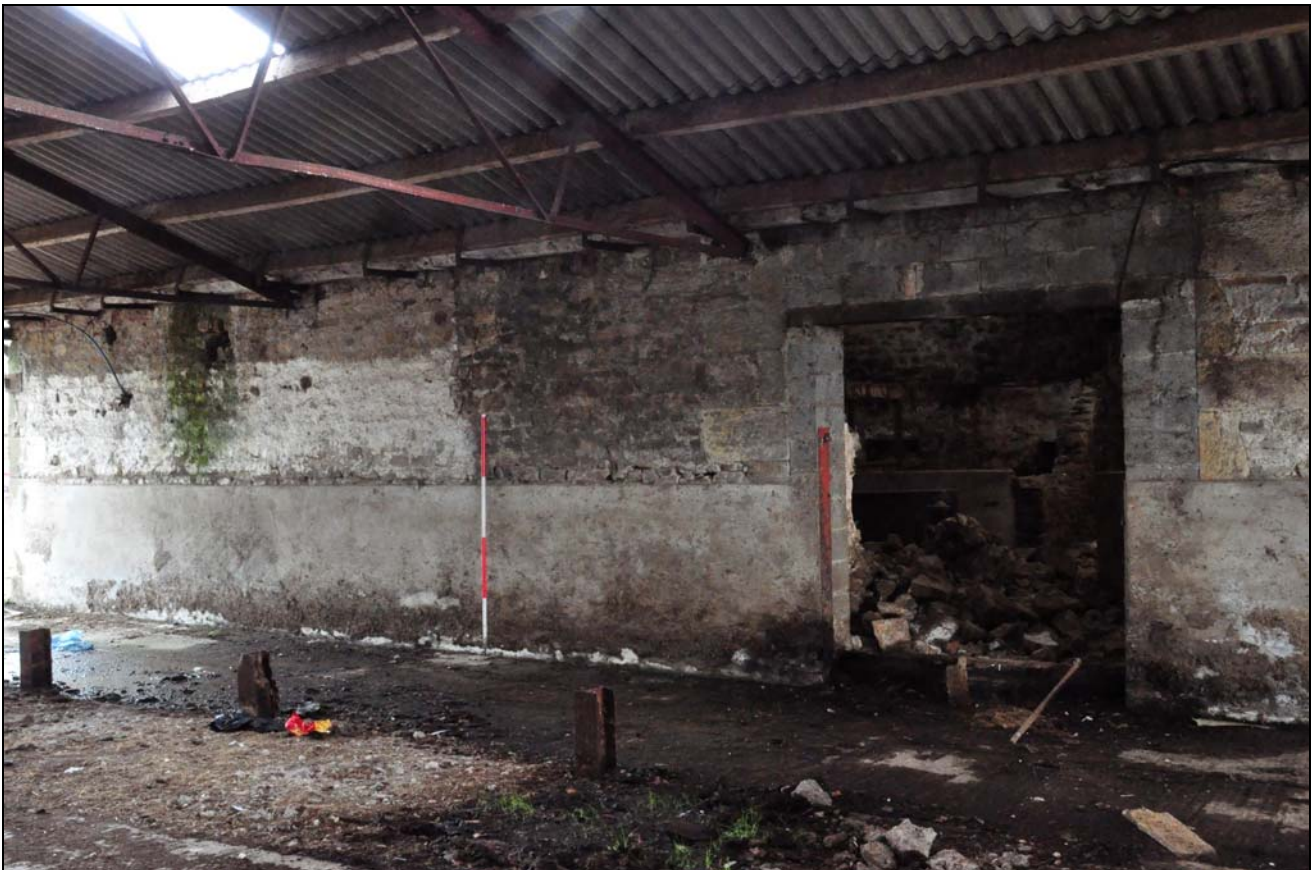
- 8.14 The barn's long, north-east elevation contains a cart entrance, reduced in size by modern blockwork, and its arch hidden by the adjacent shed roof (49-51). However, a stone arch with timber lintel beneath can be seen from inside the barn (52). A second doorway of similar size has been inserted to the right, in the late 20th century. A number of breathers, at ground floor and loft level, can also be identified within this wall from inside the building, and similar breathers are also present in the north-west gable (the lower ones blocked) (53); this gable also has a small, plain owl-hole. The presence of Building 3, together with whitewash, internal render, and a modern milking parlour, all hinder details within the south-west elevation. However, the original winnowing doorway to the threshing bay remains intact (54), as do some of the higher level breathers.

Photo 51: Building 4: cart entrance in north-east side, looking south

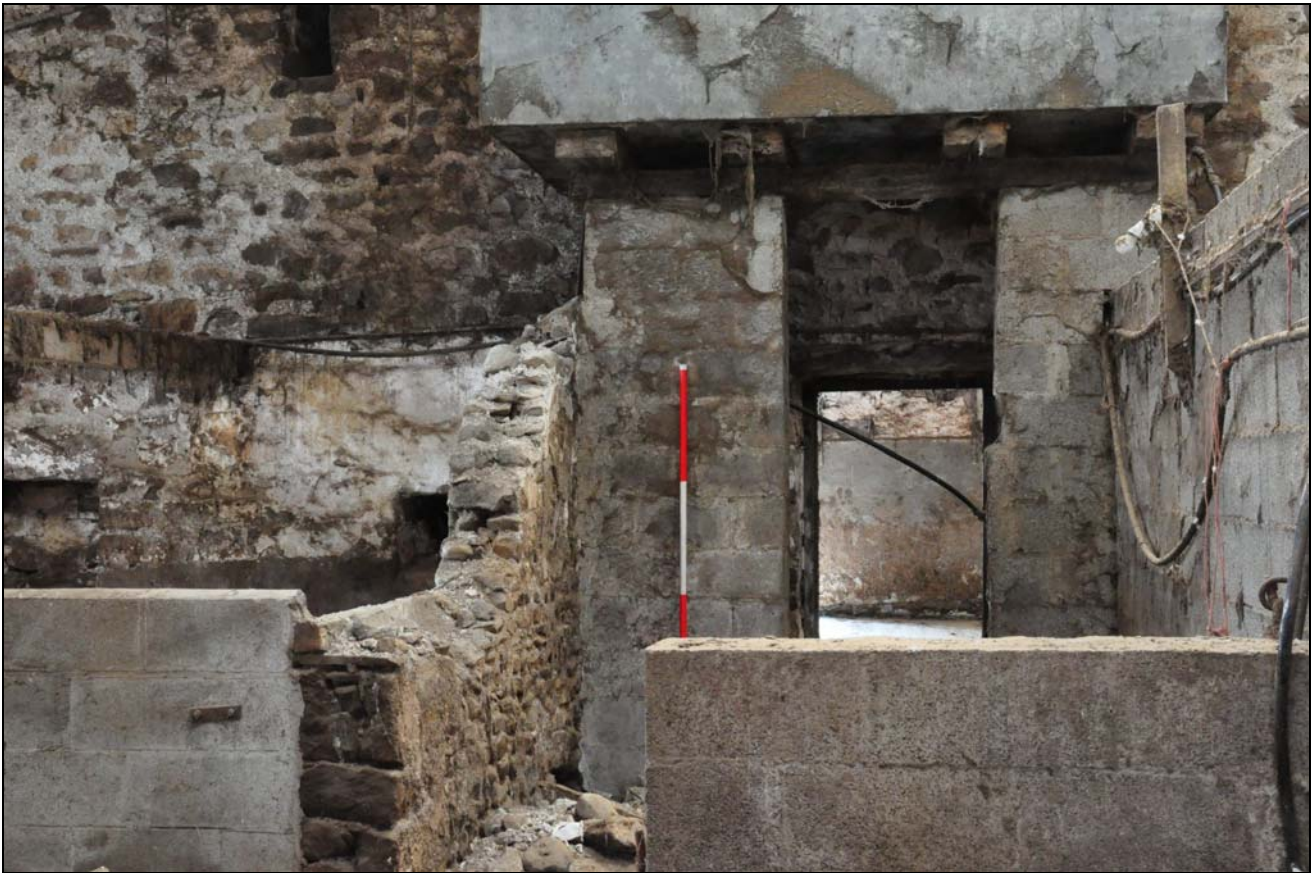
- 8.15 A thin rubble cross-wall within the barn, now largely demolished, separated the shippon from the threshing bay, and supported the end of a hayloft (55-57). Despite 20th century alterations, the essence of the shippon arrangement survives, with the central feeding passage retaining its cobbled floor. The original timber posts which supported the loft beams, and formed part of the boskins separating pairs of stalls, have been replaced by steel columns. Large upright slate flagstones also survive in places, where not replaced by concrete blockwork, and it appears that at one time these formed all the panels within the boskins, and between the stalls and the feeding passage (58-60). Recesses and breathers in the long walls would have held lamps and provided a very small amount of natural light within the shippon (61); otherwise it would have been very gloomy, given the number of openings and hayloft overhead.

Photo 55: Building 4: threshing bay, looking south-west, with remains of cross-wall at left

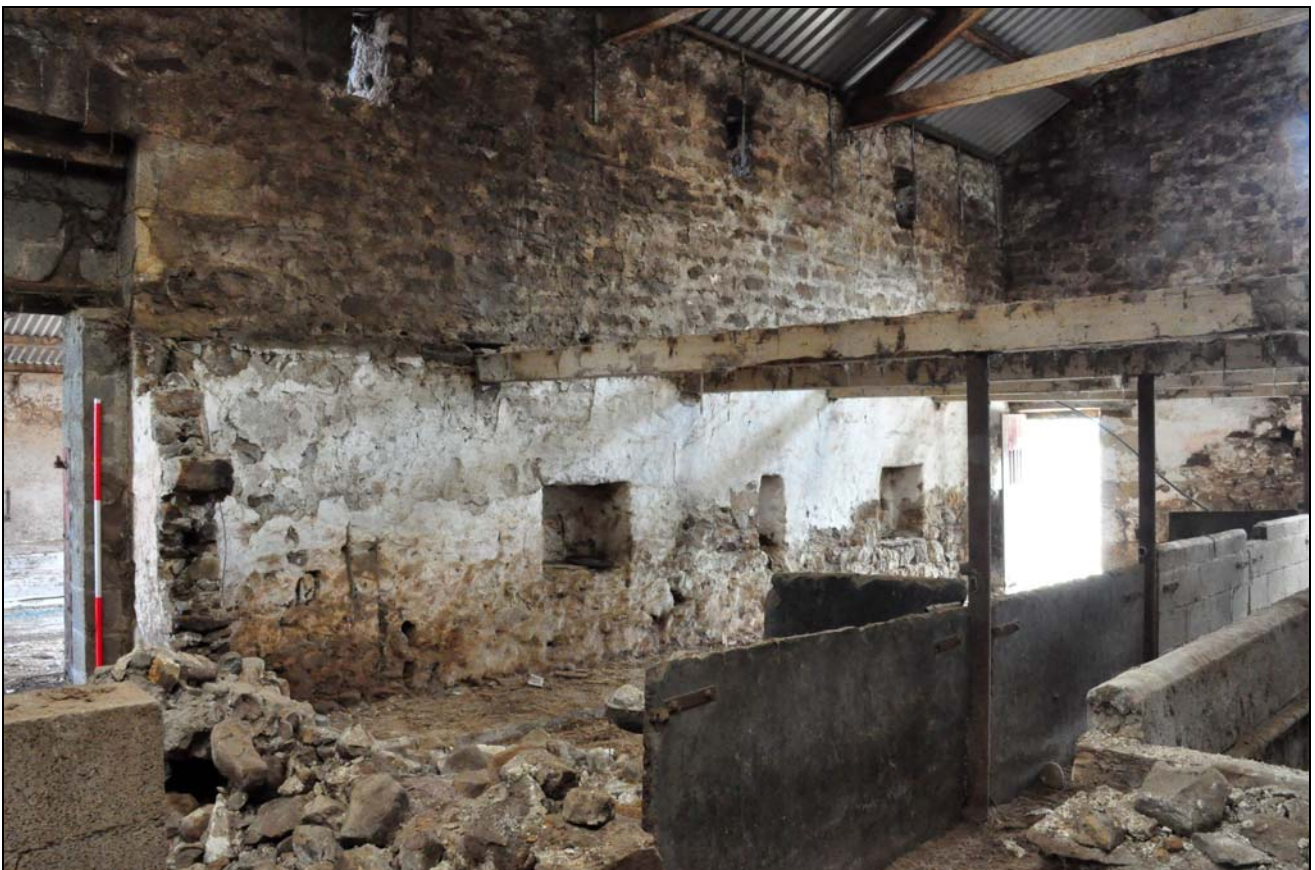
Photo 57: Building 4: view into shippon across former cross-wall, looking east

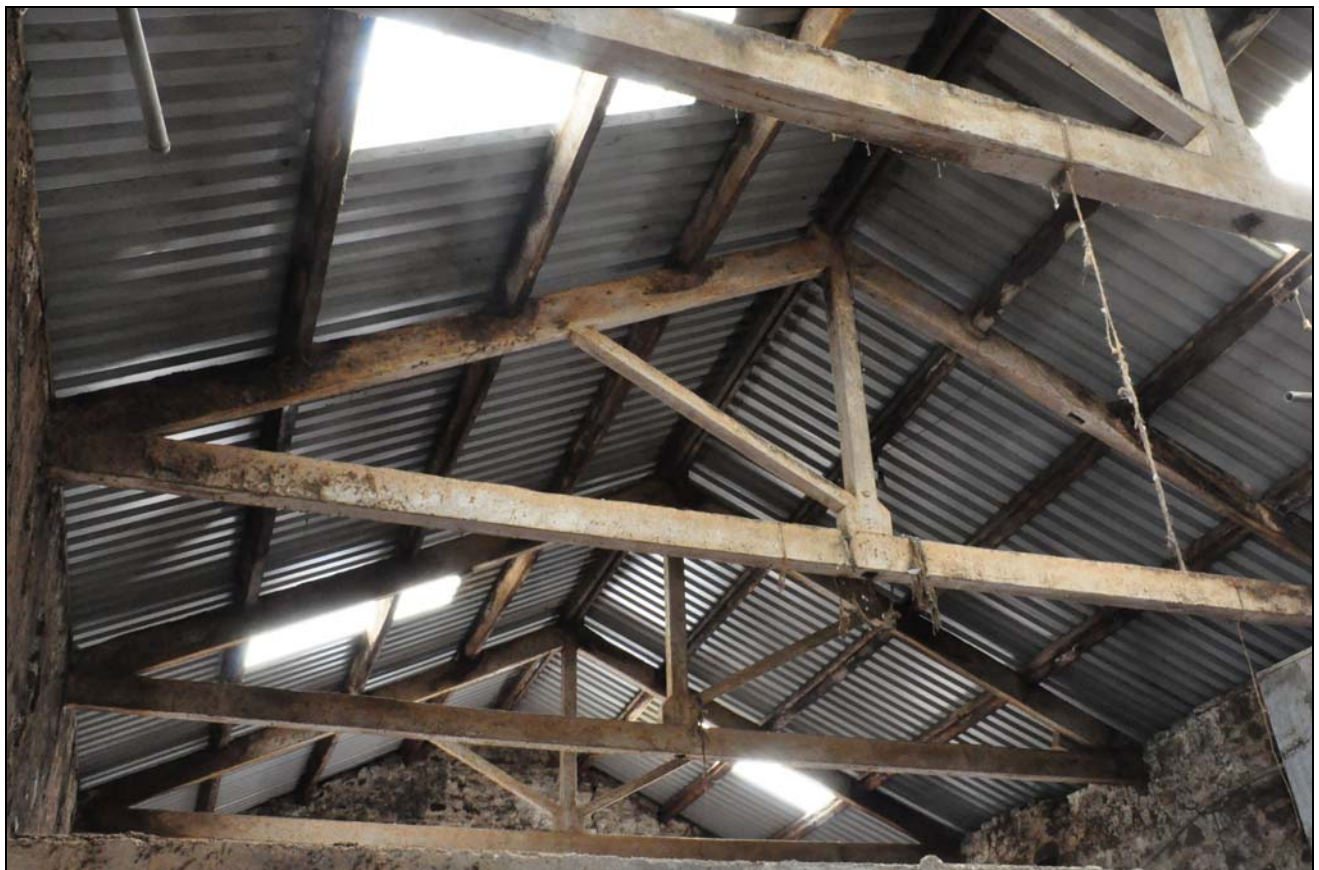
- 8.17 The barn roof consists of five identical trusses, all of imported softwood and with bolted king posts and raking struts (65,66). Some of the struts were removed in the 20th century, to allow hay to be forked more easily through the trusses. The trusses are numbered from I to IIIII [5], with I being at the south-east end (67). Although the roof trusses are entirely of softwood, there is some re-used oak within the building, for example as a lintel over the pitching eye in the south-east gable (68).

Photo 66: Building 4: roof trusses, looking south-east

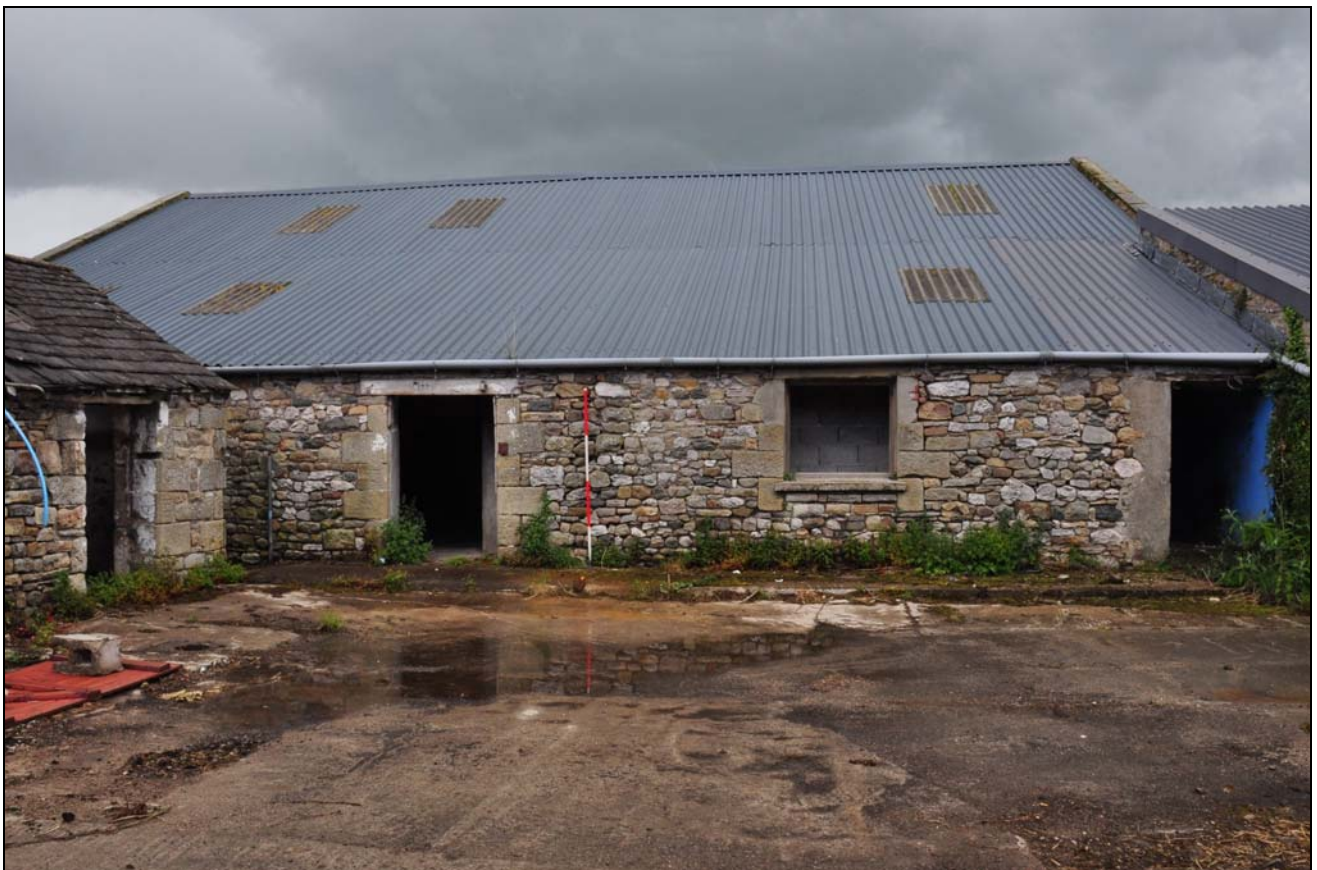
- 8.18 Building 3 is a simple lean-to addition to the south-west side of the barn, which can be dated to the period between 1890 and 1910, from Ordnance Survey maps (69). Its walls are of random rubble, and dressings vary; openings in the south-west front include two doorways and two windows (70,71).

Photo 69: Building 3: south-west side

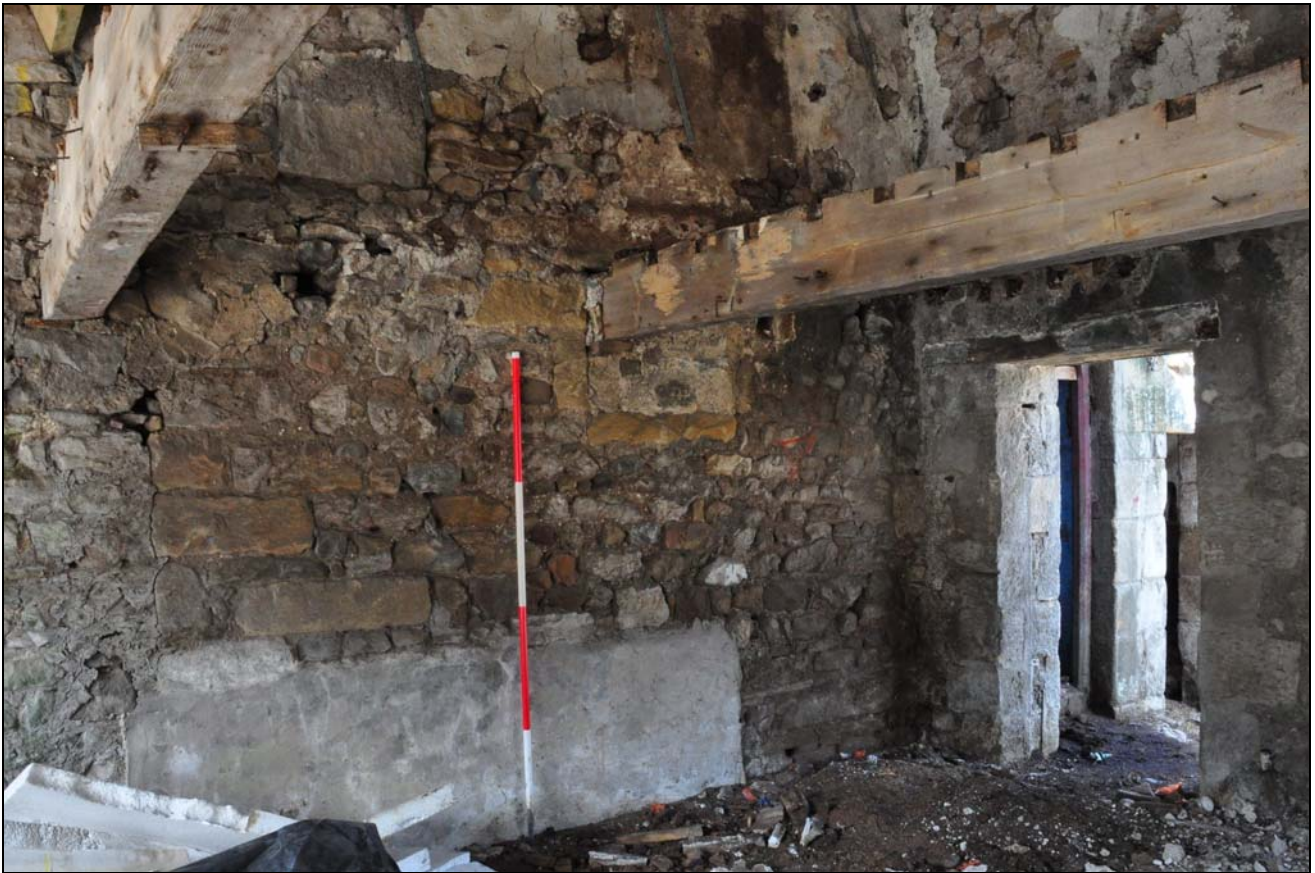
- 8.21 The interior is undivided and modern in form (**78,79**), but one or two features should be noted. A straight joint in the north-west side seems to represent the corner of the predecessor to Building 3, suggesting that Building 10 was an addition to the range which at one time formed the north-east side of the fold-yard. The blocked opening close to the straight joint contains the end of a first floor beam, and is further evidence for this phased construction. At first floor level, the east corner retains plaster to its wall surfaces, with a large amount of graffiti in both pencil, and red chalk or raddle (**80-82**). The earliest date written appears to be 1887, alongside the name G Metcalfe.

Photo 78: Building 10: interior, looking north

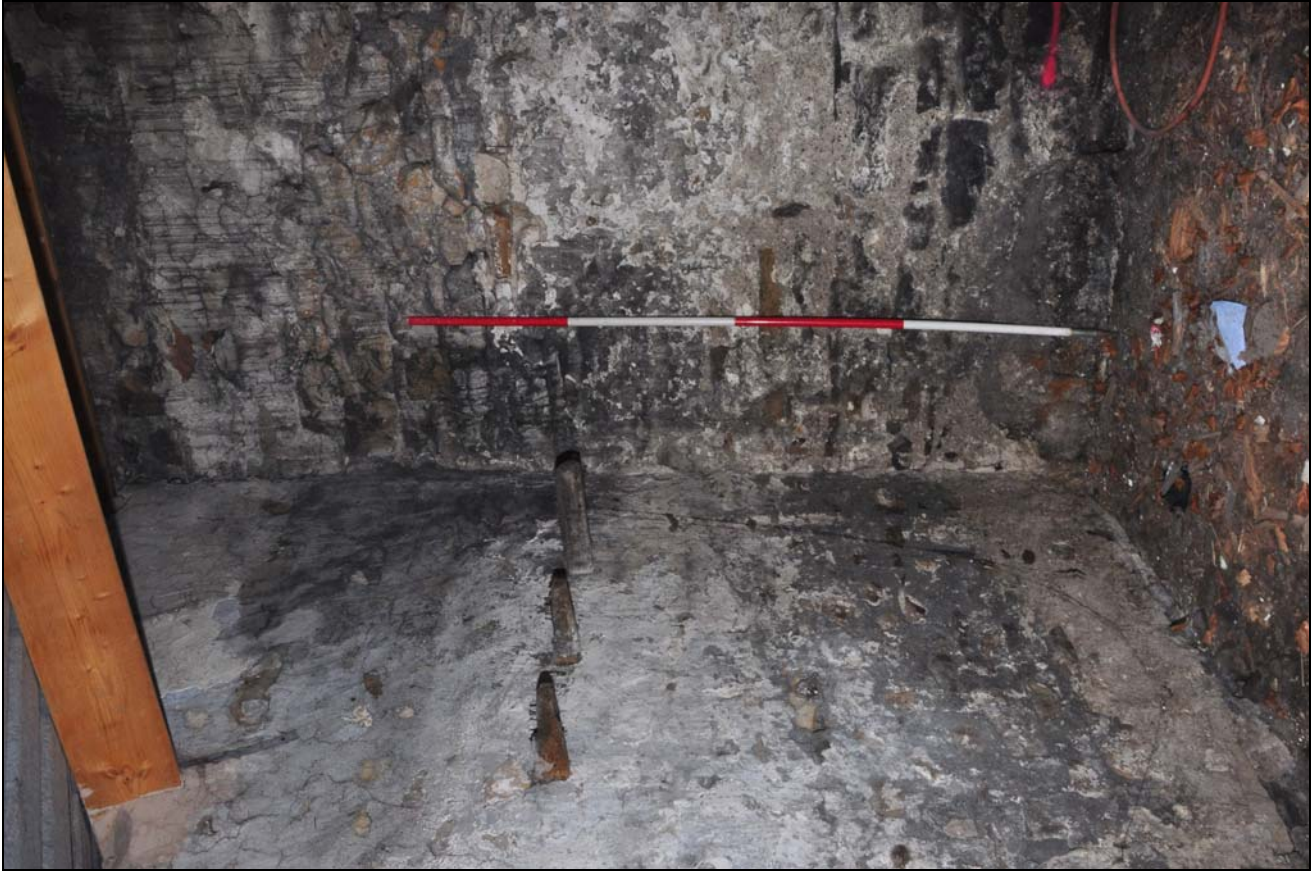
- 8.29 The north-west room lacks any fixtures or fittings, and most likely was used to accommodate livestock, as a loose box (**108**). Next to it, the smallest, central room seems to have been a small tack room, to judge from timber pegs set into one of the walls (**109**). The end room, which communicates with the rear range

Photo 108: Building 7: lean-to at rear, central room, with harness
pegs on wall at left

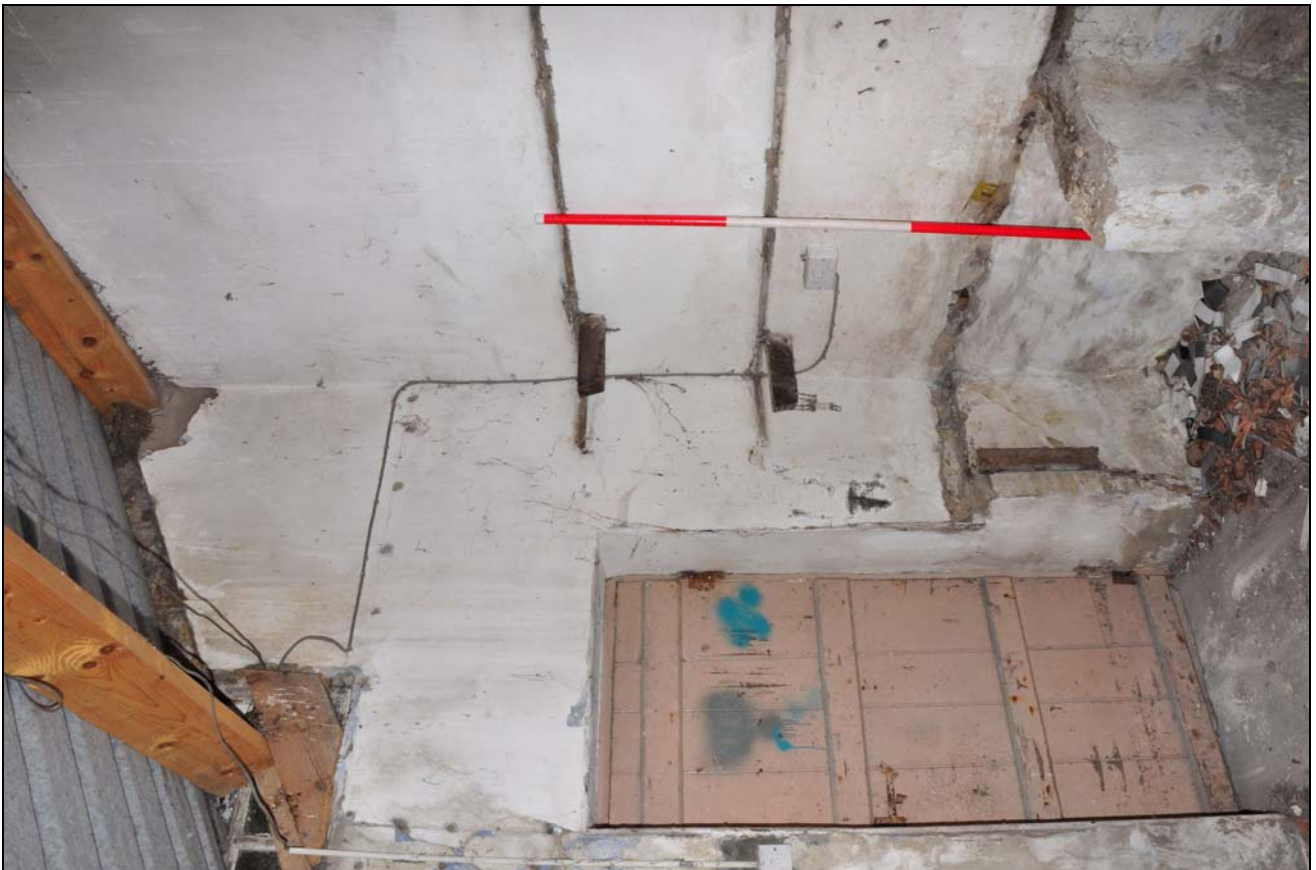
Photo 109: Building 7: lean-to at rear, east room (pantry), with
door to house and traces of shelves
