Barn at New Ing
Bolton-by-Bowland, Lancashire:
Historic Buildings Record

STEPHEN HAIGH
Buildings Archaeologist

Barn at New Ing Bolton-by-Bowland, Lancashire: Historic Buildings Record

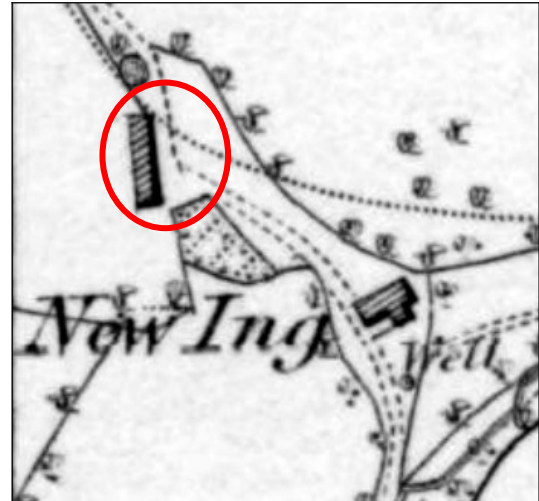
Figure 5: OS 1:10560 map, 1853

- 6.3 The Ordnance Survey's 1:10560 map, surveyed 1849-50⁷ (figure 5), depicts the same arrangement of buildings, but their 1:2500 map, surveyed in 1892⁸ (figure 6), shows significant changes to have taken place. These include the construction of the outbuilding to the east of the barn, and the creation of an enclosed lane in place of the formerly wide yard around the house. It is also apparent from this map that the barn range had nearly attained its present length, although a later edition of the map, revised in 1907⁹ (figure 7) shows that it was again extended to the north before 1907, and the detached outbuilding was lengthened to the south during the same period.

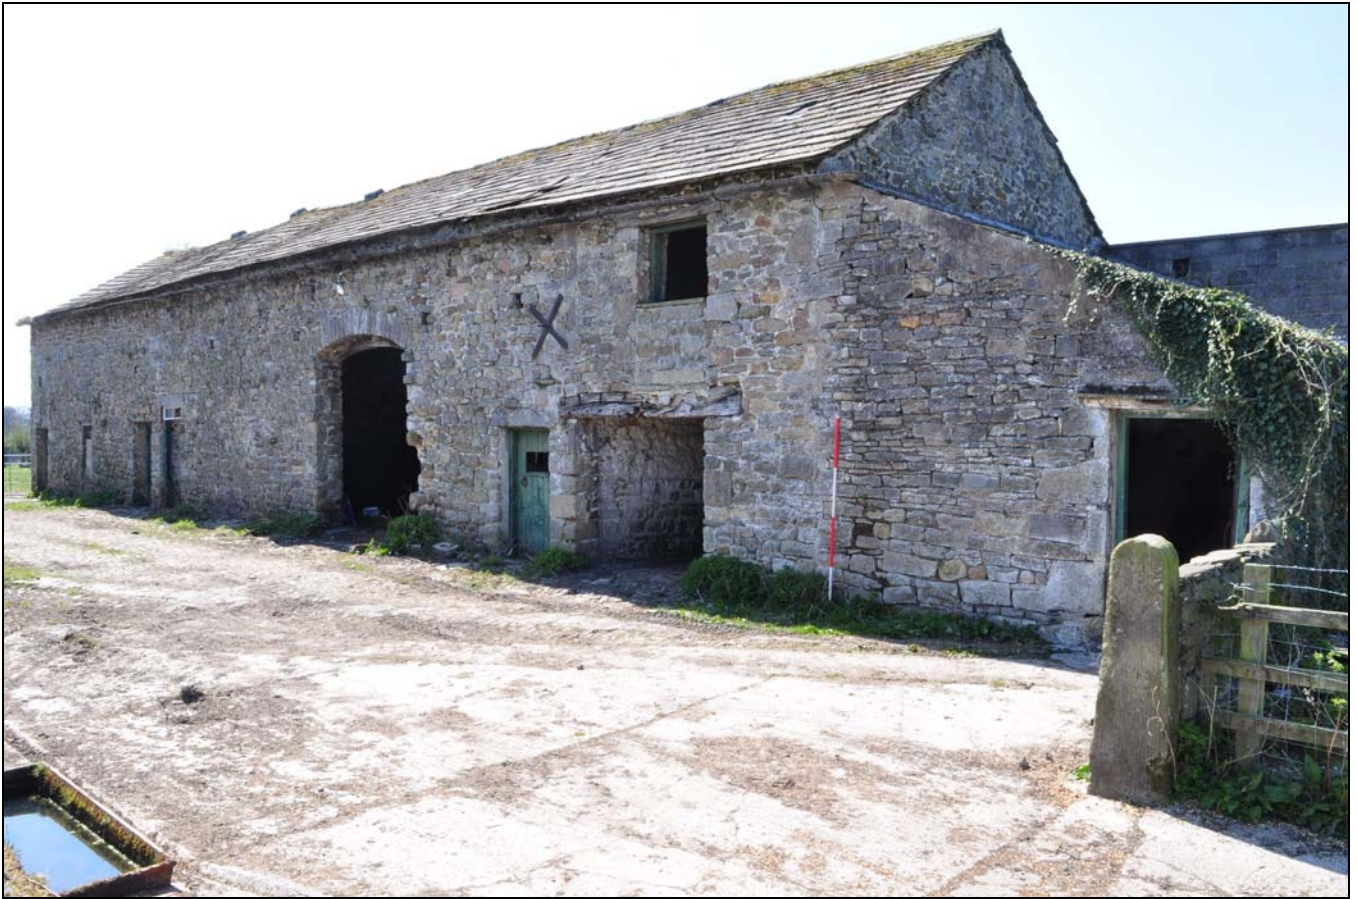
- 8.1 The barn range contains four distinct phases of construction, believed to date from between the late 18th century and circa 1900, and there is also a late 20th century lean-to on the west side, constructed from concrete blockwork (**1,2**). The range faces east onto the yard, which is cobbled in places.

Photo 1: Front of the barn range, looking south-west

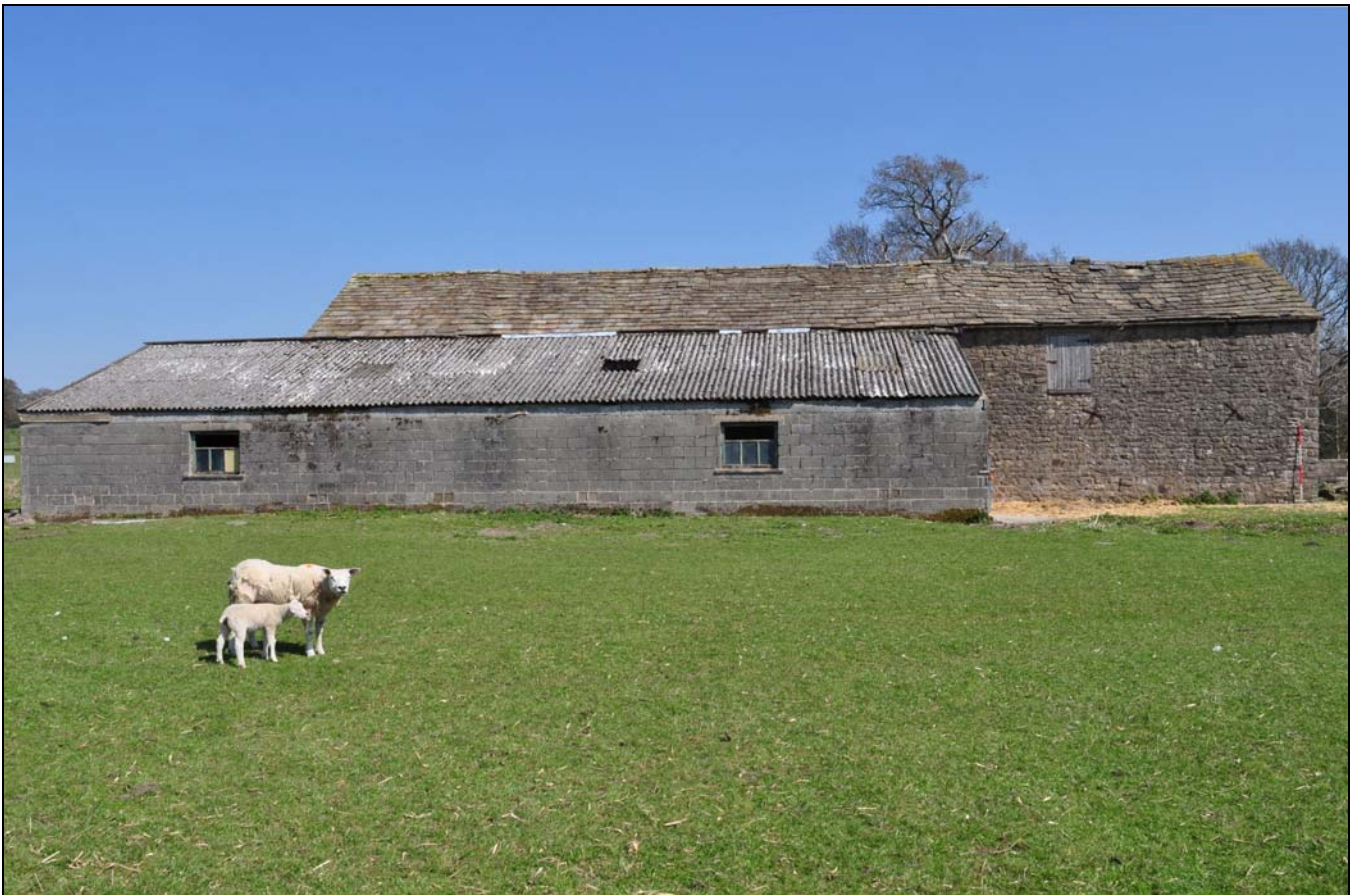
Photo 2: Rear of the barn range, looking east

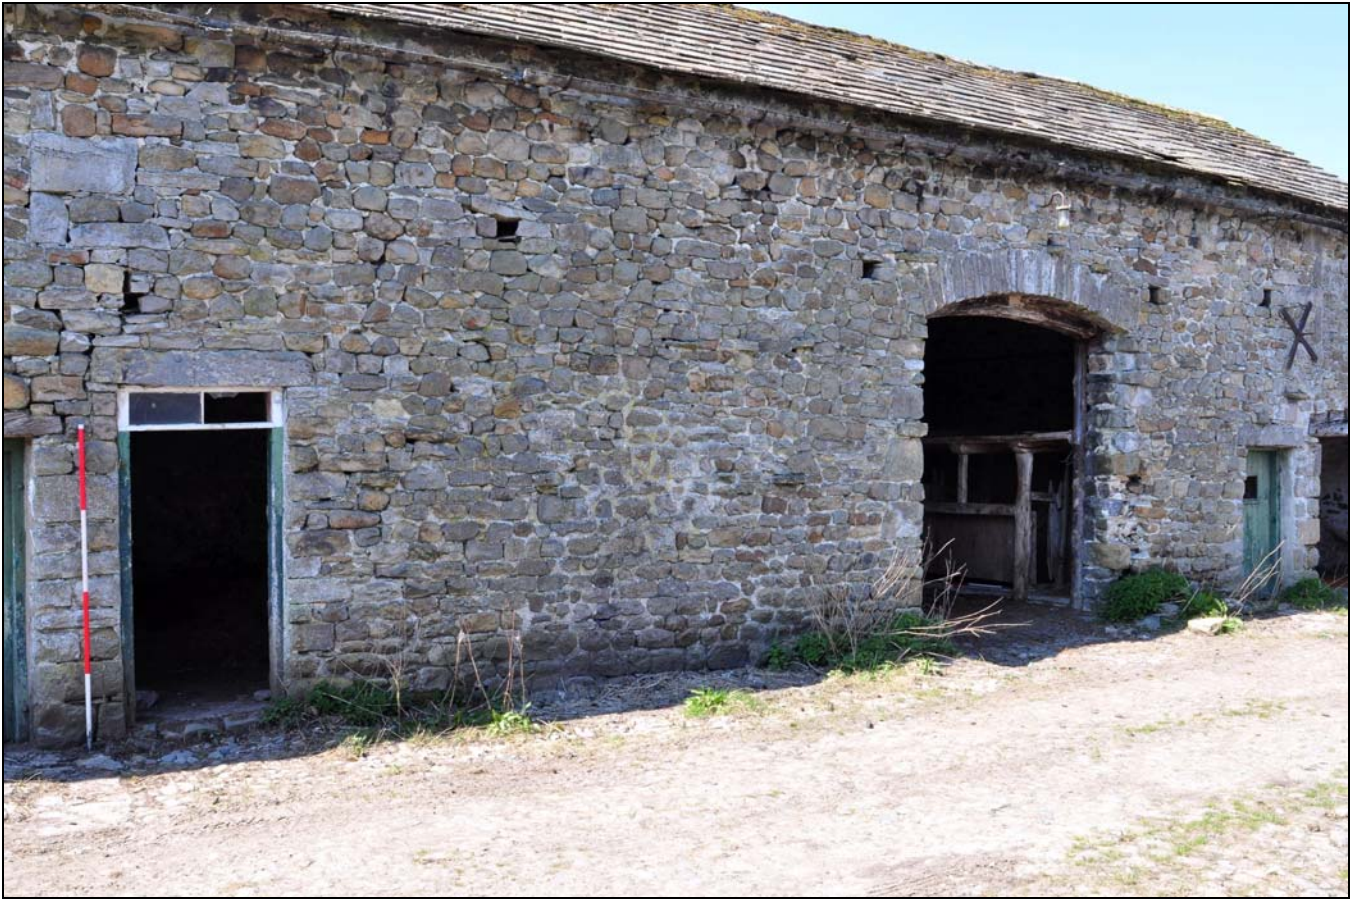
- 8.2 The earliest part of the range was built as a four-bay combination barn, from local hammer-dressed sandstone rubble, laid in irregular courses with very few dressings, and with a roof of stone slate (**3**). The later extension of it to the south has left only a few of its quoins in place here, but the original north end is better defined (**4**), at the junction with the later cart-shed. Within the east elevation is the principal opening, a cart entrance with segmental arch and inner lintel of oak, which formerly held a pair of doors with a central post and fixed by iron hinges. The low doorway to the right serves a shippon in the north end of the barn, while the taller doorway with overlight at the south end is of a form which suggests it was the entrance to a stable, a theory supported by the building's depiction on the 1894 map, which marks an internal division there. There is no suggestion that this doorway is not original to the building.

Photo 3: Original part of barn range

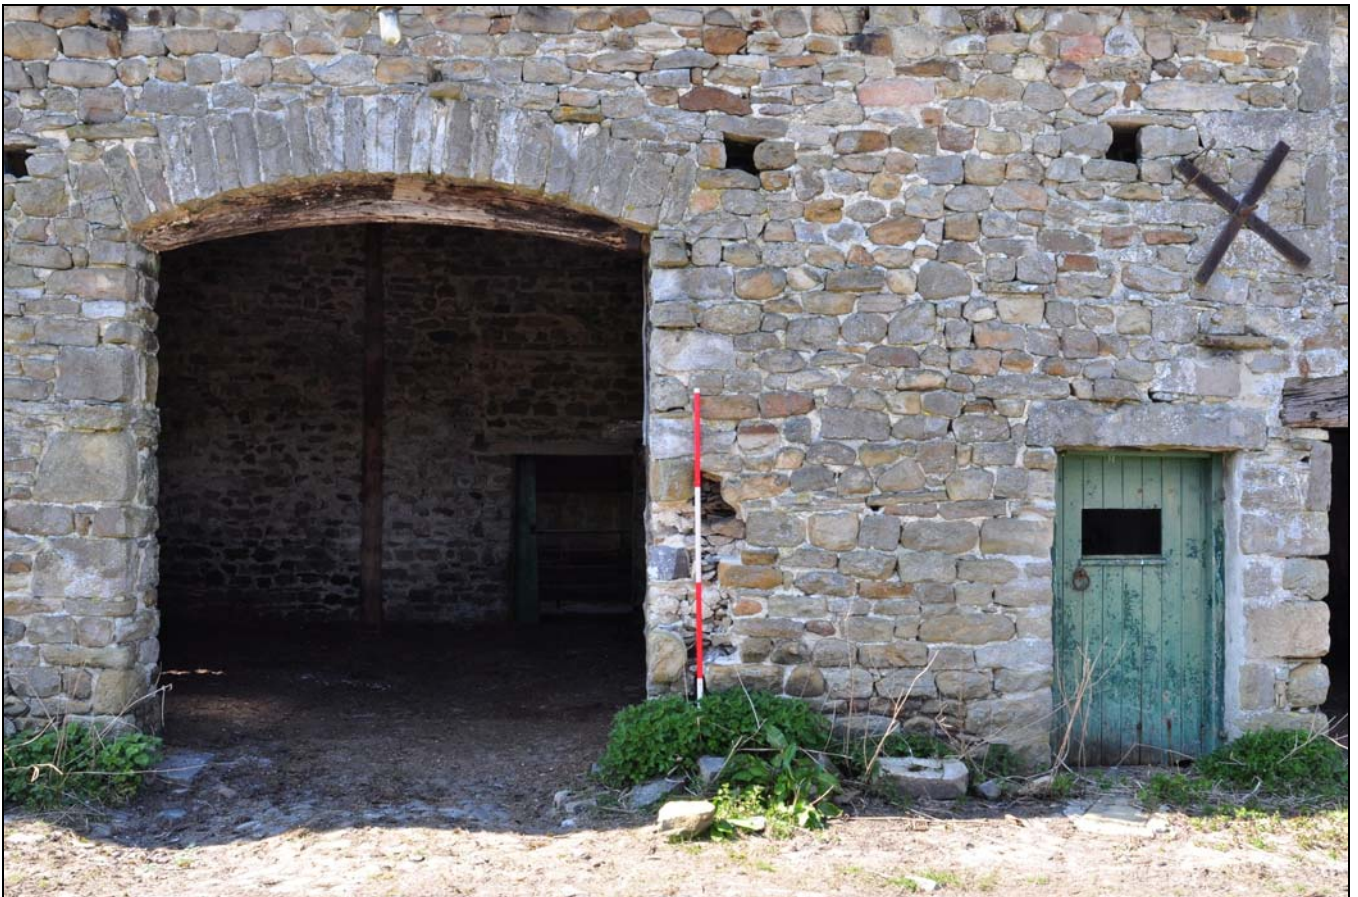
Photo 4: Cart entrance and shippon doorway, in front of original barn

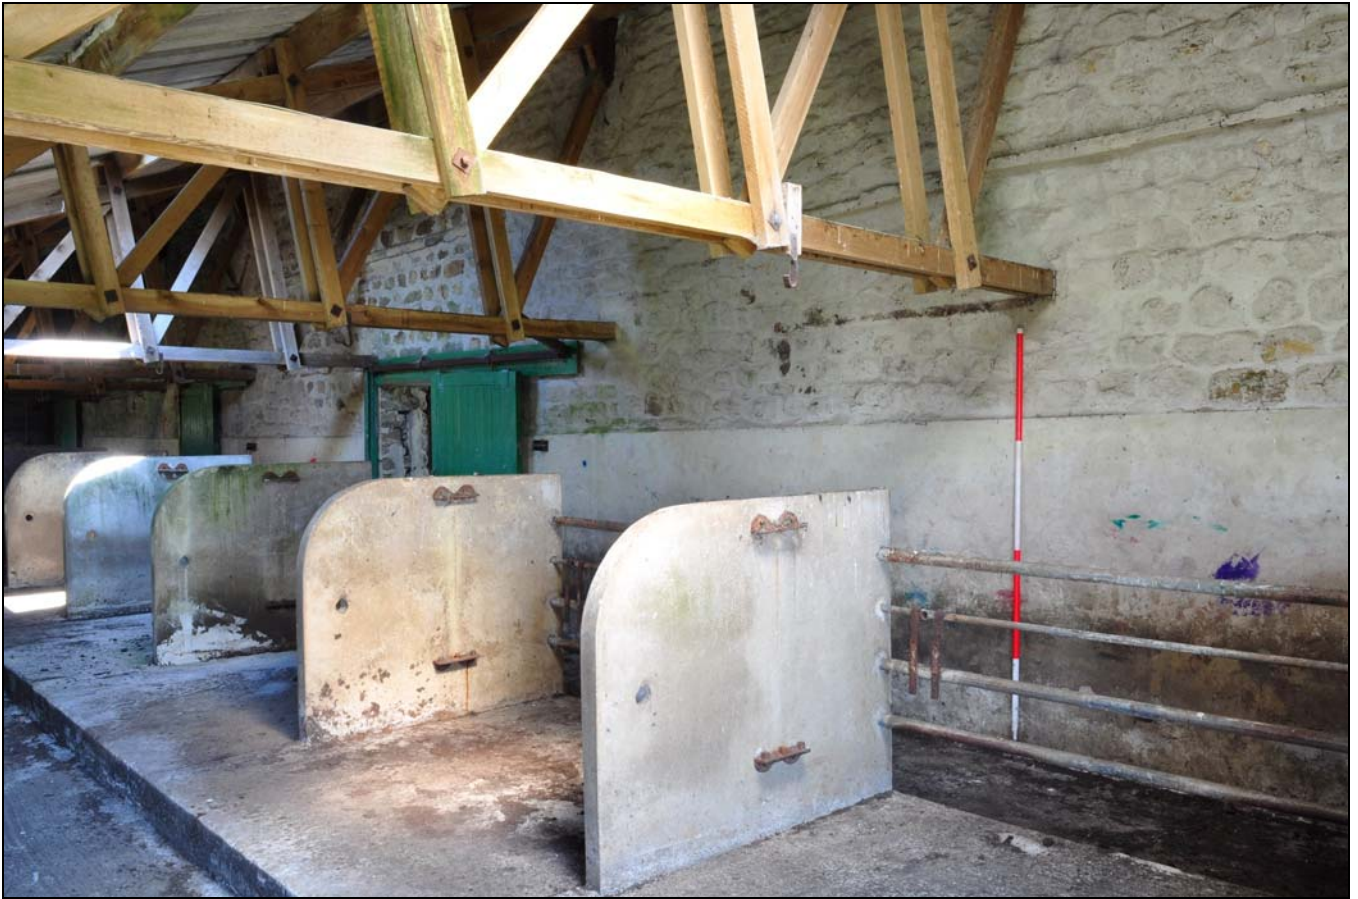
- 8.4 Much of the barn's west elevation was rebuilt in the 20th century, with the wall incorporating courses of flagstone throughs. The only opening in that side of the

first phase building is a pedestrian doorway, opposite the arched entrance, and although this is set within the rebuilt fabric, there is likely to have been a doorway in this approximate position from the outset (5).

Photo 5: Rear of original barn, in modern lean-to, with areas of rebuilding

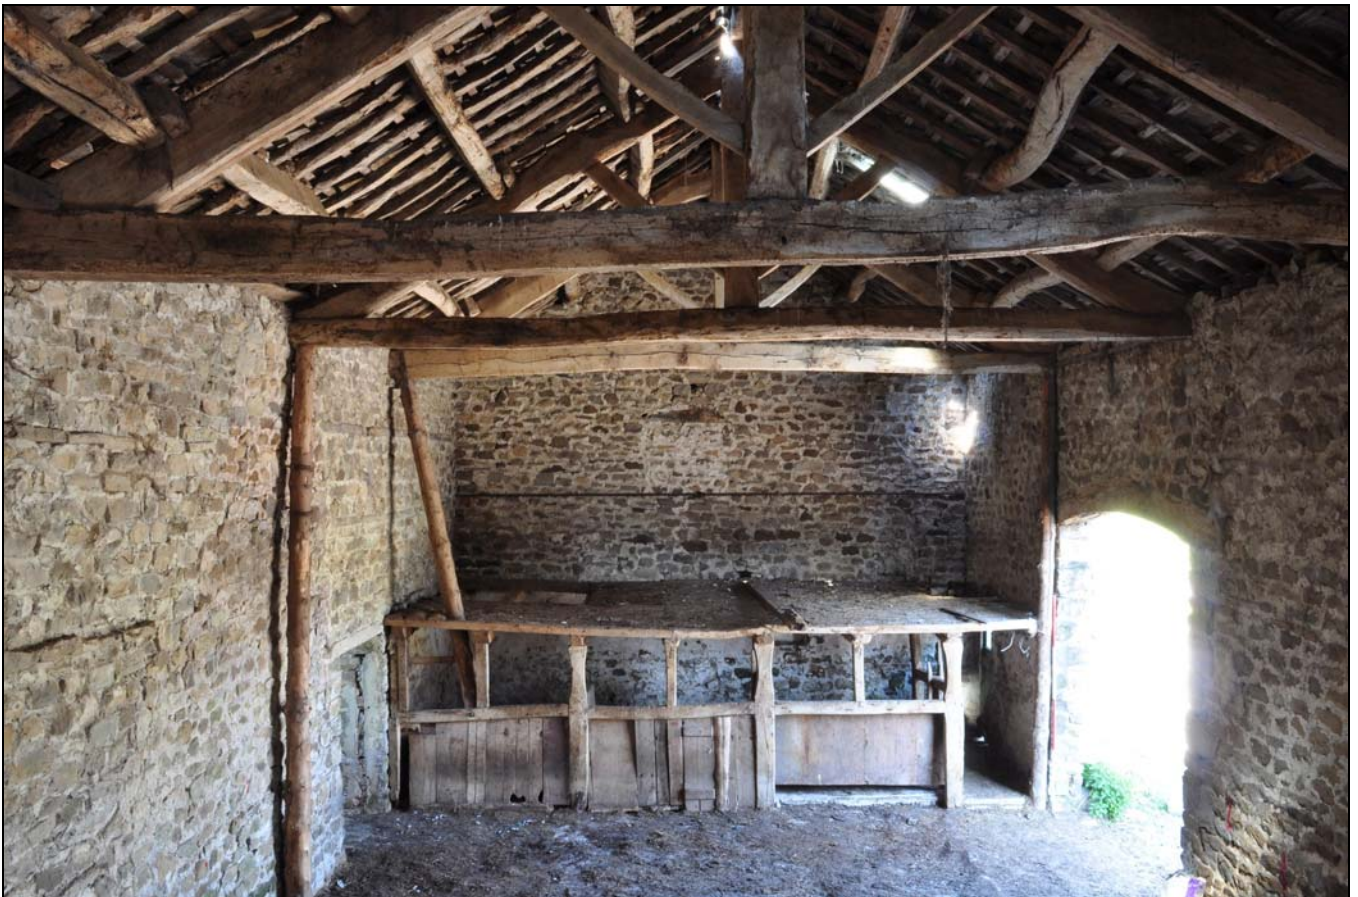
- 8.5 The barn's four bays contain the threshing bay, onto which the cart entrance opens, as well as a timber-framed shippon with loft over in the north bay (6). The two bays at the south end did at one time contain some form of vertical and horizontal divisions, but are now a single space open to the roof (7).

Photo 6: Interior of original part of barn, looking north

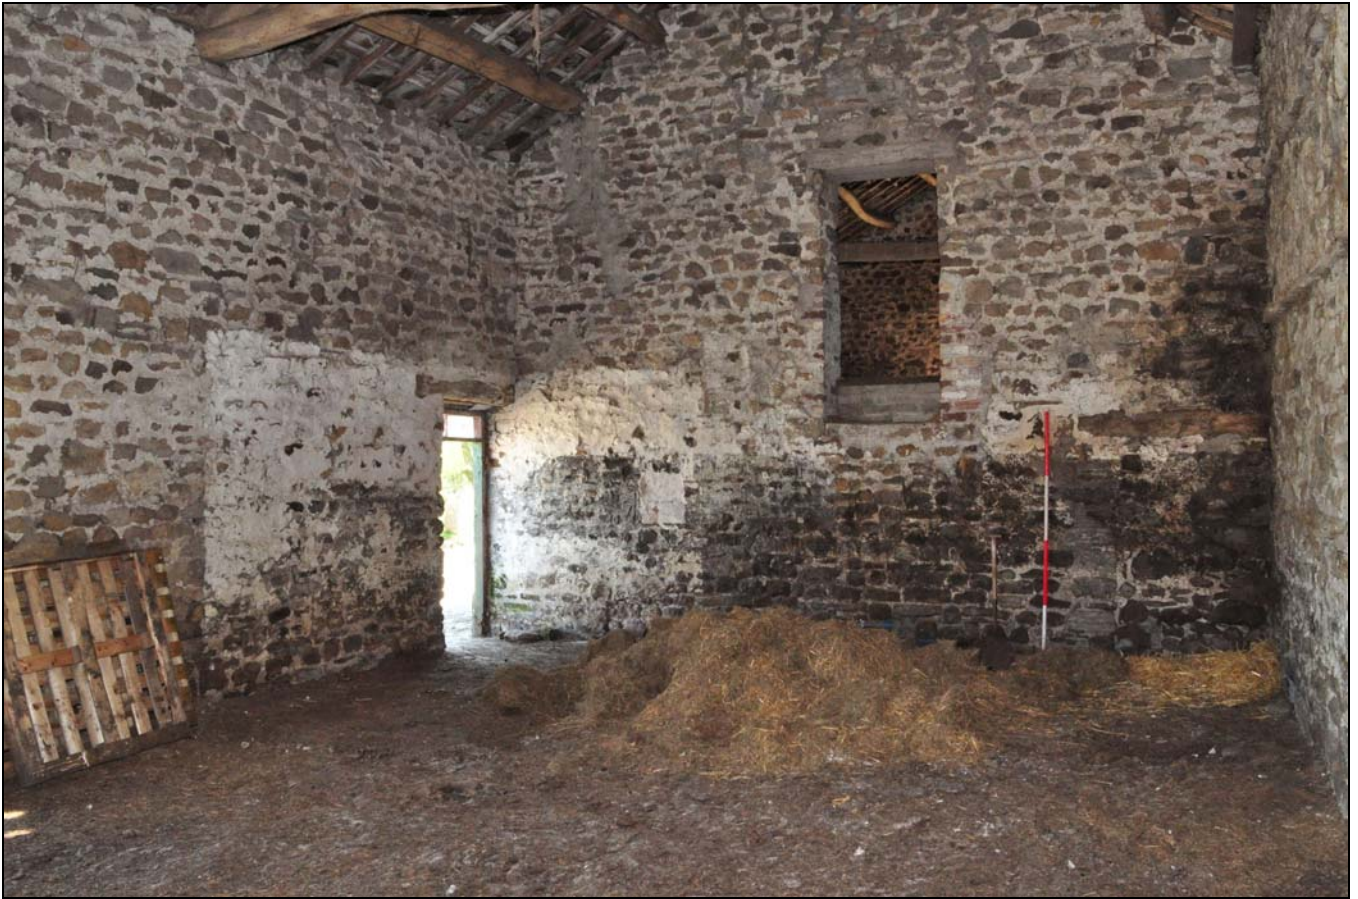
Photo 7: Interior of original part of barn, looking south-east

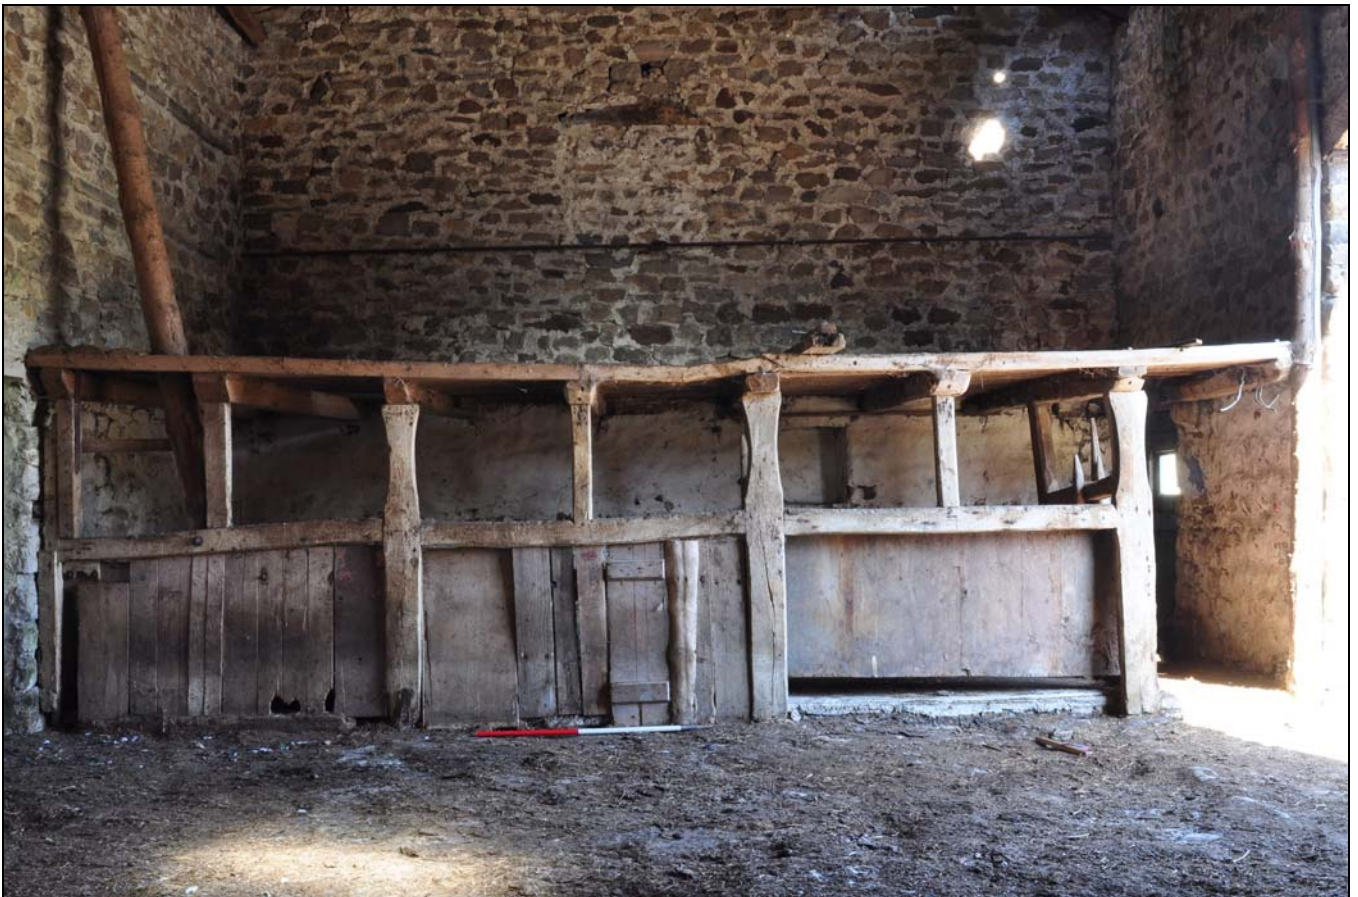
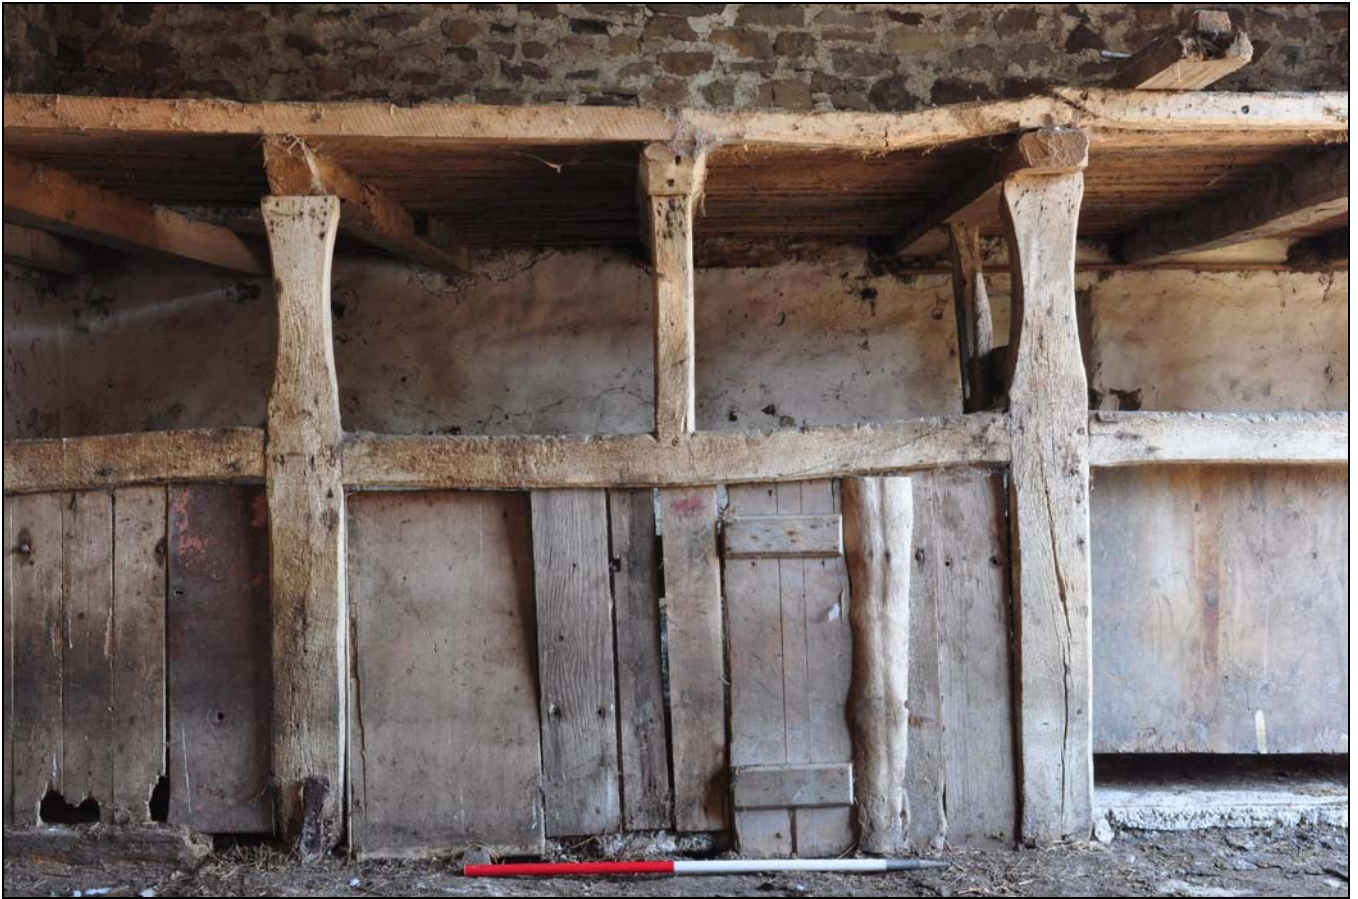
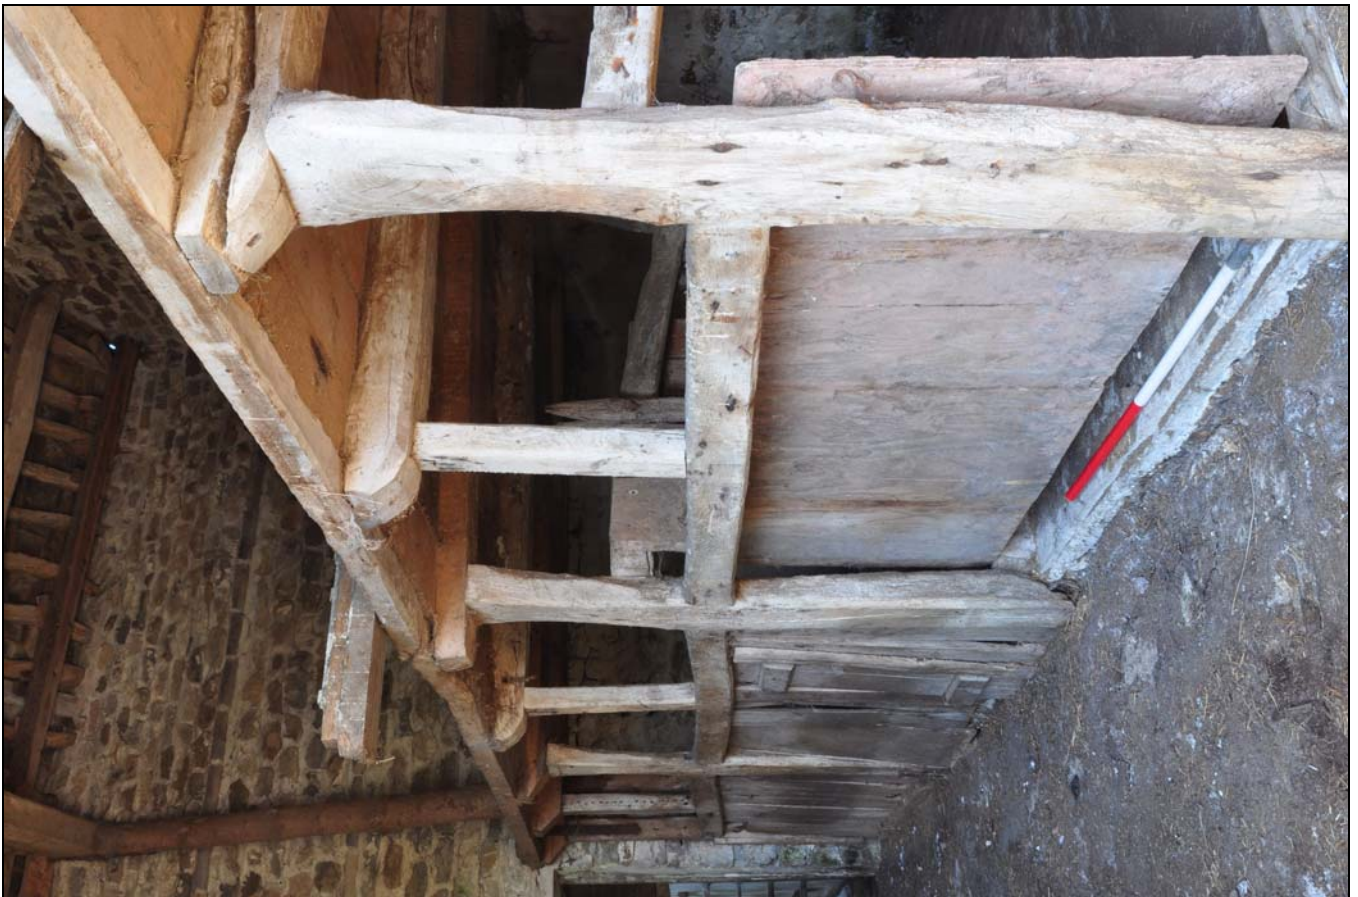
- 8.6 The shippon's timber frame was built in a characteristic form for the district, with all principal members of oak, but much of it has been lost or replaced, particularly the infill panels (8-13). The three surviving head-posts have hour-glass profiles above the rail, and the latter is tenoned and pegged into them. Each post carries a beam for the loft or balks, with narrower, plain posts also supporting beams between them; the ends of the beams are shaped at their south ends (14), and one, next to the east wall where there is no post, is supported by a dressed corbel (15). Two elbowed heel-posts survive (16-19), along with the rails forming the tops of the boskins, but the third boskin has been replaced by one of brick. The floor is laid with concrete.

Photo 9: Front of timber-framed shippon

Photo 11: Front of timber-framed shippon (centre)

Photo 13: Front of timber-framed shippon, looking west

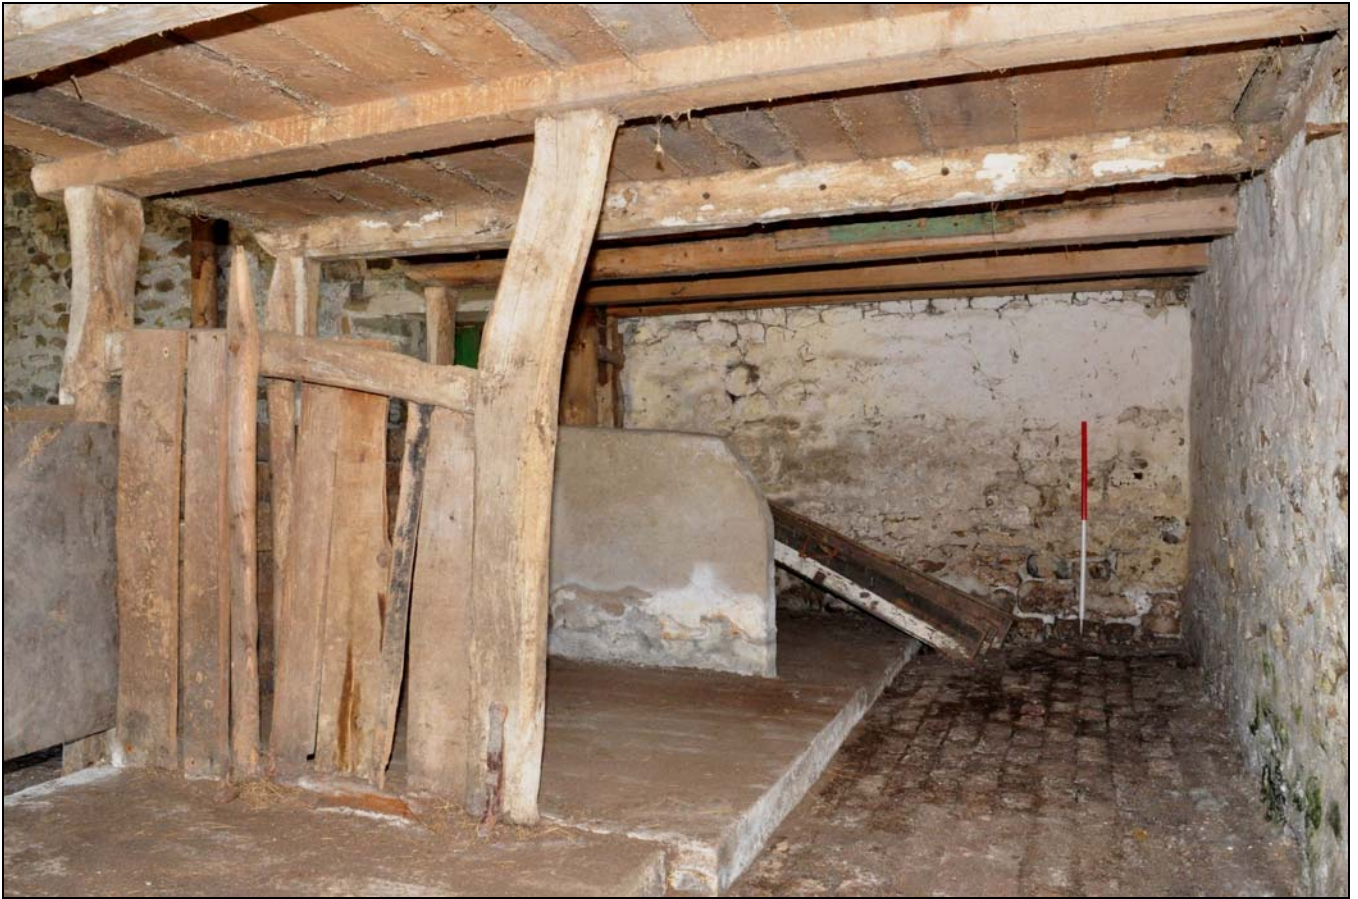
Photo 17: Stalls in shippon, looking west

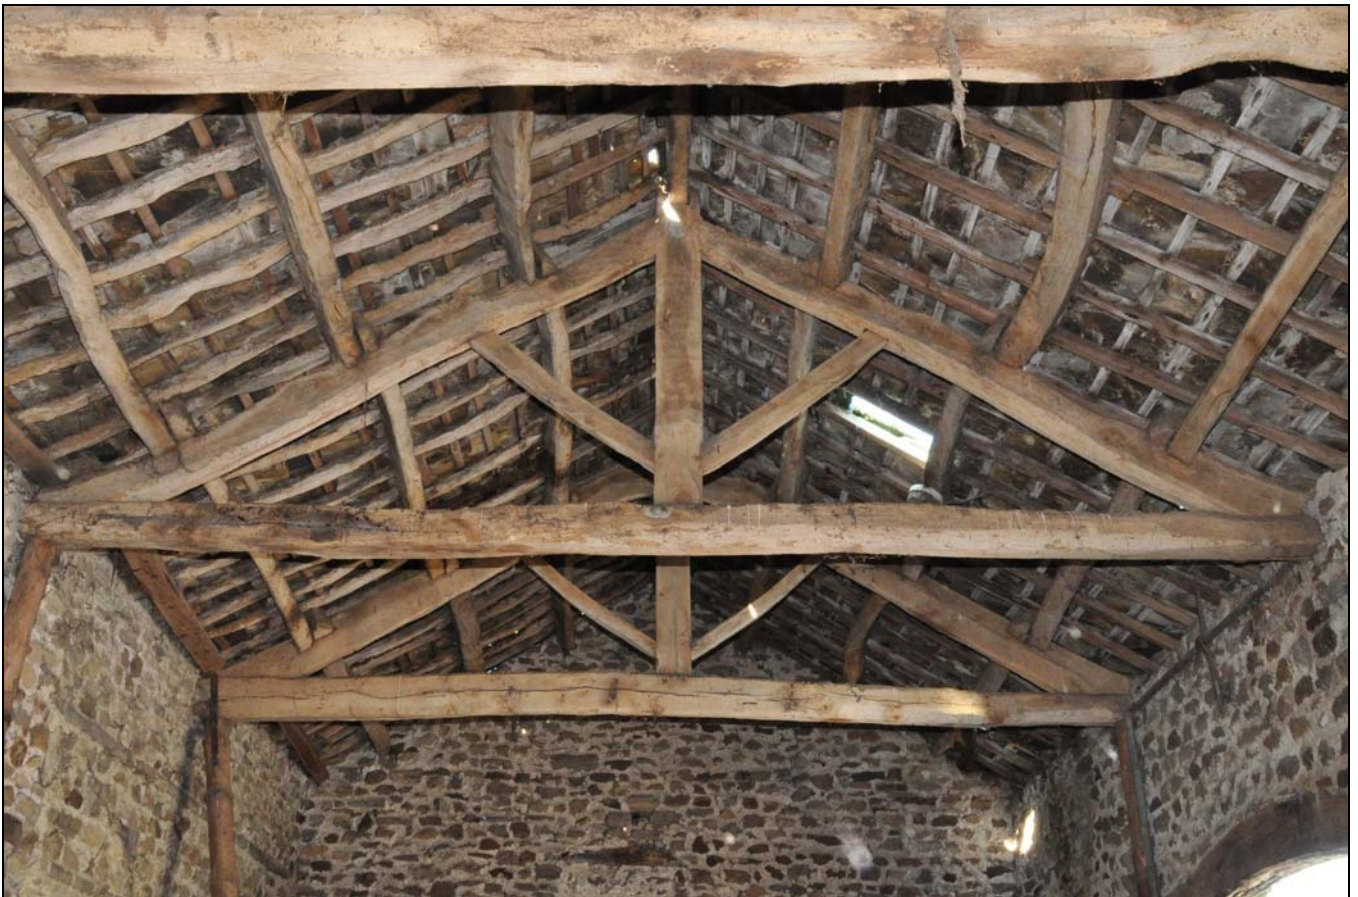
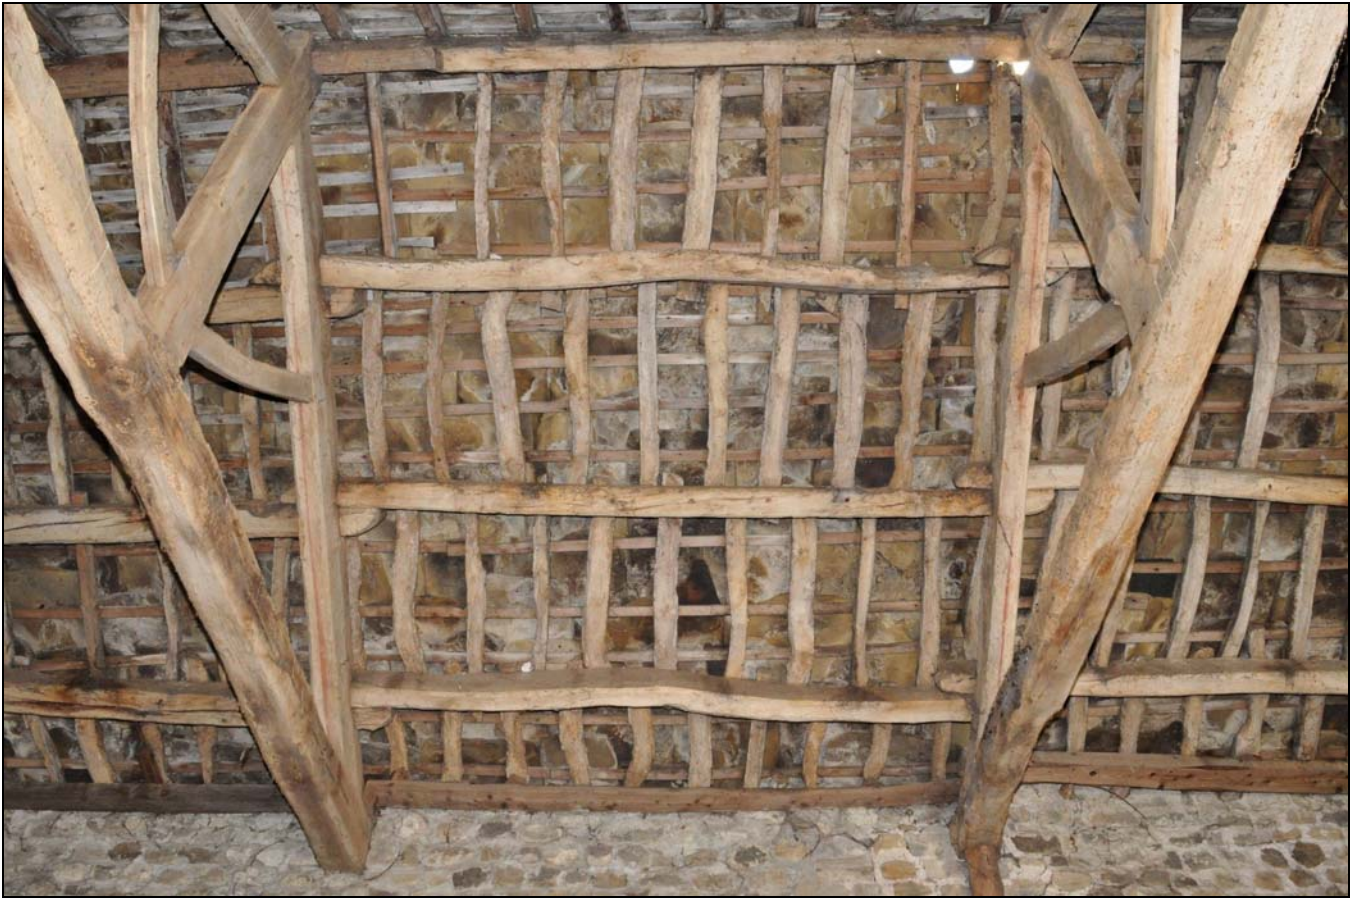
- 8.8 The roof structure of the barn comprises the three original trusses, along with original purlins and some rafters, though the rafters in the east pitch have all been replaced with sawn softwood (22-24). The roof trusses are typical for the district and period, and are composed of pegged, hand-converted oak members, with king-posts and angled struts; in each case, the pair of elbowed principal rafters is formed from a single tree, halved down the middle. The purlins are trenched into the principal rafters and each runs for a single bay. On the west roof pitch, the rafters are also of local timber, short in length and with distinctive irregular forms (25). The form of the roof is a primary means of dating for the barn, and suggests that it was built in the late 18th century.

Photo 23: Central roof truss in original barn, looking north

Photo 25: Underside of west roof pitch in original barn

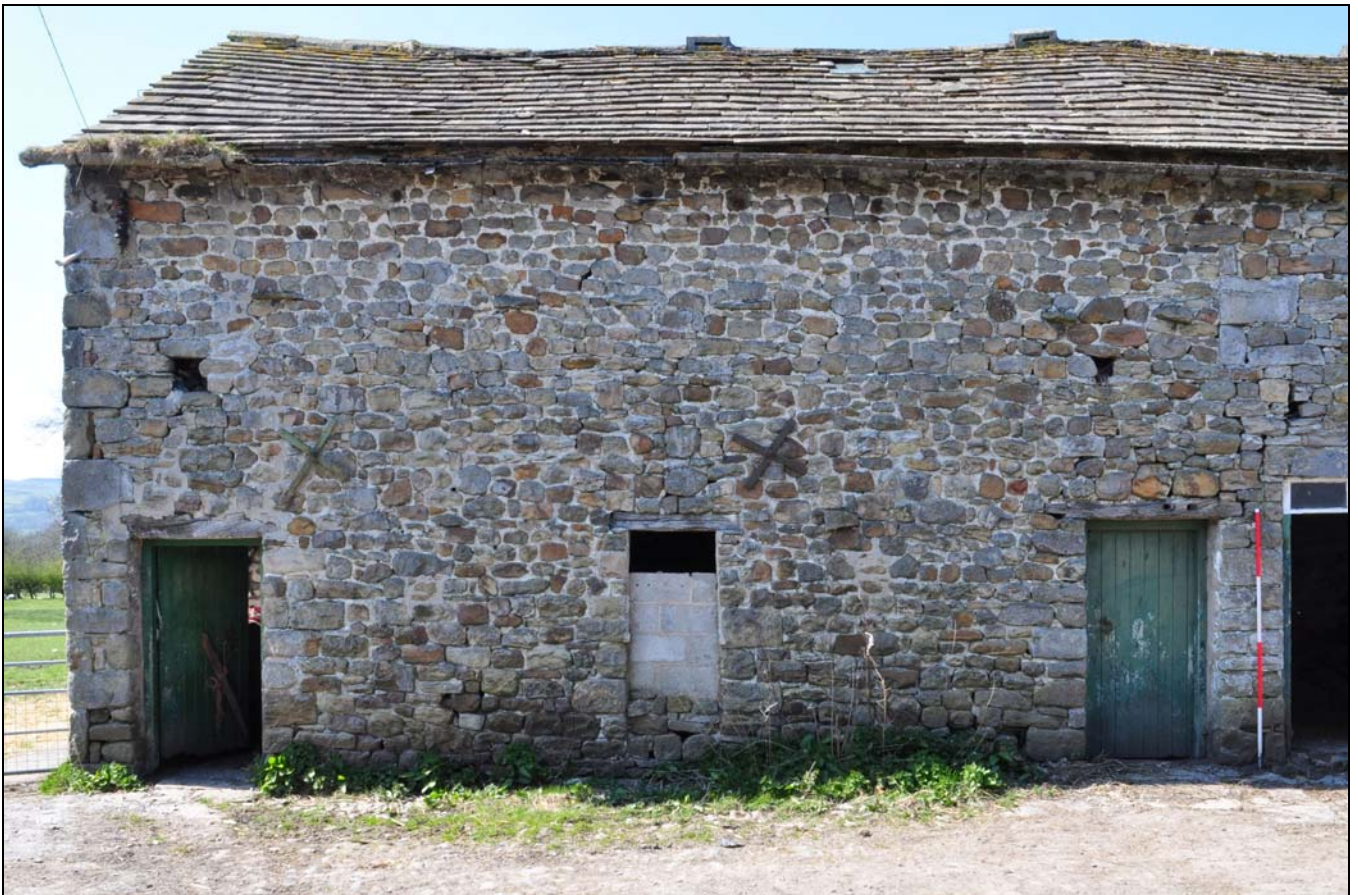
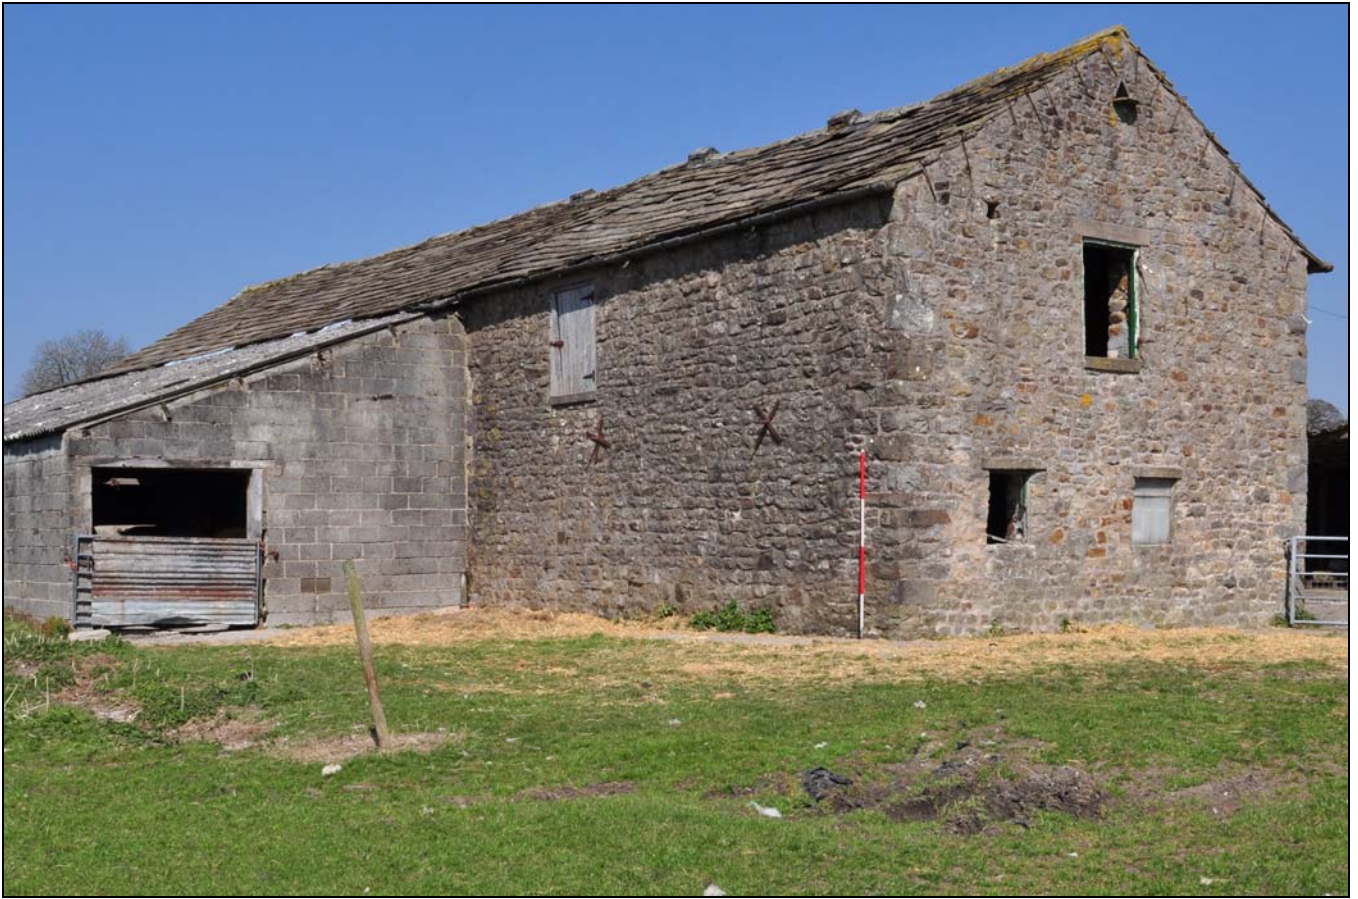
- 8.9 The two-bay addition at the south end of the barn was probably built shortly after the barn itself, and was certainly extant by the 1840s, according to the Ordnance Survey (26,27); it seems to have been intended as a double shippon, with hayloft

over. It is built of similar stonework, although the three doorways in the east side have outer lintels of re-used oak, which is unusual, due to its poorer longevity compared with stone (28). The central one of the three doorways is rather narrow, and was the entrance to a feeding passage, while the outer two gave access to the livestock stalls. In the south gable, the two ground floor windows both appear to be secondary openings, while the forking hole at hayloft level seems to have been enlarged to its present size (29). The triangular owl-hole above does appear to be original but another forking hole, in the west side, has concrete sill and lintel (30,31).

Photo 28: Front of added shippon to south of barn

Photo 30: Added shippon to south of barn, looking north-east

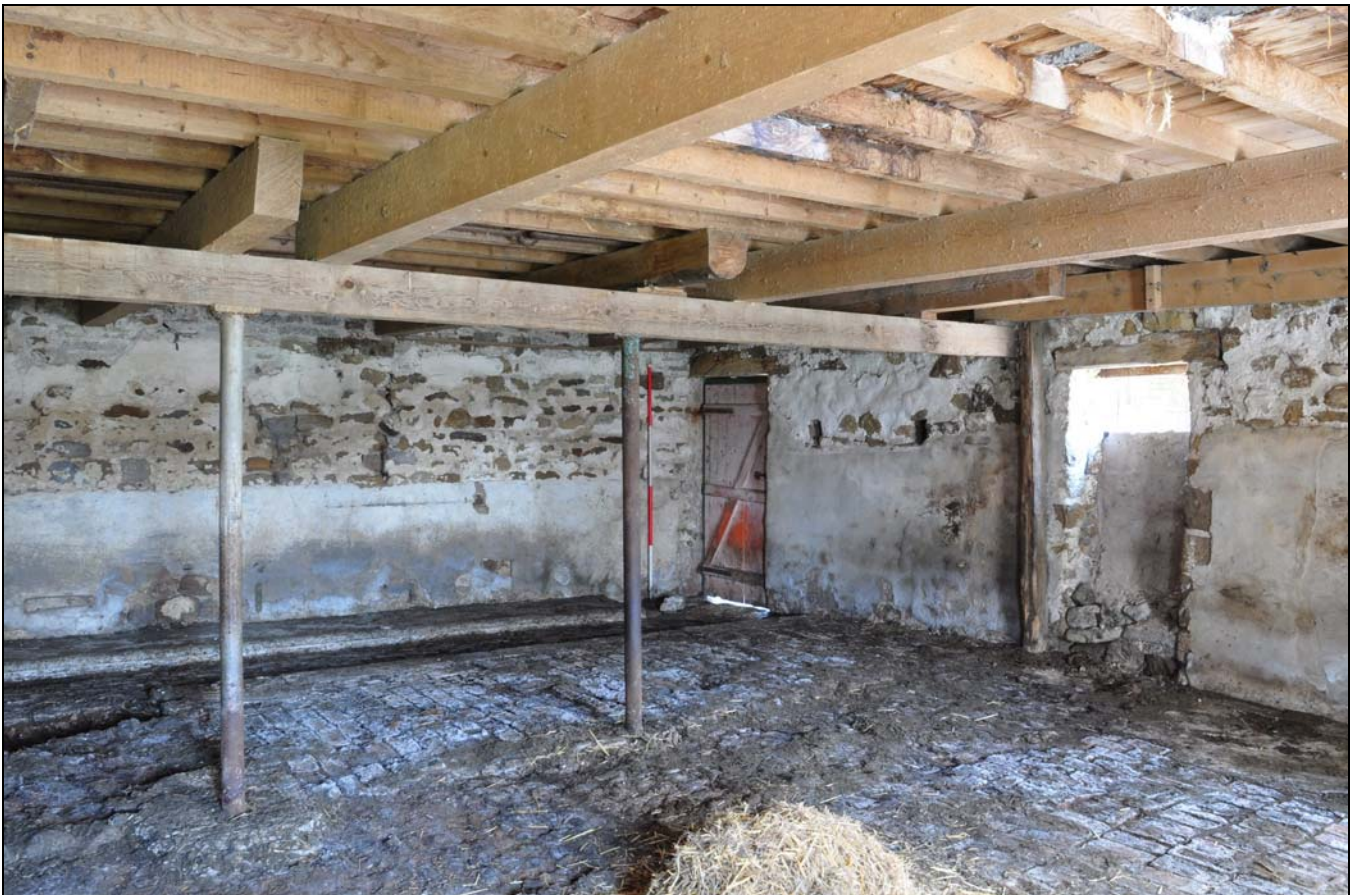
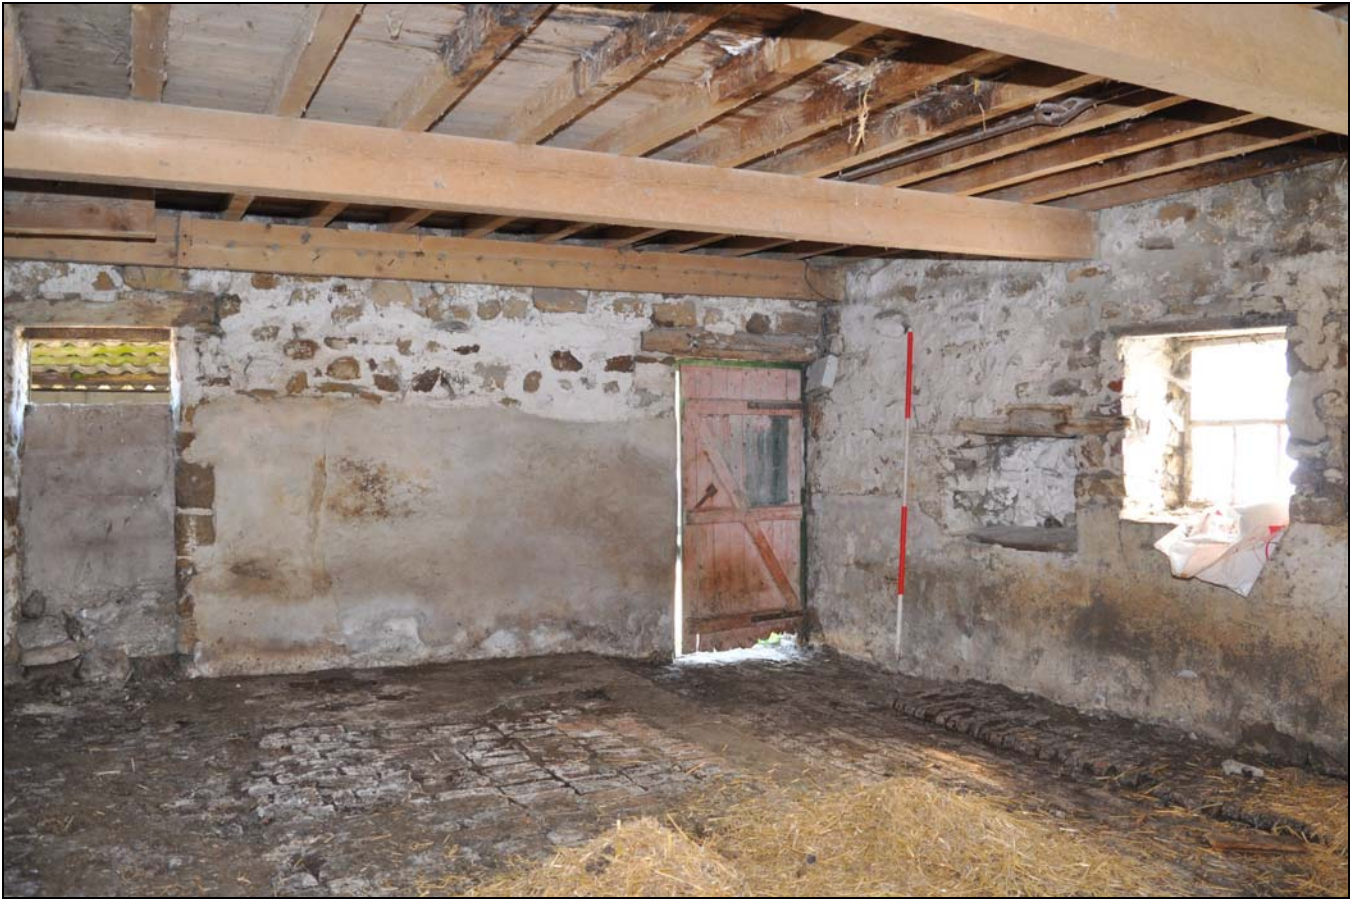
- 8.10 The interior of this south end of the range was much altered in the 20th century. The ground floor is now undivided, except for two steel columns which support a modern cross-beam, but the floor surface indicates a former double shippon arrangement (32-35). It contains two manure channels ("groups"), of concrete but with stone kerbs, brick floors to the standings, and cobbles to the feeding passage. The boskins have been entirely removed, but there are likely to have been stalls for eight animals in each side; a recess near the south-east corner is likely to have been a lamp-hole. The hayloft and the beams which carry it have all been replaced.

Photo 32: Added shippon to south of barn: ground floor, looking north-east

Photo 34: Added shippon to south of barn: ground floor, looking south-east
