Barn at New Ing
Bolton-by-Bowland, Lancashire:
Historic Buildings Record

STEPHEN HAIGH
Buildings Archaeologist

Barn at New Ing Bolton-by-Bowland, Lancashire: Historic Buildings Record

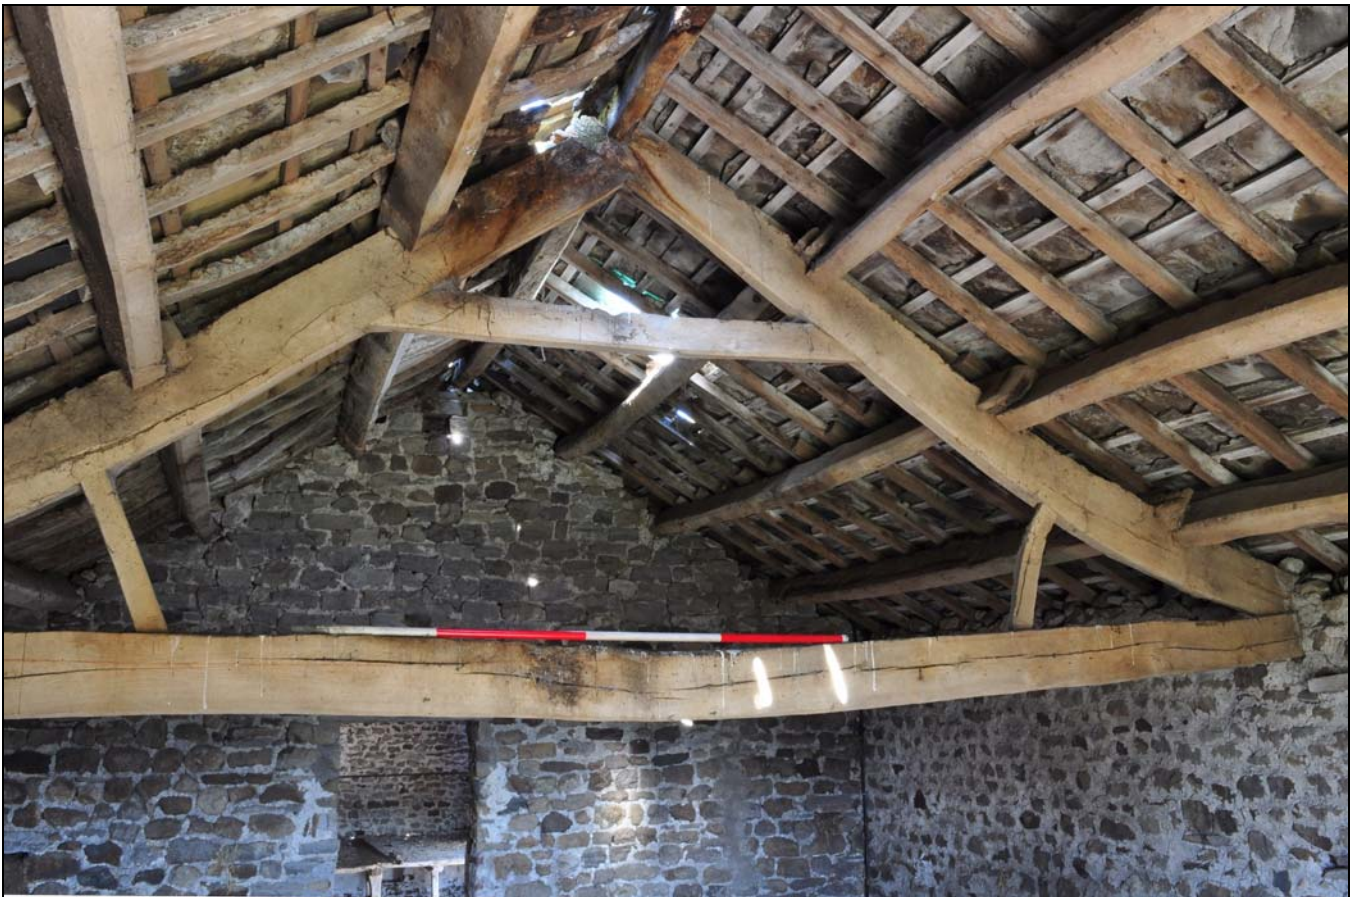
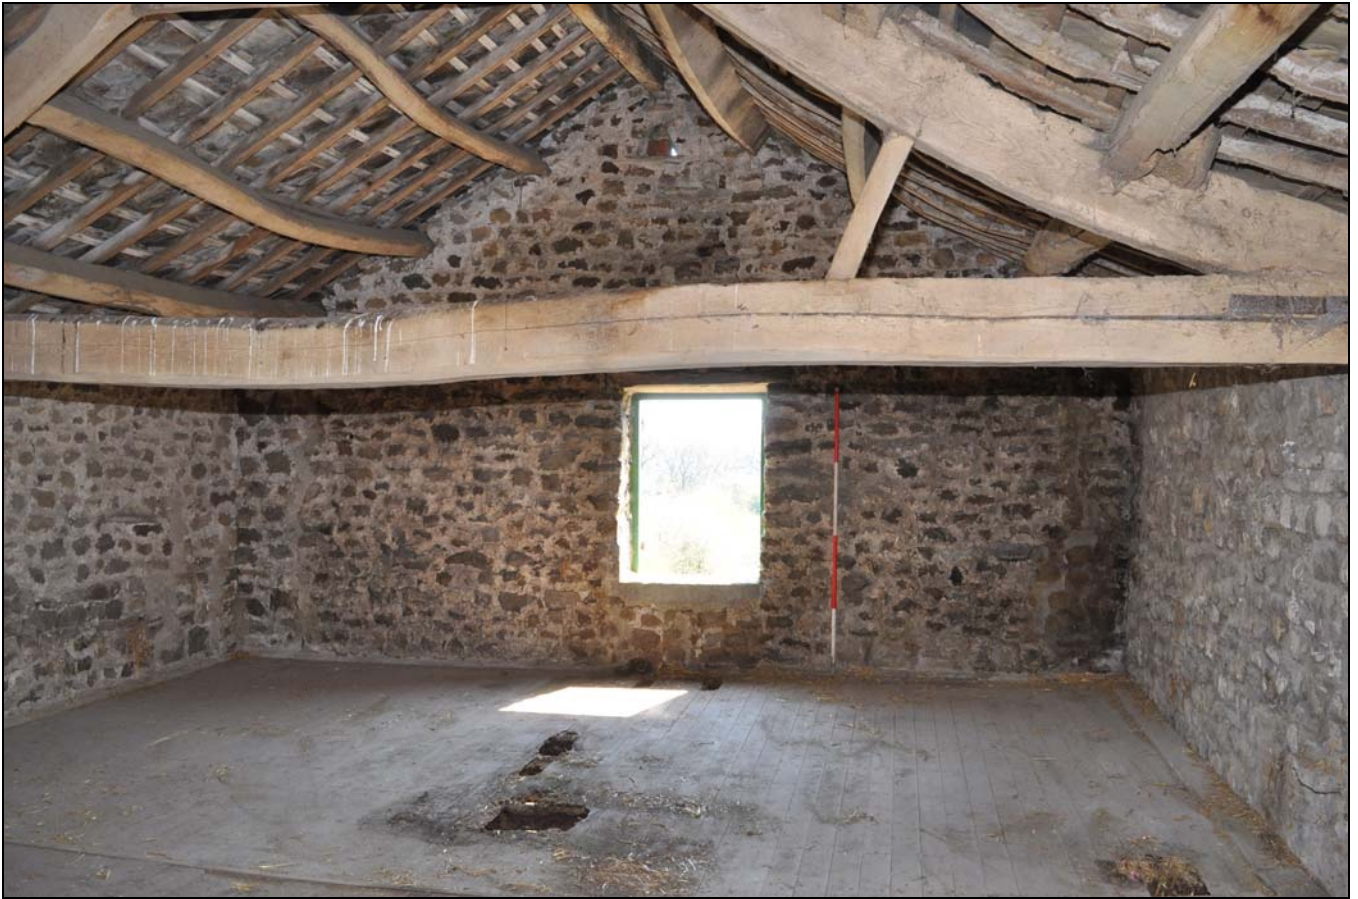
- 8.11 Despite these radical modern changes, the south end of the range does retain its original oak roof structure, probably late 18th or early 19th century (36-40): it has a principal rafter truss with collar, and trenched purlins as in the barn, some of them with signs of previous use.

Photo 36: Added shippon to south of barn: roof truss, looking north-east

Photo 40: Added shippon to south of barn: hayloft, looking south

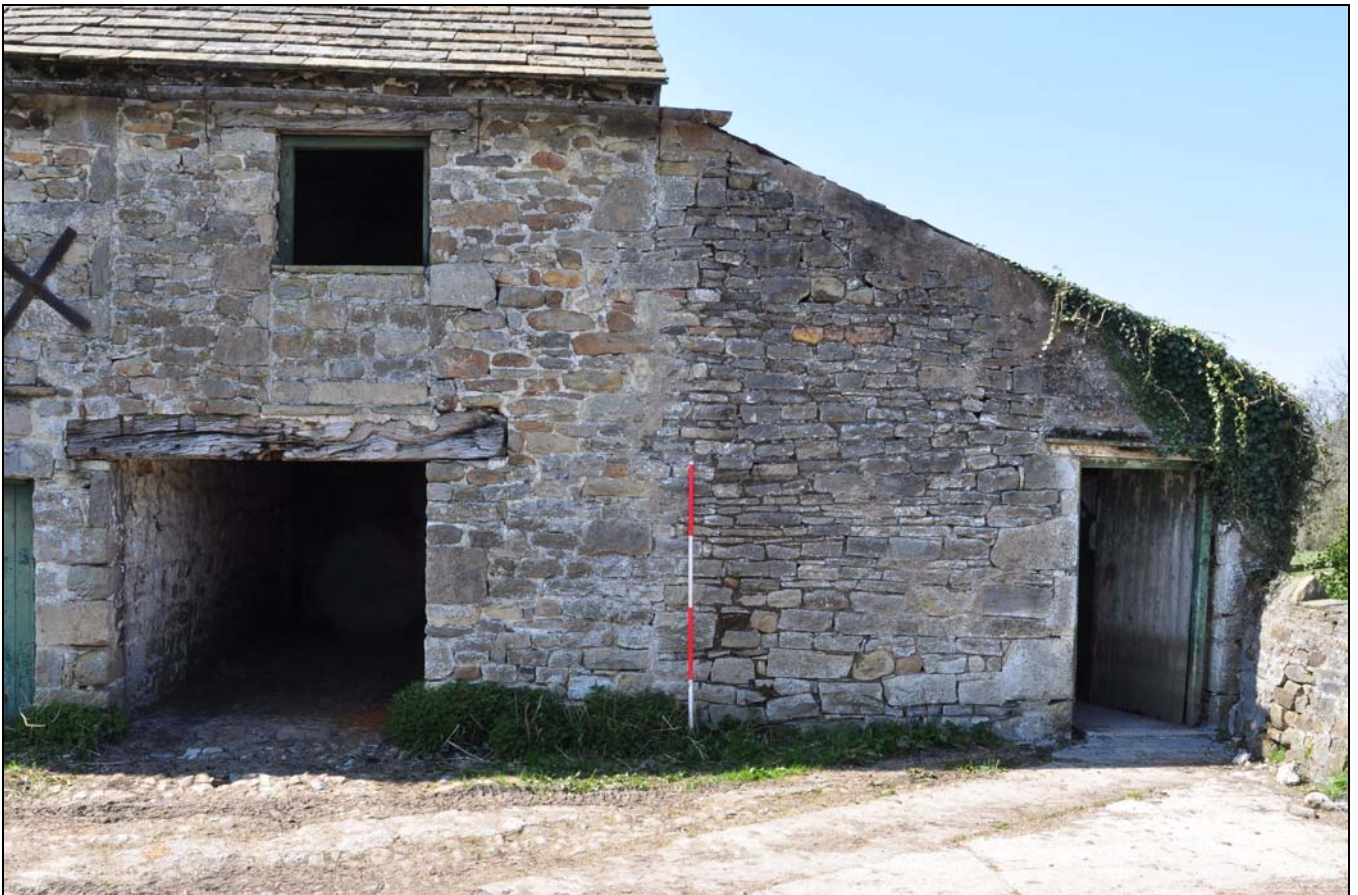
- 8.12 The third phase in the barn range's development was the addition of a single bay at the north end, to serve as a cartshed or perhaps trap-house (41). This was extant by 1892 (see figure 6), and is probably mid to late 19th century. It is also built of sandstone rubble, and has a wide doorway with timber lintel to the ground floor room, and formerly had a taking-in doorway to the first floor, though that has now been reduced to a smaller opening. There is also an inserted 20th century pedestrian ground floor doorway in the west side, within the wider area of rebuilding in that side of the range, and now facing into the large lean-to cowshed there.

Photo 41: Front of added cart-shed and later lean-to at north end of barn, looking west

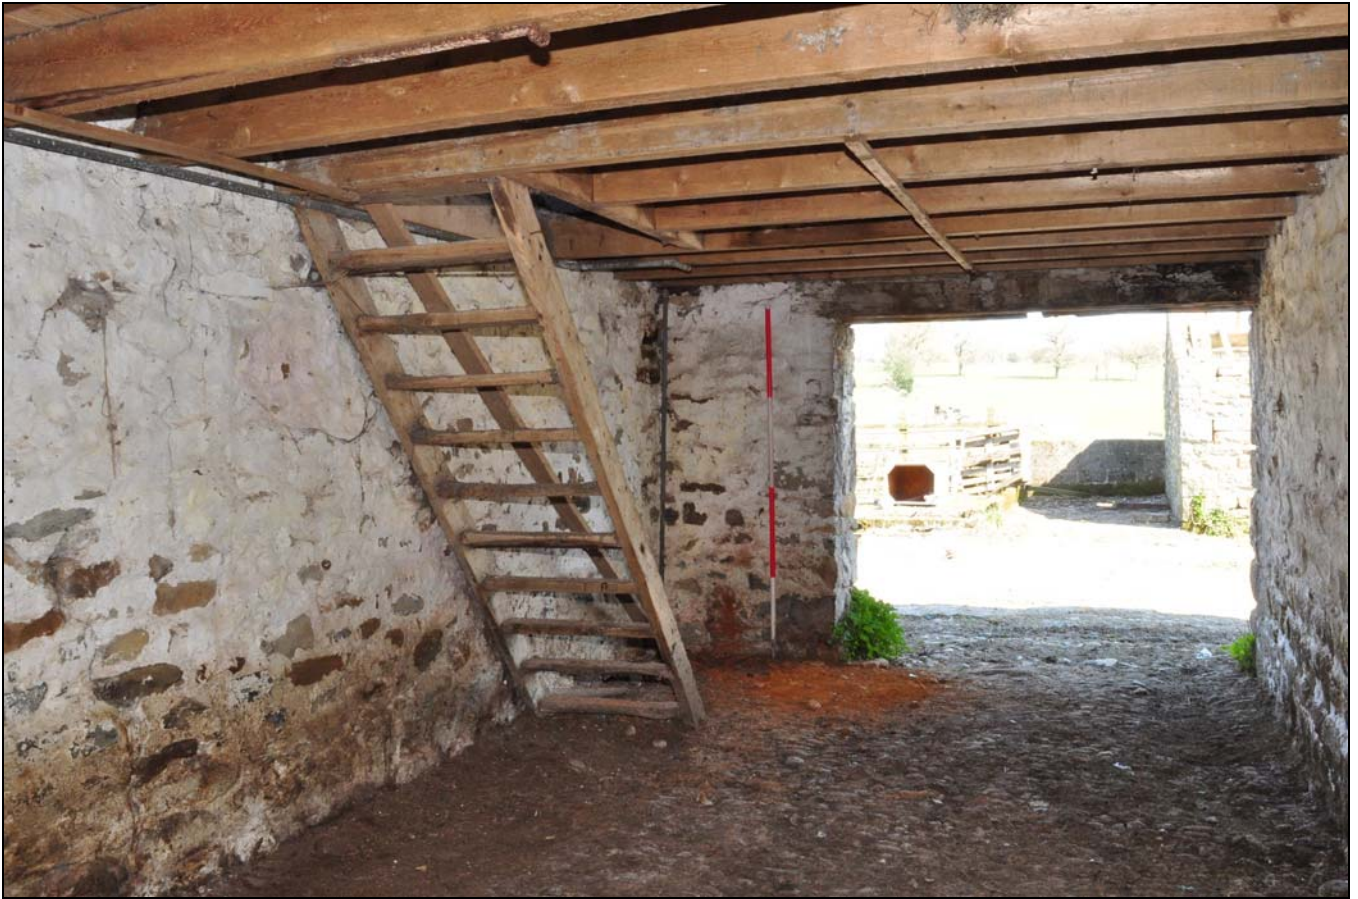
- 8.13 The cart-shed comprises a single room with cobbled floor and timber ladder-stair to the loft over (43,44). The upper floor may have been intended as a hayloft or granary originally, but might have been used as a bothy more recently, as it has plastered and limewashed walls (45). The roof is carried on square-sawn softwood purlins, a structure which is obviously more modern than that in the earlier parts of the barn, but is similarly covered with stone slate.

Photo 43: Cart-shed: ground floor, looking east

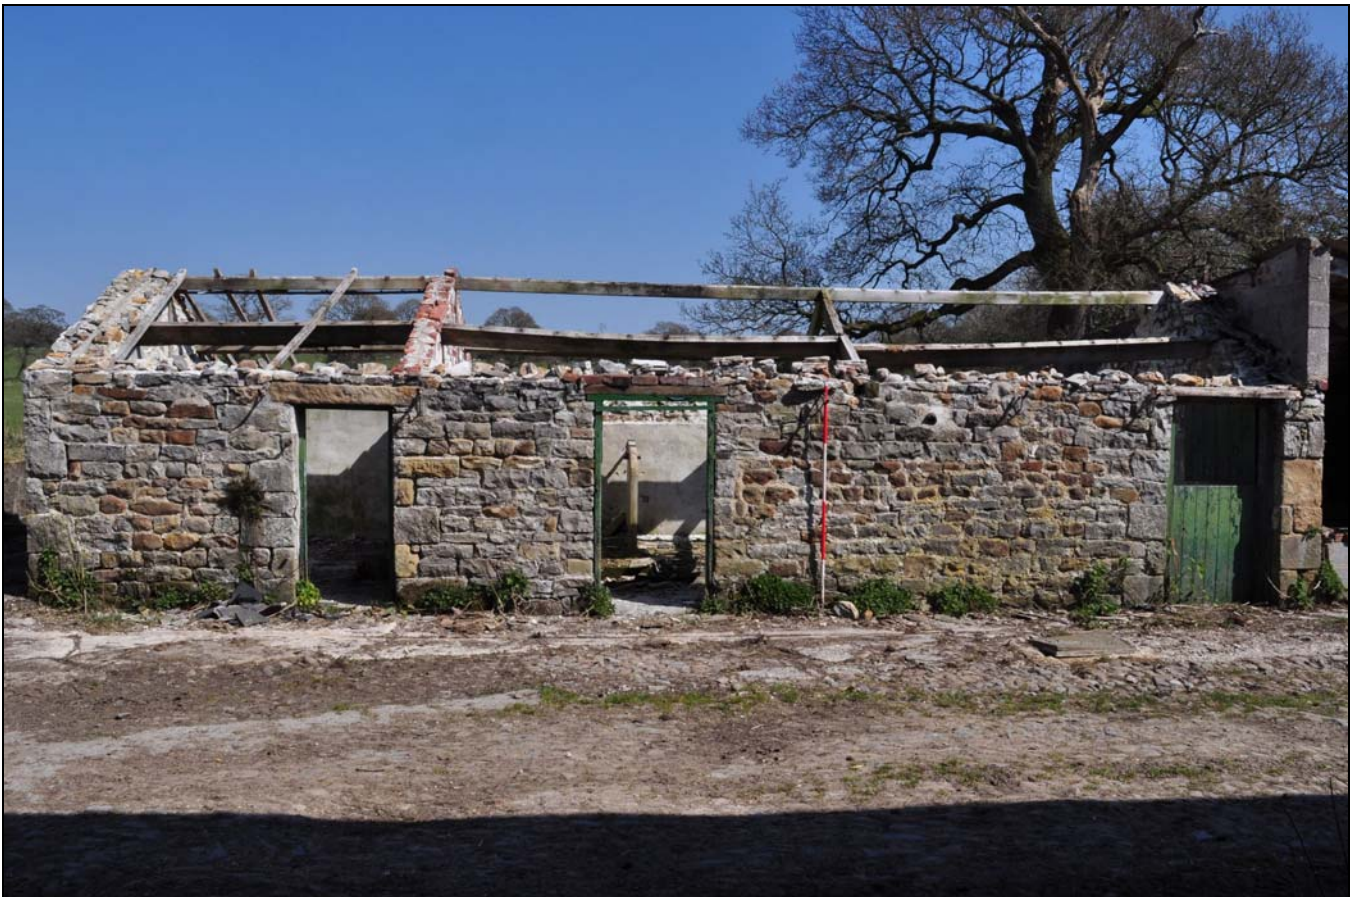
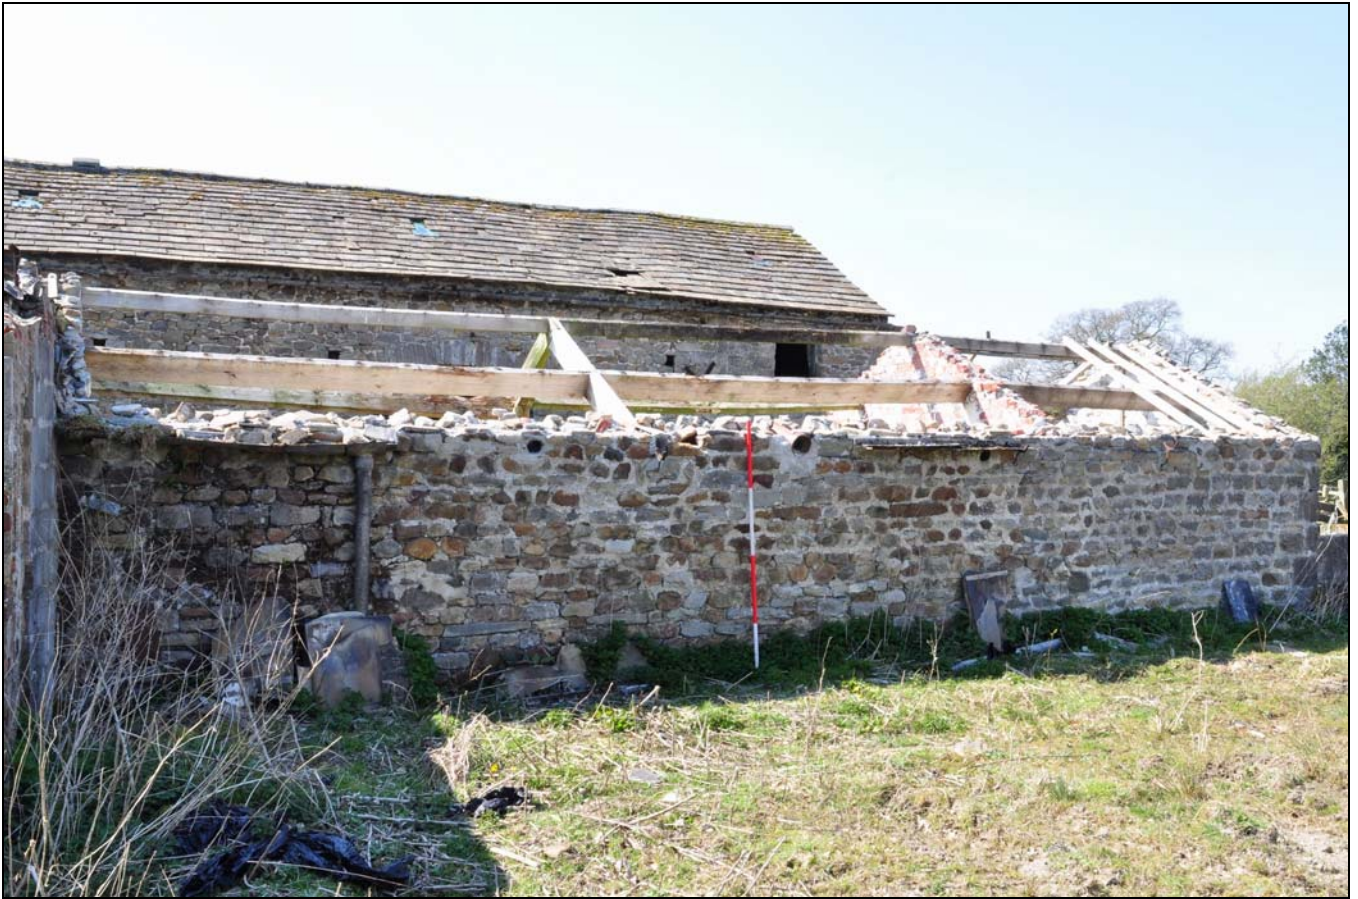
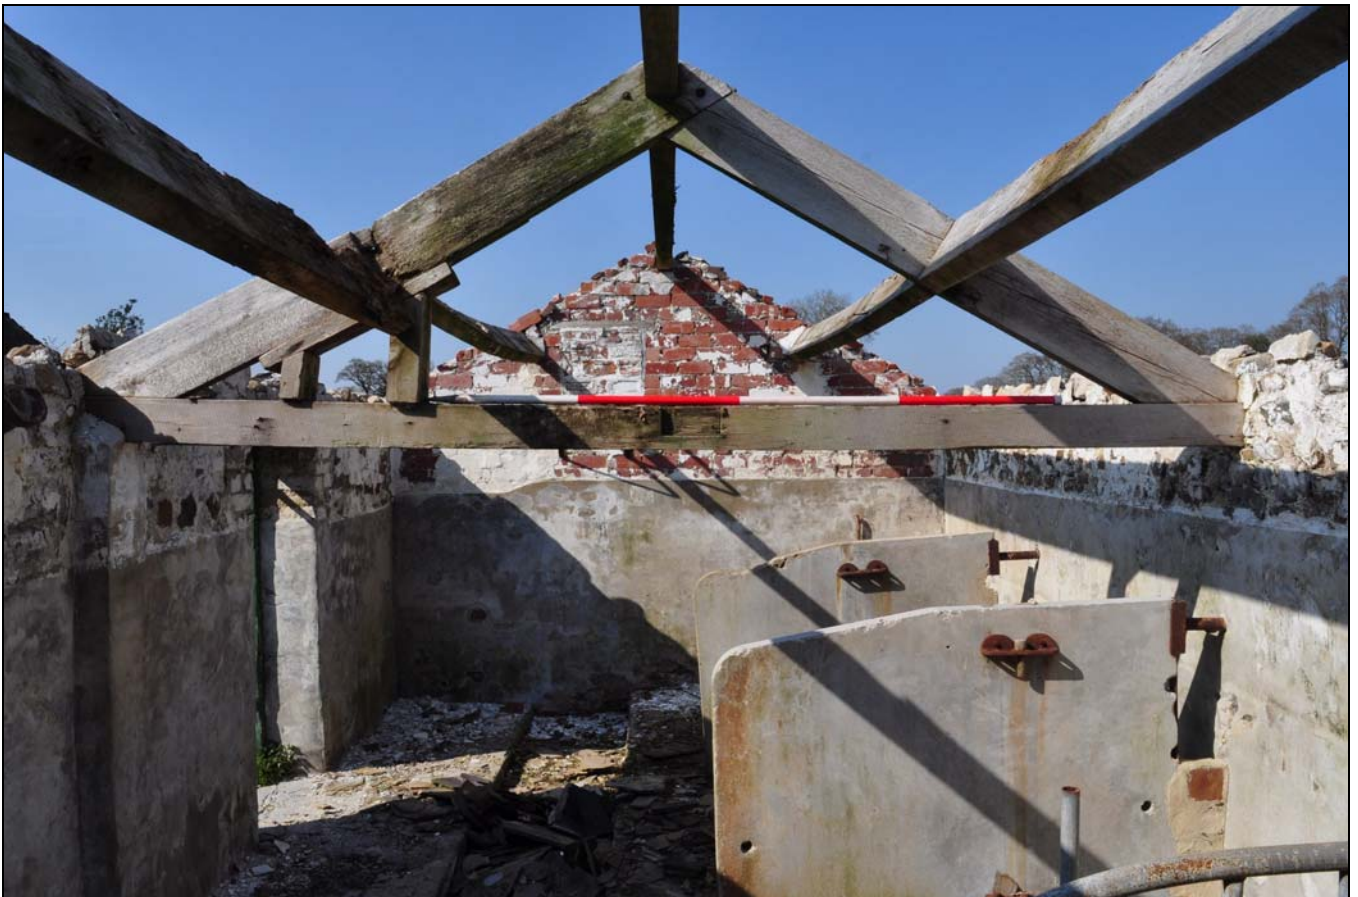
- 8.15 On the east side of the yard, the existing single-storey outbuilding appears to have been built in the period between 1850 and 1892, though it was later extended at the south end, where there is presently an open-fronted shed (46-49). In common with the barn, it is built from sandstone rubble, but its stone slate roof and tile ridge have been removed recently for safety.

- 8.16 There are three doorways to the front elevation, and a window in the north gable. A brick cross-wall divides the building into a larger south end (served by two doorways), which presently has mid 20th century boskins for housing tied cattle, and a simple truss of sawn softwood (50). The smaller north room was last used as a dairy, in the mid/late 20th century (51). These present arrangements mean that the original use of the building is no longer clear, but it may well have been first intended as additional livestock housing.

Photo 46: Detached outbuilding, looking east

Photo 49: Detached outbuilding, looking north-west

Photo 50: Detached outbuilding: south room, looking north
