Sweetclough Cottage  
Baxenden, Lancashire:  
Historic Building Survey (Level 2 Record)

July 2021

STEPHEN HAIGH

# Sweetclough Cottage Baxenden, Lancashire: Historic Building Survey (Level 2 Record)

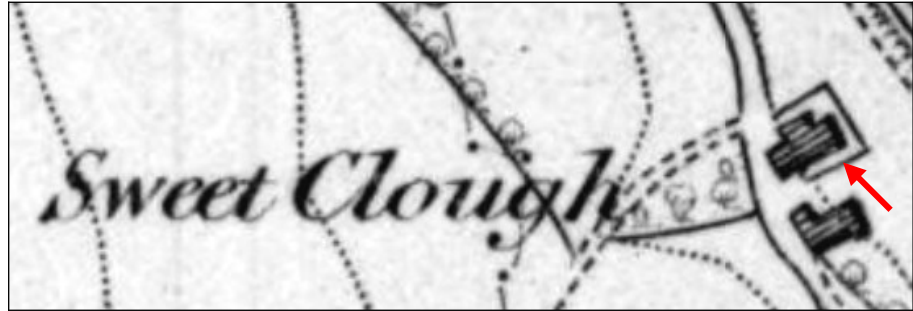
Figure 4: OS 1:10560 map, 1849

- 5.1 The Ordnance Survey 1:10560 map of 1849<sup>2</sup> (figure 4) shows cottage and farmhouse, but the scale is too small to infer precise details of the building's footprint.

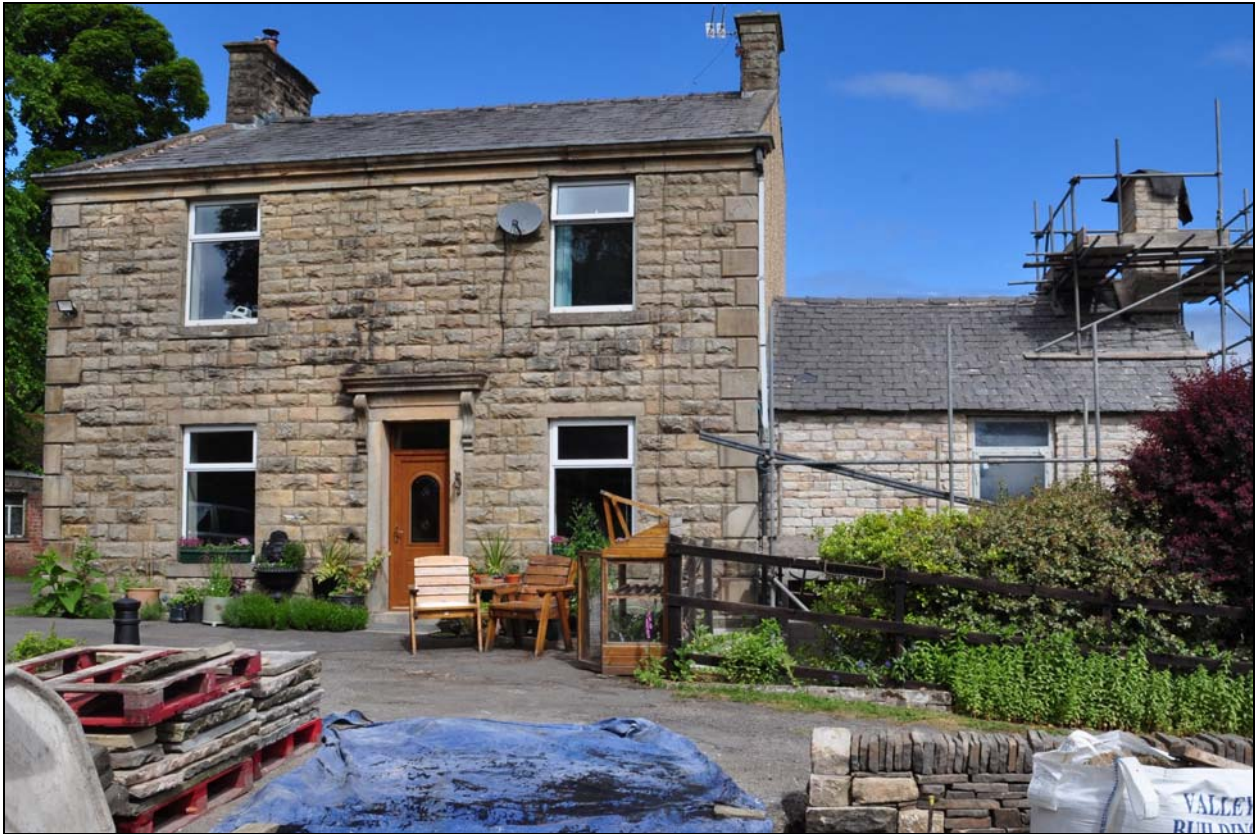
- 7.1 The cottage is built into a slope which rises to the south-west, so is set considerably below the level of the adjoining later farmhouse (**1**), and the front doorway is reached by descending a set of stone steps from the built-up ground further forward (**2**).

Photo 1: General view of Sweetclough Cottage (right) and Farmhouse (left), from the south-east

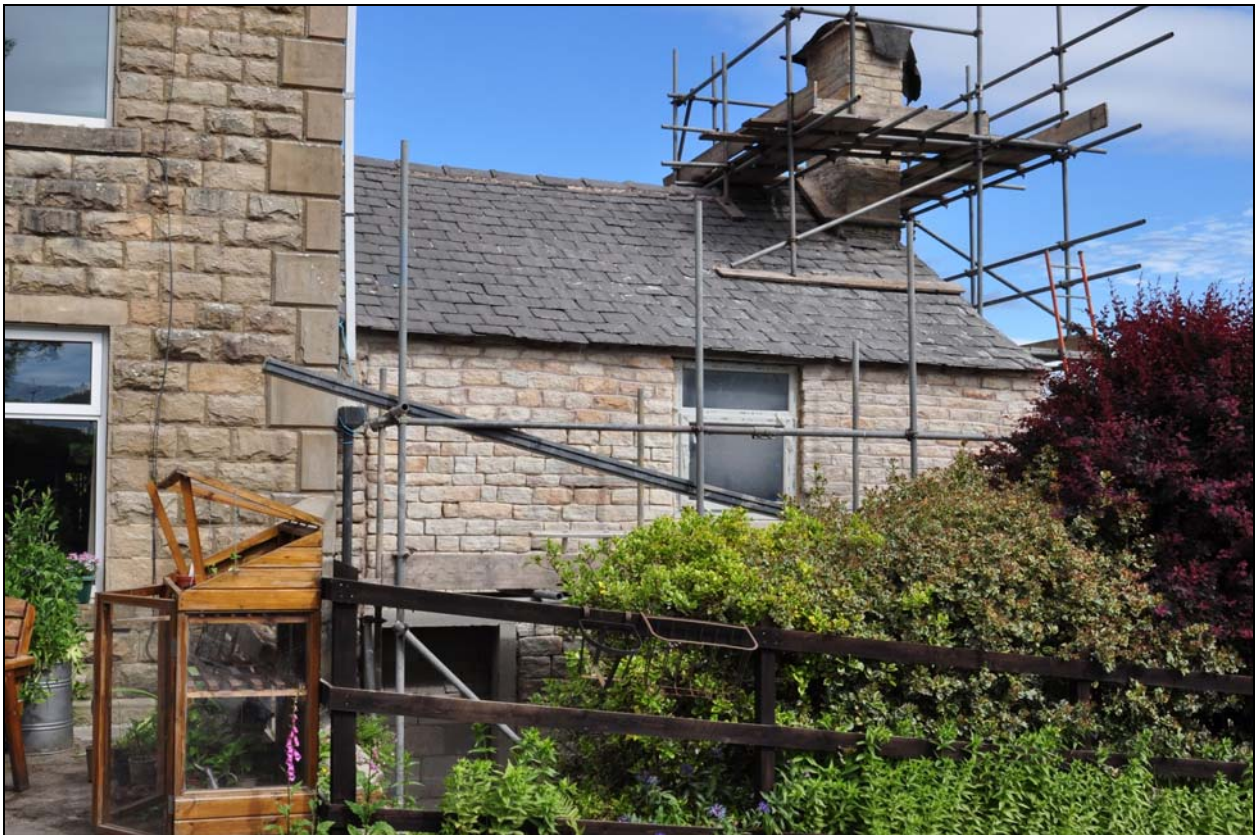
Photo 2: Front elevation of cottage

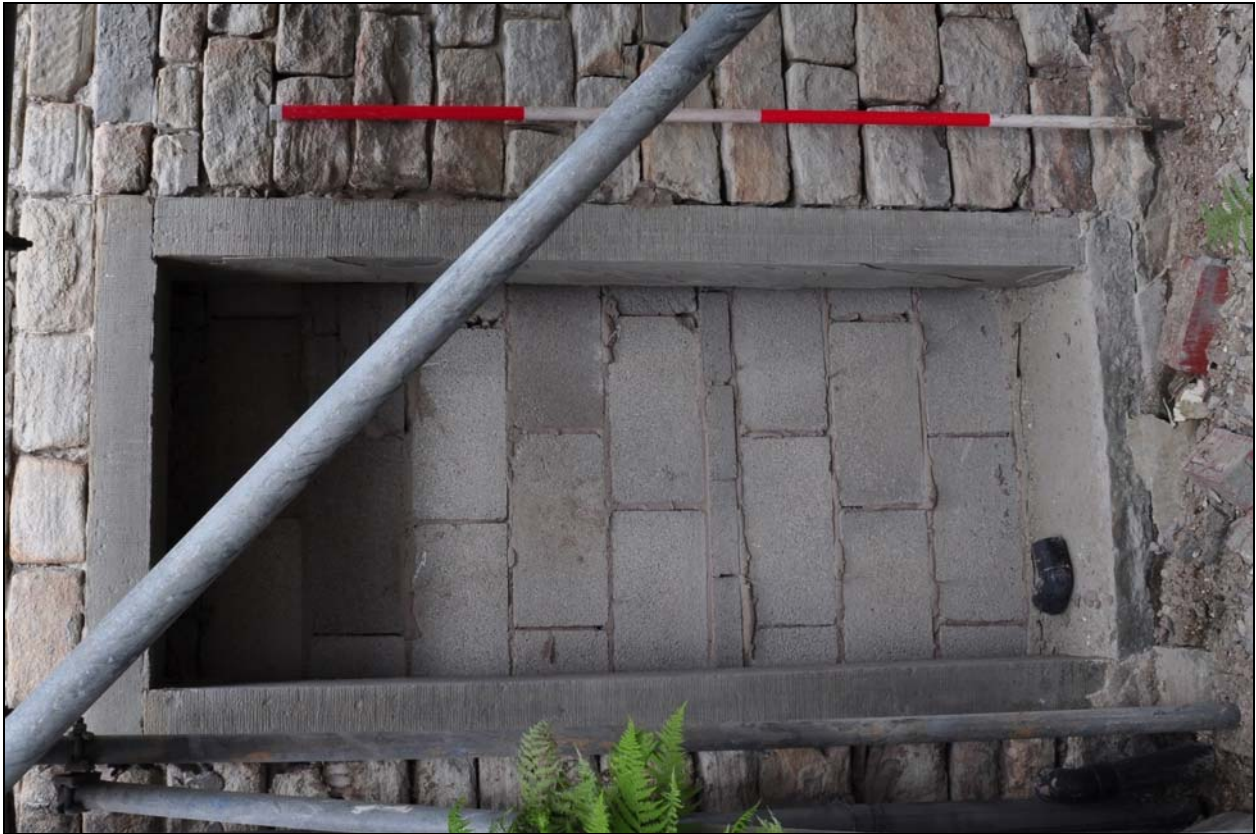
- 7.2 The front of the cottage is faced with coursed, watershot sandstone, and its doorway has a monolithic surround, characteristic of the period around the turn of the nineteenth century (**3**). To the right of it, the present window with a vertical emphasis is not an original opening, but probably dates from a late nineteenth or early twentieth century phase (**4**). The sill of the original window has been cut through to accommodate it, but the lintel, which extends further to the left than the present window dictates, survives intact. The first floor window has similarly been changed, from a longer and shallower opening (**5**).

Photo 3: Front entrance to cottage

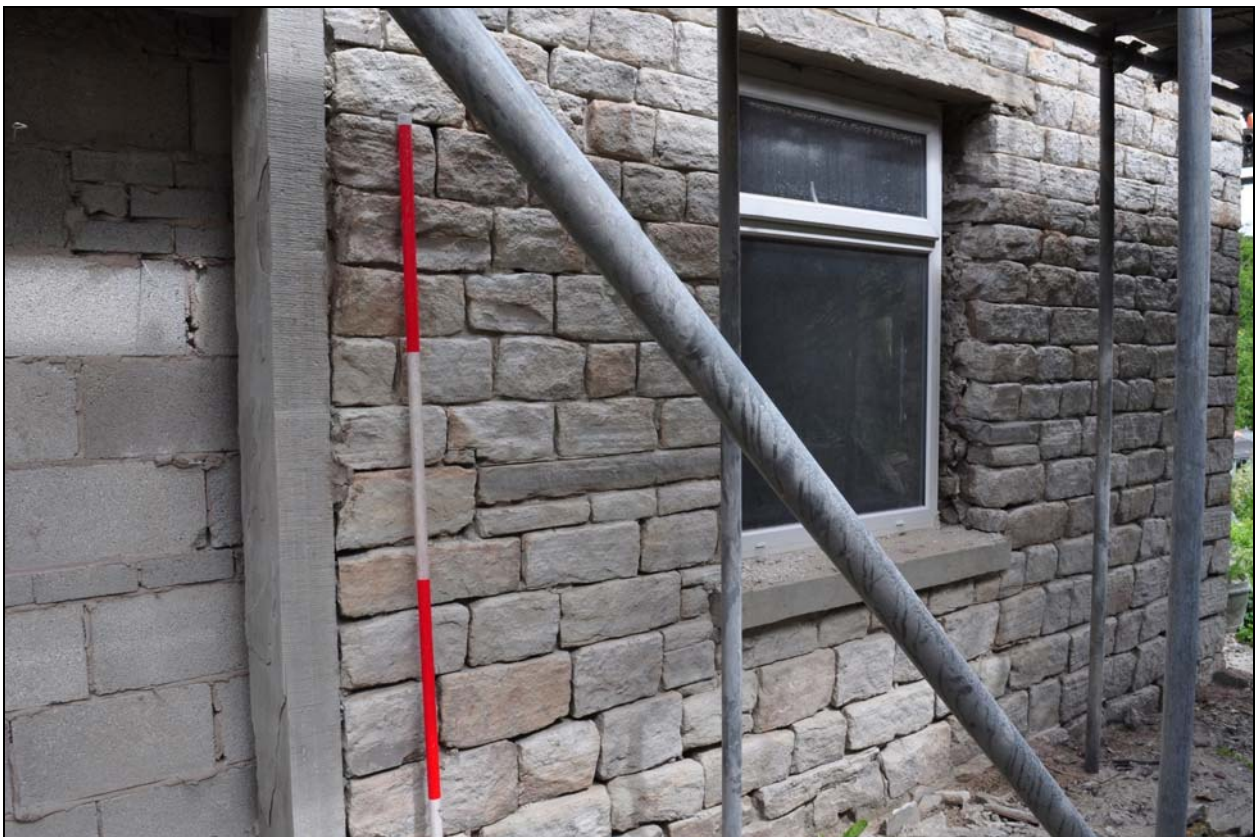
Photo 4: Ground floor window in front elevation, with earlier sill visible at higher level

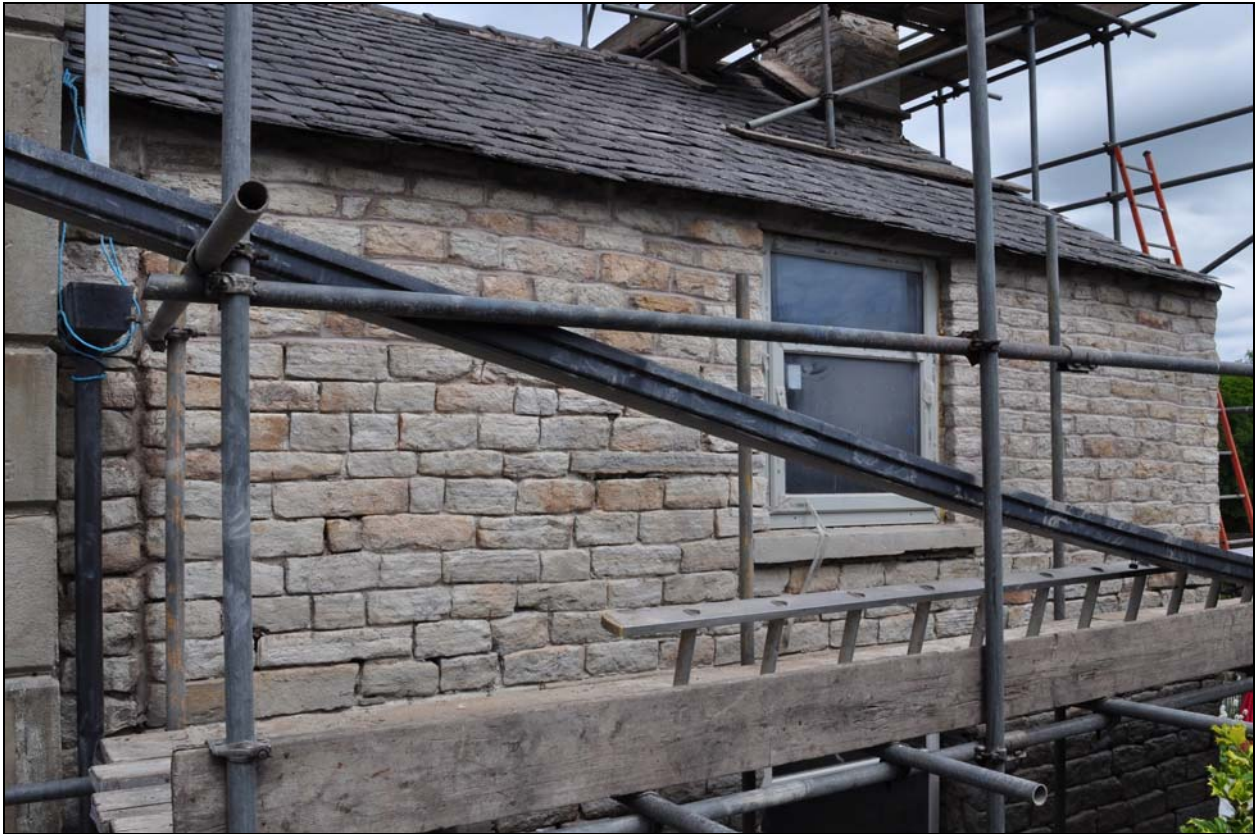
- 7.3 The upper part of this front elevation contains a vertical joint, 230mm from the side of the adjoining farmhouse (**5**). This seems to represent the outer face of an earlier building adjoining to the south-west, probably the predecessor to the present farmhouse. Further evidence relating to it can be seen inside the cottage (see below).

Photo 5: First floor in front elevation: straight joint at left, and earlier window sill visible

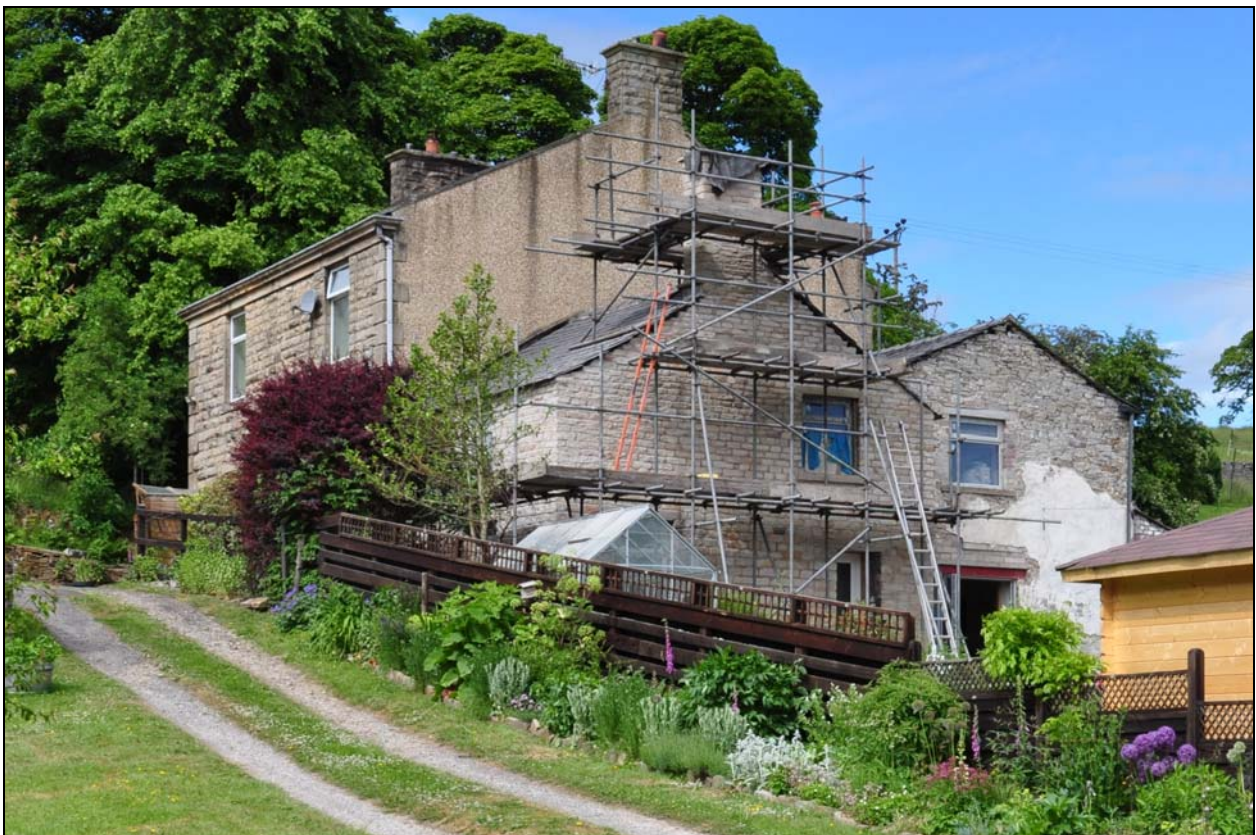
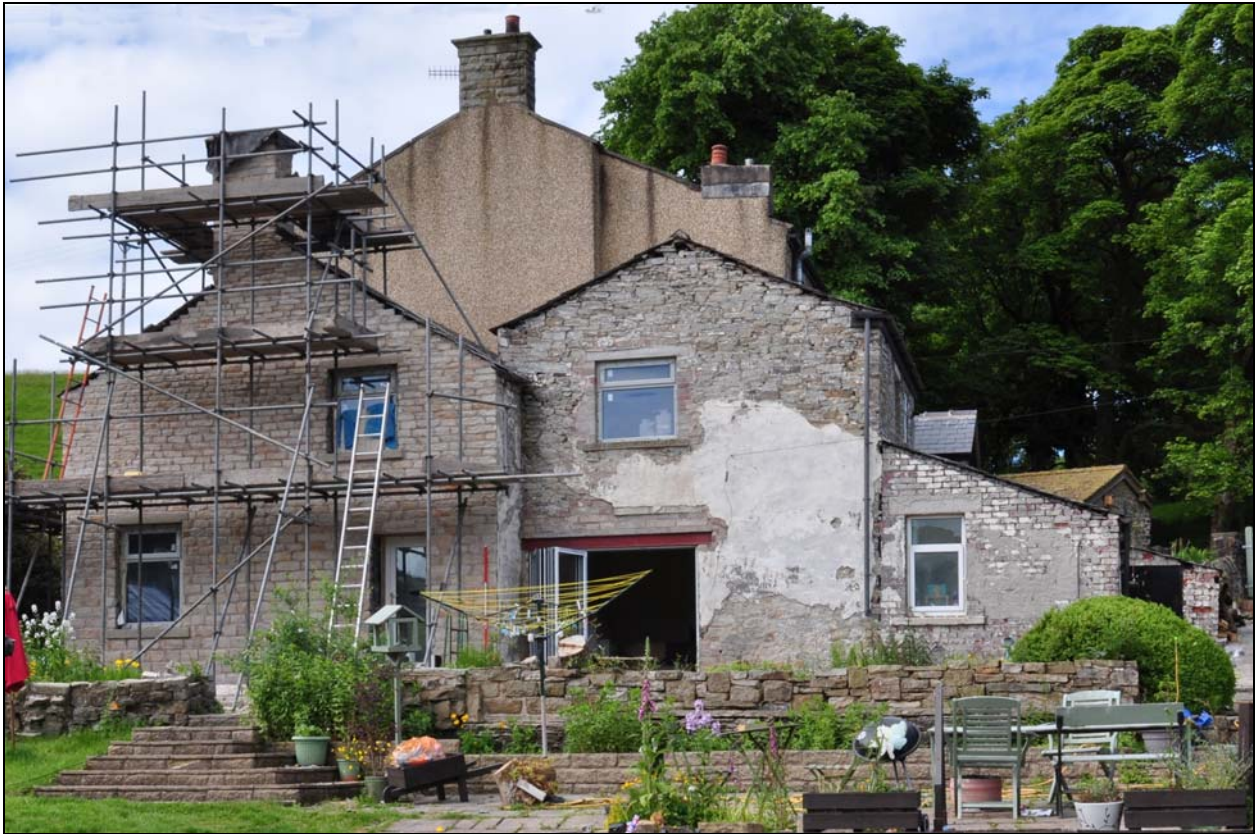
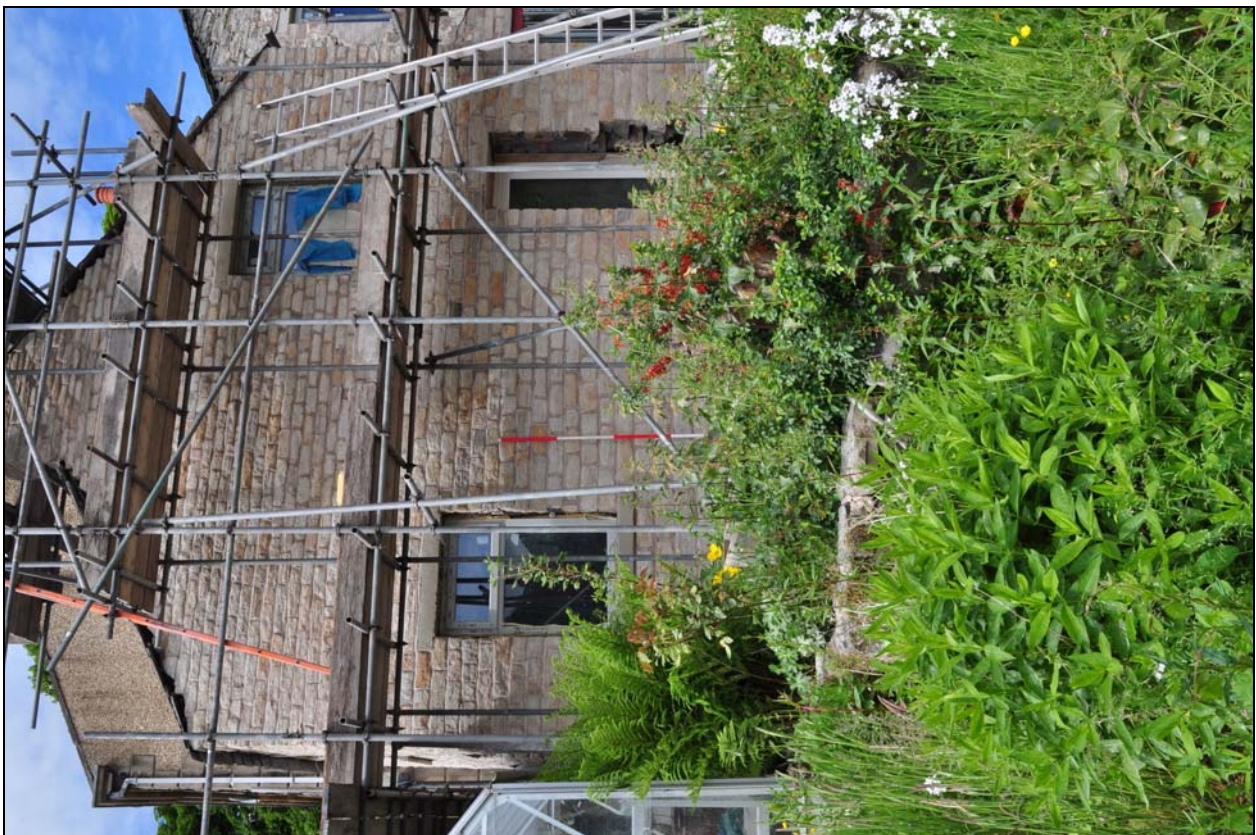
openings are thought to be original, and they are likely to have been inserted at least partly to compensate for the loss of windows caused by the extension of the house to the rear (**6-8**). The original house's rear wall (now facing into the extension) was also of coursed, watershot stone, and does contain at least one former window on both ground and first floors.

Photo 6: General view of Sweetclough Cottage (lower) and Farmhouse (upper), from the east

Photo 7: General view, from the north-east. Original part of cottage to left, nineteenth & twentieth century extensions to right

Photo 8: Gable of original part of cottage

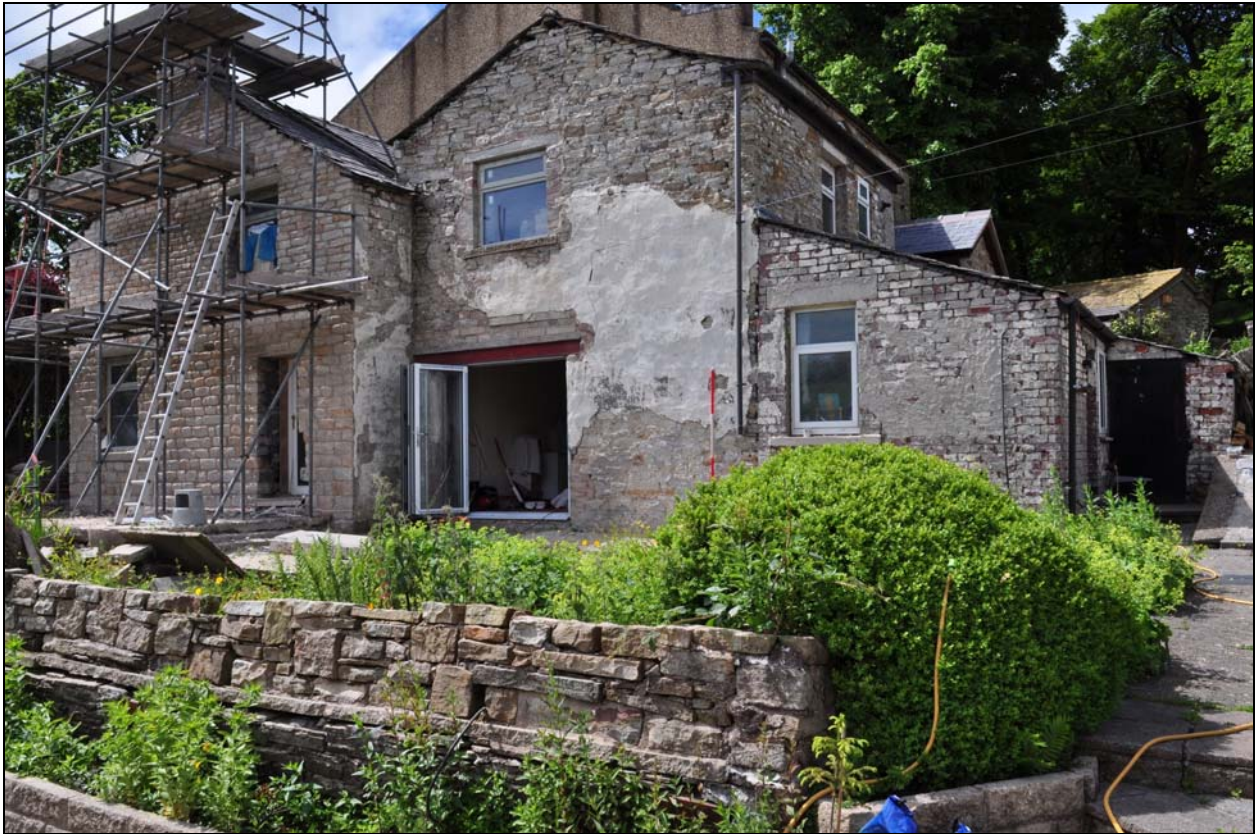
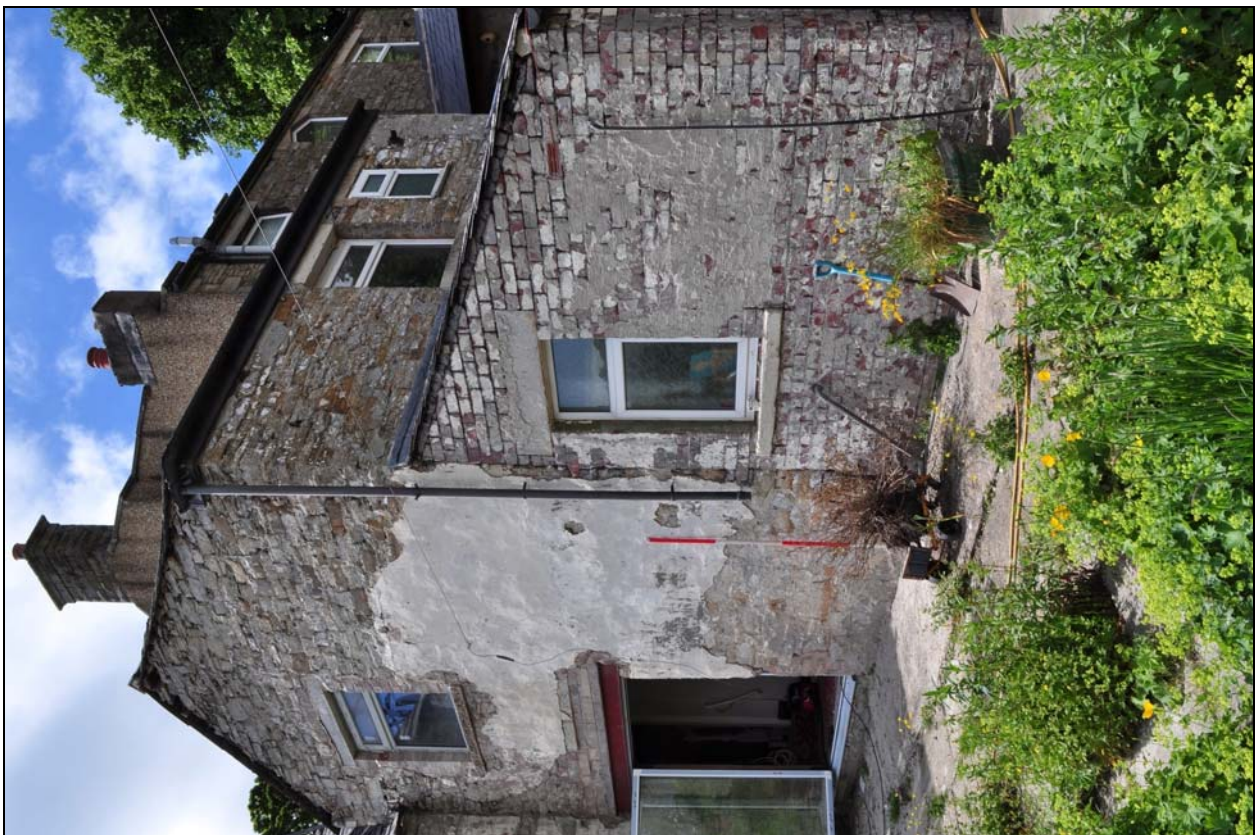
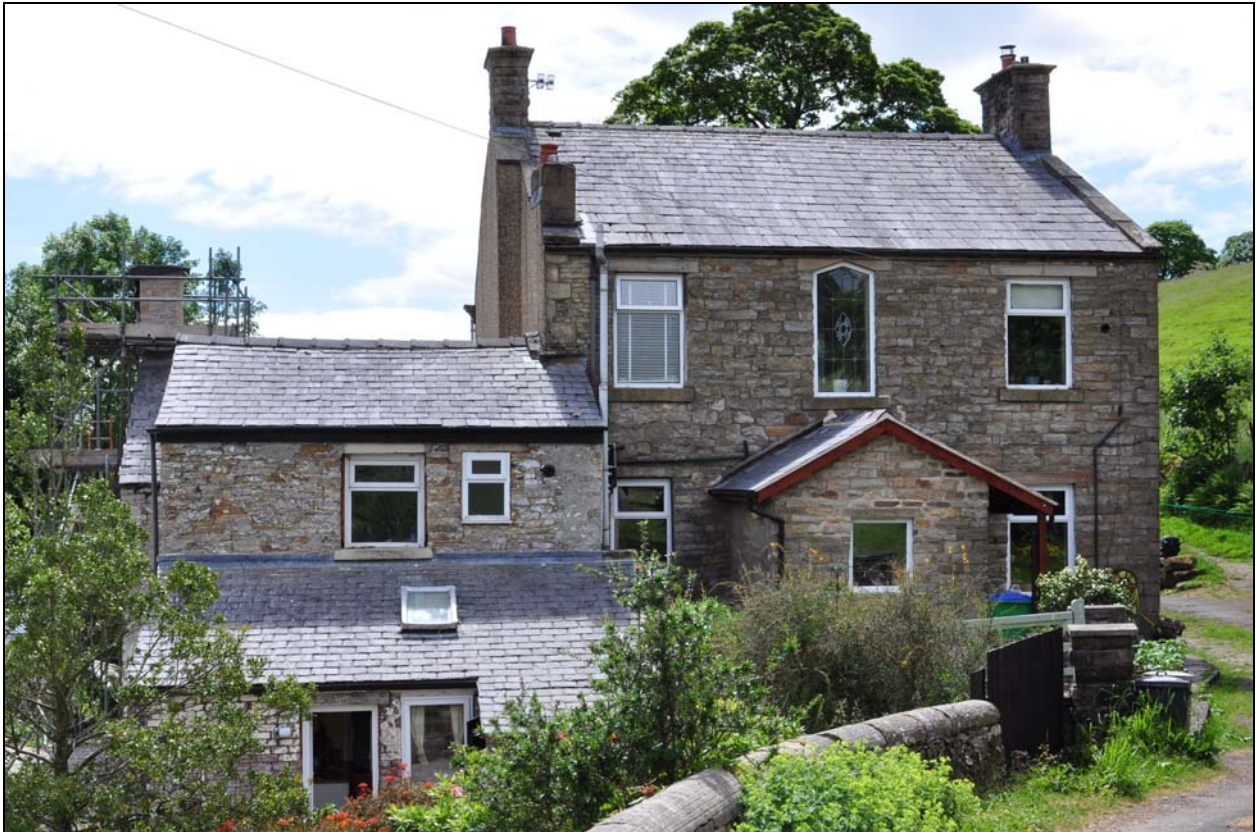
- 7.5 The two-storey, nineteenth century extension is built from random, squared sandstone, and involved the heightening of part of the original rear wall, to form a roof valley. It has a number of openings in its north-east and north-west sides, although only the first floor rear window appears unaltered and original (**9-11**).

Photo 9: General view, from the north-east

Photo 10: Nineteenth and twentieth century extensions, from the north

Photo 11: Rear view of Sweetclough Cottage (left) and Farmhouse (right), from the north-west

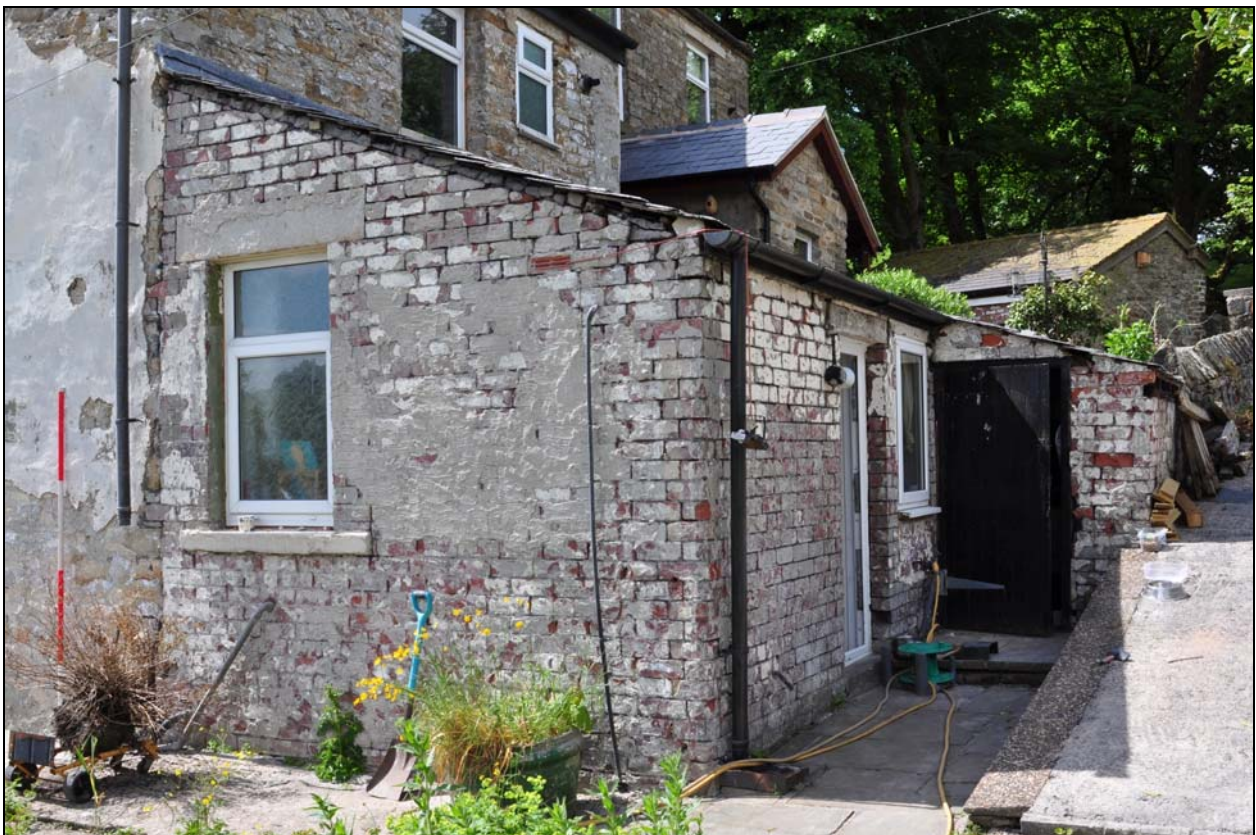
- 7.6 During the mid twentieth century, a single-storey brick lean-to of L-shaped plan was built up to the rear of the nineteenth century extension, and this presently contains the kitchen (**12**).

Photo 12: Twentieth century rear extension, from the north

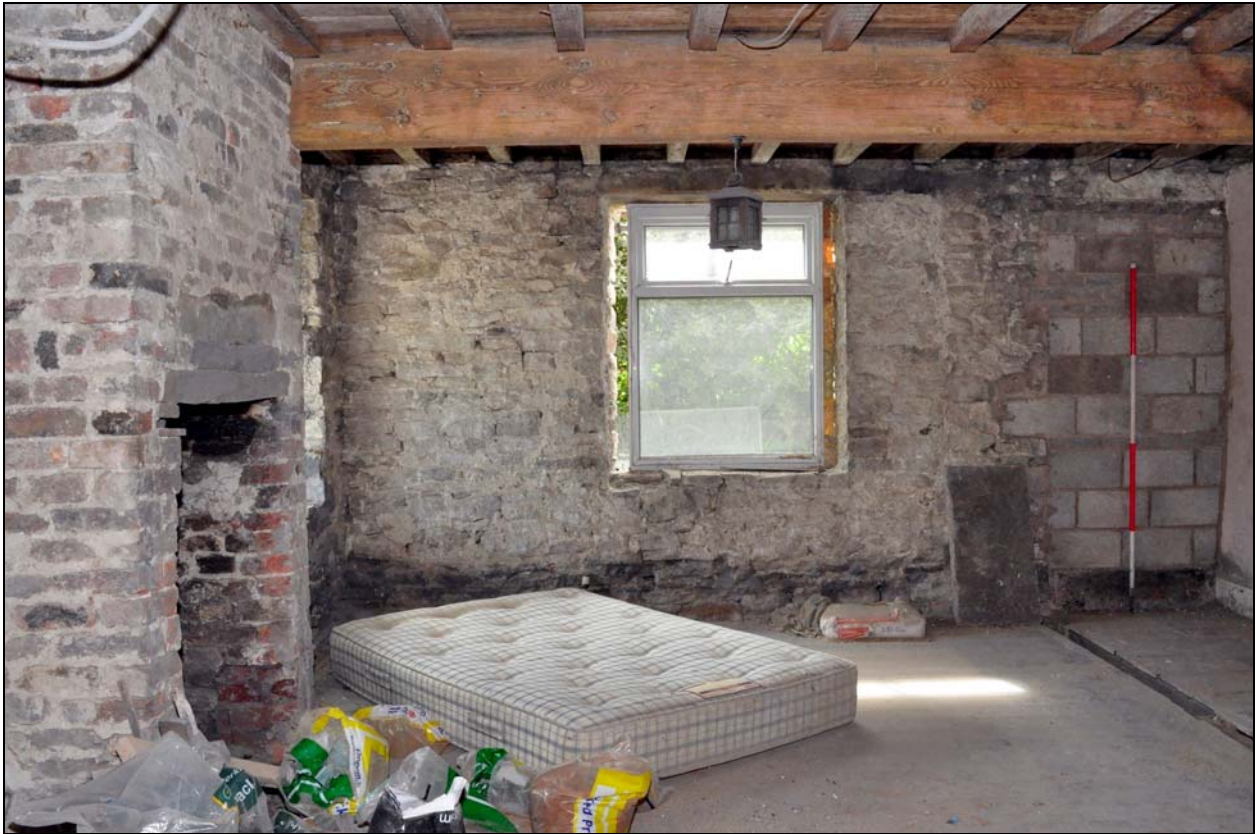
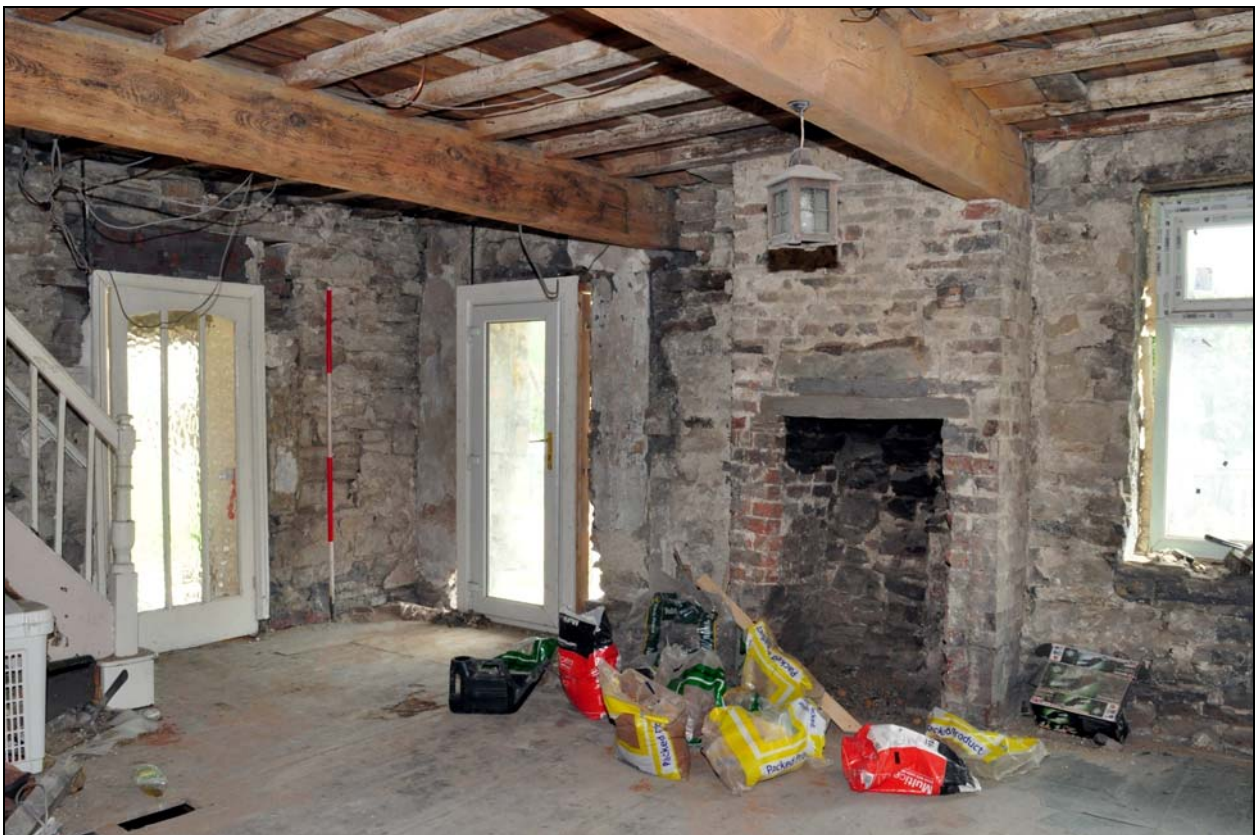
- 7.7 All parts of the cottage are roofed with blue slate, though in part this is likely to have replaced local stone slate.
- 7.8 The main ground floor room of the cottage has a gable fireplace set within a chimney-breast of handmade brick (**13-15**), and a suspended timber floor, which overlies the original flagstones, where they survive. Overhead are two deep, square-sawn softwood beams, of which the rear one formed the line of a partition. It meets the south-west wall over a tall recess, possibly a former doorway (**16**). The joists are also softwood, and whitewash beneath the first floor indicates that the ceiling was not underdrawn originally (**17**). At the back of the room is the closed string timber staircase, with turned newel and square balusters, whose form suggests it is later than the supposed date of the cottage (**18,19**).

Photo 13: Ground floor room in front part of cottage, looking south-east

Photo 14: Ground floor room in front part of cottage, looking north

Photo 15: Ground floor room in front part of cottage: detail of fireplace and chimney-breast

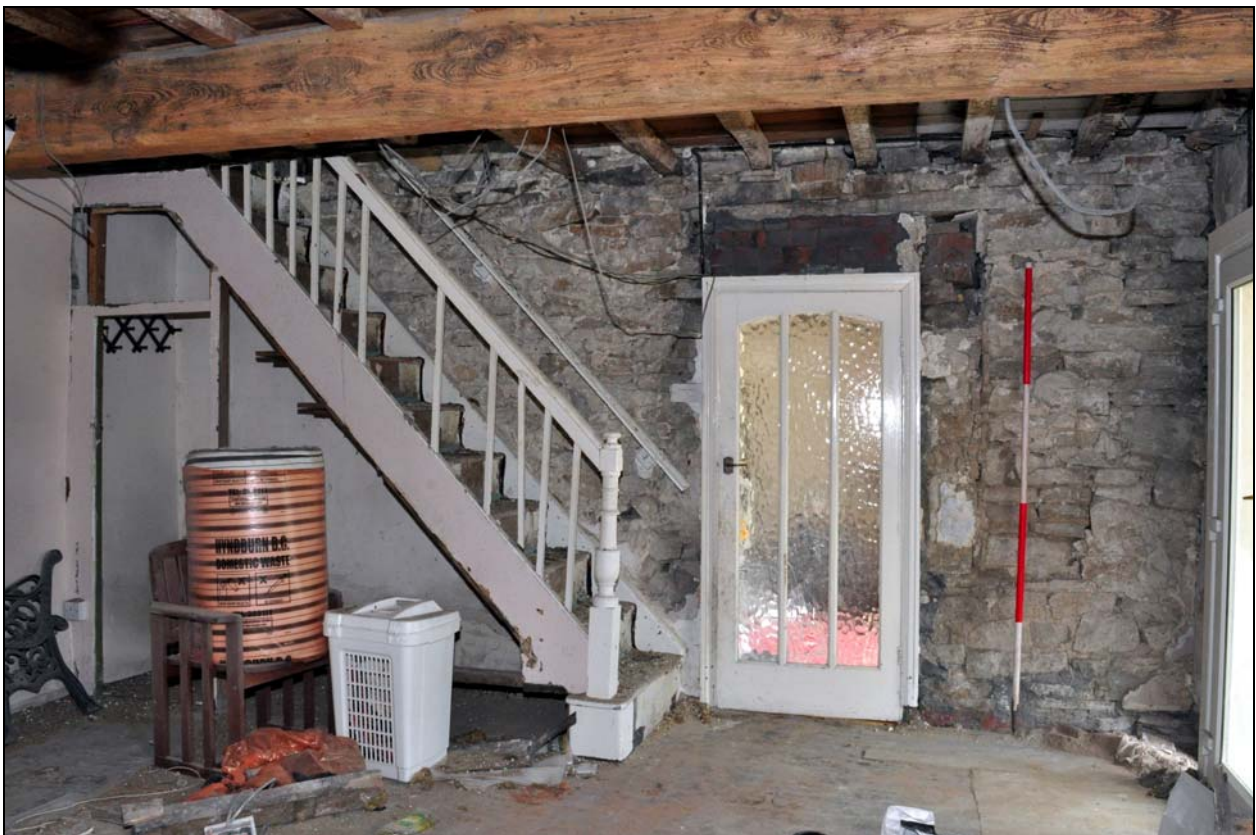
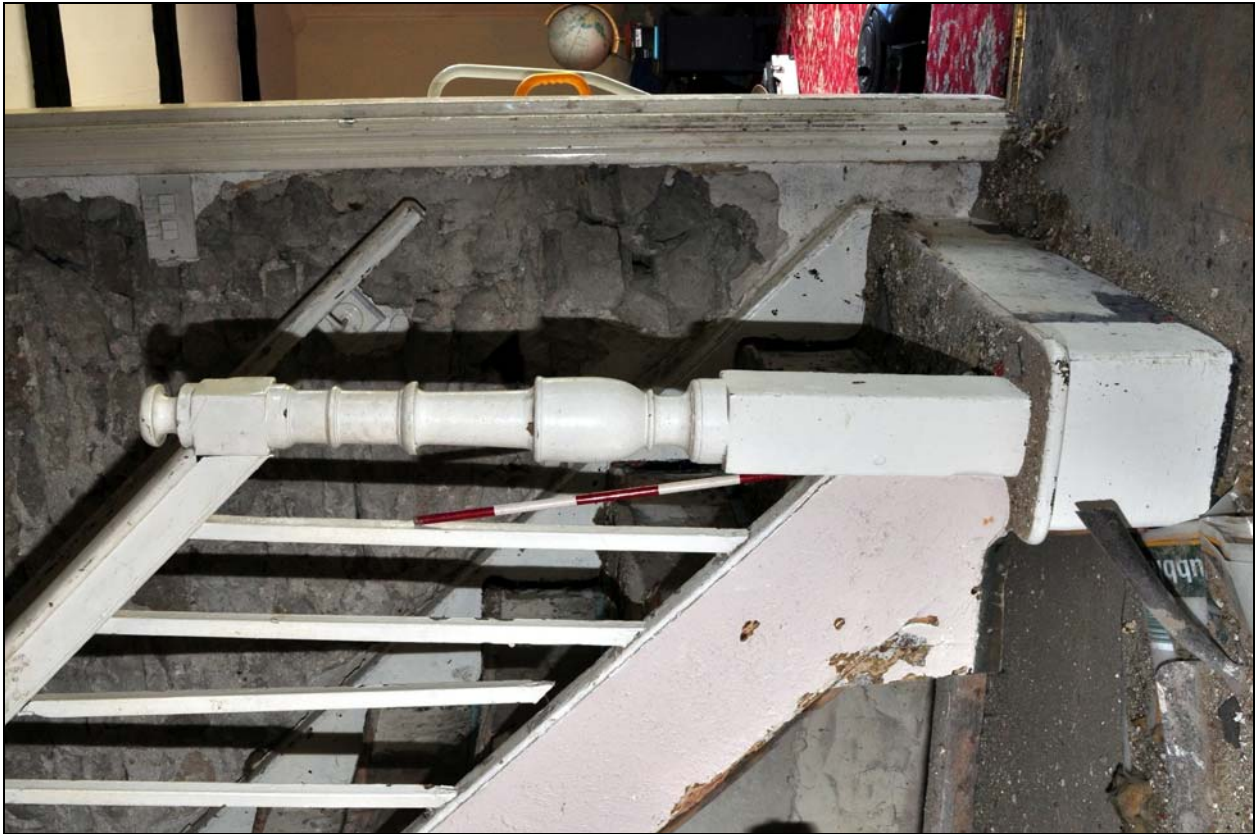
Photo 18: Ground floor room in front part of cottage, looking north-west

Photo 19: Ground floor room in front part of cottage: detail of stairs

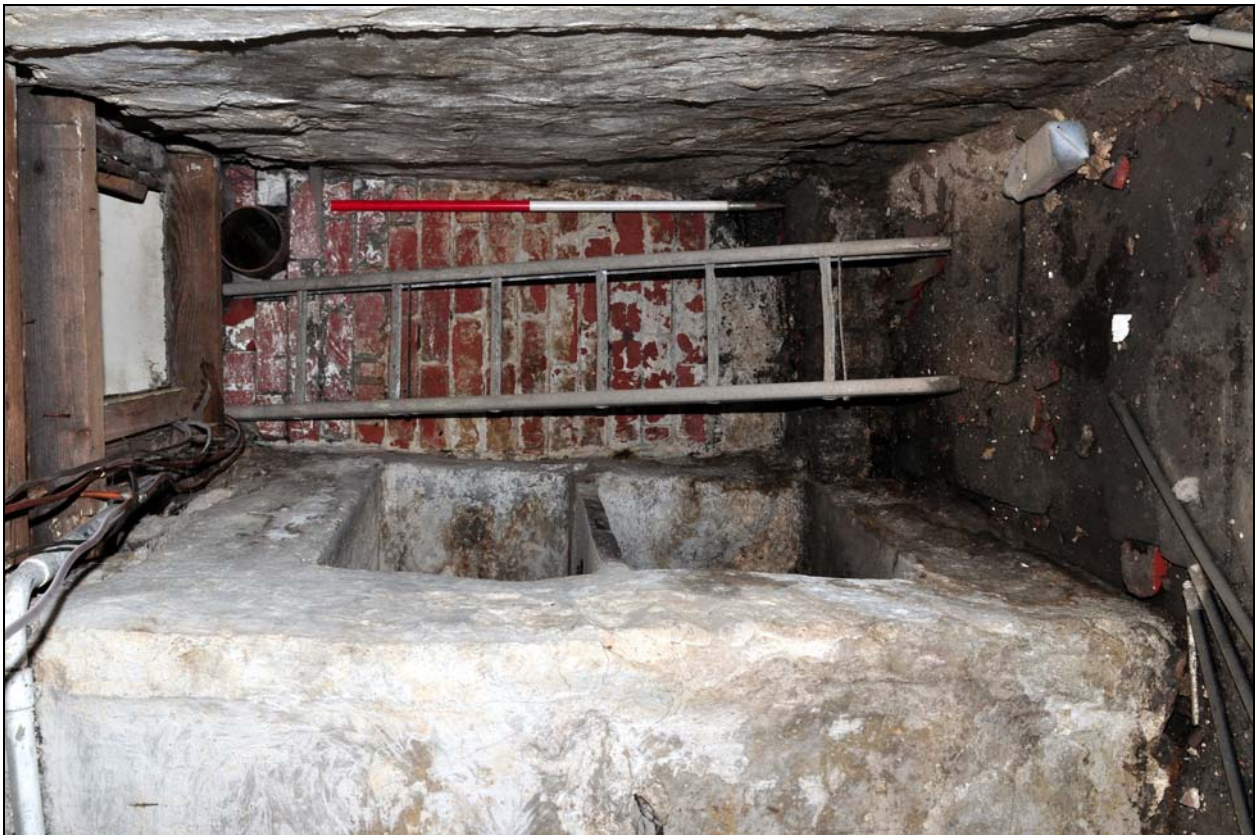
- 7.9 Beneath the staircase is a trap to the cellar, which occupies about a third of the area of the ground floor room. It seems that this was formerly entered from the building to the south-west, via a now bricked-up opening (**20**). The cellar has various wall recesses (**21**), one of which may be a former light-well (**22**). A cross-wall and the original flagged ceiling have been removed, historically.

Photo 20: Cellar: looking south-west towards blocked doorway in wall with Farmhouse

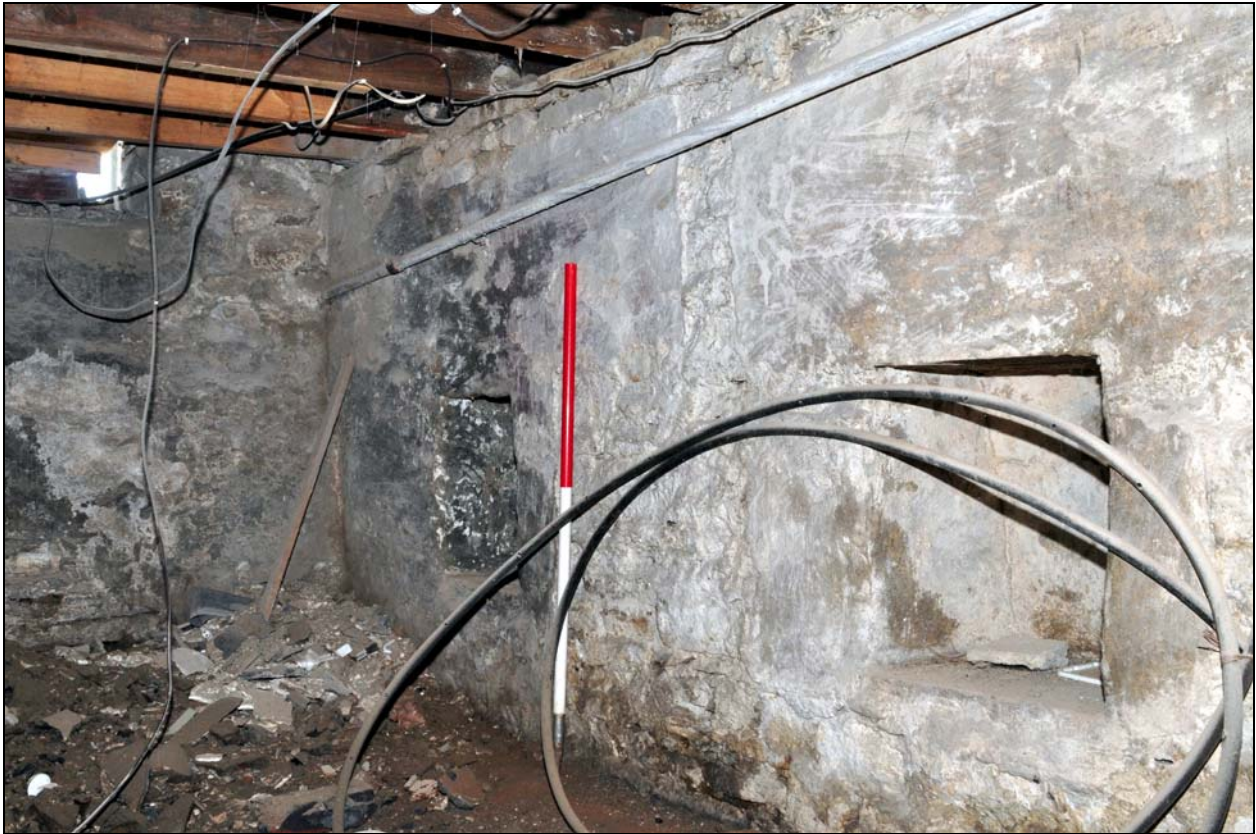
Photo 21: Cellar: recesses and scar of cross-wall, in south-east side

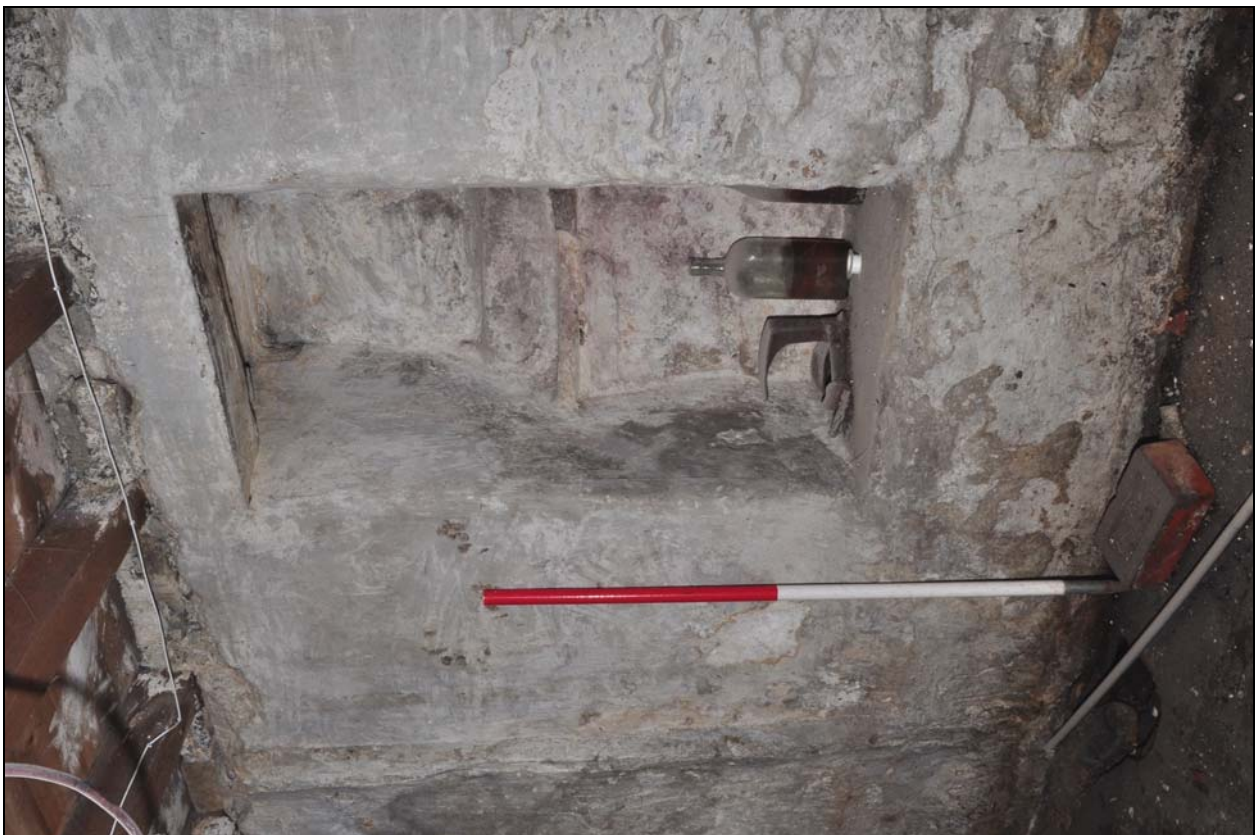
Photo 22: Cellar: recess (light-well?), in north-west side

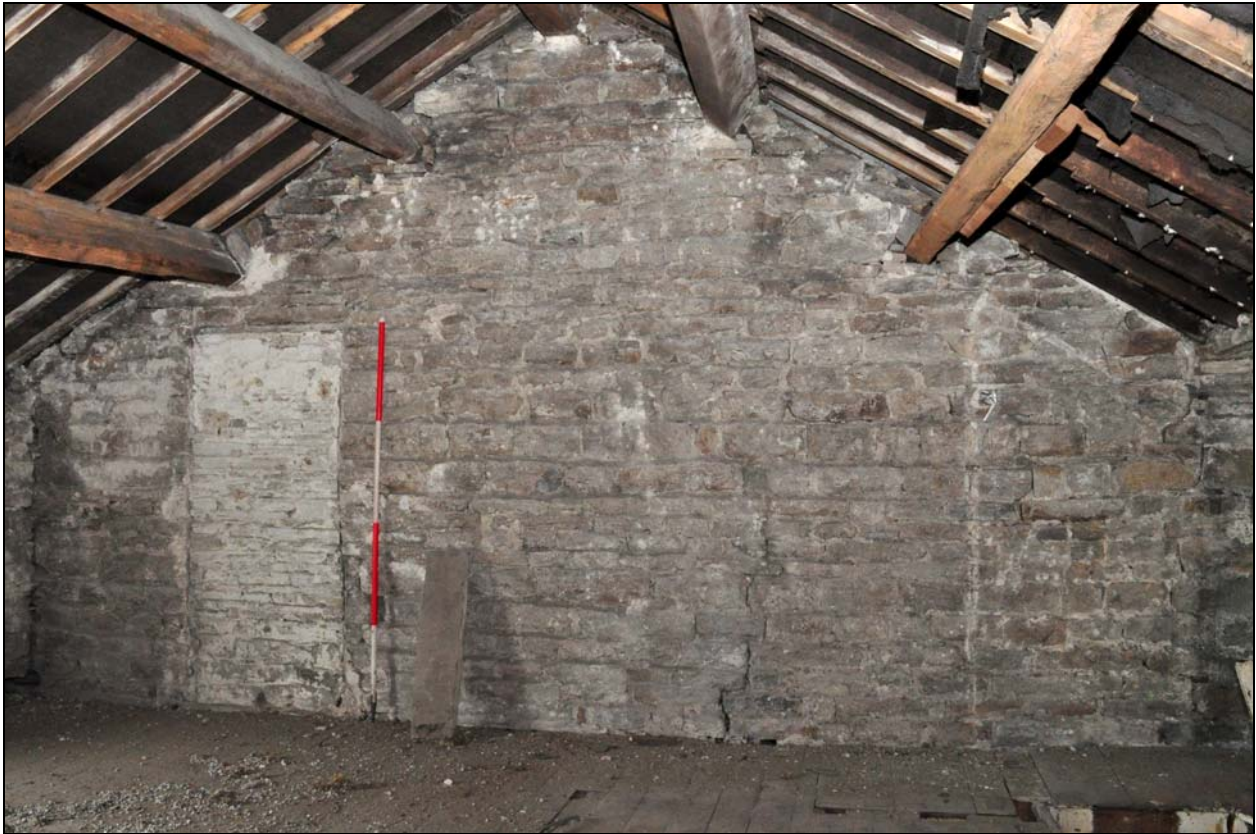
- 7.10 The main first floor room contains good evidence for the cottage having been built against an earlier building to the south-west, as this side of the room (which runs through to the straight joint in the front elevation) is of watershot stonework, contrasting obviously with the rubble of the other internal faces (**23,24**). There is a blocked doorway within it, implying that the cottage was occupied by the same household as that other building. It seems that this room was unheated at the outset, as the stone chimney-breast lacks any opening but was later widened in

Photo 23: First floor room in front part of cottage: south-west side (former external wall face)
