Sweetclough Cottage  
Baxenden, Lancashire:  
Historic Building Survey (Level 2 Record)

July 2021

STEPHEN HAIGH

# Sweetclough Cottage Baxenden, Lancashire: Historic Building Survey (Level 2 Record)

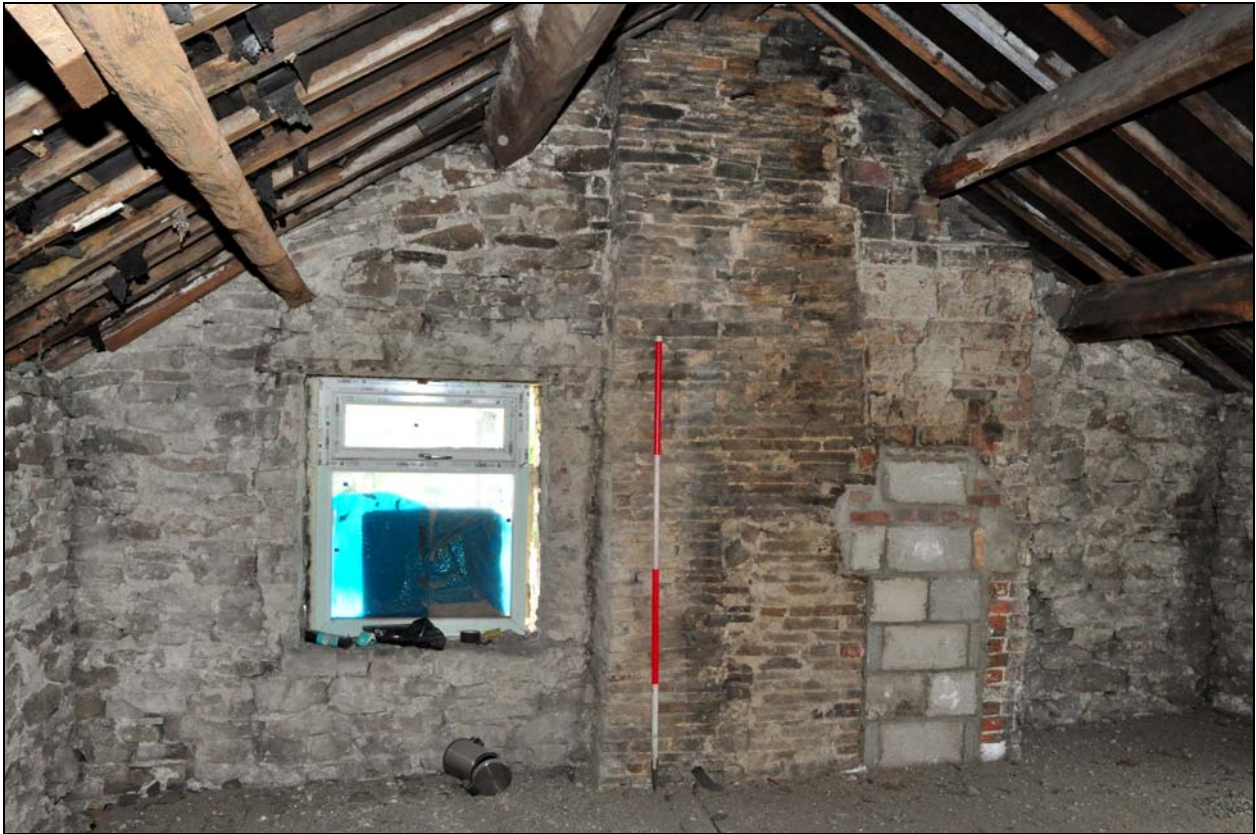
- 7.10 The main first floor room contains good evidence for the cottage having been built against an earlier building to the south-west, as this side of the room (which runs through to the straight joint in the front elevation) is of watershot stonework, contrasting obviously with the rubble of the other internal faces (**23,24**). There is a blocked doorway within it, implying that the cottage was occupied by the same household as that other building. It seems that this room was unheated at the outset, as the stone chimney-breast lacks any opening but was later widened in

brick so as to accommodate a fireplace (25). A rear window has been slighted by the new doorway connecting to the nineteenth century extension (26). Roof timbers are of similar material and size as the first floor beams.

Photo 25: First floor room in front part of cottage, looking north-east towards widened chimney-breast

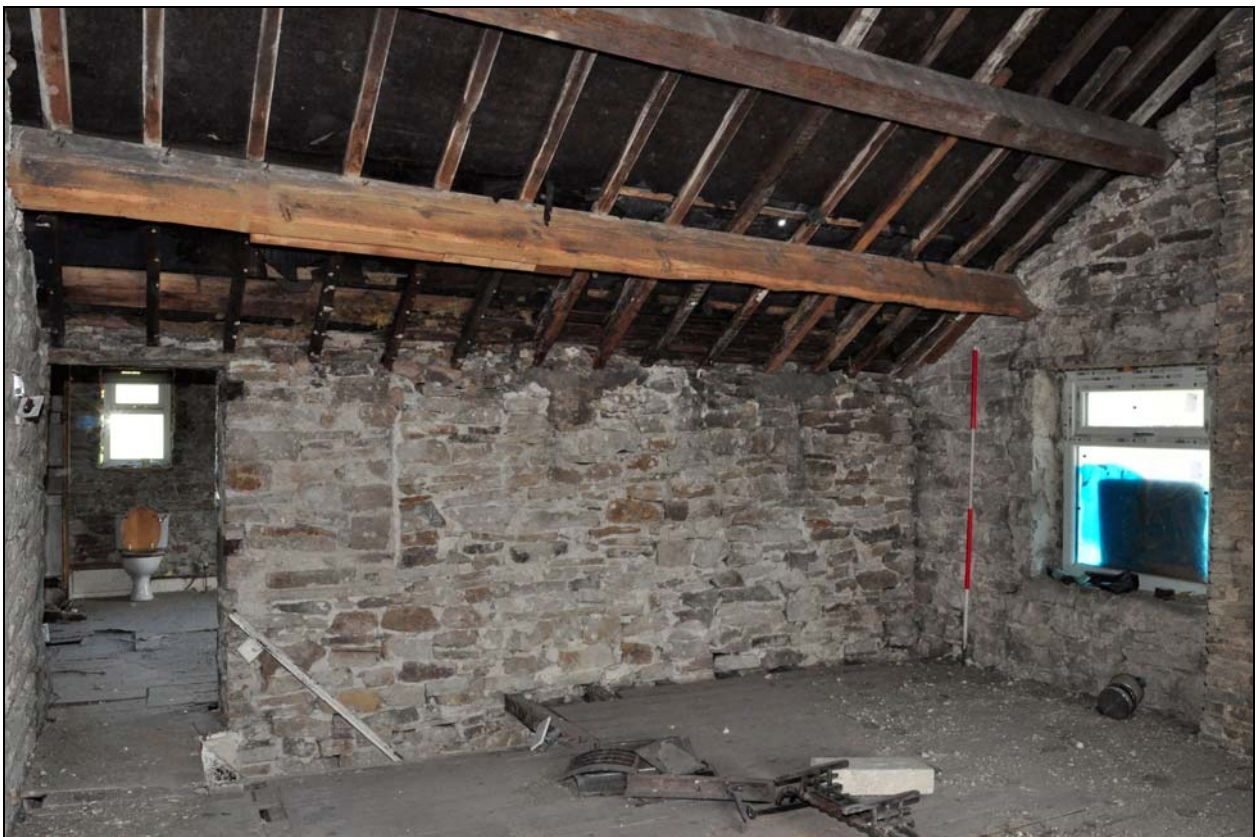
Photo 26: First floor room in front part of cottage, looking north

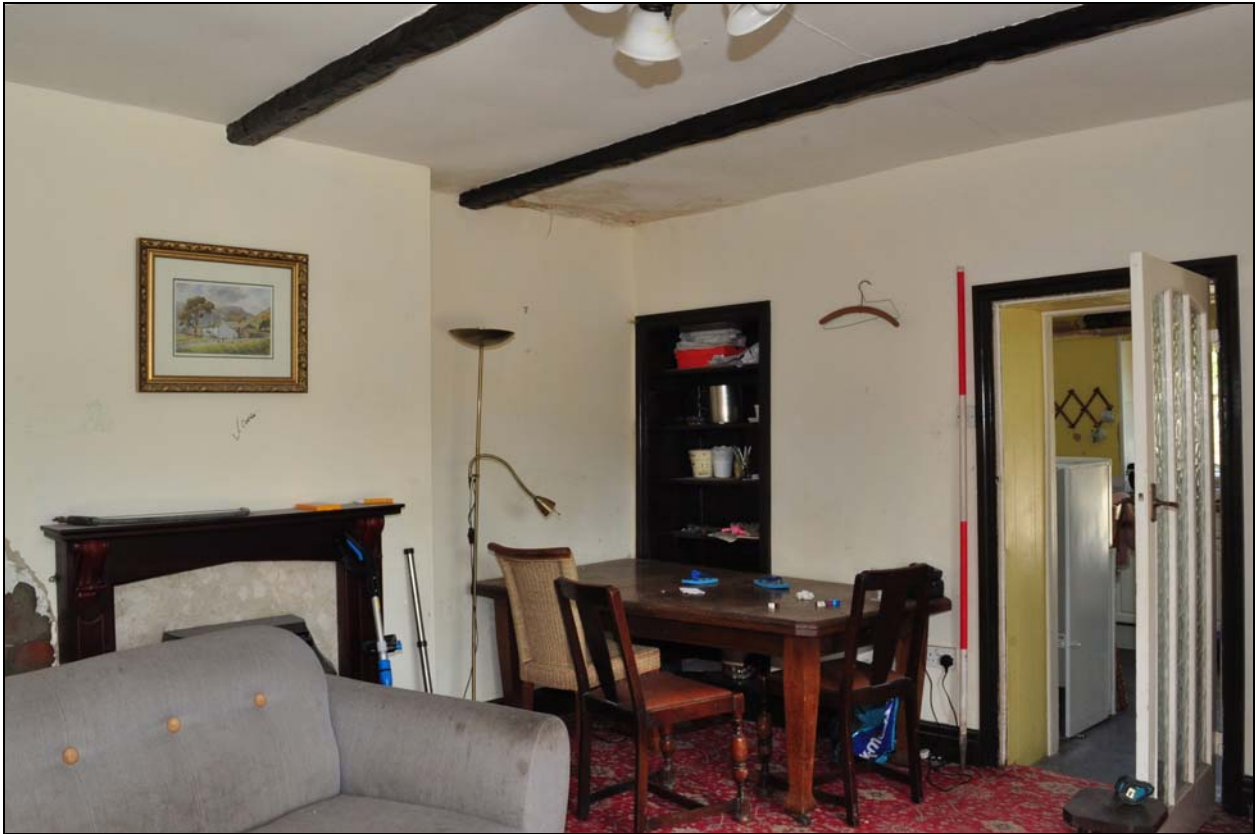
- 7.11 The ground floor rooms of the nineteenth and twentieth century extensions are entirely modern in appearance, and have not been stripped of plaster or their modern fixtures and fittings (27). The first floor room of the former contains a plain stone fireplace surround in its shallow chimney-breast (28), but no other features of particular interest (29,30).

Photo 27: Ground floor of nineteenth century extension, looking west

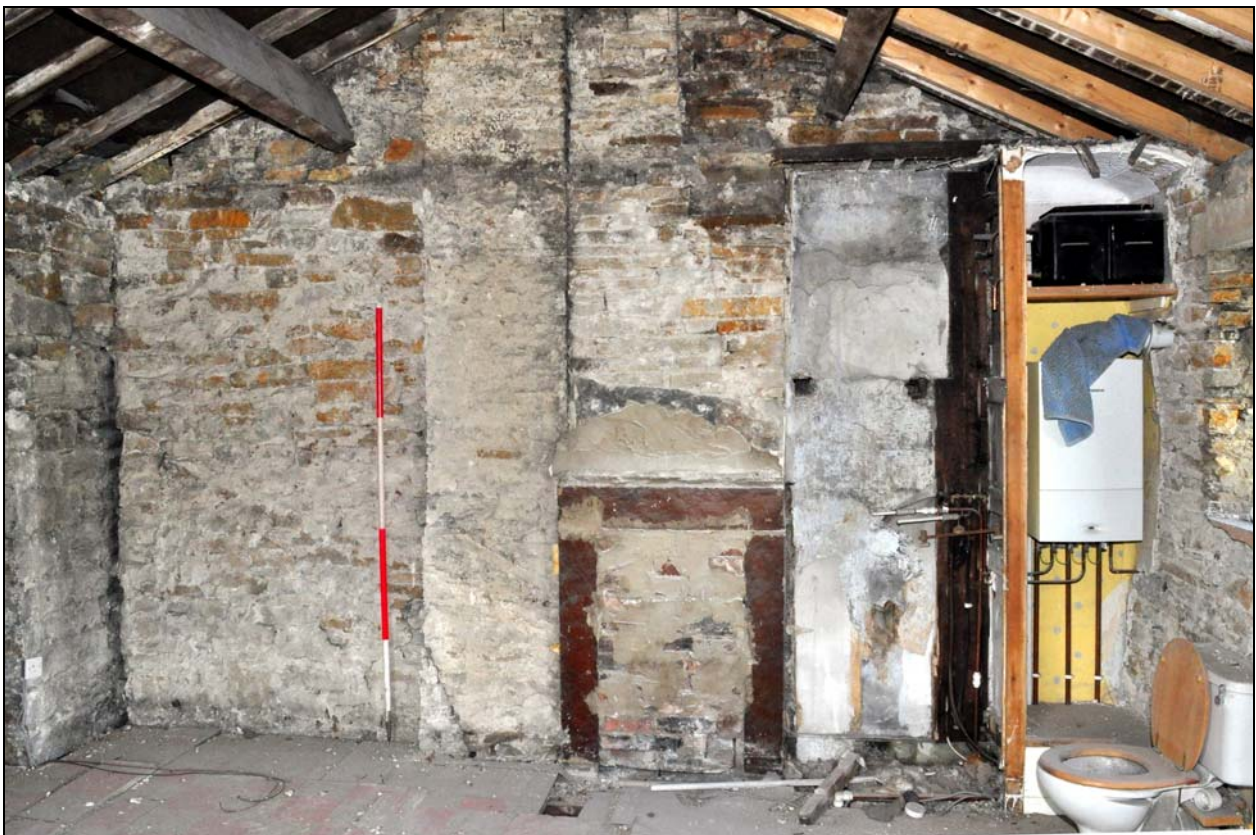
Photo 28: First floor of nineteenth century extension, looking south-west

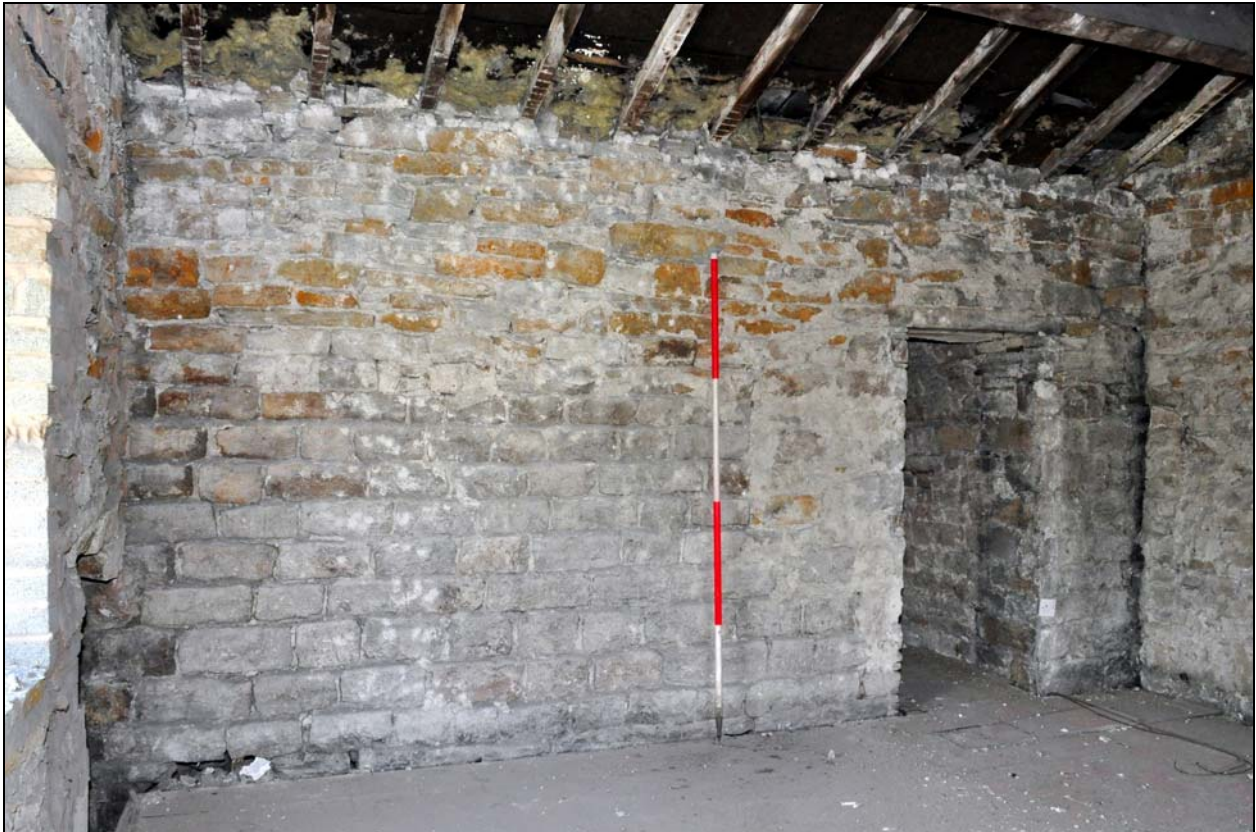
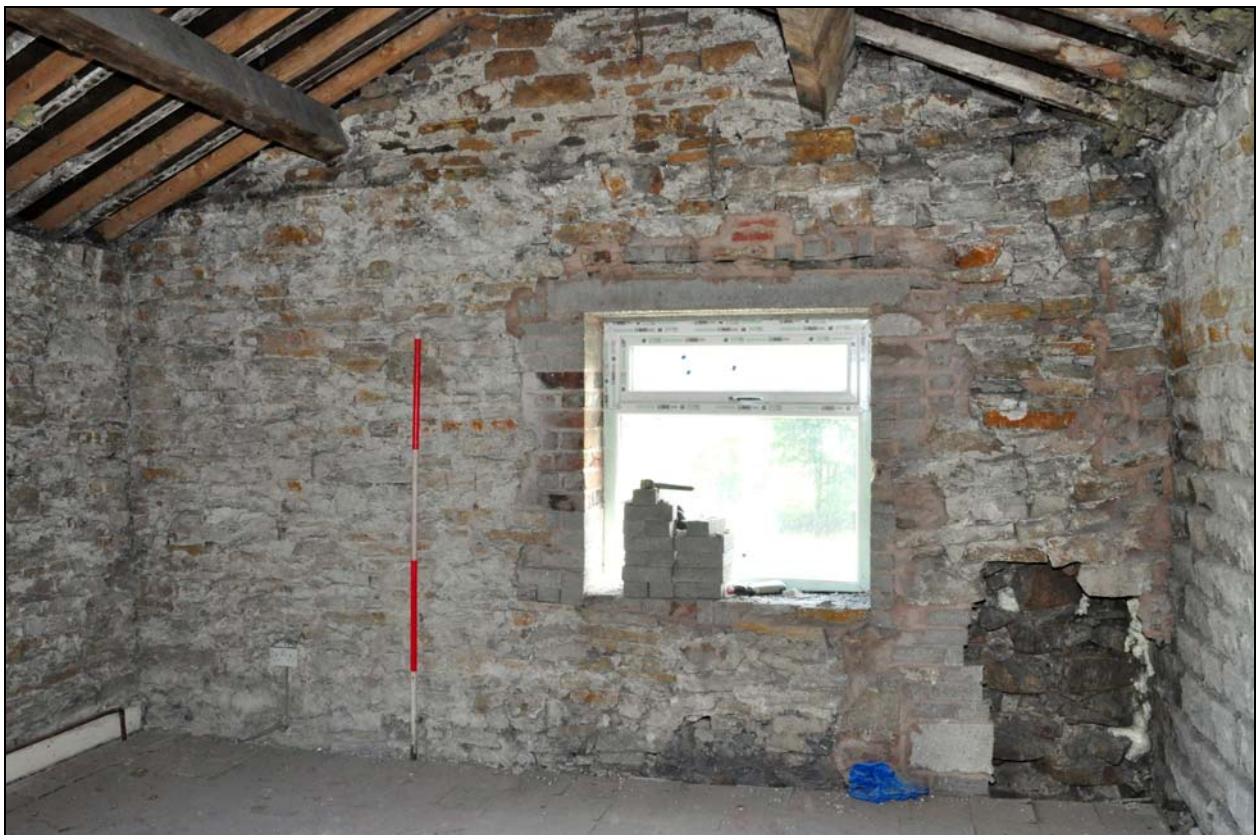
Photo 29: First floor of nineteenth century extension, looking south-east

Photo 30: First floor of nineteenth century extension, looking north-east
