Barn at Higher Side Beet  
Rishton, Lancashire:  
Archaeological Building Recording

# Barn at Higher Side Beet Rishton, Lancashire: Archaeological Building Recording

Archaeological building recording was carried out for Sammon Estates Ltd in October 2006 at a barn at Higher Side Beet, a farm near Rishton, Lancashire (NGR: SD 708300), before its conversion to residential use. The building comprises a large stone-built nineteenth century barn, with a small adjoining shippon. The records made include a floor plan, section drawing and photographs, as well as a written account.

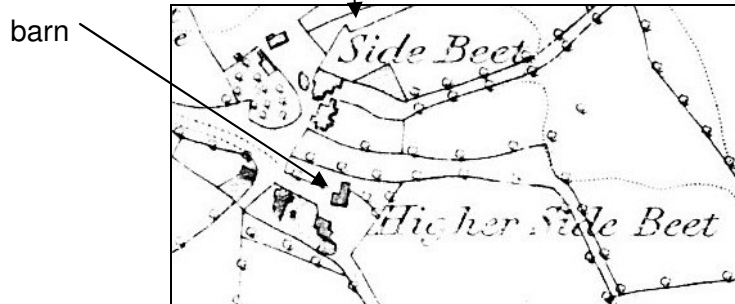
**Figure 3:** Extract from Ordnance Survey 1848 6" to mile map (surveyed 1844-6)  
Sheet no: Lancashire, 63

- 4.2 Little is known of the history of Higher Side Beet, but the first edition Ordnance Survey 6" to the mile map, surveyed 1844 - 1846, appears to show two farmsteads at the site, one named Side Beet, the other Higher Side Beet, with some seven or more buildings in total (Figure 3). The 1893 1:2500 map shows only "Higher Side Beet", with a reduction in the number of buildings to five or six (Figure 4), suggesting that the two farms had been merged, perhaps with the loss of a farmhouse; confusingly however, that now standing and known as Higher Side Beet, is that shown on the 1840s map as Side Beet. There is little overall change between the 1893 and 1931 editions of the 1:2500 map (Figure 5).

- 4.3 The barn which is the subject of this report is shown on the 1848 map as an L-shaped building, but on the 1893 map as a rectangle with an irregular east side. It is shown with a slightly different profile on the 1931 edition, but in both cases the building is wider than the present structure, although of the same length.

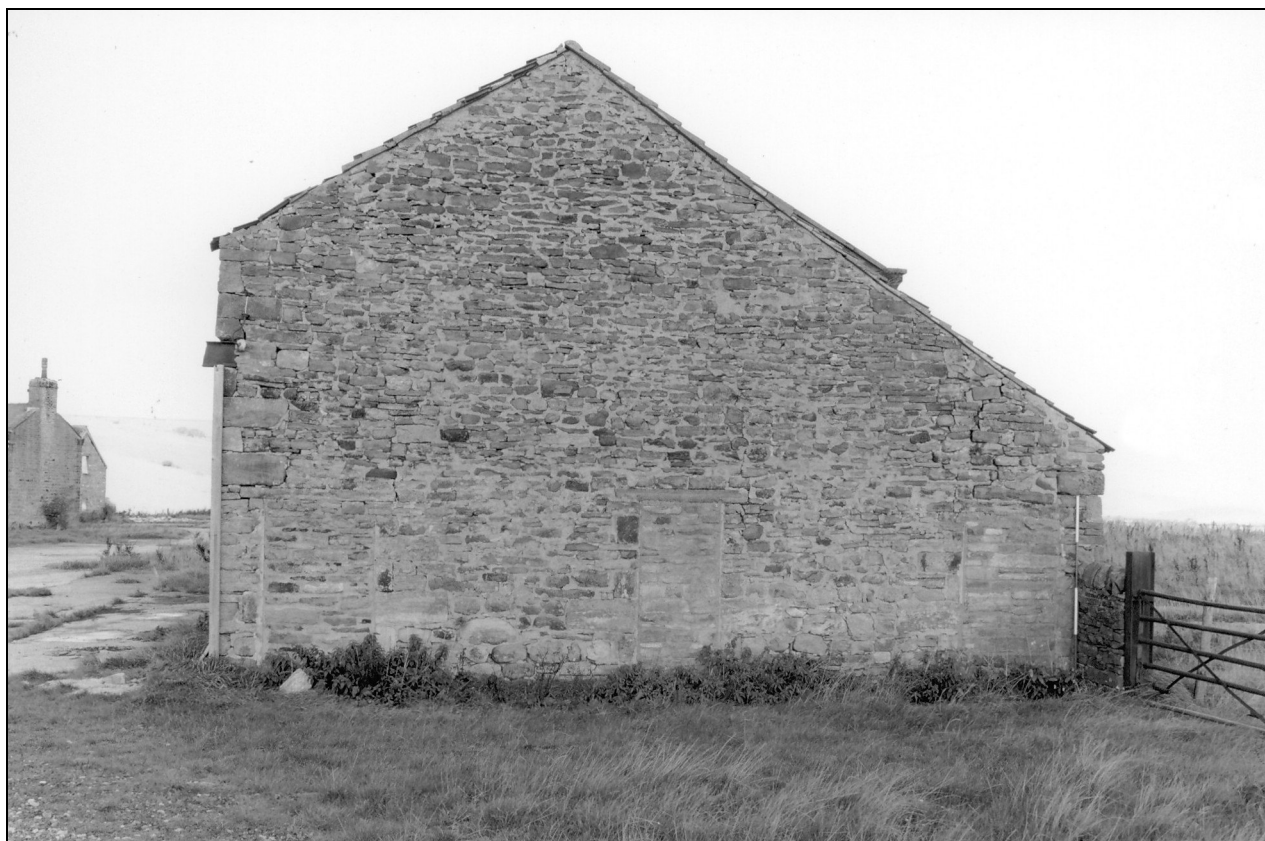
Photo 7: South gable of the shippon

- 6.3 The south end of the building has an asymmetric gable (6,7), of random gritstone rubble: different masonry again. It incorporates three blocked ground floor doorways in the typical arrangement which indicates a central feeding passage and two outer doors to cattle standings. The asymmetric profile is thought to result from the taking-down of part of the building, which was then re-roofed.

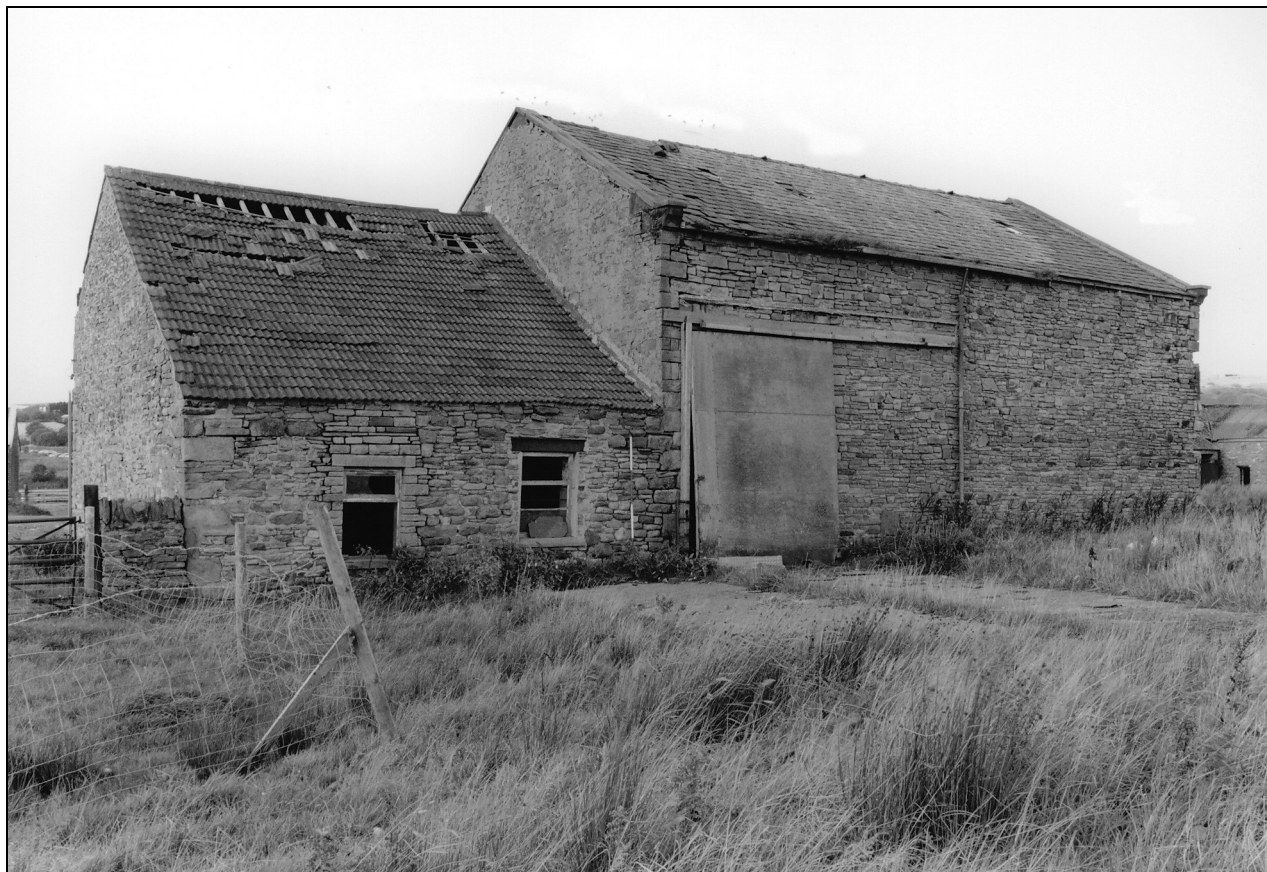
Photo 8: The barn and shippon, from the south-east

- 6.4 At the rear of the building (8,9) the east side of the shippon has clearly been altered, with the two windows having been inserted into the much weathered

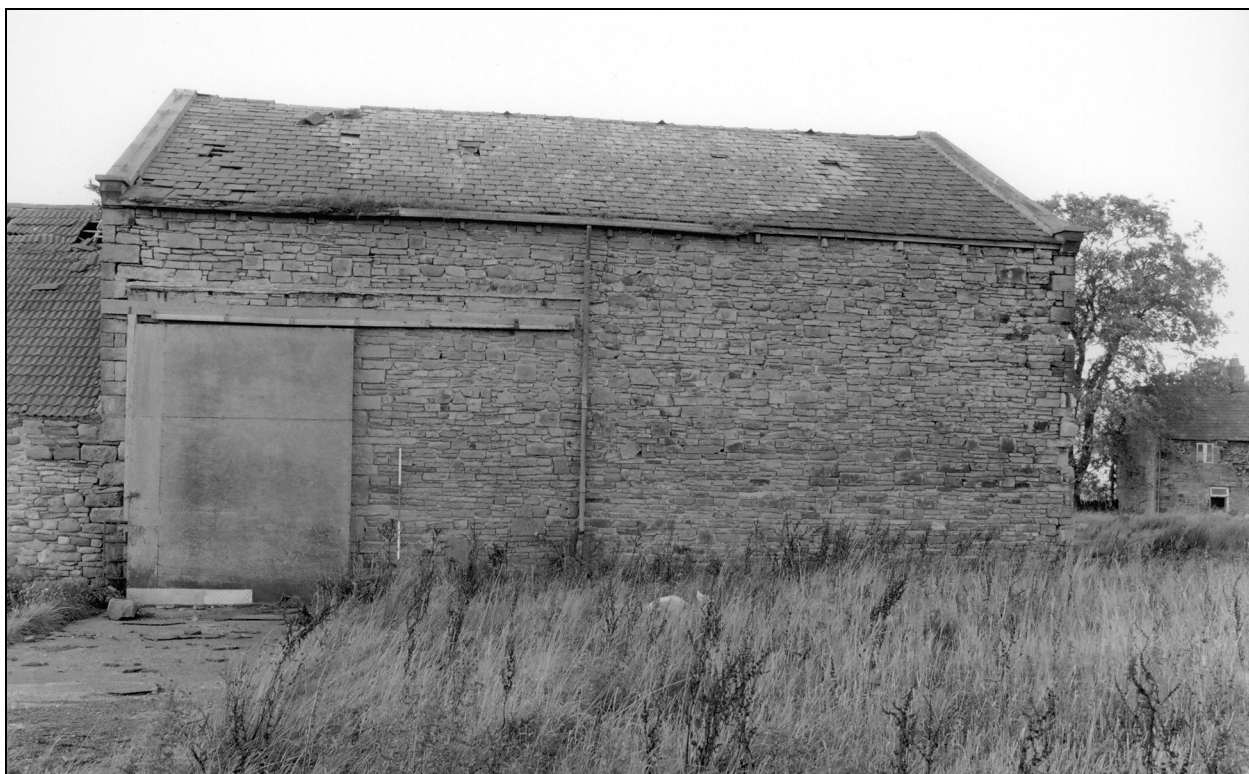
Photo 12: East elevation of the barn

random rubble (10). To the north of here (11,12), the barn is faced with random rubble similar to that on the front elevation, and has a large doorway with quoins, flat, softwood lintel and sliding door, the latter characteristic of the late nineteenth or early twentieth century. There are also similar eaves brackets and kneelers, but no suggestion that this elevation has been raised. What may be a blocked opening is suggested by two vague straight joints near the north end.

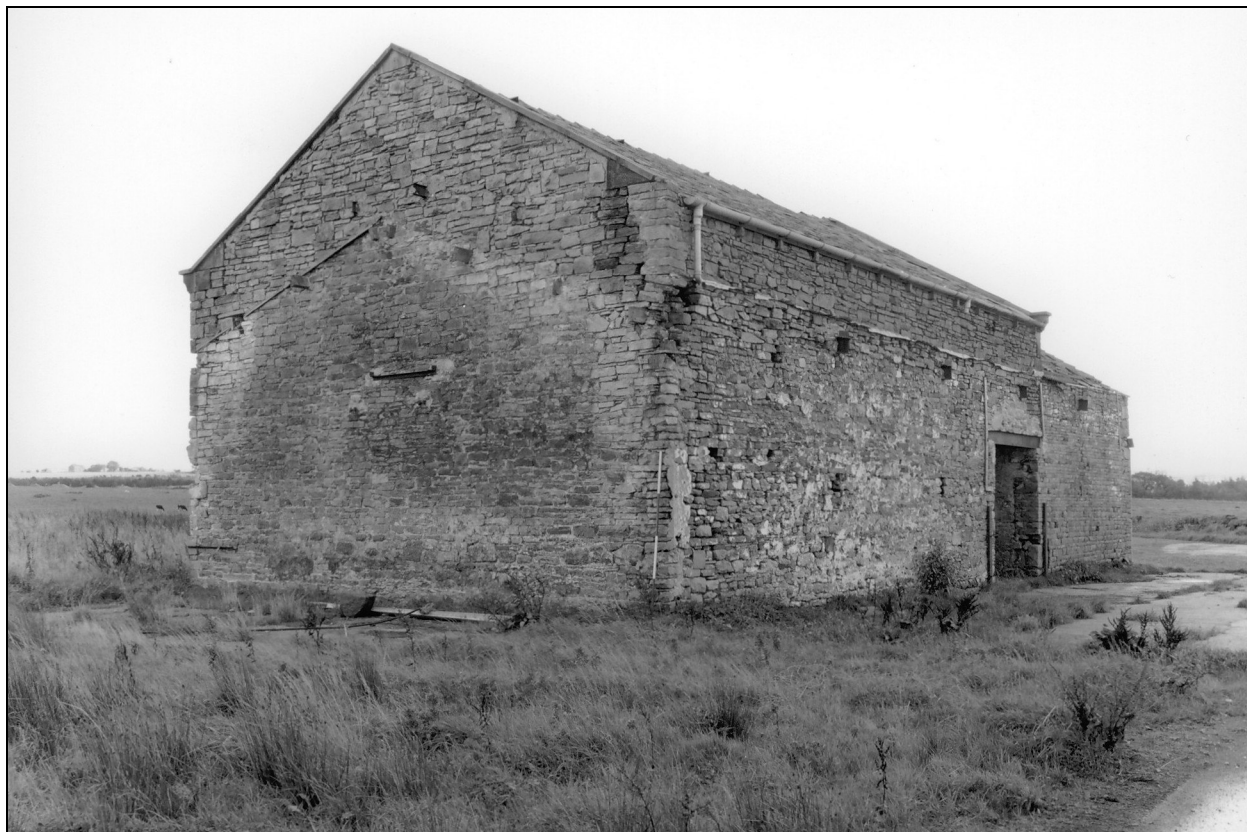
Photo 15: The barn, from the north-west

- 6.5 The north gable of the barn is built from similar material, and has also had an adjoining building demolished (13-15). Both this and the barn's south gable have dressed stone coping, matching the kneelers, and likewise of a similar date.

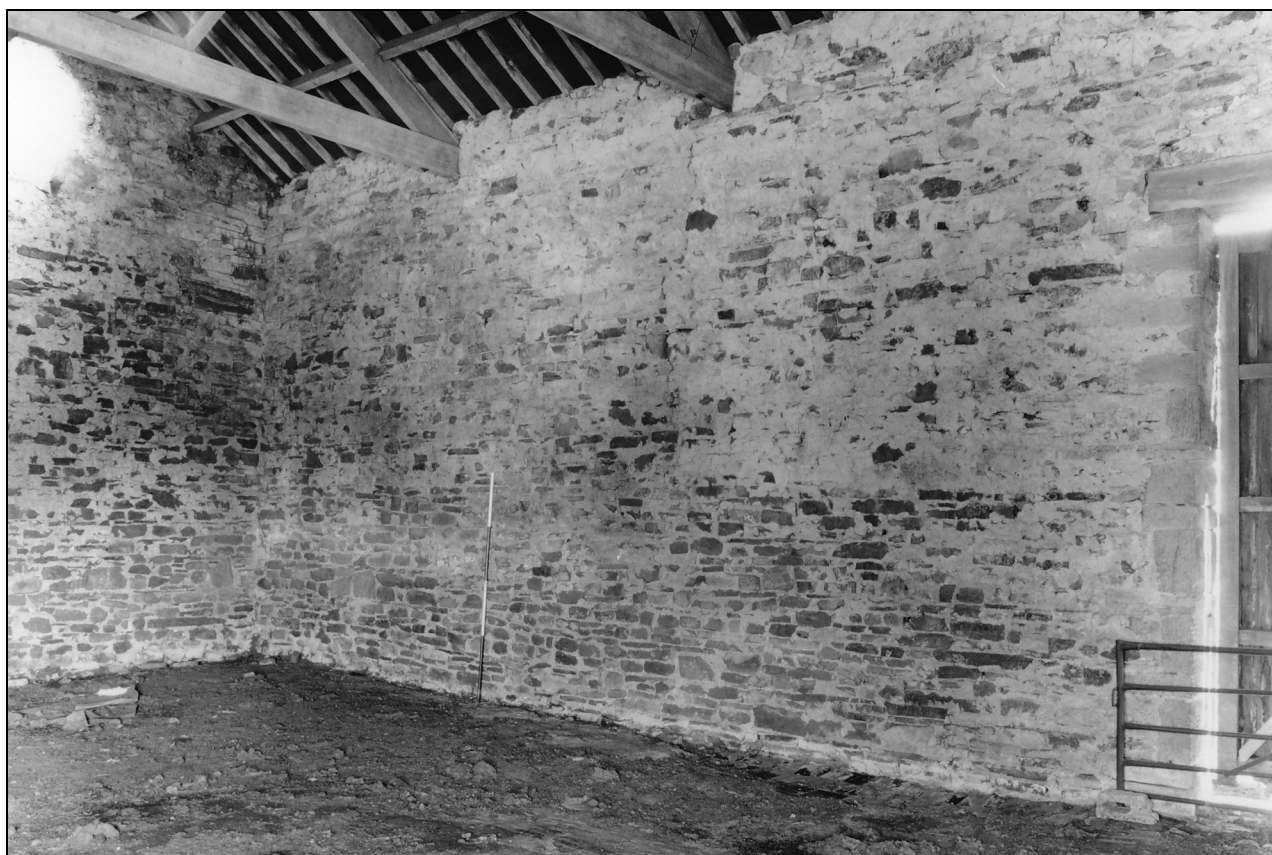
Photo 18: Interior of barn, from the south-west

- 6.6 The interior of the main part of the building forms a large single space open to the roof, with no evidence for former partitions or lofts (although there may have been timber divisions which have left no trace), suggesting that the barn was intended for crop or hay storage, rather than a number of different purposes (16-19). The floor is mostly of earth except for the space between the two doorways, which may have been a threshing floor: this is surfaced with a mixture of cobbles and flags. There are no features in the west, north or east sides but the south wall, dividing the barn from the shippon, has a ground floor doorway which has been narrowed, and a first floor doorway to a loft in the shippon (20,21). The barn roof has three softwood trusses with an iron tie in place of a king-post, and two raking struts (22); the form of the roof is indicative of a late nineteenth or even early twentieth century date.

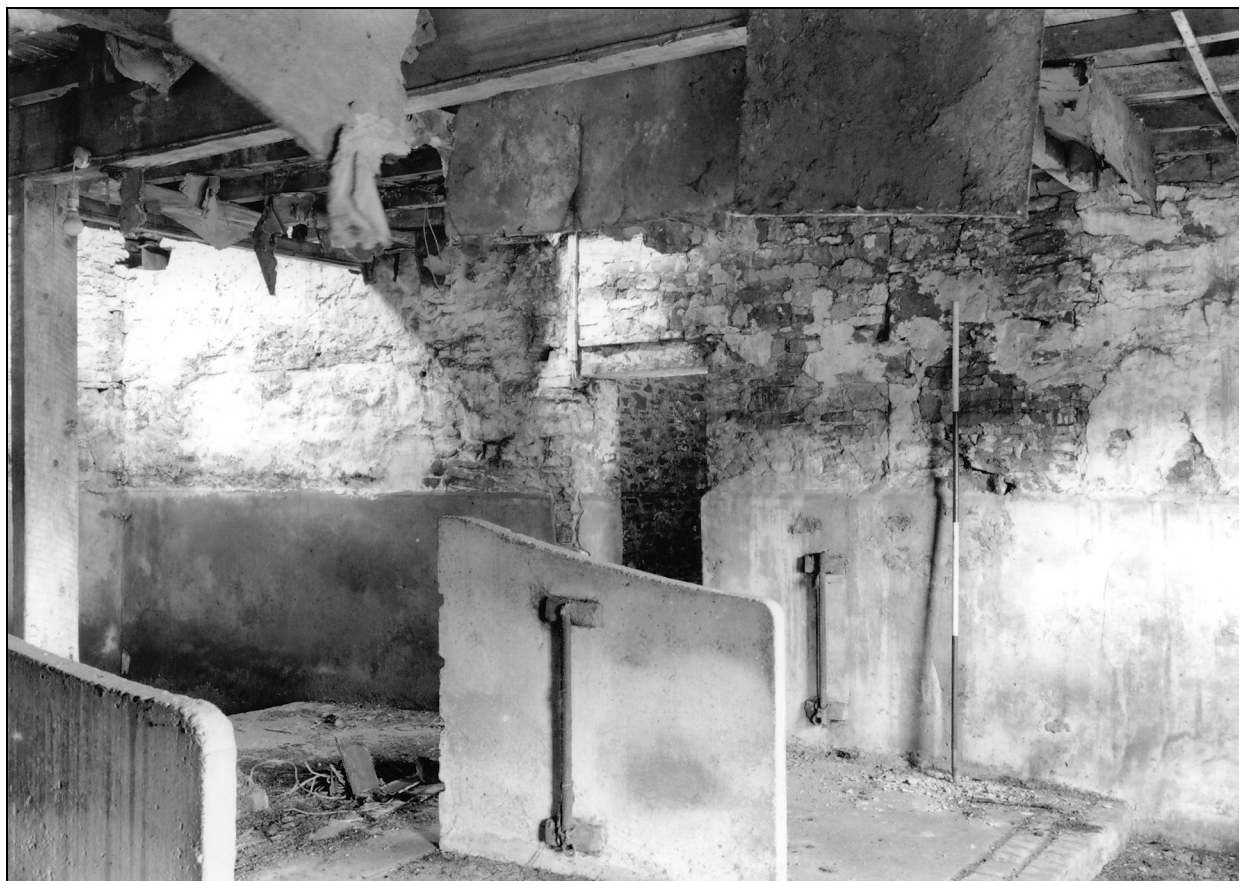
Photo 24: Interior of shippon, from the south-east

- 6.7 The shippon has been fitted with concrete boskins, the lower parts of the walls rendered, and the floor surfaced with concrete in the mid or late twentieth century, but the arrangement of three pairs of standings to each side, facing onto a central feeding passage, has been retained (23-24). There are two recesses in the west side, probably lamp holes which may have been matched in the east side before the insertion of the windows there (25-26). Overhead is a hay or feed loft with plank floor, and a single softwood roof truss of late nineteenth or early twentieth century date.
