Geslings Farmhouse
Dent, Cumbria:
Historic Building Record (Level 2 Survey)

Geslings Farmhouse

Dent, Cumbria:

Historic Building Record (Level 2 Survey)

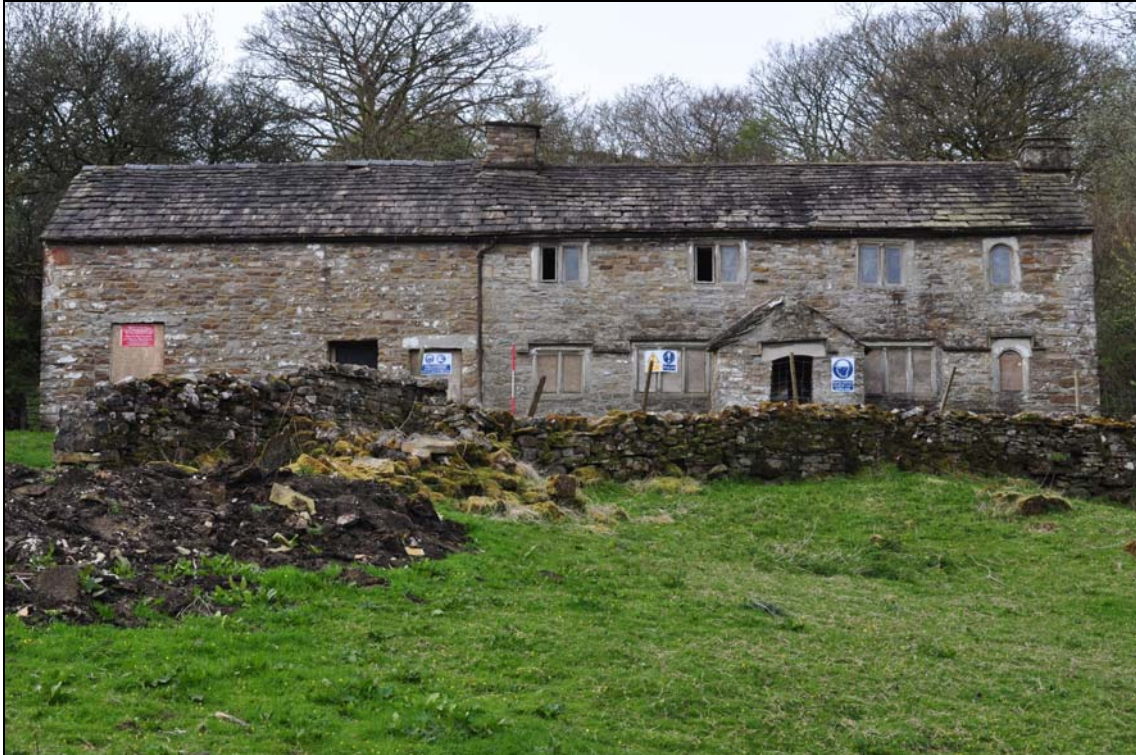
Photo 1: Front of the farmhouse range, looking south

- 8.1 The farmhouse range faces north-north-east (hereafter north) **(1)**, and comprises two main components: the seventeenth century part at the west end **(2)**, and an addition, probably early eighteenth century, forming the east end **(3)**; an obvious straight joint, partly hidden by a down-pipe, marks the division between the two. All parts are of local sandstone rubble, with some throughstones, and the roof is local stone slate, with stone ridge to the earlier part and tile ridge (clearly secondary) to the east part. There are two surviving chimney stacks: at the junction between west and east parts, and at the west gable. There are traces of limewash in many places and it appears the whole building would have been so coated historically, in common with many others in the district.

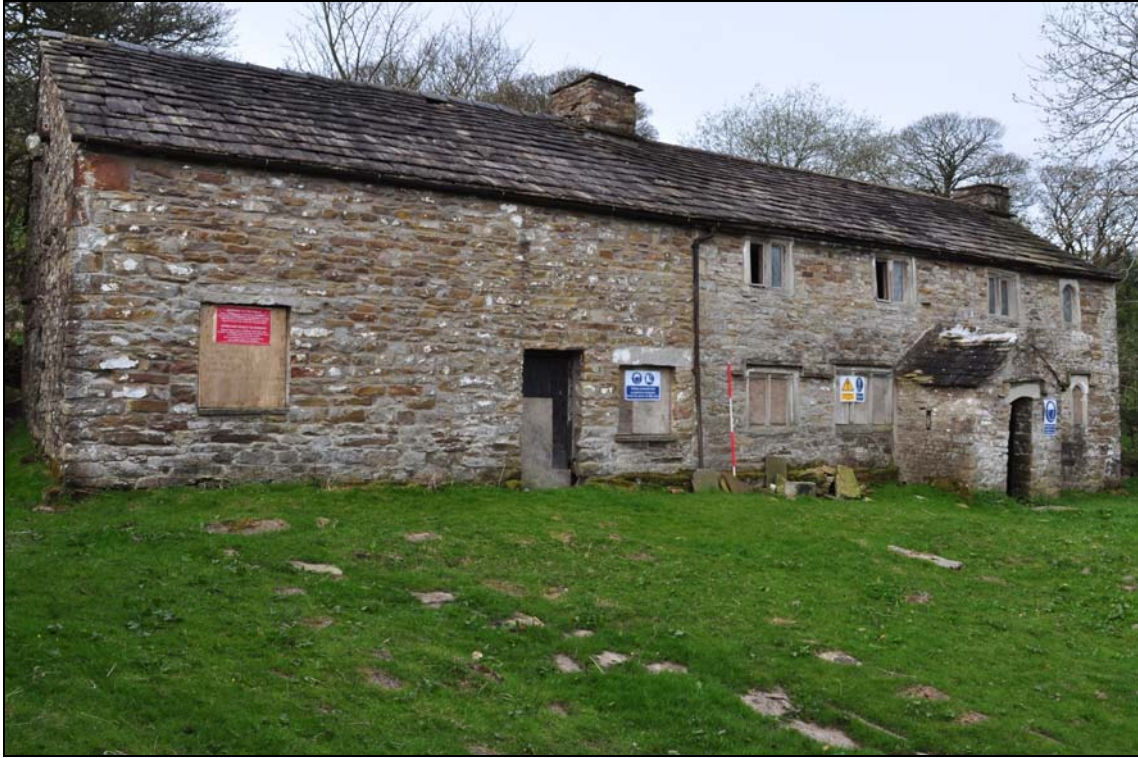
Photo 3: Front of the farmhouse range, looking south-west

- 8.14 The front elevation (3) contains a doorway opening without dressings, and two similarly plain, ground floor windows, at different levels, which reflects the rising ground; these all appear to be secondary, to judge from their size and proportions. A third, blocked window is also present at first floor level, again without dressings, and only obvious from the interior, but its length and low height suggest it is original.

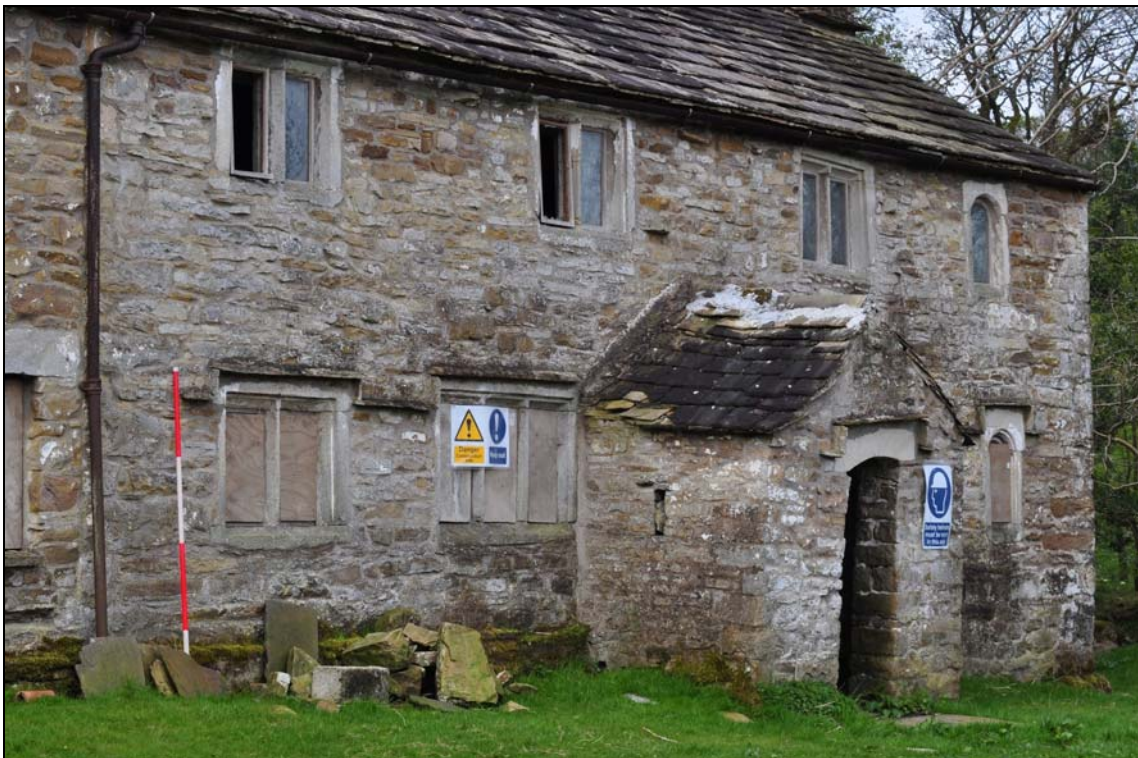
Photo 4: West part of farmhouse, front elevation, looking south-west

- 8.2 The earlier, west part of the range is four bays long and has a gabled porch enclosing the front entrance, in bay 3 **(4)**. This porch was clearly an addition, but

very probably built at an early stage in the building's life, and has a hood-mould and dressed lintel with segmental arch cut into it over its own entrance, narrow slits to the side elevations, and a stone bench within the west side (5,6). The doorway to the house itself has a stone arch, and contains a counter-boarded oak door, fastened with a full array of timber pegs, and hung on strap hinges (7,8).

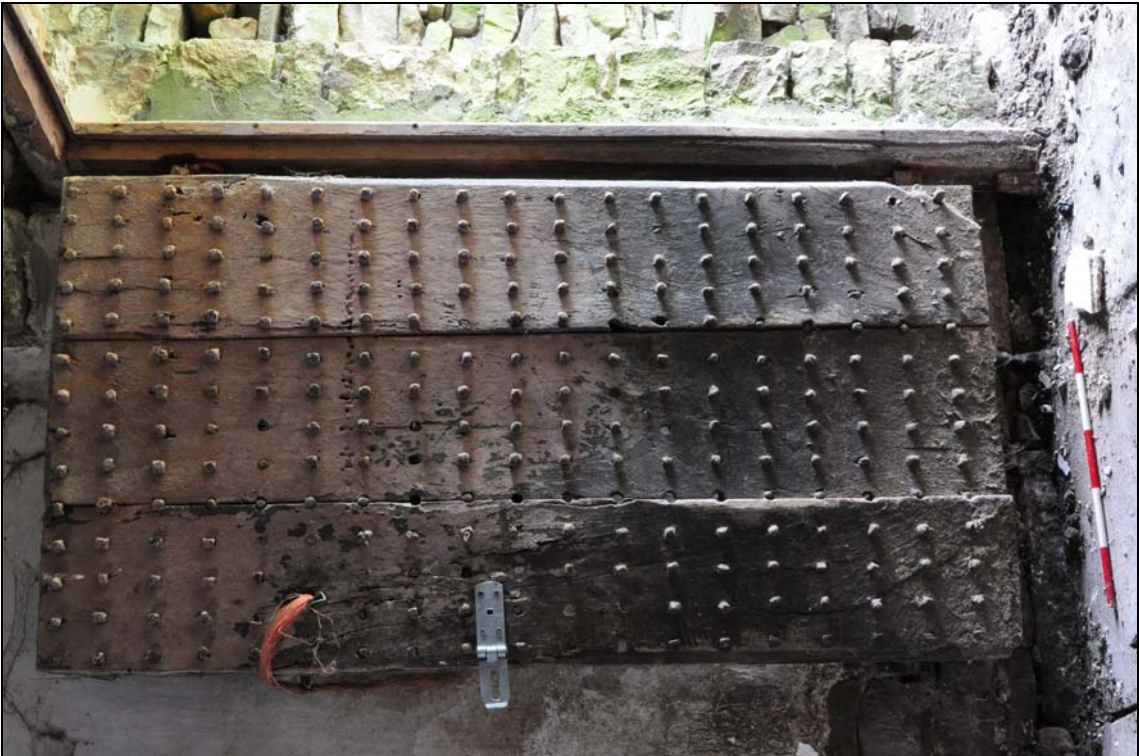
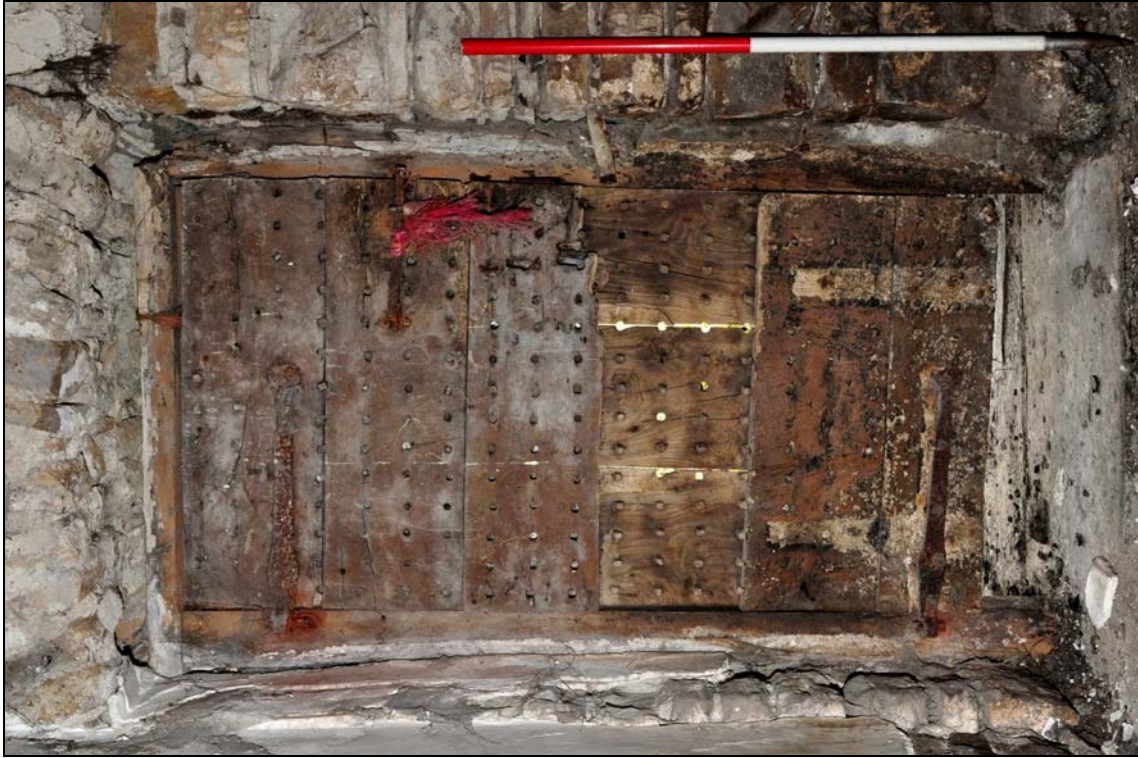
Photo 7: Detail of front door to farmhouse (outer face)

Photo 8: Detail of front door to farmhouse (inner face)

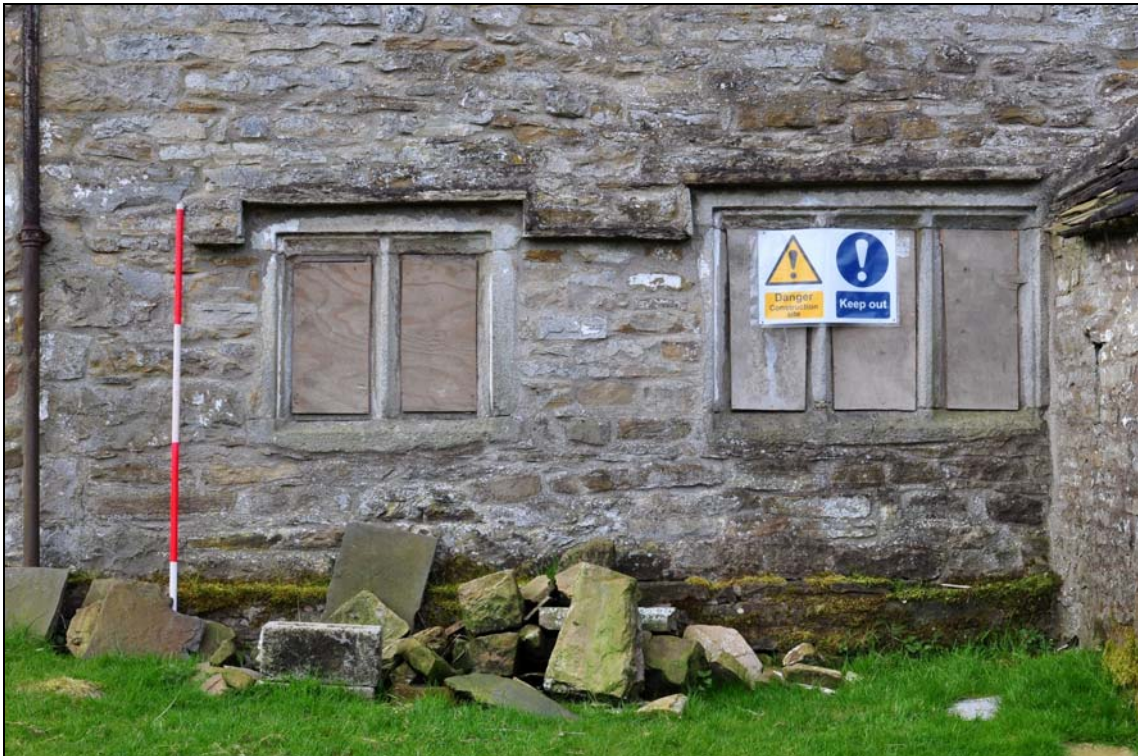
Photo 9: Housebody windows in front elevation

- 8.3 The front windows in the west part of the farmhouse include a two and a three-light opening to the housebody (left of the porch) (9), and three-light and single-light openings to the parlour (10); all have shallow rebates, slightly hollow (cavetto) chamfers, and simple hood-moulds of projecting slate. The single-light parlour window (11), a fire window, is finely dressed, with a segmental arch and sunk spandrels containing small decorative circles. The first floor front windows lack hood-moulds, being so close to the eaves, but are otherwise very similar, although slightly plainer (12,13), particularly the east window to the chamber over the housebody (14).

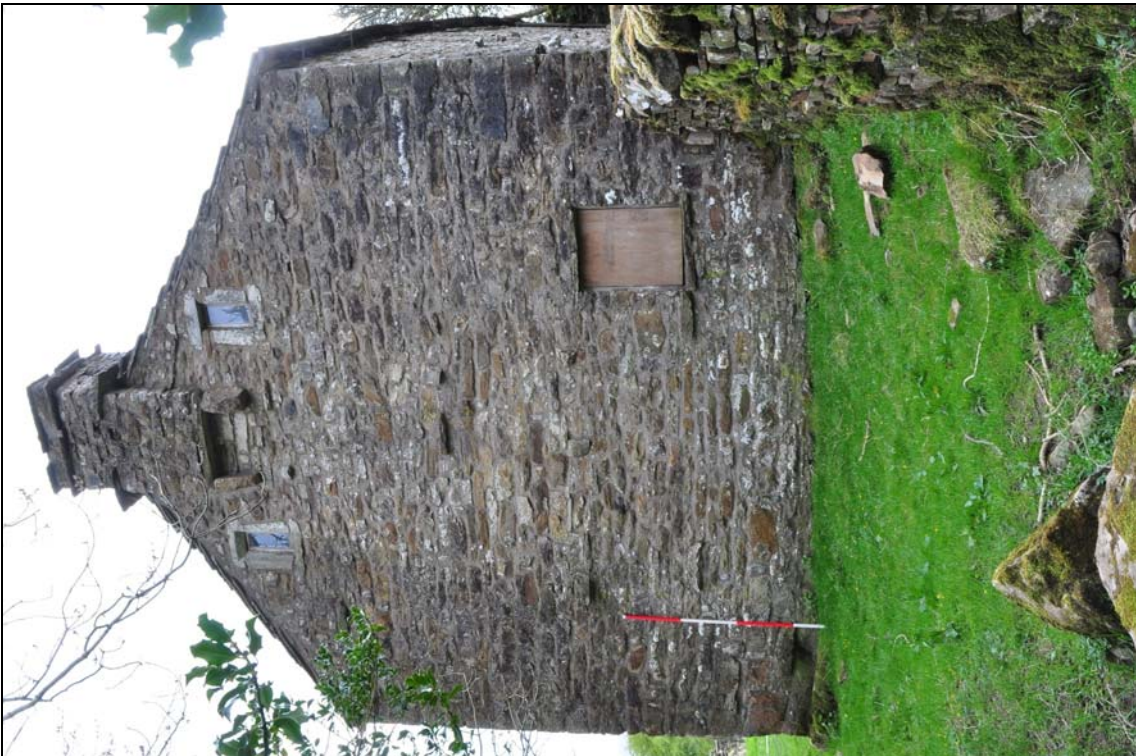
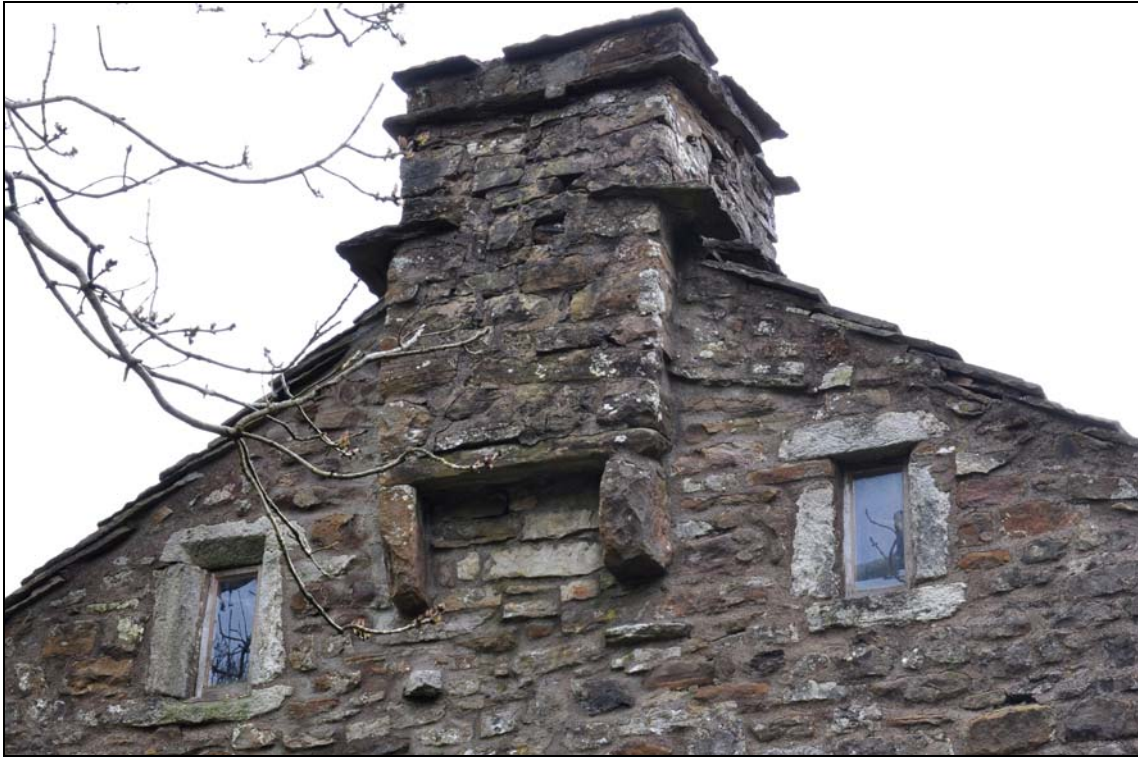
- 8.4 The farmhouse's west gable has a plain window at ground floor level, which may have been inserted, and two small, single-light attic windows with various dressings (15,16). The chimney stack between them is carried out on stone corbels.

Photo 15: West gable

Photo 16: West gable: detail of attic windows and corbelled chimney

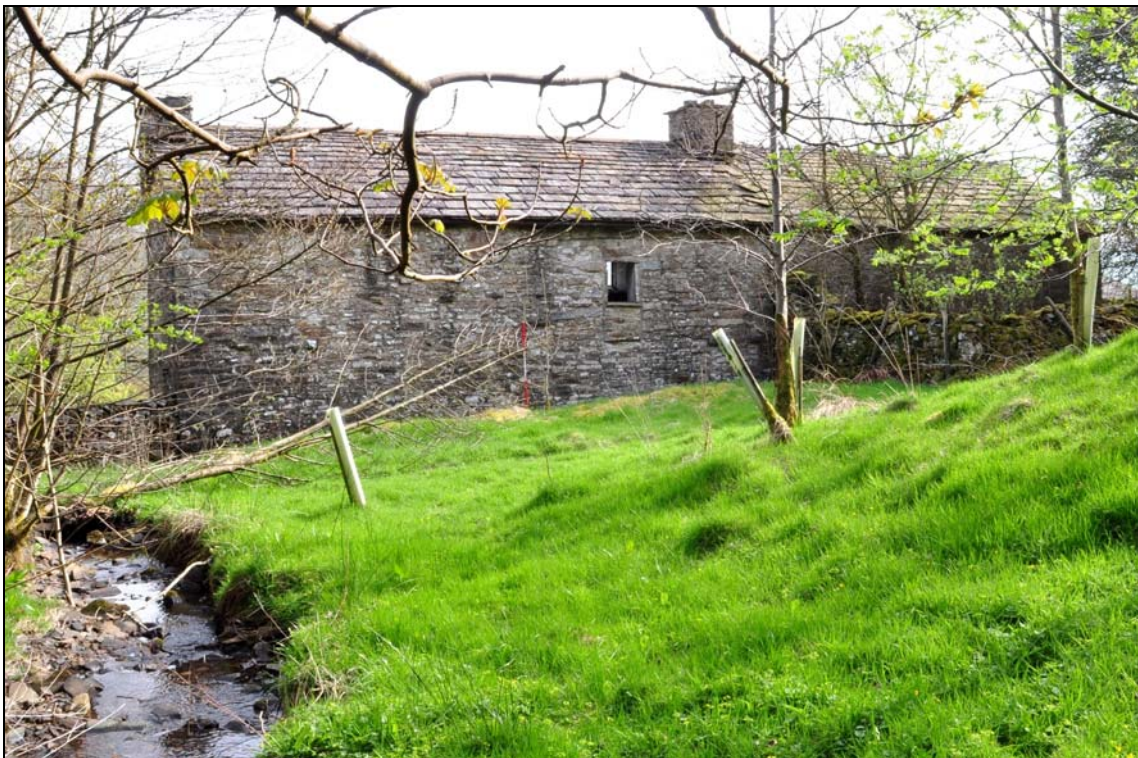
Photo 17: Rear elevation of farmhouse range, looking north-east

- 8.5 At the rear, the two parts of the range share the same building line (17), but there is a short length of projecting wall at the junction between west and east parts, which continues as a dry-stone wall enclosing a small rear garden (18-20). Where it adjoins the building, the wall is keyed in, and is notably of coursed construction, which contrasts with the more random character of the earlier buildings to both west and east, and this implies a more recent date. The wall corresponds to the west side of a narrow extension shown on the 1894 and 1909 (but not 1852) maps, so may be a late nineteenth century addition. However, to the west of it there is evidence in the building for a rather larger lean-to or outshut, which has been completely demolished (21). This would have measured approximately 4.2m wide, according to the slightly inset masonry just below the existing eaves, where its roof would have adjoined (22), but there is no clear evidence for the positions of its other three sides, though the existing projecting wall is not thought to have been one of them. The outshut is presumed to have contained the farmhouse staircase, as was often the case in vernacular houses in the region of this date, and the present first floor window is clearly a former doorway, which would have been situated at the head of those stairs (23). On the ground floor, two blocked doorways are clear (more so inside the building), and one of these would have led to the foot of the stairs, the other perhaps to a pantry, also within the outshut.

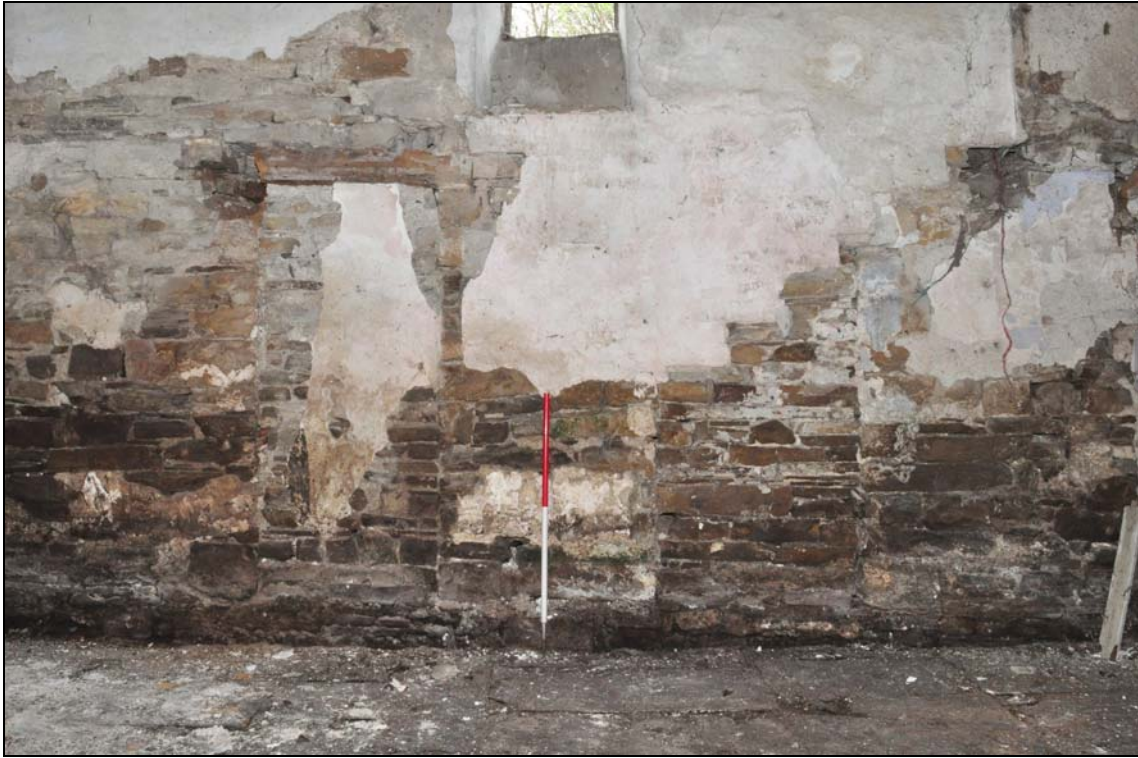
Photo 33: Farmhouse interior: housebody, looking south, towards blocked doorways to former stairs outshut

- 8.7 The front doorway now leads directly into the housebody, but there is faint evidence in the flagged floor for there having been a timber partition (perhaps a relatively late alteration), creating a passage parallel to the stone wall (**24-26**). The housebody would originally have been heated by an open fire beneath a smoke-hood, supported on a bressumer projecting from the front wall between the two windows (**27,28**), but now has a nineteenth century or early twentieth century iron cooking range made by Moorhouse of Kirkby Lonsdale, set within a later fireplace, and served by a stone flue (**29-31**). To the north of the fireplace are two recesses in the wall, probably salt or spice cupboards originally, and to the south a trough (perhaps for ash) formed by upright flagstones (**32**), as well as an inserted doorway. The two blocked doorways within the housebody's rear wall are clearly visible, and the west one is slighted by the marks of a later timber staircase, no doubt the successor to that which is inferred to have been situated within the rear outshut (**33**).

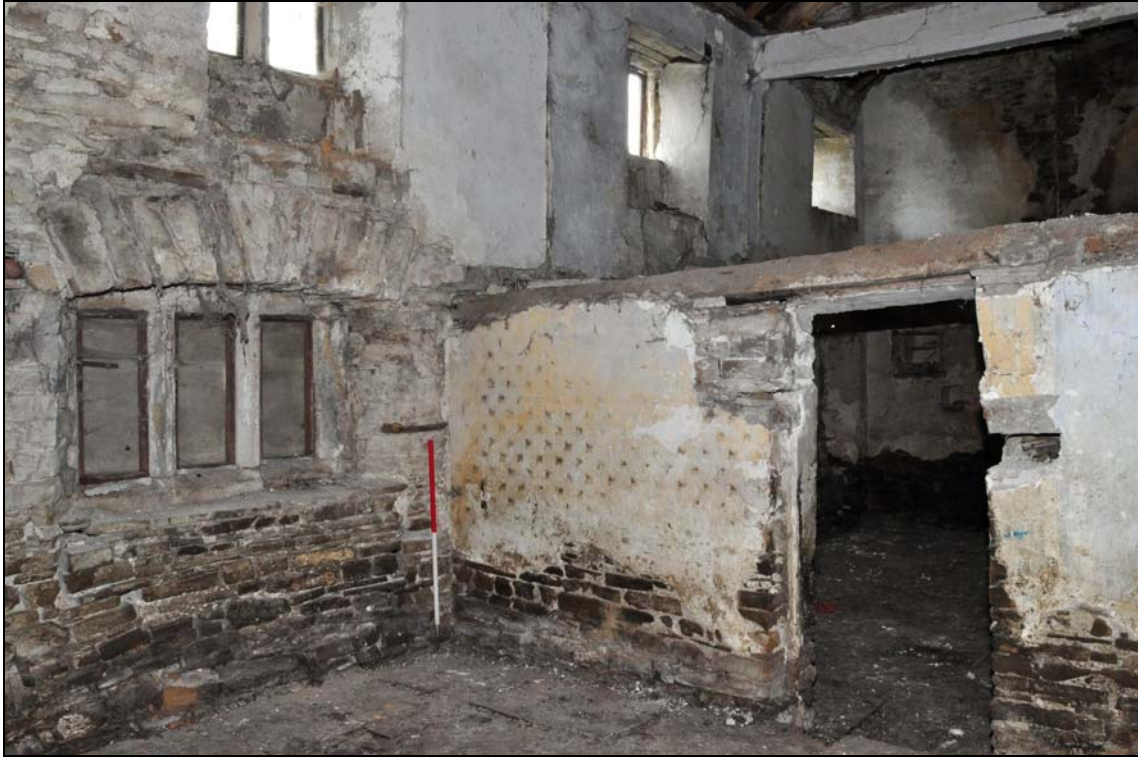
Photo 39: Farmhouse interior: parlour, looking north-east

- 8.8 West of the housebody, the parlour was a second heated room, also likely to have held a fireplace under a smoke-hood, which would have taken up nearly half the floor area, and been lit by the fine arched window to the north, but as with the housebody, this room has also been provided with a later stone flue and fireplace (here containing the fragment of a hob grate, perhaps early nineteenth century) (**34-36**). There is also evidence for a former timber partition within the room, in this case enclosing a store or similar along the south side, which may have necessitated the insertion of the gable window (if not original) (**37-38**). There is painted decoration on the plaster in the north-east corner of the room (**39**).

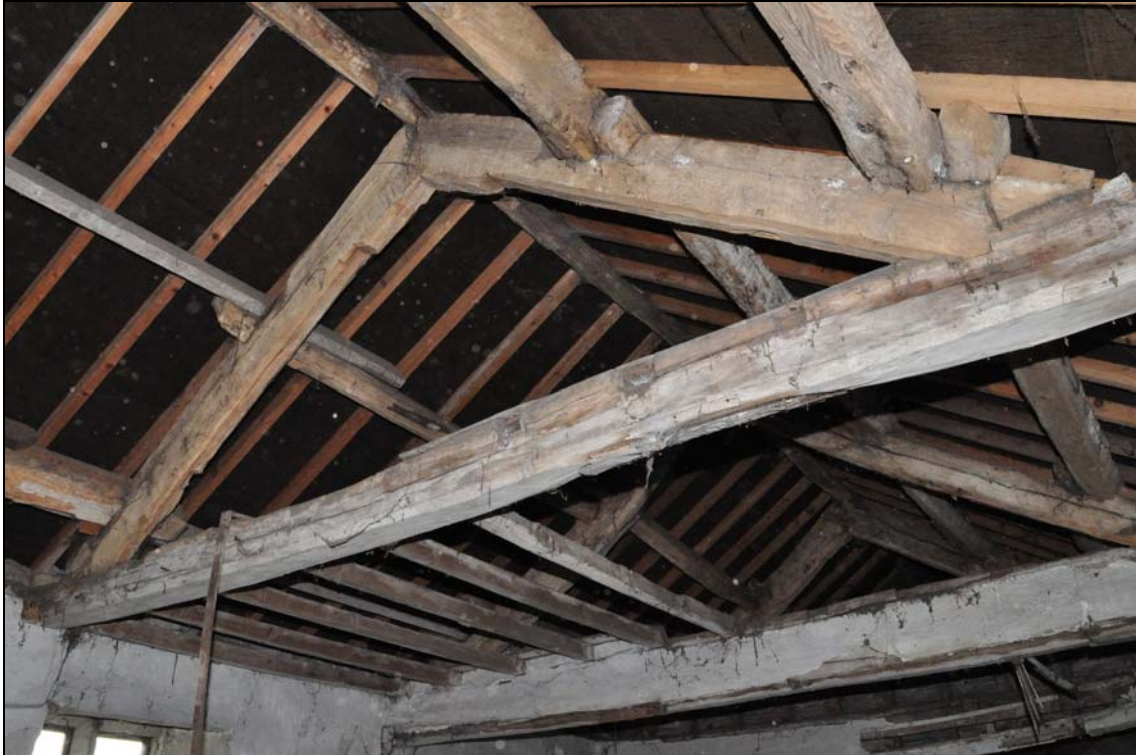
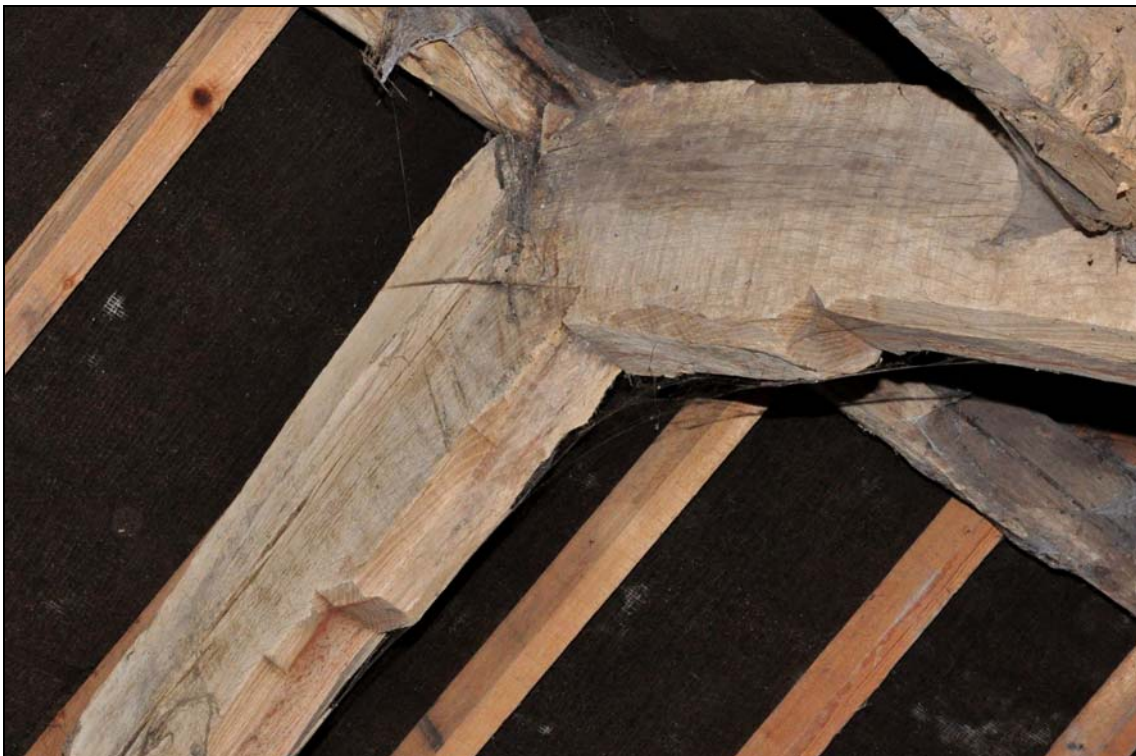
- 8.12 The west truss, over the parlour, is the most finely carpentered of the three (47-49); close to the ridge, the principal rafters widen, and the combination of chamfers and stops results in a slight impression of cusping. The two other trusses lack this ornamentation (50-52).

Photo 47: Farmhouse roof: west truss, looking north-east

Photo 49: Farmhouse roof: detail at top of west truss, looking north-east

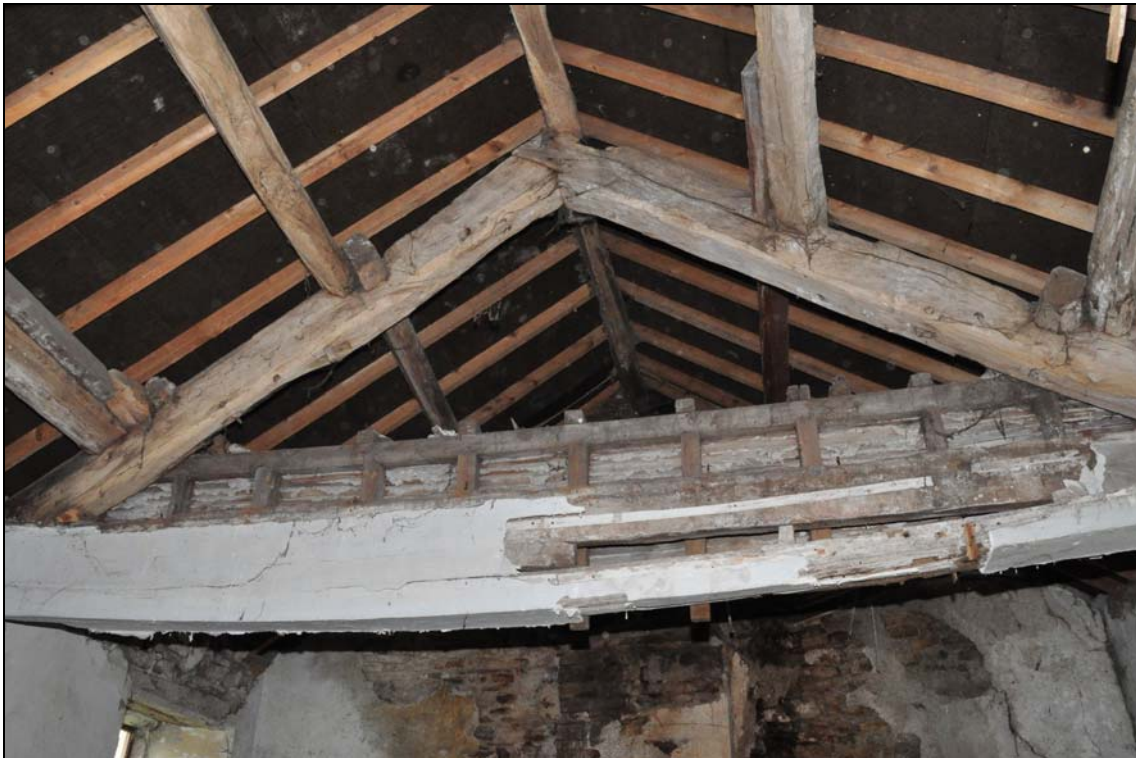
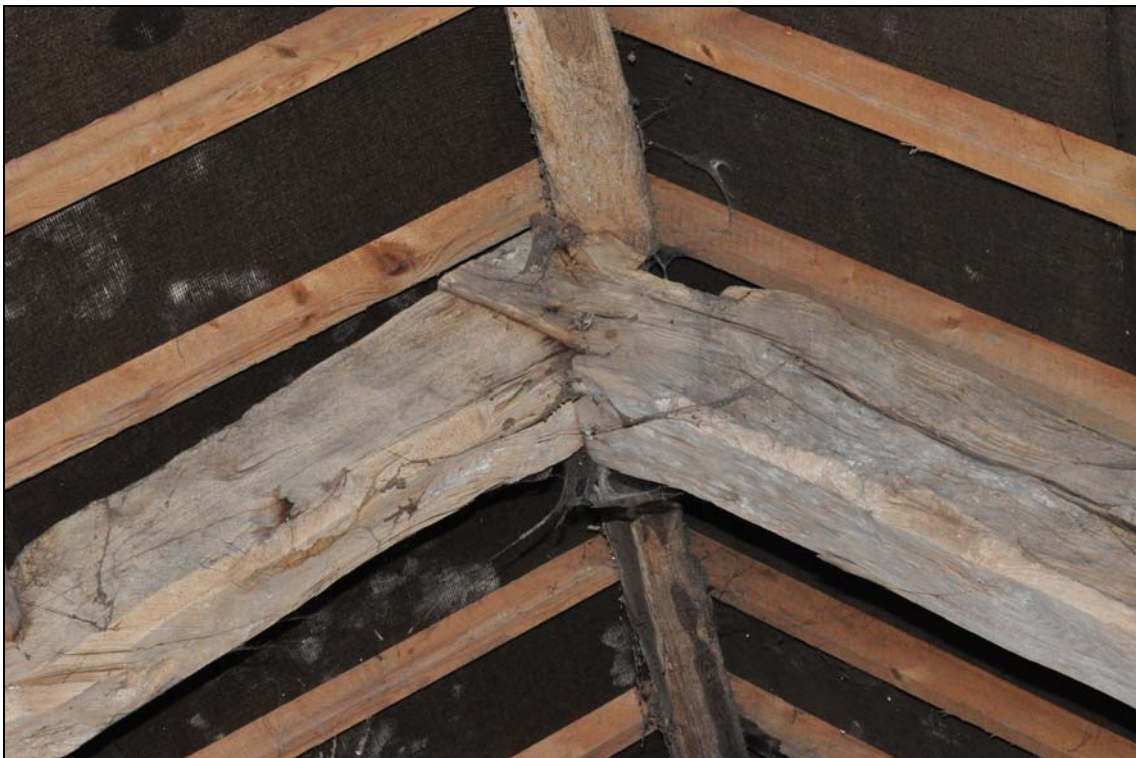
Photo 51: Farmhouse roof: east truss, looking east

Photo 52: Farmhouse roof: detail at top of east truss, looking east

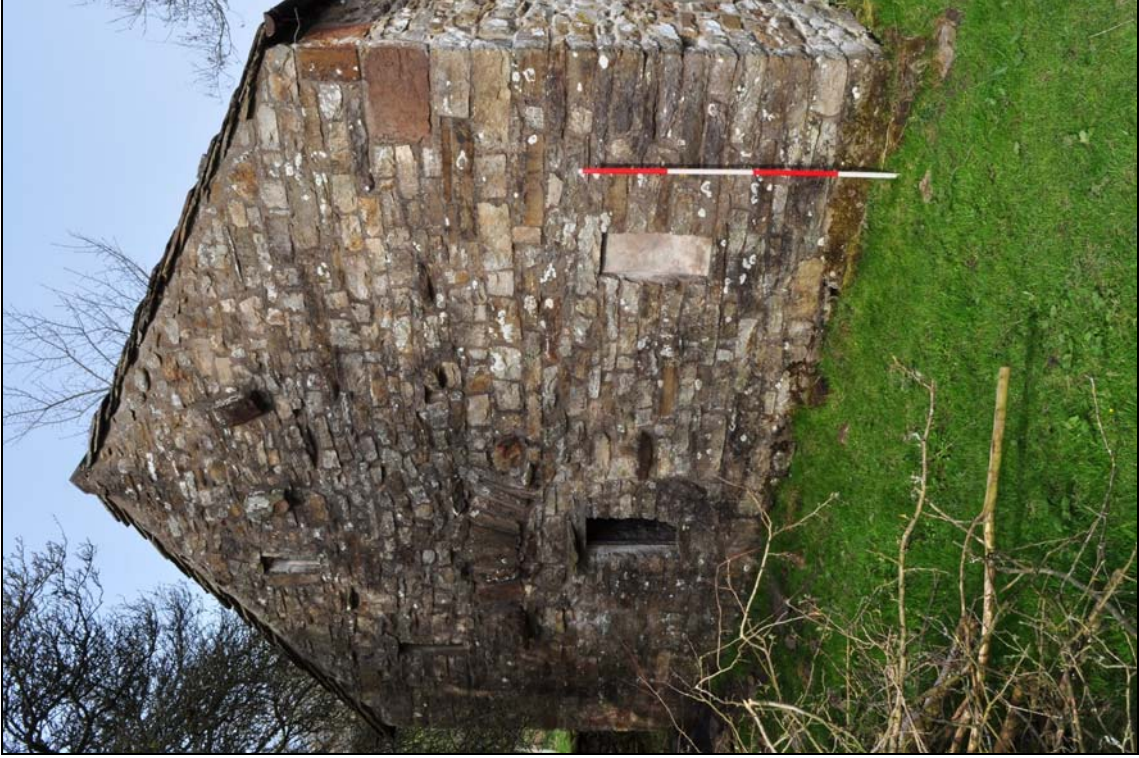
Photo 53: Farmhouse range: east gable

- 8.15 The east gable has a variety of openings (53): they include a former, arched doorway, which, at 1.43m wide, is too large for a domestic opening, and suggests it was perhaps for agricultural use (54). Above it are two narrow but splayed "breather" openings at different levels, again agricultural in character. Contrasting with these are the two projecting corbels near the ridge, evidence for a former chimney (see below), and therefore a domestic use (55). The rear of the east end faces into the small enclosed garden (56), and has a plain doorway and window (likely to be secondary), as well as a blocked, splayed breather (clearer on the interior) (57).

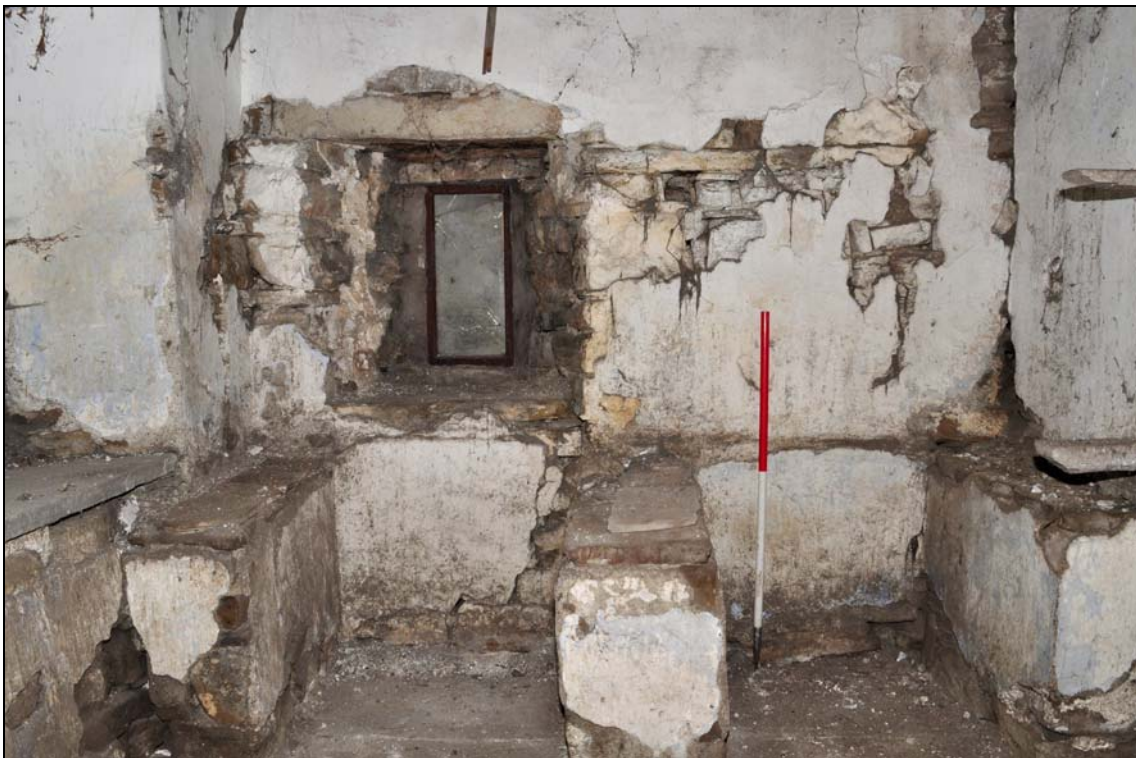
Photo 66: East part, interior: pantry, looking east

- 8.18 Of the two rooms in the east end, the north one is fitted out as a pantry, although the stone and timber shelves it would once have contained have been removed (**64-66**). The south room has a rather different appearance as it lacks wall plaster, and has a variety of openings of different dates, but in its present form appears to have served as a store (**67-69**). It appears not to have had a loft over it, although this might be a consequence of modern intervention.

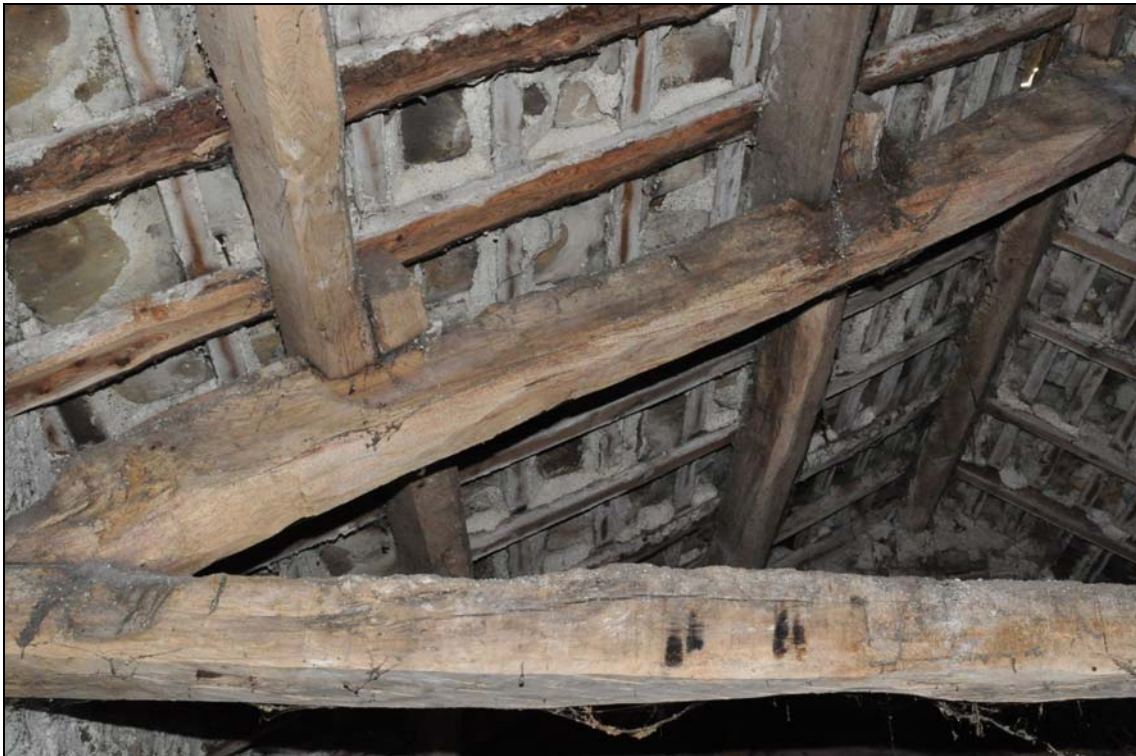
Photo 78: East part, interior: candle marks on east tie-beam, looking east

- 8.20 The two roof trusses are of principal rafter design, and also of oak, in common with those of the west half of the range, and raddle setting-out lines are also visible on them, but they lack any mortices for raking struts (**75-77**). The soot marks of candles are visible in a number of places on the tie-beams; these are often interpreted as having an apotropaic (evil-repelling) function (**78-80**).
