Leyland's Barn  
Middle Lane, Kettlewell, North Yorkshire:  
Archaeological Assessment and Building Recording

### Archaeological Assessment and Building Recording

Leyland's Barn, standing in the village of Kettlewell in upper Wharfedale, North Yorkshire (NGR: SD 97167237), is a four-bay "combination" barn, probably of 18th or possibly 17th century date, which was extended by the addition of a stable at one end in the 19th century. It contains relatively few individual significant features but is important as a traditional agricultural building. Assessment and recording was carried out before its conversion to a dwelling by Mr Richard Tankard, in December 2008, and this record includes measured drawings, photographs, and a written description.

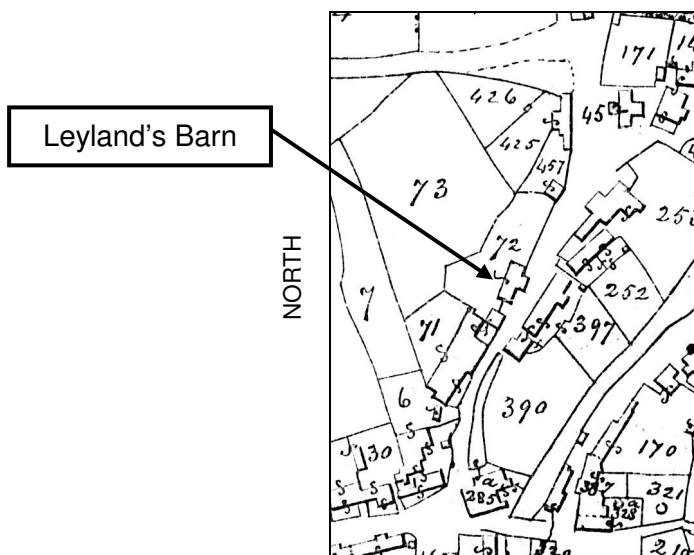
**Figure 3: Extract from Kettlewell tithe map, 1847 (NYCRO MIC 2983)**

- 4.3 In the tithe award of 1846<sup>2</sup>, enclosure number 72 in which the barn lies ("Crow Croft"), is noted as pasture, owned by Mrs Dorothy Bolland and occupied by John & William Marshall. The award makes no reference anywhere to anyone called Leyland and the origin of the present name has not been elucidated.

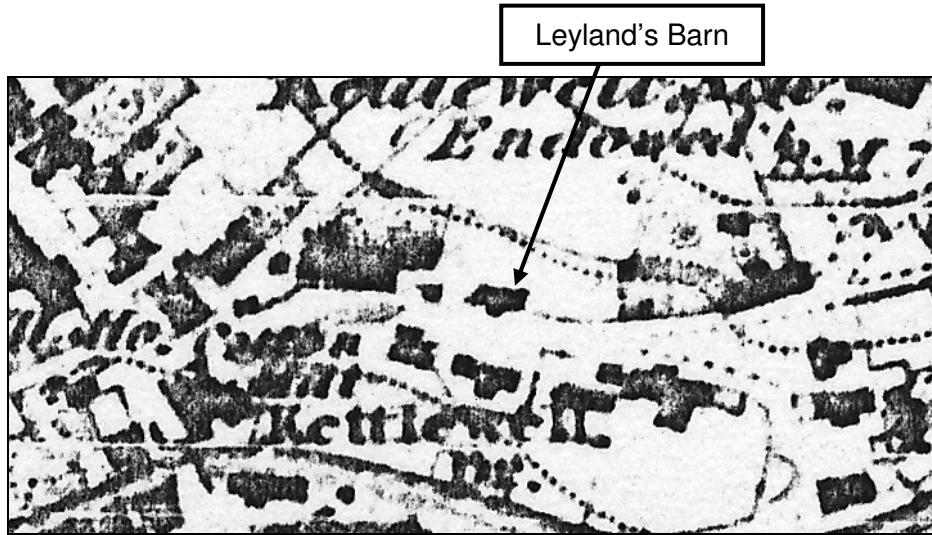
**Figure 4:** Ordnance Survey 6" to mile map (here enlarged)  
published 1851 (surveyed 1847-8)  
Sheet no: Yorkshire [West Riding], 115 (NYCRO MIC 1830)

- 4.2 No detailed historical study has been carried out for the site but an examination of historic maps available at the North Yorkshire County Record Office (NYCRO) was undertaken. The Kettlewell tithe map<sup>1</sup> and the first edition 6" to the mile Ordnance Survey (OS) map, both surveyed in the late 1840s, show that the barn was then present, and probably already had been extended to the west (Figures 3 and 4). The outline of the building does not appear to have undergone any subsequent changes, as the 1893 6" to the mile and 1935 1:2500 maps show (Figures 5 and 6).
