Stable at Lane Side
Grindleton Road, West Bradford, Lancashire:
Archaeological Building Recording

October 2008

STEPHEN HAIGH

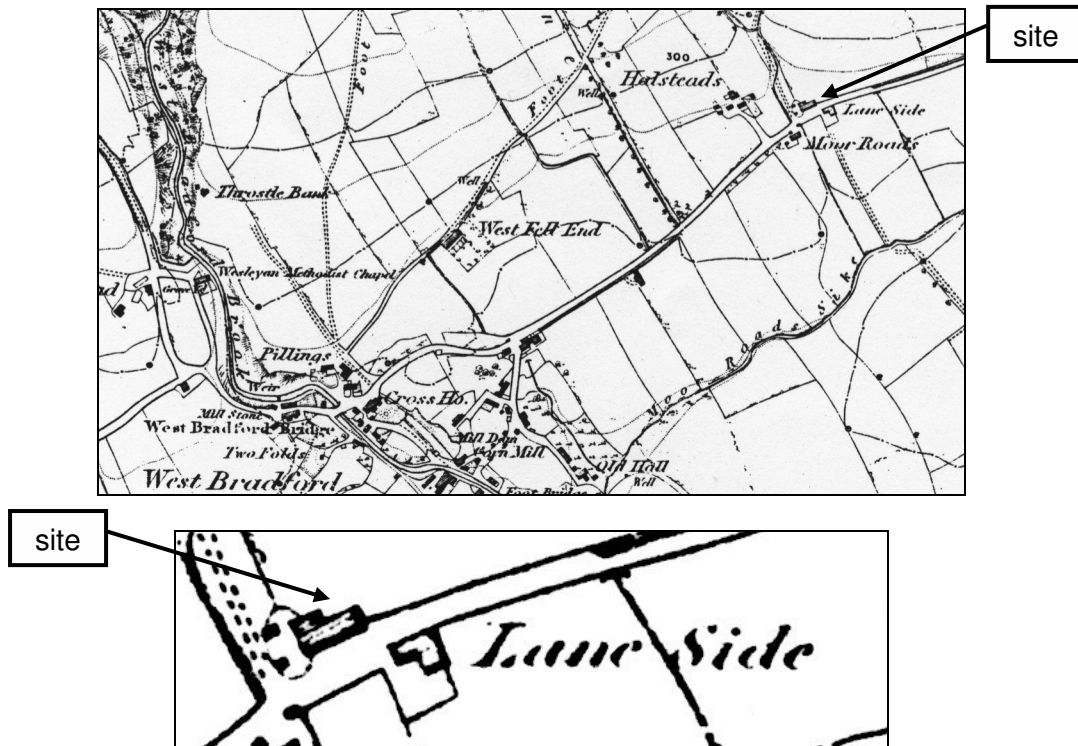
Figure 3: Ordnance Survey 6" to mile map (lower extract enlarged to 1:2500) published 1850 (survey date: 1847) Sheet no: Yorkshire [West Riding], 187

- 4.3 The first edition Ordnance Survey 6" to the mile map, surveyed in 1847, shows the group of buildings at Lane Side with its present outline (Figure 3), and the more detailed map of the 1880s shows the same arrangement in more detail (Figure 4), including the outside steps to the stable. Thirty years later there were few changes to the outlines of the buildings (none at all to the stable), although one outbuilding to the west of the house had been demolished and a new one had been built to the south of the large barn, to the south of the road (Figure 5).
