Shippon at 11 Lytham Road
Freckleton, Lancashire:
Archaeological Building Recording

March 2009

Shippon at 11 Lytham Road Freckleton, Lancashire: Archaeological Building Recording

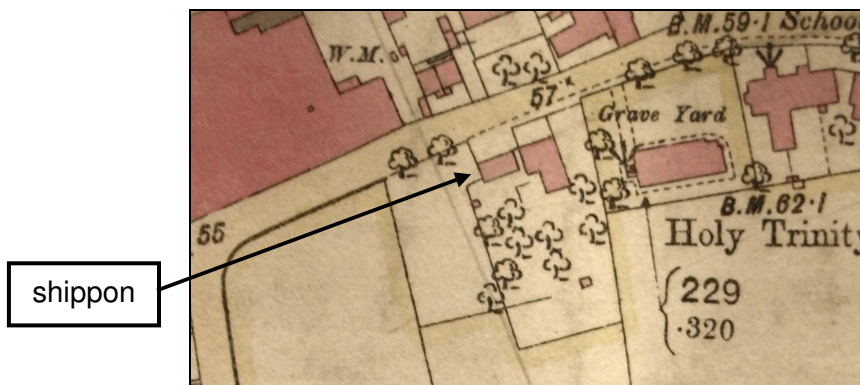
Figure 4: Ordnance Survey 1:2500/25" to mile map (not at original scale)
Published 1893 (surveyed 1892); Lancashire sheet 60.13

- 4.5 By the 1890s the cotton mill (Balderstone Mill) which stood on the north side of Lytham Road appears to have led to the building of a long row of terraced houses to the west of the site, but the shippon remains unaltered in outline on the map of this date, and the house appears to have been extended or rebuilt to

its present size (Figure 4). At this date an orchard and small field or close still lay to the south, a situation which is shown to have persisted in 1909 and 1937 (Figures 5 and 6), although by the latter date some residential encroachment had taken place within the immediate vicinity.

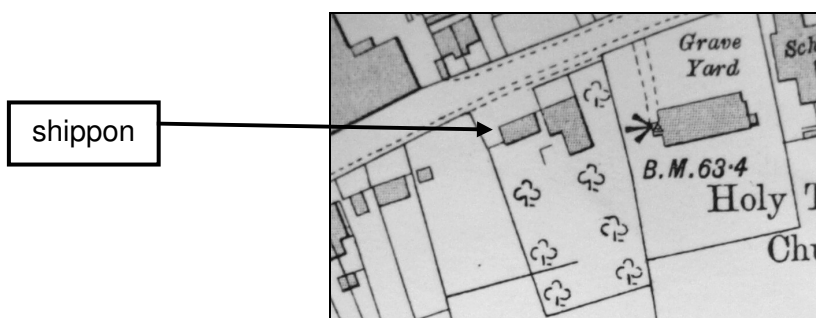
Figure 5: Ordnance Survey 1:2500/25" to mile map (not at original scale)
Published 1911 (revised 1909); Lancashire sheet 60.13
