29 Church Street
Ribchester, Lancashire:
Historic Building Assessment

29 Church Street Ribchester, Lancashire: Historic Building Assessment

29 CHURCH STREET, RIBCHESTER, LANCASHIRE: HISTORIC BUILDING ASSESSMENT

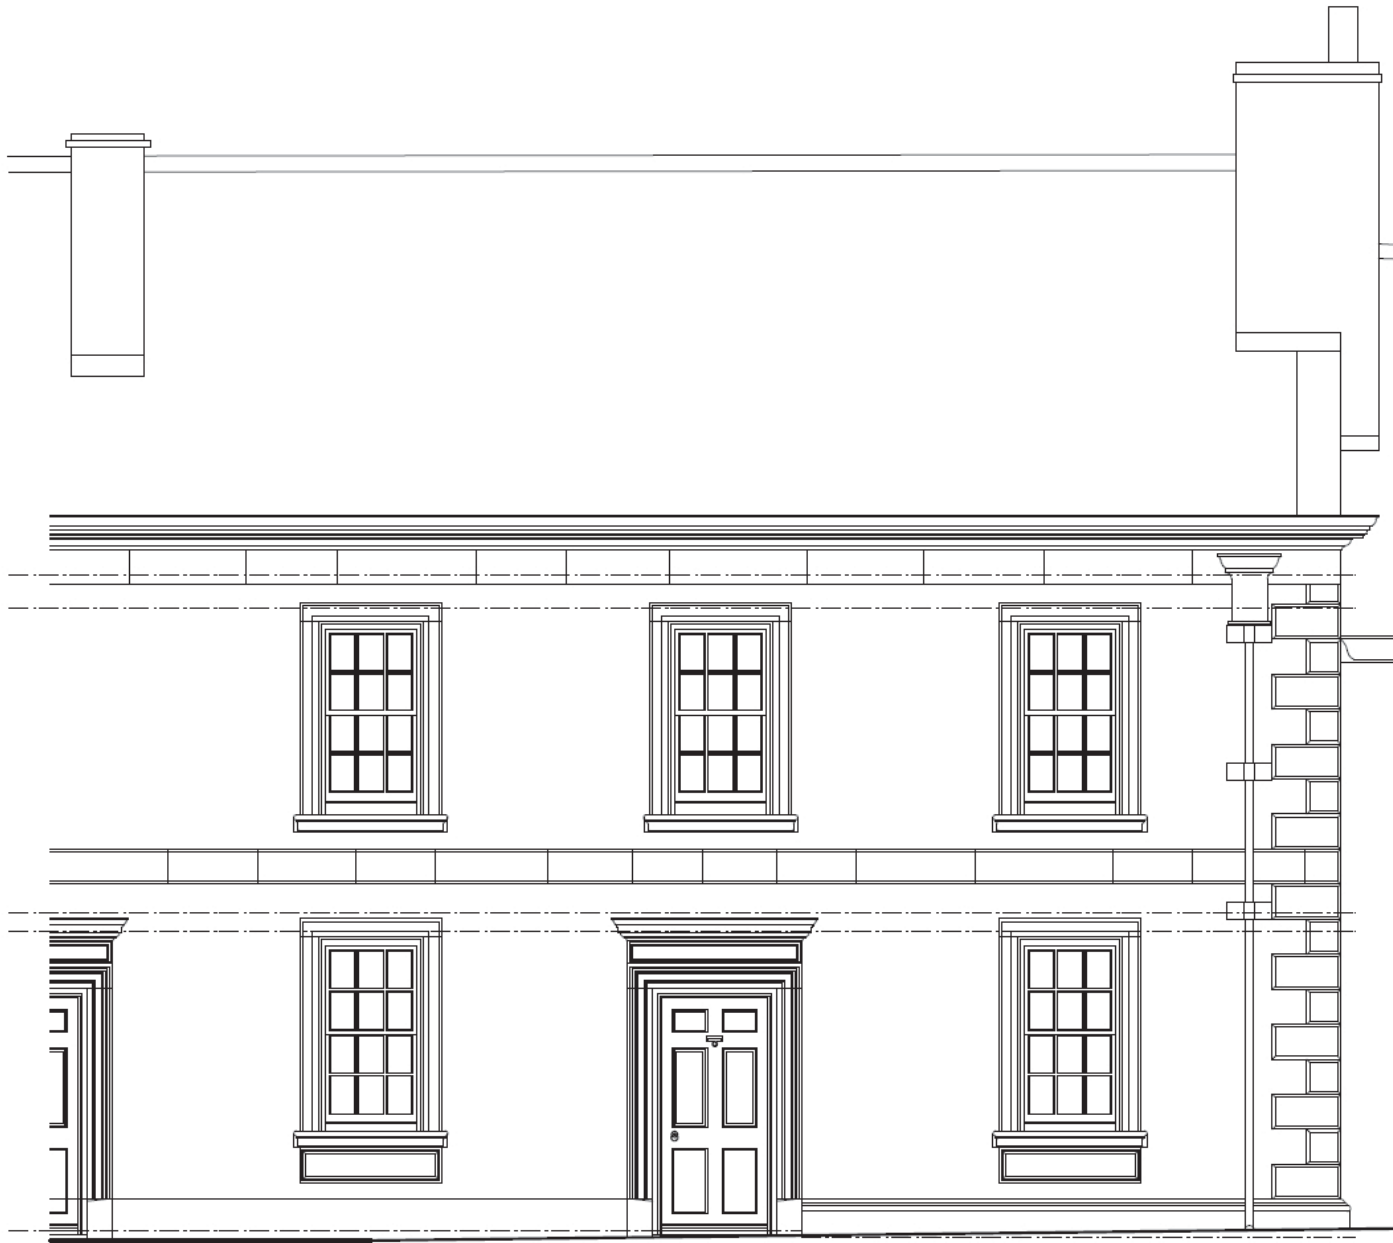
Figure 10: Front elevation (IWA Architects)

Front Elevation (North East)

- 5.1 The house fronts directly onto Church Street and this elevation is distinguished by the use of Flemish bond brickwork with sandstone dressings, an unusual use of brick in a district where stone was readily obtained in the mid 18th century. The style is classical and accomplished, and there appear to have been almost no changes to this front, apart from the replacement of the window frames, those to 29 being modern sashes only a few years old, and believed to closely replicate those they replaced (Photo 1). The front door itself is original as is some of its furniture, which includes massive L-hinges primitively hung on pintles (Photos 2, 3). It is not clear whether the presence of two doorways in this front indicates that 28 and 29 were originally two houses, and internal arrangements suggest otherwise, so an alternative explanation for the dual entrances should be sought. No 30 abuts the north gable of the house, so very little of this side of it is visible; the blue slate roof covering is no doubt a replacement of earlier stone slates.
