Barn at Harrop Gate
Grindleton, Lancashire:
Historic Building Recording

Barn at Harrop Gate Grindleton, Lancashire: Historic Building Recording

BARN AT HARROP GATE, GRINDLETON, LANCASHIRE:

HISTORIC BUILDING RECORDING

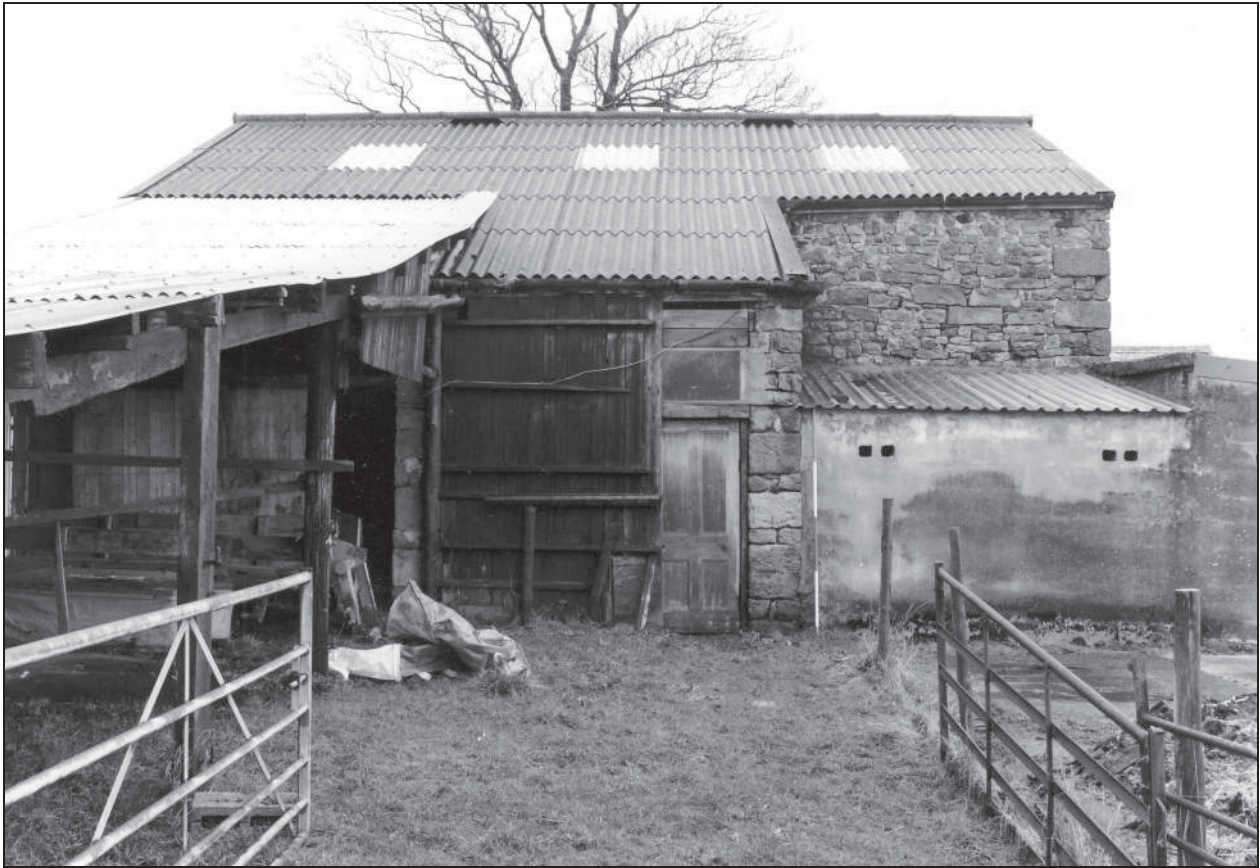
Photo 1: The barn, from the south

- 6.1 The barn faces south-south-east and is T-shaped in plan, in essence a rectangle measuring 11.4m by 7.7m wide, with a central porch projecting to the front, now hemmed in by modern accretions to a large degree (**1,2**). The walls are of local sandstone rubble, 0.55m thick and roughly coursed or random, bedded on lime mortar, with edge-laid, squared quoins, while the roof, which was no doubt of stone slate originally, has been replaced with asbestos cement sheets.

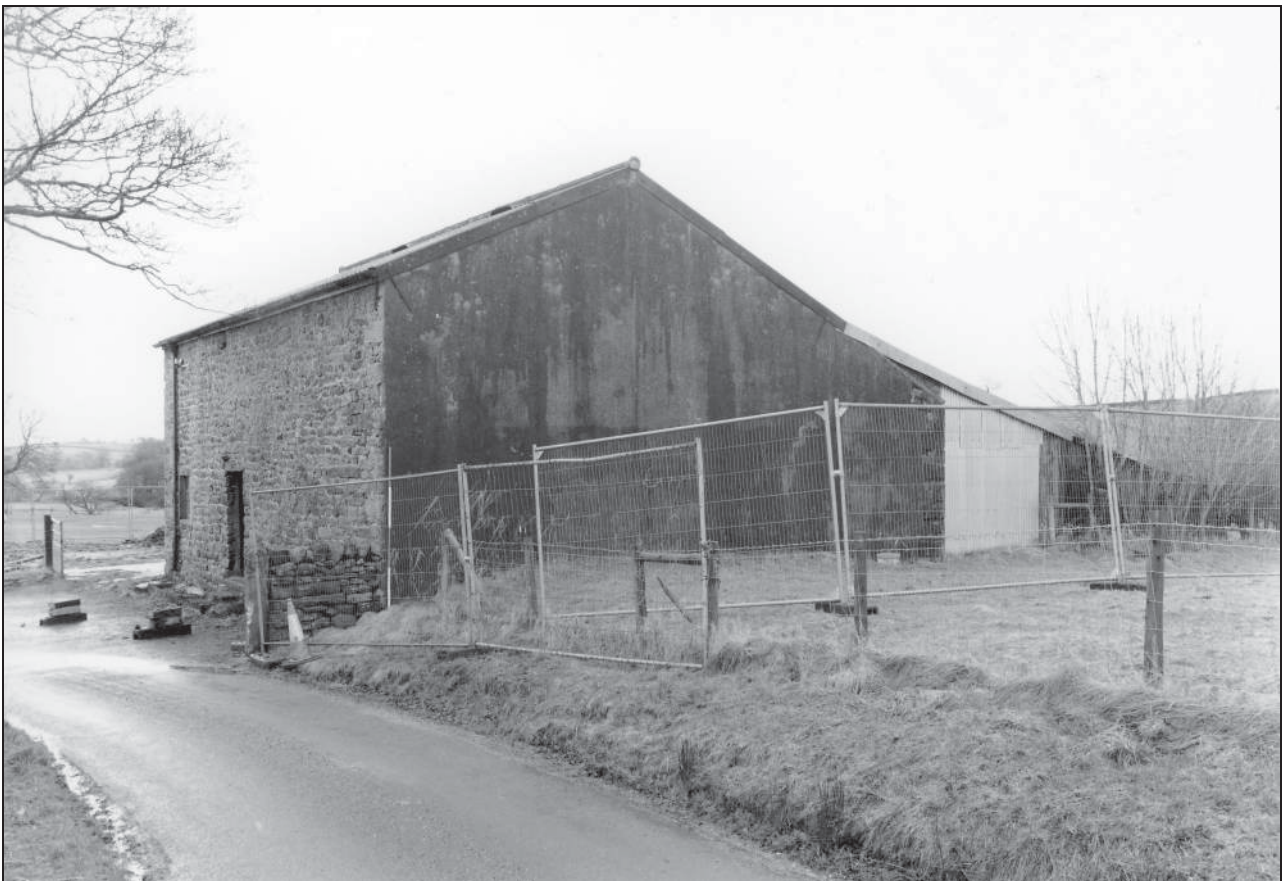
Photo 5: View of the barn, from the north-west

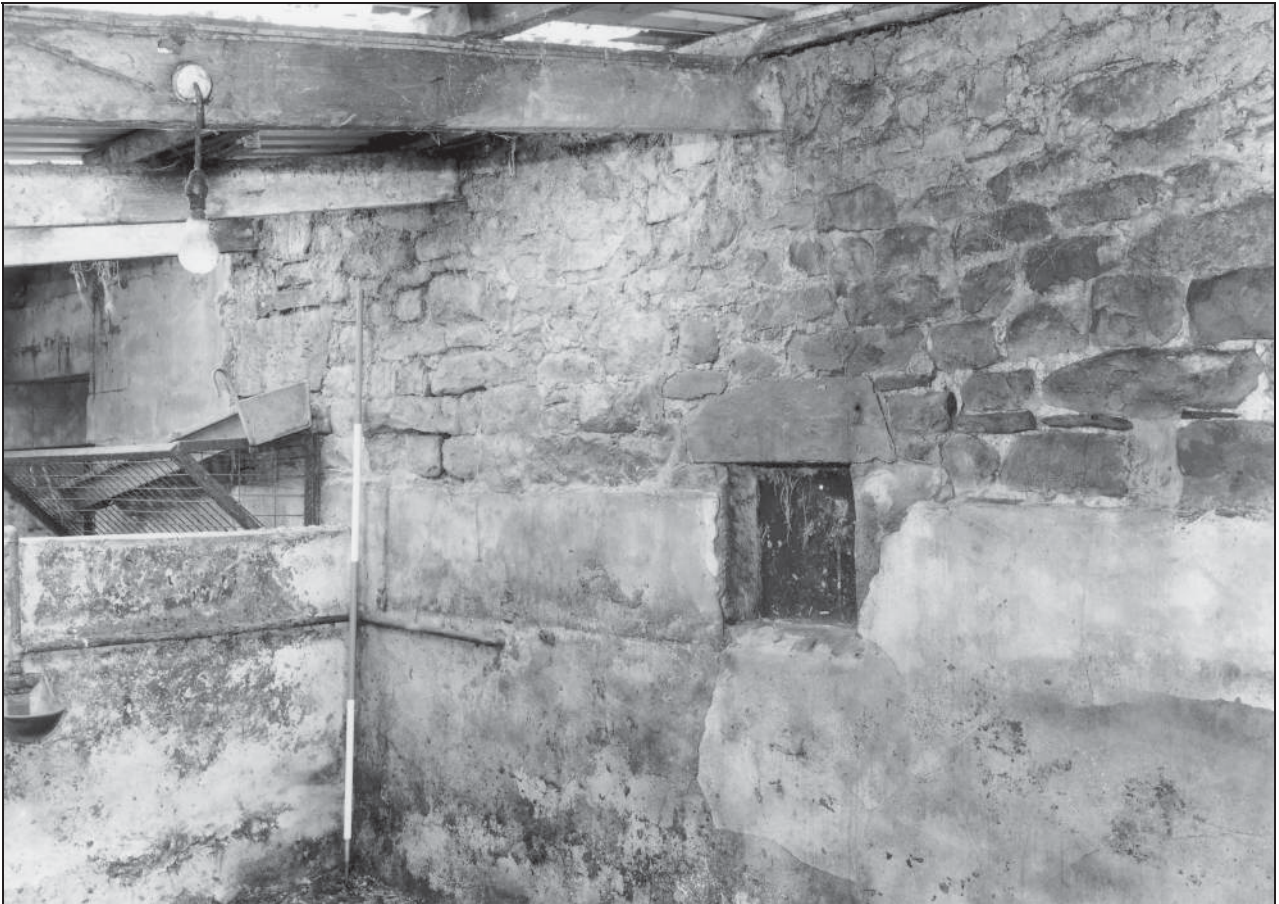
Photo 7: Muck hole and blocked breathers in east gable of barn

- 6.2 To either side of the main doorway in the front elevation are shippons within the later lean-tos on the outside of the barn: there are no openings in the south wall in that to the west of the porch (**3**), but to the east is a small opening with dressed surrounds, which has been inserted, either to provide a window or a mucking-out hole (**4**). The west gable is rendered (but is thought not to have any apertures in any case) (**5**), as is part of the east side which is now within the later lean-to (**6**). However, a number of openings can be identified here, including a central square one, now glazed but probably a mucking-out hole originally, flanked by at least three blocked breathers which had narrow slits to the exterior, splaying to wider openings within the building (**7,8**). At the north-east corner of the barn is an entrance to the shippon (**9,10**), and at the apex of the east gable is a small rough ledge close to the ridge, which may represent the base of a former owl-hole. To the rear (the north), the doorway to left of centre might be termed a "winnowing doorway", and would have allowed a draught through the building during threshing; to the east of it is a window which has been inserted, or perhaps enlarged from a smaller opening, in the 20th century (**11,12**).

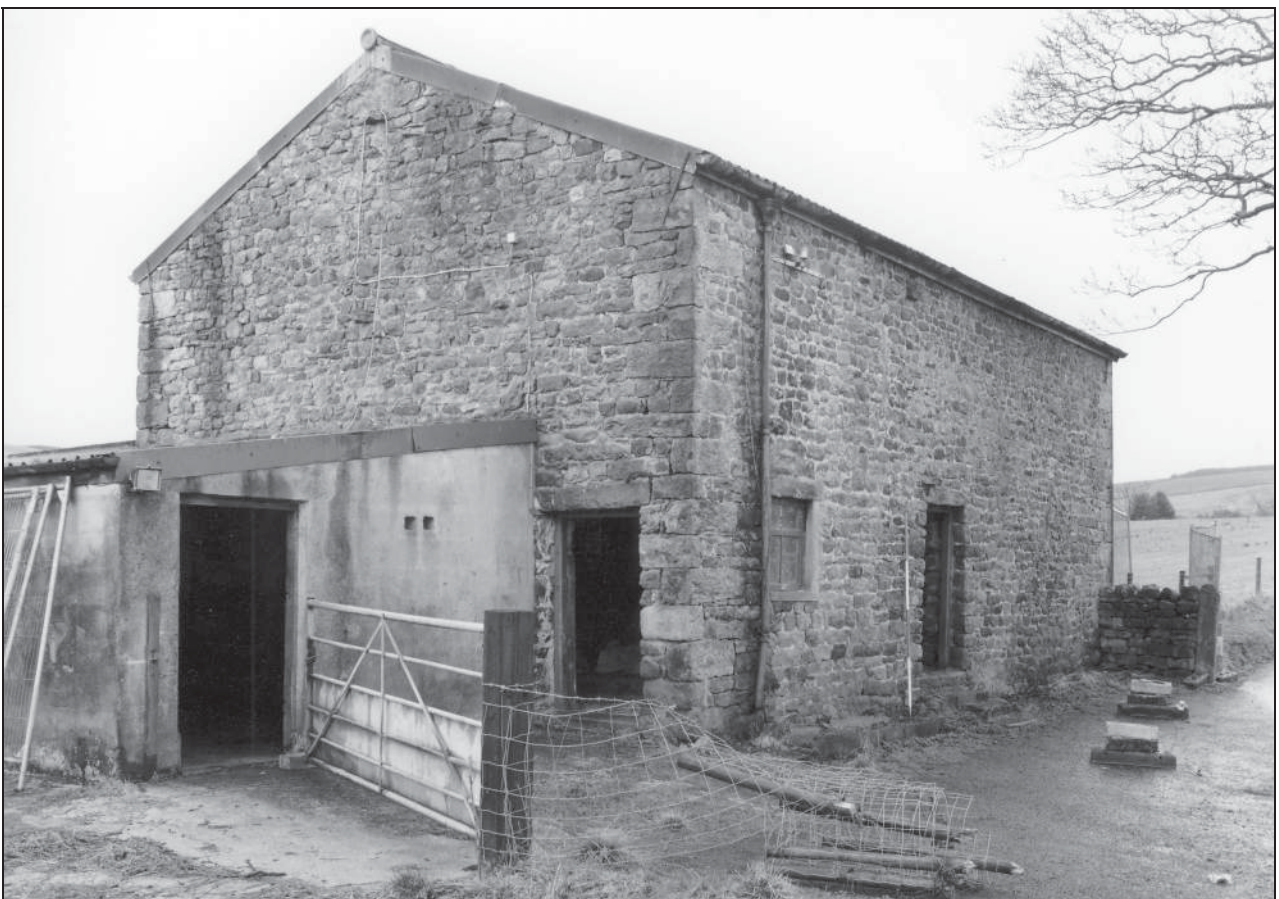
Photo 9: The barn, from the north-east

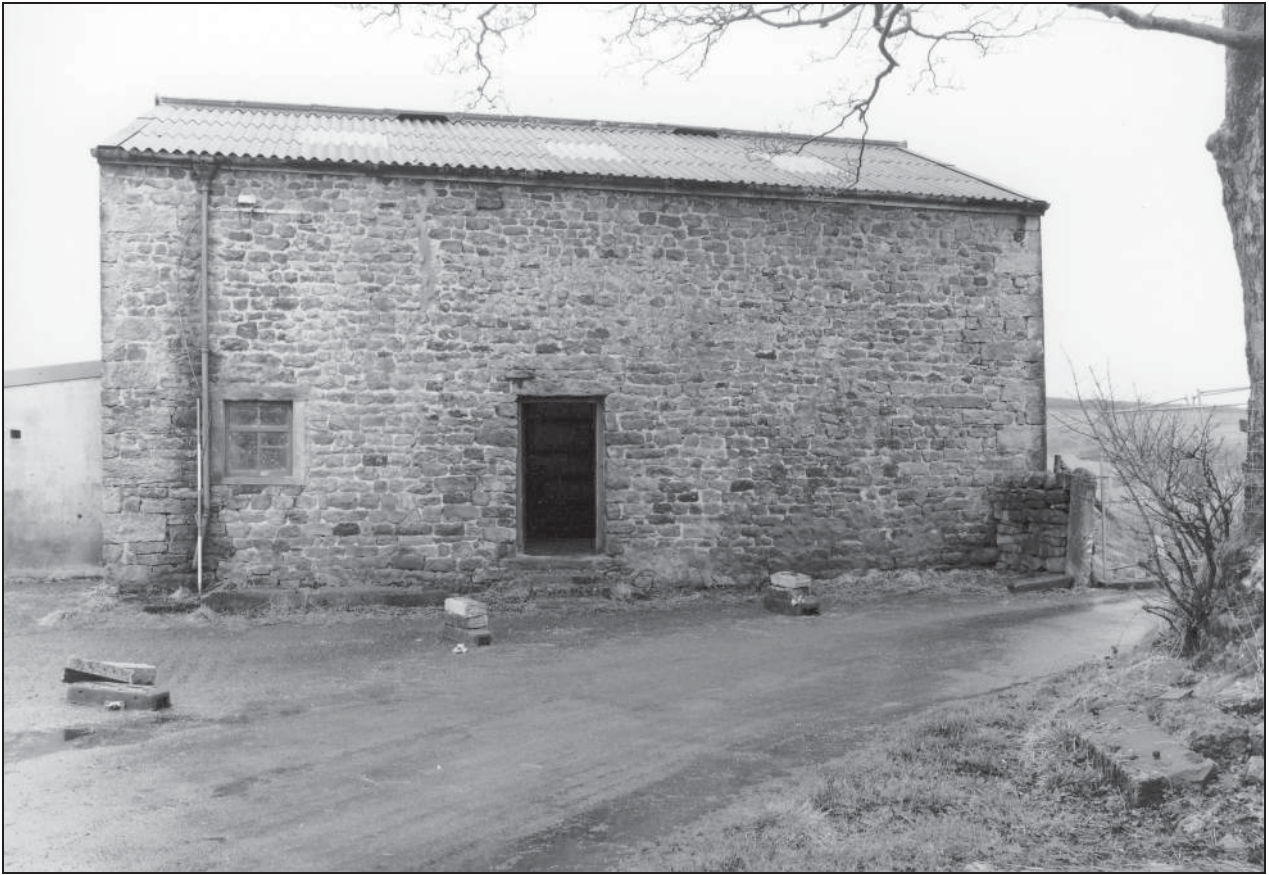
Photo 12: North elevation of the barn

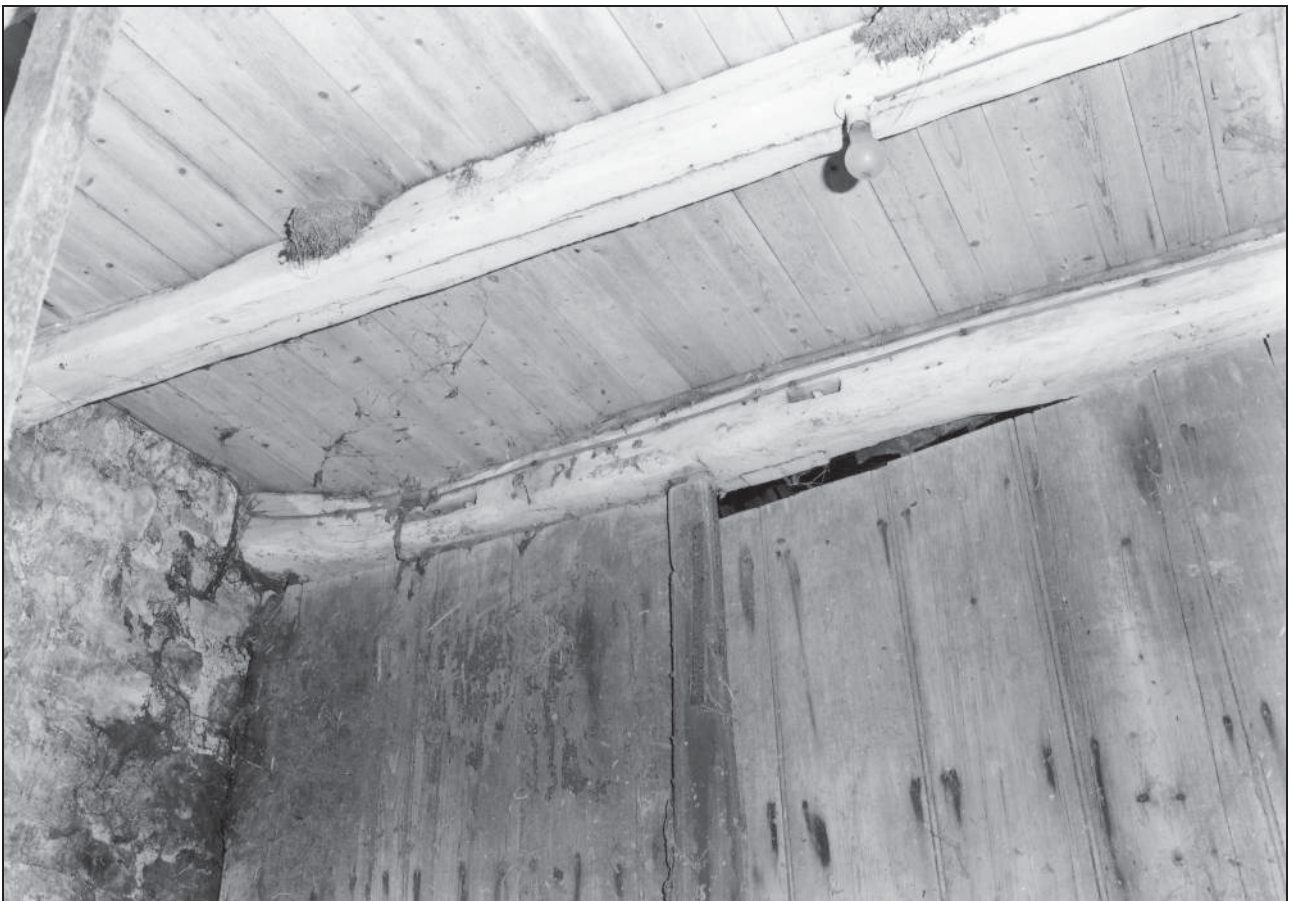
Photo 15: Re-used timber (elbowed principal rafter), over main doors

not overlain by concrete), with small square recesses in the flanking walls (13), and a loft overhead. The latter has modern, replacement softwood boards but the oak joists on which they rest appear original; the two outer ones bear halvings, mortices and peg holes which indicate that they have been re-used, and that over the inner doorway was clearly a principal rafter with elbowed lower end (14,15). The doors within this porch appear to be original to the barn and are harr-hung, with an asymmetrical arrangement and off-centre post between the two leaves (16-18). They are constructed from wide boards, and one of the rails bears graffiti which is only partly legible, but which appears to read "PROVE ..." (19), the meaning of which is obscure.

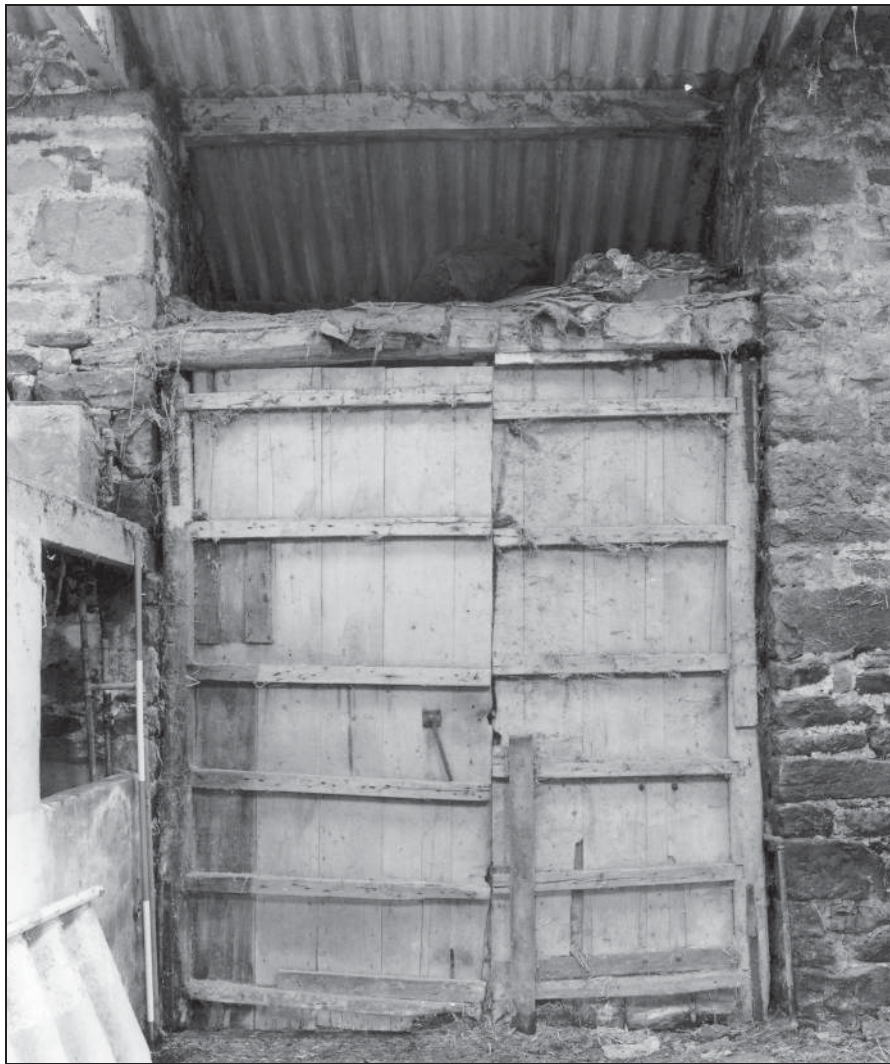
Photo 18: Interior view of main doors, from the north

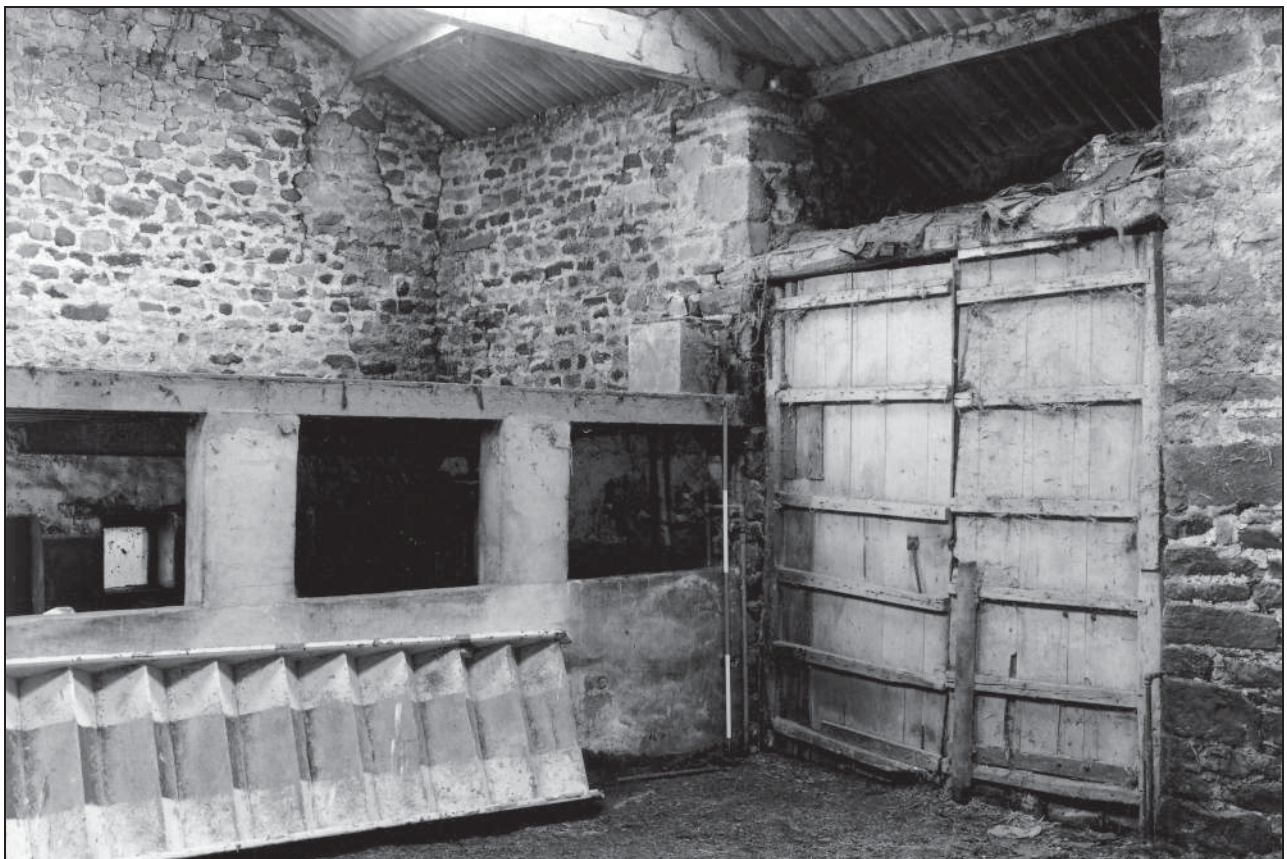
Photo 21: Interior of the barn, from the north-west, showing main entrance and modern shippon

- 6.4 The interior of the barn proper, which has three bays, is given over to a shippon in the lower (east) third, a central "threshing" bay, and a mewstead at the west end, where crops and perhaps other material or implements would have been stored: the last is characterised by an absence of fixtures or openings in the walls (20). This, and the central bay, appear to have stone floors, although not fully visible at present. The central bay, between the two doorways, may have been used for threshing (although very few arable crops would have been grown here in the 19th century), but more importantly perhaps as a means of bringing a loaded cart or sled into the building for unloading hay onto the loft over the shippon (21,22). The rear doorway appears too small for a horse to exit, so was probably simply pedestrian access, or perhaps used to create the through draught when threshing. The door itself appears more modern than the main doors, but this opening also has a lintel of re-used oak timber (23).

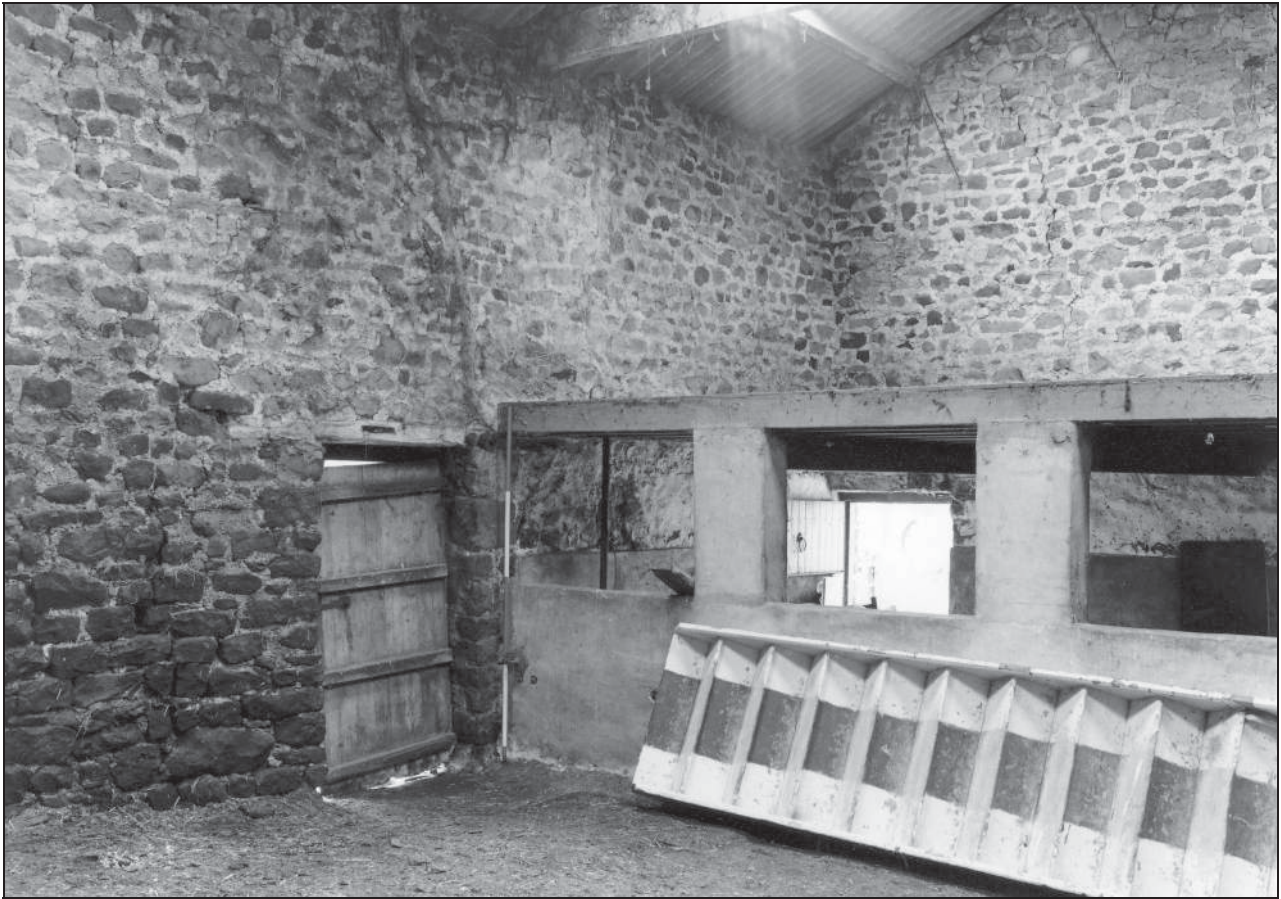
Photo 22: Interior of the barn, from the south-west

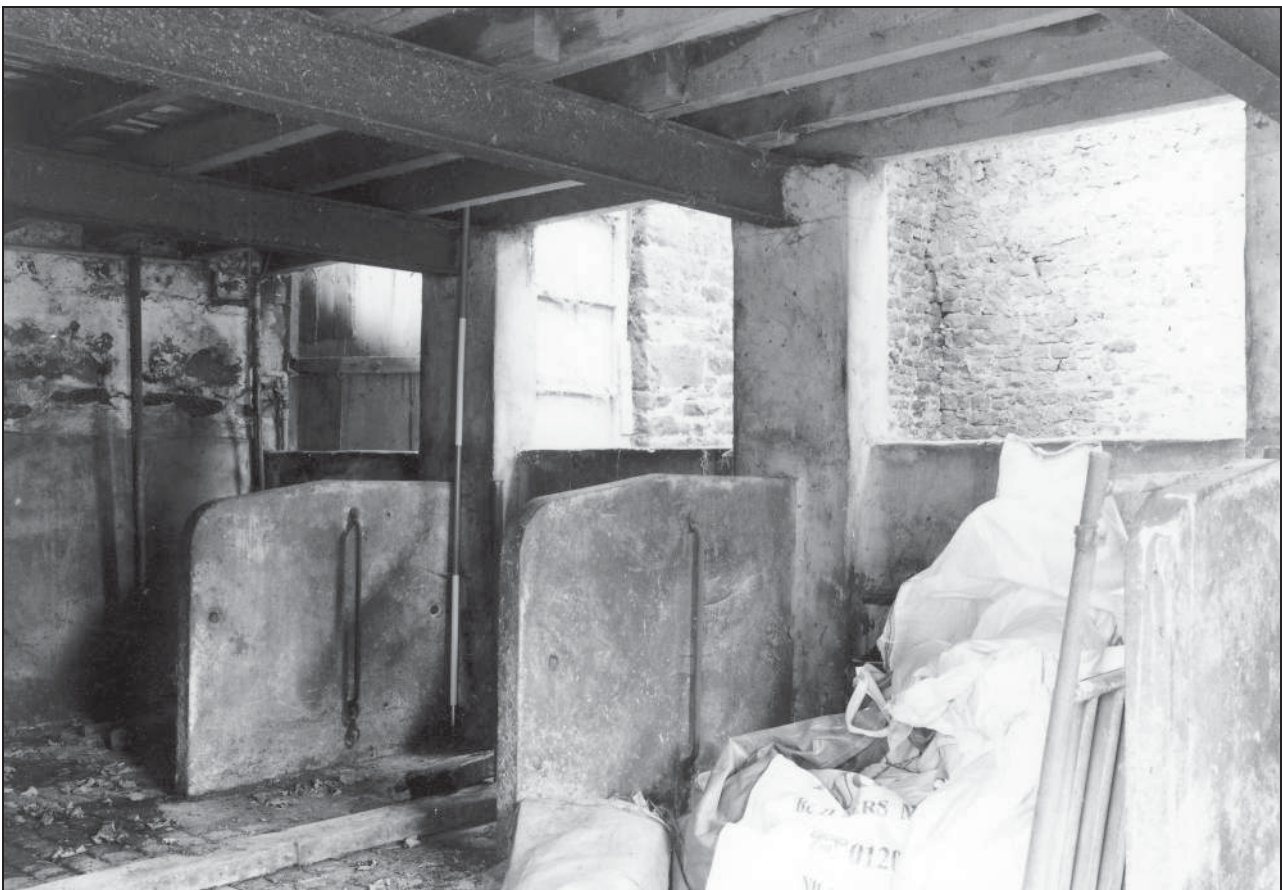
Photo 24: The shippon, from the north-east

- 6.5 The eastern third of the barn is occupied by a shippon for six animals in three pairs of standings, and although its structure is mid 20th century (concrete floor and boskins, and steel beams supporting a softwood loft) (24), no doubt it is a fairly close re-creation of the previous arrangement, which would have been timber-framed. The shippon has two recesses and a window in the east side (25,26), the former apparently created within the blocked, splayed breathers observed on the exterior.

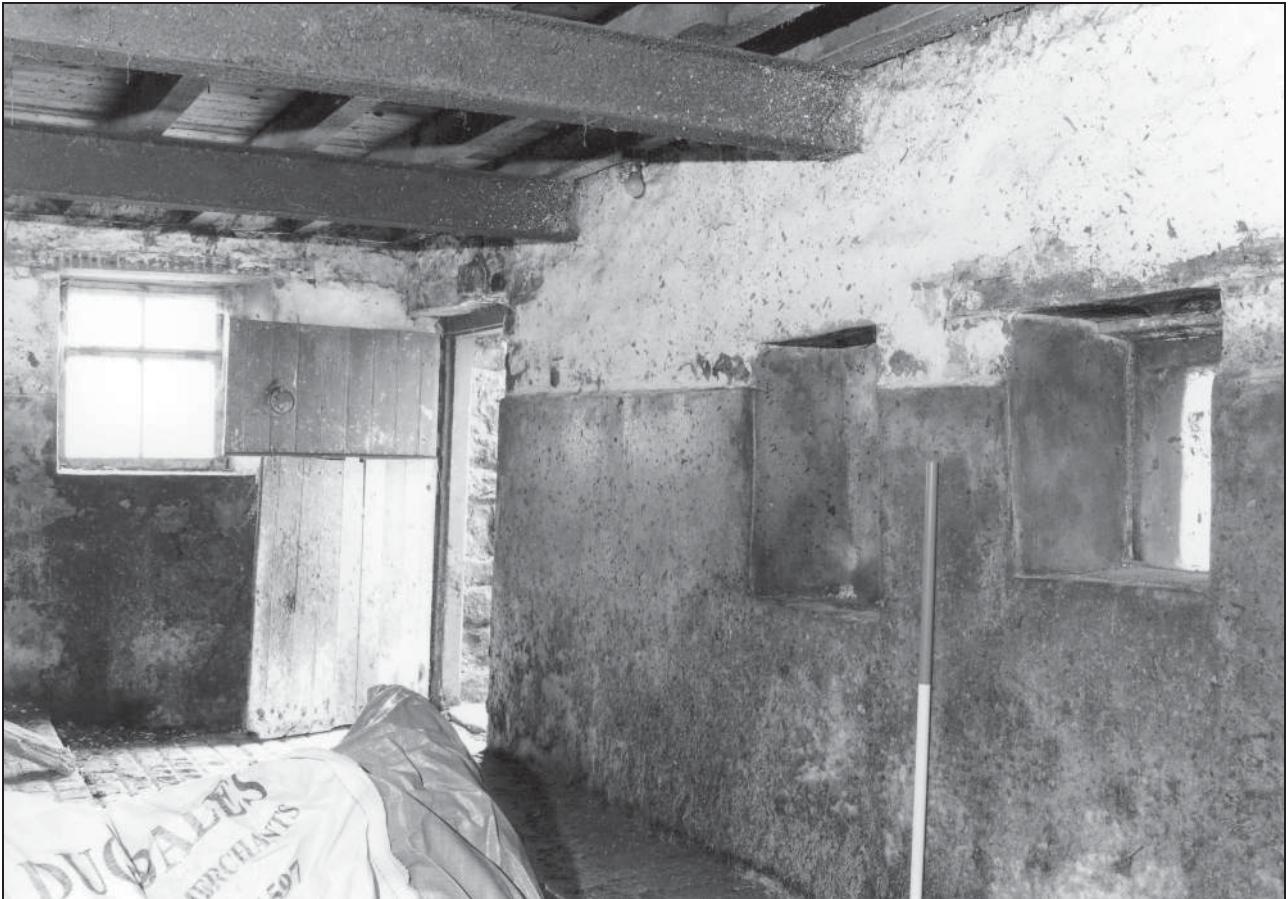
Photo 25: The shippon, from the south-west

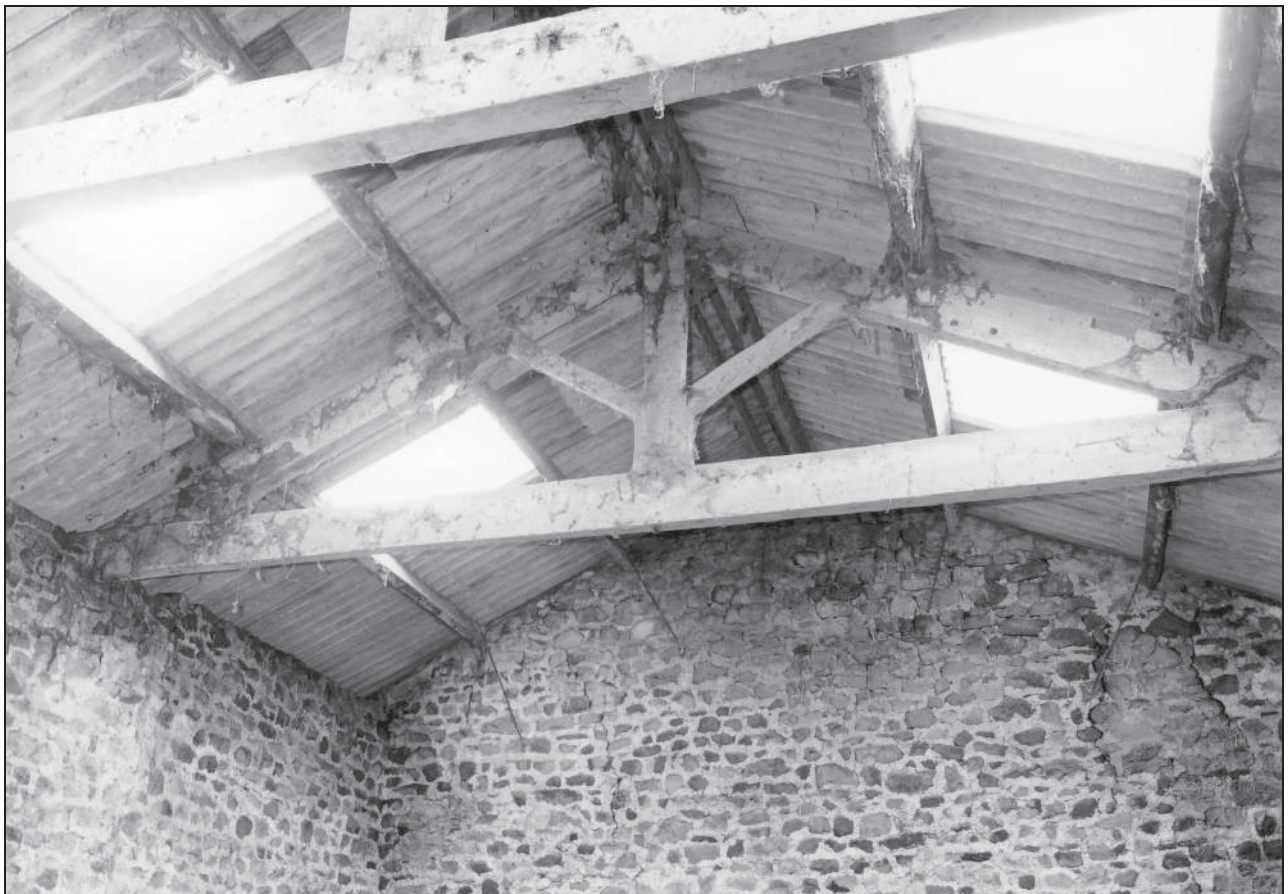
Photo 27: The east roof truss, from the west

- 6.6 The two roof trusses over the barn are of king post design with raking struts, and clearly pre-date the present asbestos roof covering, as they have redundant trenchings for purlins, and the present purlins are seated lower down the principal rafters (27). These trusses are fashioned from sawn softwood (as far as can be determined from floor level), and have bolted king posts in a very common design which suggests that they are early 19th century, or possibly late 18th century.
