# REPORT ON ARCHAEOLOGICAL MONITORING OF EXCAVATIONS RELATING TO MARISCHAL COLLEGE REDEVELOPMENTS: *The Final Stages; Resurfacing, Drainage and Sewerage Installation.*

January to April 2011

NGR NJ 9424 0653

Marischal College  
Redevelopment,  
Broad Street, Aberdeen  
Archaeological Watching Brief  
Report  
Resurfacing, Drainage, Sewerage

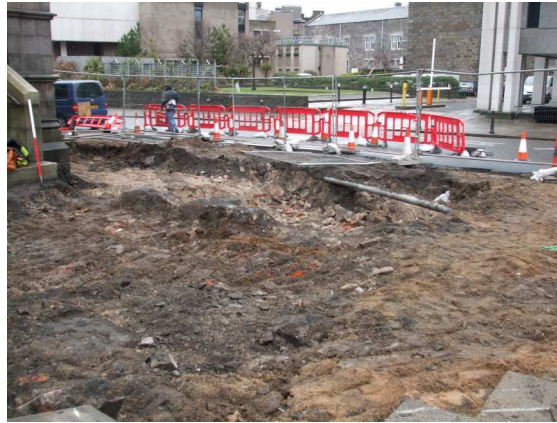
- 3.2.2 Feature 1, located close to the entrance steps to Greyfriar's Church, was a rectangular granite and brick-built structure measuring 4.1m by 5.2m (Plate 1). It seemed to have had a brick vault forming at least part of its roof, with an alcove in the south west wall which was arched in brick (Plate 2). The north eastern wall was also of brick construct and appeared to include an entrance, with a jamb visible on its southernmost side (Plate 3). A wall extended from the rectangular feature (Feature 3) north-eastwards for 8m, and met another wall (Feature 5) which was on a north-west, south-east alignment and was 5.4m in length. A drain made from brick and mortar was noted at the northern

Plate 1: Feature 1 facing north-east

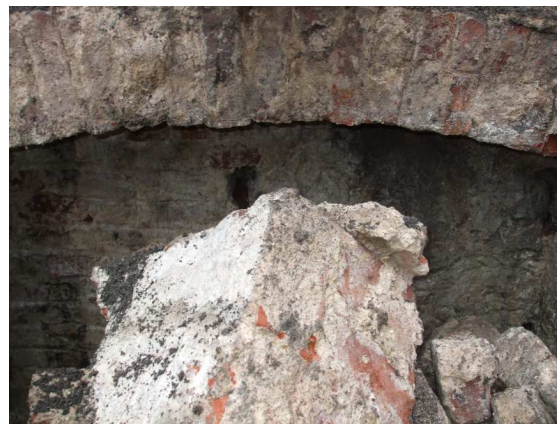
Plate 2: Brick alcove in Feature 1 facing south-west

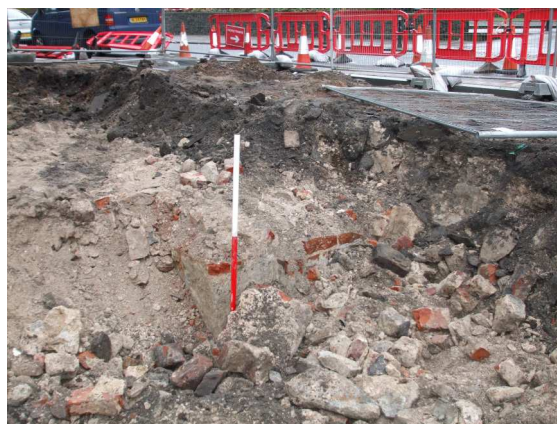
Plate 3: Entrance jamb of Feature 1 facing north-east

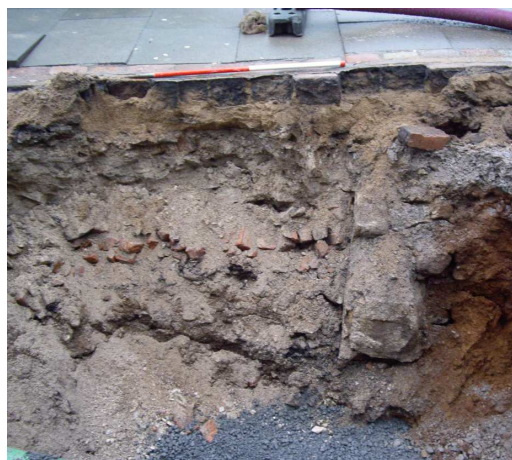
- 3.2.4 Features 10 and 11 were further remains of wall features and both were 0.62m in width, suggesting that they too once formed part of the same north-east to south-west aligned linear wall. Attached to Feature 11, at a 90 degree angle, was a row of angled bricks, located at 0.5m below the ground surface (20.73m AOD) which may represent a pre-existing vaulted brick ceiling, suggesting that this was once part of a cellar (Plate 5).

Plate 5: Feature 11, wall (right) with angled bricks

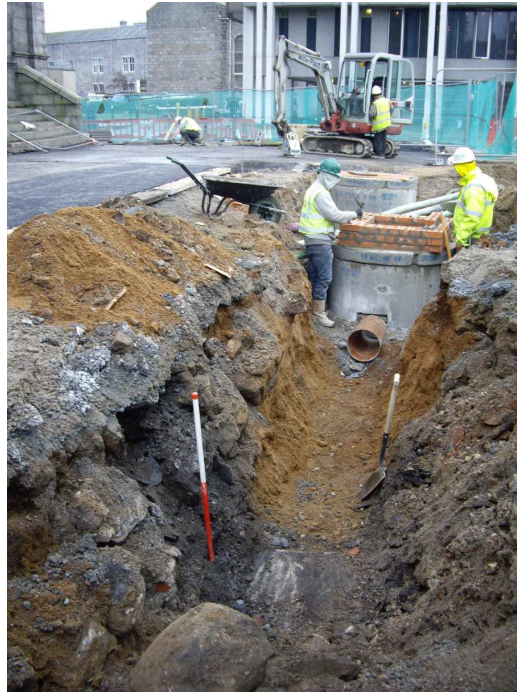
- 3.2.5 Feature 12 was a north-east south-west aligned wall made from large blocks of stone. It was observed in an area of deeper excavations for sewerage, at a depth of 0.65m below ground level (20.58m AOD). It measured 1.04m in length and 0.65m in width (Plate 6). It may be that traces of this wall survive beyond the confines of the sewerage trench that was excavated, and may yet survive.

Plate 6: Feature 12 facing south-east

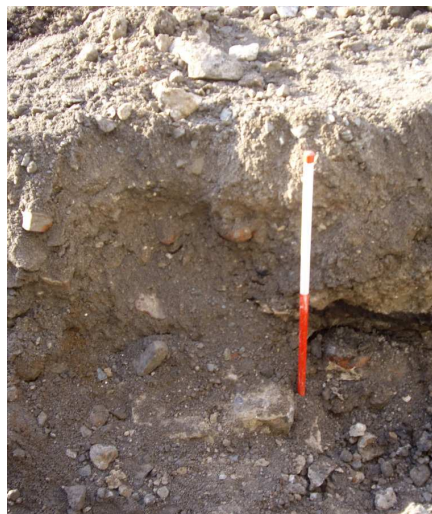
- 3.2.6 Features 13 and 14 were small sections of walls on a north-west to south east alignment. Both were 0.6m in width, Feature 13 surviving to a length of 2.7m, and Feature 14 to a length of 2m. Both were stone-built, and Feature 13 was encountered at a depth of 1m below ground level (20.23m AOD; Plate 7).

Plate 7: Feature 13, to left of ranging rod, at base, facing north-east

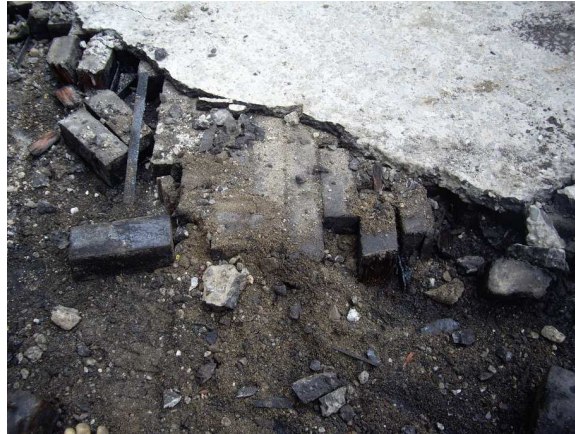
- 3.2.7 Features 16 and 17 were located close to the entrance to Marischal College (Figure 3). Feature 16 was an area of wooden cassies, each cassie measuring 0.23m in length, 0.09m in width, and 0.08m in height, and all aligned north-west to south-east respecting the alignment of Broad Street (Plate 8). They survived in an area approximately 4m in length and 2m in width. A sample cassie was retained for future reference (Find 1). Feature 17 was the top of some angled bricks observed at a depth of 0.5m. Not much of the feature was revealed, but it could be that it represented the top of a brick-vaulted ceiling of a cellar.

Plate 8: Feature 16

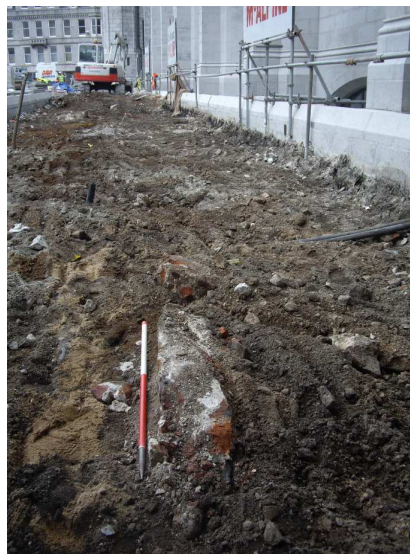
- 3.2.8 Two further features were encountered closer to the Marischal Building. Feature 22 was a narrow brick built wall 0.24m wide and 1.2m in length, observed on a north-west south-east alignment 2.2m from the college building (Plate 9). It is likely to have been the remains of the pre-existing low boundary wall, largely removed earlier in the redevelopment of Marischal College. Feature 23 was an L-shaped section of stone wall, 2.7m in length and 0.52m in width and on a north-west south-east alignment (Plate 10).

Plate 9: Feature 22 facing north-west

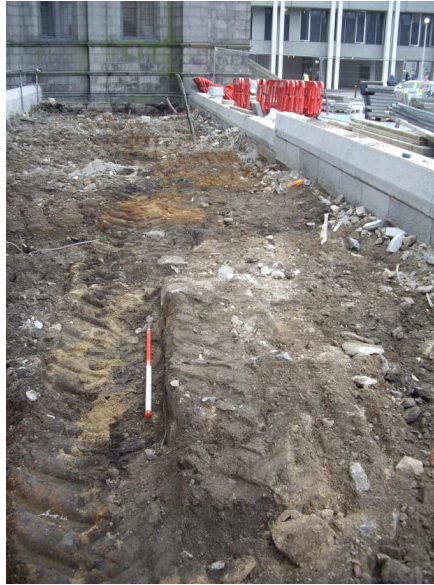
Plate 10: Feature 23 facing south-east

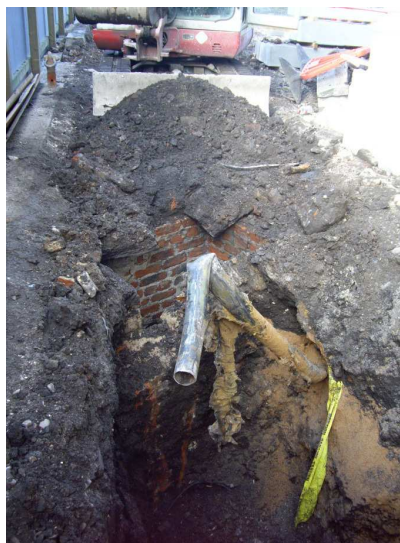
3.2.10 The first was a brick and mortar constructed rectangular feature measuring 0.58m by 0.9m (Feature 15; Plate 11). This was interpreted as an old personnel access chamber, or manhole, for pre-existing services in the area and may relate to Victorian drainage.

Plate 11: Feature 15 facing north

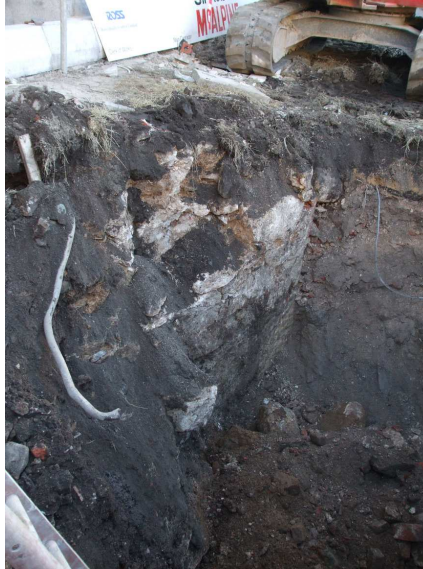
- 3.2.11 Features 18, 19 and 20 were walls 0.8m wide and 2m depth, cut directly into the natural. The areas exposed within the trench were removed to make way for new drainage pipes, but traces may survive beyond the boundaries of the trench. Feature 20 was interpreted as being an internal partition wall attached to Feature 18 (Plate 12). Feature 18 was 3m long, and Features 19 and 20 were 0.76m and 0.75m long respectively.

Plate 12: Feature 18 facing east

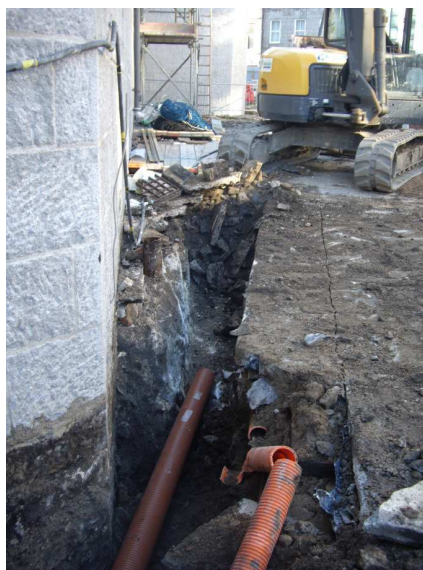
- 3.2.12 Feature 21 was the disturbed remains of a stone-built wall, with some loose bricks marked 'GIBSON' found in the vicinity. It was aligned north-east to south-west at the far corner of the drainage trench and close to the Marischal Building wall (Figure 4). It measured 1.96m in length and 0.8m in width and was located at a depth of 0.4m below ground level and was observed at the final depth of the trench, which in this part, was 1.1m (Plate 13).

Plate 13: Feature 21 facing south-west

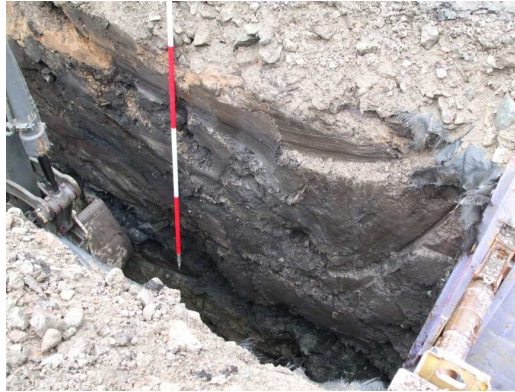
3.2.13 Also encountered within the drainage excavations was an area of organic loams close to the Gallowgate (Finds 2, 3 and 4; Figure 4; Plate 14) at a depth of 2.8m. Samples were taken. The loams included fish and mammal bone (Find 2), leather scraps (Find 3) and horn cones (Find 4). These relate nicely to similar finds located at Gallowgate Middle School which encountered leather scraps of 12<sup>th</sup>-14<sup>th</sup> century origin (Cameron and Stones 2001, 76-77) and a late 14<sup>th</sup> century tannery at Nos. 45-75 Gallowgate (*ibid*, 93). The area that these deposits were located is at the edge of a midden area centred on the Gallowgate Middle School and 45-75 Gallowgate sites.

Plate 14: Area of organic loams (Finds 2, 3 and 4)

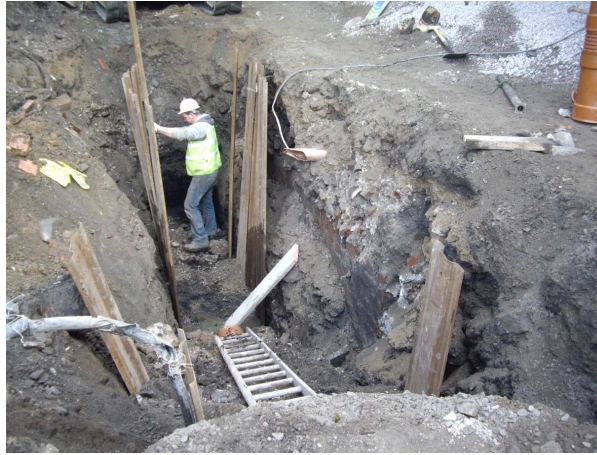
3.2.14 **Sewerage Excavations:** the sewerage excavations took place to the rear of Marischal College to the south east of the new multi-storey car park accessed from Queen Street (Figure 1). They involved an initial removal of existing paving slabs and surface to a depth of 0.4m across the whole area, followed by the excavation of a trench 1.8m wide and up to 2.9m deep. Several archaeological features were encountered in this area (Features 24-29; Figure 3) as well as some broken glass bottles and jars, some of which were of some interest (Finds 5 and 6). Features 24-29 were all stone built walls, the tops of which were located 0.5m below the existing ground level. They varied in width from between 0.4m and 0.6m, and in length, from 1m to 1.6m. Features 24, 25 and 27 were north-west south-east aligned, whereas Features 26, 28 and 29 were all north-east south-west aligned. Feature 25 was brick faced (Plate 15). Feature 26 was a stone-built wall with a brick faced wall adjoining it (Plate 16). The others were short sections of stone walls.

Plate 15: Feature 25 in right side of trench, facing north-west

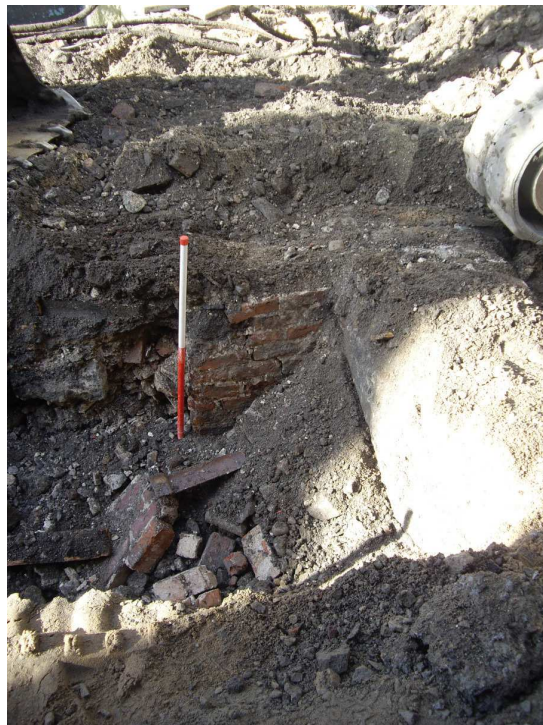
Plate 16: Feature 26 to right with adjoining brick wall, facing south-west

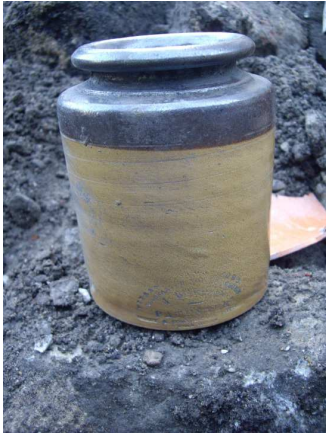
3.2.15 Several broken stoneware jars, ceramic plant pots and glass jars were encountered in this area. Two were of some interest; the first a stoneware jar with some writing at the base (Find 5) saying 'Vitreous Stone Jars/ Warranted not to Absorb/ J Bourne/ Patentee/ Denby and Codnor Park Pottery/ Near Derby' (Plate 17). This jar was a typical stoneware style jar and dates from between 1833 and 1861. It measured 14.5cm in height and had a diameter of 11cm at its base. The second was a green glass bottle (Find 6) saying 'Yorkshire Relish/ Goodall Backhouse and Co' (Plate 18). This company was founded in 1837 but changed its name to Incorporate the 'and Co' in 1858. The bottle measured 18cm in height and had a 5cm diameter at its base.

Plate 17: Stone Jar, Find 5

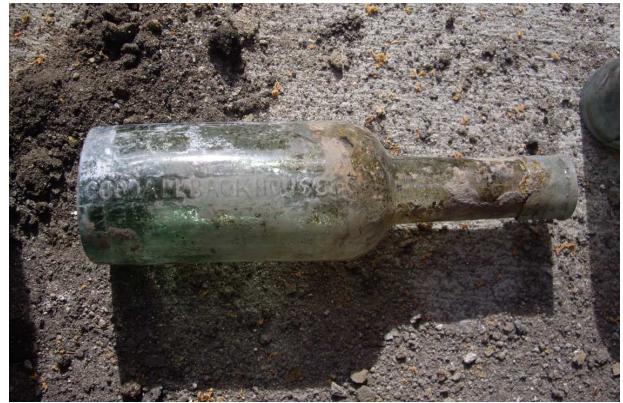
Plate 18: Glass Bottle, Find 6

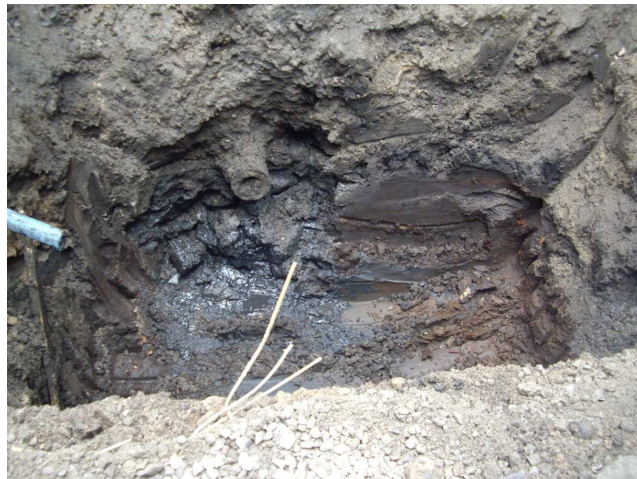
3.2.16 In the far western part of the excavated area for the new sewerage, a dark peat-like organic material was observed below modern services from the trench base (Plate 19).

Plate 19: Organic material at base of trench (right), facing south-west
