MARISCHAL COLLEGE, ABERDEEN
Archaeological field evaluation

MARISCHAL COLLEGE, ABERDEEN

Archaeological field evaluation

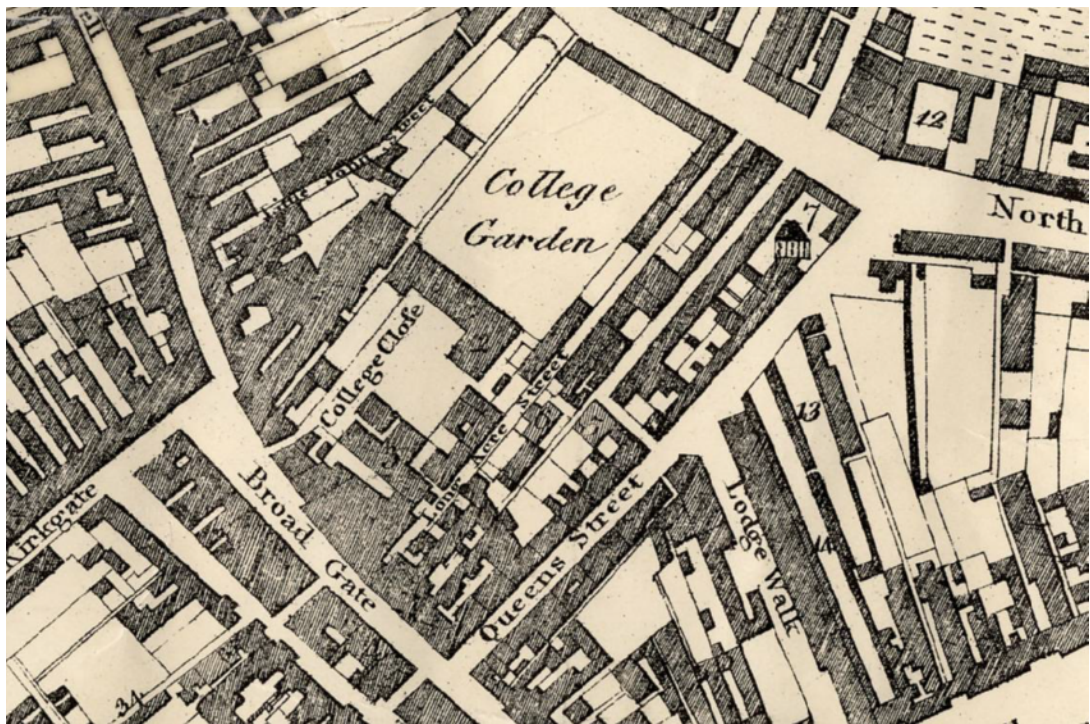
Ill 6 Extract from Milne's map of 1789, showing the 1768 north-east extension to the church

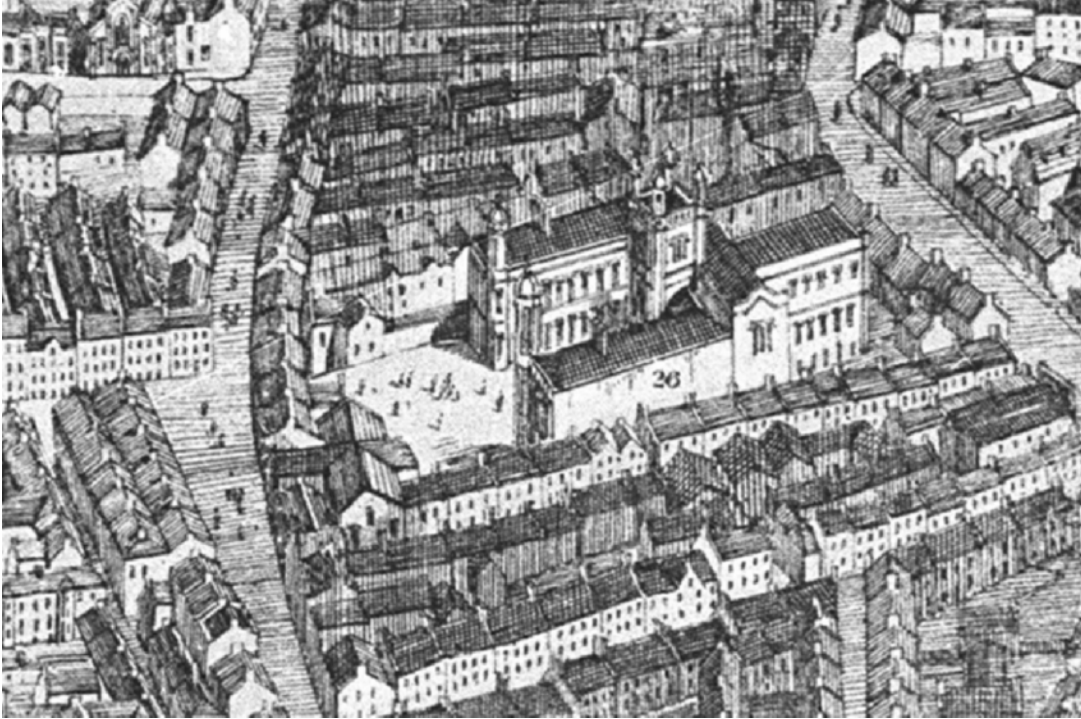
Ill 7 Extract from George Washington Wilson's bird's eye view, 1850, showing the 1768 north-east extension to the church

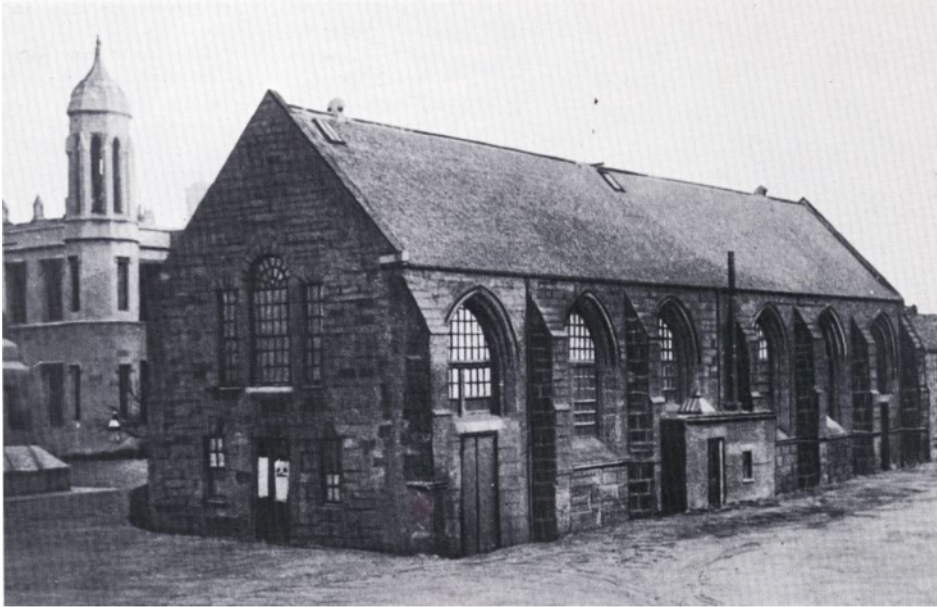
Ill 13 Greyfriars Church, from the north-west with College buildings (left) and obelisk (extreme left)

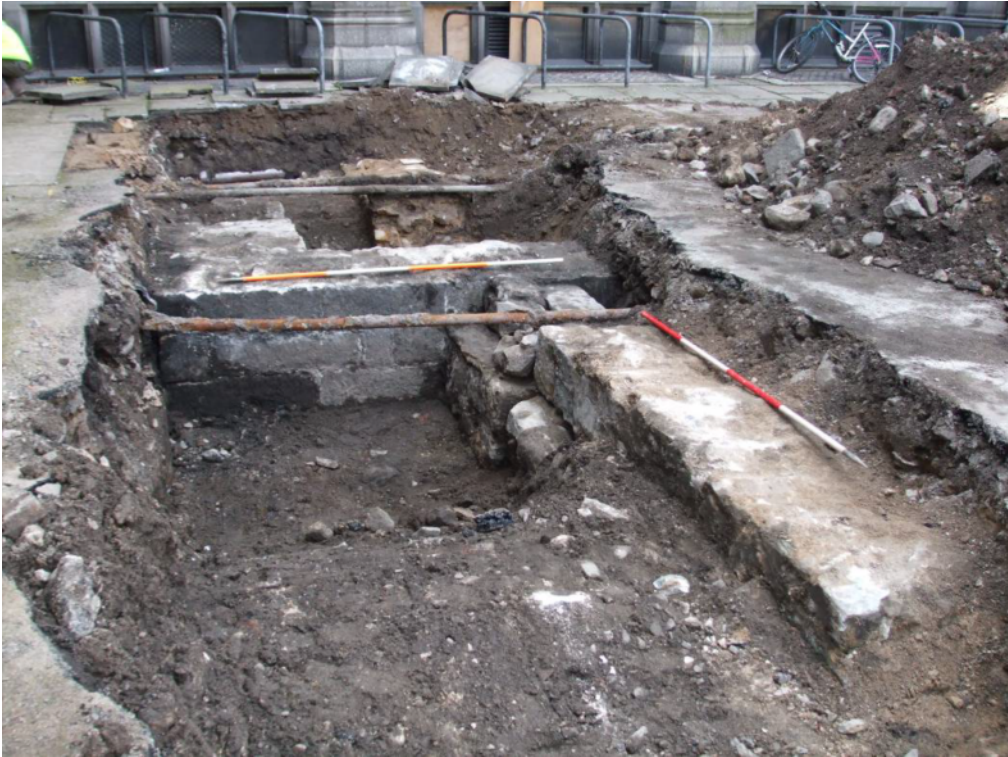
Two stone walls bonded with light brown mortar, AA and AH may be 15th or 16th century in date or earlier. Wall AA is at least 0.88m wide and is on the possible alignment of the internal wall of the cloister (Ills 17; 30). AH is 0.86m wide and on a NE-SW alignment.

Ill 17 Wall AH (right foreground), structure AE (centre); facing SW

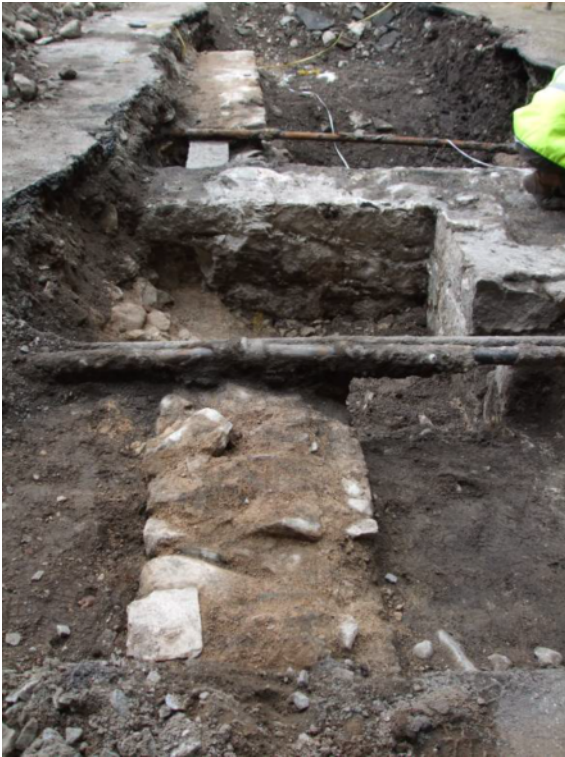
Ill 18 Wall AH (foreground), structure AE (centre), Wall AA (background); facing NE

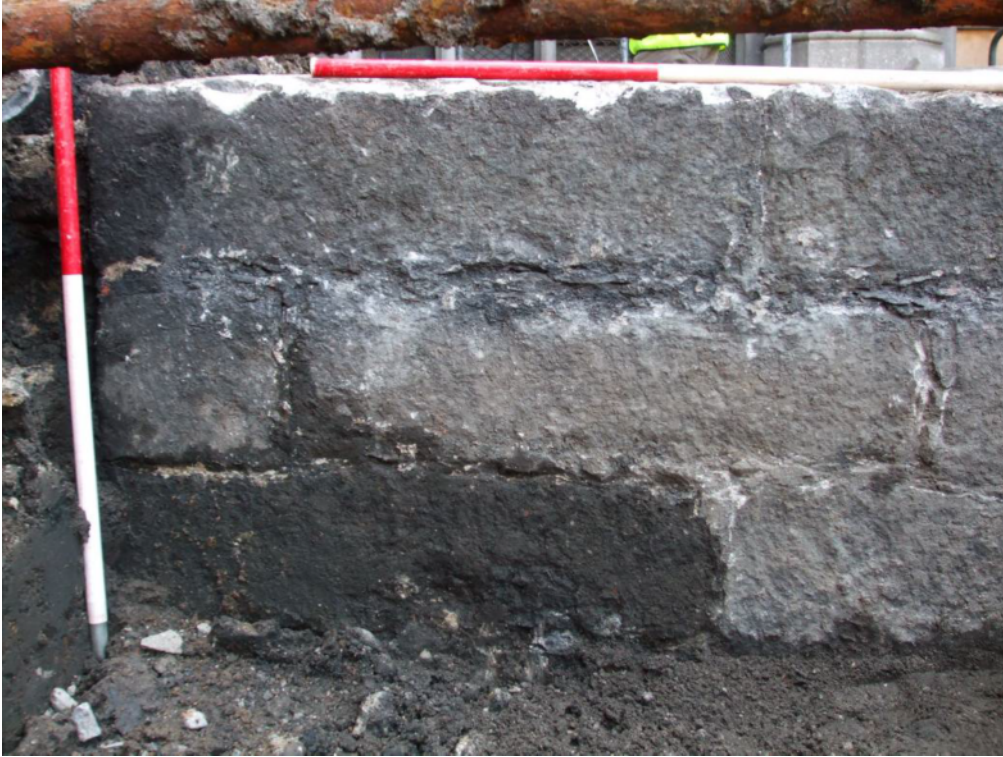
Wall AE, bonded with hard white mortar, formed a corner of a structure of which wall AK in Trench 2 was also part. The walls were 0.76 and 0.84m wide and probably formed the NE corner of an extension built onto the church in 1768 (see below). A granite step, AI and its foundation appeared to be contemporary with

Ill 19 detail of face of wall AE; facing SW

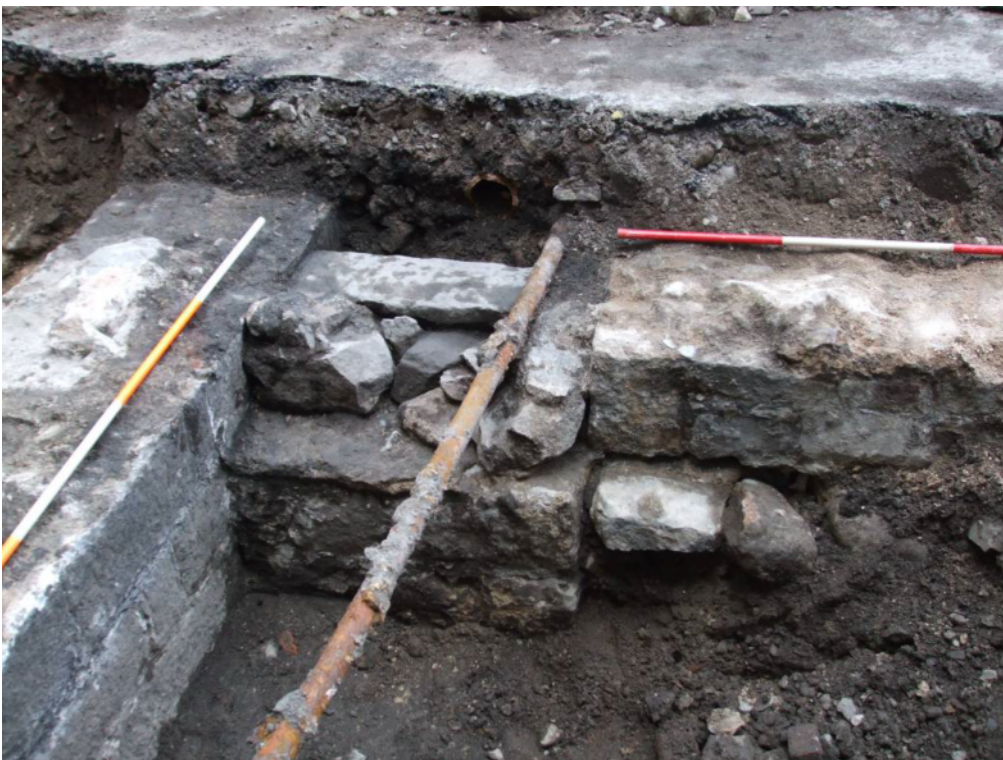
AE. Its purpose is unknown but it seems unlikely that it was to access the extension.

Ill 20 Structure AE (left), step AI (centre), wall AI (right); facing W

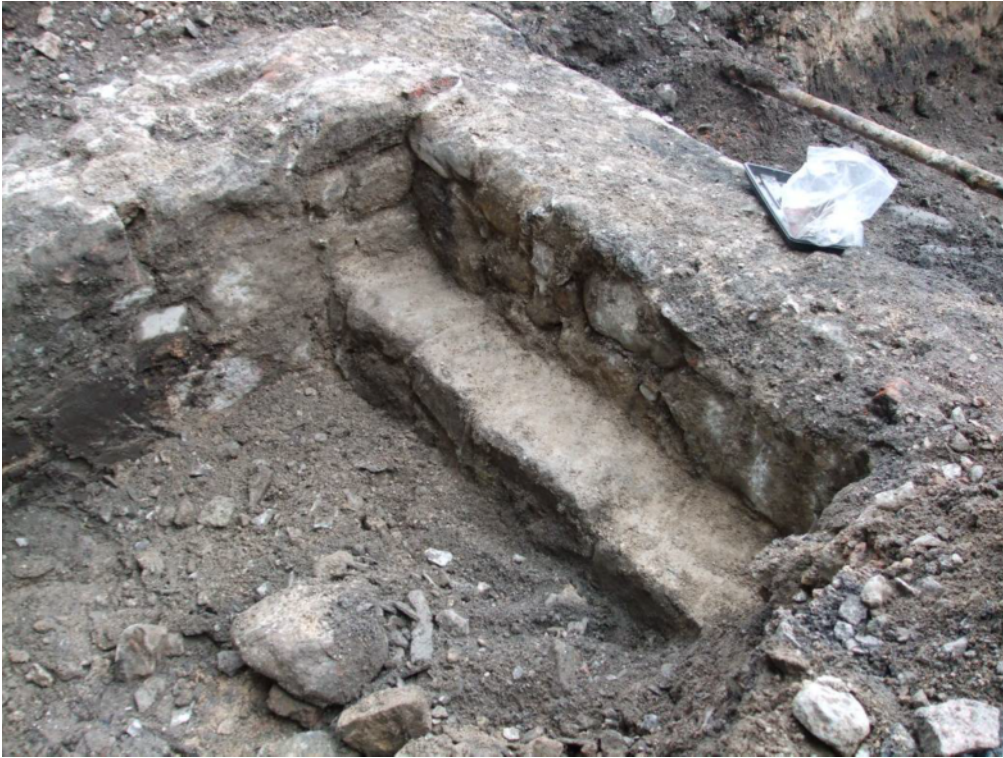
Walls AK (=AE in Trench 1) formed the corner of an extension built onto the NE of the church in 1768. The internal length of this extension is 9.8m NW-SE; 4m (of a total dimension of c7.5m) was excavated. The walls were constructed of very hard white mortar and stone. The walls were excavated internally to a depth of 0.85m. No internal floors were identified.

Ill 21 Structure AK with wall AM underneath; facing NW

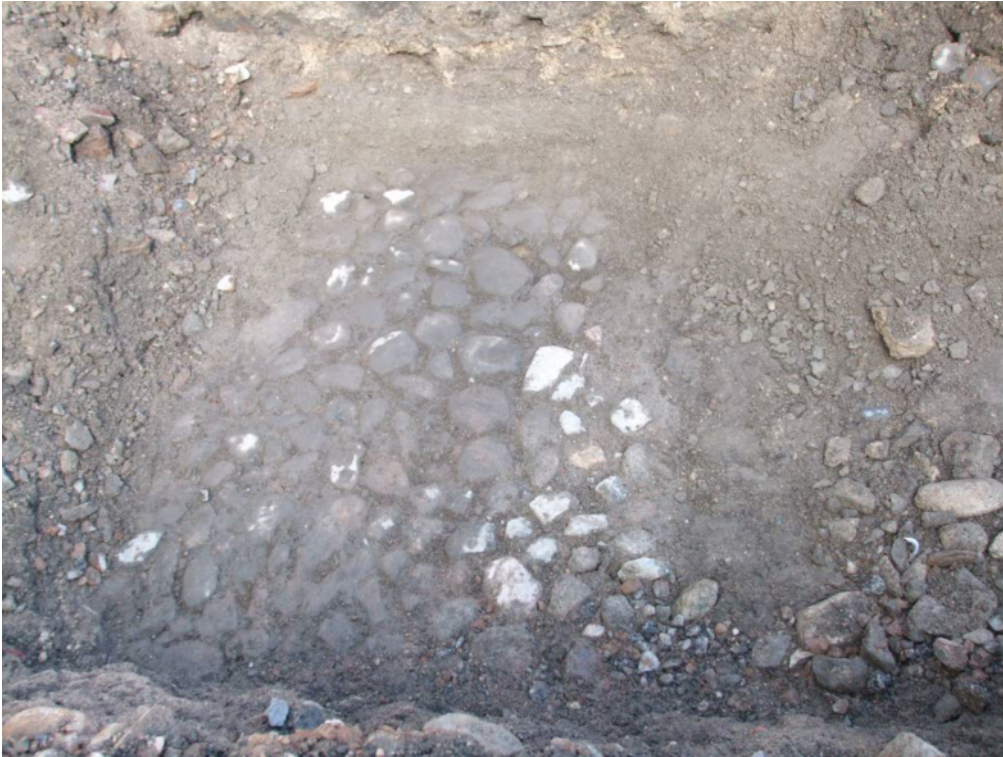
Small rounded cobbles formed a surface, AO, 2.2 x 1.4m of which was exposed, may be the earliest features excavated in these trenches. This cobbled surface was left in situ; two fragments of clay pipe were recovered from immediately above the cobbles, but there was no dating evidence for the surface itself. Larger cobbles AN appeared to be contemporary with structure AK/AE.

III 22 Small cobbles AO; facing NW

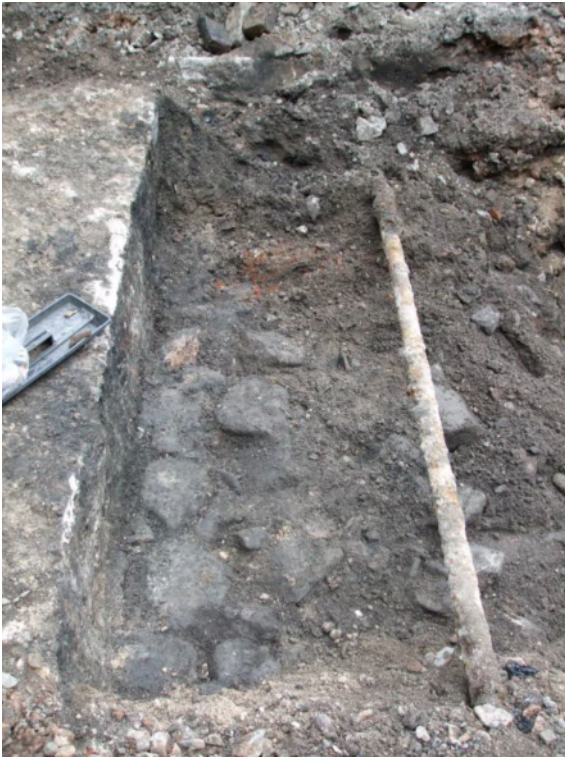
III 23 Medium cobbles AN; facing NW

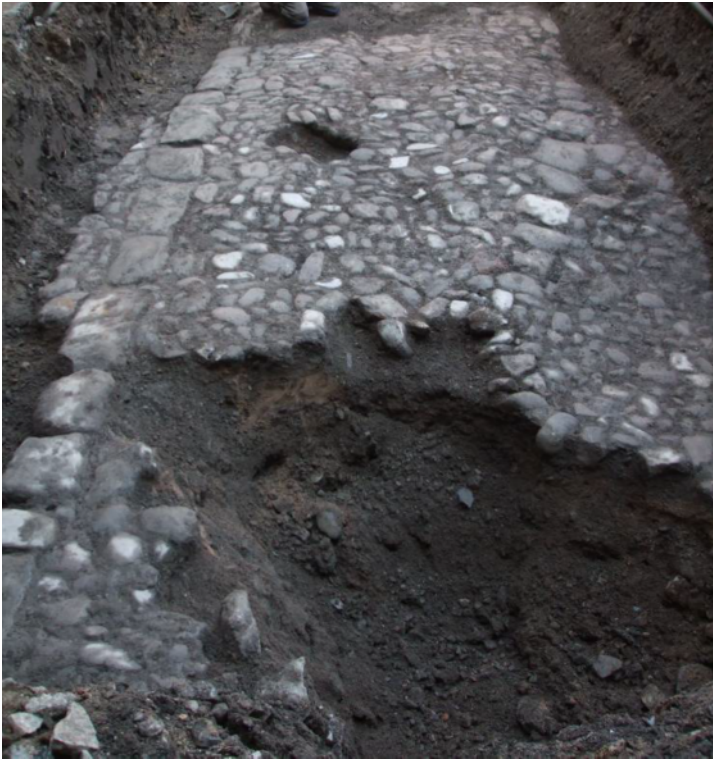
Virtually the entire area of Trench 3 was occupied by a cobbled surface (AQ), consisting of small and medium water-washed granite cobbles set in a clean sand. There was no dating evidence for the construction of these cobbled surfaces; finds from above the surface included 18th to 19th-century clay pipes and pottery sherds. The cobbles were edged with large rectangular cobble stones (AR) and there was an internal setting, possibly forming a radiating pattern (AS).

Ill 24 Cobbled surface AQ with edging cobbles AR (left) and decorative line of cobbles AS (right)

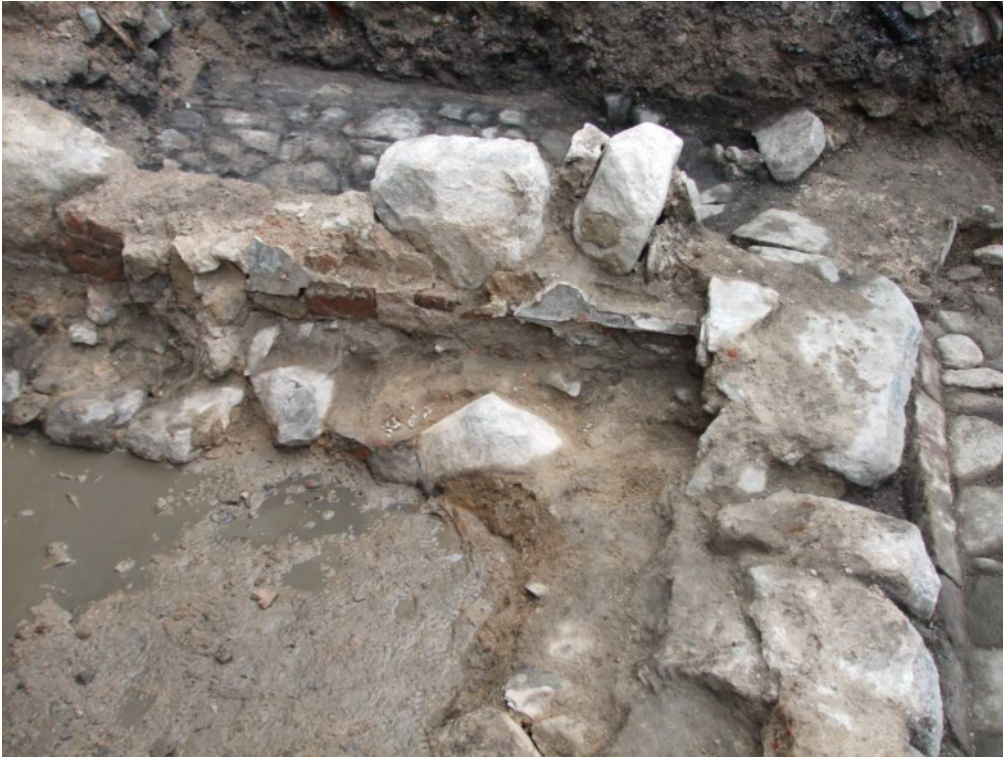
The corner of a mortar and clay-bonded stone foundation (BC) was uncovered in this trench. The walls were 0.86 and 1m wide and had been altered by the addition of a brick rebuild and replastering (BD, 43, 47 and 48). This may be the remains of the corner of the medieval church, which may have been subjected to flooding or damp, necessitating the repairs in brick and concrete. This end of the church was reduced in length by 20 feet (McGibbon and Ross, 1897, 358-9) to allow for access to Marischal College from Broad Street.

Ill 25 Foundation of corner of church, BC, showing brick infill and plaster BD and 48; facing NW

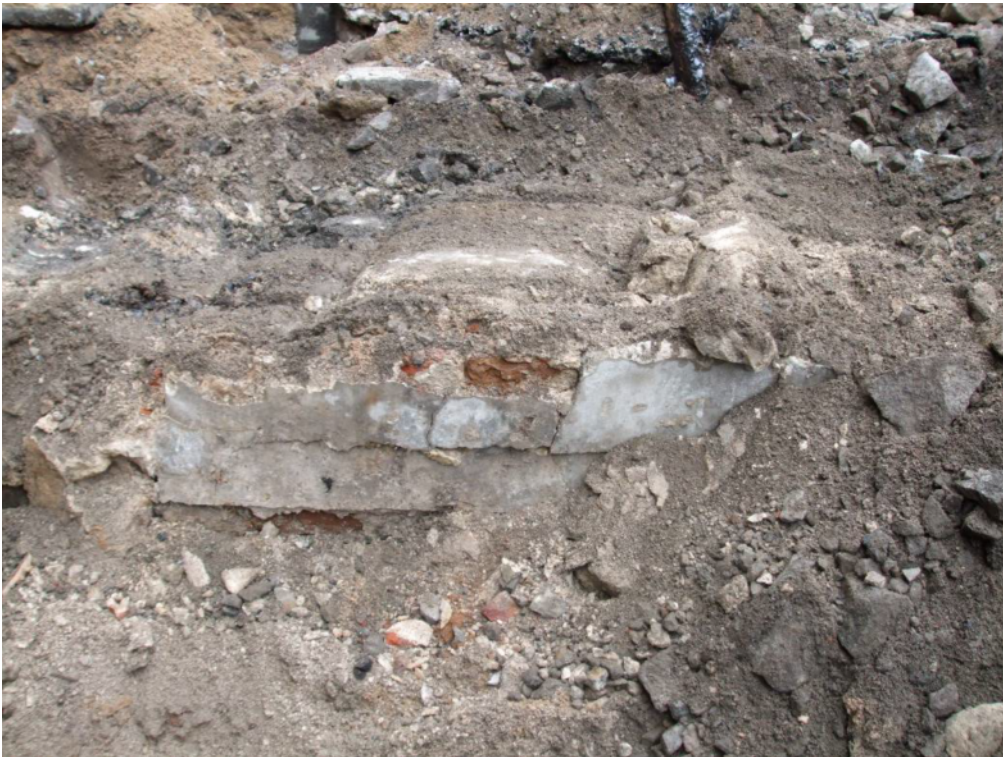
Ill 26 detail of plaster and brick infill; facing NW

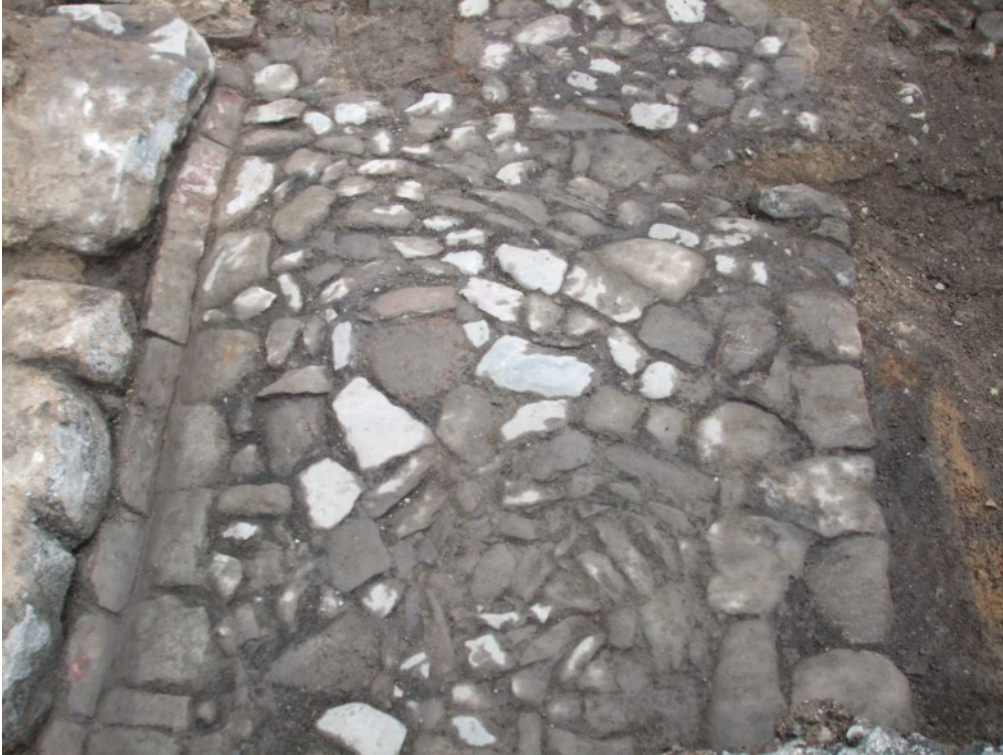
Cobbled surfaces around the north and west sides of this building may have been contemporary with it. To the north a small and medium-sized cobbled surface or path had been edged with brick to form a drainage channel or runnel (BE). Small finds from this drain included copper alloy pins, glass and small sherds of pottery. A scatter of green window glass had smashed on this surface

Ill 27 Cobbled pathway AY, brick drain BE (left) and wall BC (extreme left); facing NW

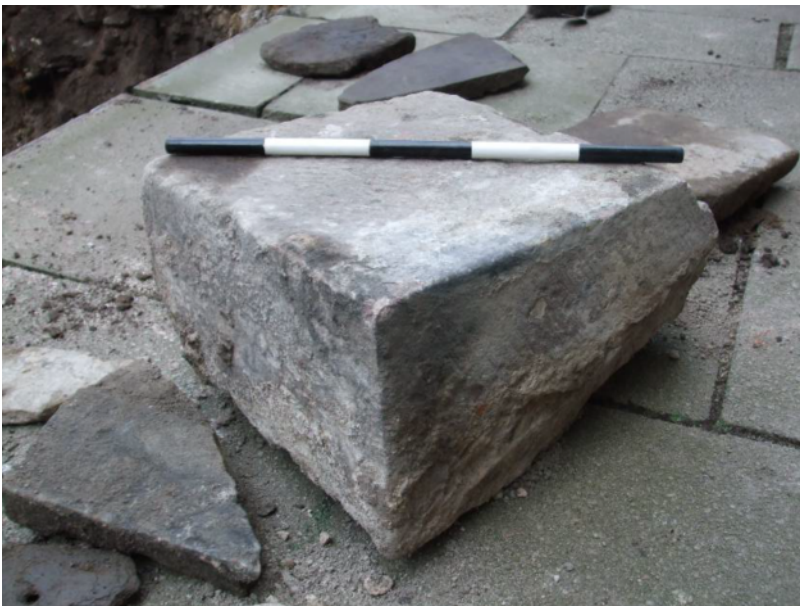
Up to 1m of demolition material was removed from above these walls and cobbled surfaces. It included building stone, brick, slates and stone floor and roof tiles, some presumably from the 1768 demolition.

Ill 28 Examples of medieval stonework recovered from Trench 4

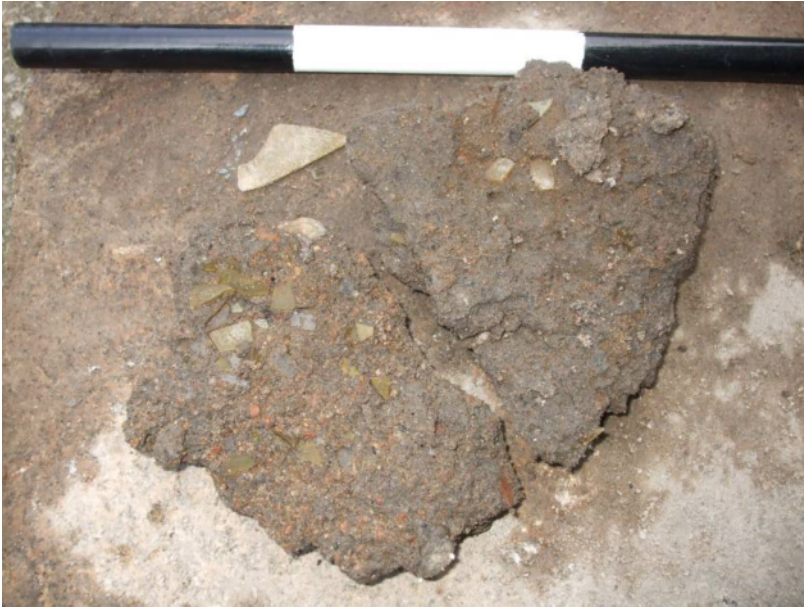
(Ill 29); this may have come from one of the windows of the church demolished in 1768 during the foreshortening of the building.

III 29 detail of scatter of green window glass smashed on cobbled surface AY

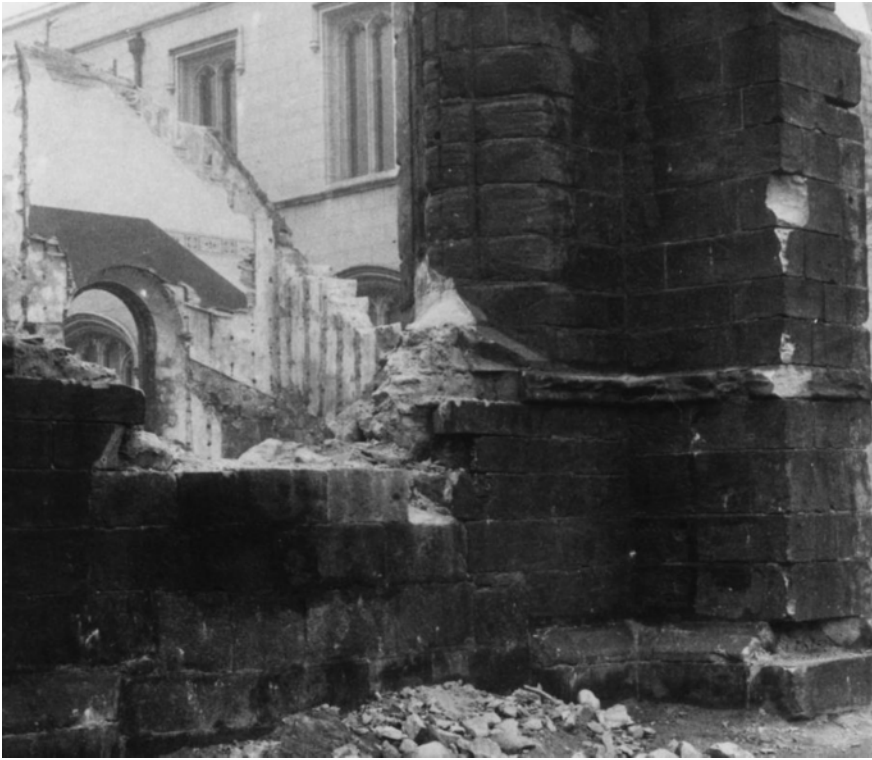
III 31 Demolition of the church (foreground) with the 1768 extension (top left) (Aberdeen City Libraries).

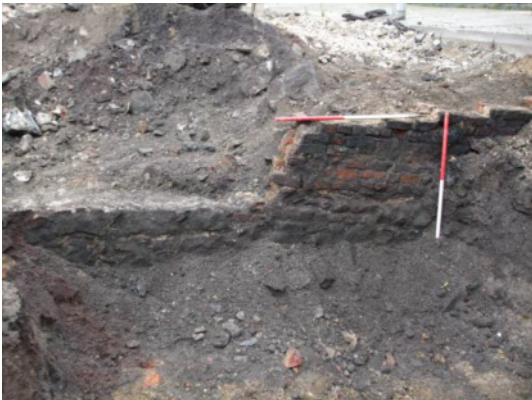
Remains of the tenements (Walls BE, BF and brick floors BF and BG) on the 1867 and 1901 Ordnance Survey maps were found 2.2m below the modern tarmac surface.

III 35 Wall BE facing NW

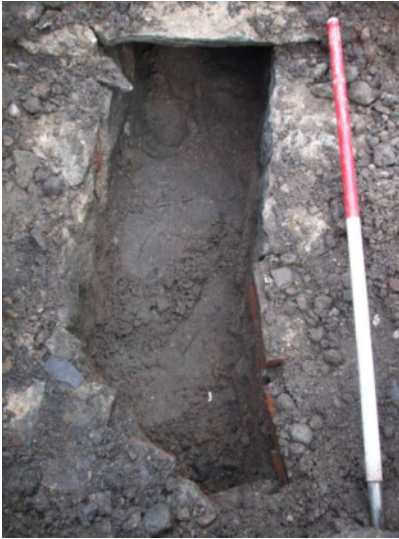
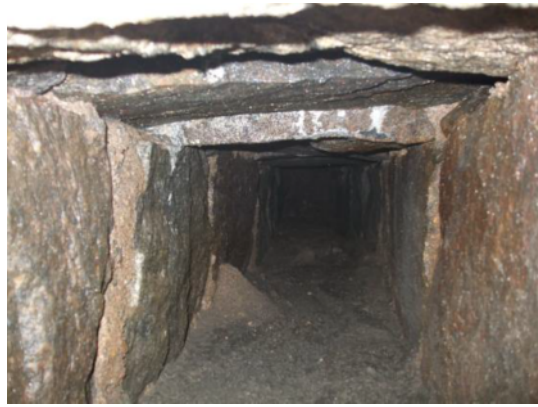
A stone-lined drain (BG) was uncovered and recorded.

III 36 Drain BG, facing S

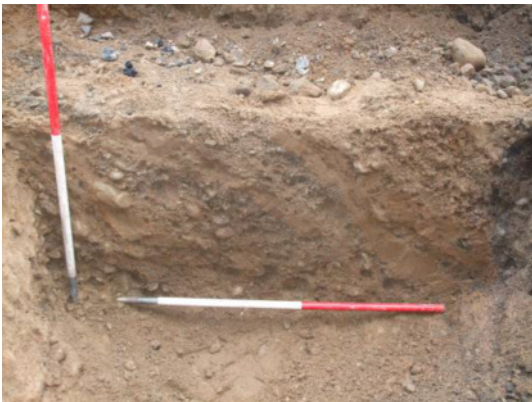
This trench was positioned along the longest axis of the car park to determine levels of natural subsoil. Subsoil was identified c 0.5m down at the north end of this trench and at least two medieval pits/dumps were identified.

III 37 Section through natural subsoils

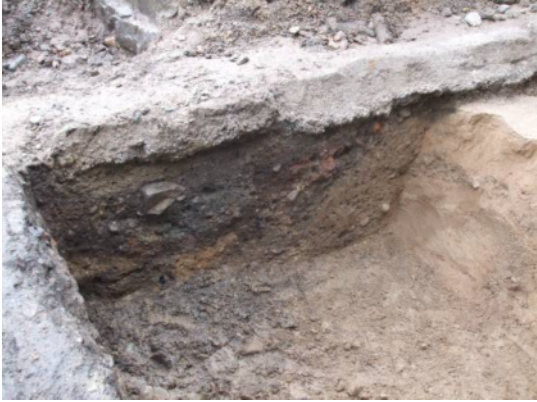
BS was cut through the natural sand and had presumably originally been dug to extract sand. It had been backfilled with layers of clay and daub, demolition material from a medieval structure. The bottom of this pit was not reached.

III 38 Pit BS facing E

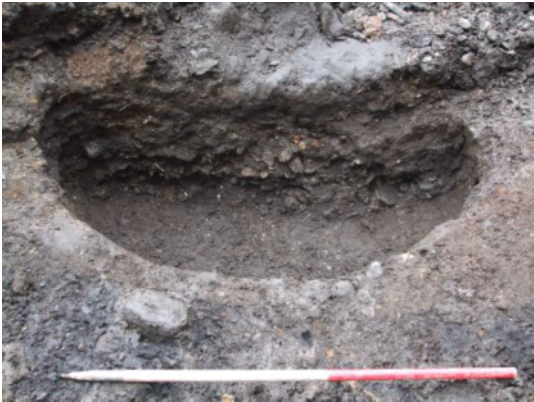
CA was probably a dump rather than a pit. It consisted of small stones, clay, animal bones, ceramic floor tile, stone roof tile and pottery including 15th or 16th-century stoneware. This appeared to have filled a hollow in the natural subsoils and may be filling a natural dip or gully.

III 39 Pit or middle CA facing E

This midden material may represent demolition of a friary building, possibly a kitchen area based on the evidence of the amount of pottery and mammal and fish bone. Material of this type (particularly the ceramic floor tile and stone roof tile) is rare from excavations in Aberdeen: the only notable site producing similar material was the Carmelite friary site in the Green (Stones 1989; Cameron 1994).

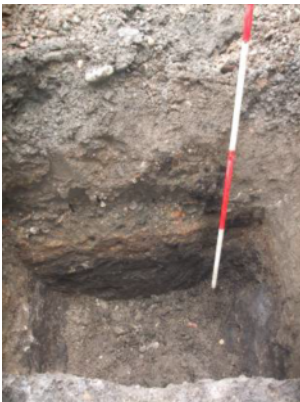
Ill 40 black loam 88 at bottom of trench below CA

A very small portion of this feature was excavated; under it black loam (88) containing twigs, bark and other plant material. Analysis will determine if this is similar material to deposits found at Mealmarket Street and Littlejohn Street. At these sites this material was found to fill a hollow between the high ground of Broad Street/Gallowgate and the rising ground of King Street.

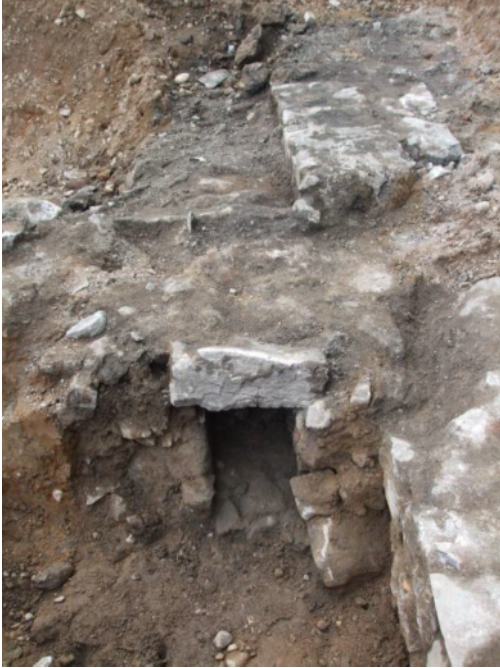
Other features in this trench were late 19th or 20th century in date and included drains (BV, BZ and BQ) and walls BO, BU, BR and BP which are remains of buildings which appear on the 1867 Ordnance Survey map.

Ill 41 Drain BQ with wall BO left, and BR/BP right; facing S

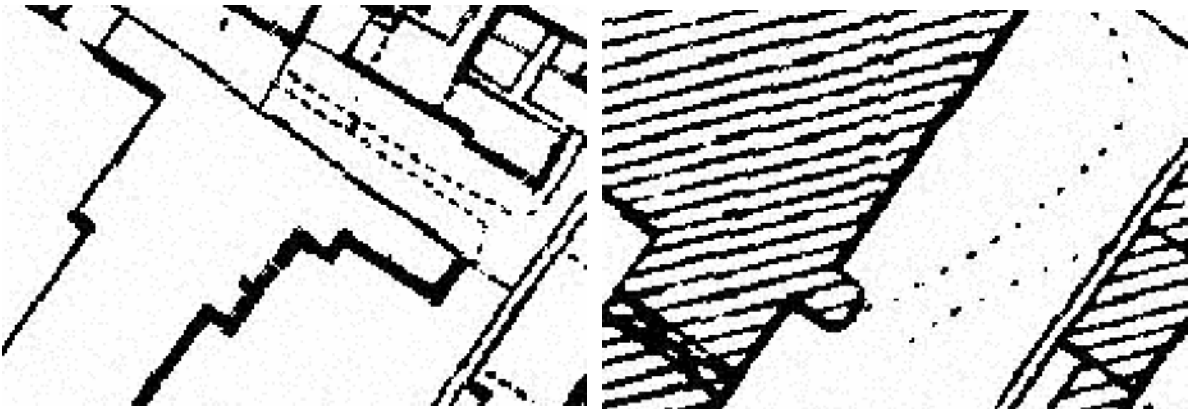
Ill 42 1867 Ordnance Survey map (left) and 1901 (right) showing walls BO and BW, demolished by 1901

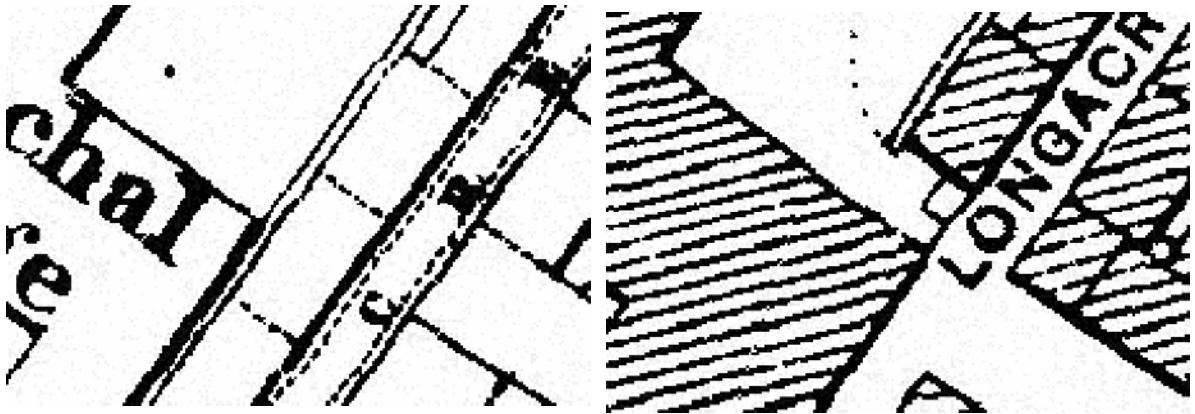
19th-century walls CG, CH and CI are the remains of terraced houses or cottages present on the 1867 Ordnance Survey map but demolished by 1901 to make way for an extension to Marischal College.

Ill 43 1867 Ordnance Survey map (left) and 1901 (right) showing terraced structure (walls CG, CH and CI) standing in 1867 and demolished by 1901 to make way for the extension of the Marischal College building to Longacre
