PETERSEAT, TORRY BATTERY AND ST FITTICK'S CHURCH, ABERDEEN

1 ABSTRACT

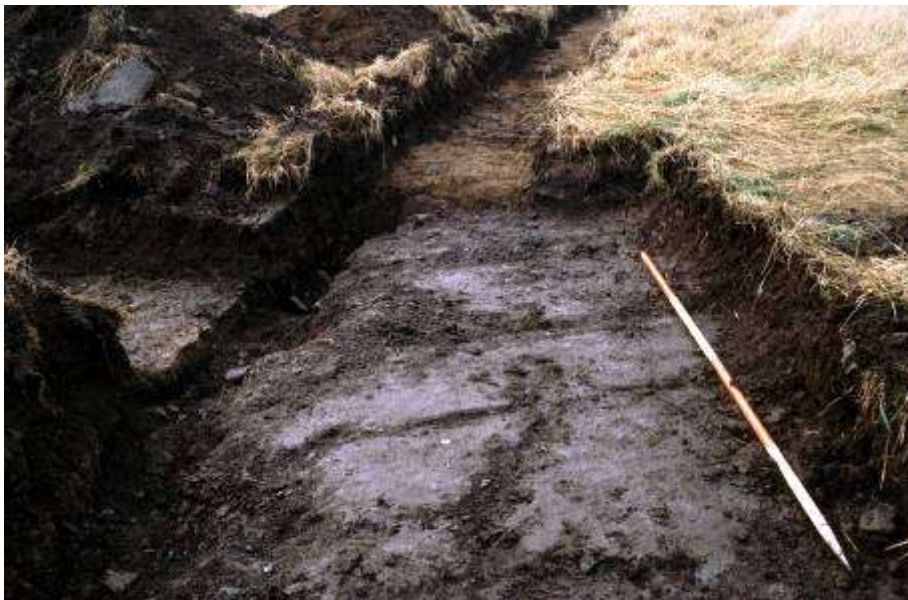
Illus 8 tarmac road surface, AH, scored by later plough marks

From the NW end of hut base AI, the remains of a tarmac road (AH; Illus 8-9) was traced to the north-east corner of the field and across the north edge of the next field. It was then recorded running along the east edge of the next field and down to the field boundary where two huts had functioned as guard posts.

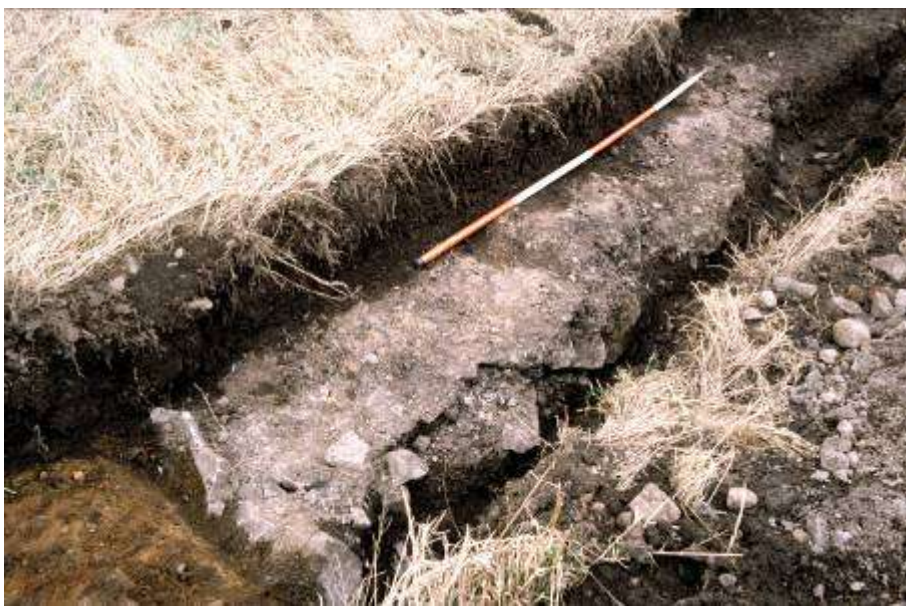
Illus 10 *Surface AK*

A compact pink clay and clinker surface (AK; Illus 10) was recorded but a extant mast did not allow further investigation of this area. Towards its NE end, a pit (BF), 2.6m wide and at

least 1m deep, had been dug to bury metallic waste including painted corrugated iron roofing material, posts and tins and a small amount of 'domestic' rubbish. AK is within the radar netted area and may be the remains of a surface associated with the radar equipment. A well-preserved Battery with radar mounting survives at Blyth
(<http://www.airfieldinformationexchange.org/community/showthread.php?2903-Search-Light-Batteries/page3>)

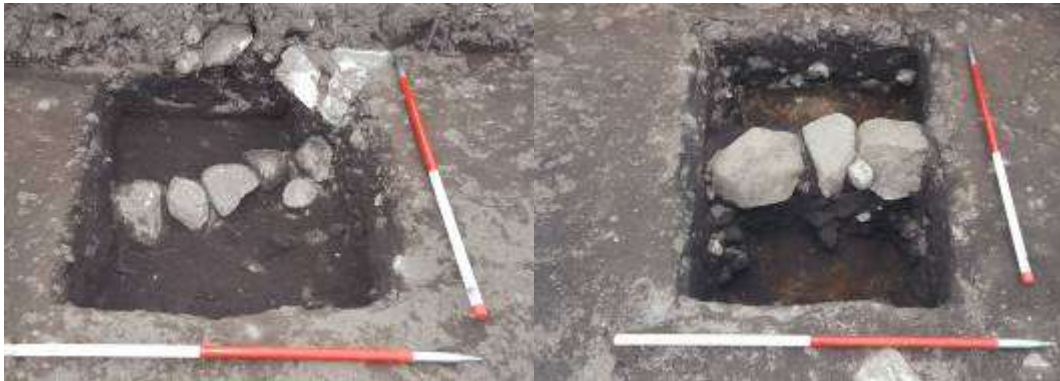
Illus 27 Terracing wall AK under the manse building

that this was a terracing feature to allow cultivation on the slope and discourage the plough soil from eroding through wind and water action (Illus 27, 28).

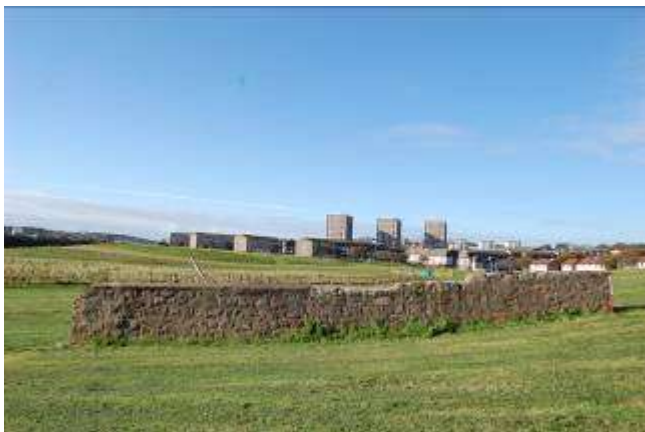
Illus 34 Building 3, Upstanding wall, the east wall, BZ, of the agricultural building facing west

An upstanding wall was thought (from cartographic evidence) to be the east wall of a long farm building. The wall is 14.5m long and 1.6m high (Illus 34) and it contains a blocked doorway close to its SSE end (Illus 34, 35). This range and the manse are both depicted as roofed on the 1st and 2nd editions of the OS 6-inch map (Kincardineshire, 1869, sheet iv and 1902, sheet iii.SE). This building was called ‘The Piggery’ by a local farmer who farmed the surrounding land in the mid 20th century (Alastair Corbett pers comm).

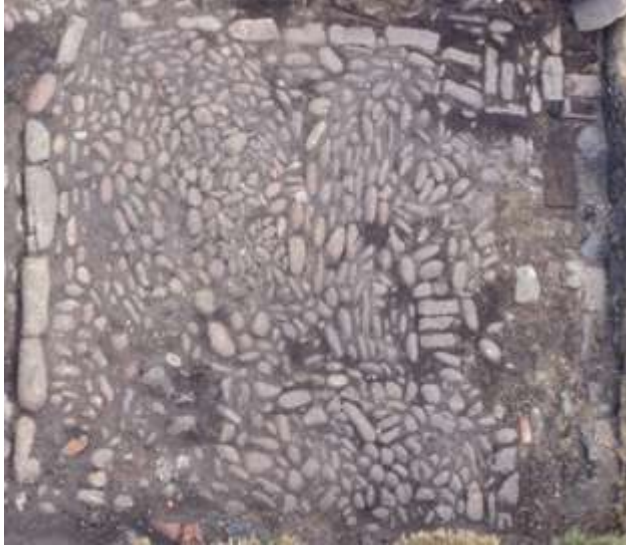
Illus 38 Building 3: Cobbled surface BF showing circular patterns made during laying

South of this was a room with a floor made from water-worn beach pebbles, BF (Illus 38).

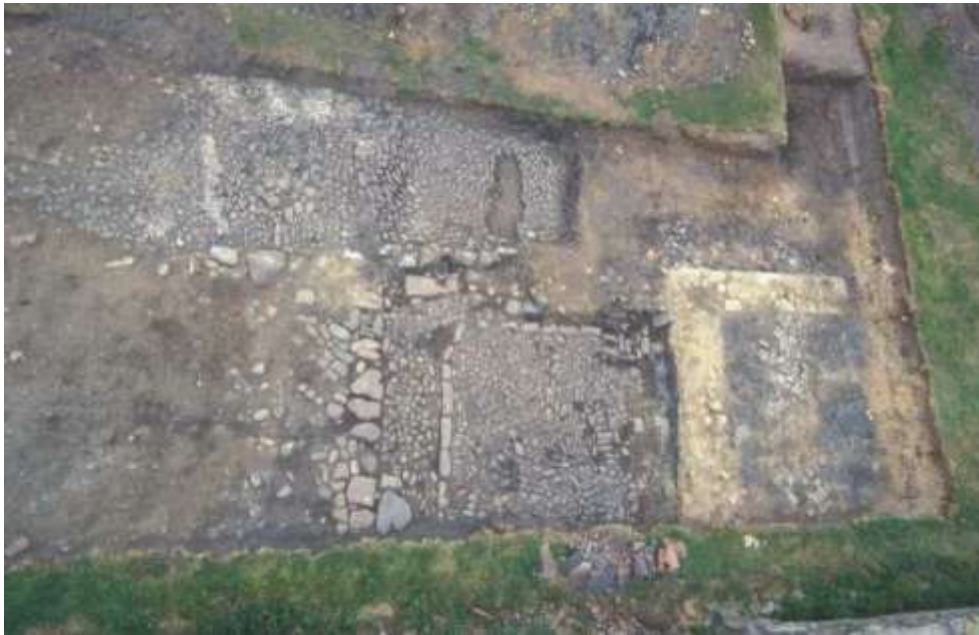
Illus 39 Building 3: The agricultural building or 'piggerie' showing wall BA (right), waterwashed pebble floor BF (left), wall BH (bottom) and exterior cobbles BN (top)

At the south of this trench the topsoil was very shallow and the south end of the building had been completely demolished leaving no traces of flooring or walls. Large amounts of pantile were recovered from this trench indicating that this was the roofing for the building (Illus 37) The building was constructed on a N-S alignment popular with this type of structure as it allows an equal distribution of natural light within the building) (Forsythe 1960: 7).

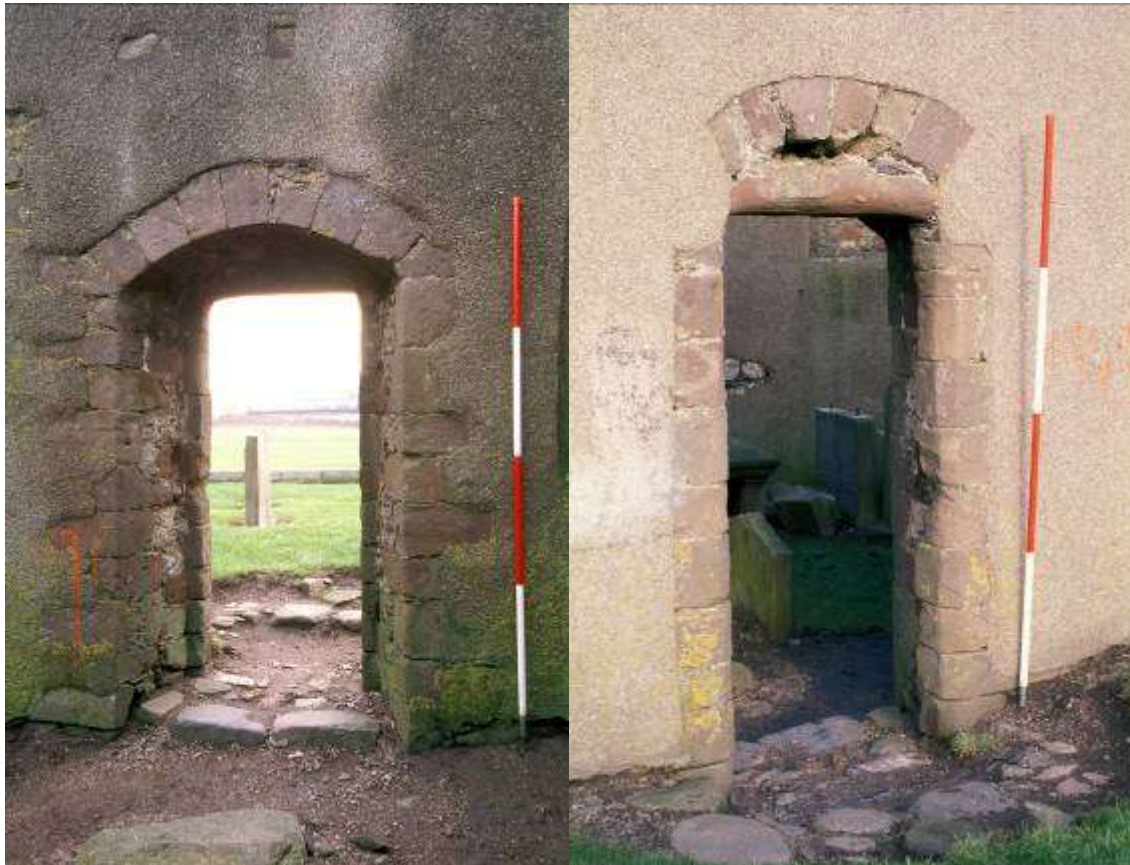
Illus 45 South wall: D1 interior (left) and exterior (right)

D1 (Illus 45, 46) was presumably one of the two principal entrances into the church.

Externally it is a lintelled opening with ashlar jambs, and with a narrow chamfer running around both jambs and lintel; above the lintel is a well-formed segmental relieving-arch that appears to extend through the wall thickness to form the rear-arch. Externally the outer part of the tails of the jamb stones and relieving-arch voussoirs are masked by the cement render, and the junctions of the jambs, lintel and relieving arch are also masked. Internally the embrasure is slightly splayed, and the tails of the quoin stones are left largely exposed, but not the outer parts of the segmental rear-arch voussoirs. There seems no reason to doubt that this doorway is medieval, albeit it is more likely to be of a relatively late medieval date on the evidence of the narrow chamfer and the lintelled head.

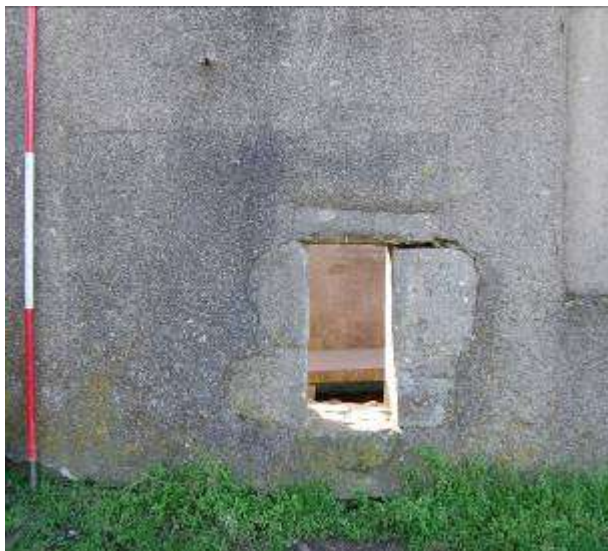
Illus 53 North wall: W4 (centre) with scar of W6, left and infilled window W3, right

W4 and W6 (Illus 50, 52, 53), which are close to the mid-point of the north wall, have to be considered together, since one is set inside the other, though the inter-relationship between the two is now extremely difficult to determine. W6 is expressed both externally and internally as nothing more than a barely discernible rectangular panel. W4 is a small rectangular window inset towards the western side of that panel. Externally it is a small rectangular opening with narrowly chamfered jambs and lintel, that is of only two irregular

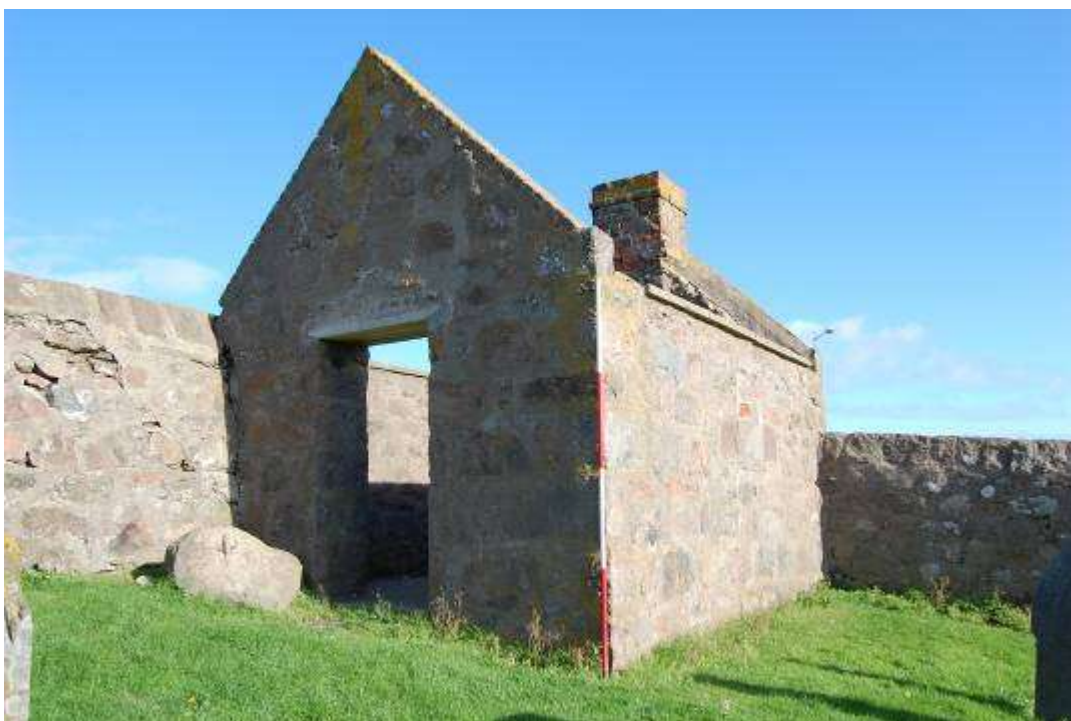
Illus 57 Building 5 from the SW

This structure is granite rubble built and is 7.5m long, 3.5m wide and 2.1m high (Illus 57). It is similar to other watcher's houses in Aberdeen graveyards such as St Fergus, Dyce and St Machar's, Old Aberdeen. It has a small window (now blocked) in the south wall which allows a view of the greater part of the graveyard. It had a fireplace to warm those who kept watch in the winter nights.

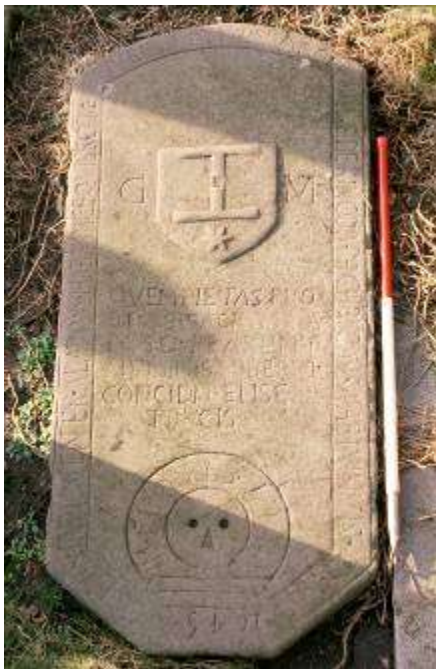
Illus 60 gravestone 176 dated 1645;

The oldest surviving stone dated 1645 reads 'Gviel McMylne, Incola Villae de Kincorth, Chricaus ab inimicis, 16th? 1? 1645 [Occisvs] Innocenter Albore his. in pace quies cit. Ovem pie tas pro. Bitas Sacr ie oe. Dvso Bearvnt Nvinis Hiberni *Concidit ense* trycis'. William Milne who lived at Kincorth and was 'slain...on 10th of July, 1645, ...fell by the sword of a savage Irishman (Jervise 1875: 15). The stone is sandstone and the inscription remarkably well-preserved. It depicts a stylised skull and a possible coat-of-arms.

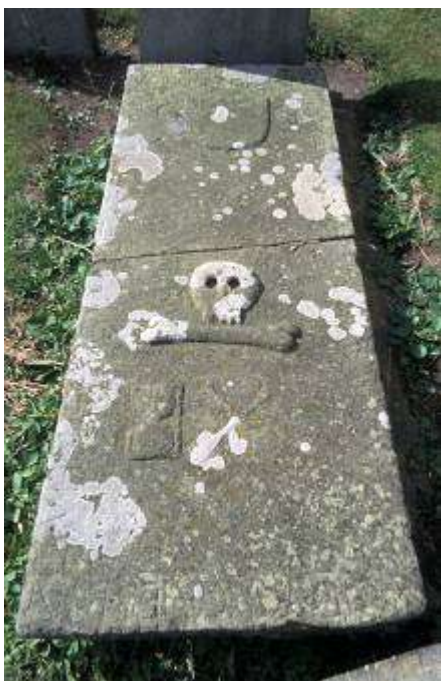
Illus 61 *gravestone 165*

One of the oldest stones (165: Illus 61) is of granite and is now broken in two pieces. It depicts a high relief decoration of a skull and crossbones, hourglass and crossed spades. The inscription reads 'Here lyes an honest man, George Gartli in Lorstown and husband to Agnes Boner, departed this life 19th Nov.1658 aged 49yrs.

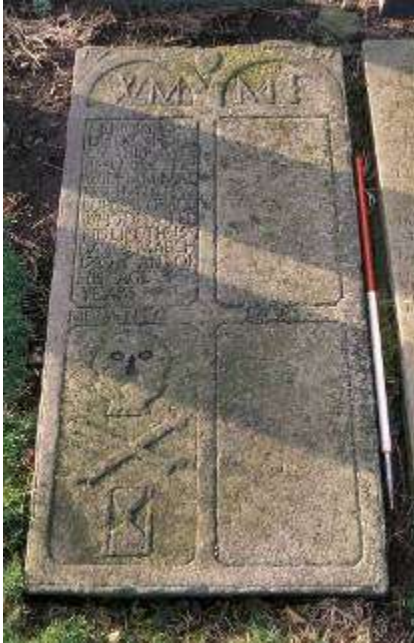
Illus 62 *gravestone 147*

Stone 147 (Illus 62) is sandstone and is inscribed on one half 'W.M. William Marnoh, merchant, Burgess, Aberdeen d. 15th Mar.1706 aged 33yrs'. The other half was prepared presumably for his wife and headed M.F. but no detail has been added suggesting she was buried elsewhere.
