REPORT ON AN ARCHAEOLOGICAL WATCHING BRIEF AT HILLHEAD OF CLINTERTY, BUCKSBURN, ABERDEEN

NGR NJ 8467 1059

19 October 2009

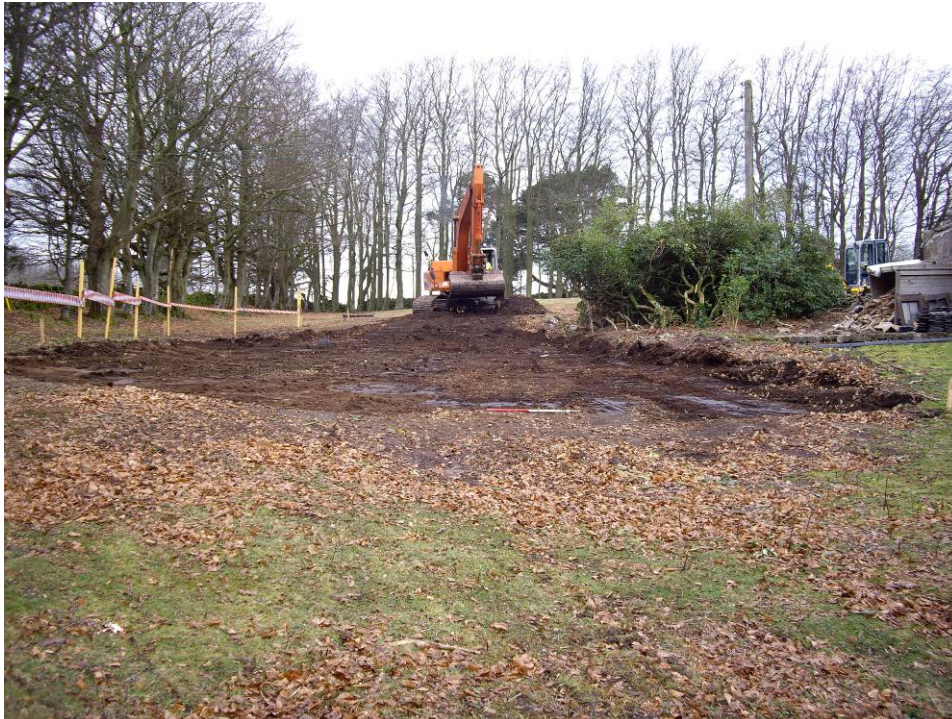
Plate 1: Soil Scrape of workshop footprint area, facing west

- 3.2.1 **Soil Scrape:** the soil scrape was undertaken by an excavator with a toothless ditching bucket, removing up to 0.3m of material from the area due to house the workshop building, the car parking area and the access route. The excavations revealed a loose dark brown topsoil, the depth of which was not reached during the soil scrape. In the westernmost area, more stones and modern debris was observed within the topsoil, including slate, concrete blocks and the metal part of a shovel, indicating use of the area as a dump. No archaeological features or finds were encountered.

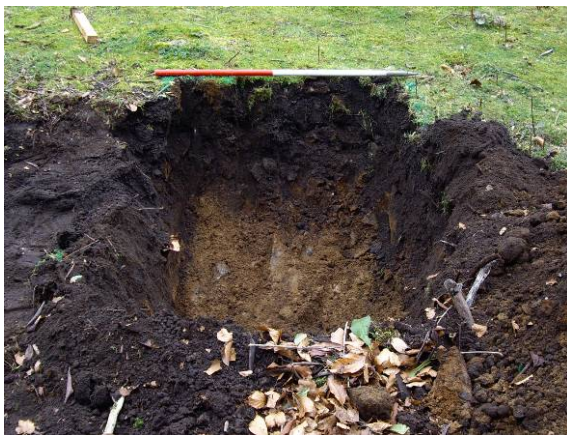
Plate 4: Pit 1 facing north

3.2.3 Each pit revealed a depth of between 0.32m and 0.4m of loose dark brown soil which overlay a pale orange-brown sandy silt (Plates 4-7). This is consistent with a topsoil directly overlying the natural.
