REPORT ON AN ARCHAEOLOGICAL WATCHING BRIEF AT NESS FARM AND TULLOS HILL LANDFILL SITE, NIGG, ABERDEEN

NGR NJ 9559 0355

15 June 2010

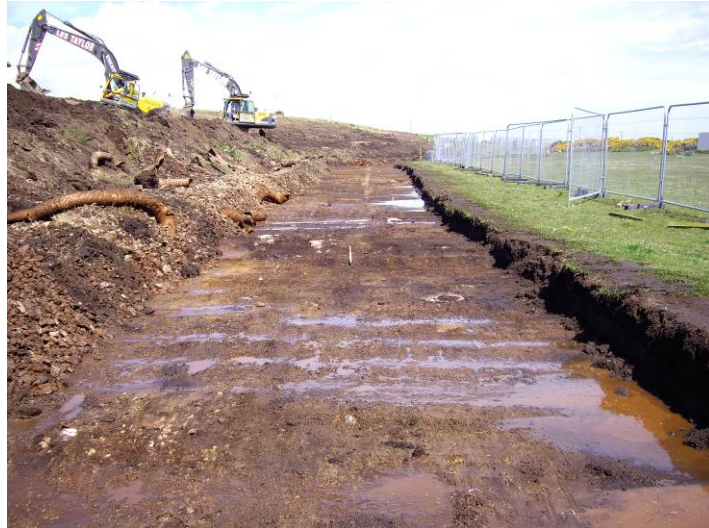
Plate 1: General view of topsoil strip, south-eastern area, facing north-east

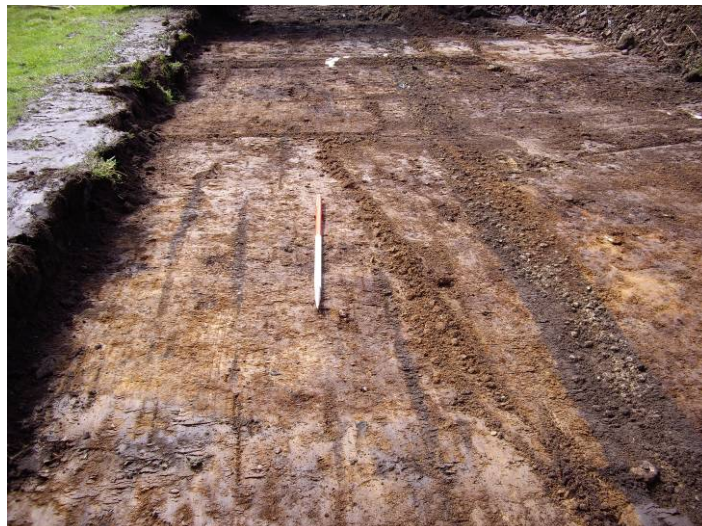
- 3.2.3 A number of features were encountered during the topsoil strip for the drainage gully, including modern plastic orange drainpipes and associated gravel backfill which ran the inner length of the excavated area, with an offshoot that ran centrally north to south along the initial north-south aligned section of the drainage gully. Of greater antiquity were four features (Features 1-4; Appendix 2), the locations of which are illustrated in Figure 2. These consisted of 2 probable sets of cultivation marks (Features 1 and 2). The first set (Feature 1; Plate 2) was roughly on a north-east to south-west alignment, each mark being 0.05m in width, the eastern two being 0.37m apart with the western one 0.74m beyond. The two eastern marks covered a distance of 1.2m, whereas the western one was 2m in length. A pottery sherd, white ceramic, was retrieved from the easternmost mark (Find 1).

Plate 2: View of Feature 1 to left, and modern drain to right, facing south-west

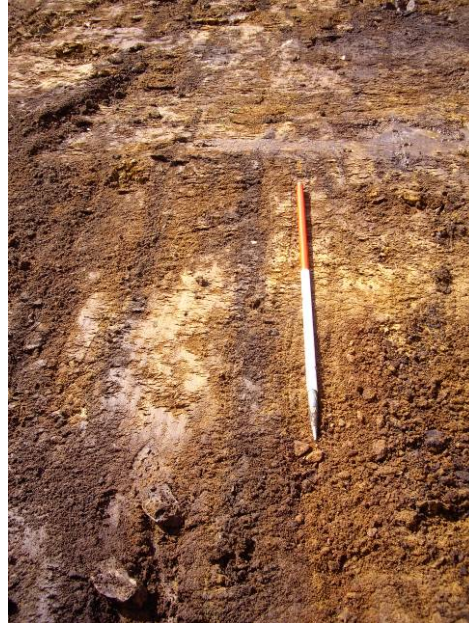
(Feature 2; Plate 3). It consisted of 2 marks, 0.37m apart, of 0.05m width and 1.2m length. A small pottery fragment was observed within the southernmost mark, again of white ceramic, but with blue patterning. The cultivation mark locations are indicated on Figure 2.

Plate 3: Feature 2, facing north-west

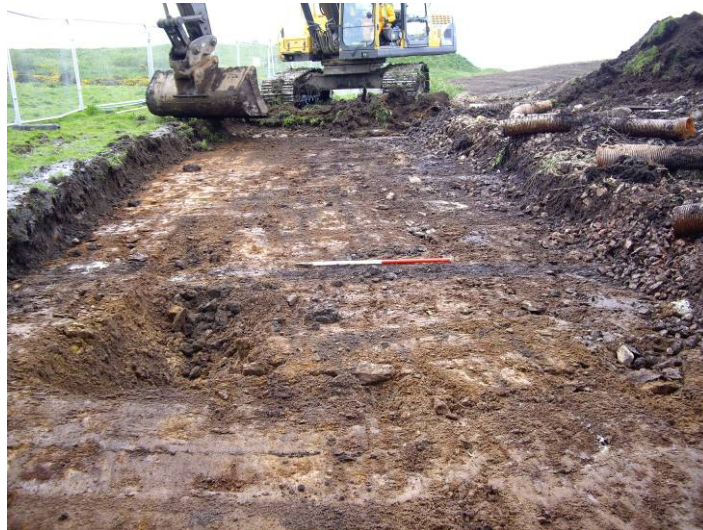
Plate 4: Feature 3 facing north-west

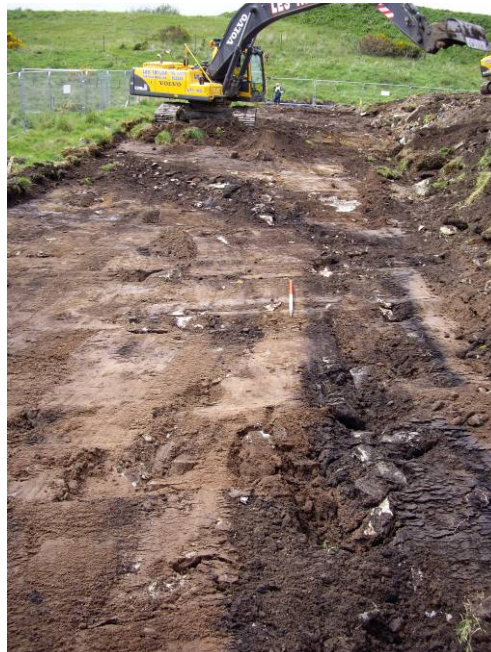
Plate 5: Feature 4, facing north-west

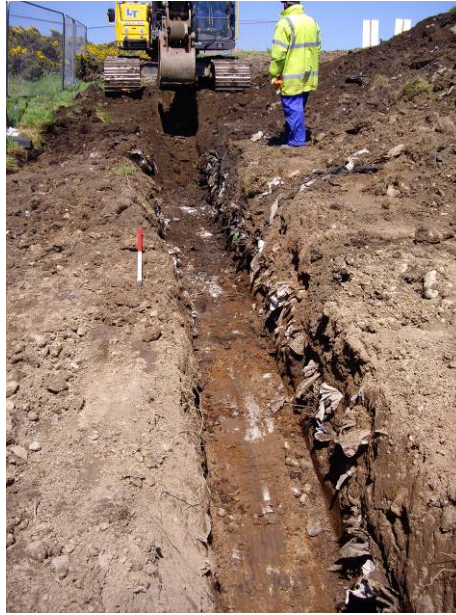
- 3.2.6 The stripping of topsoil for leachate protection drainage systems was extended from the western extent of the 4m width area, to the north-east, adjacent to the boundary and outside the landfill area, towards Crab's Cairn. This extension was a maximum of 0.8m wide and 1.0m deep. This revealed a dark brown topsoil which varied between 0.1m depth at the south, and 0.8m at the north. This overlay a loose orange sandy natural, with up to 30% large boulder and stone fragment (up to 1.6m diameter) inclusions (Plate 6). No archaeological features were revealed within this extension, which did not impact on the Crab's Cairn Scheduled Monument exclusion zone, of which it stopped 20m to the south.

Plate 6: General view of topsoil strip extension, facing north

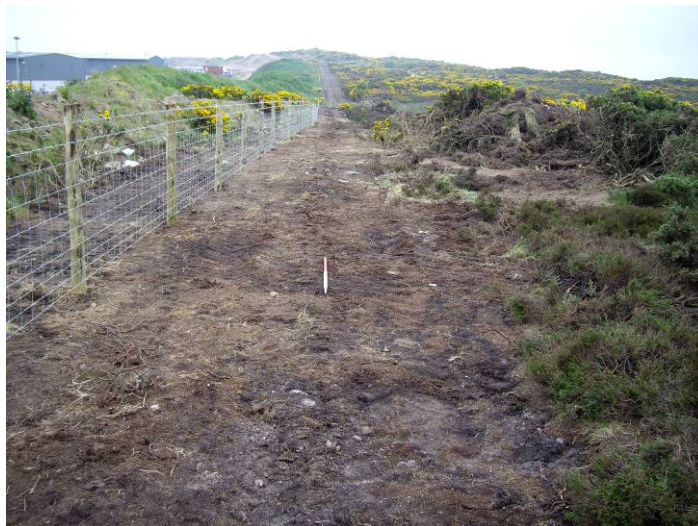
- 3.2.7 **Stripping of area along southern boundary between Crab's Cairn and Baron's Cairn:** the southern boundary of the site, between Crab's Cairn and Baron's cairn, avoiding works within the scheduled monument's exclusion zones, was stripped of undergrowth to provide a level platform of an area 4m in width for stock-proof fencing to line the boundary (Figure 4; Plate 7). First Edition Ordnance Survey Mapping of 1867 (Figure 2) indicates a boundary along this line, demarcating the agricultural fields to the south from the more scrubby hinterland to the north. The map shows that this boundary did not extend into the easternmost part at Crab's Cairn.

Plate 7: General view of strip, facing west

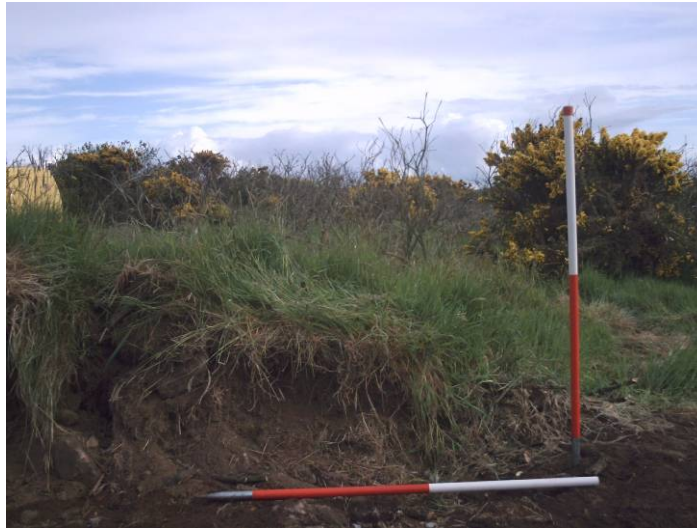
- 3.2.8 One possible feature (Feature 30) was cut through during these operations. This was a mound, 3m in diameter and surviving to a maximum height of 0.6m

at its centre (Plate 8). This appeared to be a natural feature and as such was of little archaeological interest.

Plate 8: Section through Feature 30, facing north

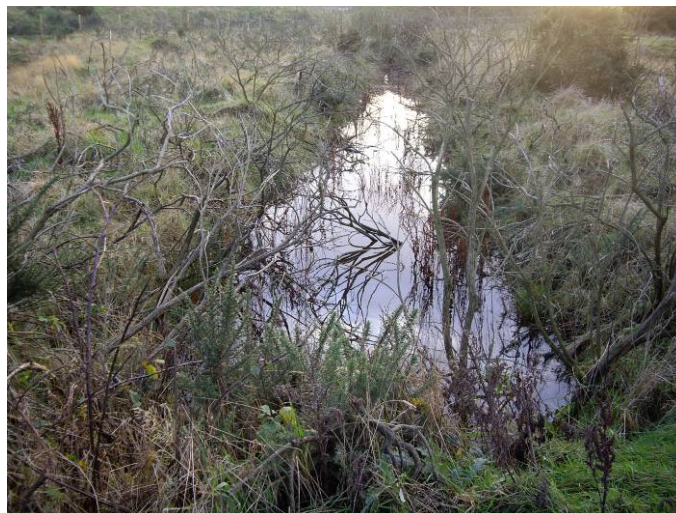
- 3.2.9 Two further features, Feature 33 (Plate 9) and Feature 34 (shown in Figure 5) appeared to be related, the latter representing the upcast for ditch Feature 33. The ditch (Feature 33) was 1m in width and was observed during two different operations on the site, across a distance of at least 180m. It could originate from agricultural improvements, providing drainage from Tullos Hill to provide water to the adjacent farmland to the south.

Plate 9: Feature 33, facing south

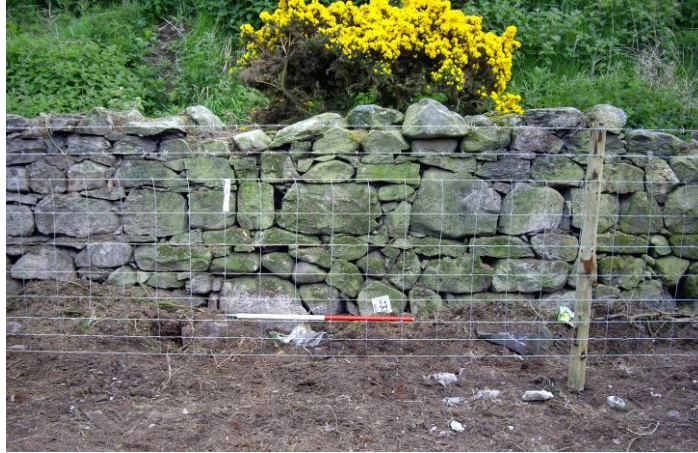
- 3.2.10 The removal of the gorse also revealed more of the boundary wall, or dry stone dyke observed across the southern boundary of the site (Feature 5). Clearly, parts had been robbed or obscured where adjoining developments had utilised the boundary area for spoil dumping. In some places the wall formed a fine 5 or 6 coarse high rubble built boundary (Plate 10). Unfortunately the erection of the stock-proof fencing, some 1m to the north of the boundary,

has made the wall more vulnerable to robbing, and some workers from an adjoining development were observed removing stone from the wall. Several general photographs were taken of the wall, once the fence was erected, to record the structure as-was. Figure 6 shows a detailed section of the wall.

Plate 10: Central portion of Feature 5, facing south

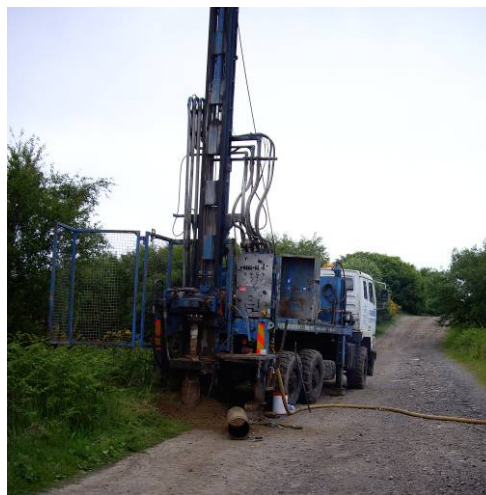
3.2.11 **Gas monitoring drill holes:** drilling activities were monitored in the vicinity of the central part of the northern boundary to the south of the Refuse Disposal Plant (Figure 7). A total of three drill points were augered in this area, 0.3m in diameter to a depth of 17m. Cylindrical metal segments were drilled into the ground with a drill hammer, reducing the matter to a ground-up, loose, mid-brown soil (Plate 11). As the cylindrical metal segments were left in place, to aid future monitoring, no assessment of archaeological potential was possible. Other drilling operations across the site occurred in areas of known landfill, and thus did not require archaeological supervision.

Plate 11: General view of eastern gas monitoring drill hole, facing north-east

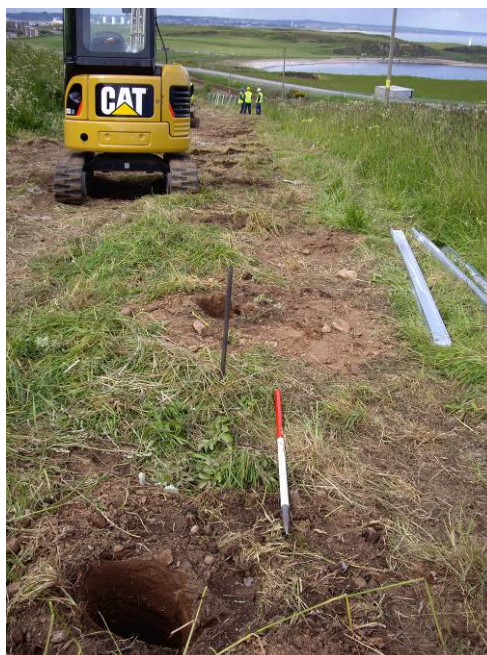
the Ness Farm landfill area (Figure 8). This began, to the north, at the existing bridge over the railway, southwards, and required an initial removal of undergrowth and levelling of an area 3m in width. Any existing wire and post fencing was removed during these operations. The area extended along the eastern boundary southwards to the road, where it took a 90 degree turn to the west and covered the area to the north of the existing attenuation pond or reservoir, and finished where it met the main entrance access track. Parts of this area were scraped clean with a toothless bladed ditching bucket, where a maximum of 0.05m of grass and topsoil was removed (Plate 12). No archaeology was encountered during these operations.

Plate 12: General view showing excavated fence post holes within area of fenceline clearance, facing north-east

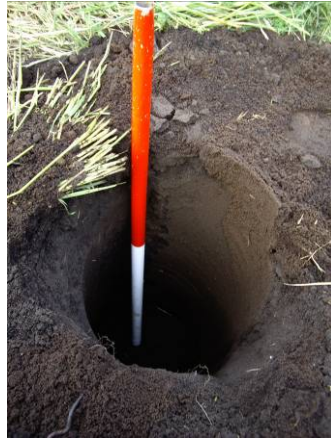
3.2.13 Following the fenceline clearance, teams of sub-contracting fencers were drafted in to erect the palisade fencing along the eastern boundary of the Ness Farm landfill area. This required the excavation of fence post holes 2.8m apart, across the entirety of the cleared area. The majority of these were excavated by auger, attached to a mini digger, in which case the fence post holes were 0.25m in diameter, and excavated to a maximum depth of 0.8m (Plate 13). Where stones or other hard material made auguring impossible, the fence post holes were excavated by a toothless bladed ditching bucket, sometimes by a JCB, where the holes were 2.0m by 1.0m to a depth of 0.8m, or by mini digger, where the holes were 1.4m by 0.4m to a depth of 0.8m. A total of 339 fence post holes were monitored within the eastern boundary. In places, the topsoil extended to a depth of at least 0.8m, particularly in the northern areas where it was a dark brown loose soil with plastic and rubbish inclusions. The majority of the fence post holes revealed a topsoil depth of c. 0.18m to 0.30m, overlaying an orange loose sandy natural, though this became more claylike in the southern area. No features of archaeological interest were encountered during the fenceline operations at the eastern boundary of Ness Farm landfill area.

Plate 13: Example of a fence post hole excavated by augur, facing east

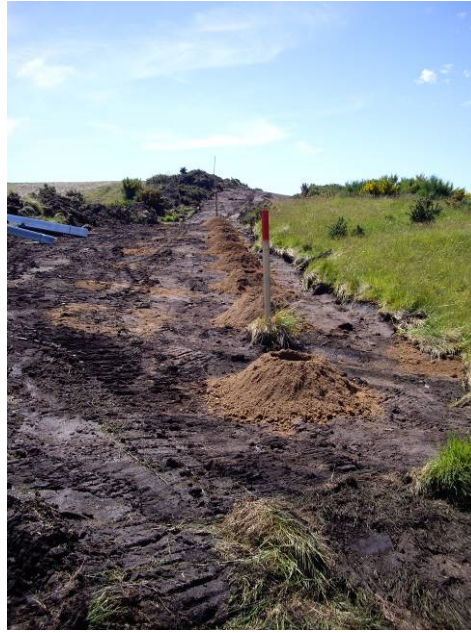
- 3.2.15 A similar programme of fence post hole excavation ensued, 2.8m apart, across the entirety of the cleared area (Plate 14). A total of 202 fence post holes were excavated, preference given to auguring, 0.35m in width and 0.8m in depth, although excavation by mini digger with a toothless bladed ditching bucket was sometimes necessary, making the fence post holes 1.4m by 0.4m to a depth of 0.8m (Plate 15). The dark brown loose topsoil varied from 0.05m in depth to 0.25m, relating to the natural undulations of the ground. This overlay a soft pinkish orange sandy natural.

Plate 14: General view showing excavated fence post holes by auguring within area of fenceline clearance, facing north-west

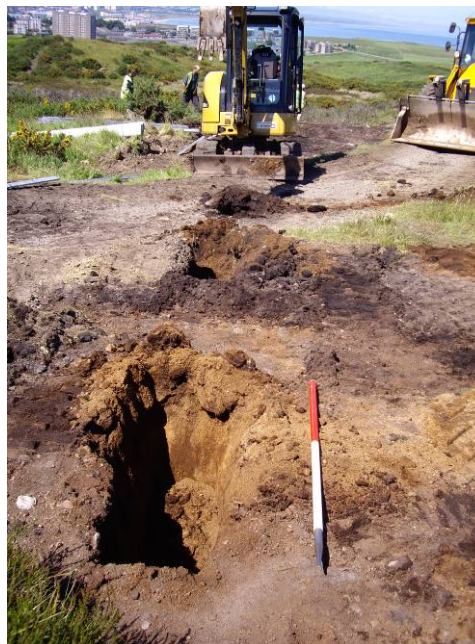
Plate 15: General view showing excavated post holes by bucket on mini-digger, facing north

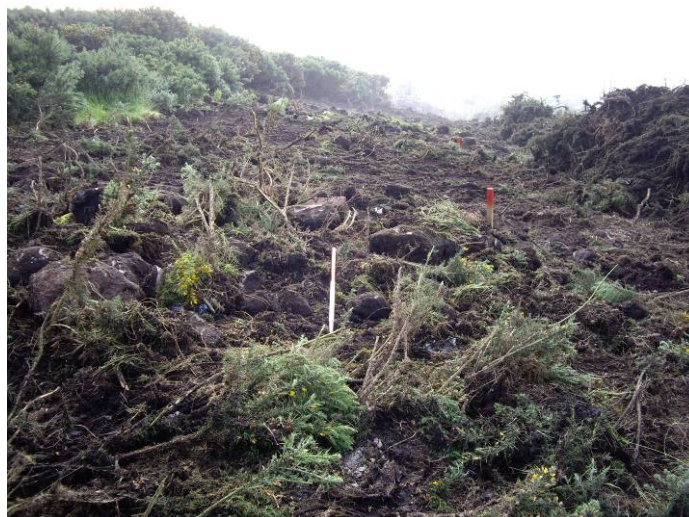
- 3.2.16 A survey of the hill was carried out in 2004 by CFA Archaeology . The survey revealed a concentration of known archaeological features in the eastern part of the Conservation area, of which the fenceline skirted just to the east (Figure 9). A small spread of stones, between 20 and 30 in total, ranging from between 0.2m and 0.6m in diameter, covering an area of 4.8m north to south, and 4.4m east to west was encountered in the northern north-west to south-east aligned stretch (Feature 11; Figure 9; Plate 16). This was in the line of fencing, which could not be altered, so was removed under archaeological supervision. The eastern side was removed first, revealing blue plastic and tin cans, suggesting

this was a modern dump of stones, perhaps deposited when the adjacent road was constructed.

Plate 16: Feature 11, prior to removal, facing north-west

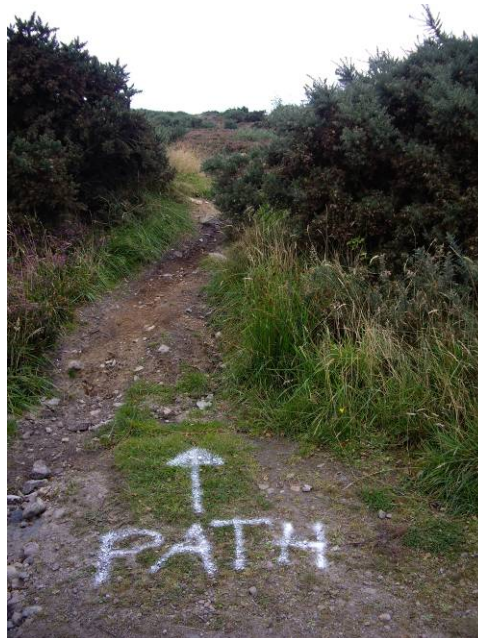
- 3.2.20 The provision for the new pedestrian access track was monitored on 28th September 2009 and involved the clearance of gorse and topsoil across the length of the new track, a width of 2m and a distance of approximately 450m. Figure 11 shows the location of this track. No archaeological finds or features were encountered along this route, which followed where possible, an existing informal trackway, meaning that archaeological features in the area were not unnecessarily disturbed (Plate 17).

Plate 17: Route of new access track, following pre-existing informal trackway, facing east

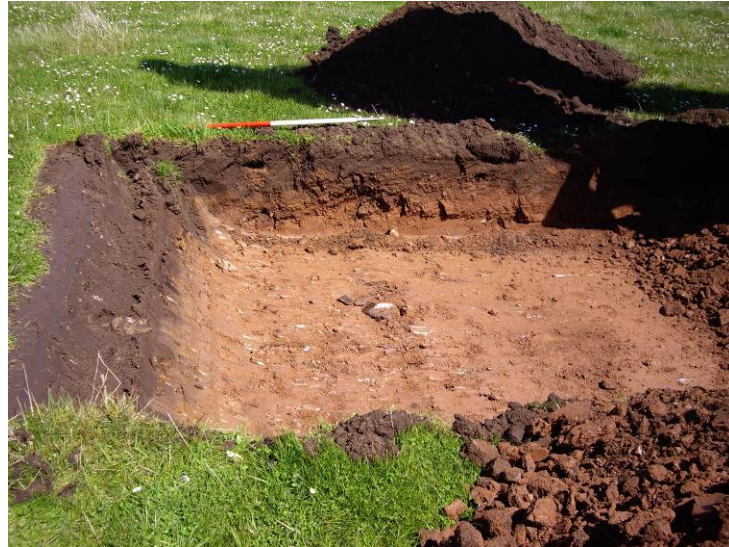
Plate 18: Test Pit 5 upon excavation, facing north

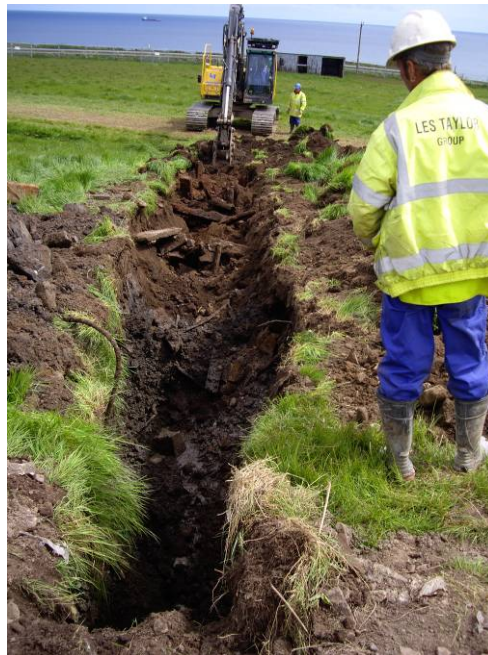
Plate 19: Test Pit 10 under excavation, facing south-east

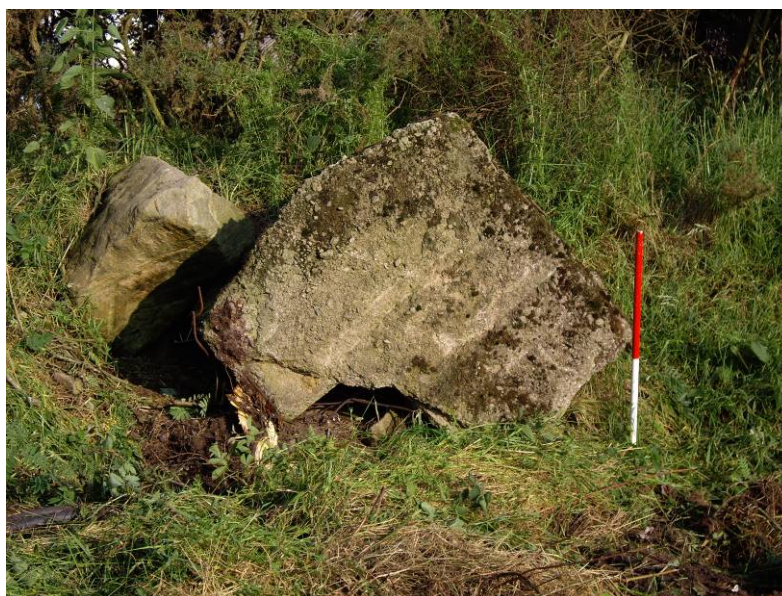
3.2.23 **Clearance for north gas venting trench:** this occurred just to the south, and east of the fenceline clearance along the northern central boundary of the site (Figure 13). It began with an initial tree clearance by toothed ditching bucket, followed by a more systematic clearance of the area due to be excavated for the north gas venting trench. A concrete block, 3m by 3m and 3m in height/depth was located by the north-eastern boundary of the location of the north gas venting trench, with wire protruding (Feature 12; Plate 20). This suggests the presence of a structure that once stood in the vicinity, and indicates a mid 20th century date. It could also represent a waste deposit, dumped on the site at some point since the mid-20th century.

Plate 20: Feature 12, facing north-west

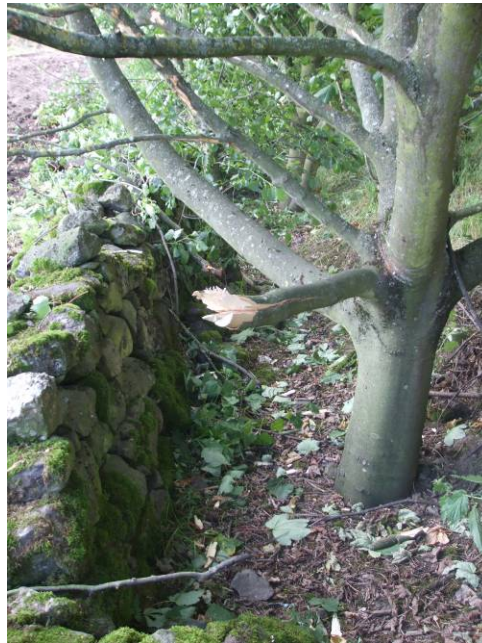
Plate 21: Feature 50, with Feature 51 on the left, facing south-east

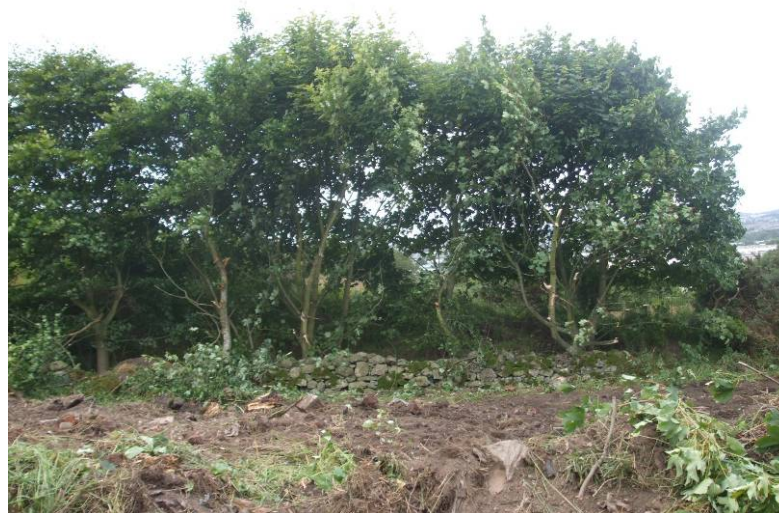
Plate 22: Feature 51, facing south-west

west arms running adjacent to the site's boundary wall (Feature 51). A rich mid-dark brown loose loam topsoil was encountered, ranging between 0.45m deep (at the northern extent) and 0.25m deep (at the southern extent), overlay a mid-orange loose sand with occasional (less than 15%) boulder inclusions (varying between 0.1 and 0.7m diameter). The eastern part of the south-west arm was brought closer to the boundary wall (2m to the south of it), in order to avoid the landfill encountered during the clearance of the area, giving the 'v' a kink (Figure 13). Where the kink was (25m west of the eastern extent), a red brick-built structure was observed in the north-facing section of the north gas venting trench (Feature 52; Plate 23). It consisted of bricks laid in stretcher bond formation, 10 courses high (0.8m) and 0.65m wide, the topmost course visible was 0.15m below the ground surface. A ceramic pipe was observed either side (east and west), protruding from the brick built structure, which measured 0.22m in diameter. This suggested that the feature represented an access chamber relating to a drainage or waste system. This might further suggest the survival of related buildings which the services served, in the vicinity. Aerial Photographs of the site in 1947 show some buildings nearby (Figure 3), to the south of the north gas venting trench area.

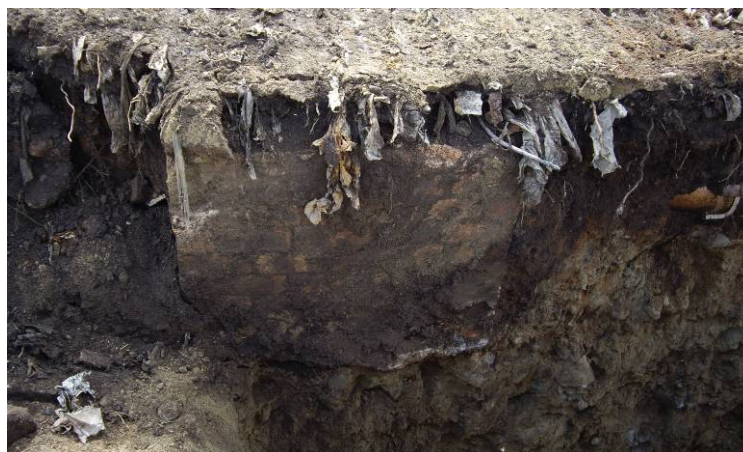
Plate 23 Feature 52, facing south

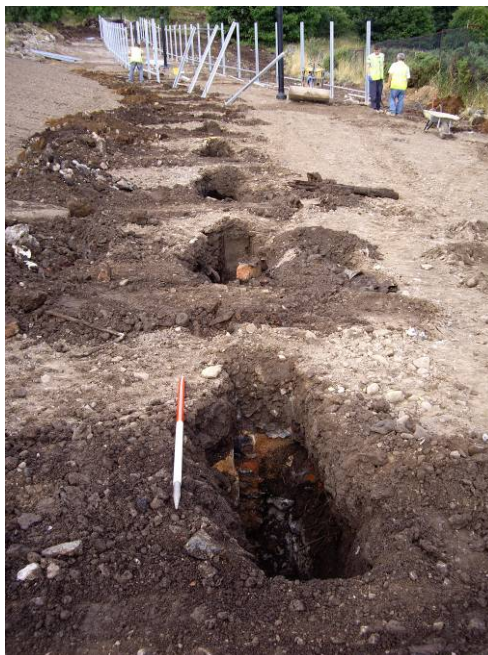
embedded), timber, ceramic drain and lead pipe fragments. This was observed in a sequence of seven fence post holes (Figure 13).

Plate 24: Feature 56, facing south-west

- 3.2.27 The structural debris, Feature 56, may relate to a pre-existing structure in the vicinity, perhaps partially damaged by landfill related operations in the area. It could be that some archaeological evidence for such structures, seen in Aerial Photographs of the site in 1947 (Figure 3), could survive *in-situ*, sub-surface in the vicinity.

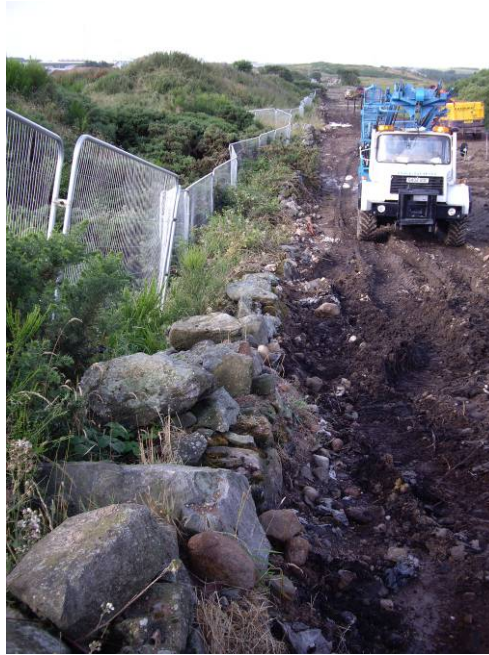
- 3.2.29 Initially, the clearance revealed the north-west face of Feature 22, a dry stone dyke known from Ordnance Survey mapping to exist in the area. It was revealed across the 770m distance of the clearance, though less well preserved in some areas than others (Plate 25). The average width of the wall was 0.4m. It survives as a good example of boundary dry stone dykes, and is comparable to Features 5, 51 and 57.

Plate 25: Western part of Feature 22 facing south-west

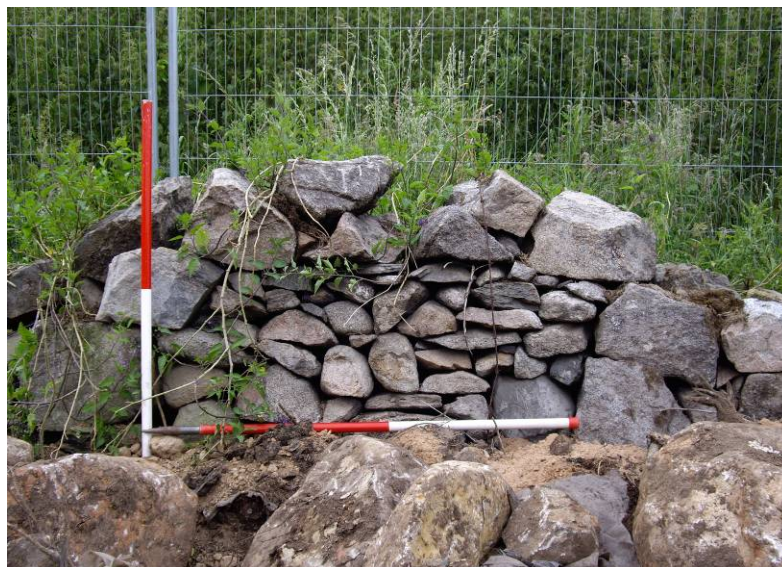
3.2.30 Of additional interest, was the appearance of a blocked thoroughfare (Feature 35) in the dry stone dyke (Feature 22) within the north-eastern part of the clearance area (Figure 15). This was discernible by a row of large stones, akin to quoin stones in appearance, 1.2m apart, and separated by a jumble of smaller stones within (Plate 26). This suggests that there was once an access routeway through the wall at this point, although the poor state of preservation of the wall in this area makes it difficult to ascertain whether the thoroughfare was an original feature, contemporary with the wall's erection, or a later alteration. Clearly there was a need at some period for access to be prevented at this point, perhaps when the area was used as a tip in the 1970s.

Plate 26: Feature 35 facing south-east

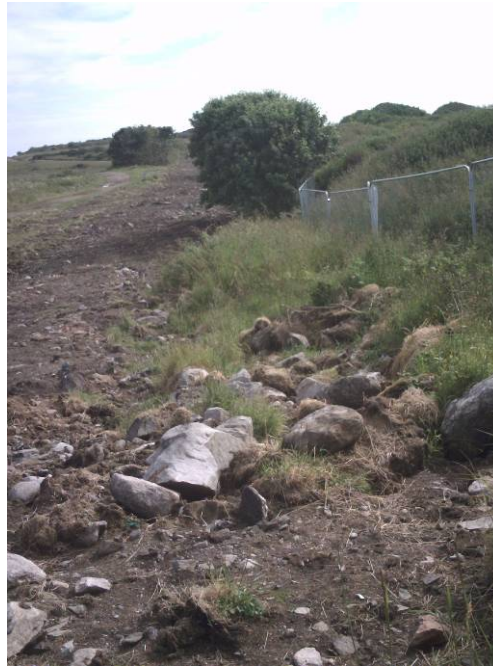
- 3.2.31 A consumption dyke, known from the Aberdeen Sites and Monuments Record to exist in the vicinity, was observed towards the western part of the clearance area (Feature 23). This was much tumbled and has not survived well (Plate 27). Parts are obscured by undergrowth, but it appears to consist of just one or two courses of large boulders, running along the boundary of the development site. It has remained unaffected by the development.

Plate 27: Feature 23 facing north-east

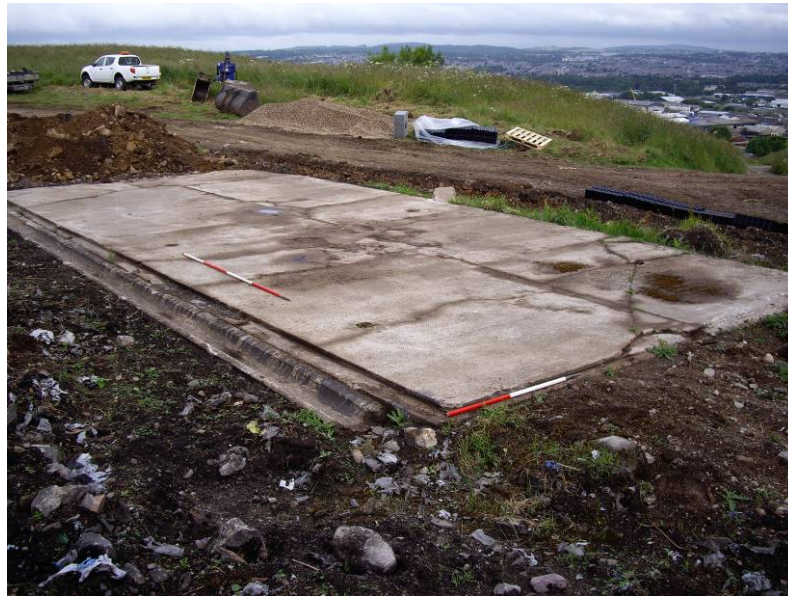
- 3.2.32 Further features which related to 20th century usage of the site, were revealed by the clearance for the south gas venting trench; the archaeological remains survived to a good level of preservation. The easternmost of these features was a rectangular concrete platform, a floor and foundation for a hut-base (Feature 6) on a north-east to south-west alignment, measuring 11.2m in length and 5.1m in width (Plate 28). A U-shaped trough-like feature ran the length of the feature on the southern edge. Four circular indentations were observed within the eastern half of the feature as well as two bolts (Figure 16). This feature has been exposed for some time.

Plate 28: Feature 6 facing west

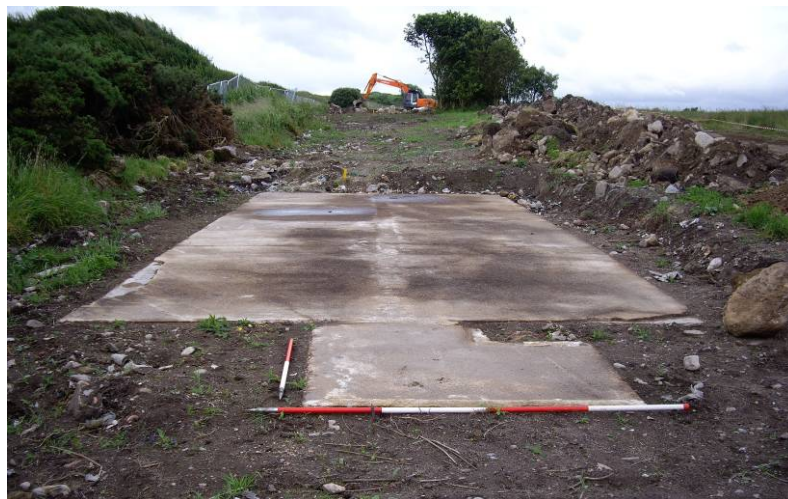
3.3.33 A similar feature was located some 50m to the south-west of Feature 6, this one with an L-shaped extension on the north-eastern edge (Feature 29; Plate 29). The rectangular part measured 10.95m in length and 4.8m in width. As the landfill was exposed just to the north-west of the feature, it was left revealed, rather than exposed to any depth, so any drain feature seen at Feature 6 would remain sub-surface if surviving. This feature is the base and foundation for a wooden or Nissen-style hut, and the L-shaped extension may relate to an entrance porchway.

Plate 29: Feature 29 facing south-west

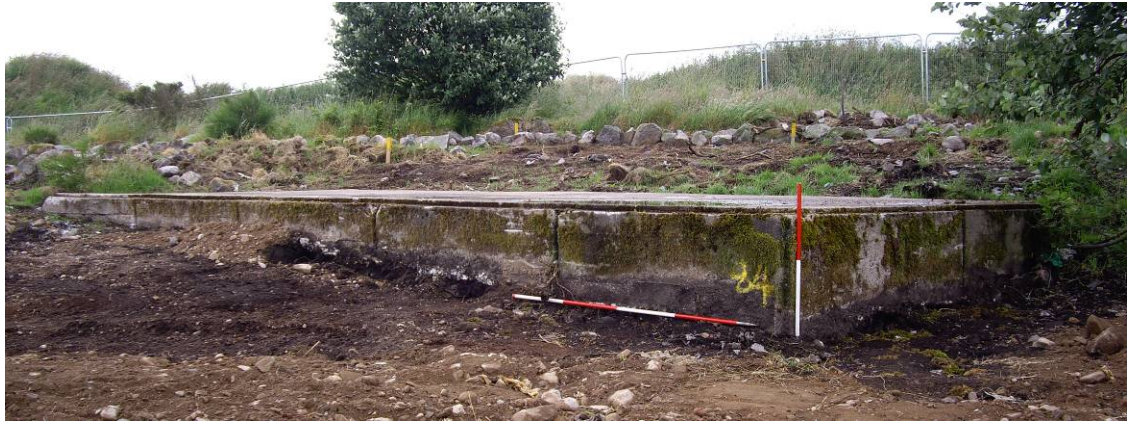
concrete surface 0.1m thick adhering to the top of the blocks, to create a floor (Plate 30). The ground must then have been built up on the southern side, so that the abutting drain slotted into place, as a separately constructed feature which did not seem to have the 0.9m depth of the rest of the structure (Plate 31). This structure had been exposed for some time, although not, until now, subjected to archaeological recording.

Plate 30: Feature 7 facing south-east

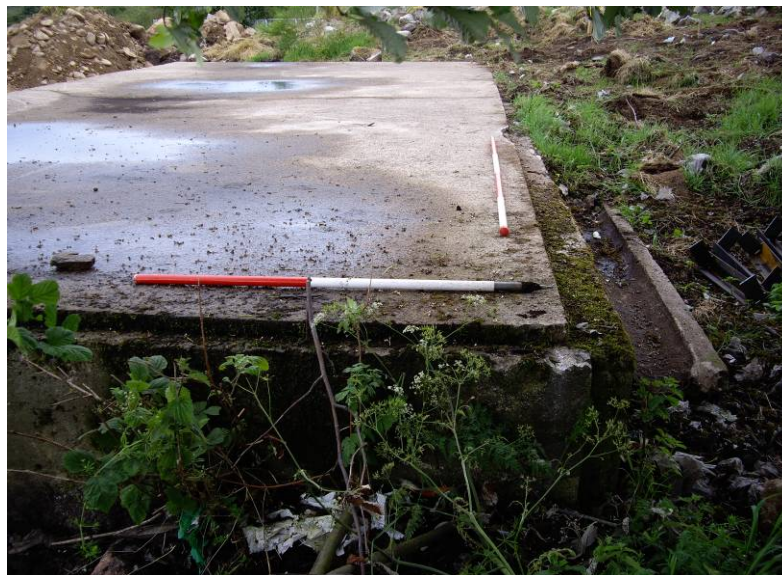
Plate 31: Detail of south-west corner of Feature 7 facing east

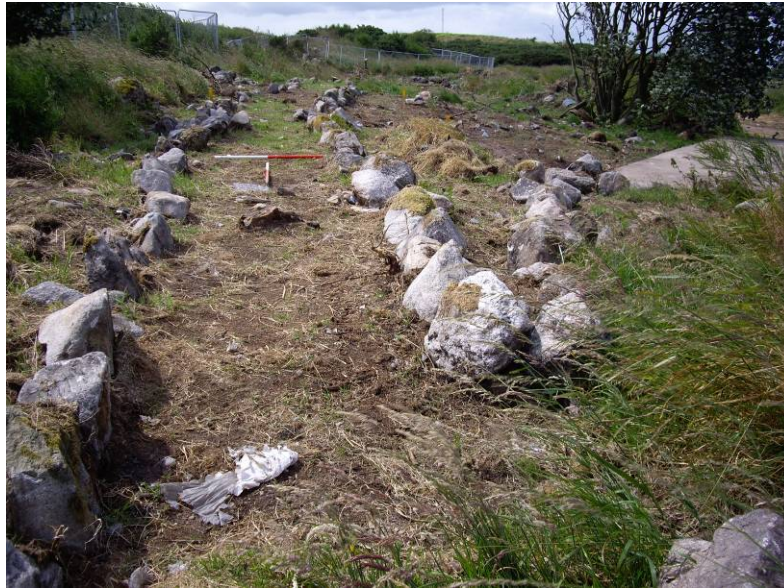
Plate 32: Junction of Features 9 (left) and 10 (right), facing south-west

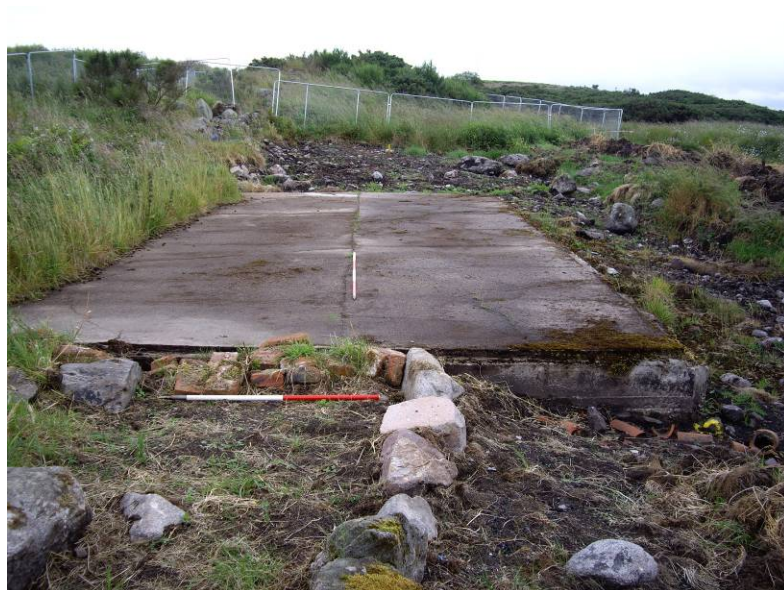
3.2.36 The westernmost end of Feature 9 ends at a further concrete platform feature (Feature 8) which had large tumbled bricks within the pathway, as if once forming a step into the hut whilst it was in use. One of these bricks was retained as a sample (Find 4). The rectangular platform measured 11.2m in length and 5m in width and was aligned on a south-west to north-east orientation (Plate 33). A U-shaped drain type feature was located on the southern side, though undergrowth obscured much of it. Bolts survived on the lip on the northern side, indicating how the walls would have been attached (Plate 34).

Plate 33: Feature 8 facing south-west

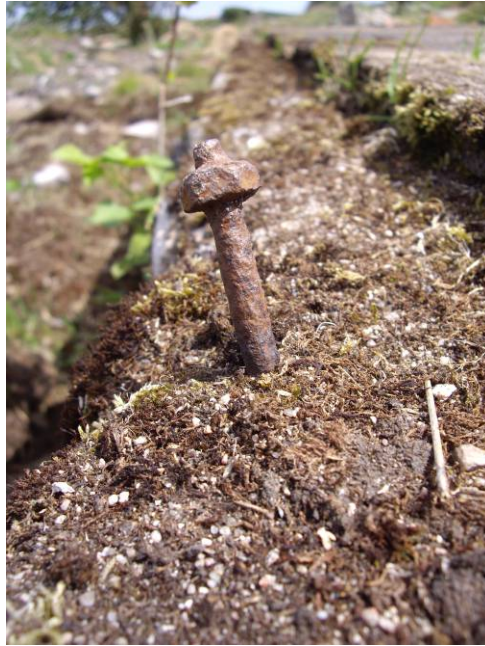
Plate 34: Bolt on northern edge of Feature 8, facing north-east

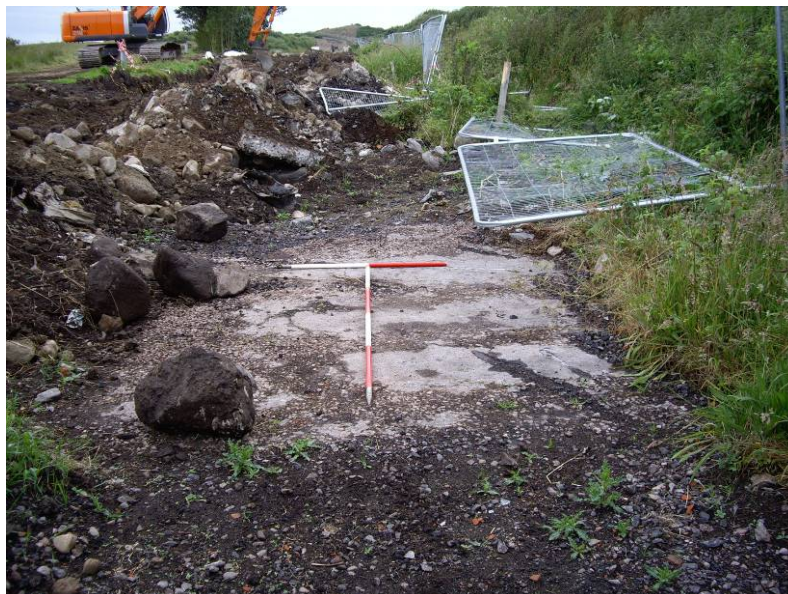
- 3.2.37 A further feature relating to mid 20th century use of the area was located 45m to the north-east of Feature 9 in the form of a levelled rectangular tarmac area measuring 5.4m in length and 2.5m in width (Feature 13; Plate 35). It is likely that this relates to known roads linking the hut bases for the Ack-Ack Battery, later converted into a Prisoner of War Camp (Figure 17).

Plate 35: Feature 13 facing north-east

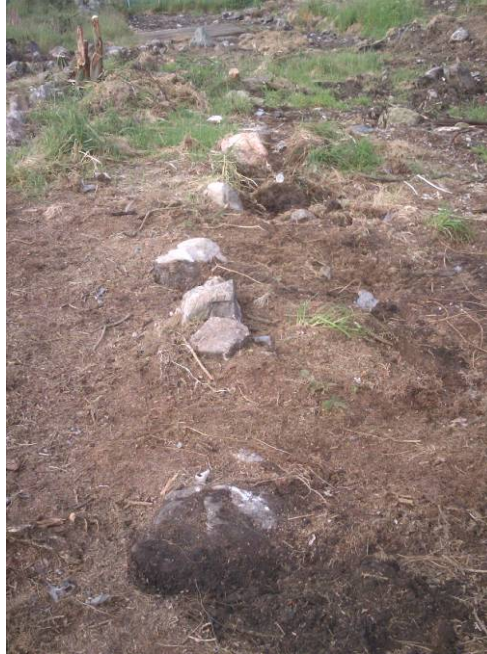
Plate 36: Feature 31 facing south-west

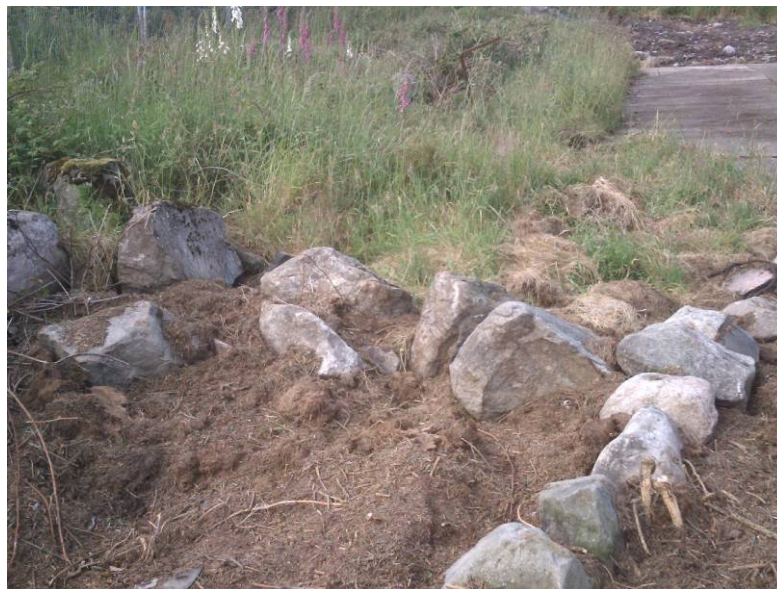
alignment of a path, or perhaps a garden edging feature. Similarly, Feature 32 consists of a short row of larger stones covering a distance of 2.5m on a north-west to south-east alignment (Plate 37), beginning at Feature 9, and stopping at Feature 23.

Plate 37: Feature 32 facing west

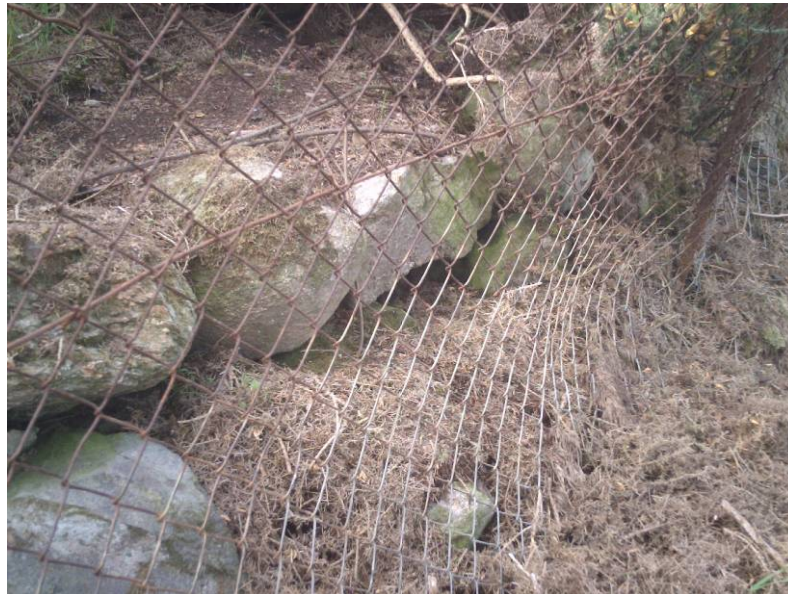
3.2.39 The last feature encountered during the clearance of the south gas venting trench area was the remains of a 2m high wire mesh fence with iron posts (Feature 26; Plate 38). Stays and fixings relating to this fenceline were visible between the rows of stones forming Feature 9, suggesting that the fence post-dates the Ack-Ack Battery and Prisoner of War camp phase of the site, and may have formed the perimeter fence for the tip, perhaps dating to the 1970s.

Plate 38: Feature 26, facing south

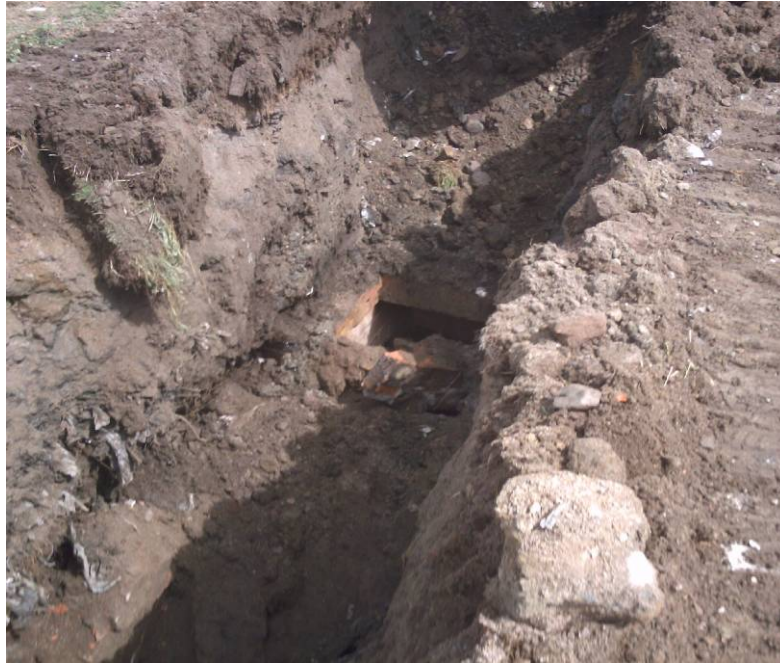
Plate 39: Feature 20 facing south-west

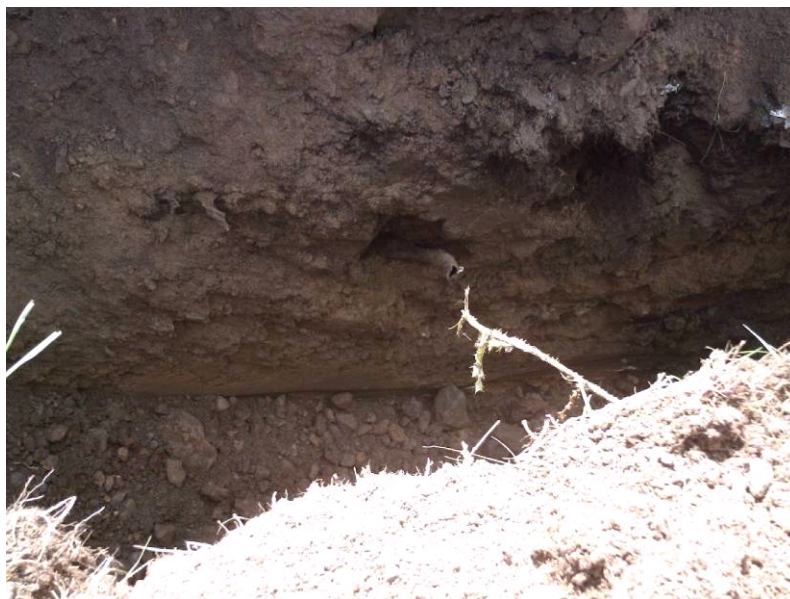
3.2.42 In addition, two lead pipes were observed within the trench (Features 24 and 25; Plate 40). These were corroded pipes made from lead, located at a depth of approximately 1.5m below the present ground surface. Feature 24 was 0.06m in diameter and ran on a north-south alignment, whereas Feature 25 was 0.04m in diameter and ran north-west to south-east. It is likely that these relate to the water supply for the Ack-Ack Battery and Prisoner of War camp. As the gas venting trench was only 1m wide, it is probable that other surviving examples exist within the area, undisturbed by the present development.

Plate 40: Feature 25 facing south

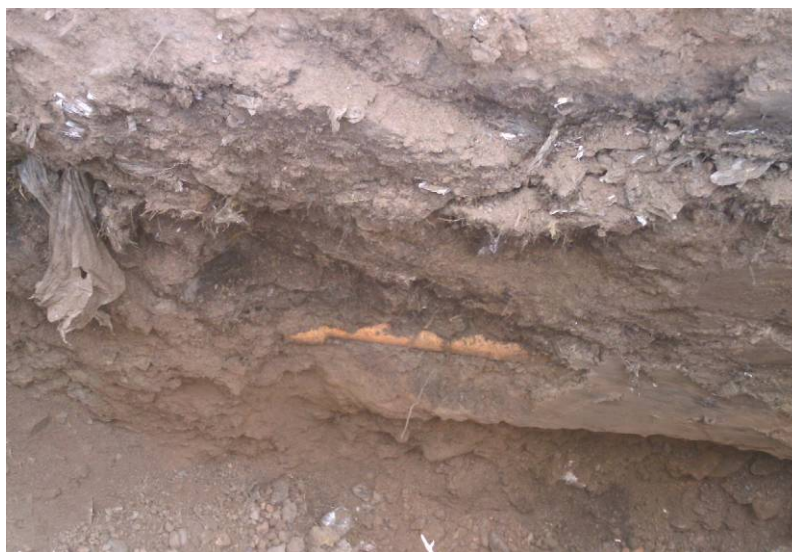
3.2.43 Further evidence for service supply and utilities in the area of the Ack-Ack Battery and Prisoner of War Camp were observed in the form of ceramic pipes, located within the south gas venting trench (Features 36, 41 and 49; Plate 41). These were located at a depth of approximately 1.2m below the present ground surface and were approximately 0.2m diameter. Features 36 and 49 were on a north-south alignment. Feature 41 was orientated north-east to south-west and was connected to brick drain traps Feature 21 and Feature 22, indicating that these orange ceramic pipes were part of the drainage system for the Ack-Ack Battery and Prisoner of War camp. Again, it is likely that other surviving similar features will survive in the vicinity.

Plate 41: Feature 41 facing south

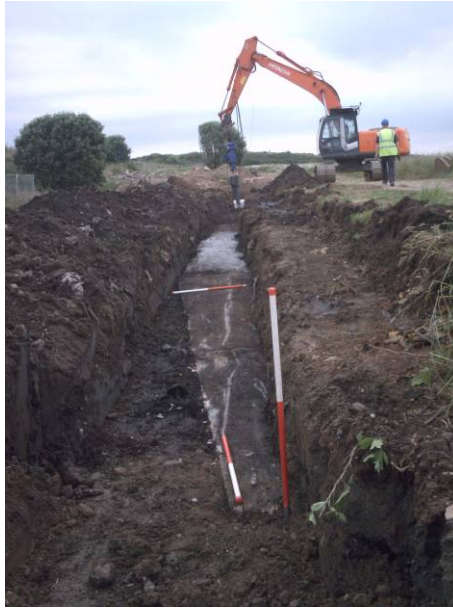
3.2.44 The excavation of the south gas venting trench also encountered surviving structural remains, relating to the Ack-Ack Battery and Prisoner of War Camp, including a further section of tarmac surface located just 1.2m to the north of Feature 13 (Figure 15), and thus probably an extension of the same tarmac road. In addition, several concrete surfaces were observed within the 1m wide gas venting trench. The first, and westernmost (Feature 14; Plate 42) consisted of the south-eastern edge, and eastern corner of a hut base feature, as well as the entire southern edge across a distance of 21.5, and was comparable to those revealed by the clearance. It was located approximately 1.1m below the present ground surface. During the demolition of the feature revealed in the trench, a metal rectangular object 0.23m by 0.04m and 0.01m thick with a central slot and an inscription above the slot reading 'J& R HOWE LTD' was deposited with on the spoil heap (Find 9). Although the 1m width strip encountered during the groundworks was destroyed by the works, the rest of the hut base must survive sub-surface. Research suggests that this may have been the southernmost part of the southern double hut base feature, thought to have been the medical centre (Figure 17). A further concrete surface, 11m in length and 1m wide (Feature 15) located 10m to the north-east of Feature 14 was destroyed by the trench excavations. No edges, corners or other features were observed, but it seems to relate to a shorter hut base known from the area (Figure 17).

Plate 42: Feature 14, facing south-west

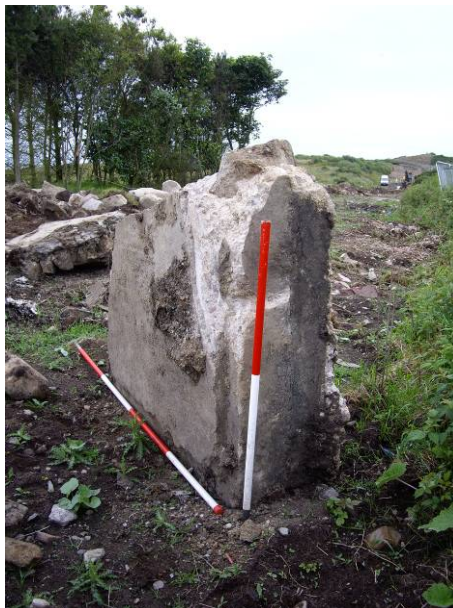
3.2.45 In addition, a triangular segment of concrete was excavated by the operations for the south gas venting trench, measuring approximately 1m by 1.6m on the right-angled edges (Plate 43), with a depth of 0.35m. This corroborates with aerial photographic evidence and Ordnance Survey mapping, as the corner of a further concrete hut base relating to the Ack-Ack Battery and Prisoner of War Camp (Figure 17). The remainder of the hut base must survive *in-situ*. A further concrete surface was exposed at a depth of 2.75m below the present ground level (Feature 17), compared to the 1.1m depth of the other features. It was 4.75m in length. No feature is known from this location on Ordnance Survey mapping of the area, but a white rectangle appears on aerial photography at this point (Figure 17).

Plate 43: Feature 16 facing north-east

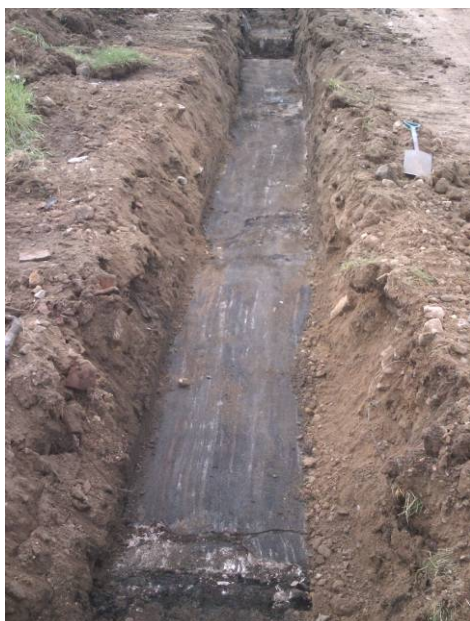
Plate 44: Feature 18 facing north-east, with Feature 28 behind

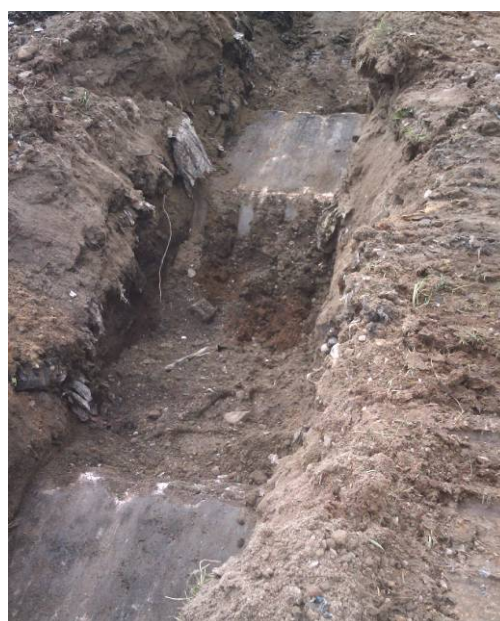
Plate 45: Feature 28 facing north-east, with Feature 18 in foreground
