REPORT ON AN ARCHAEOLOGICAL WATCHING BRIEF AT NESS FARM AND TULLOS HILL LANDFILL SITE, NIGG, ABERDEEN

NGR NJ 9559 0355

15 June 2010

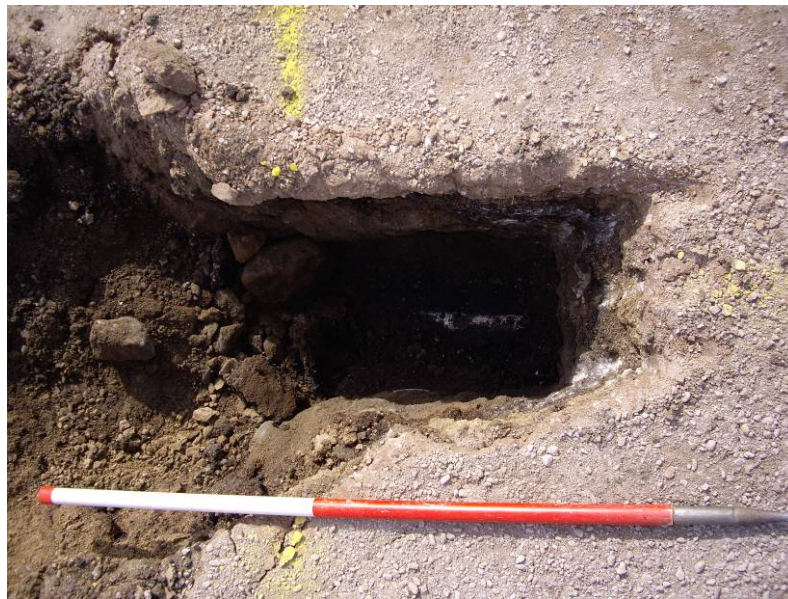
Plate 46: Feature 53, facing south

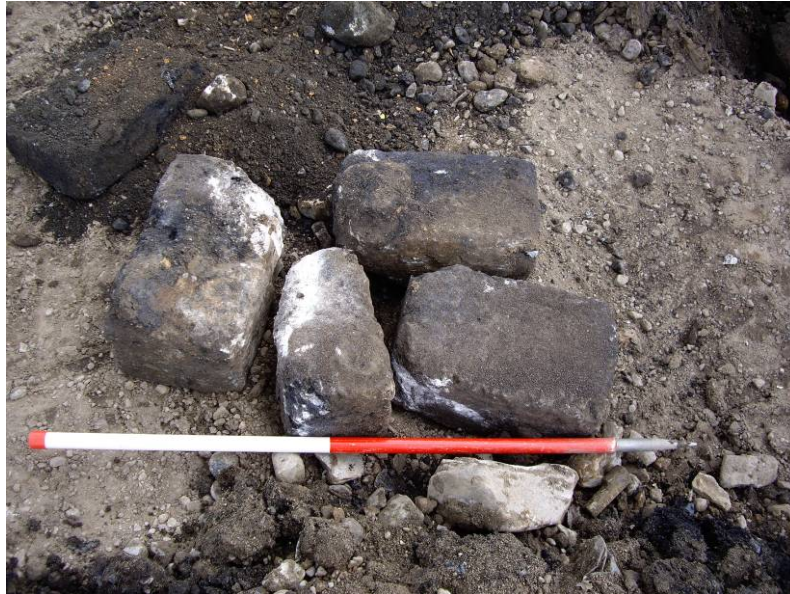
Plate 47: Feature 54, excavated from fence post hole

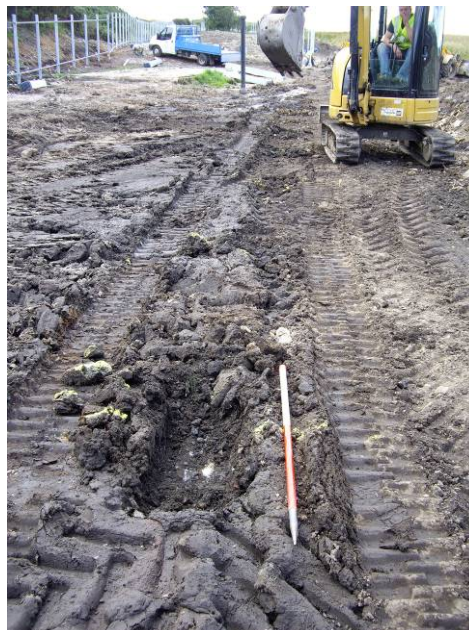
3.2.49 The last feature encountered by the fenceline excavations for the south gas venting trench occurred in the form of a tarmac surface, at times marked with yellow paint, located 4.6m to the north of the north-eastern corner of Feature 6, and 11m to the north-east of Feature 54 (Feature 55; Plate 48). It was observed in 6 consecutive fence post holes, at the westernmost of which it lay 0.35m below the present ground surface, and at the easternmost, 0.1m at a depth of 0.1m. The presence of yellow paint, and the alignment of the feature with a track depicted on modern Ordnance Survey mapping, suggests that this was an area of hard standing or trackway relating to landfill usage of the site, and may even have been a recent public access route across the site.

Plate 48: Feature 55, revealed in six consecutive fence post holes, facing south-west

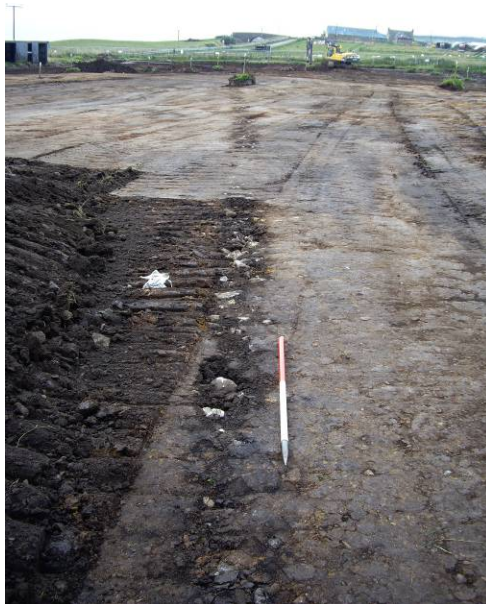
Plate 49: Feature 58 facing south

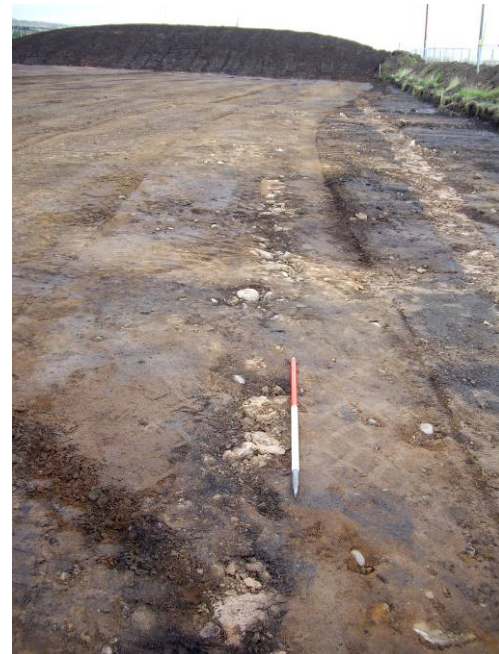
Plate 50: Feature 59 facing north

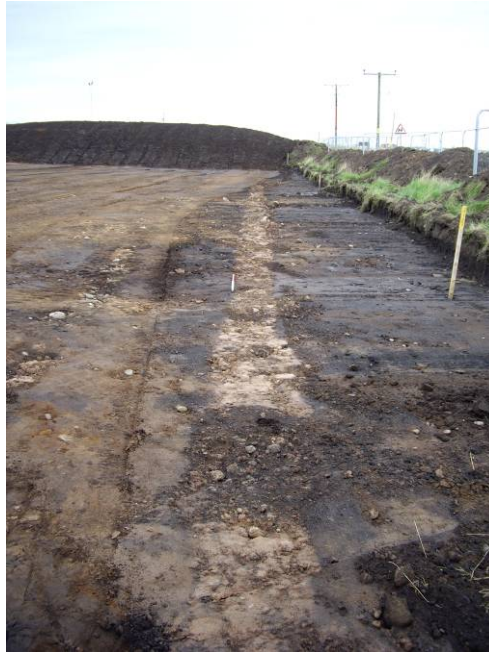
Plate 51: Feature 60 facing north-east

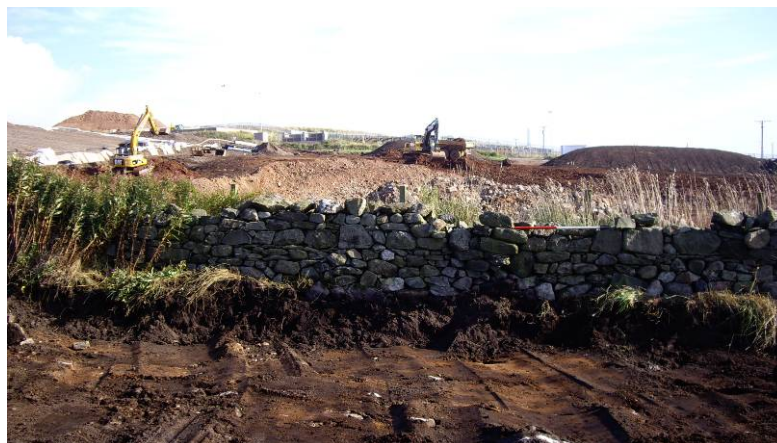
3.2.52 Stripping of an area 4m in width to the south of the boundary wall (Feature 57) of the above field revealed the eastern part of the south-west face of Feature 57 (Plate 52), a dry stone dyke boundary noted from First Edition Ordnance Survey mapping (Figure 3). This has been much altered over the years, being truncated at its western end, and having a gap in it at its eastern edge (Plate 53) for a gateway to link this field into the adjoining one to the north. Just to the west of this gap, a trough feature with a north-east to south-west aligned promontory truncated wall was recorded, showing more recent adaptations to Feature 57 to aid changing agricultural practices and needs. Some graffiti in this area, in cement similar to that holding the trough, is dated 31st January 1984 (Plate 54).

Plate 52: South-west face of Feature 57

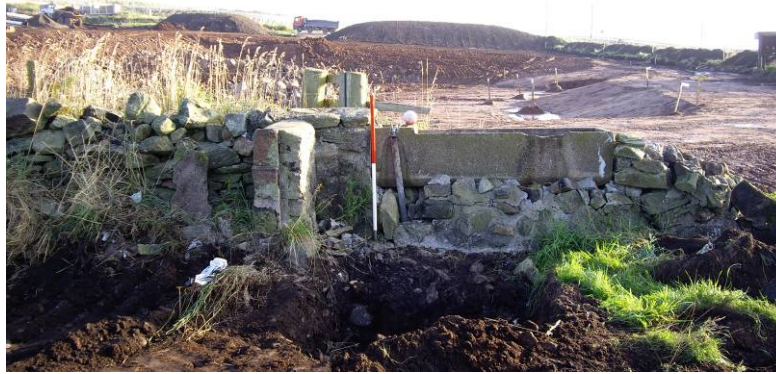
Plate 53: Trough and wall features in Feature 57, facing north-east

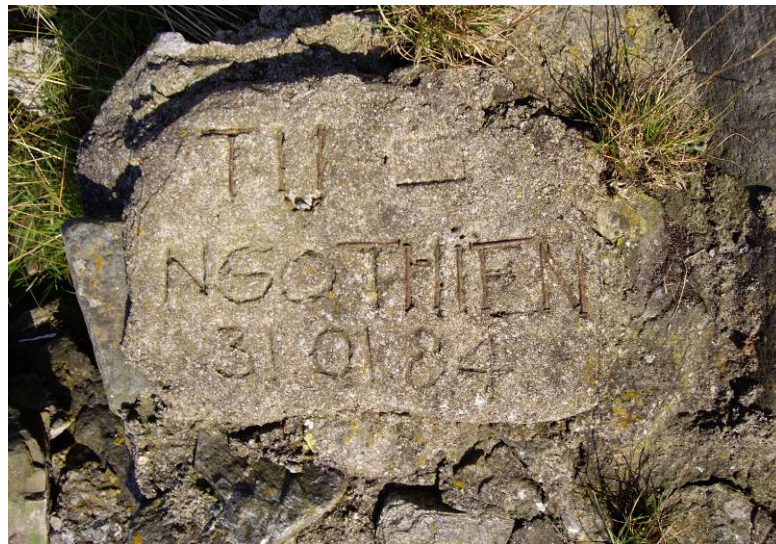
Plate 54: Graffiti by trough feature relating to Feature 57

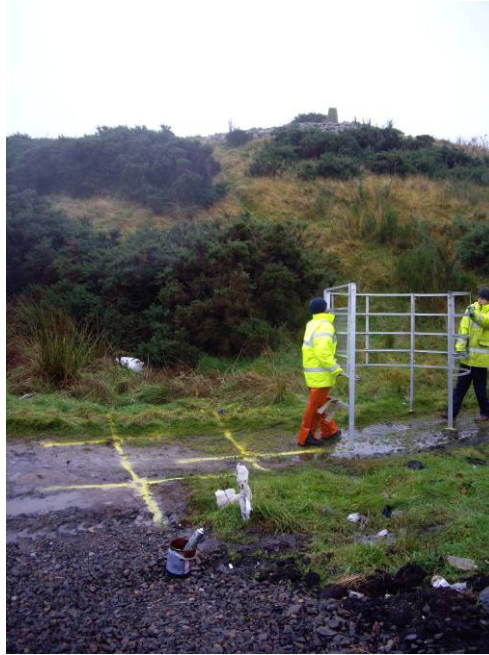
3.2.53 ***Kissing gates and fencelines at Cairns:*** this stage of the groundworks occurred at the known cairn sites along the southern boundary of the site (Figure 19). The kissing gates at each cairn required the excavation of two holes measuring 1m by 0.5m to a depth of 0.8m, excavated by JCB with bladed ditching bucket (seen in preparation in Plate 55). Each encountered a loose mid-brown topsoil of a depth of between 0.18m and 0.32m above a firm orange sand and clay deposit with occasional stone inclusions. At the newly-scheduled cairn (Fig 19), landfill was encountered within the kissing gate post holes. The scheduled areas (20m radius for Crab's Cairn; 30m radius for Baron's Cairn; 30m for Cat Cairn and 15m radius for the new cairn) were not infringed upon by these works. Trenches and post-holes for the kissing gates were monitored by an archaeologist but there was no excavation for the stockproof fencing posts as they were driven in.

Plate 55: Preparation of kissing gate at Baron's Cairn, facing south
