**Traprain Law, East Lothian:  
Report on Archaeological Works for installation of water  
trough**

East Lothian Council Archaeology Service  
2<sup>nd</sup> October 2019  
Hélène Gray

Oasis No. eastloth3 -368813

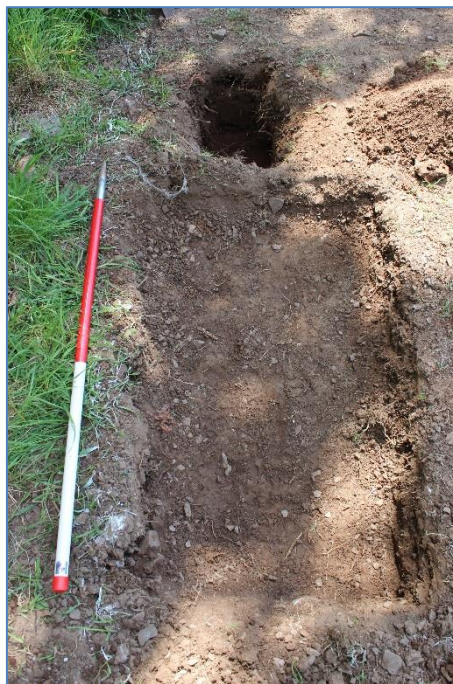
The watching brief was undertaken on the 24<sup>th</sup> May 2018. A small rectangular area measuring 1m by 0.7m by 0.15m deep was excavated for the foundation base of the trough; immediately adjacent and to the south, a sub-square area measuring c. 0.4m by 0.35m by 0.4m deep was excavated for the installation of a new water toby required for the operation of the new trough (Figures 2-4).

Deposits across the excavated areas comprised a dry, friable, stony sandy silt topsoil (**001**), 0.12m-0.2m deep, which overlay a subsoil (**002**), likely natural soil formation from hillwash etc., comprising a mid-orange brown sandy clay silt, measuring at least 0.2m deep in the area excavated for the new water toby. Natural geology was not reached in either excavation area.

Figure 2: Post-excitation of trench for trough base and hole for new water toby

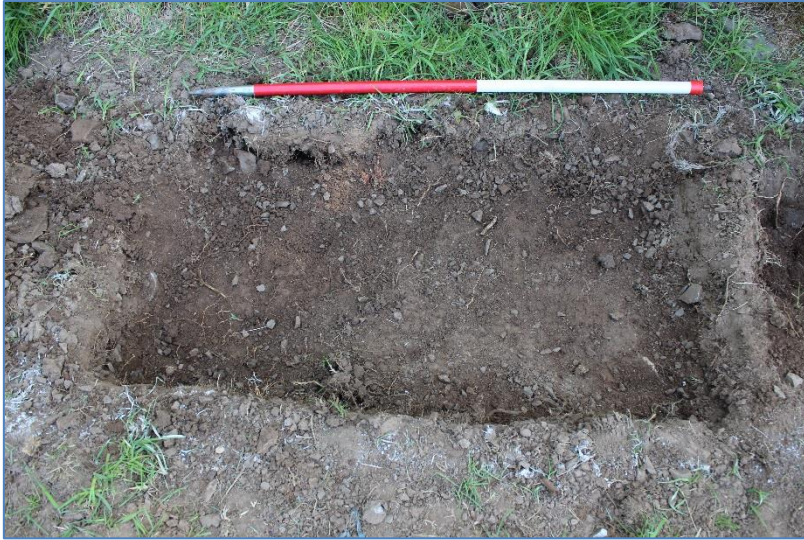
A single piece of 19<sup>th</sup>-20<sup>th</sup> century glazed ceramic water pipe was recovered from the topsoil (**001**) in the trench for the water trough base. No other archaeological finds, features or deposits were identified.

Figure 3: Post-excitation of trench for trough base

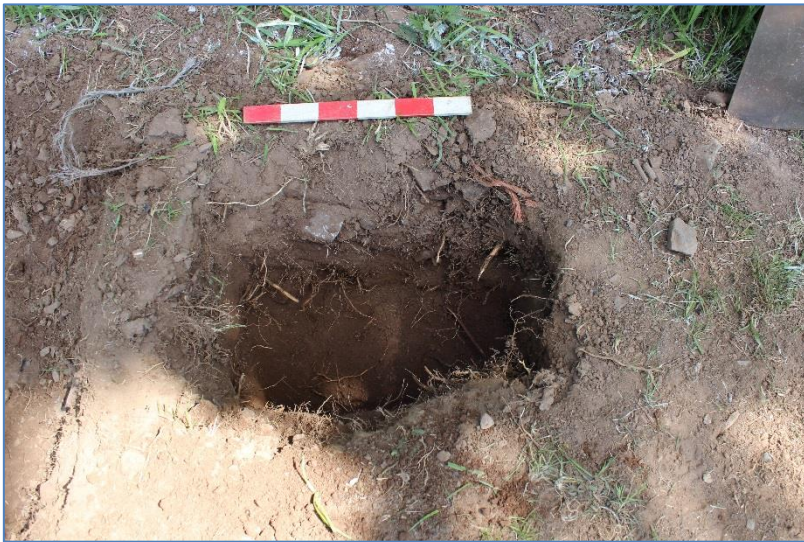
Figure 4: Post-excitation of hole for new water toby

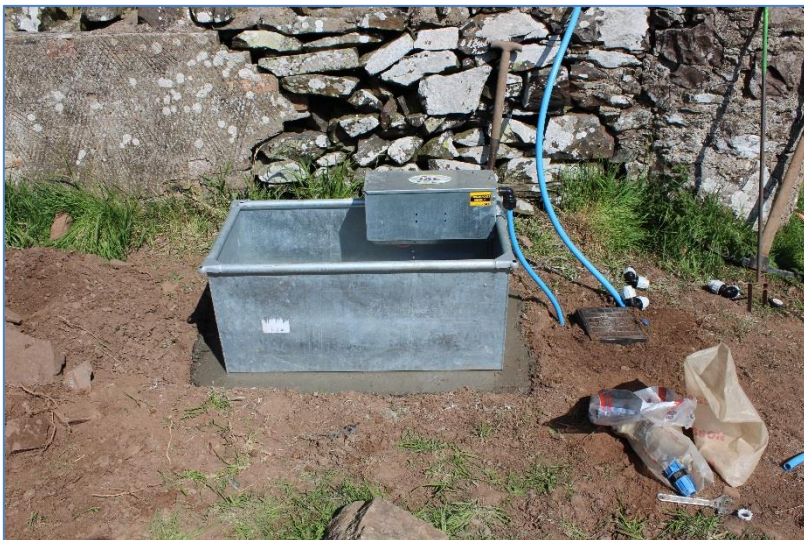
Figure 5: After water trough base and new toby installation

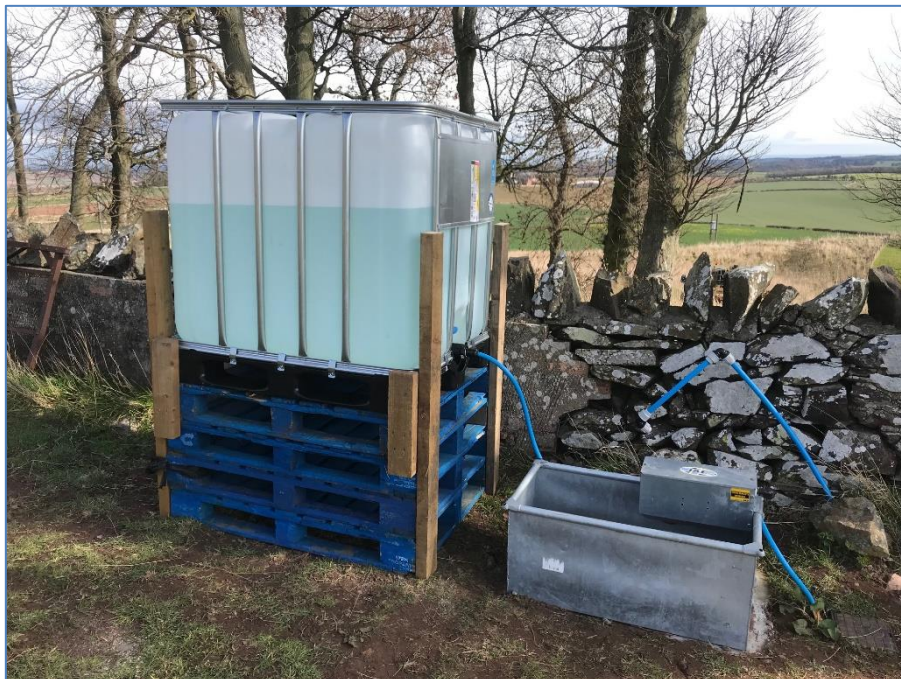
Due to problems locating a buried piped water supply near to the trough, East Lothian Council's Landscape & Countryside Service proposed that a 100L clear plastic water storage tank be placed on approximately five wooden pallets, located adjacent to the new trough on its northern side so as not to block the farm access gate. The tank would be connected to the trough using the existing pipework (or additional above ground piping of the same specification as that already used for the trough).

Figure 6: Water tank and trough following installation

The tank was subsequently installed in March 2019 (Figure 6).
