**THE BANYERS HOTEL
MELBOURN STREET
ROYSTON
HERTS
SG8 7BZ**

An Archaeological Watching Brief

Report No. AES/2014/4

December 2014

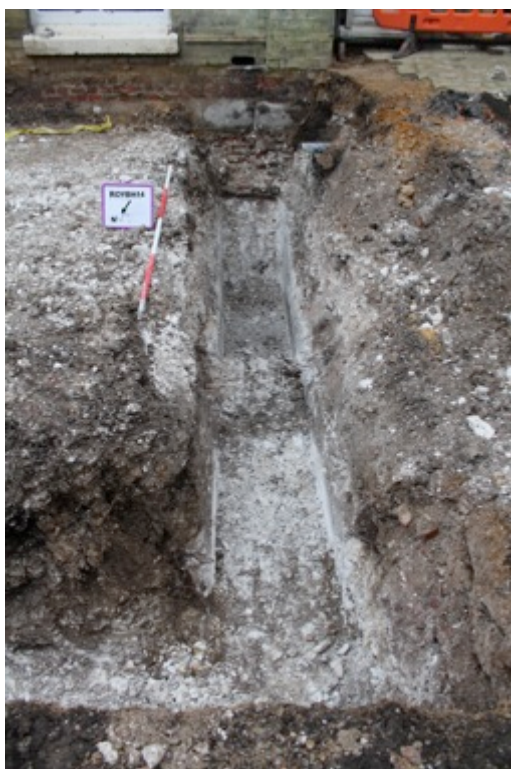
During clearance of ground to the rear of the building three features of archaeological significance were exposed: the original footings of the building that had been covered by made up ground, 1.64m deep and a large structure possibly part of a water management system were revealed (figures 3 and 4). The structure was 4m long x 2m wide x 2m deep, rendered with concrete with a brick base and vaulted brick roof within which two capstones were laid, two drainage pipes, one lead, from the roof of the building lead into the cistern F11 and one pipe at the northern end located approximately 0.9m deep lead out of the cistern into the outside ground. The structure was built directly onto the northern face of the building. The vaulted roof appeared to follow the line of a further vaulted roof along the side of the eastern wall of the cellars and was approximately 6m long.

Figure 3: Footings of Banyers facing north west

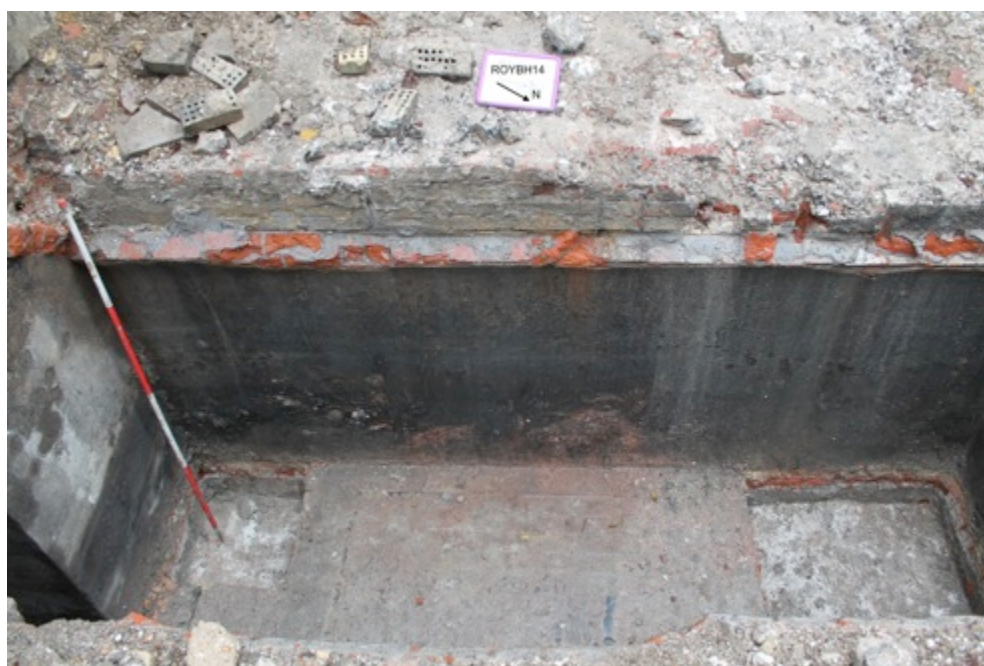
The discovery of a large rectangular concrete rendered structure with pipework leading from the roof at the rear of the Banyers F11, and two further discoveries of circular concrete rendered structures F13 and F14, one with lead pipe leading from the roof of the Banyers and the other with a clay drain leading into it, give rise to an indication that all three may have been part of a water management system, whereby water may have been collected for use within house and garden.

Figure 4: Brick lined water tank F11 at rear of Banyers facing north east

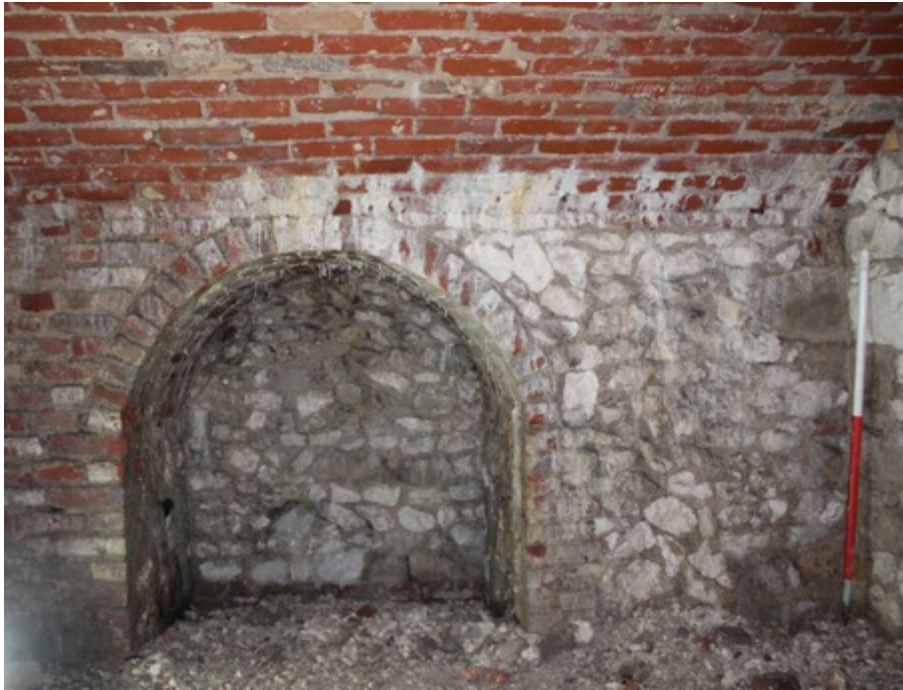
During the machining of trench footings to the rear of the building a complex of structures of archaeological significance were revealed. Located 4.5m from the building, the first was the entrance, archway and roof of a chalk and red brick vault roofed structure, approximately 4m long x 3m wide x 1.5m deep, with a oval feature in the floor which is possibly a drain. Inset into the southern wall was a small archway. The vaulted roof consisted of five courses of vertical brickwork followed by eight courses of curved brickwork making up the vaulted roof. The latter is acclaimed to be a possible icehouse. The second, set alongside the possible icehouse was a brick wall possibly the retaining wall for the icehouse and further brick walling lying at the west end of the icehouse. In the North and Western sides were two chalk niches, possibly used for candles (figure 6).

The structure at the Banyers was totally submerged beneath the ground. It is possible that layers of made up ground, some of modern date, have masked the depth of the structure originally lying below and above ground. The walls are constructed of thick blocks of chalk and red brick with a drain in the floor and a vaulted roof (figure 5).

Figure 5: Archway in chalk lined structure F8, facing north west

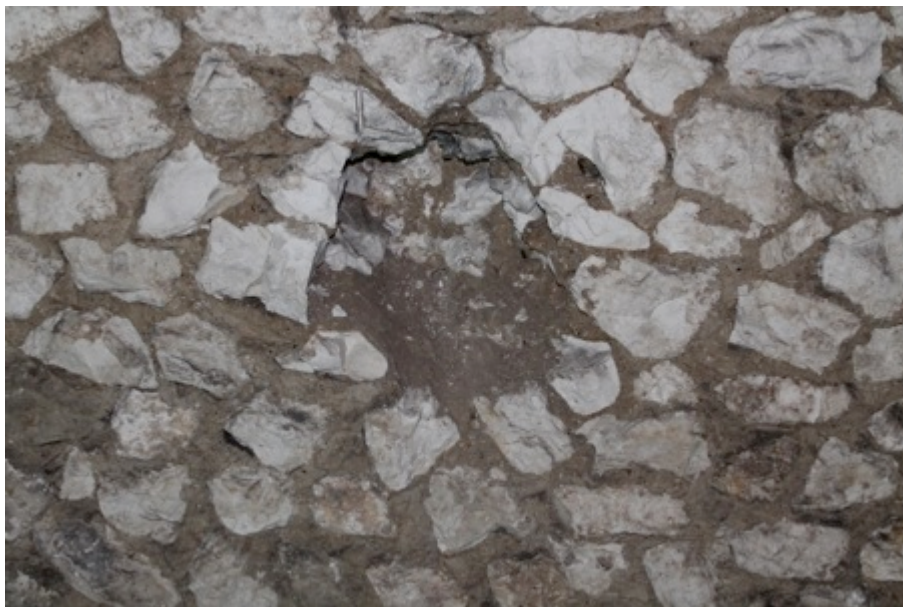
Figure 6: Niche in wall of chalk lined structure F8

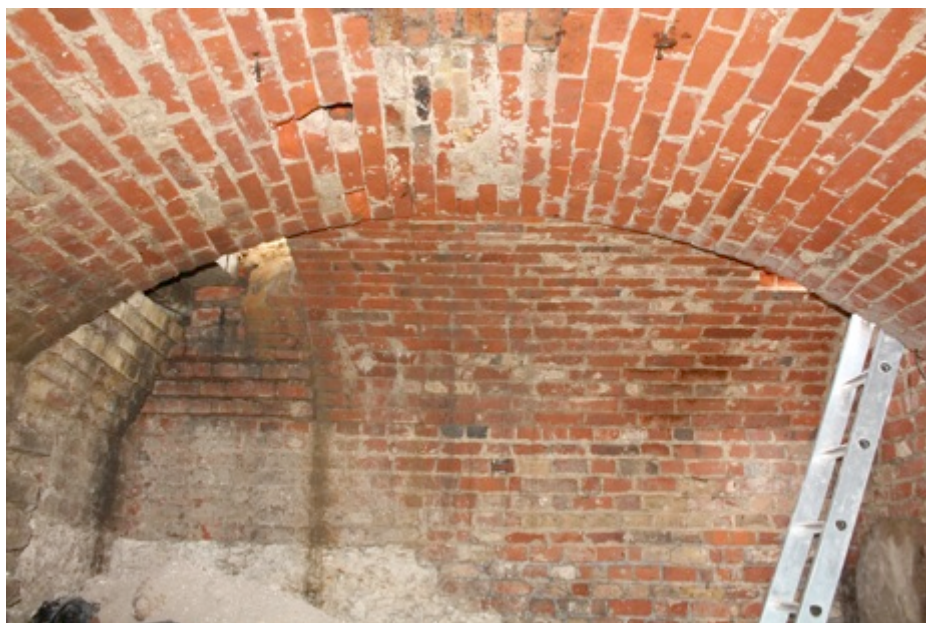
A remodeling of the structure appears to have occurred during the later development of the Banyers in the late 18th century. At the north eastern end the wall was built of red brick with two holes in the roof, with a capstone lying over the entrance. A main entrance seems to have been inserted at the northern end (figure 7).

Figure 7: End wall of chalk lined structure facing south west

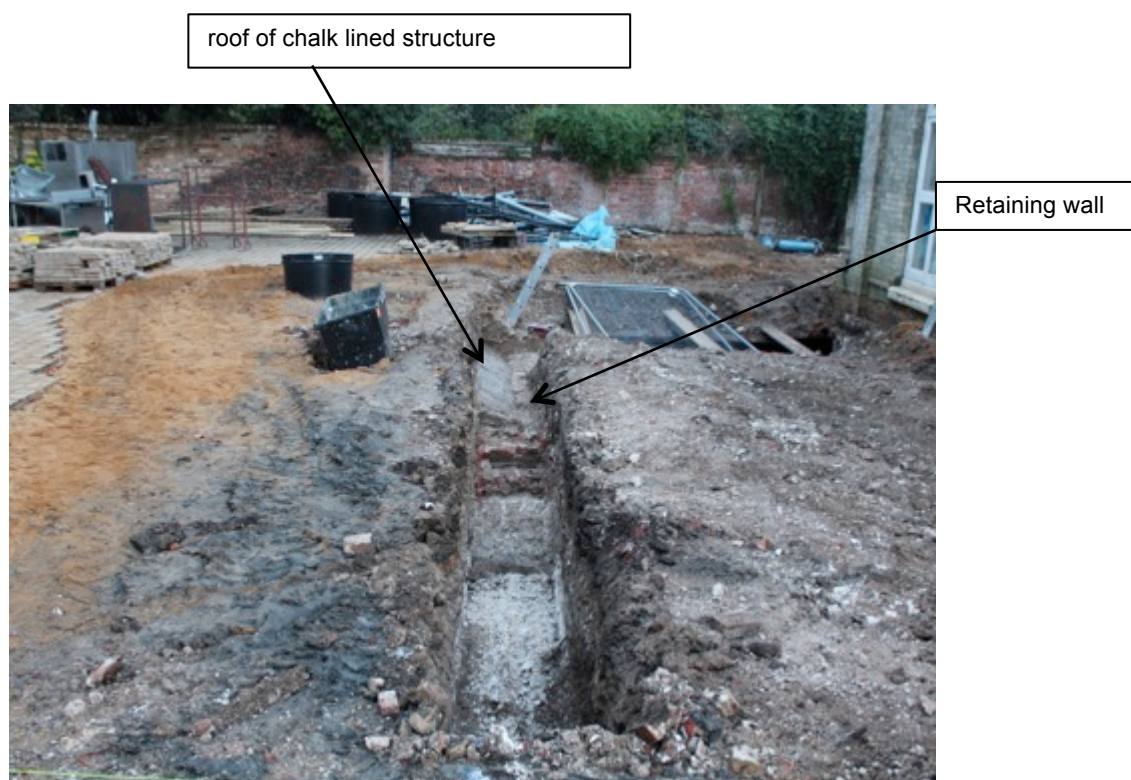
Figure 8: Trench showing chalk lined structure and retaining wall

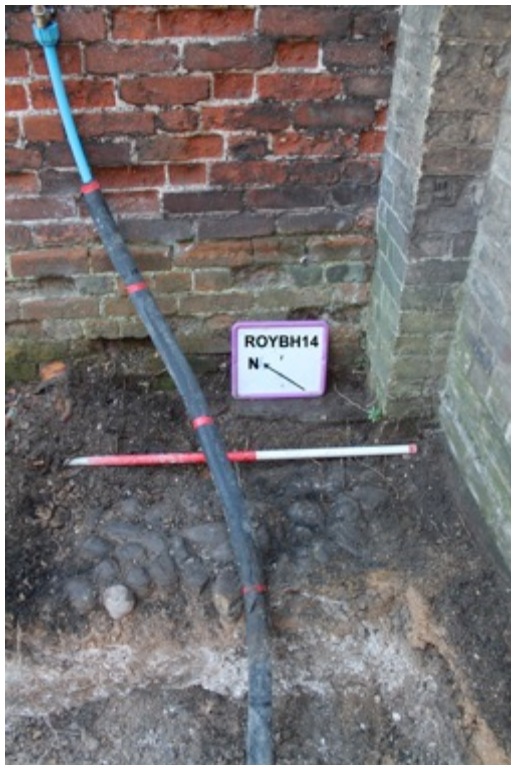
The second feature was the remains of a cobbled surface F12 located in the trench in front of the rear gateway to the Banyers, .44m wide x .10m deep x .70m long (figure 9). It was located beneath made up ground of paving and sand.

Figure 9: Cobbled surface F12 facing south west

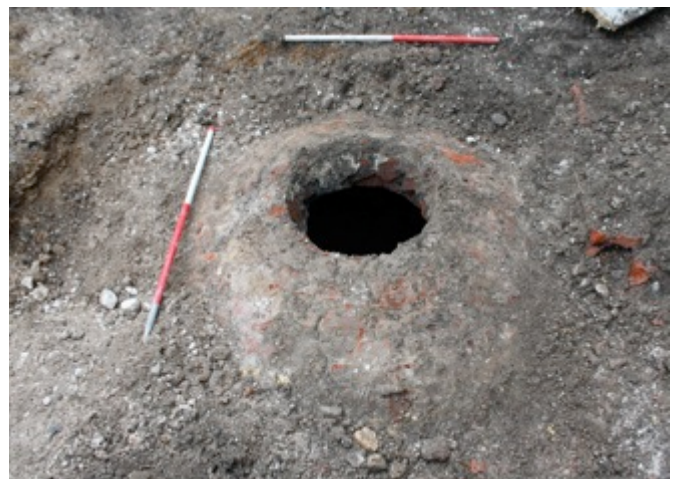
During clearance of ground to the east of the building a structure was revealed that is also possibly part of a water management system for the building. The structure was circular in shape with a vaulted red brick roof with an opening in the top (figure 10). It was rendered with concrete, with a lead pipe set against the side of the structure leading towards the building. It was 1.90m diameter and 5m deep.

Figure 10: Possible water cistern F13 facing north east

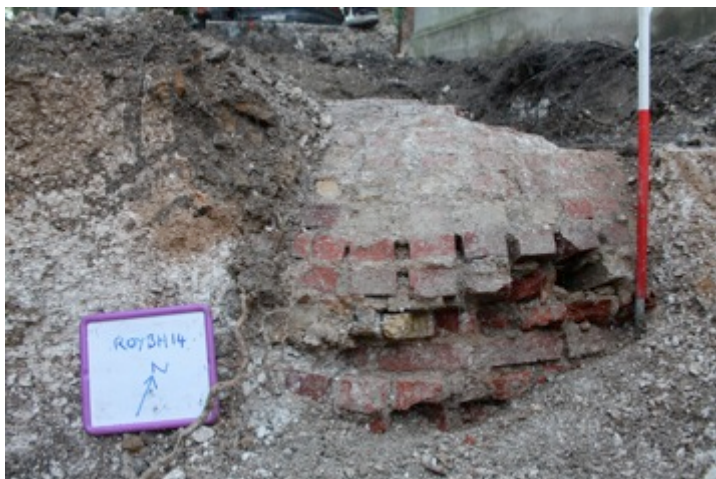
During the machining of trench footings, 0.80m wide x 1m deep x 4.76m long, for the proposed extension to the east of the building, two features of archaeological significance were exposed. The first was a further circular structure, 1.90 in diameter, with a red brick vaulted roof and circular opening in the top, .97m in diameter, with a drainage pipe leading into the top of the side wall on the northern side (figure 11). This structure was backfilled with a mix of chalk and rubble.

Figure 11: Possible water cistern F14 facing south east
