Cottam Wind Farm, Nottinghamshire

Archaeological Desk-based Assessment
&
Field Walkover

CAP Report No. 491

Date: **October 2007**

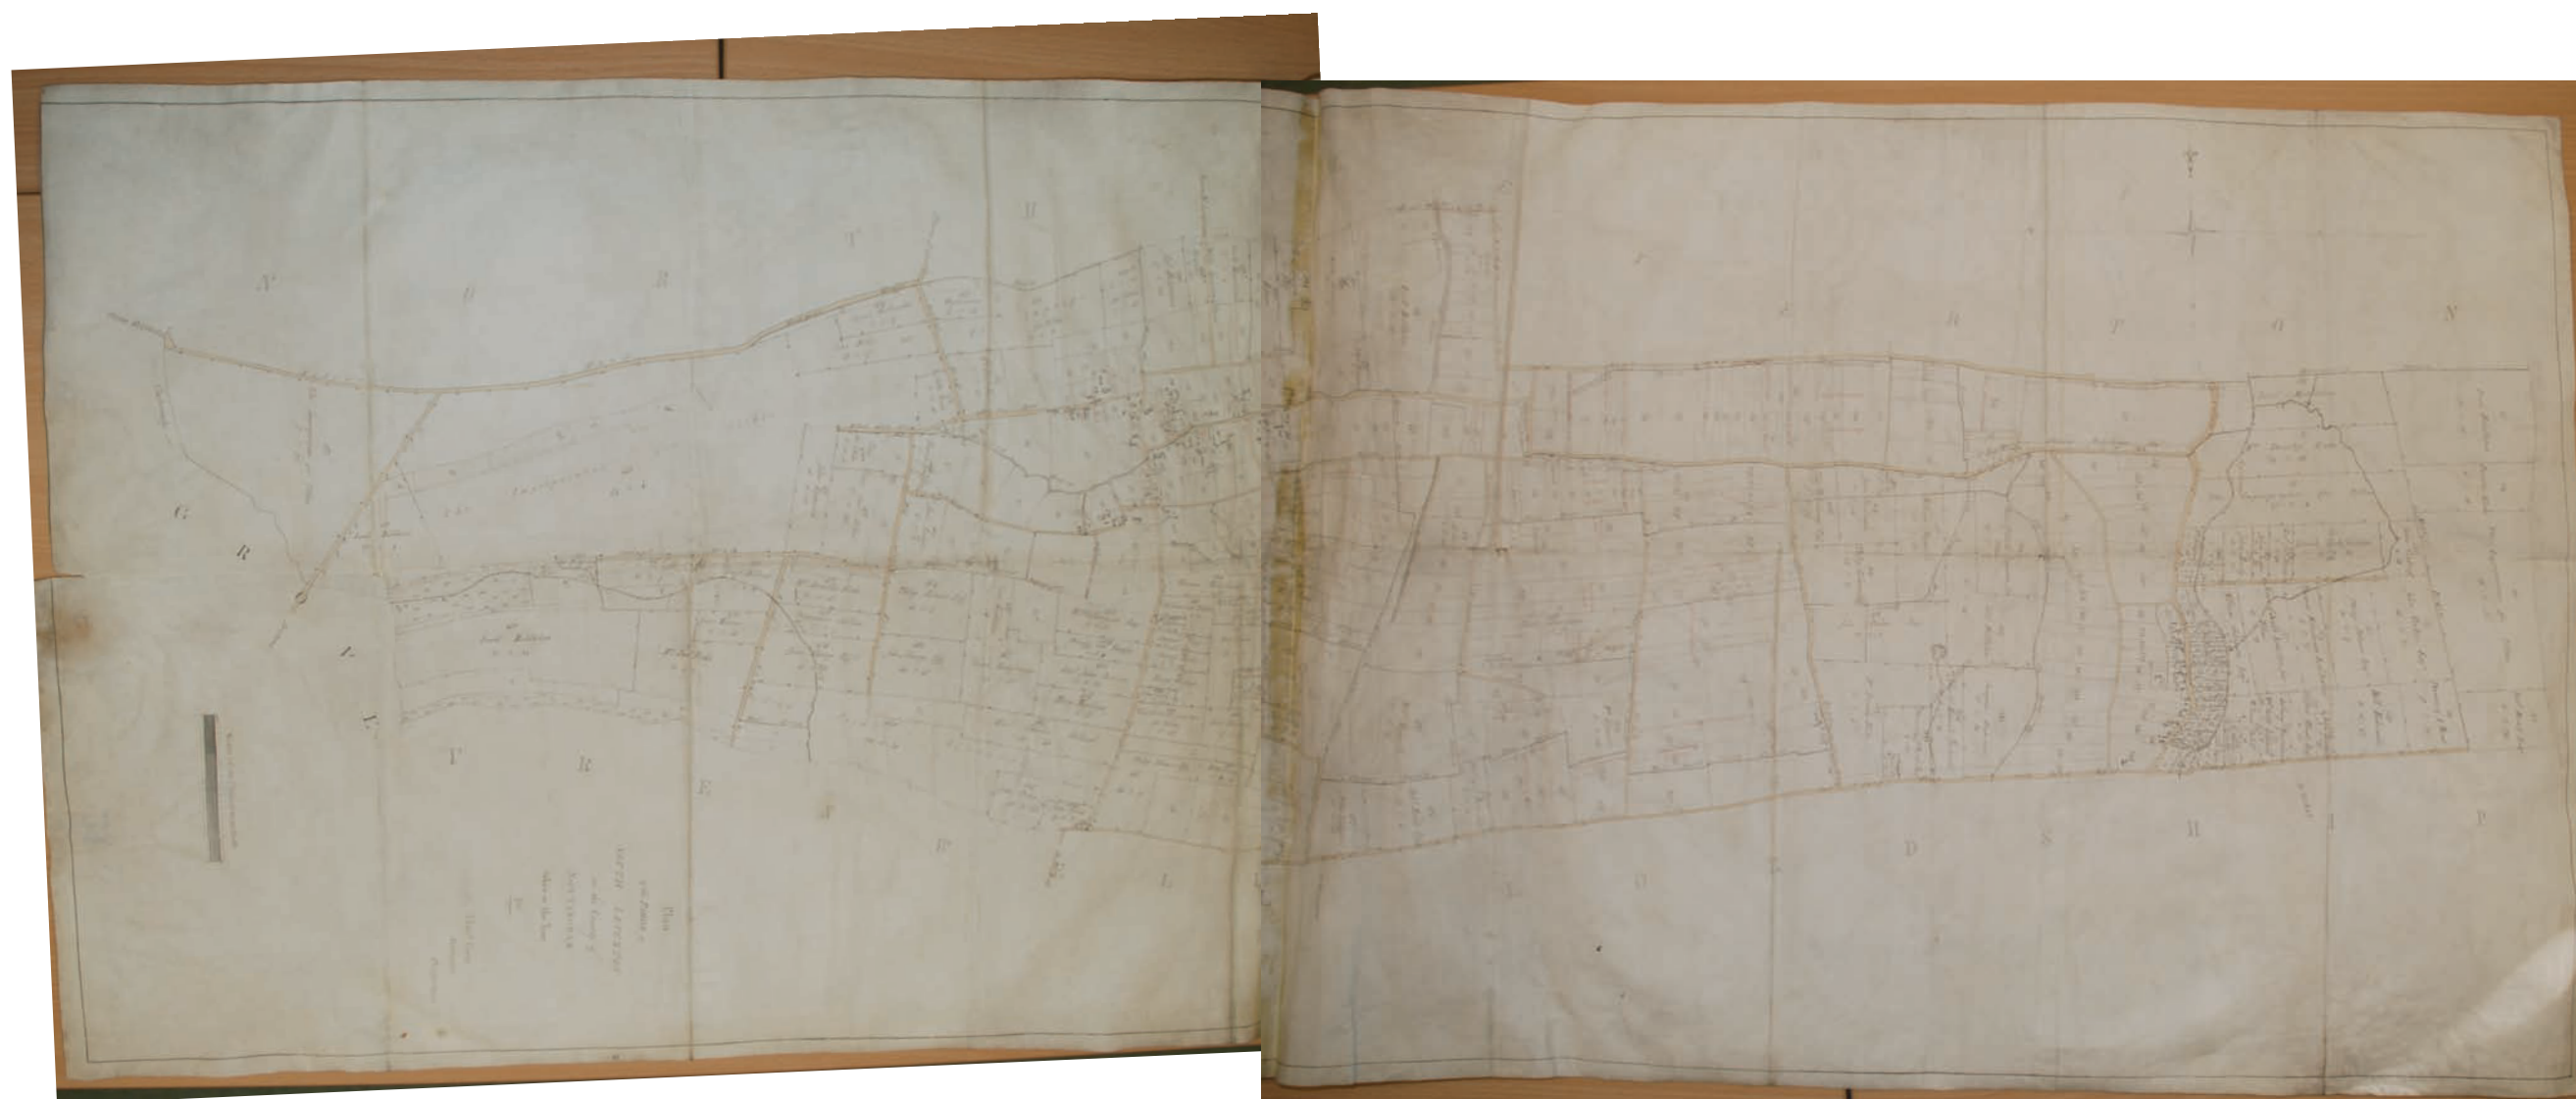
Fig 4: 1796 Enclosure map of Cottam and South Leverton showing strip field patterns in the areas of Turbines 1 - 8

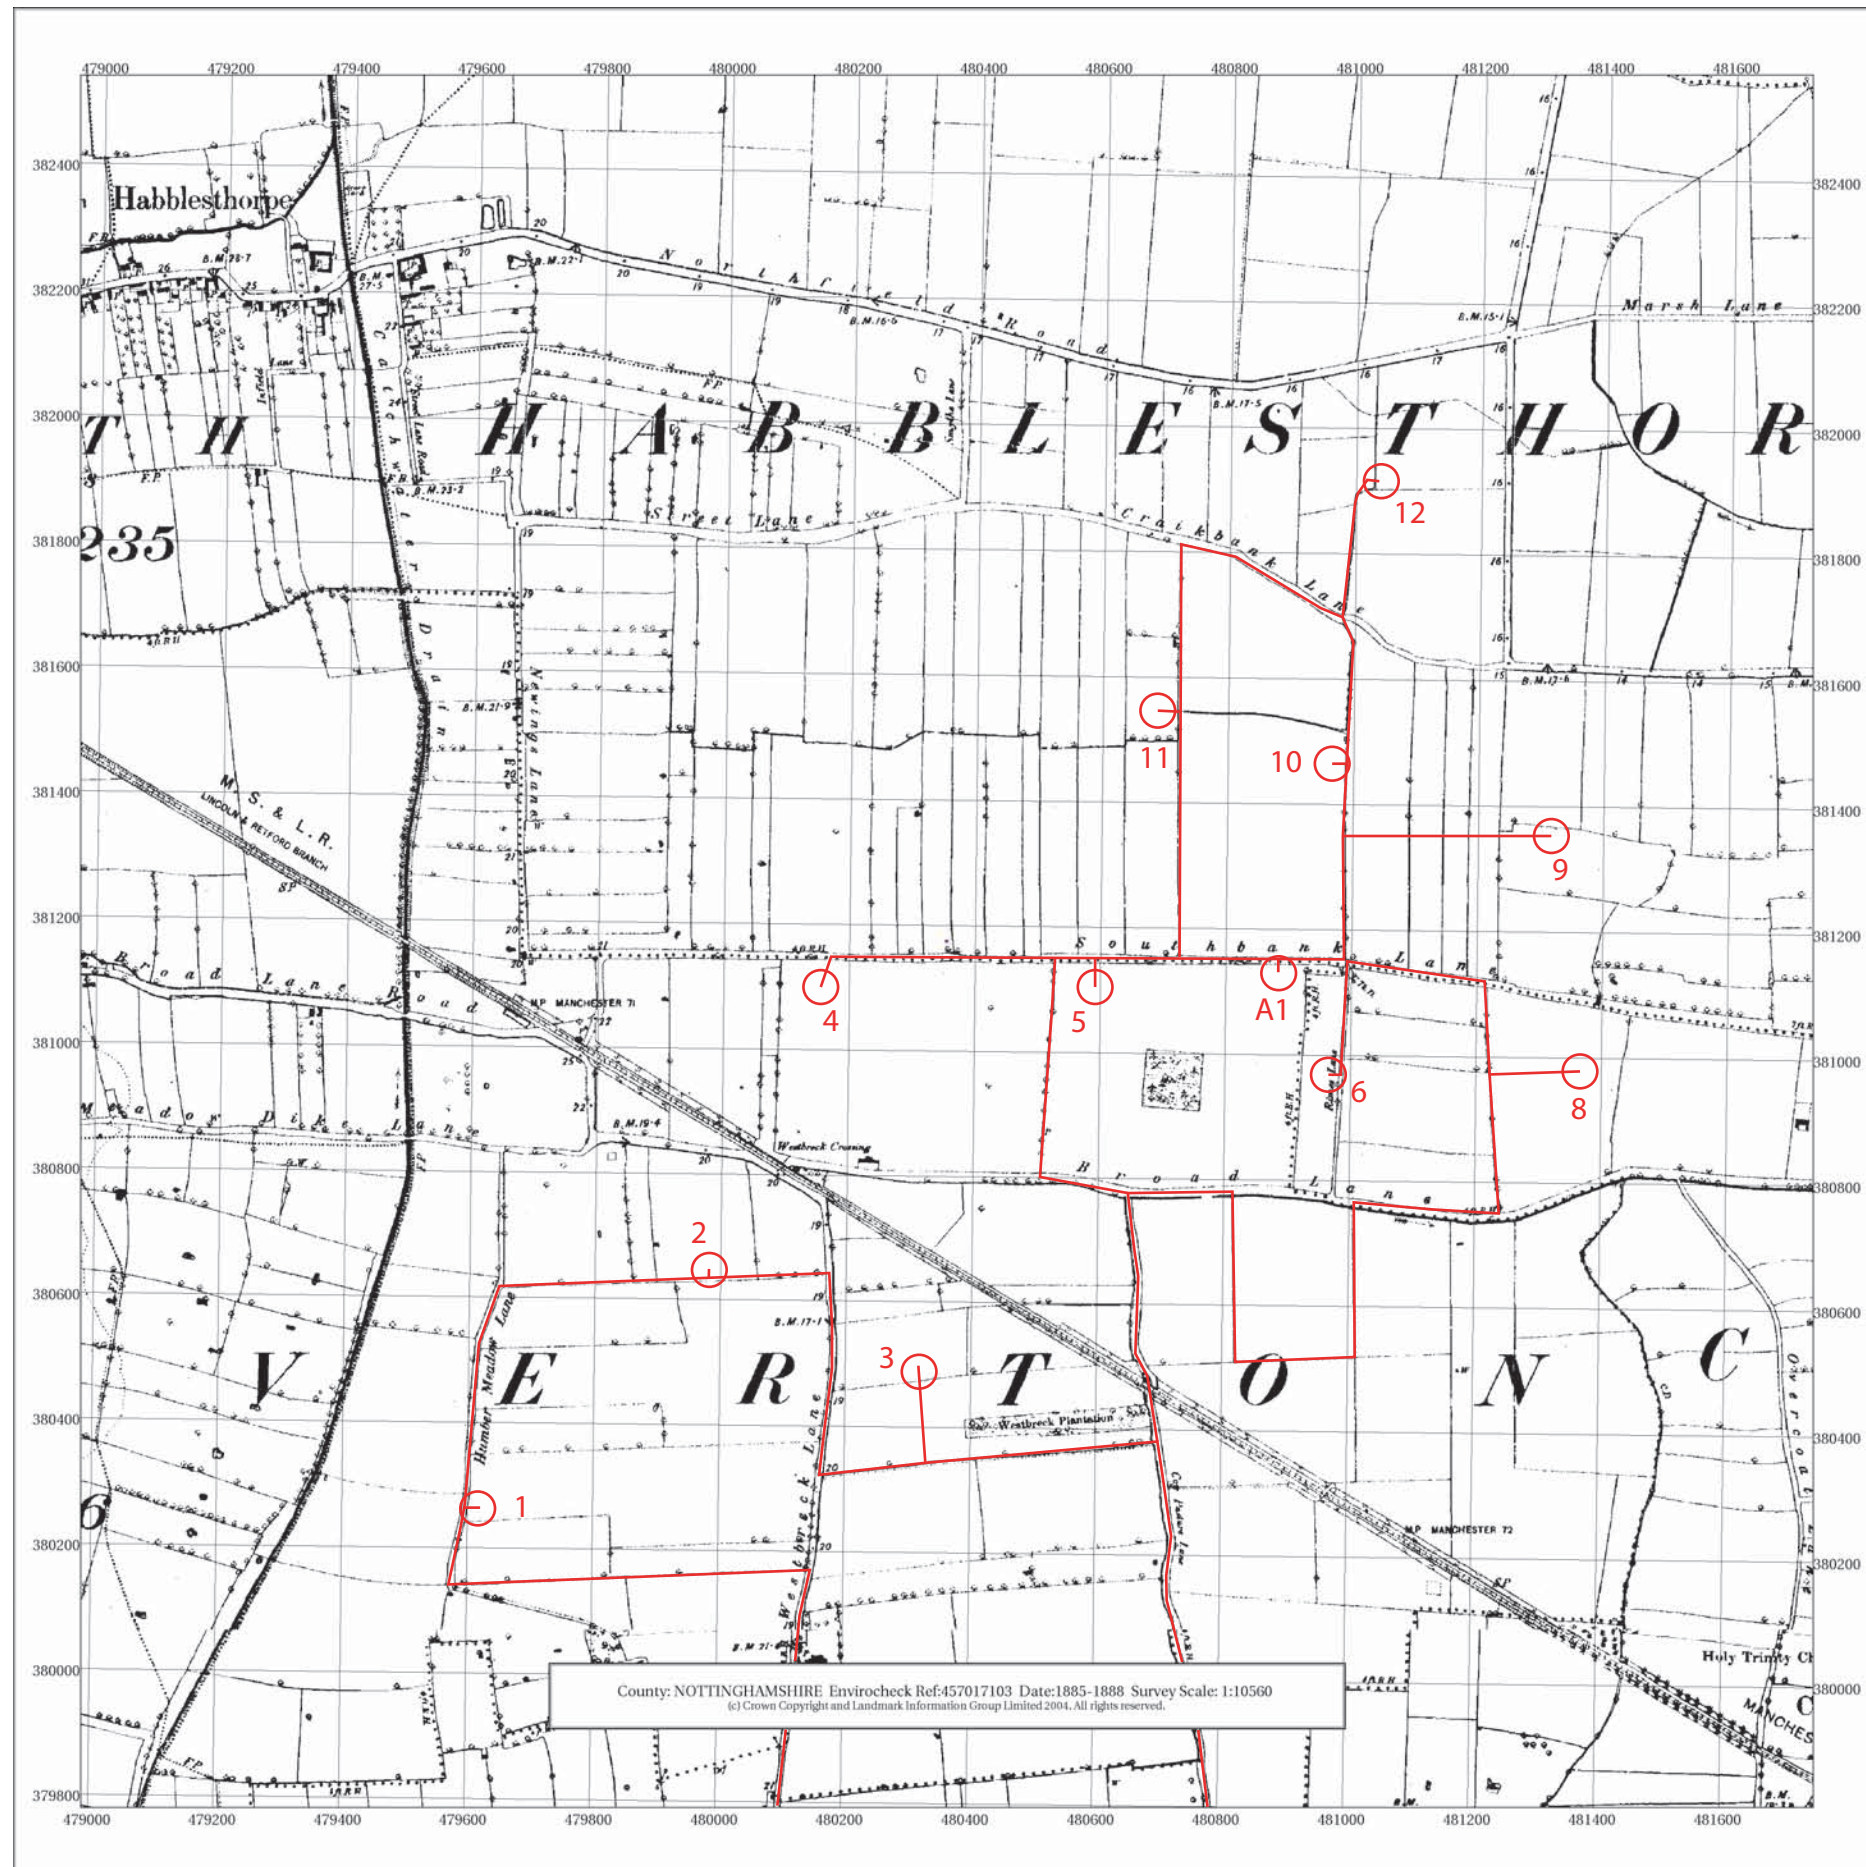
Fig 5: 1885 1st Edition Ordnance Survey map with proposed locations of Turbines overlaid in red

- 5.1.2 The 1885-88 First Edition Ordnance Survey map (Fig 5) shows the area of proposed development in close detail. The landscape is characterised by a series of small co-axial ‘strip’ fields and drainage ditches the same as shown 100 years earlier in Fig 4. None of the twelve turbine locations appear to be located near any structures or other features apart from field boundaries. The access track to Turbine 9 appears to cross four field boundaries of the above mentioned ‘strip’ fields.

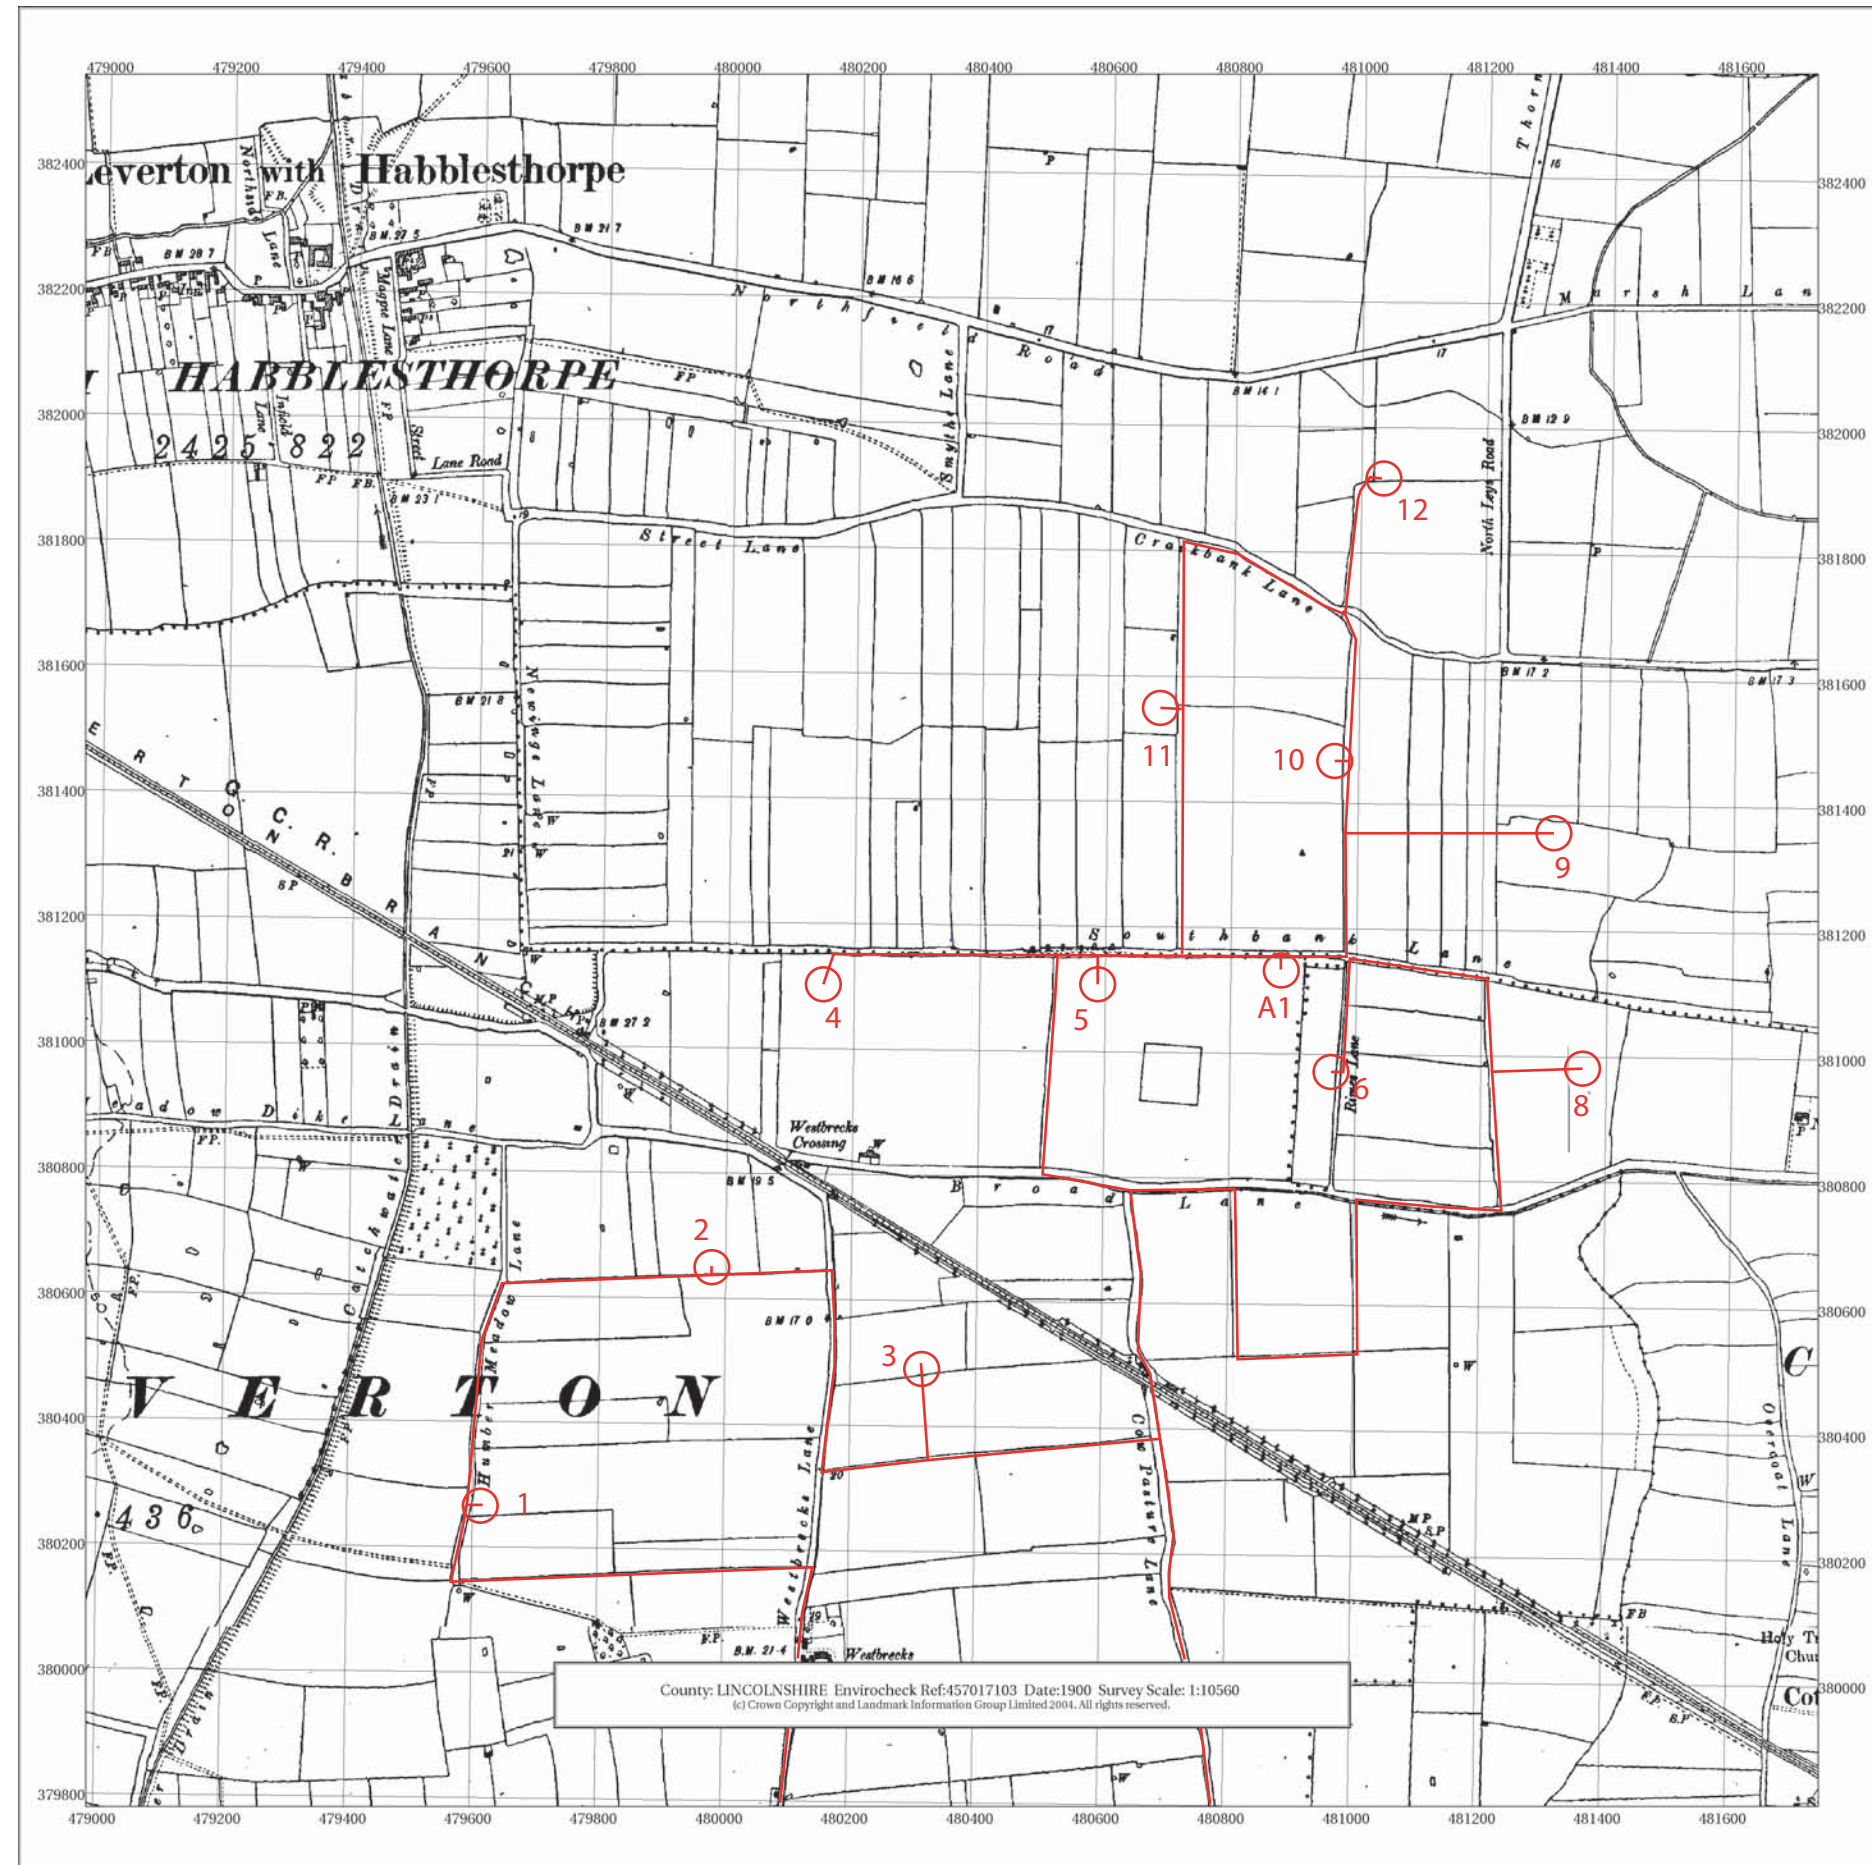
Fig 6: 1900 2nd Edition Ordnance Survey map with proposed locations of Turbines overlaid in red

- 5.1.3 The 1900 Second Edition Ordnance Survey map (Fig 6) shows largely the same detail as that seen on the first edition with very few if any changes within the proposed area of development. The large plantation to the south of Turbine 5 appears to have been cleared of trees since the publication of the First Edition map in 1885.

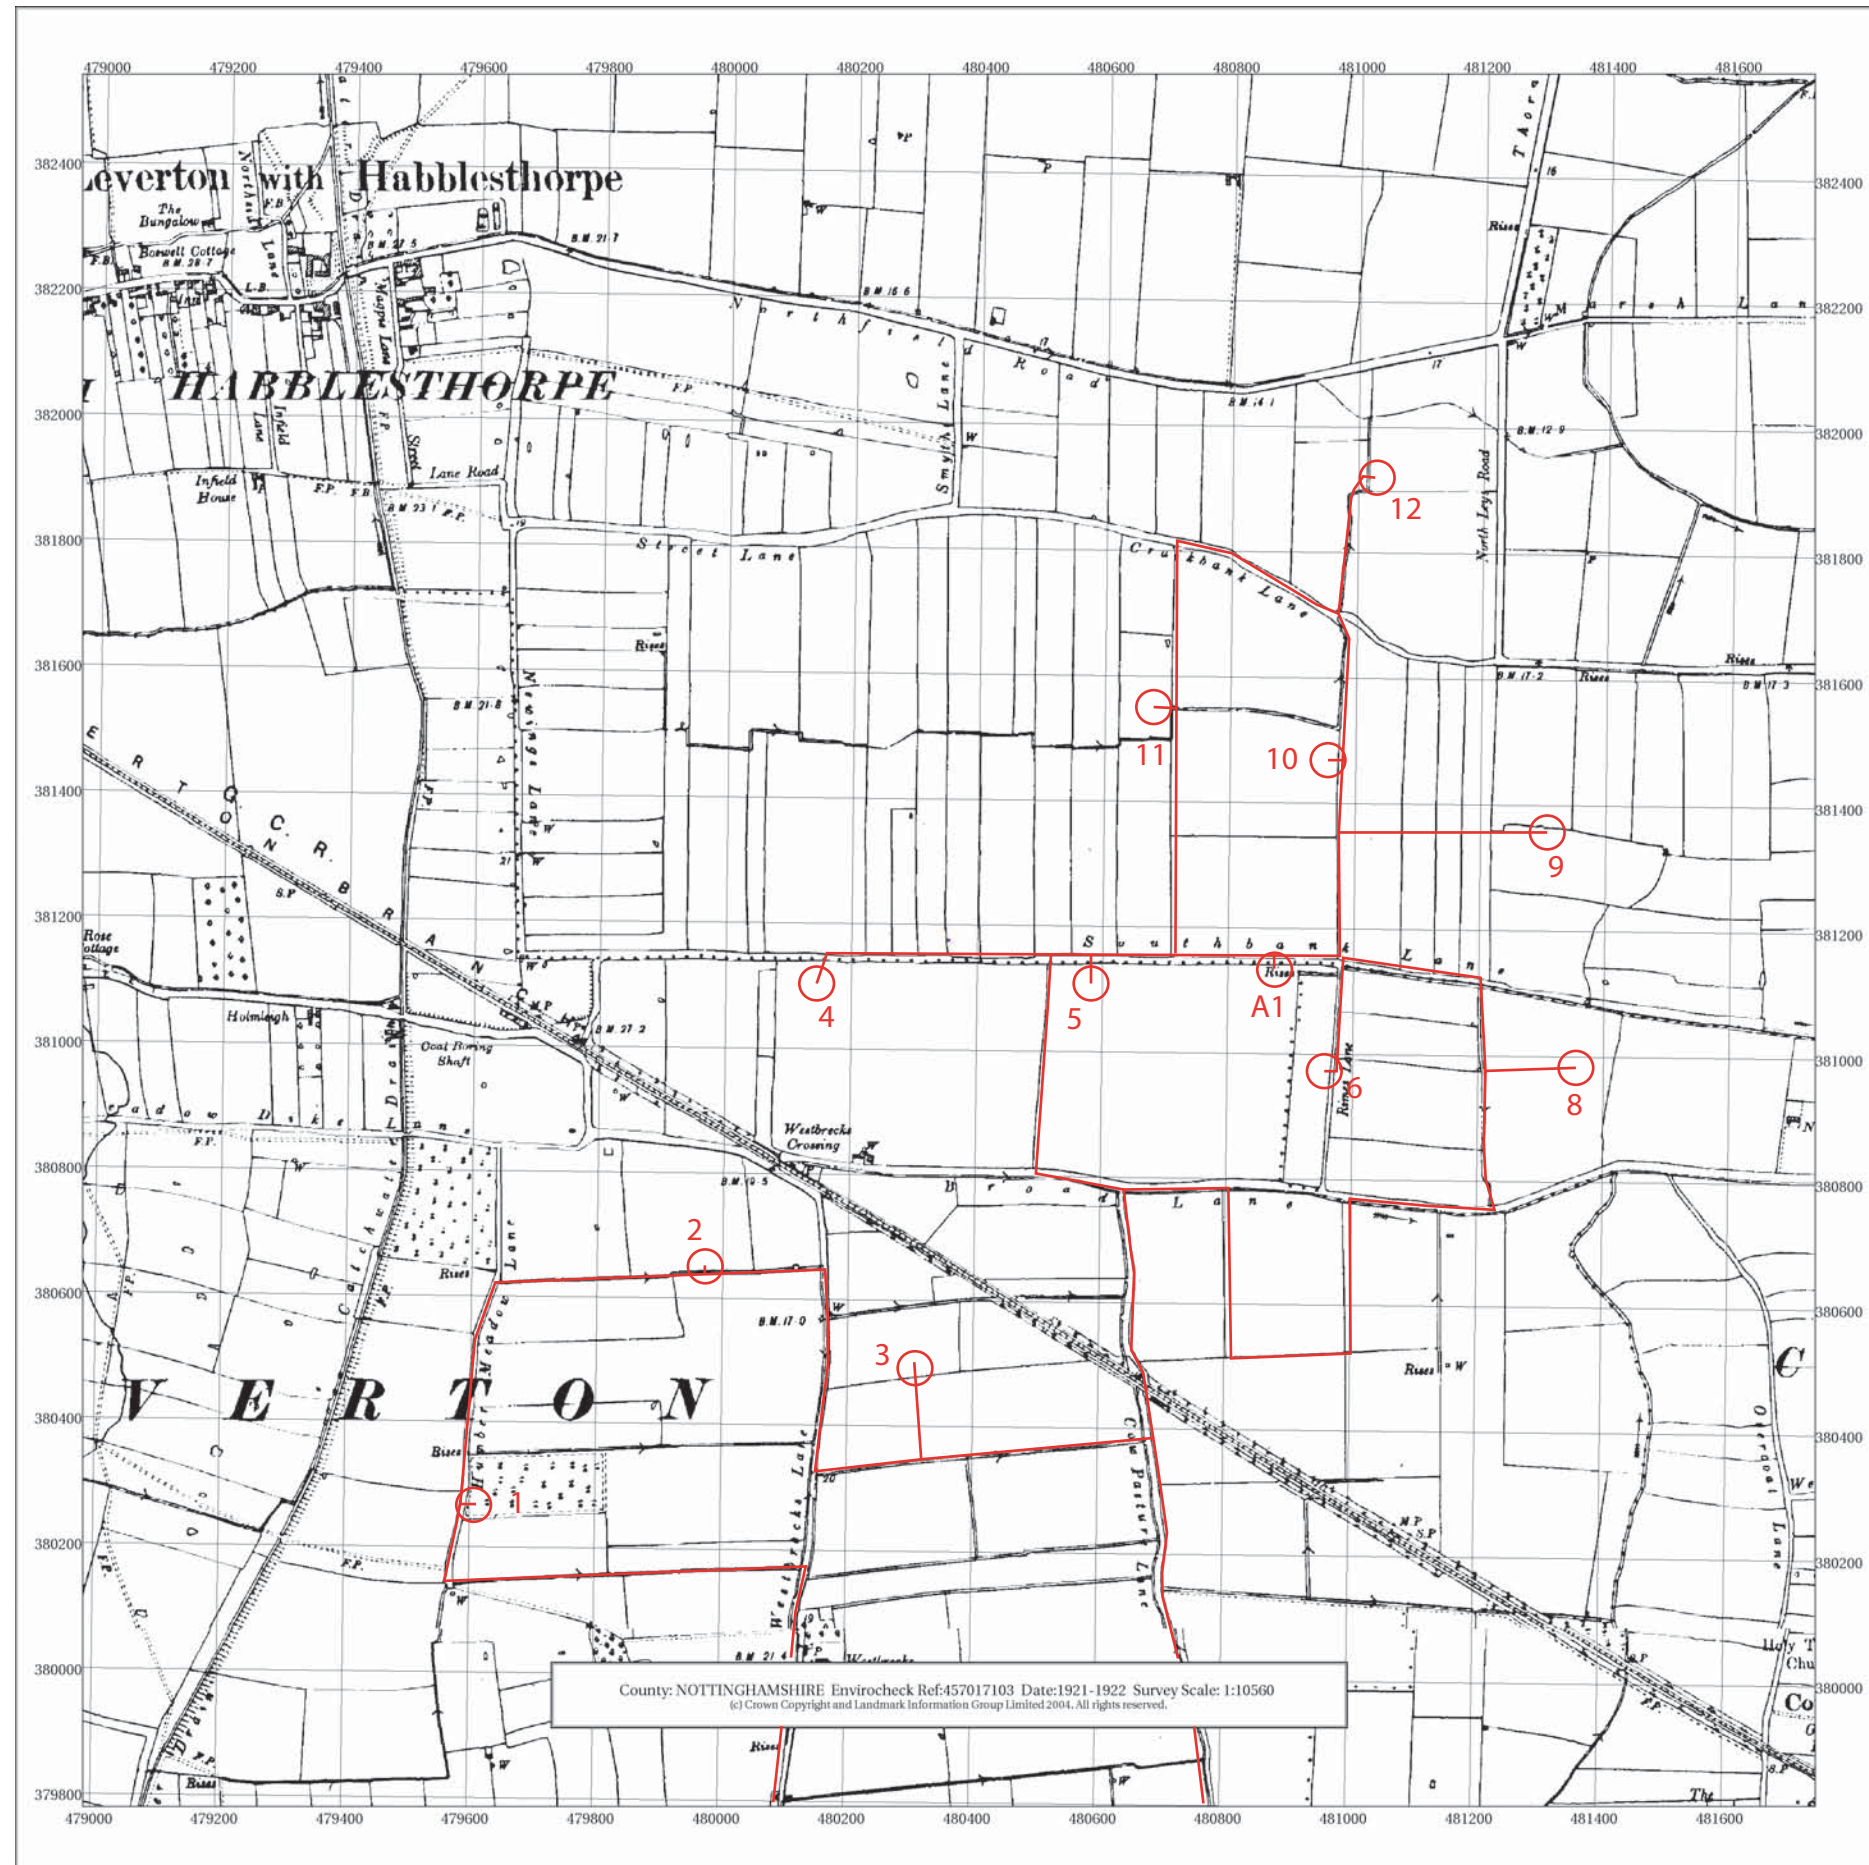
Fig 7: 1921-22 3rd Edition Ordnance Survey map with proposed locations of Turbines overlaid in red

- 5.1.4 The 1921-22 Ordnance Survey map (Fig 7) again shows a largely unchanged landscape in the area of proposed development. The plantation south of Turbine 5 now appears to have been completely removed. Also, an area around the location of Turbine 1 appears to have been enclosed and turned into an Osier bed (any of certain Willow trees, especially *Salix Viminalis*, whose flexible branches or twigs are used for making baskets). No other significant changes were noted.

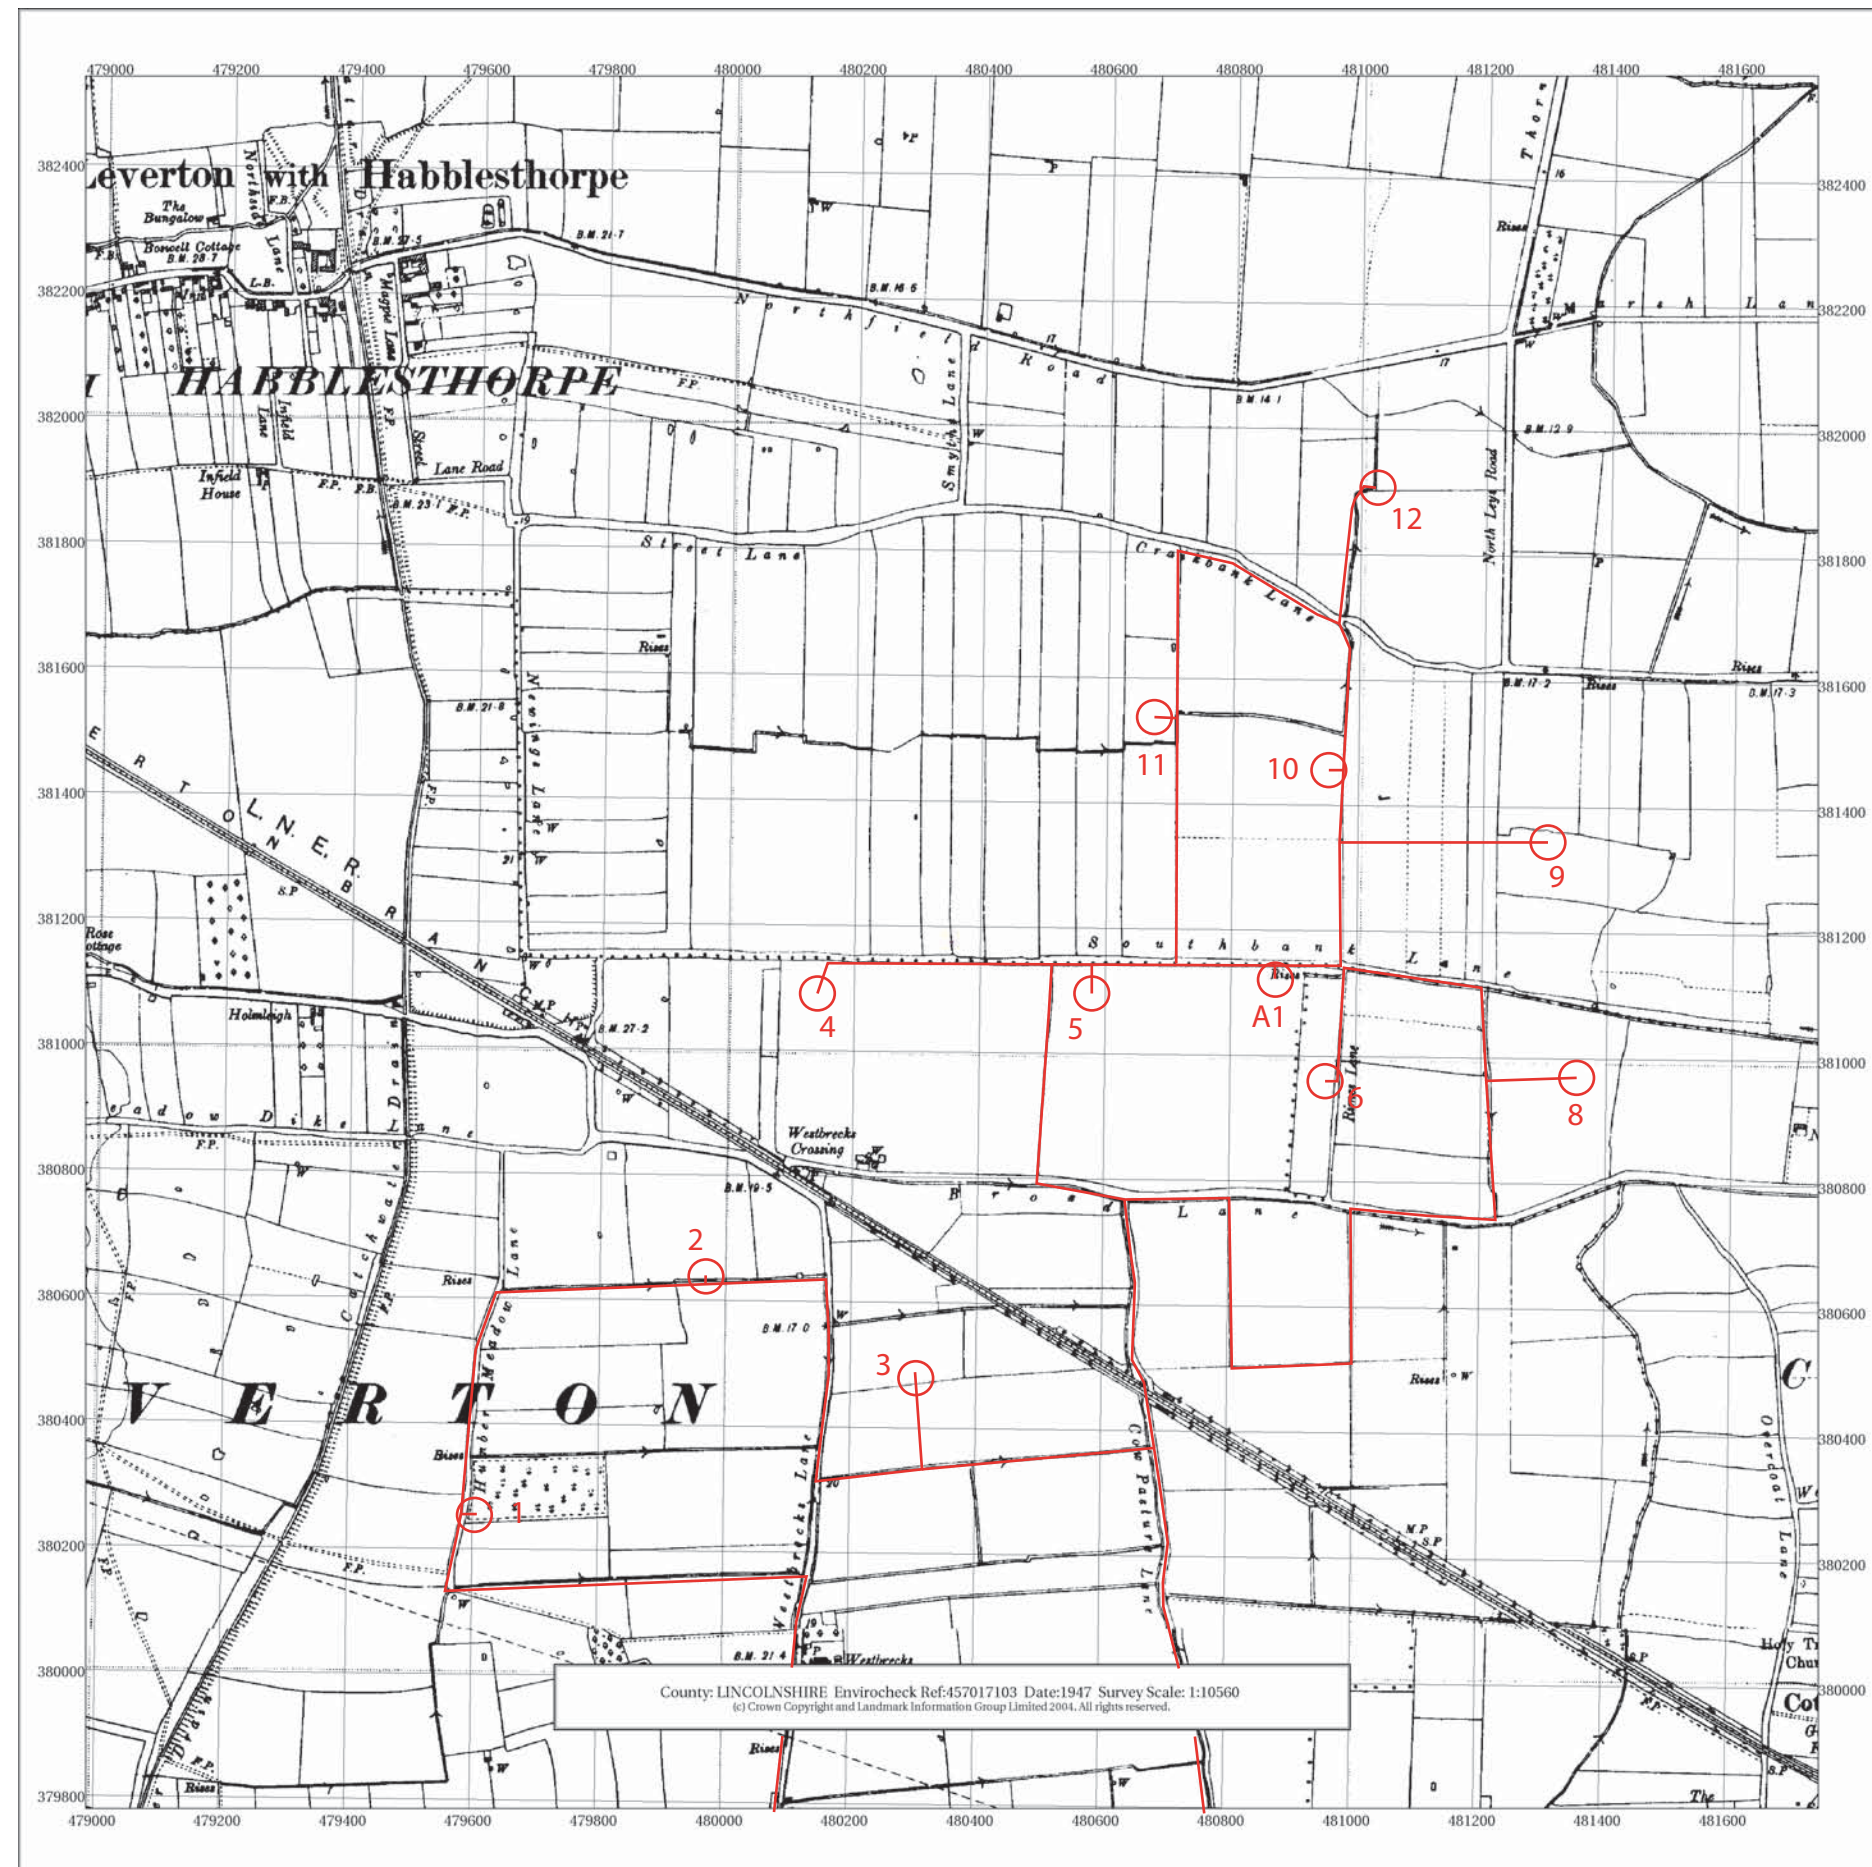
Fig 8: 1947 Edition Ordnance Survey map with proposed locations of Turbines overlaid in red

- 5.1.5 The 1947 Ordnance Survey map (Fig 8) again shows a largely unchanged landscape in the area of proposed development. The Osier bed around Turbine 1 is still in place. Some small changes to boundaries within the assessment area are evident but none with direct relevance to the proposed development. No other significant changes were noted.

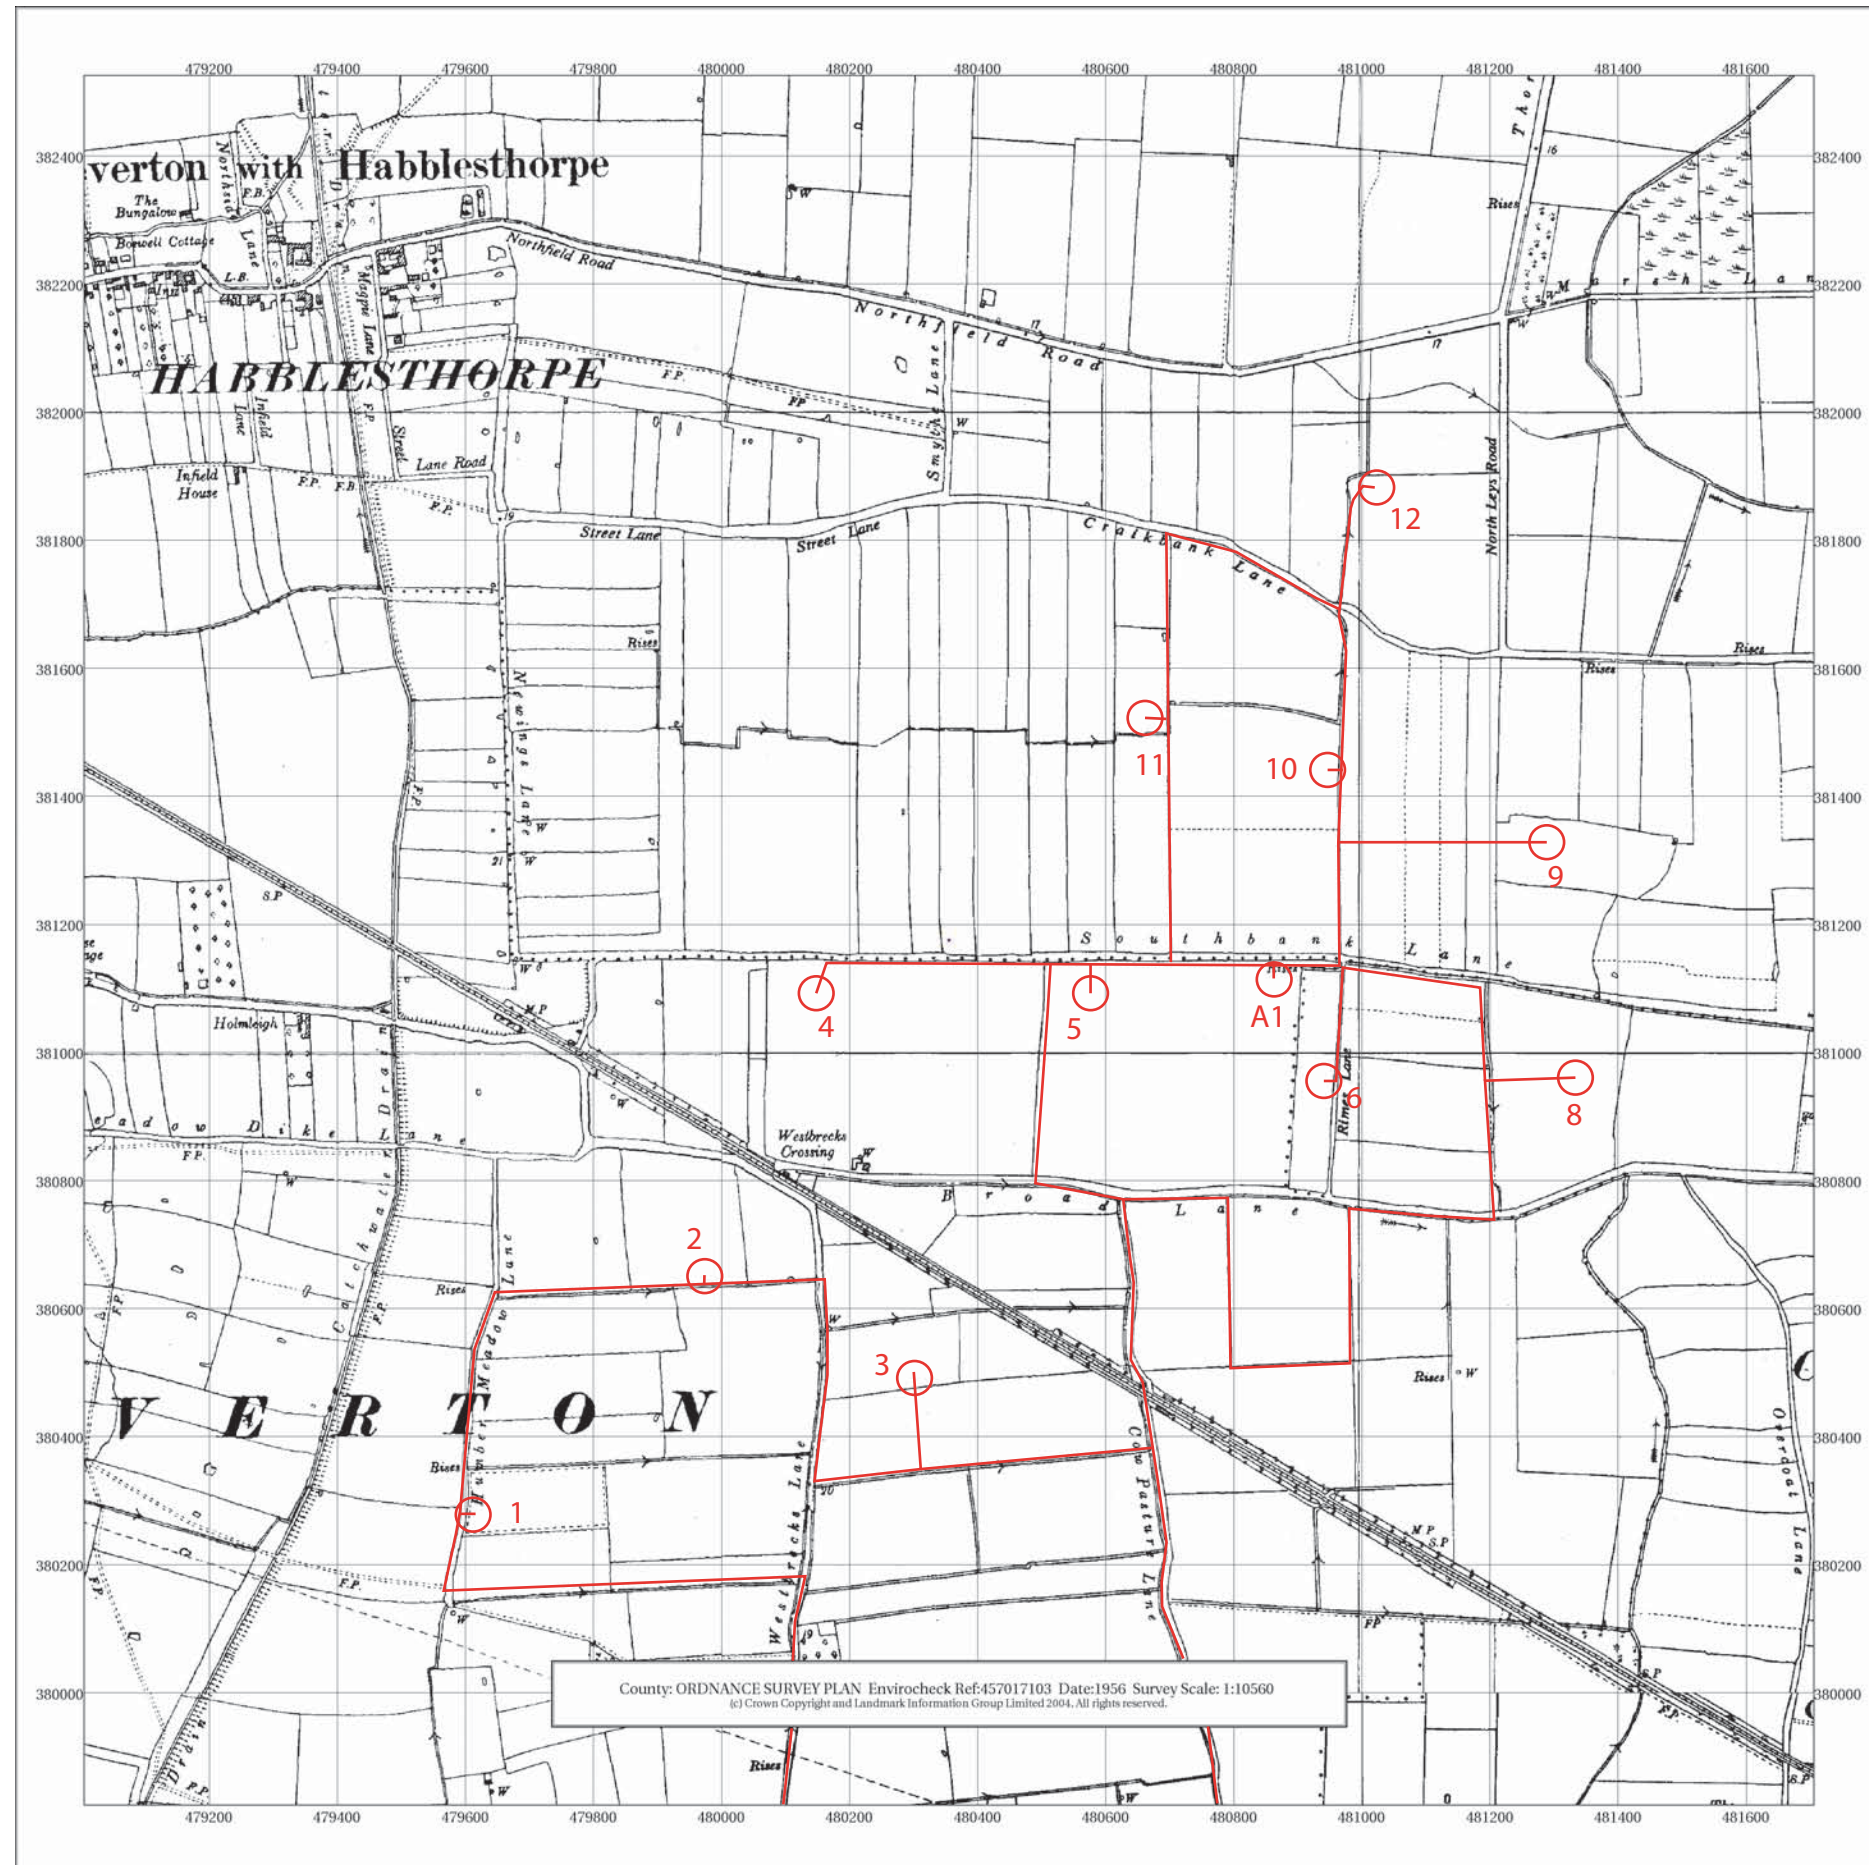
Fig 10: 1978-80 Edition Ordnance Survey map with proposed locations of Turbines overlaid in red

- 5.1.7 The 1978-80 Ordnance Survey map (Fig 10) shows significant change in the field boundaries of the study area since the publication of the 1956 Ordnance Survey map. Field boundary removal appears to have taken place in the area of most of the turbines leading to a much more open landscape. No other significant changes were noted.
- 5.1.8 The 2007 Ordnance Survey map (Fig 11) shows the landscape of the assessment area as it appears today. More boundaries and 'strip' fields appear to have been removed since the publication of the 1978-80 Ordnance Survey map leaving a landscape of largely open fields and drainage ditches. No other significant changes were noted.
