Cottam Wind Farm, Nottinghamshire

Archaeological Desk-based Assessment
&
Field Walkover

CAP Report No. 491

Date: **October 2007**

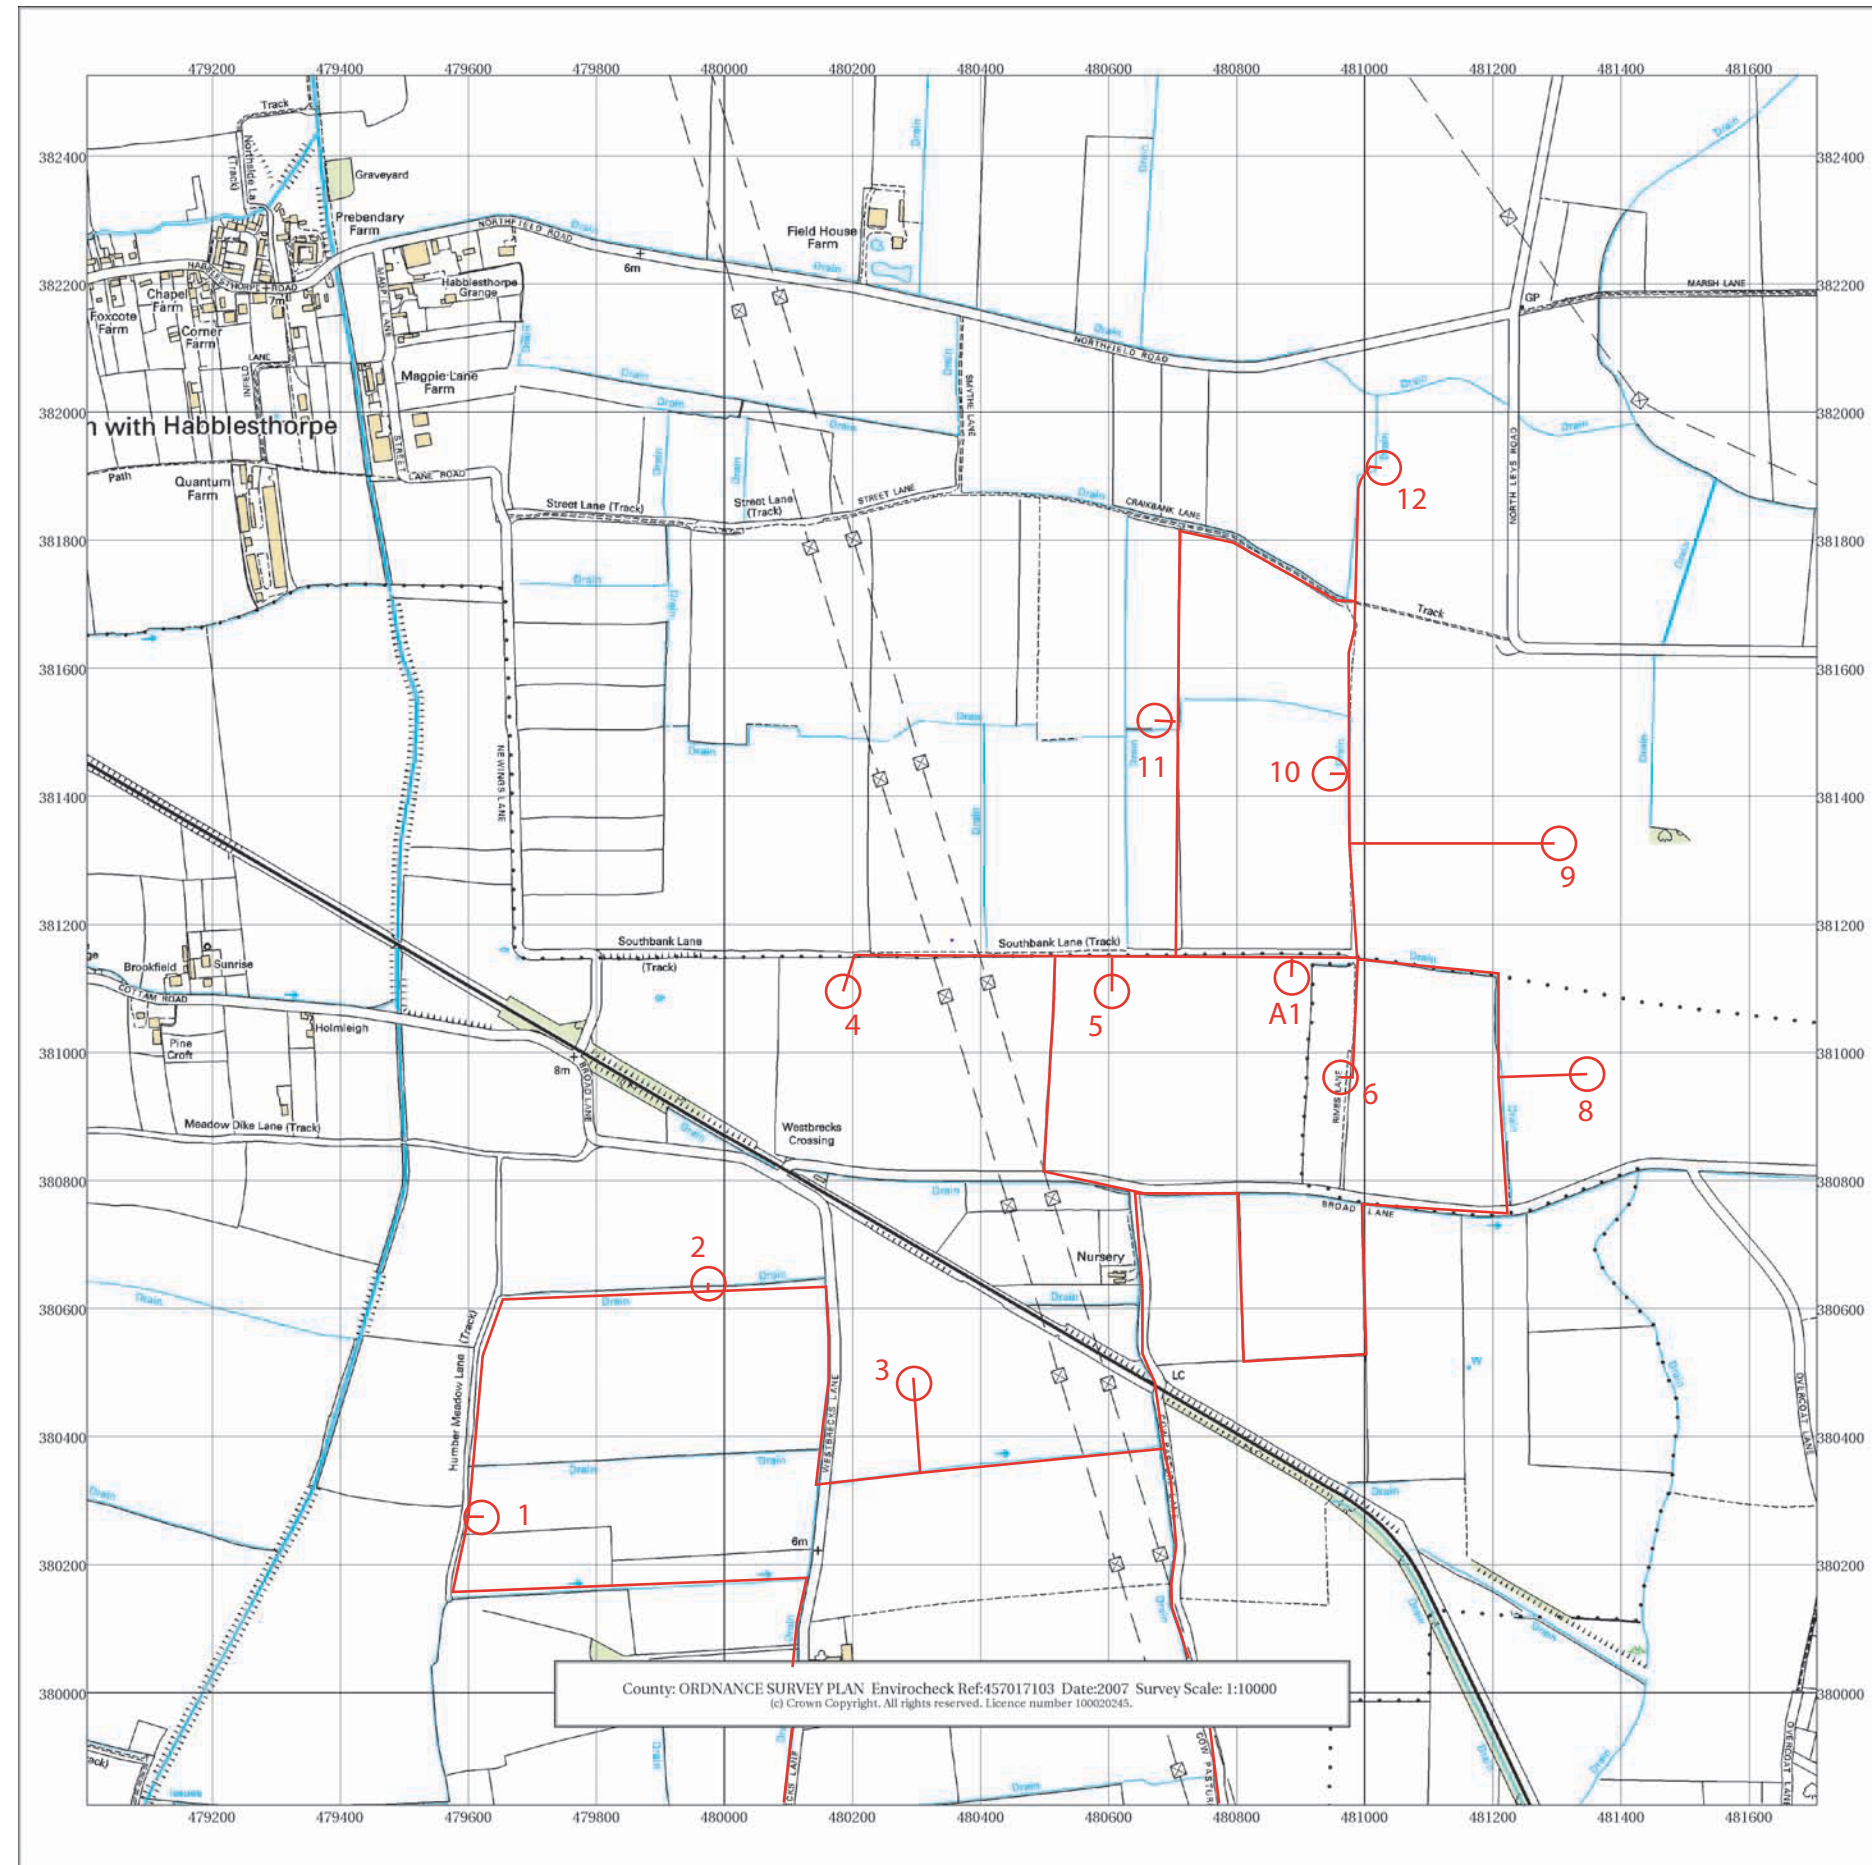
Fig 11: 2007 Edition Ordnance Survey map with proposed locations of Turbines overlaid in red

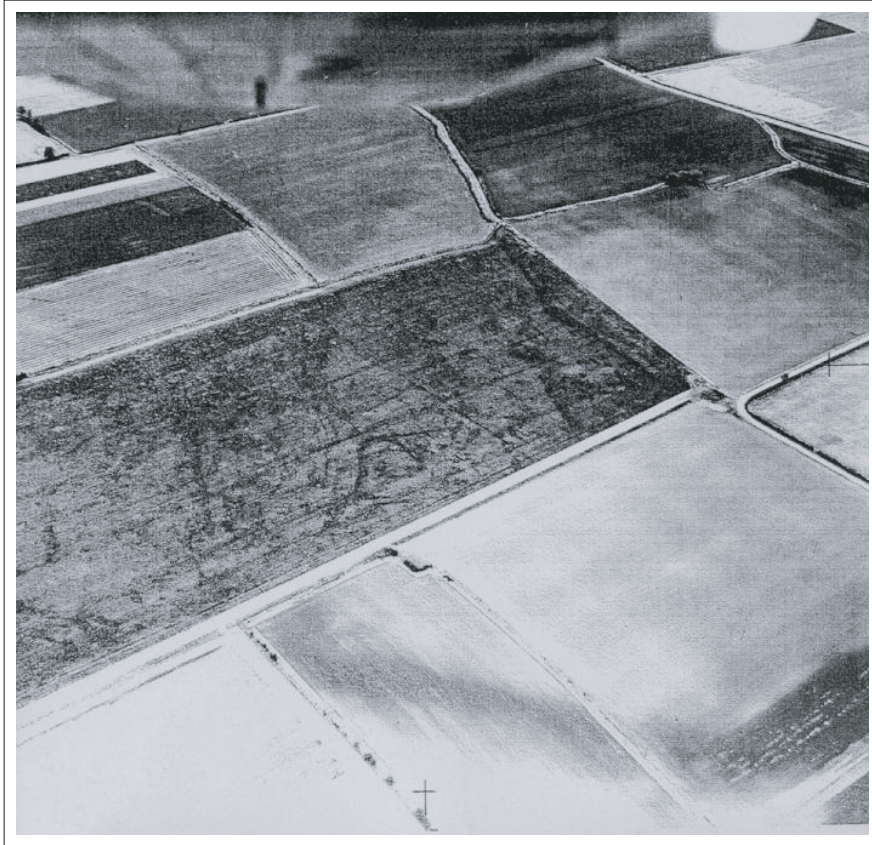
Plate 1: BKR 71 - Cropmarks close to Turbine 9

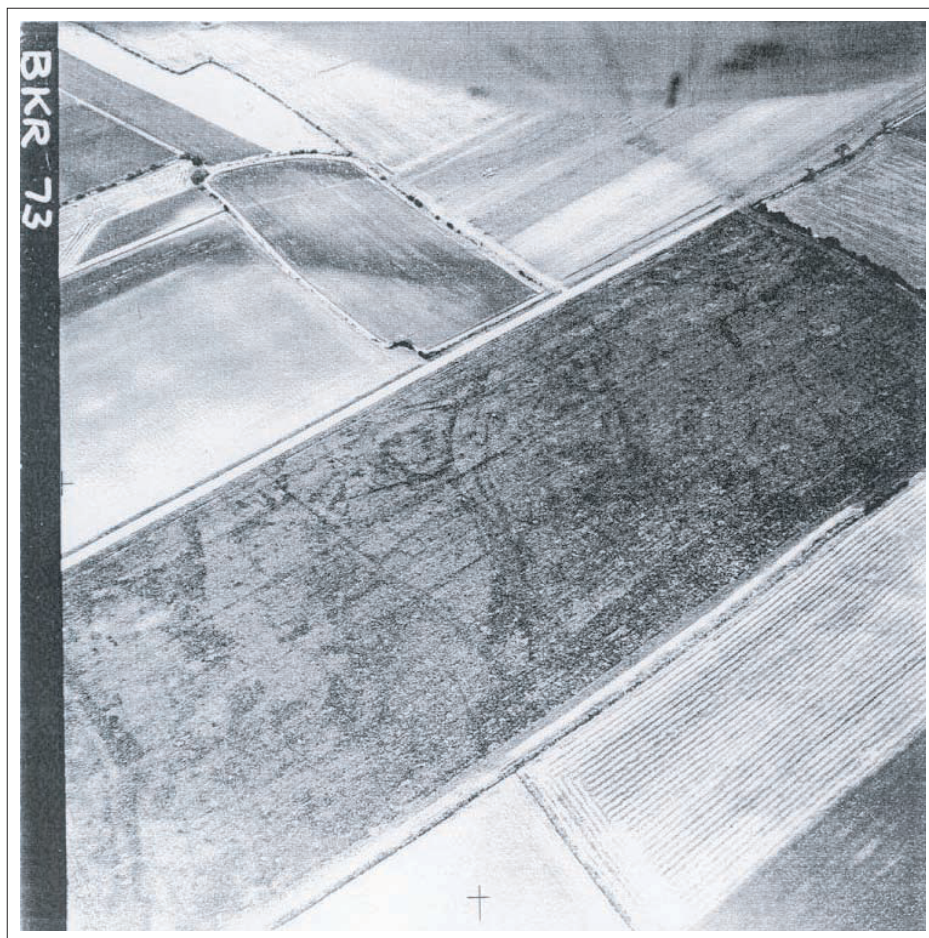
Plate 2: BKR 73 - Cropmarks close to Turbine 9

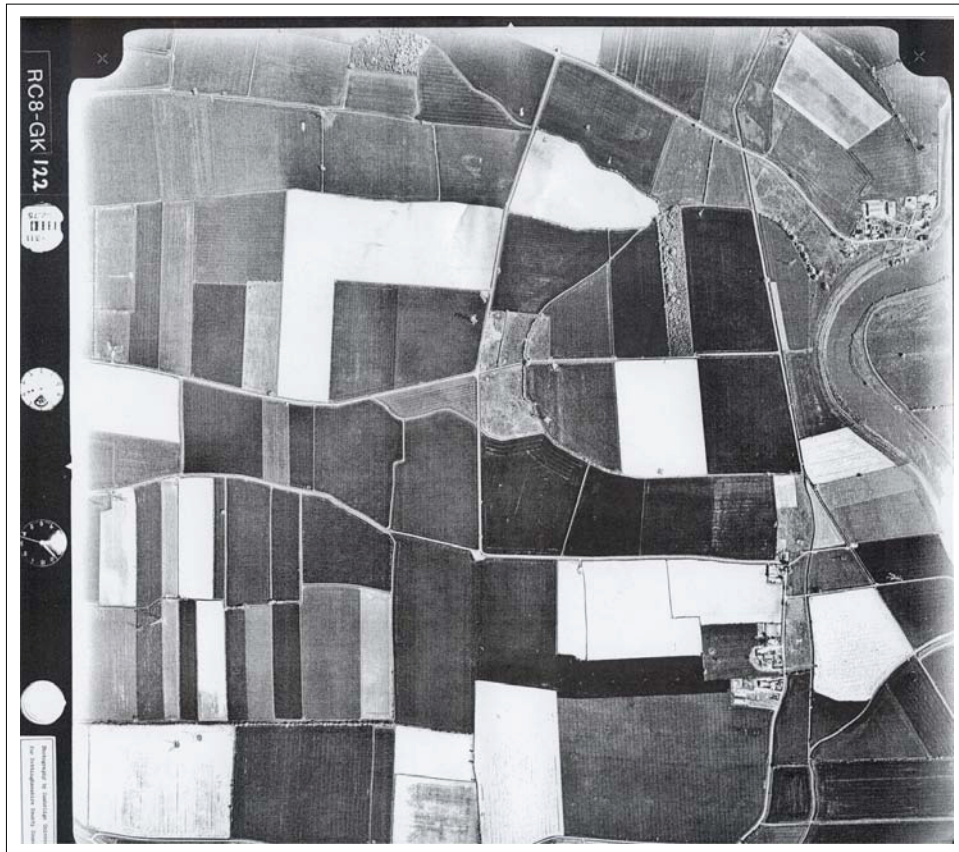
Plate 3: RC8-GK 122 - Aerial Photograph showing the areas of turbines 4 - 12 plus faint cropmarks close to turbines 8 and 6

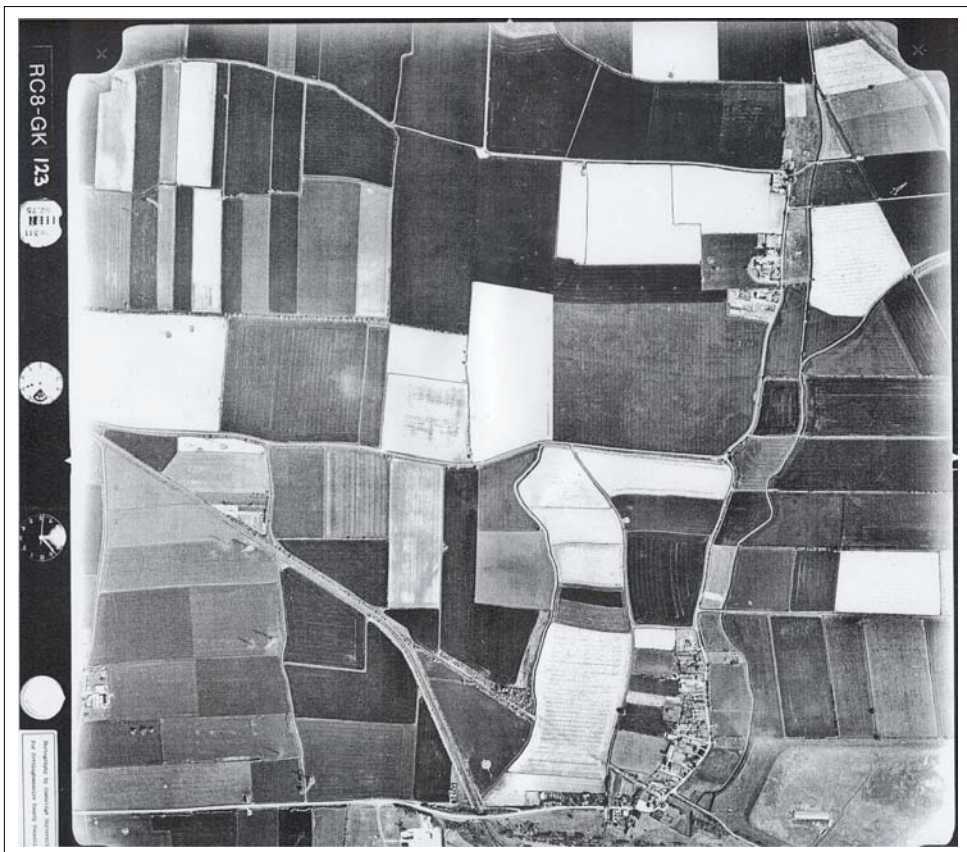
Plate 4: RC8-GK 123 - Aerial Photograph showing the areas of turbines 3 - 12 plus faint cropmarks close to turbines 8 and 6

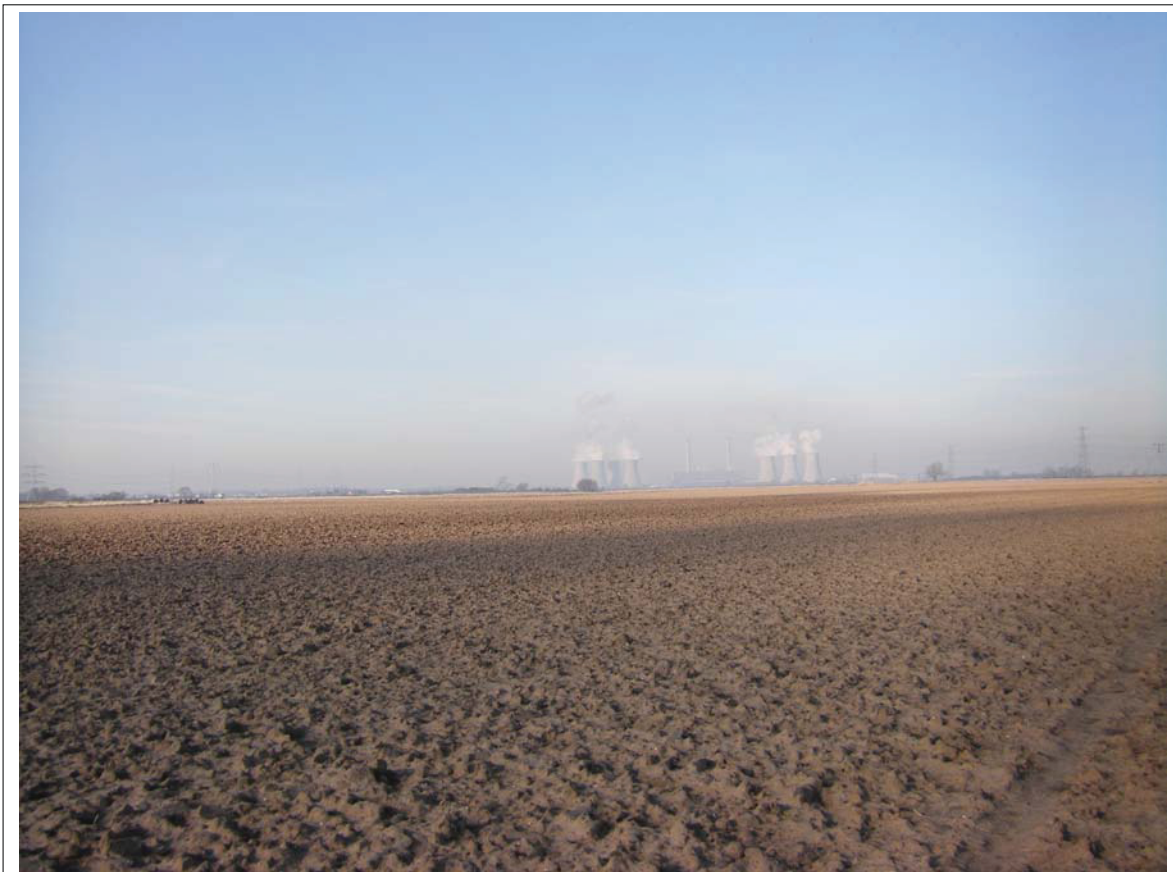
- 6.1.8 Turbine 8 – Plate 5. The area appears flat with no immediately obvious extant archaeological features. Fragments of ceramic building material, pottery of Roman date and worked early Neolithic flint (Pannett, pers.comm) were noted underfoot in the general area of the proposed turbine.

Plate 5: View of general area of Turbine 8, Looking north west towards West Burton power station

- 8.1.5 Turbine 6 is in close proximity to Spot no. 05039a which is marked as a 2nd – 4th century Roman finds scatter.
- 8.1.6 Whilst the field walkover produced finds from the area of Turbine 8 it should be noted that material of unknown date, i.e. pottery, tile and other ceramic building material was scattered over the locations of all of the turbines and access tracks.

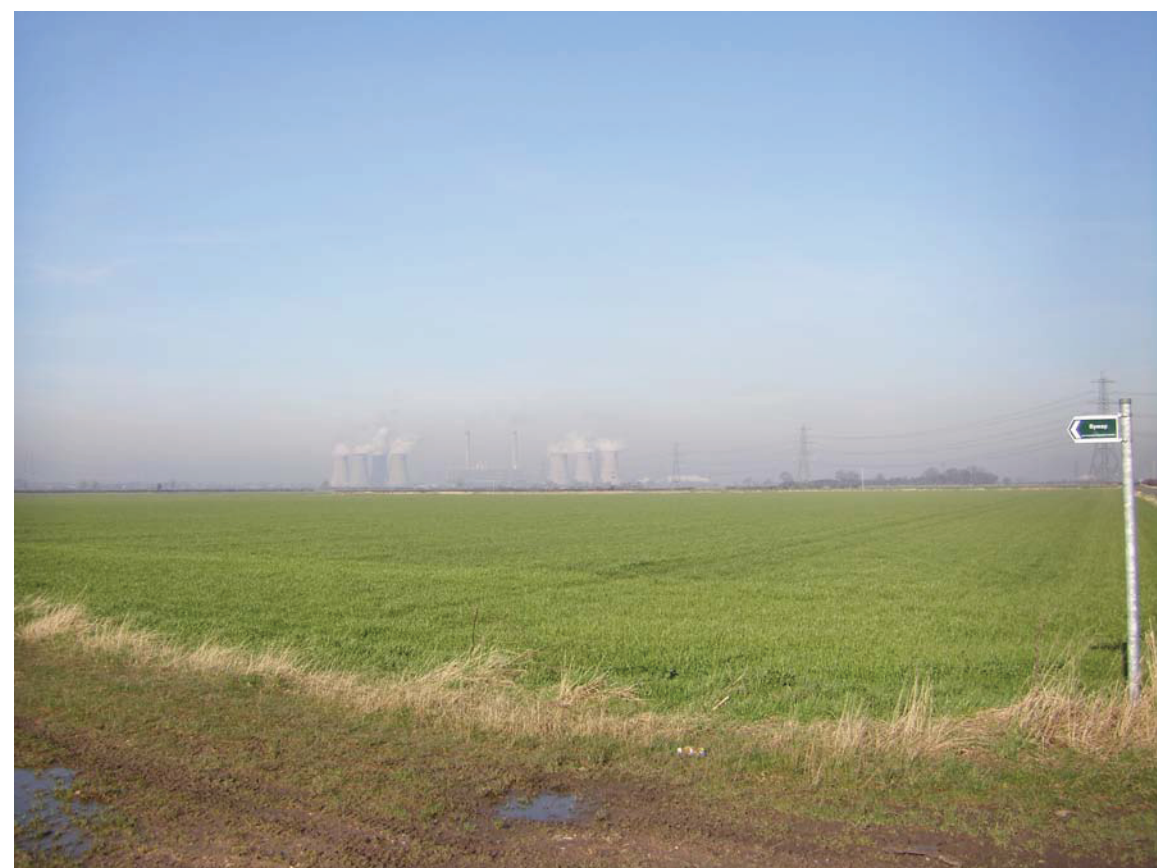
- 6.1.12 Turbine 12 – Plate 6. The area appears flat with no immediately obvious extant archaeological features. Fragments of ceramic building material, pottery, clay pipe, glass and slate were noted underfoot in the general area of the proposed turbine. This material has been ploughed into the field in recent years after a spoil heap at ‘Muckhill corner’ (the corner in the road to the north west of turbine 9) was largely flattened (tenant farmer, Pers. Comm.)

Plate 6: View of general area of Turbine 12, taken from 'Muckhill Corner' looking north west towards West Burton power station
