# **Bilton Road, Rugby Bofors Gun Emplacement**

Archaeological Excavation

**CAP Report No. 344**

**Date: October 2004**

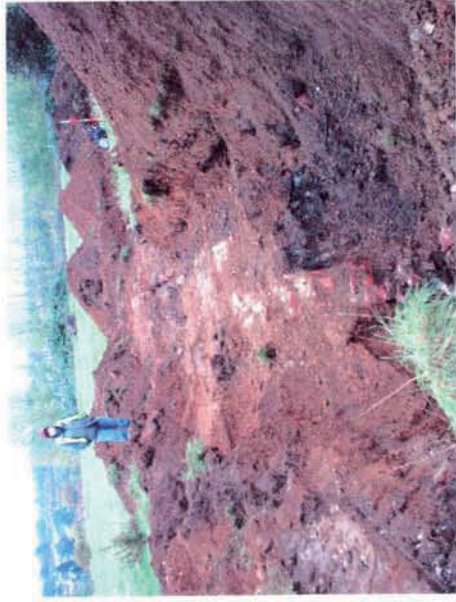
Plate 01: Trench 1 East Wall

The trial trench was excavated revealing two lengths of brick wall with an offset corner, towards the north-east end of the trench (Plate 1). The walls extended north/south for approximately 2 m across the trial trench, at a depth of 0.5 m. To the west of the wall at the northern end was an area of greasy black fill with various bits of wire springs, glass and fabrics (Plate 2). This was felt to be consistent with modern dumping implying the possibility that the blackened area may be part of an internal room of the structure.

Trench 1 (Fig 3) was excavated, diagonally across the site revealing a section of brick wall towards the north-east end (Plate 1). As a result of this find, Trench 2 was excavated across the north end of the site to locate the orientation and extent of the structure. Trial trench 3 was found to be superfluous to requirements and was therefore not undertaken.

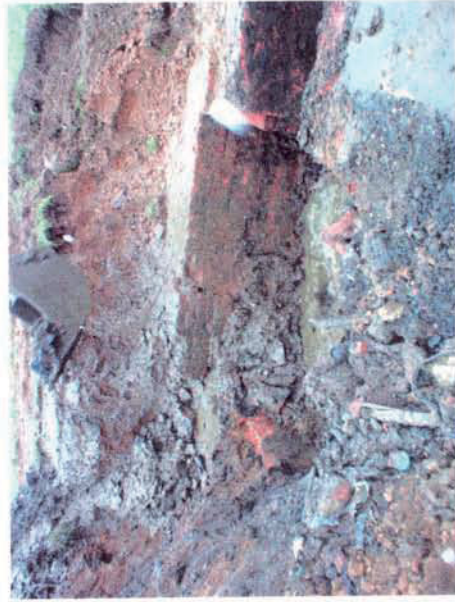
Plate 03: Bunker and steps

The main excavation Trench 4, concentrated firstly on revealing the area of exposed wall in order to determine the size and orientation of the structure. Removal of soil along the north line of the wall resulted in the exposure of the sunken bunker and steps (Plate 3). The depth of the floor of the bunker and the logistics of the working space for the machine then dictated that the best approach would be to locate the southern edge of the structure first allowing it to be uncovered from south to north.

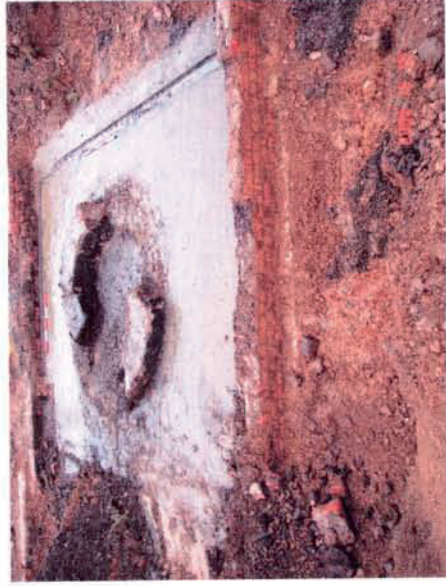
Plate 04: Concrete platform

The concrete platform (Plate 4) measures 7.22 m east/west by 6.4 m north/south with an average thickness of 0.16 m. The foundation for the platform consists of a bed of yellow sand on to which was laid a single layer of house bricks (Plate 5). The concrete was then laid over the top of these and levelled in one section. The edge of the concrete platform has a rough edge with a rounded, upturned lip, (Plate 6) which would indicate that the platform was surrounded by earthen banks rather than any shuttering. There was also no evidence that any foundation trench existed beyond the limit of the existing platform.

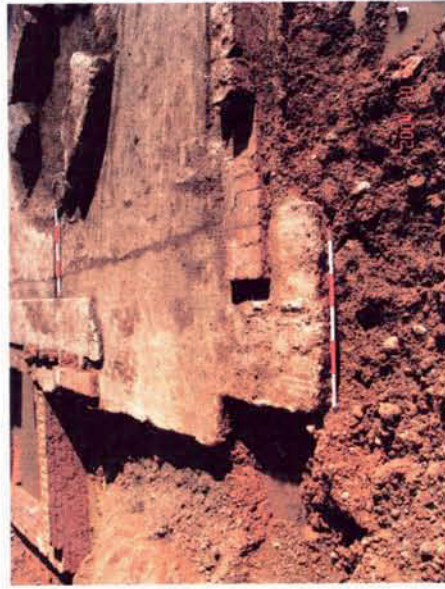
Plate 07: Modified north-west edge

The north-west corner of the platform is foreshortened 0.4 m for a distance of 0.9 m creating an internal cut-out (Plate 7). The westerly edge is also modified in this area, creating an additional section 1.3 m long by 0.2 m wide. The purpose of this feature is unknown.

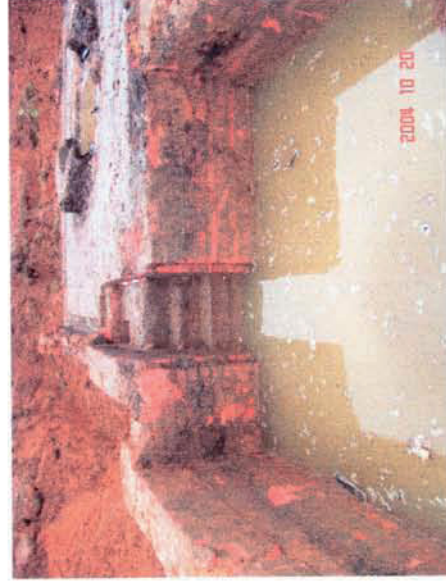
Plate 08: Steps to bunker

The steps are enclosed in an area of 2.01 m by 0.63 m and result in a drop of 1.02 m from the concrete gun platform to the concrete floor of the bunker (Plate 8). Each riser has a depth of 0.2 m except the third step from the bottom which has a fall of 0.22 m. The first two steps from the bottom have a top width of 0.2 m, the third step is 0.22 m, the fourth 0.13 m and the fifth 0.2 m.

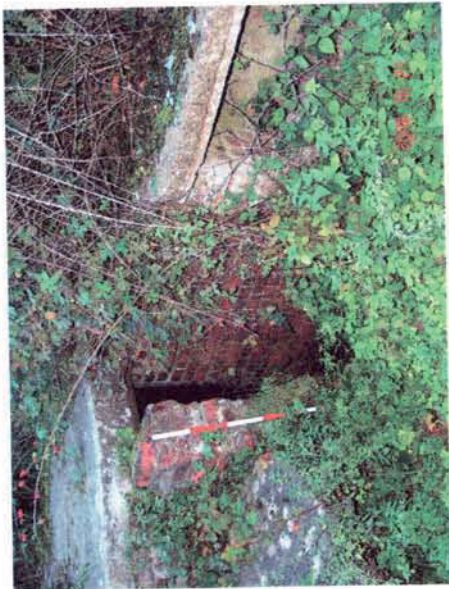
Plate 10: Side entry to steps (Long Lawford)

The steps are shuttered concrete construction with the entrance from the west, as a wall for the magazine used to stand across the south edge, as can be seen in the example from the nearby site at Long Lawford, Rugby (Plate 10).

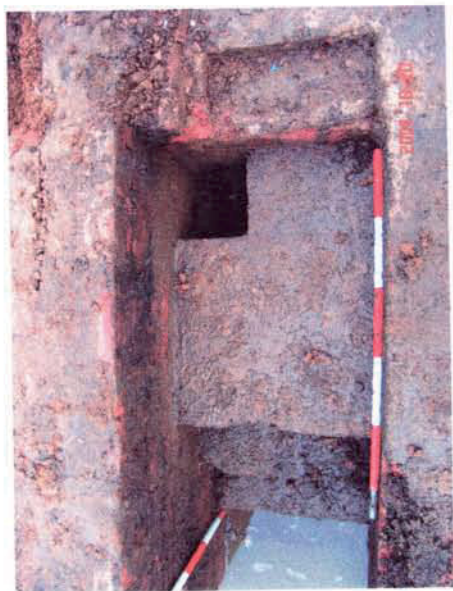
Plate 09: Hole at top of steps

Cut into the south-east corner of the fourth step from the bottom, is a rectangular hole 0.24 m by 0.24 m by 0.24 m of unknown purpose (Plate 9).

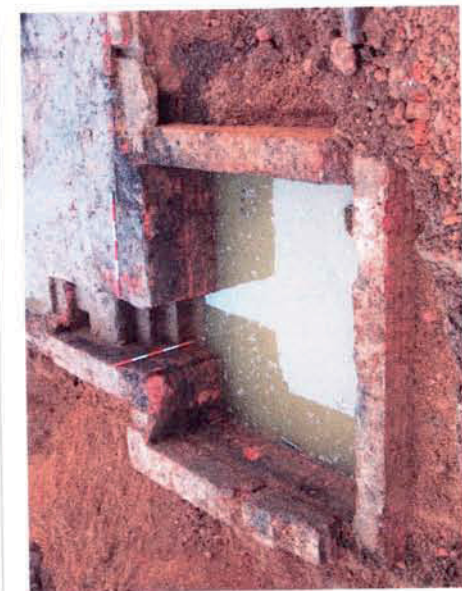
Plate 11: Bunker

The bunker is a solid brick construction measuring, externally 2.98 m north/south by 3.5 m east/west. The internal measurements are 2.82 m by 2.3 m (Plates 11). The bunker has a concrete floor the depth of which is 1.02 m beneath the concrete gun platform. The highest section of remaining wall was to the east at a height of 1.2 m above the bunker floor.

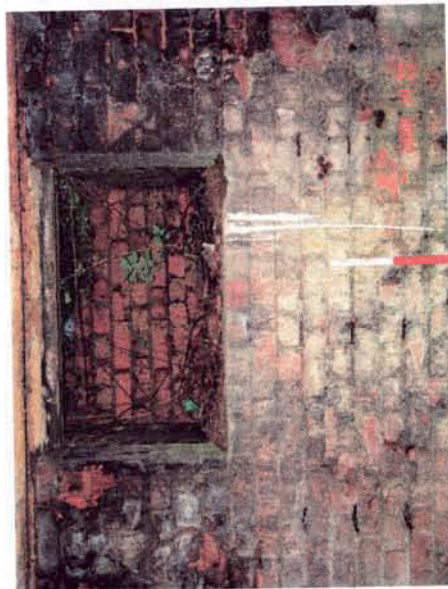
Plate 12: Escape hatch (Long Lawford)

Comparison of the site at Long Lawford, shows that the bunker would have stood at least 2 m above the surface of the gun platform and would have had a concrete roof. The internal structure would have had an opening, possibly an escape hatch, to the north, (Plate 12) and a lowered ceiling at about 1.5 m, to the west (Plate 13) carried. The lowered ceiling would have been carried on a steel lintel about 1.5 m above the floor and serves as the base for the firing room which is unfortunately missing from both structures.

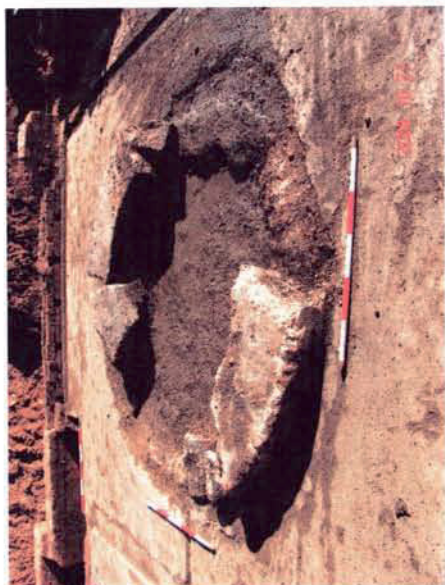
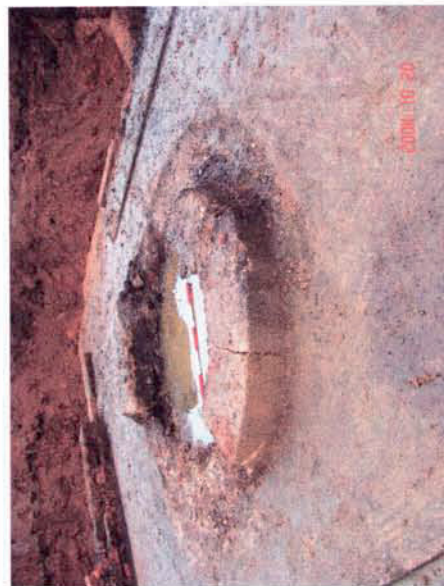
Plate 14: Outer ring of gun hold-fast

The gun hold-fast remains consist of three sections of concrete ring with an outer diameter of 2.7 m and an internal diameter of 1.7 m (Plates 14 and 15). The concrete ring itself therefore has a width of 0.5 m. The ring stands above the concrete base to a height of 0.26 m. Inside the ring the concrete platform has been dropped by a depth of 0.5 m leaving a rough surface (Plate 16) which would suggest that an internal structure has been removed.

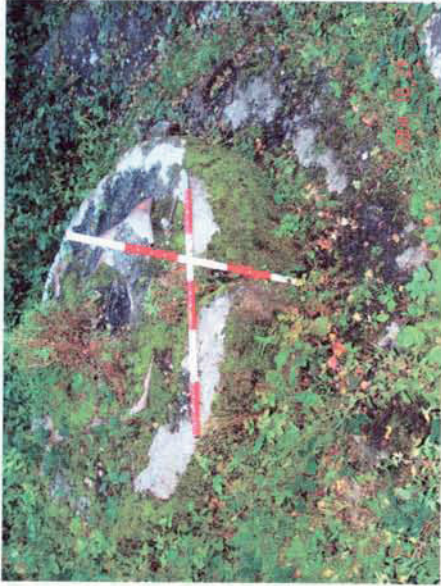
Plate 17: Gun hold-fast (Long Lawford)

The form of the missing structure can be seen at the Long Lawford site (Plate 17). Missing from the Bilton Road site is the upper ring of concrete which encloses a rectangular block of concrete which is surmounted by a metal plate connected by a series of long metal bolts.

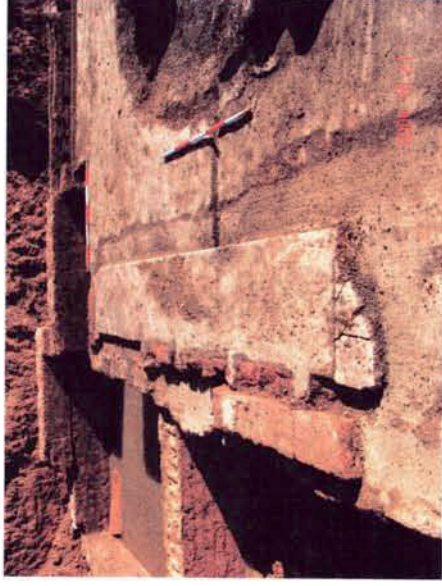
Plate 18: Gulley for firing cable

To the north of the circular ring is a linear gulley cut into the concrete, 0.1 m wide and 0.15 m deep (Plate 18). The gulley runs from the concrete ring and under the north magazine rack to the building that would have stood to the west of the bunker. The gulley used to house the firing cable for the gun which was operated remotely from the missing building.

Three magazines were located on the concrete platform: north, east and west. The remains of the north platform have been reduced to a raised concrete platform which can be seen, running across the picture (Plate 18). Part of the brick wall can also be seen as well as drainage channels formed by concrete extensions between the bricks. Parts of the east and west outer walls survive as lengths of double skin wall; the single skin standing on the inside (Plates 19 and 20). On both the west and east walls drainage channels can be seen as gaps between the bricks.

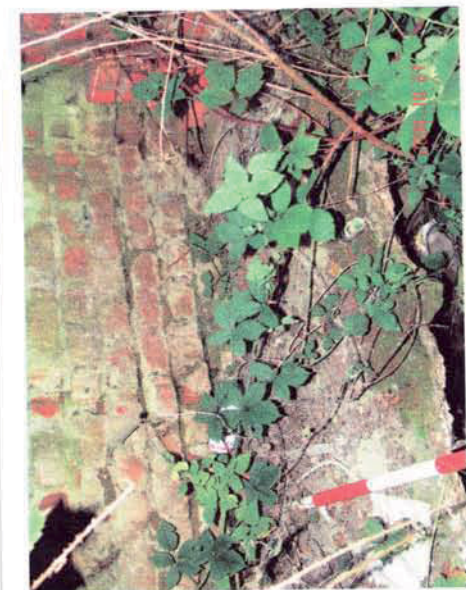
Plate 21: Magazine rack base (Long Lawford)

By comparison with the long Lawford site it is possible to interpret the inner wall as a shelf on which stood a raised concrete platform for holding the ammunition. Plate 21 shows part of the raised platform in place whilst plate 22 shows the underside of the same platform. Plate 22 also

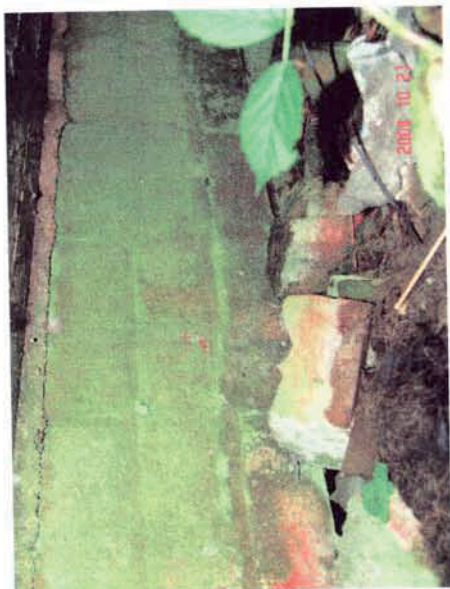
Plate 22: Underside of magazine rack base (Long Lawford)

shows that the height of the platform above the concrete base, at four bricks; the left hand corner of the photograph shows the top of one of the drainage holes left between the lower course of bricks, which can be still be seen in the east and west walls at Bilton Road.

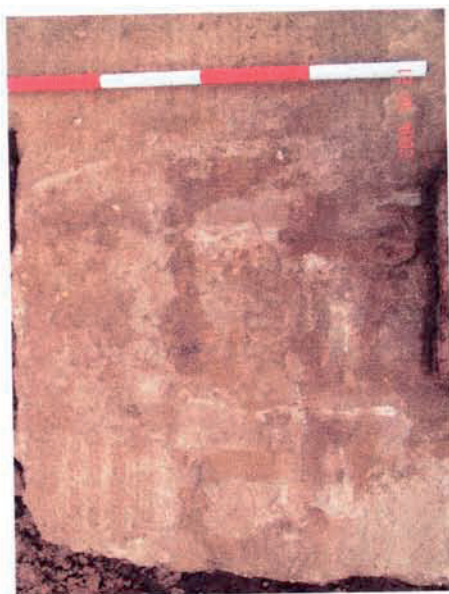
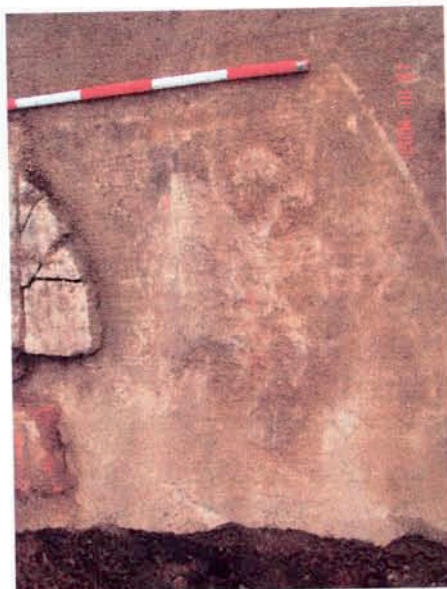
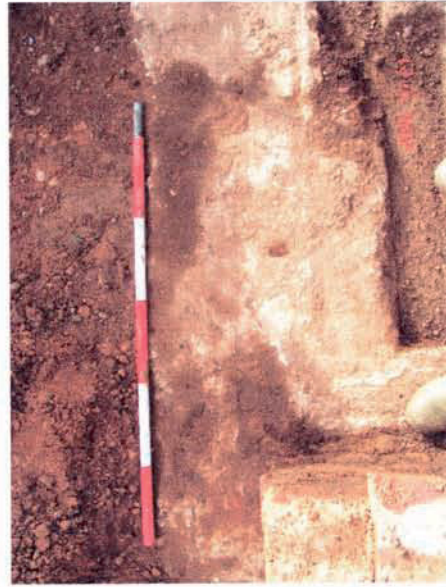
Each of the magazines would have had side walls but none of these remain at Bilton Road although it is possible to detect traces of the brickwork on the concrete floor. Plate 23 shows the position of the northern extreme of the west wall, Plate 24 the west extreme of the north wall and Plate 25 the southern extreme of the east wall.

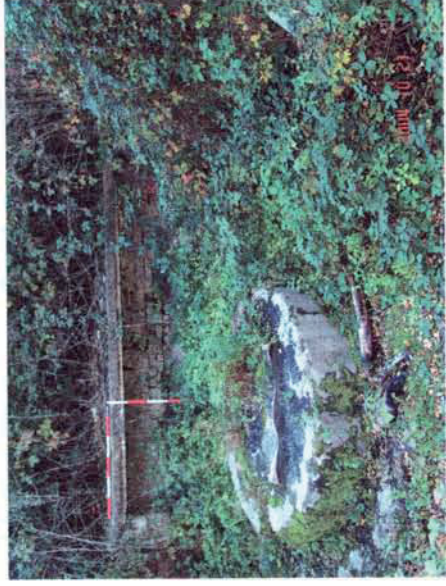
Plate 26: Magazine racks (Long Lawford)

Again the best way to interpret the magazine racks can be gleaned from the Long Lawford site where they exist in a good state of preservation (Plate 26). Plate 27 shows the construction of the concrete shelf; exposed are some steel wires which may have suspended the shelf above the floor so as to remove vibrations caused by the gun.

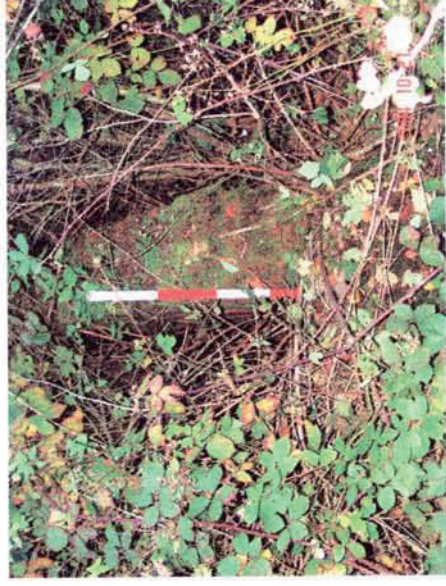
Plate 28: Firing room, front wall (Long Lawford)

The structure of the firing room which would have been located to the north of the platform, adjacent and above the bunker has been lost, however, the Long Lawford site has provided evidence for the existence of such a structure in Plate 13. Further evidence can be seen in Plate 28 which shows the front wall which stands on the edge of the gun emplacement platform.
