Laughton Wind Farm, Lincolnshire

ARCHAEOLOGICAL EVALUATION

CAP Report No. 377

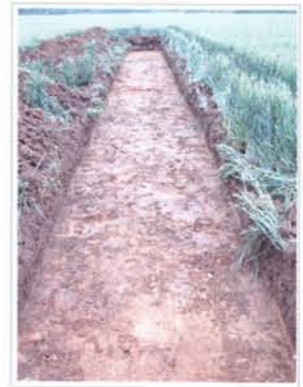
Plate.1: Trench 1 looking north, scale 1m

Trench 1 (Turbine 2) Figs.3, Plate. 1

This trench measured 20m by 1.5m and was excavated to a maximum depth of 0.3m and was excavated across two linear features located by the geophysical survey. After the removal of the plough soil (1) natural compact yellow sand (2) was revealed. A ceramic field drain (3) was then located cut into the natural sand (2) at the northern end of the trench. The field drain appears to account for the linear feature on the geophysical survey.

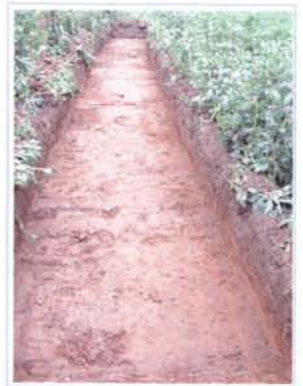
Plate.2: Trench 2 looking north, scale 1m

Trench 2 (Turbine 3) Figs. 3, Plate. 2

This trench measured 20m by 1.5m and was excavated to a maximum depth of 0.3m and was excavated across possible plough marks located by the geophysical survey. After the removal of the plough soil (5) the natural sandy clay (6) was revealed. At the northern end of the trench a former field boundary (8) was recorded, which contained fragments of red brick and tree roots (the boundary is present on the 1907 Ordnance Survey Map). Modern plough scars (9) were also present running north/south along the length of the trench.

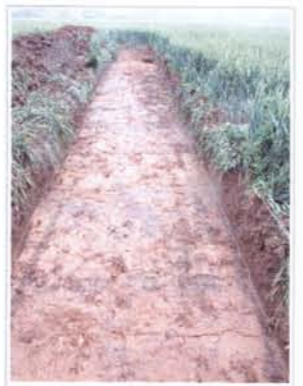
Plate.3: Trench 3 looking north, scale 1m

Trench 3 (Turbine 7) Fig. 3, Plate. 3

This trench measured 20m by 1.5m and was excavated to a maximum depth of 0.3m and was excavated in an area devoid of geophysical anomalies (used as a test for the geophysical survey). After the removal of the plough soil (10) the natural compact sandy clay (11) was revealed. Modern plough scars (12) were located running north/south along the length of the trench.

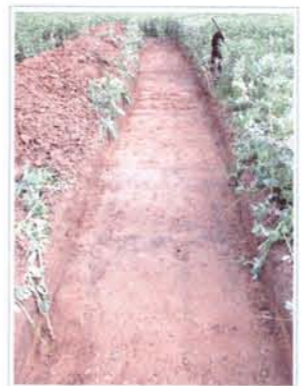
Plate.4: Trench 4 looking north, scale 1m

Trench 4 (Turbine 10) Figs. 3, Plate. 4

This trench measured 20m by 1.5m and was excavated to a maximum depth of 0.3m and was excavated to the northwest of the post-medieval structure located during the geophysical survey. After the removal of the plough soil (13) the natural compact sandy clay (14) was revealed. A ceramic field drain (16) was then located cut into the natural (14) at the northern end of the trench. Modern plough scars (17) were also located running north/south along the length of the trench.
