# Salisbury Cathedral Font

Archaeological Excavation

CAP Report No. 513

## **SALISBURY CATHEDRAL NAVE: EXCAVATIONS FOR THE NEW FONT 2008**

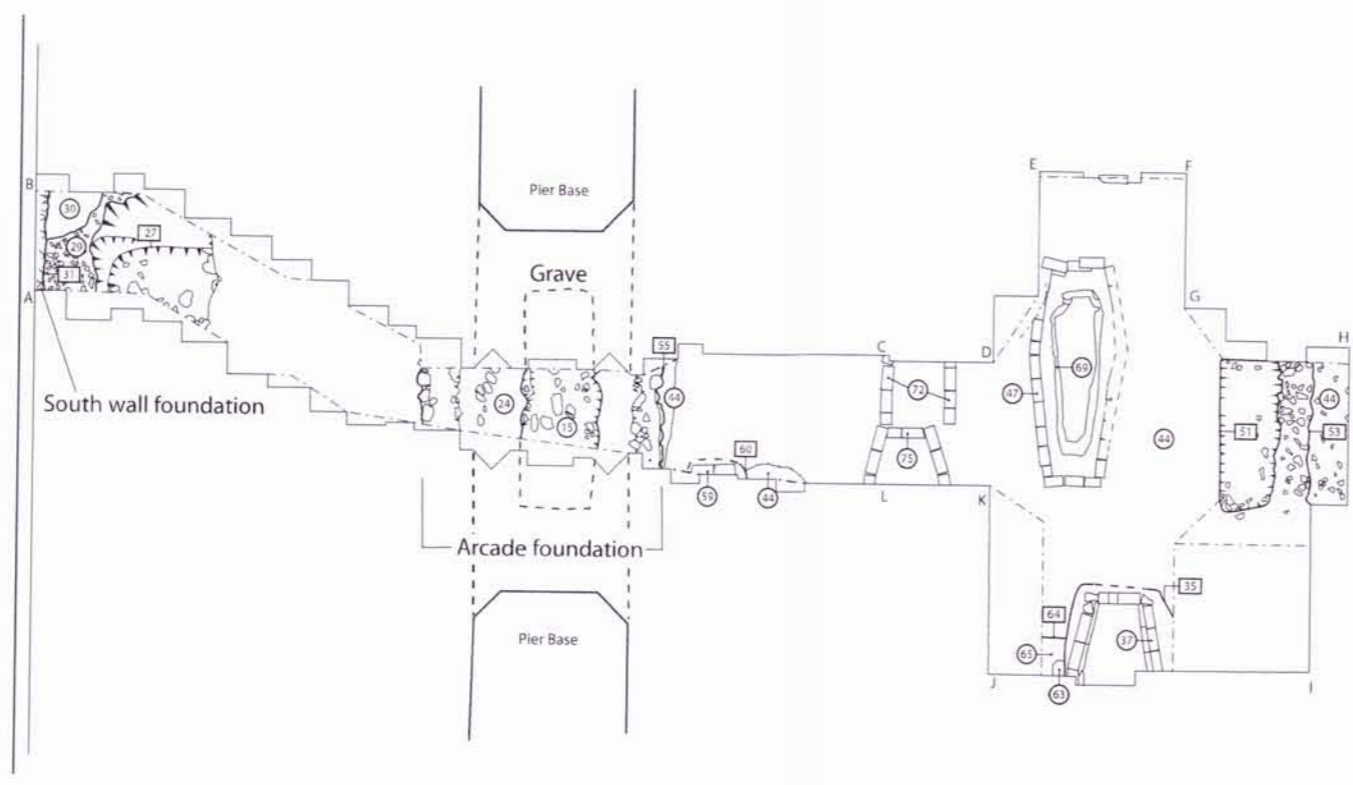
**Figure 03:**

**Drawing Title:** Medieval and Post Medieval Features

The base of the south aisle wall incorporates a stone bench and 0.22m of this wall was exposed below floor level overlying the wall foundation (31, Figs 3 & 6; Plate 7). The faced stone below floor level was of Chilmark-Tisbury stone with distinctive broad, comb tooling clearly visible. This lay on a wall foundation which stepped out 0.12m from the face of the wall and was composed of flint nodules set in a hard buff/yellow lime mortar capped by a thin layer of Chilmark-Tisbury stone fragments as a levelling course for the upstanding wall. A 0.6m depth of the wall foundation was exposed during the excavation, showing layering of the foundation, using remarkably consistent materials, in marked contrast to the foundation of the arcade wall (below).

Extending 0.5m from the south aisle foundation was a 0.05m thick layer of hard buff/yellow mortar (30, Figs 3 & 6; Plate 8) similar to that used in the foundation (31). This marks the construction level of the nave.

Below the south arcade of the nave was found a substantial wall foundation 2.5m wide (24) on which was set a plinth 1.65m wide (Figs 3 & 6; Plates 5-6). The section of plinth in the bay under excavation had been cut away when the floor was re-laid in c.1790, but would originally have extended across this bay, as can be seen in

Approximately centrally placed in the arcade foundation was a grave cut (15, Figs 3 & 6; Plate 4), robbed in c.1790. The grave cut measures 0.65m wide and extended into the foundation to a depth of 0.16m (0.32m below floor level). Given that an arcade plinth originally ran across this bay of the nave, to a height of 0.45m above floor level, then the grave would originally have been 0.77m deep.

Grave 27, 1.36m wide, lay in the south aisle (Figs 3 & 6). The west end of the grave was exposed and excavated to a depth of 0.35m into the natural gravel. The fill of the grave was of layers of pale-mid brown clayey loam containing frequent flint nodules and flecks of white lime mortar. The grave was only excavated to the level required for the insertion of the services to the new font, and did not locate a burial, which remained *in-situ*.

Grave 53, 0.4m wide was situated in the nave, cut by grave 51 (Figs 3 & 6; Plate 9). The fill of grave 53 was of compact clay and flint nodules with flecks of white lime mortar. This was only excavated to a depth of 0.35m and no burial found at this depth, and presumably remains *in-situ*.

Grave 51, which cut grave 53, measured 0.7m wide (Figs 3 & 6; Plate 9). The fill was excavated to a depth of 0.18m, but not bottomed. The fills were of loose mortar rubble and fragments of medieval tile (52), a layer comprised of fragments of

Vault 37 extending into the east side of the trench (Figs 3 & 6; Plate 10). The bricks were fine, rubbed red bricks measuring 225x110x70mm. A burial appears to remain *in-situ* at a depth of 0.75m. This was probably in a wooden coffin. The brick lining survived to within 0.17m of the surface of the floor indicating that this vault must have been capped with a ledger slab directly on top of the brick lining, rather than their having had a vaulted roof. This was probably the method of construction for all of the vaults recorded, since the high water table below the nave precluded deep excavation for burials.

Vault 47 was fully exposed. The bricks were fine, rubbed red bricks measuring 220x110x70mm. Inside the vault was evidence for a triple-layer coffin (Fig 3; Plate 12). The outer layer was of wood, most of which had decayed, with brass studs around the perimeter on leather strips. A single brass handle (plate 15) was visible on the south-west side, whilst two brass plates lay on the coffin. The plate near the foot-end of the coffin was a thick, shield-shaped brass plate engraved and in-filled with black material to make the inscription stand out (Plate 13). The lettering was obscured with lime mortar but has been made complete [in brackets] from the inscription on a nearby ledger slab...

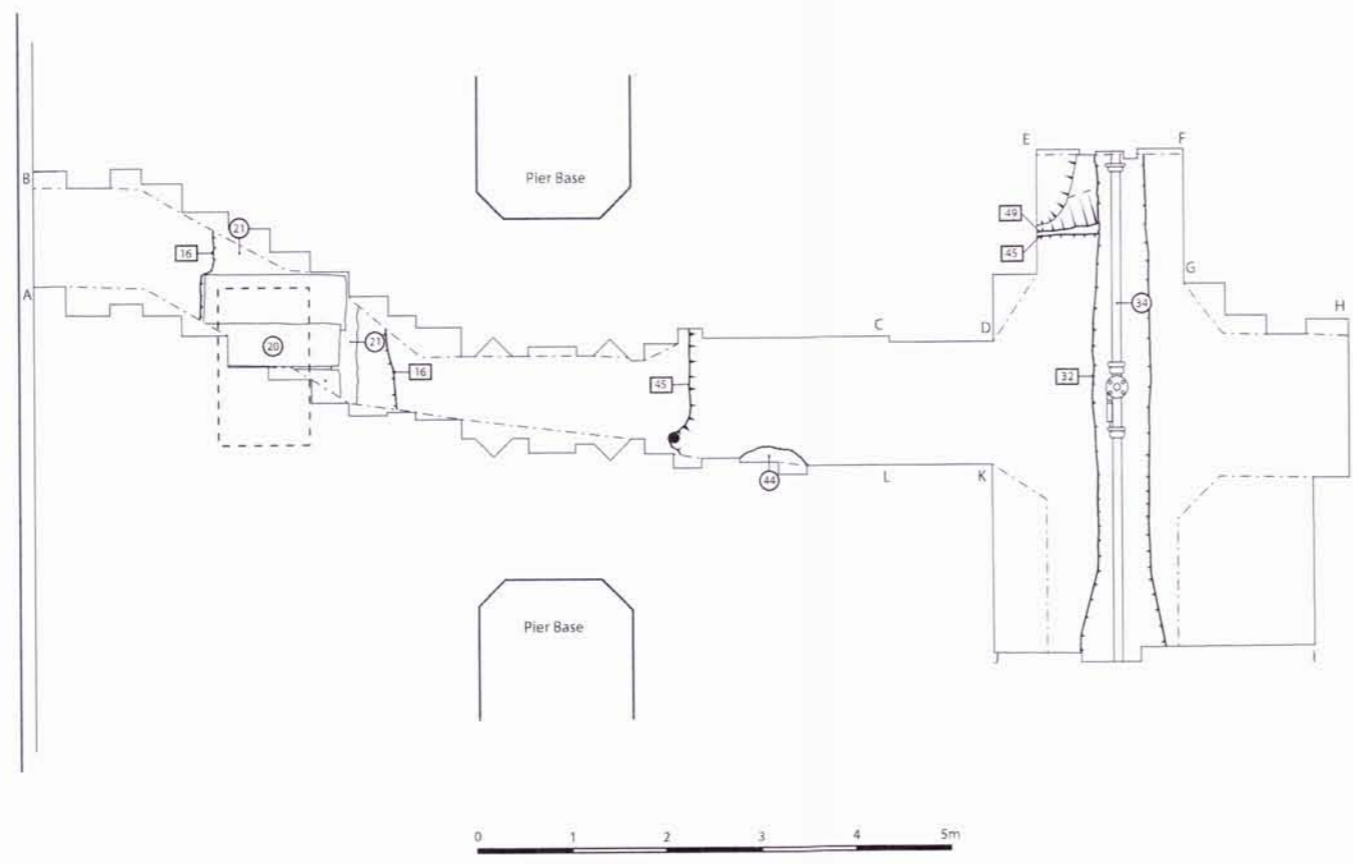
**Figure 04:**

<b>Job Title:</b>	Salisbury Cathedral
<b>Drawing Title:</b>	19th century
<b>Date:</b>	09/03/08
<b>Drawn By:</b>	Chris Smith
<b>Scale:</b>	1:80

The resulting 'clearance' craters were between 0.17 and 0.65m deep (Figs 4 & 6; Plate 18). At the base were three layers (42 of white mortar flecks, 43 of Chilmark-Tisbury stone chippings, and 48 of broken chalk blocks). These layers mark the lower level of disturbance and were spreads of waste materials.

At this level a cast iron water main had been laid along the centre of the nave, with a stop cock and fire hydrant connection in the centre of the bay (Figs 4 & 6; Plates 16-17). The pipe was 0.125m in diameter with lead filled flanges. It had cut through Phase 3 vault 37 and along the north side of Phase 3 vault 47, re-using some of the bricks from the latter to support the pipe.

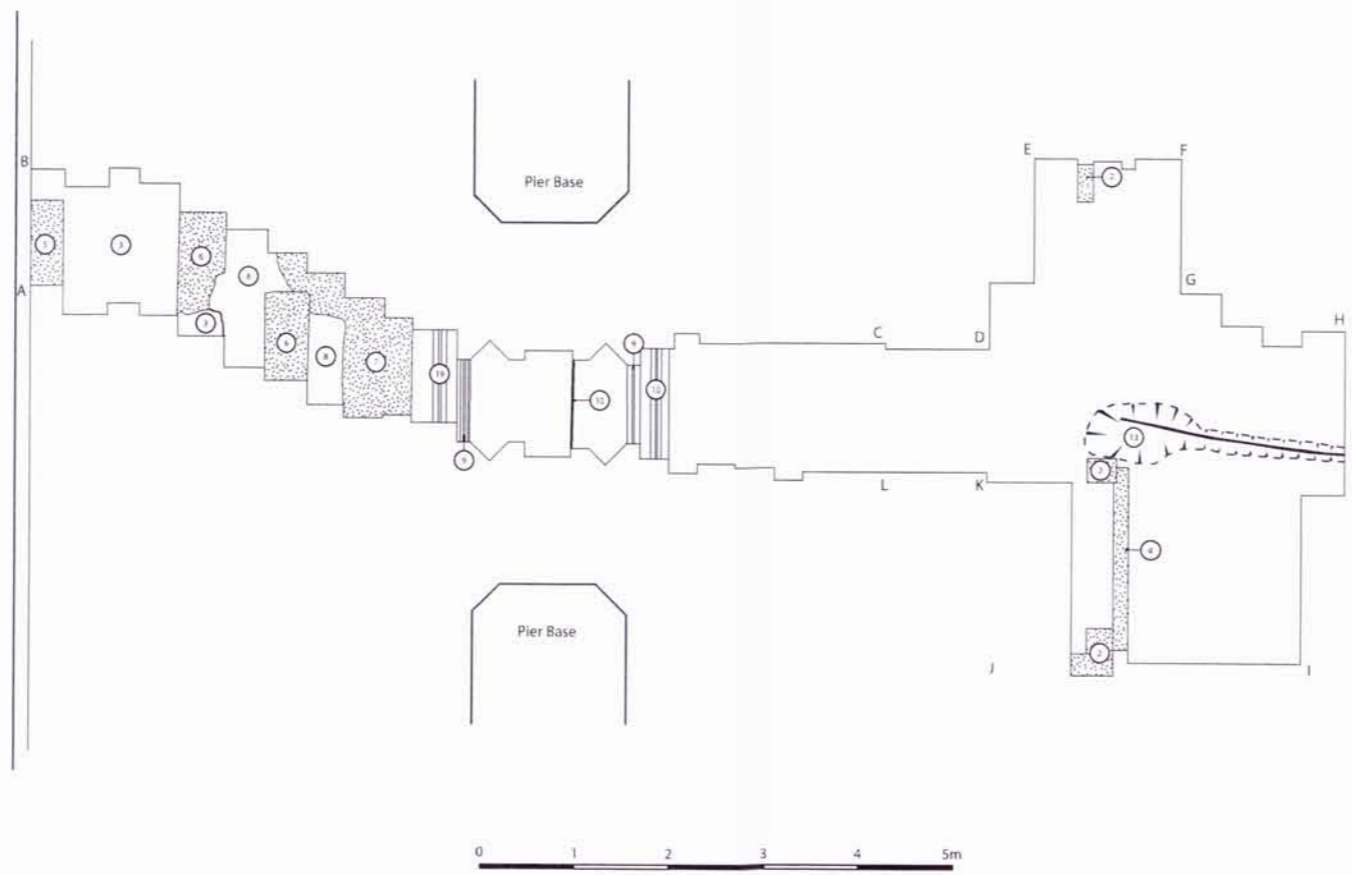
**Figure 05:**

**Drawing Title:** 20-21st century features

In the south aisle was recorded a 1.4m wide duct for electrical pipes made in 1965 (Parsons 1965). This cut to a depth of 0.88m, had concrete walls and floor and was capped with sheets of steel (16, Figs 5 & 6; Plates 27). The north side had metal tubes protruding through the concrete wall, evidently for use in a planned under-floor heating scheme for the nave (which was not introduced). The floor slabs above the duct were re-set in concrete as were later repairs to adjacent floor slabs that had subsided above the metal tubes on the north side of the duct.

pair of earlier pipes were also found. The more recent pipes were insulated (9, Figs 5 & 6; Plates 25-26).

An electrical wire had been chased into a joint between the paving (12), this was no longer in use (Figs 5 & 6).

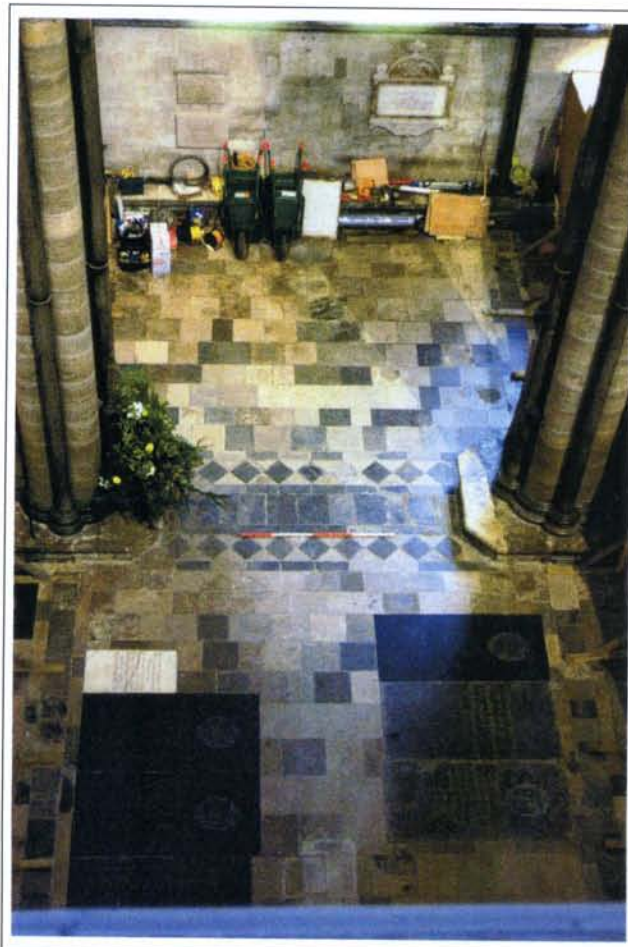
Plate 2: Pre-excavation view of area

*The nave floor* (Fig 2; Plates 2 -3)

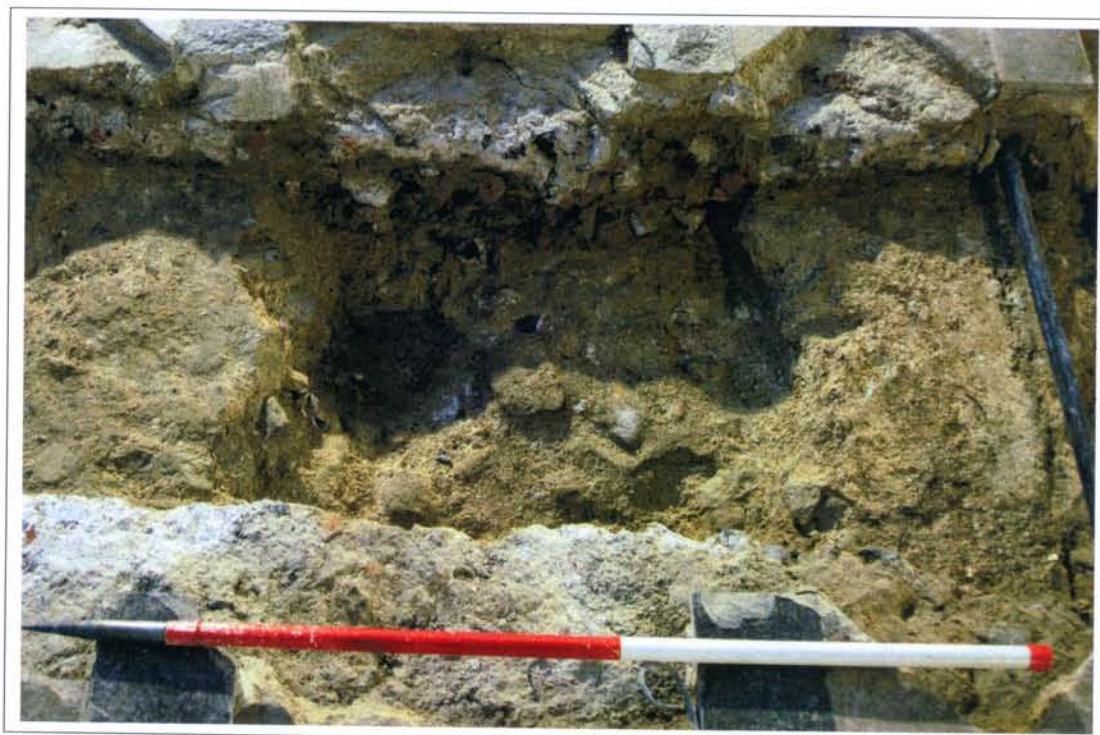
Plate 4: View of Grave 15, Scale 1x1m

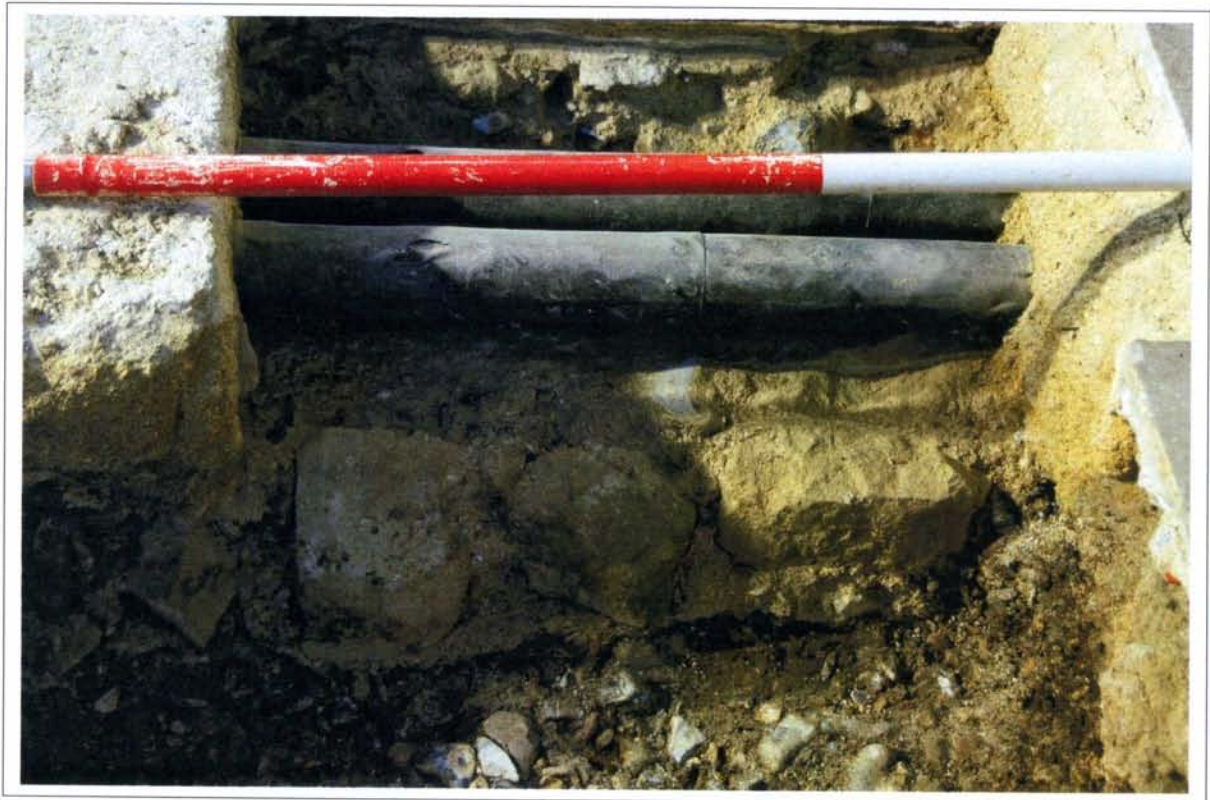
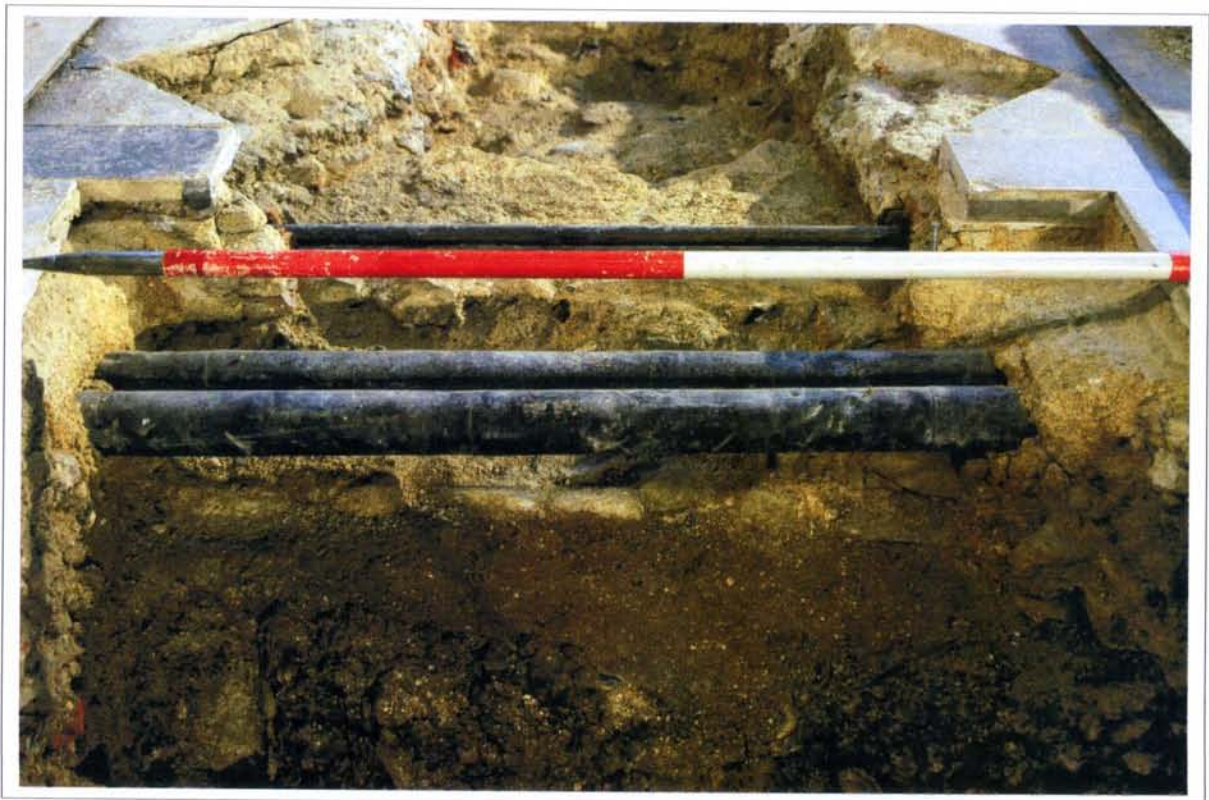
Plate 5: View of south edge of arcade wall

Plate 6: View of north edge of arcade wall, Scale 1x1m

The arcade foundation, located just 0.16m below floor level, comprised a mix of fragments of Chilmark-Tisbury stone, Upper Greensand (re-claimed from Old Sarum), and flint nodules bonded in buff/yellow lime mortar. As noted above, this is in marked contrast to the foundation for the south wall which used just flint and mortar, with no other stone evident, save a shallow levelling layer. The south face of the foundation was vertical, but on the north side the foundation stepped out some 0.15m at a depth of 0.42m below floor level.

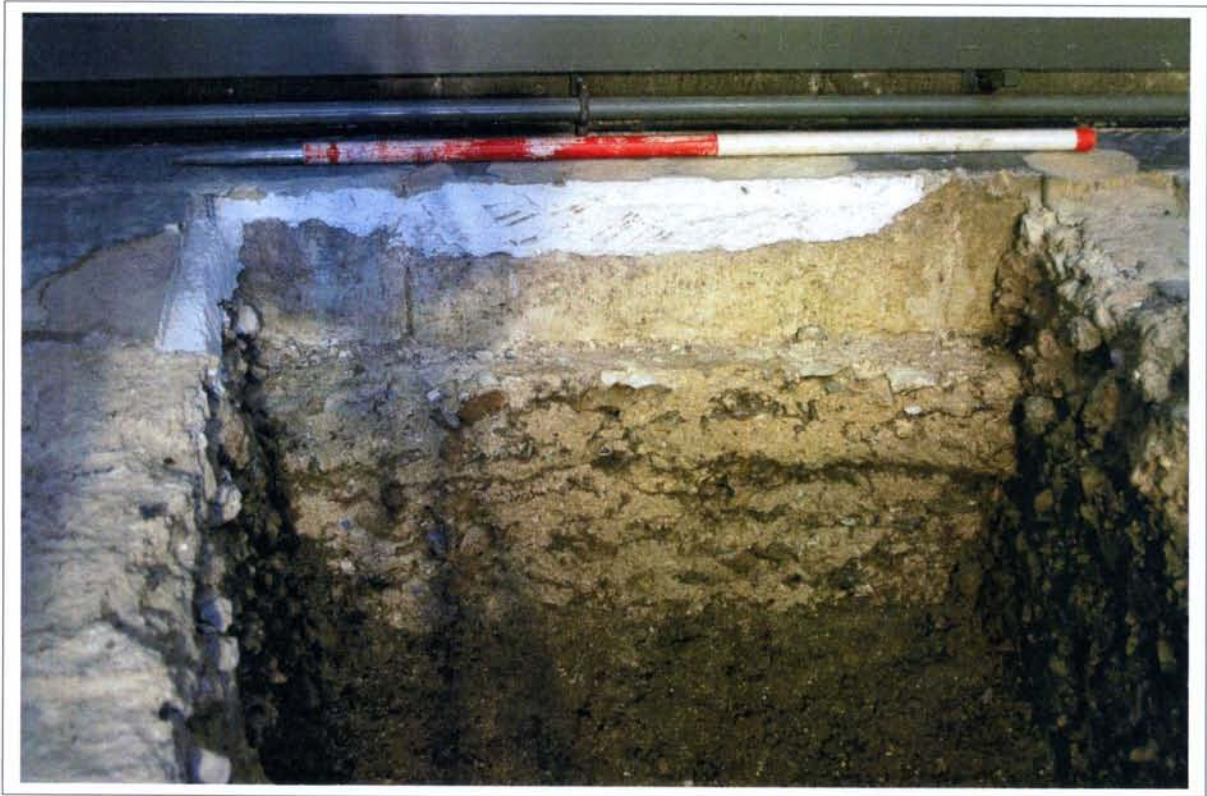
Plate 7: View of south wall and footing, Scale 1x1m

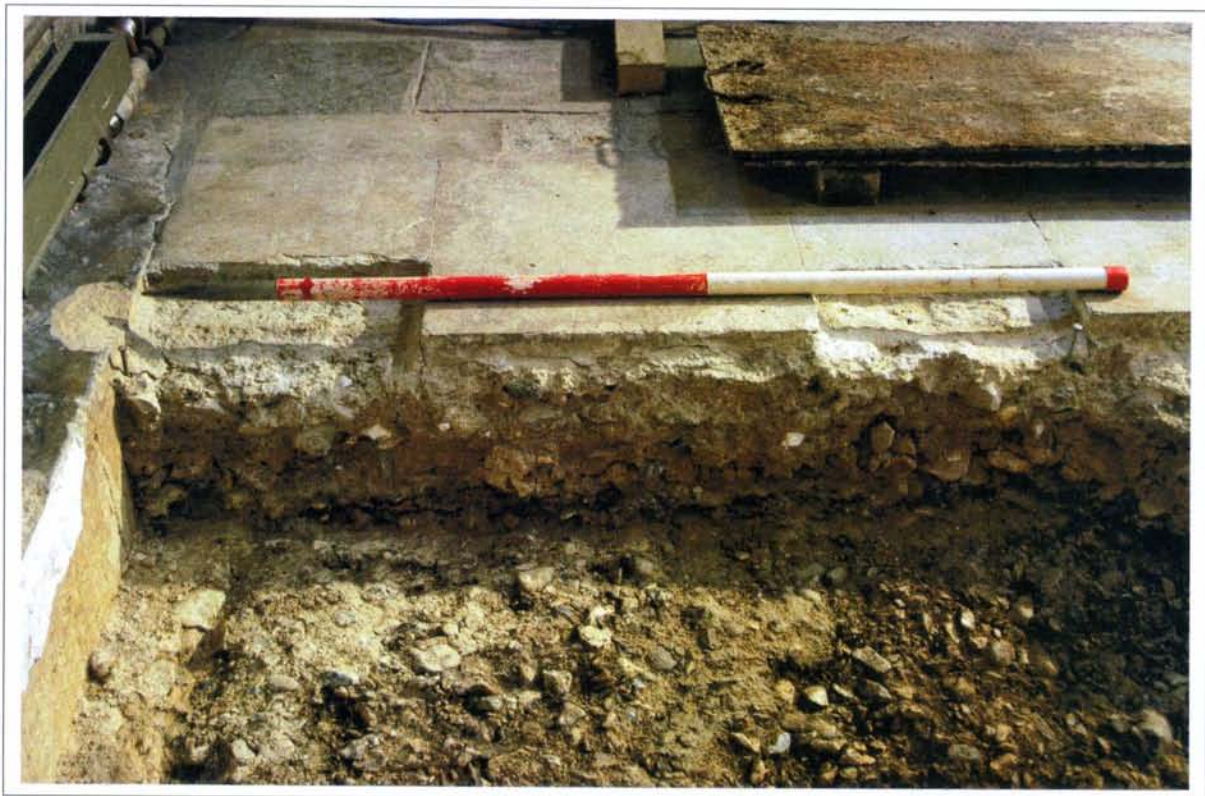
Plate 8: View of mortar 30 and gravel, Scale 1x1m

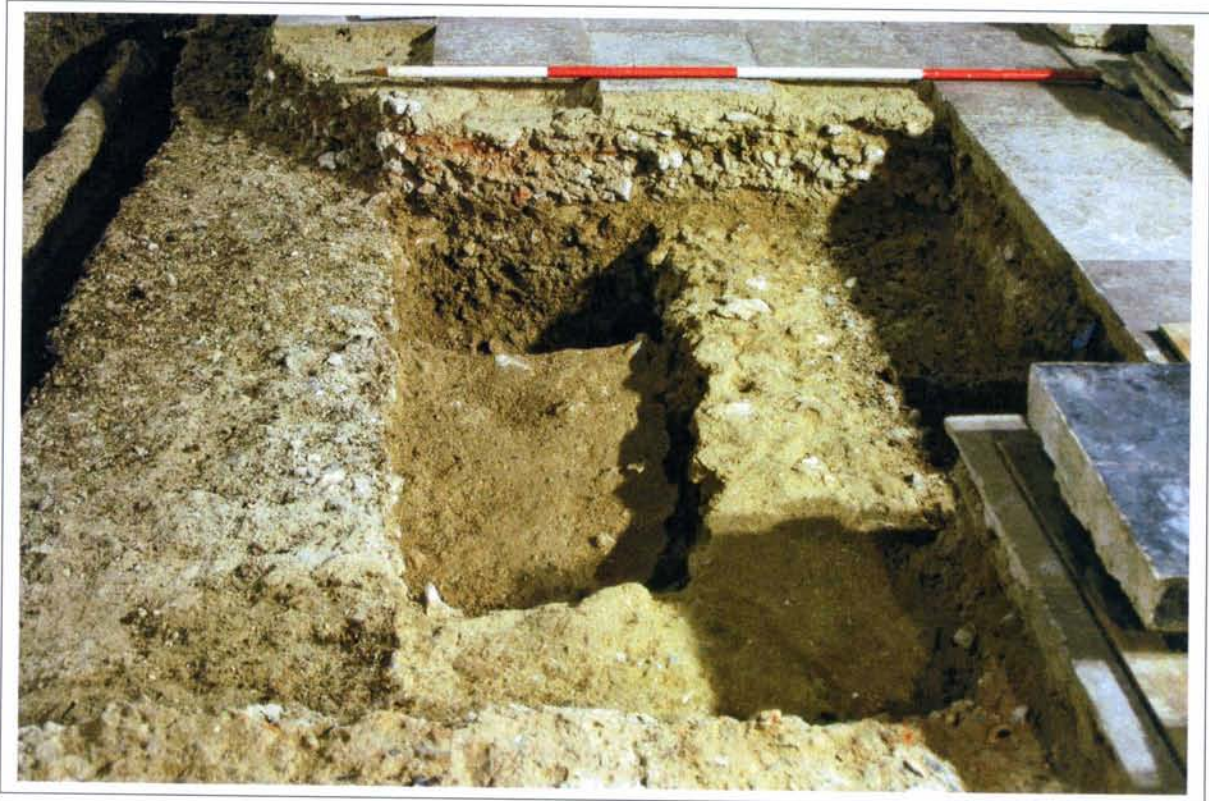
Plate 9: View of graves 51 and 53, Scale 1x2m

Chilmark-Tisbury stone (66), a layer of mid brown loam containing flecks of white lime mortar and gravel (67), and a layer of loose pale brown loam containing mortar flecks and coffin nails (68). Once the coffin nails were located the excavation was stopped as they appeared to indicate that a burial remained *in-situ*.

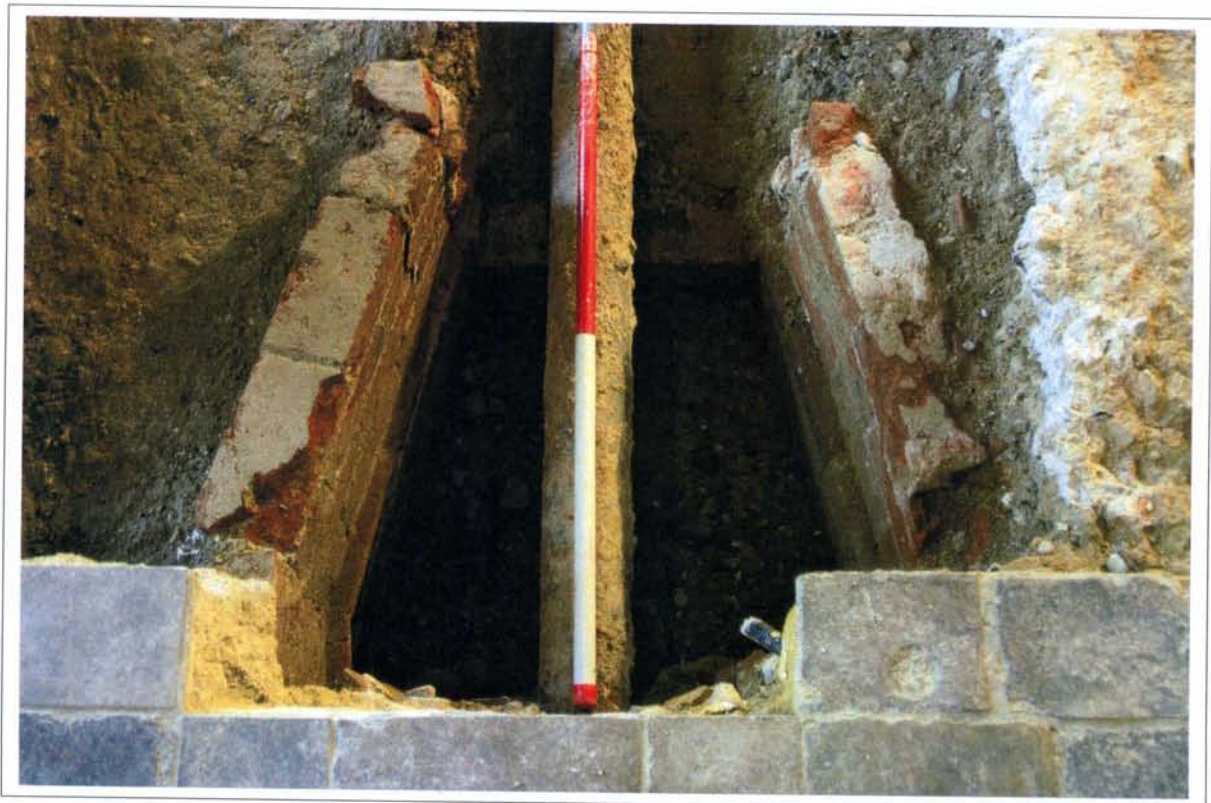
Plate 10: View of vault 37, Scale 1x1m

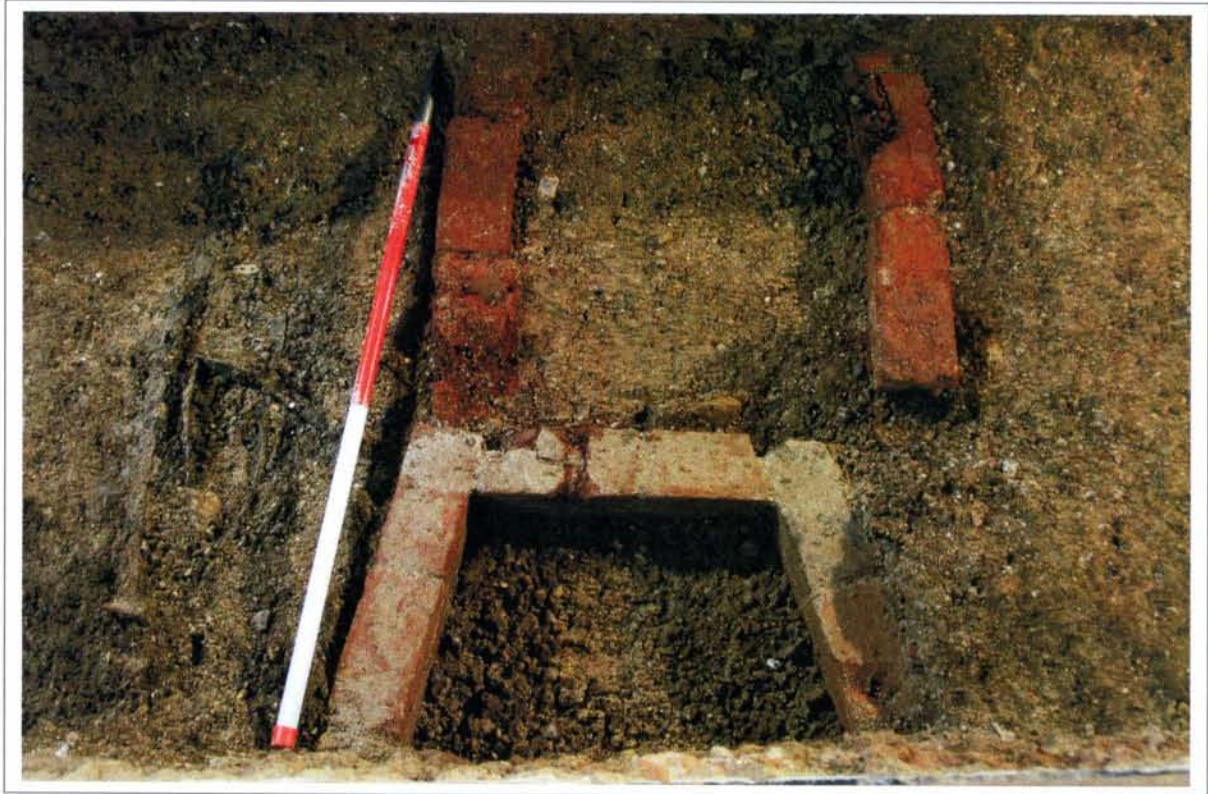
Plate 11: View of vaults 72 and 75, Scale 1x1m

Vault 72 had its west end below the west section and the east end cut by vault 75 (Figs 3 & 6; Plate 11). The bricks were fine, rubbed red bricks measuring 240x120x75mm. On cleaning rib bones were noted, indicating an *in-situ* burial, with the lower half destroyed by vault 75.

Vault 75 extending into the east section (Figs 3 & 6; Plate 11). The bricks were fine, rubbed red bricks measuring 225x105x70mm. On cleaning a skull was seen indicating that the burial remains *in-situ*.

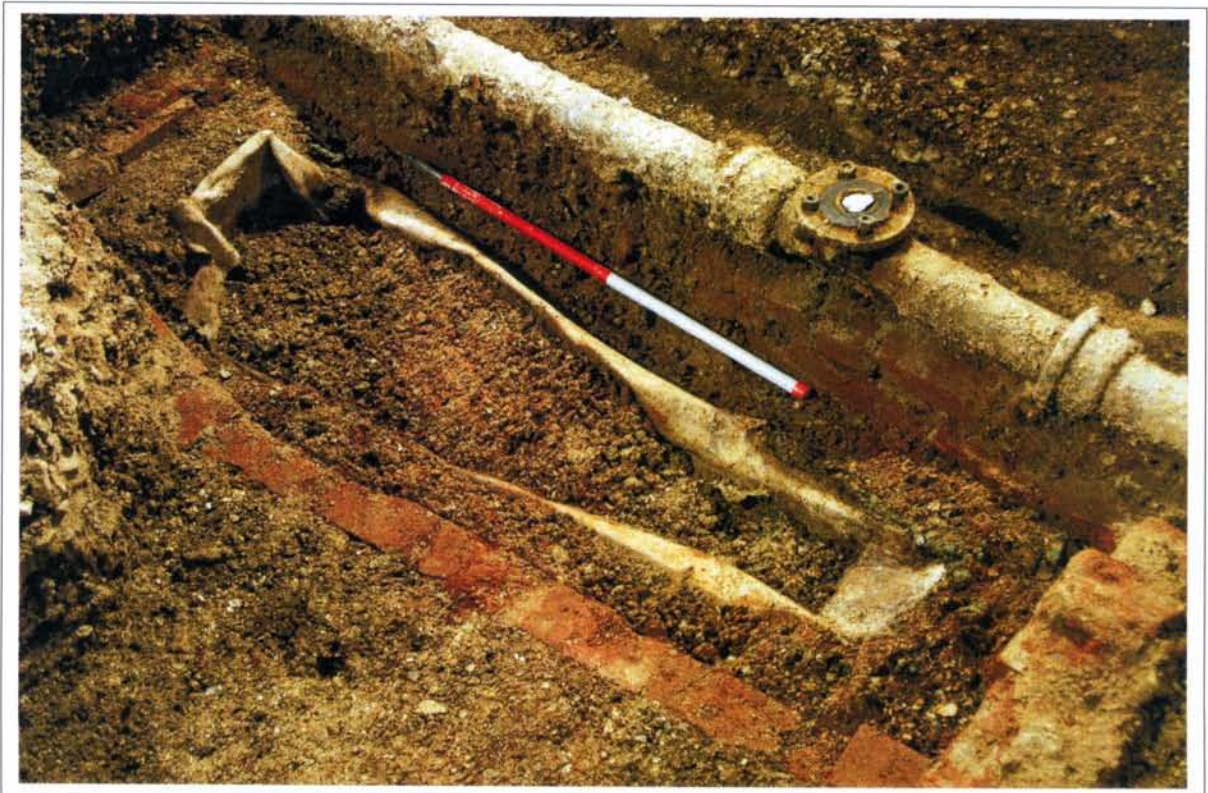
Plate 12: View of lead coffin, Scale 1x1m

Inside the outer wooden coffin was a lead coffin, intact, but distorted. It is assumed that a further wooden coffin lay inside the lead one, but this was not visible.

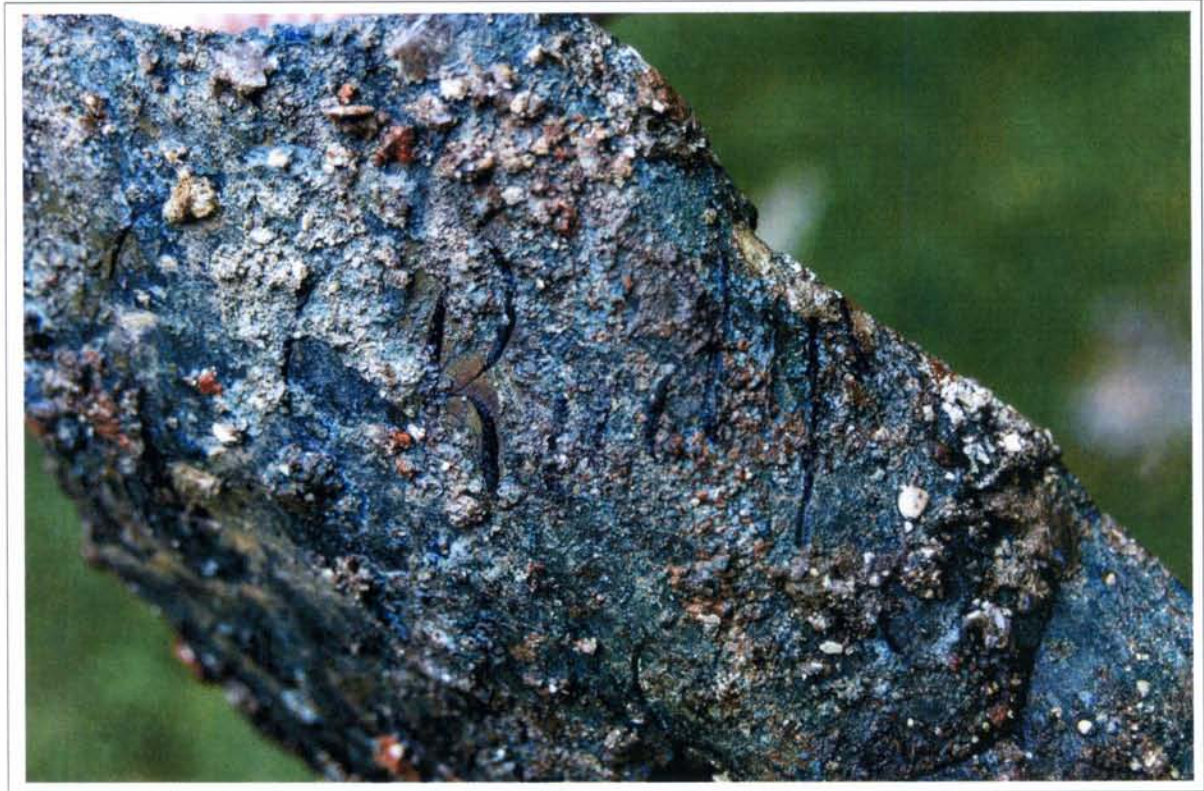
Plate 13: View of name plate

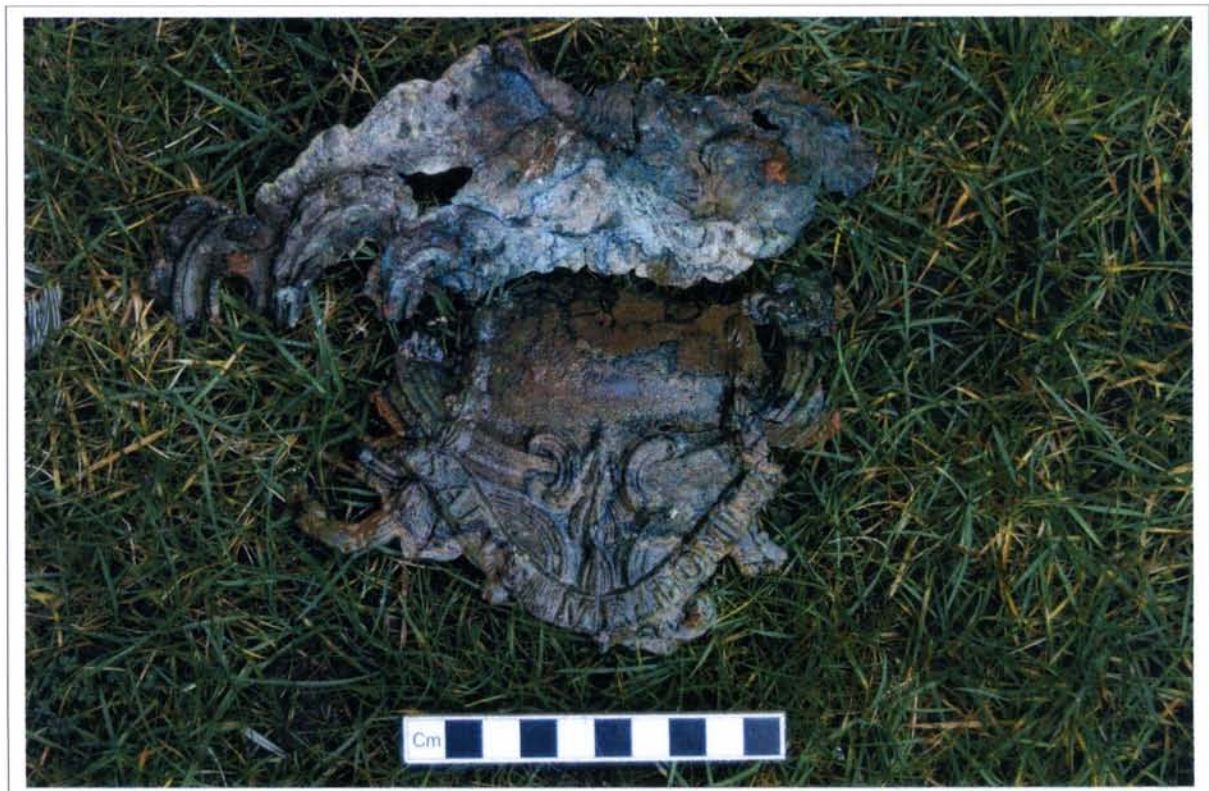
Plate 14: View of decorated plate, Scale 1x0.1m

The plate near the shoulder of the coffin was a very thin, pressed brass plate with ornate decoration (Plate 14) and the motto...

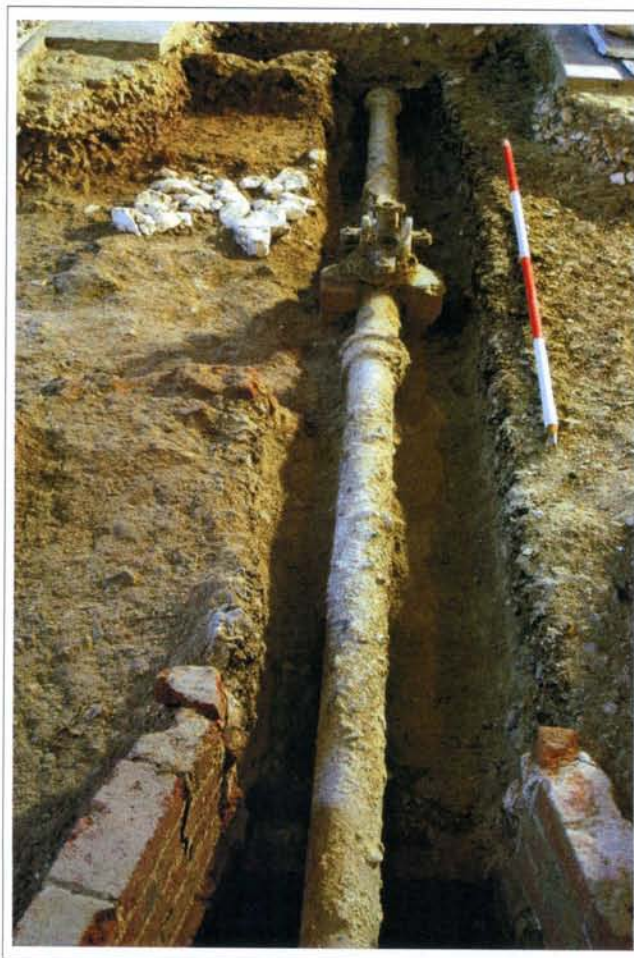
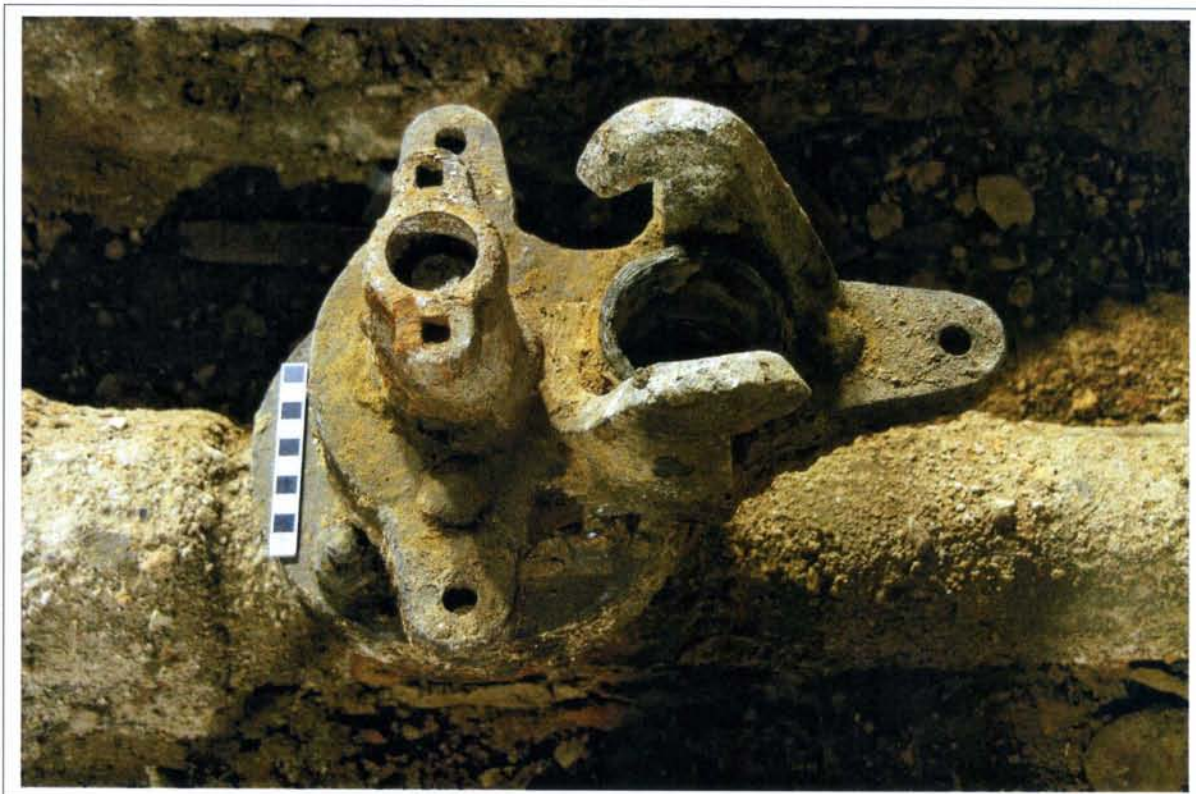
Plate 16: View of cast hydrant pipe  
Scale 1x2m

Plate 17: View of hydrant fitting, Scale 1x0.1m

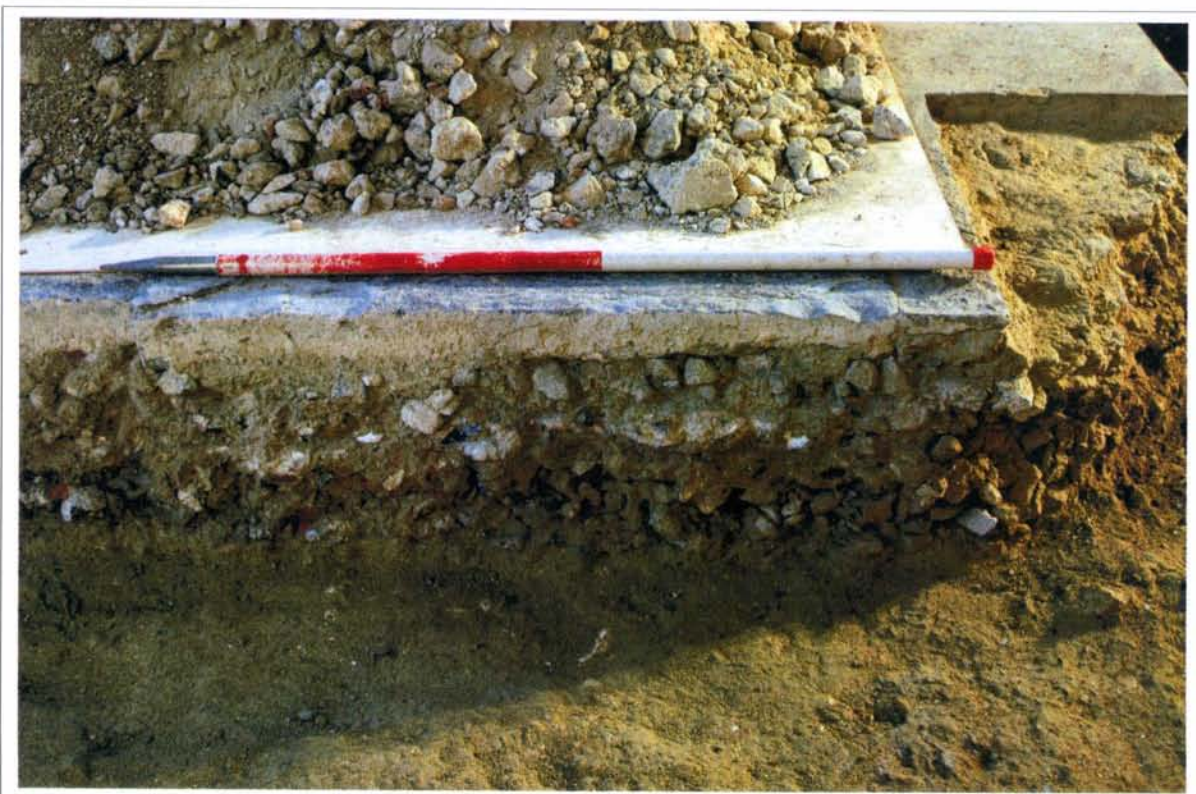
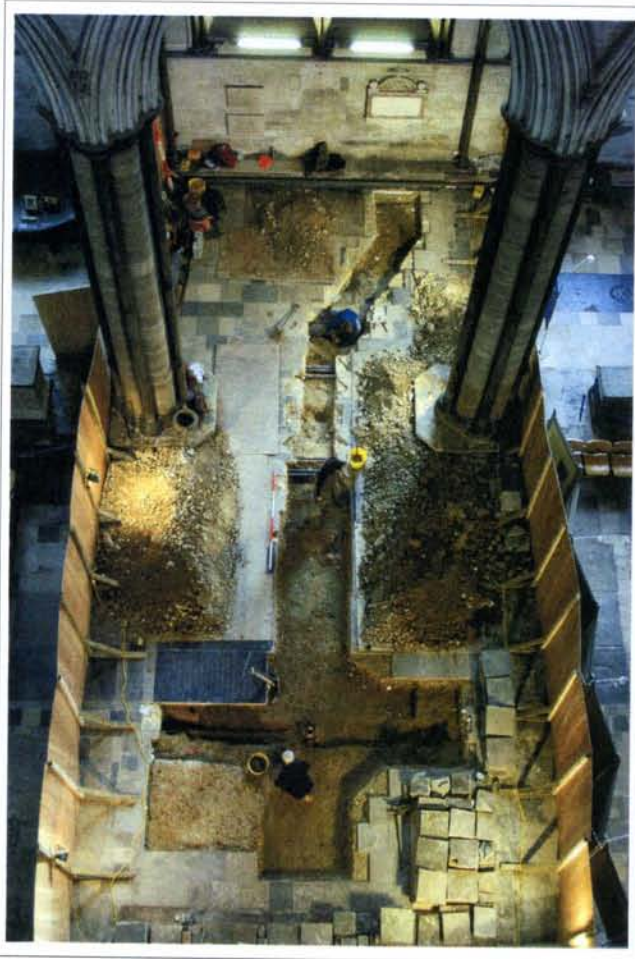
Plate 18: View of levelling, Scale 1x1m

Plate 19: View of excavated 19th century levelling, Scale 1x2m

The re-laying of the nave floor was a significant event in the cathedral which caused major disturbance to below ground deposits (plate 19).

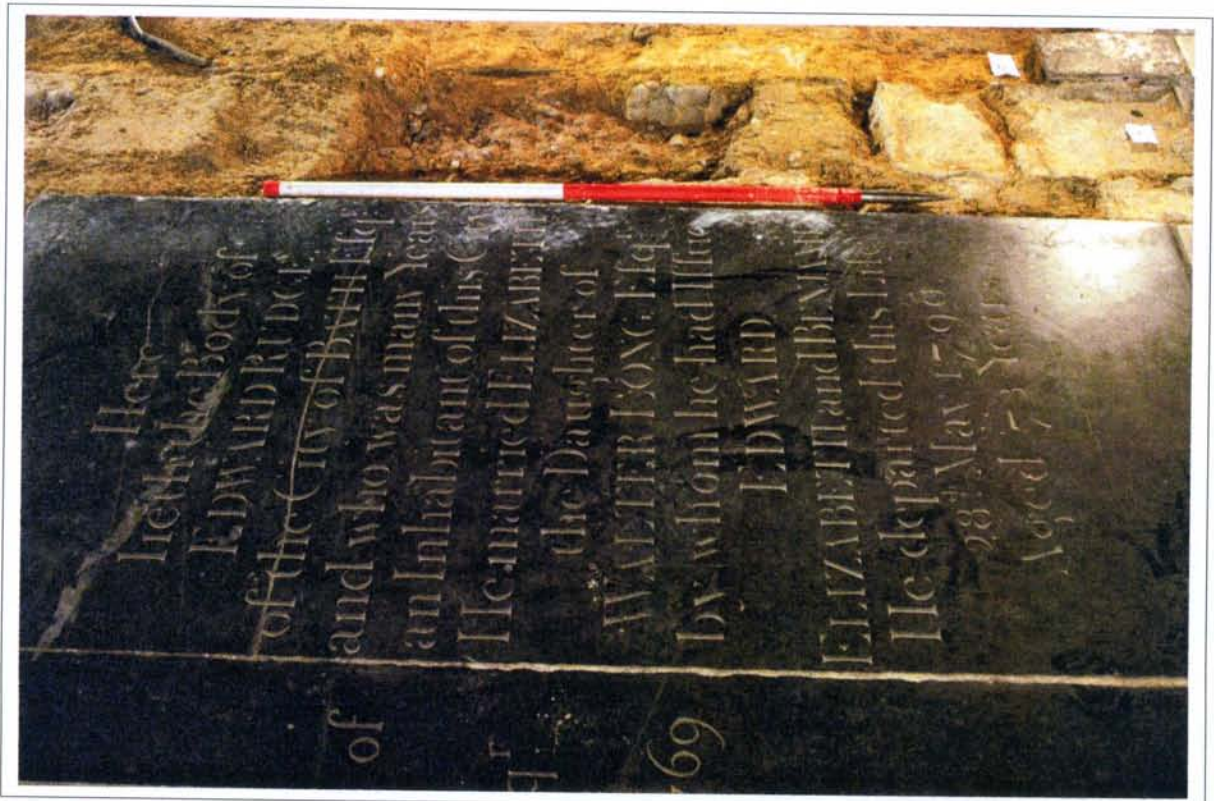
Plate 20: View of ledge, Scale 1x1m

Given the bricks used for the linings are all similar in size, save those on vault 72, which are larger than the others, it is likely that three of the vaults date to the 18<sup>th</sup> century, with vault 72 and 75 perhaps being 19<sup>th</sup> century in date. The adjacent black Belgian ledger slabs, re-laid in the 1878 paving, may relate to these burials. It has been seen above that one of the slabs, that of Edward Rudge who died in 1790, relates to vault 47 (Plate 20).
