# Salisbury Cathedral Font

Archaeological Excavation

CAP Report No. 513

## **SALISBURY CATHEDRAL NAVE: EXCAVATIONS FOR THE NEW FONT 2008**

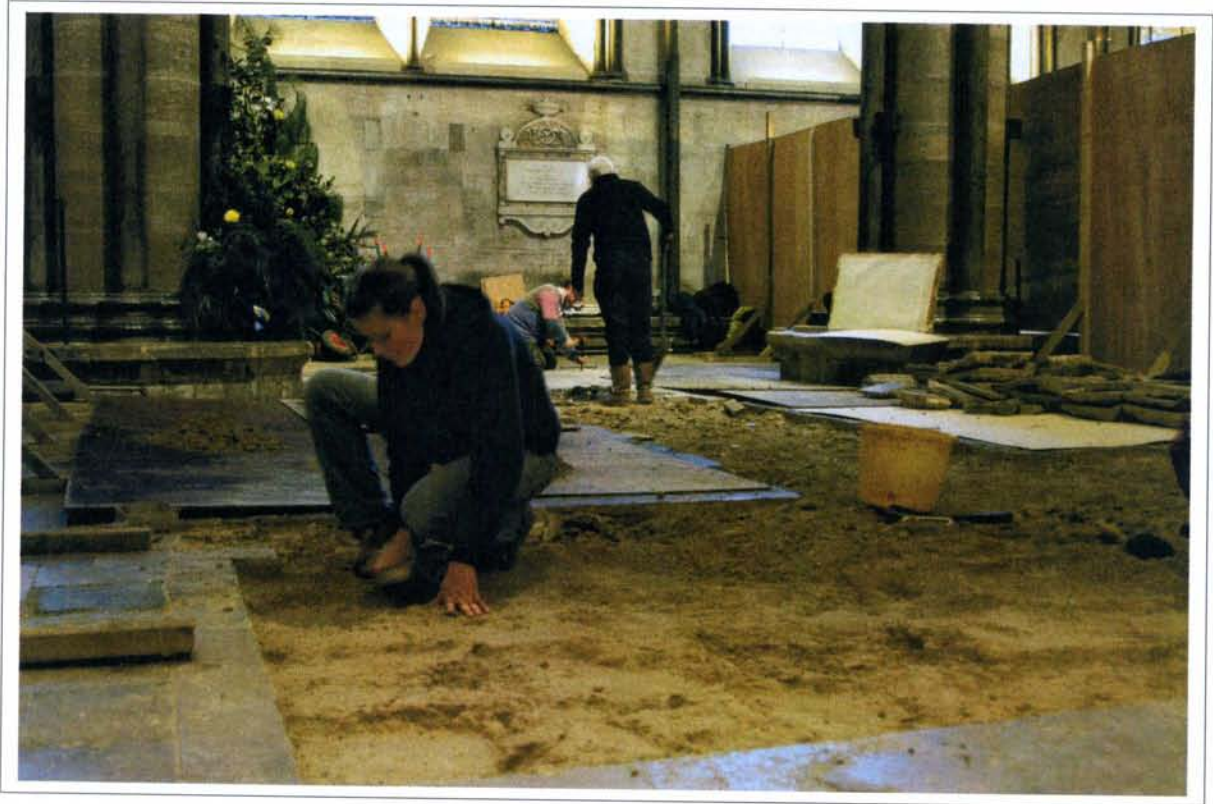
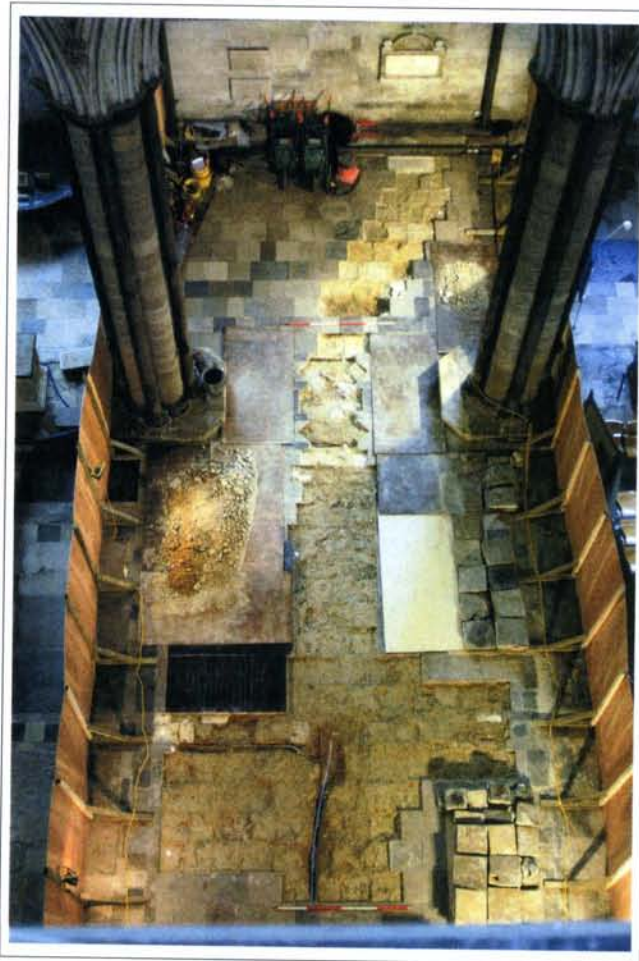
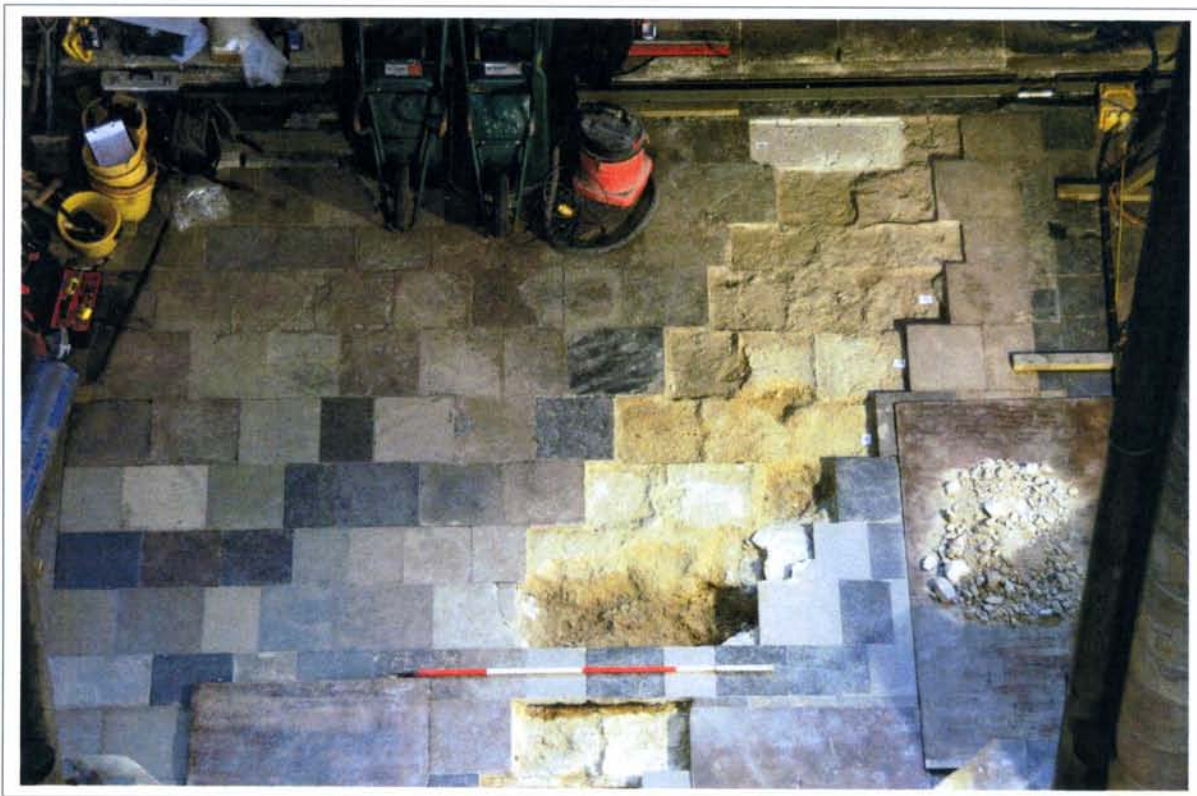
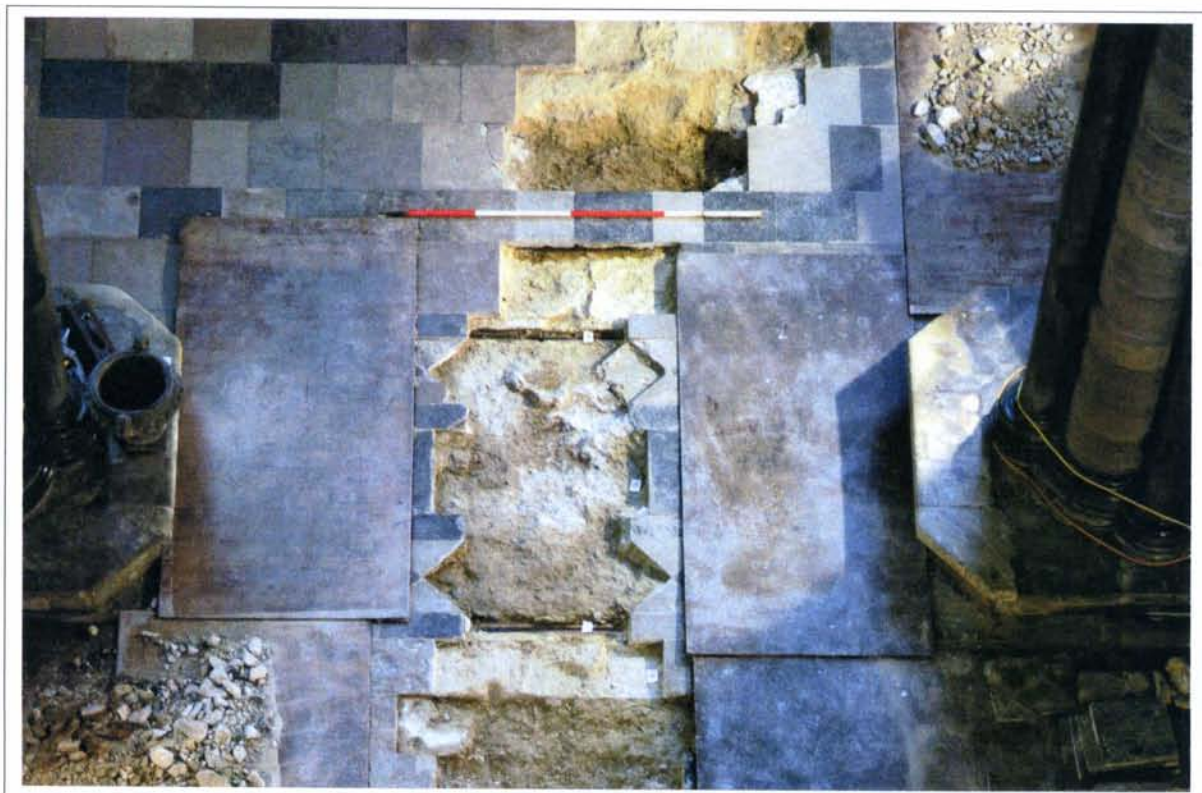
Plate 21: View of mortars being excavated

Plate 22: View of mortars below floor, Scale 1x2m

Plate 23: View of mortars below south aisle, Scale 1x2m

Plate 24: View of mortars over arcade. Scale 1x2m

The rubble was levelled and then sealed with a buff lime bedding mortar (layers 3 and 11) up to 0.05m thick onto which the floor slabs (1) were set (Plates 21-24).

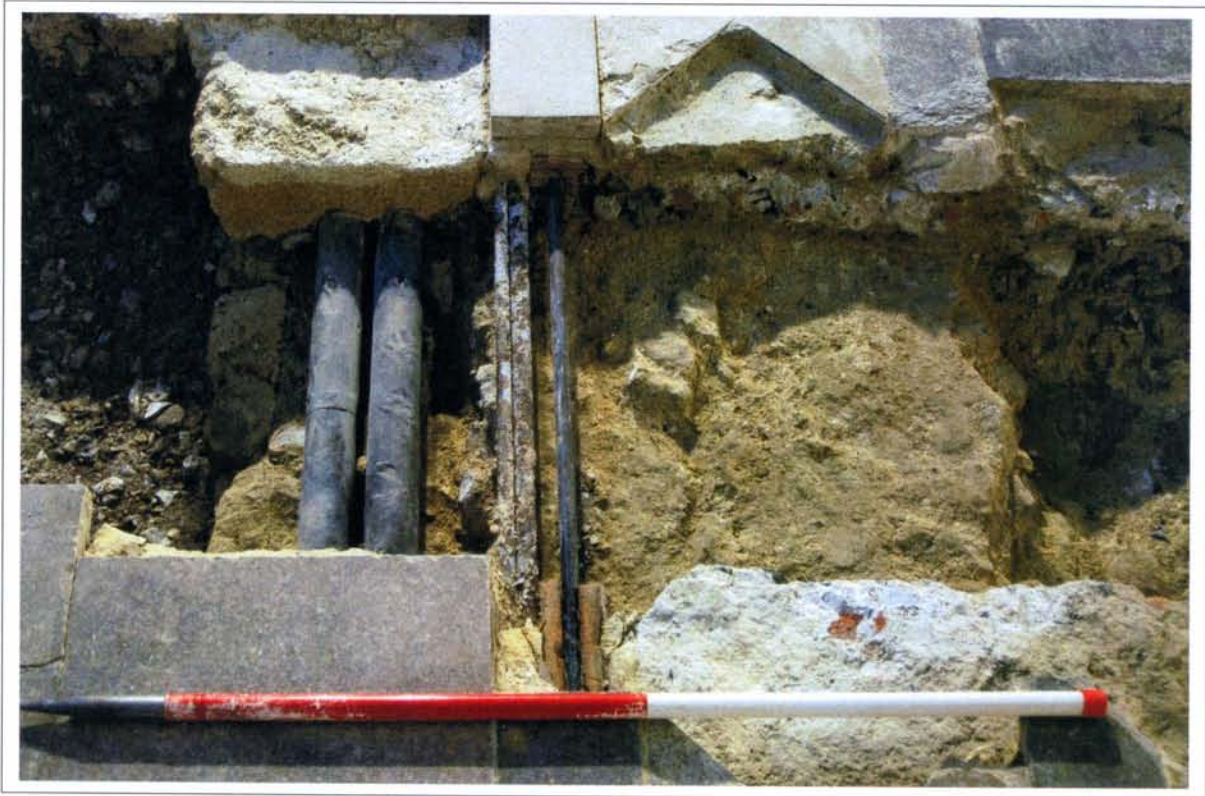
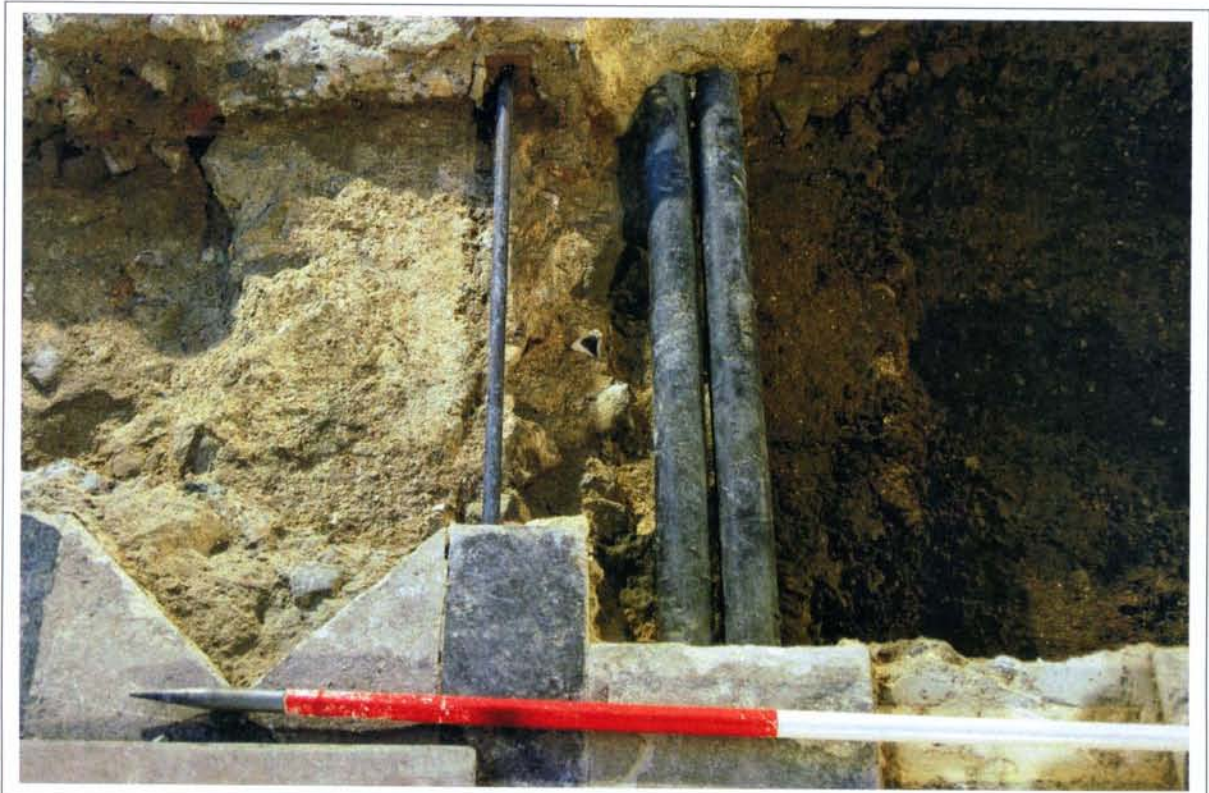
Plate 25: View of pipes on south side, Scale 1x1m

Plate 26: View of pipes on north side, Scale 1x2m

pair of earlier pipes were also found. The more recent pipes were insulated (9, Figs 5 & 6; Plates 25-26).

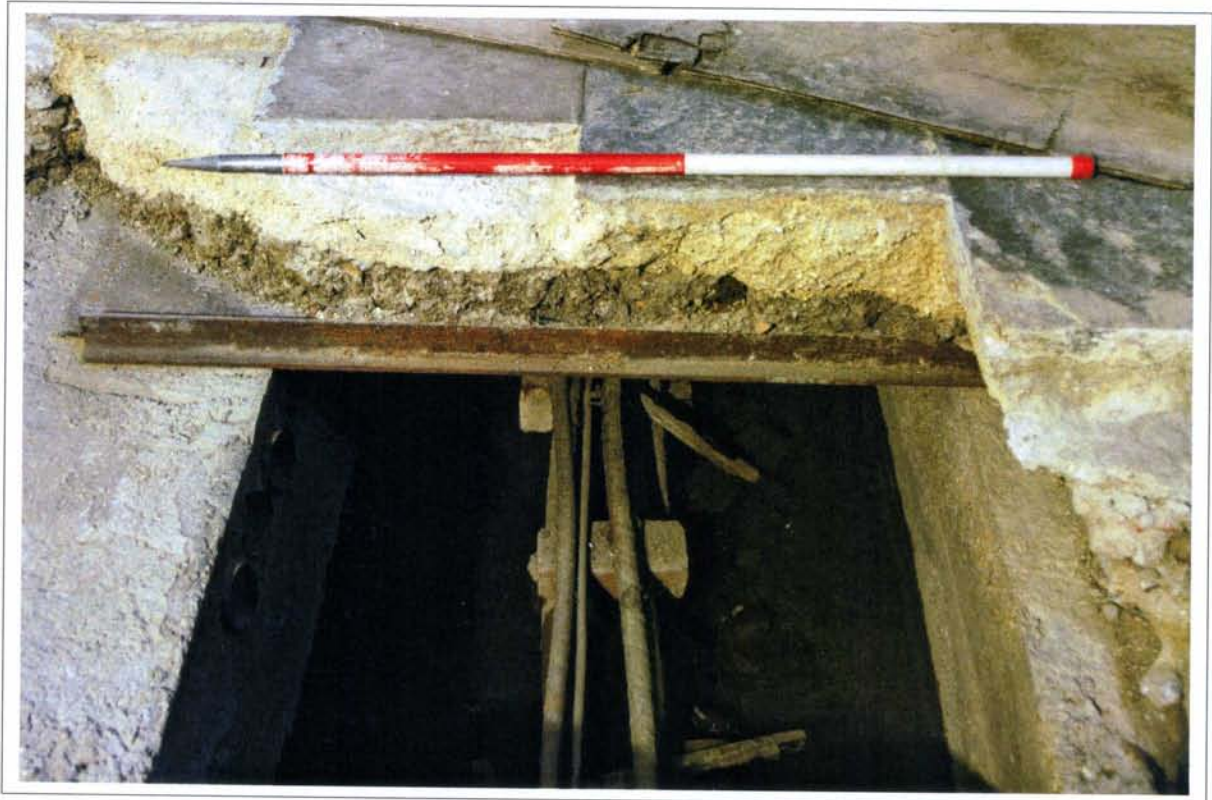
Plate 27: View of electric pit, Scale 1x1m

In the south aisle was recorded a 1.4m wide duct for electrical pipes made in 1965 (Parsons 1965). This cut to a depth of 0.88m, had concrete walls and floor and was capped with sheets of steel (16, Figs 5 & 6; Plates 27). The north side had metal tubes protruding through the concrete wall, evidently for use in a planned under-floor heating scheme for the nave (which was not introduced). The floor slabs above the duct were re-set in concrete as were later repairs to adjacent floor slabs that had subsided above the metal tubes on the north side of the duct.

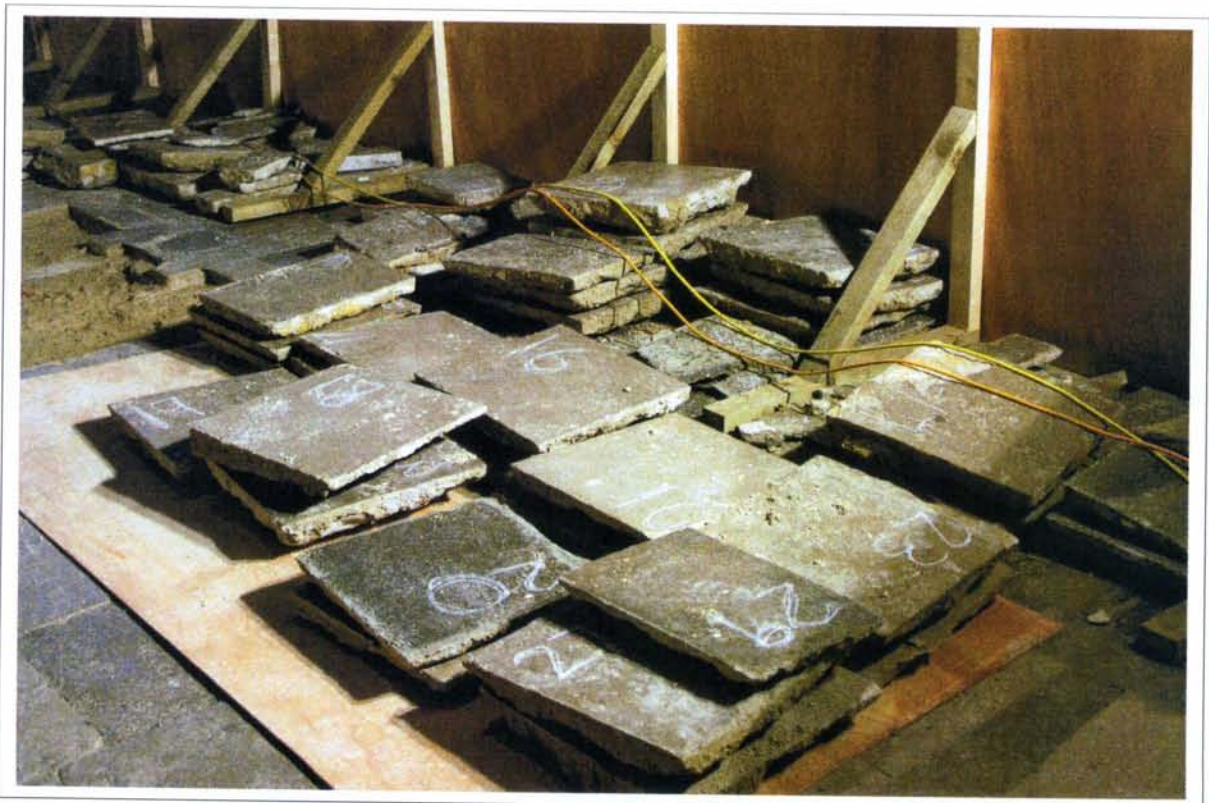
Plate 28: View of floor slabs

The 1878 paved floor (noted above) was laid out by starting with a long east-west strip (0.6m wide) on the axis, and then by setting out a pattern of linear strips across the nave to mark out the bays and the arcade. The infill of these rectangular borders was then in-filled by east-west rows of paving of varying widths. Some diagonal patterning was evident. The paving used in 1878 was a mixture of mostly earlier paving (medieval Purbeck marble, Purbeck stone, Portland stone, etc) and a little new paving (Plate 28).
