The College of St George, Windsor Castle

Desk-based Assessment
for a new Service Trench through the Canons Cloister

CAP Report No. 478

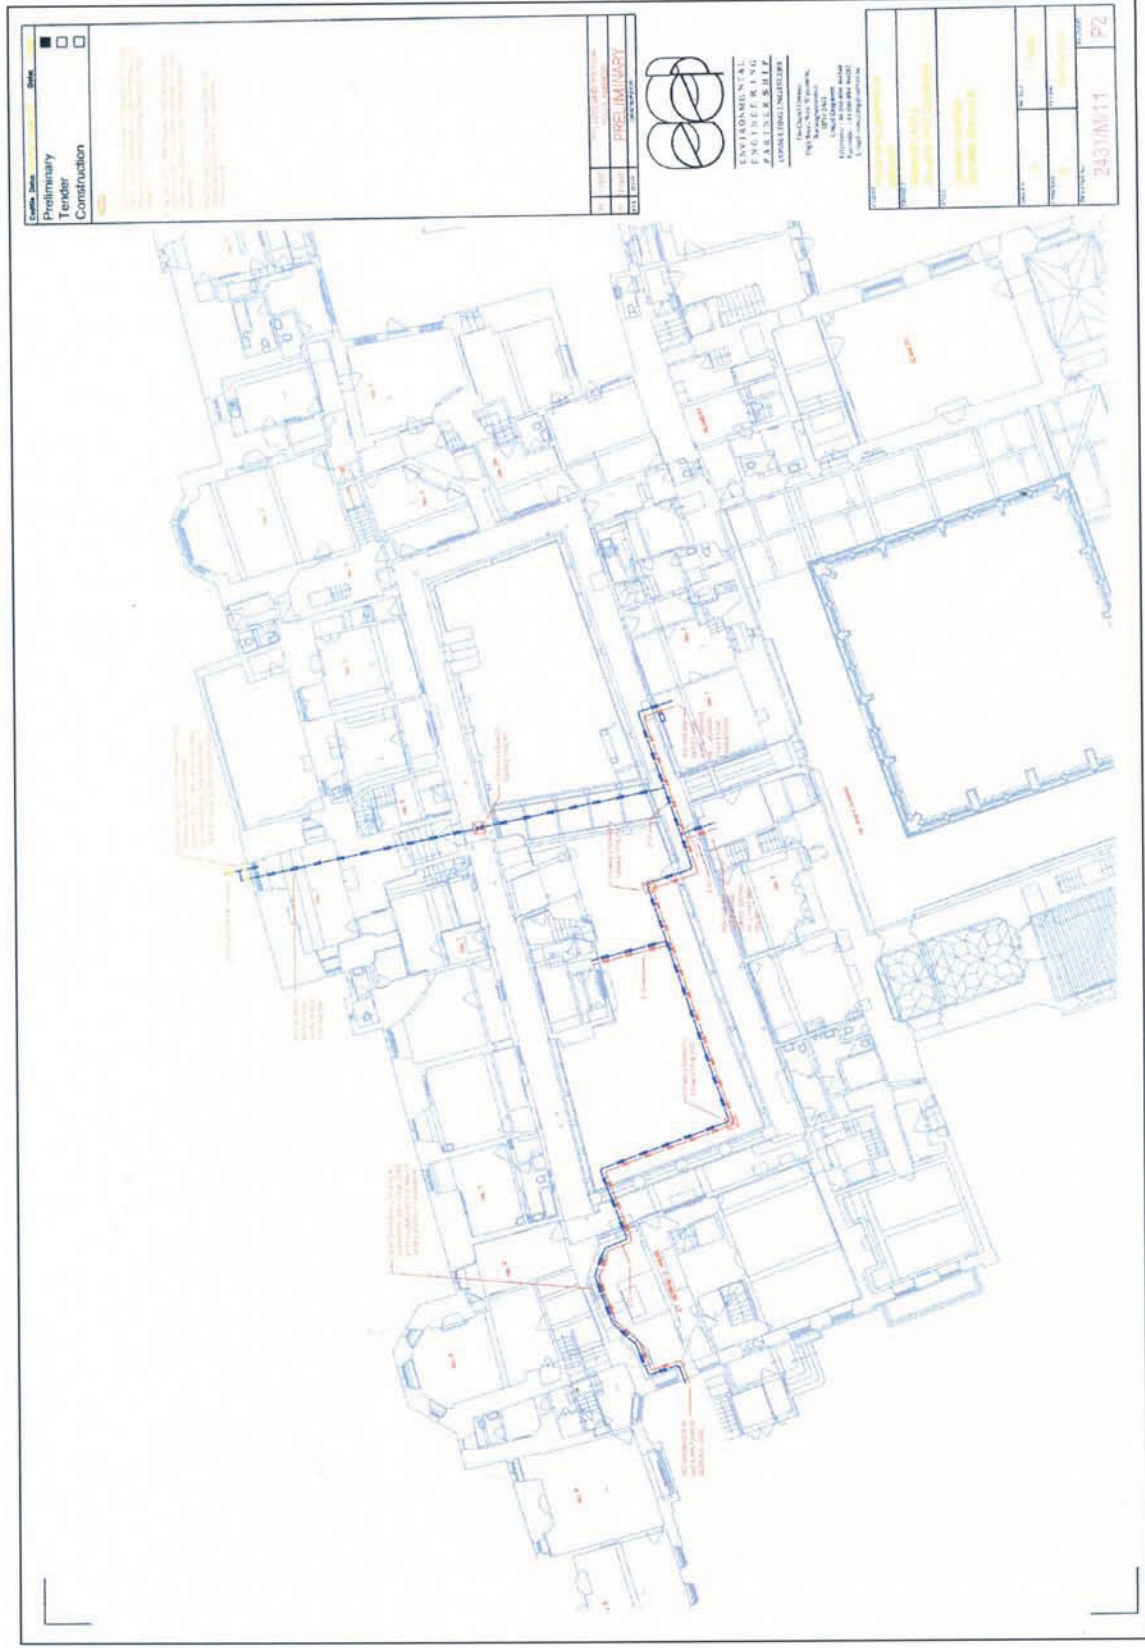
Figure 2. Proposed route of new services through yard of Canon's Cloister.

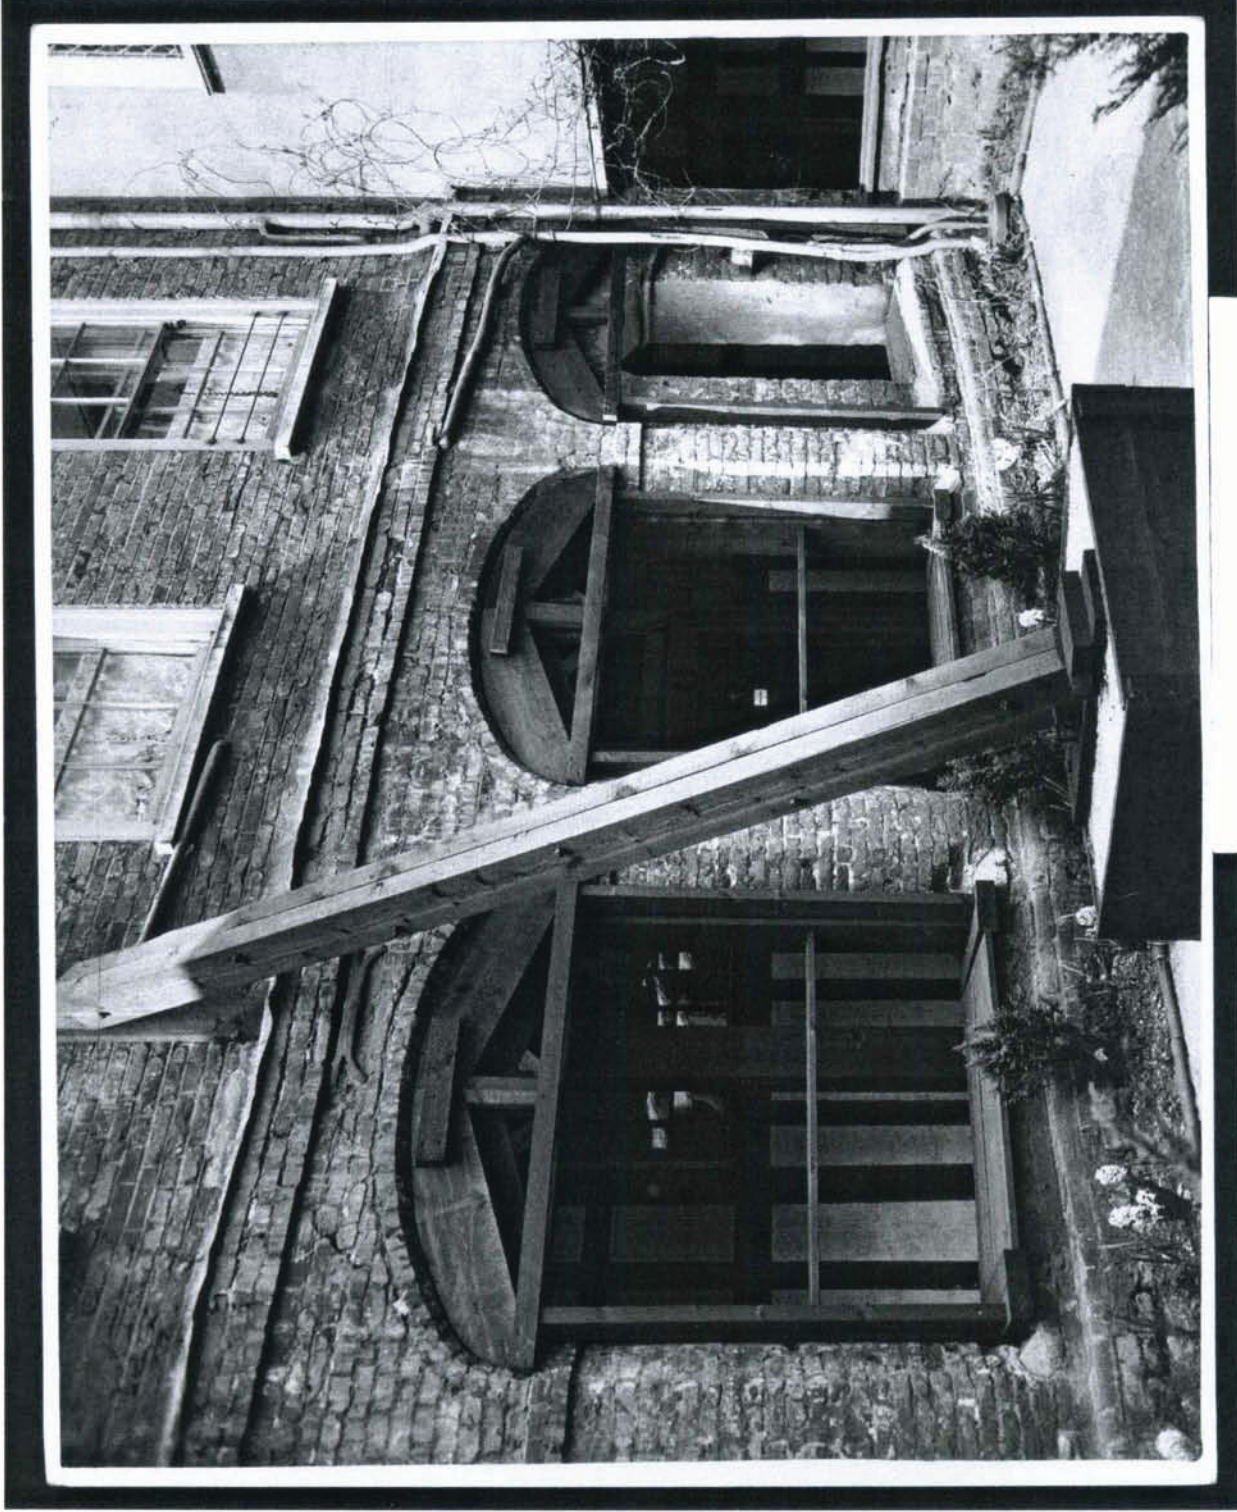
Figure 12. Photograph of east facing wall within courtyard area of Canons cloister, c. 1950, prior to consolidation work.

Photograph of c. 1950 of east facing wall of Canons cloister (see fig 12)

- 4.10 This photograph shows the east facing wall of the canon's cloister prior to consolidation work.

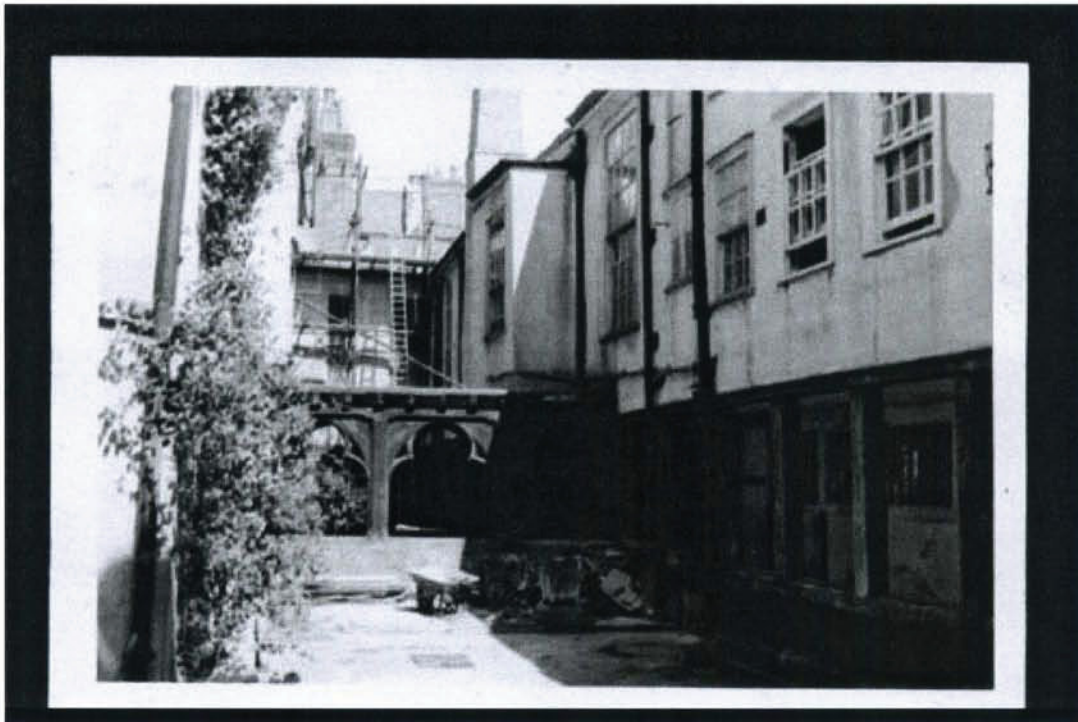
Figure 13. Photograph of Canons Cloister courtyard area looking eastwards, c. 1960.

Photograph of c. 1960 of east facing wall of Canons cloister (see fig 13)

- 4.11 This photograph shows the east facing wall of the canon's cloister prior to consolidation work.
