BISHOPTHORPE PALACE

ARCHAEOLOGICAL WATCHING BRIEF

ARCHAEOLOGICAL WATCHING BRIEF
BISHOPTHORPE PALACE
YORK

SITE CODE: YBP 13
REPORT CODE: FAS2013 545 YBP511
NGR: SE 5960 4783

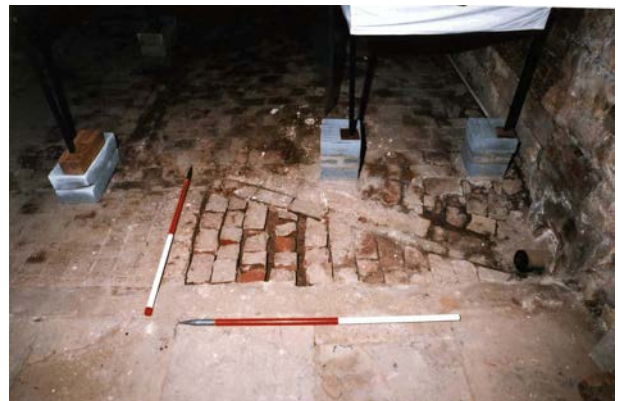
Plate 1 Location of undercroft sump pre-intervention

Prior to the excavation of the undercroft sump, a pre-intervention photographic record of its position within the undercroft was created along with a photographic index and photographic location record (Plate 1)(Appendix B). Prior to excavation, the sump location comprised a late 19th or early 20th-century brick floor, crossed by a brick culvert.

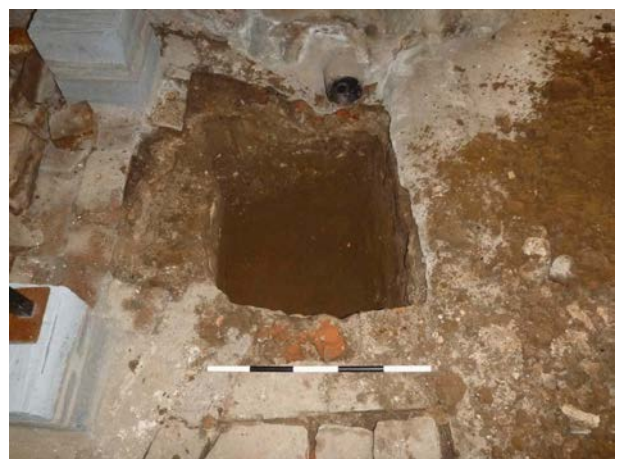
Plate 2 Location of undercroft sump

The sump measured 0.5m x 0.6m x 0.45m deep and was positioned to the immediate north of the eastern door of the undercroft (Figure 2). Removal of the brick floor revealed a clean, homogenous and compact reddish-brown coarse sand which appeared to represent a riverborne matrix (Plate 2). The clean interface between the brick floor and the sand implies the area was subject to truncation and levelling in advance of the construction of the undercroft or the insertion of the brick floor; no evidence for earlier historic floor finishes was identified.

Both interventions resulted in superficial below-ground disturbance and no archaeological remains were encountered. The results of the pump sump watching brief suggest that the undercroft of the palace overlies natural riverborne deposits directly and no evidence for historic floor finishes was encountered.

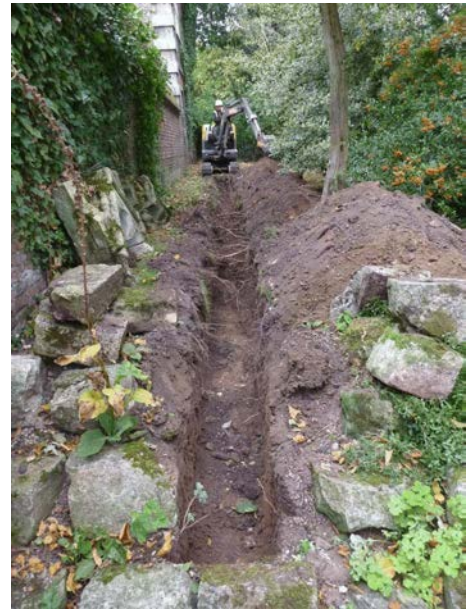
Plate 3 View of Intervention 8 looking north

The sequence encountered consisted of a dry, friable, fine topsoil with frequent roots which generally measured 0.4m deep. Topsoil overlay a layer of overburden exposed in plan in the base of the trench. Overburden consisted of a reddish-brown friable clayey silt with occasional fragments of pan tile and plain roof tile and rare early modern pottery which was noted but not retained. No remains of archaeological significance were encountered.

The cable trench did not penetrate topsoil and consequently did not disturb archaeological deposits.
