# FAS HERITAGE

## LINCOLN CASTLE

### EAST GATE SLAB REPLACEMENT

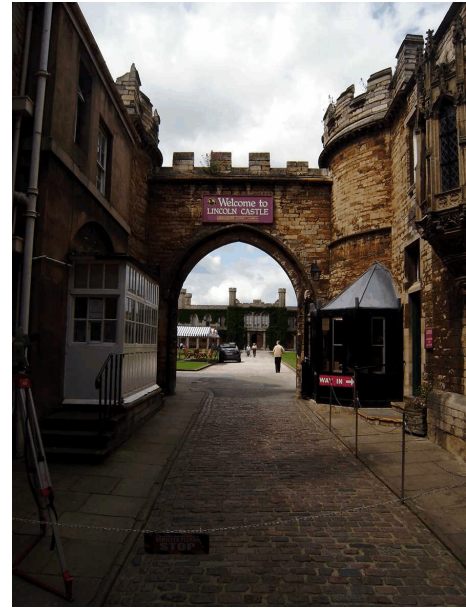
**Plate 11** View of East Gate looking west

Of the Norman gate the outer gate archway survives supported upon a pair of square section responds, behind a 13th-century replacement, in addition to masonry to either side of the gate passage including a chamfered course. Behind the modern timber doors is a contemporary portcullis groove.
