## 2-4 MILLGATE

SELBY

# ARCHAEOLOGICAL WATCHING BRIEF

REPORT  
FEBRUARY 2007

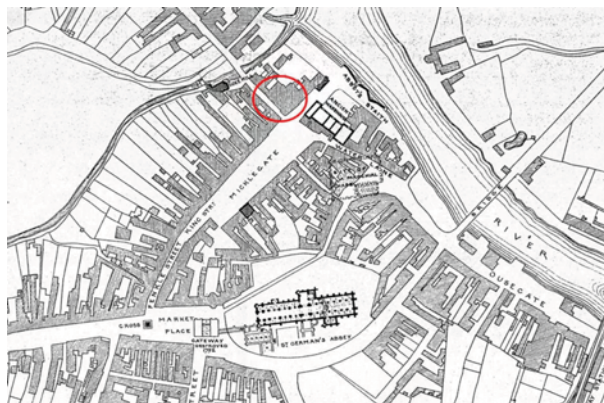
**Plate 2** C.C.Hodges' Plan of Selby

Millgate, the *gata* name of which indicates a thoroughfare of some antiquity, is likely to have fallen within the wider precinct of the abbey. The riverbank to the east of the site is known to have been the location of the Abbot's Staith, as shown on a plan of Selby by C.C.Hodges (Plate 2), and warehouses along the waterfront would have provided storage and trade for the monastery. A number of stone warehouses are thought to have

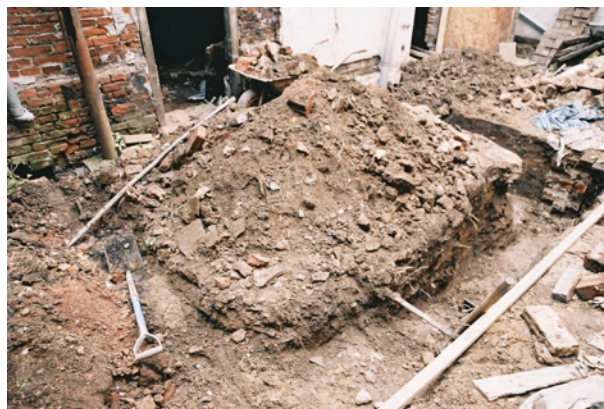
**Plate 3** Excavated foundation trench to the rear of 2-4 Millgate

The watching brief involved of the monitoring of the excavation of a foundation trench for a proposed extension to the rear of 2-4 Millgate (Plate 3). The foundation, which measured 3.1m x 2.5m, was excavated by hand to a depth of *c.*1.0m, continuing to greater depth deeper where extant ceramic pipes needed to be exposed.

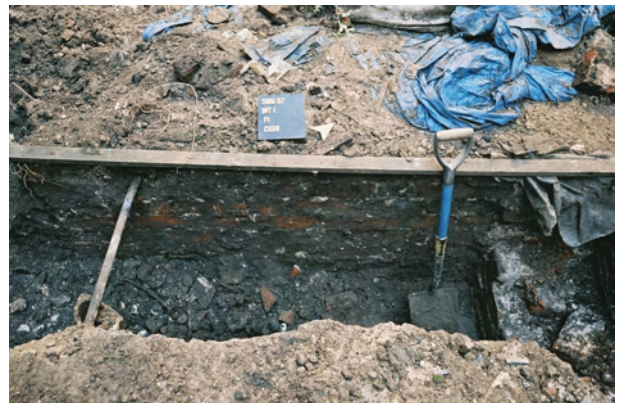
**Plate 4** F1 C1001, facing northwest

F4=F7 had been laid down prior to the construction of F1 (C1001), a rectilinear, brick-built structure that occupied the northwestern part of the trench (Plate 4). Three wall lines were exposed revealing a narrow structure, *c.* 1.20m wide internally, and *c.*2.40m in length, which appears to have abutted the rear of the property. F1 was constructed with bricks which have been dated to the 19th century (Cecily Spall *pers. comm.*), and were bonded with a firm, white mortar. The bricks appear to have been constructed against the edge of a vertical cut; the internal part of which had been backfilled with a clean, yellowish-brown clay (C1011).
