**NORTH REVETMENT WALL
LINCOLN CASTLE**

ARCHAEOLOGICAL EVALUATION

**REPORT
JANUARY 2014**

SITE CODE: LCRP 13-14
REPORT CODE: FAS2014 555 LCC522
NGR: SK 975 719

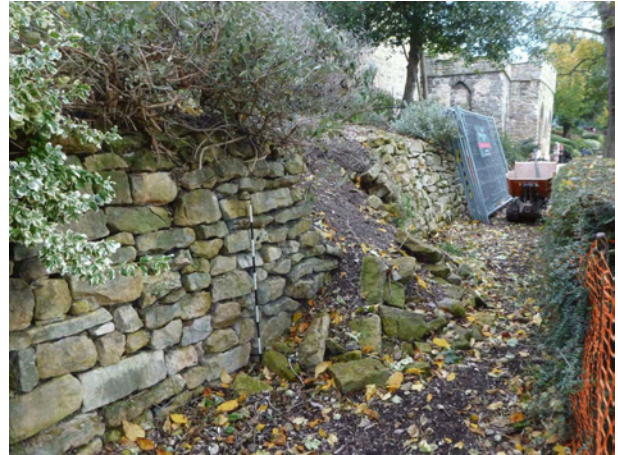
Plate 1 Location of intervention showing failed revetment wall looking east (scale 1.0m)

The evaluation trench was positioned within the landscaped garden adjacent to the north curtain wall to the west of the bath-house at a point where the revetment wall had failed (Figure 1; Plate 1).

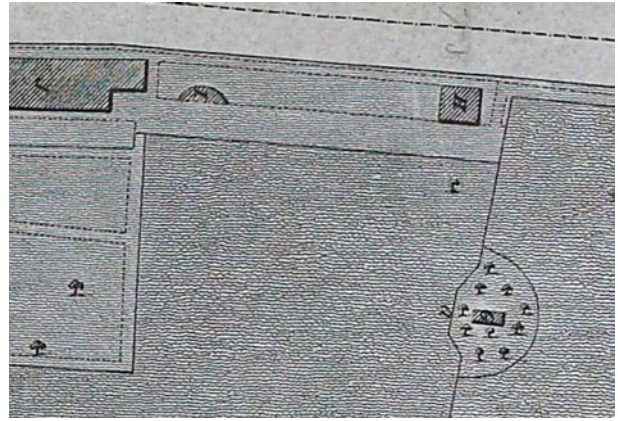
Plate 4 Detail from William Upton's plan of 1812

William Upton's plan of 1812 shows further detail of the ongoing development of the area (Plate 4). Again, the broad area of evaluation appears to be well-maintained in rectilinear plots extending along a large part of the north curtain wall. Several

structures can be noted which do not appear on Johnson's plan and so can be identified as relatively newly-built and part of the continuing gentrification of the castle grounds. Upton's plan labels various features of note. The cultivated plots are labelled 'R' denoted in the key as 'Gaoler's Garden and Orchard' while the adjacent structures labelled 'J', 'I' and 'H' are noted as 'Green and Hot House', 'Harbour' and 'Reservoir' respectively. The feature noted as 'Harbour' is of particular note since it corresponds with the location of the curving portion of revetment wall. Bower's plan of a year later is contrastingly poor and shows no clear landscaping, although he also shows the hothouse/greenhouse.

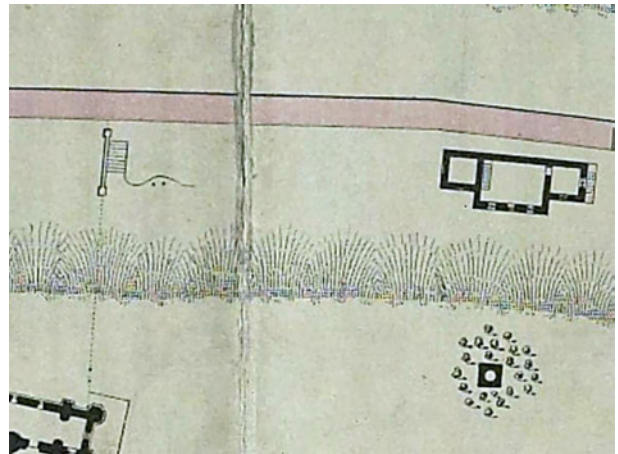
Plate 5 Detail from Edward Willson's plan of 1832

Twenty years later, Edward Willson's plan of the castle dated 1832 shows further detail of the area of evaluation (Plate 5). There is no sign of the allotments shown by Johnson and Upton and the Greenhouse and Hothouse, and the Reservoir have gone, the latter appears to have been swept away by, or perhaps incorporated into, the bath-house development. Willson shows more detail of the Harbour, which may have been subject to enhancement since Upton planned it. The feature is flanked by a short stair and possibly a wall on its western side and the simple curve shown by Upton has become more sinuous travelling further in an eastwards direction. The 'Harbour' may be understood as 'arbour' relating to a garden rest area or seat secluded by planting.

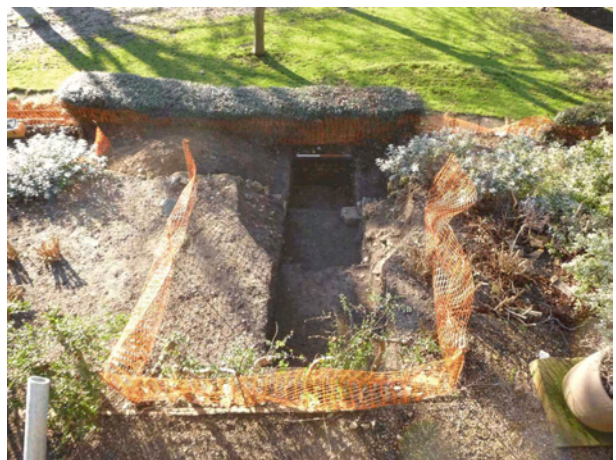
Plate 6 Intervention 25 looking south (scale 1.0m)

The evaluation consisted of a single trench oriented north-south and positioned at the point where a late 20th-century drystone revetment wall of the castle garden had failed and collapsed (Plate 6). The trench measured 1.5m wide x 4.9m long x up to 1.6m deep and was stepped in profile with edges within the northern bank battered back for safety reasons following archaeological recording (Figure 2).

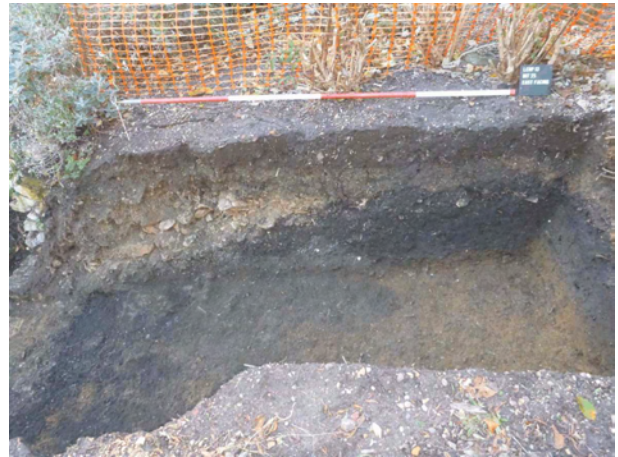
Plate 7 Intervention 25 (north), east-facing section showing buried soil C1003 (scale 2.0m)

C1004 was seen to be overlain in the northern part of the trench by C1003 a distinctive layer of humic silty clay containing occasional limestone fragments. C1003 measured 0.50m deep and had a pronounced profile dipping significantly from north to south; the upper level was encountered at 73.40mAOD (or 0.35mBGL north) dipping to 71.60mAOD (or equivalent to ground level where it meets

the revetment wall). The interface between C1004 and C1003 was marked heavily by root and worm action. Material recovered from C1003 reflected that recovered from C1004 and consisted of clay tobacco pipe of the late 18th to 19th century including a pipe likely to have been made by James Naylor, an 18th-century Lincoln pipe maker, sometime between c.1751 and 1787. Contemporary ceramic was also recovered including a sherd from a Staffordshire-type slipware dish of late 17th- to 18th-century date and the base of a small earthenware flowerpot of late 18th- to 20th-century type.

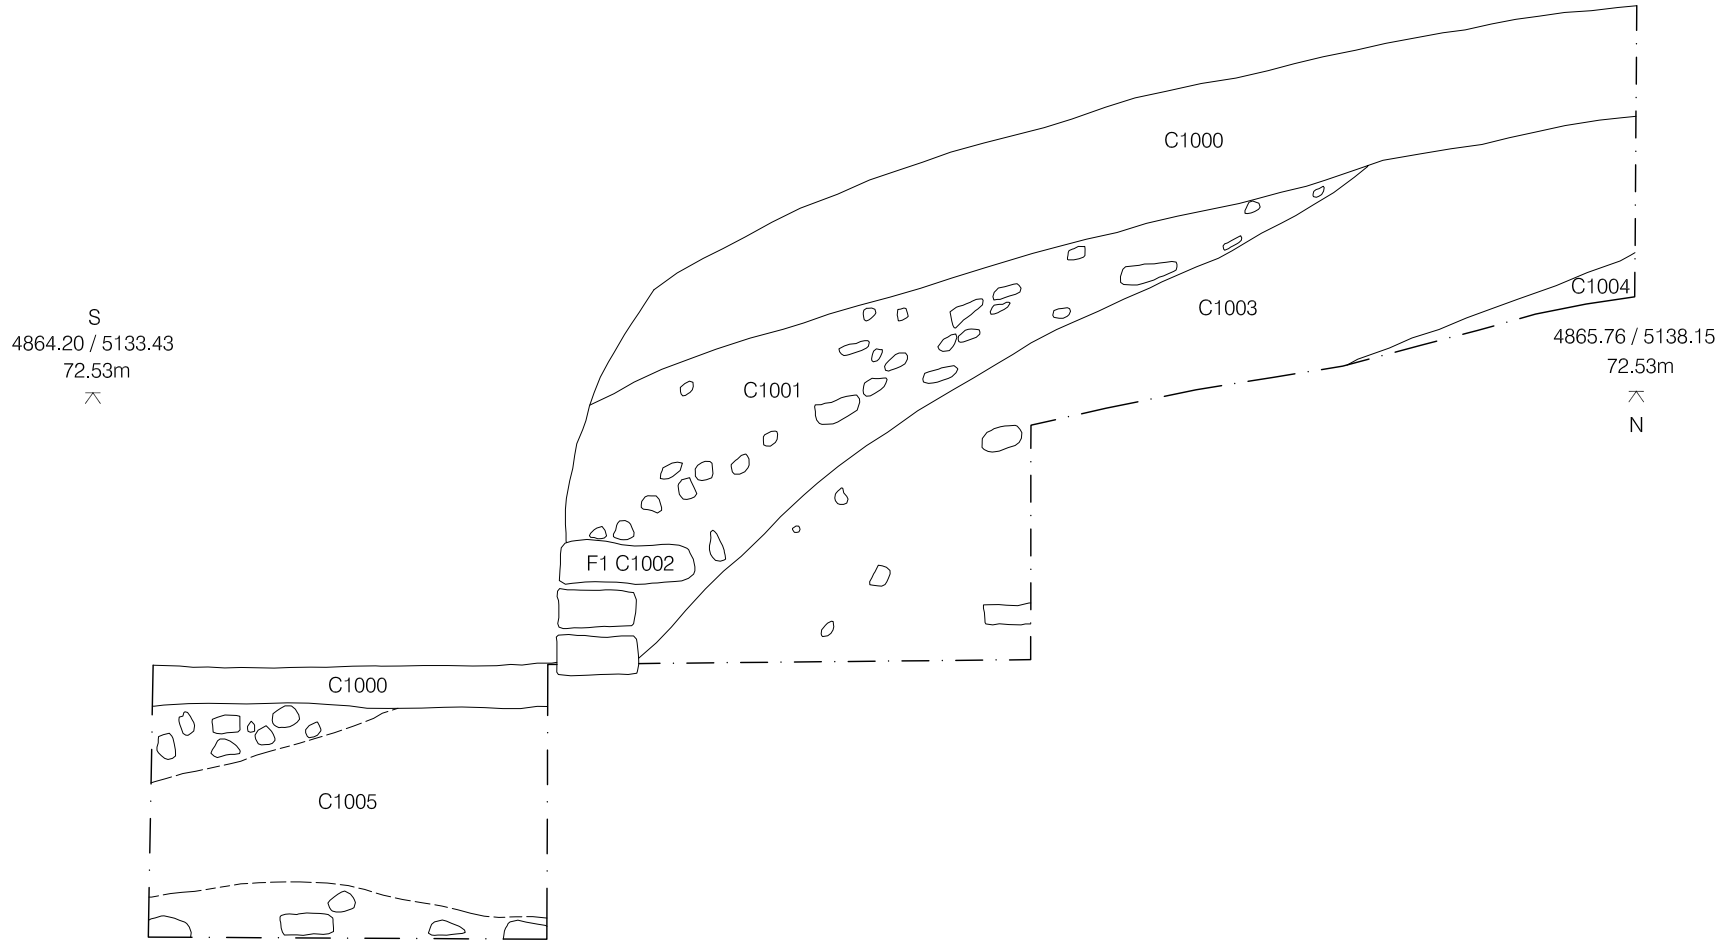
Figure 3

The earliest deposit encountered within Intervention 25 was assigned C1004 which consisted of a coarse, well-compacted silty clay with frequent limestone chippings dispersed throughout (Figure 3; Plate 7; Table 1). Only a small part of the upper interface of C1004 was exposed within Intervention 25 at 73.0mAOD (or 0.80mBGL at the northern end of the trench), and so only a small sample could be excavated. Fragments of clay tobacco pipe were recovered and as a group are dateable to the late 18th to 19th century (Appendix B). Earlier residual material was also present in the form of clay tobacco pipe which may date to the 17th to 18th century, two sherds of Lincoln Glazed Ware of the 13th to 14th century (Appendix C) and a sherd of 1st to early 2nd-century Roman pottery (Appendix D). C1004 may be the same as a layer encountered within the deepest part of Intervention 25 at the south end of the trench. This layer was assigned C1005 and consisted of a plastic silty clay with frequent limestone rubble throughout encountered at 71.50mAOD (or 0.10m BGL beneath the path flanking the revetment wall)(Plate 8). C1005 may have been reworked during the insertion of the path which flanks the base of the revetment wall as its upper interface appeared to have been levelled and sealed by geotextile. While the descriptions and heights of C1004 and C1005 appear to contrast with one another, observations of adjacent strata made during Intervention 27, a watching brief maintained on the refurbishment of the bath-house, suggests that they may nevertheless represent different parts of an extensive and variable deposit which form the uppermost levels of the northern castle bank.

Intervention 25 - east-facing section

C1003 was overlain by a deep, variable deposit of dark grey clayey silt and limestone rubble which was loosely compacted and unstable during excavation (C1001). A variety of modern detritus was noted within C1001, but not retained, including a fragmentary Coca-Cola bottle, silver foil, a glass marble and pantile and slate roof tile fragments. C1001 had apparently been deposited behind the revetment wall assigned F1 C1002, which is known to have been constructed c.25 years ago (Table 2). C1001 was overlain by the current north garden topsoil which is currently cultivated (C1000).
