LEICESTER ABBEY PARK

ARCHAEOLOGICAL EVALUATION

REPORT
JULY 2019

ARCHAEOLOGICAL EVALUATION
LEICESTER ABBEY PARK
LEICESTERSHIRE

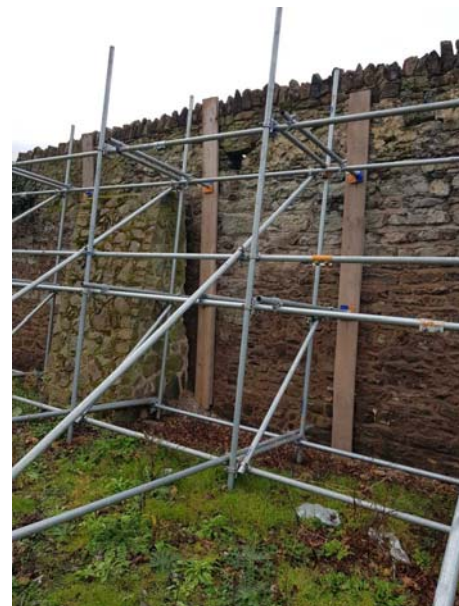
Plate 2 External view of the east precinct wall, looking southwest

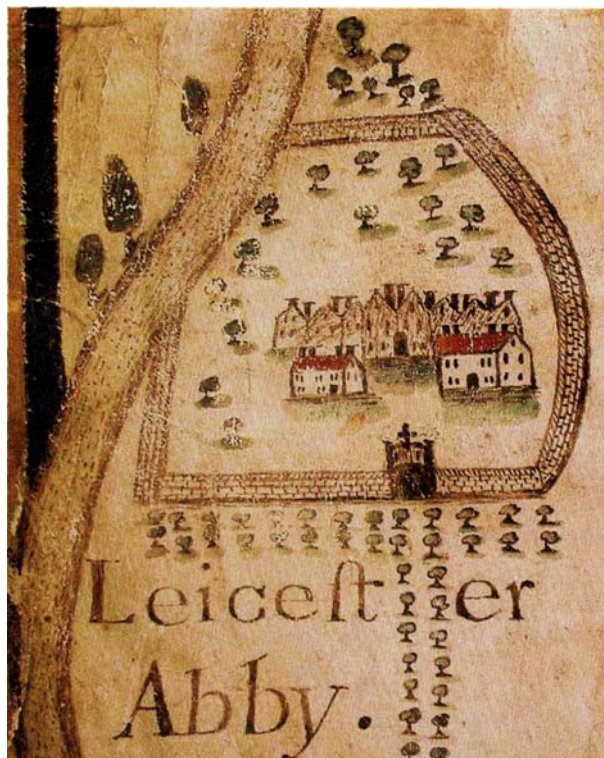
Plate 6 Illustration of 1686 by Fish (Buckley 2006a)

A plan of the abbey by William Senior (1613) for William Cavendish, new owner of the site shows the layout of the precinct at this time (Plate 5). The northern enclosure at this time included a dovecote garden (NW corner), a gatehouse (presumably the Hastings mansion, later Cavendish House), a 'hog yard' and stables (on the site of present farm buildings), 'apricock's garden' and 'ruynes' on the site of the church and claustral buildings. An orchard and 'horse pond' are also shown. Senior's map shows the location of the abbey mill, adjacent to the northeast corner; this was demolished in the late 18th century (Buckley 2006a, 17). The course of the river is shown and appears to flow immediately adjacent to the precinct wall for most of its length. A later map by Fish, dated to 1686, shows the extant precinct wall around Cavendish House (Plate 6).

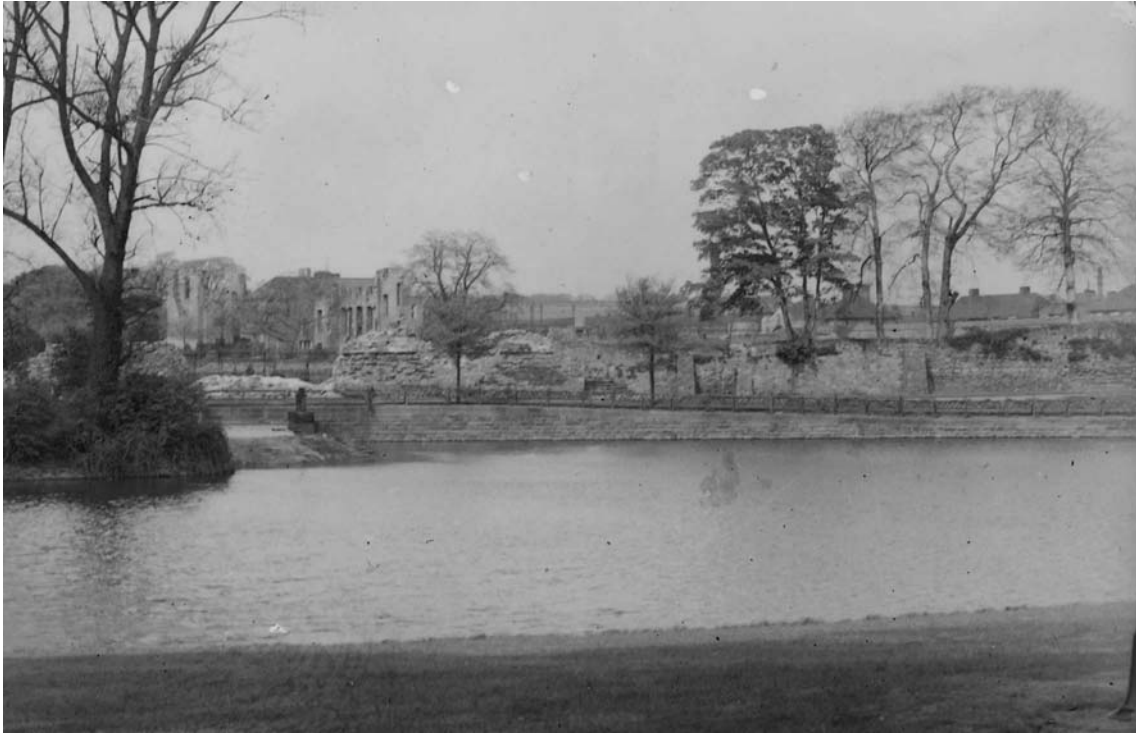
Historic images of the east wall survive, which show that by the 19th/early 20th century there had been significant collapse along this stretch (Plate 7). The early 20th-century rebuilding of several areas is evident in the fabric of the wall (FAS 2019).

Plate 7 Historic image showing the ruinous eastern wall (Leicester Archives)

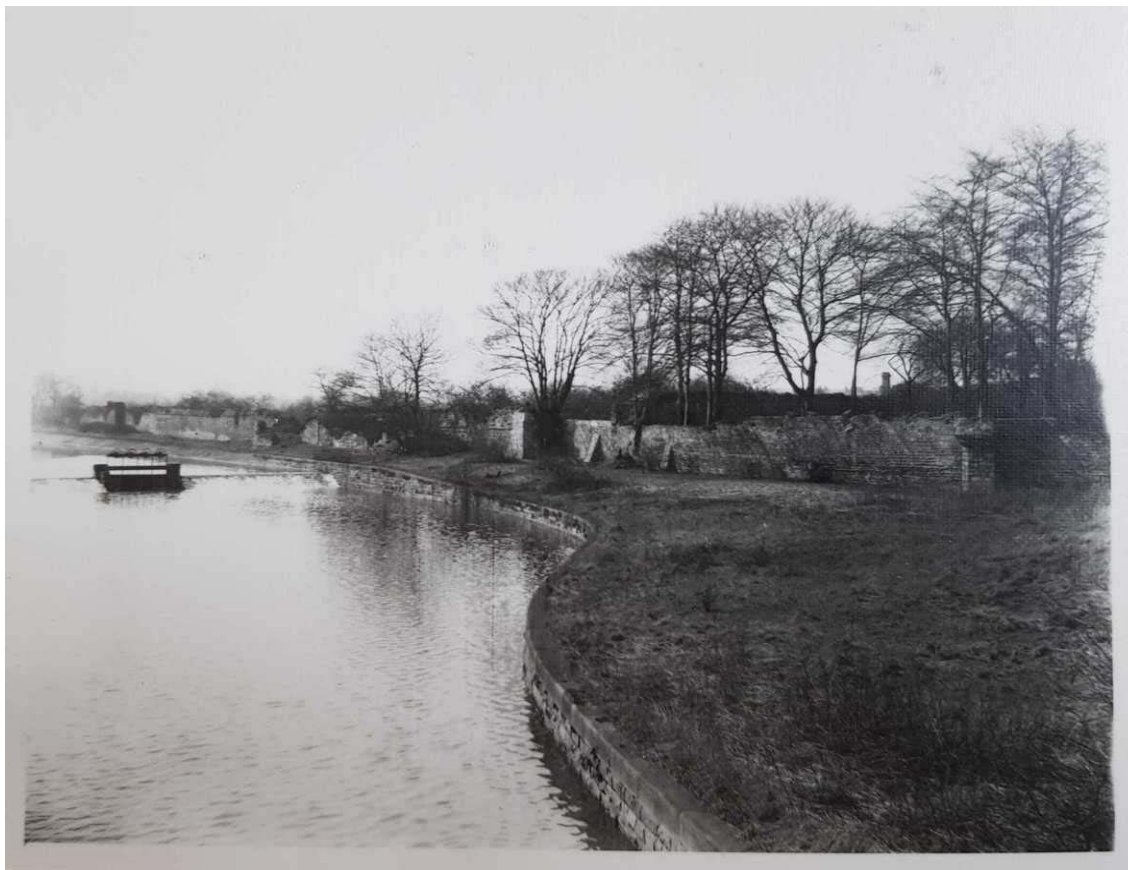
Plate 8 Photograph of the east wall of the precinct, 27th March 1909 (ROLLR Henton 1252)

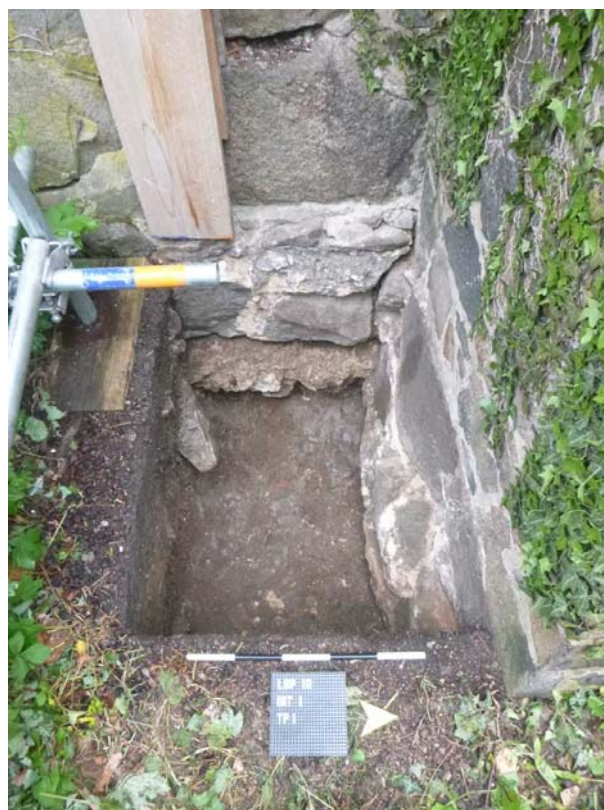
Test pit 1 was located to the immediate south of the second buttress from the north. The test pit measured 1.15m x 0.8m and was excavated to a maximum depth of 0.65m BGL, revealing the foundations of the east precinct wall and buttress, and a sequence of made ground abutting these elevations (Figure 4; Plate 9).

Plate 9 General view of Test pit 1, looking west

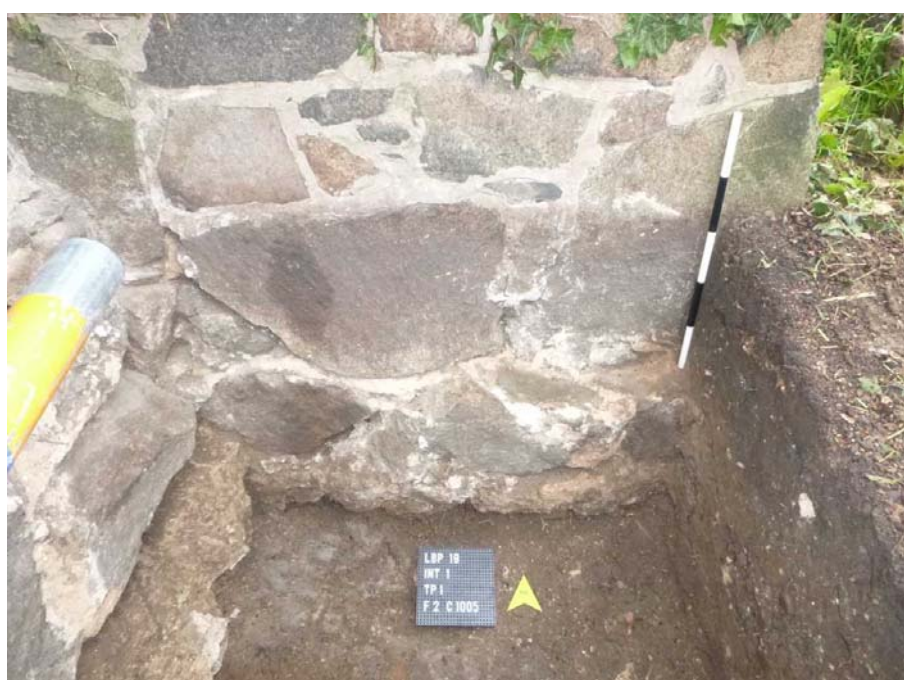
The foundations of the east precinct wall (F1) and buttress (F2) were recorded overlying C1003 (Plate 10). Both the precinct wall facing and the buttress foundations were constructed in heavily mortared rubble, encountered at c.0.33m BGL.

The buttress foundation (allocated F2 C1005) was faced with angular fragments with some limited coursing, and had a battered, rather than stepped profile. The bonding material visible on the buttress was a sandy, pale brown mortar.

Plate 10 Test pit 1, buttress F2, looking north

The mortared rubble foundation course at the base of the east precinct wall (F1 C1004), stepped out by 0.25m (C1004), over which uncoursed, rubble foundations stepped out from the elevation by 0.12m. The stepped foundations were bonded with a hard, yellowish-cream mortar.

No original, medieval fabric was observed; both the buttress and wall were faced in irregular granite which characterises later repair and refacing of the abbey wall. The buttress had leaned slightly away from the wall, resulting in a gap between the two perpendicular areas of refacing; that on the wall appears to abut that on the buttress.

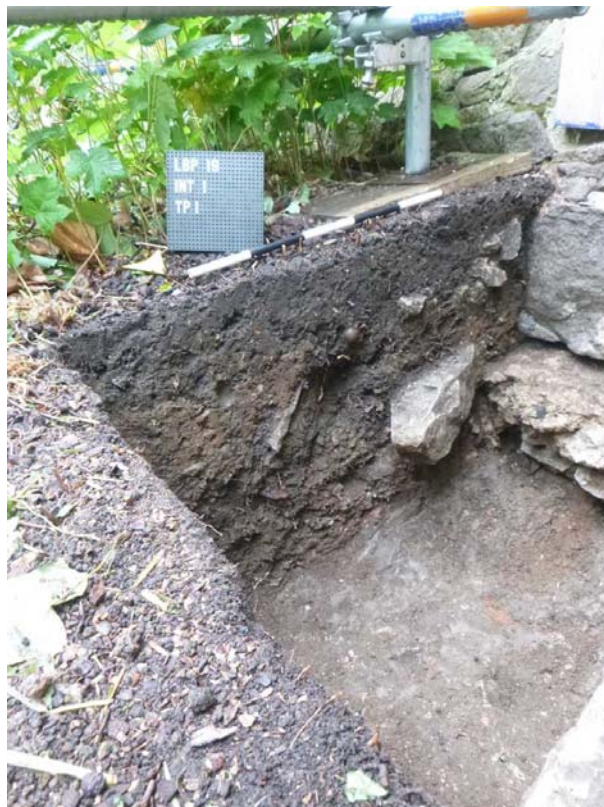
No construction cut was observed for either structure, and a sequence of three deposits was recorded abutting the wall and buttress foundations, overlying C1003 (Plate 11). C1002 was allocated to loosely-compacted, very dark greyish-brown clayey sand with heavy root disturbance and numerous stone inclusions. A fragment of slate roof tile and a single sherd of Rhenish – possibly 16th-century Siegburg – stoneware were recovered from this deposit (Appendix H).

Plate 11 Test pit 1, north facing section

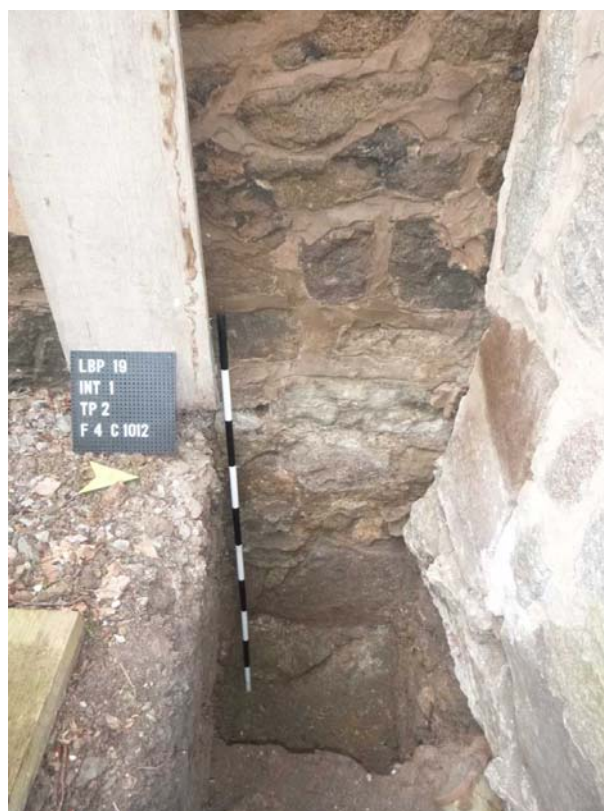
Test pit 2 was excavated in the southern re-entrant angle between the northern buttress and the precinct wall (Figure 5; Plate 12). Due to constraints of scaffolding, the test pit measured 0.75m x 0.40m in plan, and was excavated to a maximum depth of 0.55m BGL.

Plate 12 General view of Test pit 2, looking west

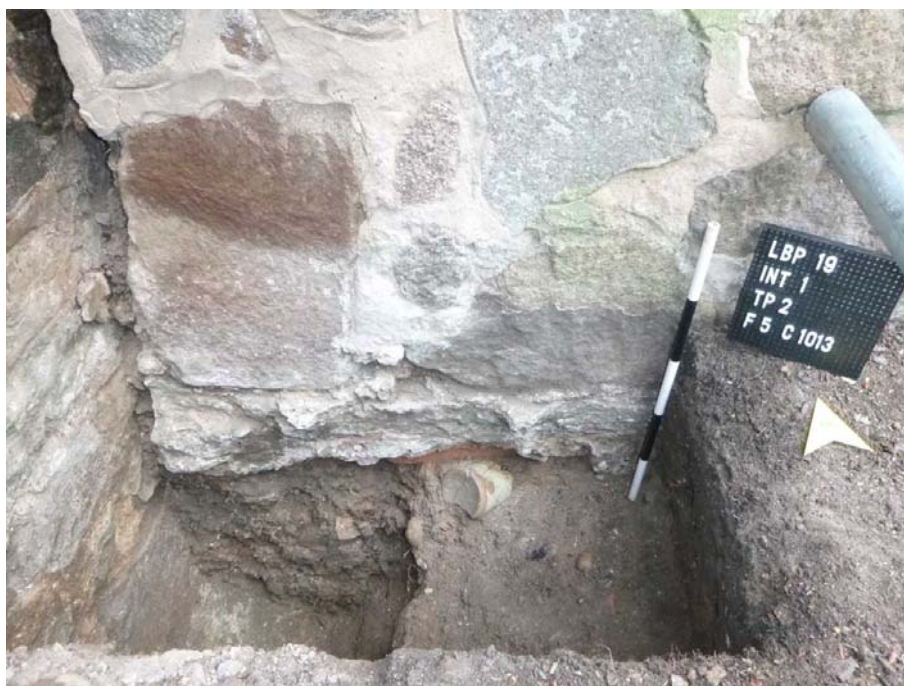
The test pit exposed the eastern elevation of the precinct wall (F4) which extended to a depth of 0.72m BGL before stepping out by 0.14m for a single course. The elevation above the stepped foundation was consistent with the elevation above ground, consisting of random or roughly coursed granite facing, with some areas of medieval coursed sandstone. The foundation of buttress F5 reached 0.42m BGL.

A clear relationship between the buttress (F5) and wall (F4) was observed; the buttress abutted the elevation of the precinct wall (albeit with a more recent gap between the two), but did not extend to its full depth, indicating that the foundation of the wall had been partially buried before the buttress was constructed (Plate 13). A fragment of modern stoneware was recovered from gravel deposits immediately beneath the buttress foundation (visible in Plate 13).

Plate 13 Test pit 2, buttress F4, looking north

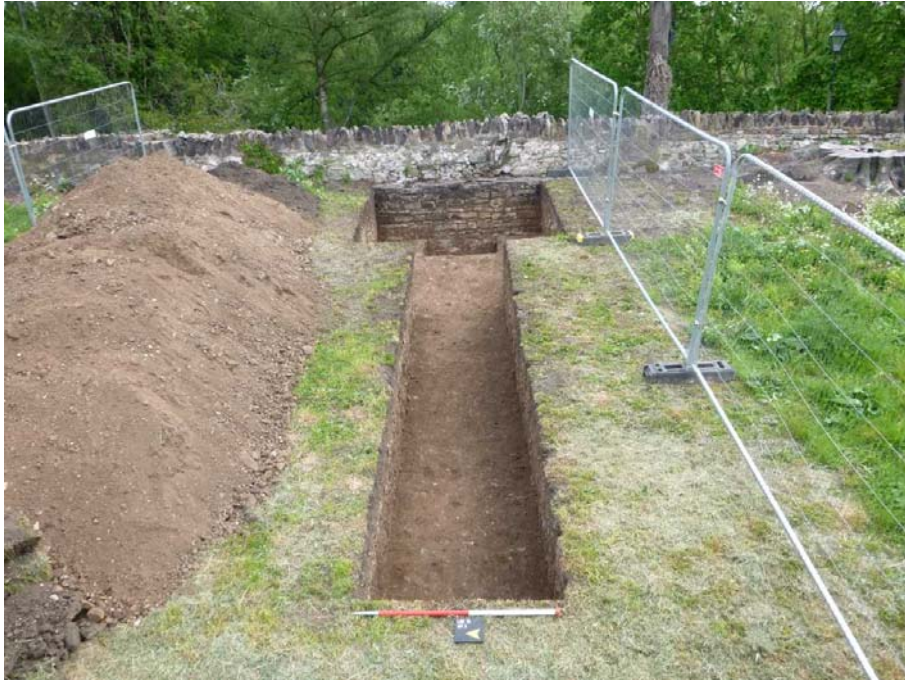
Plate 14 Intervention 2, looking east

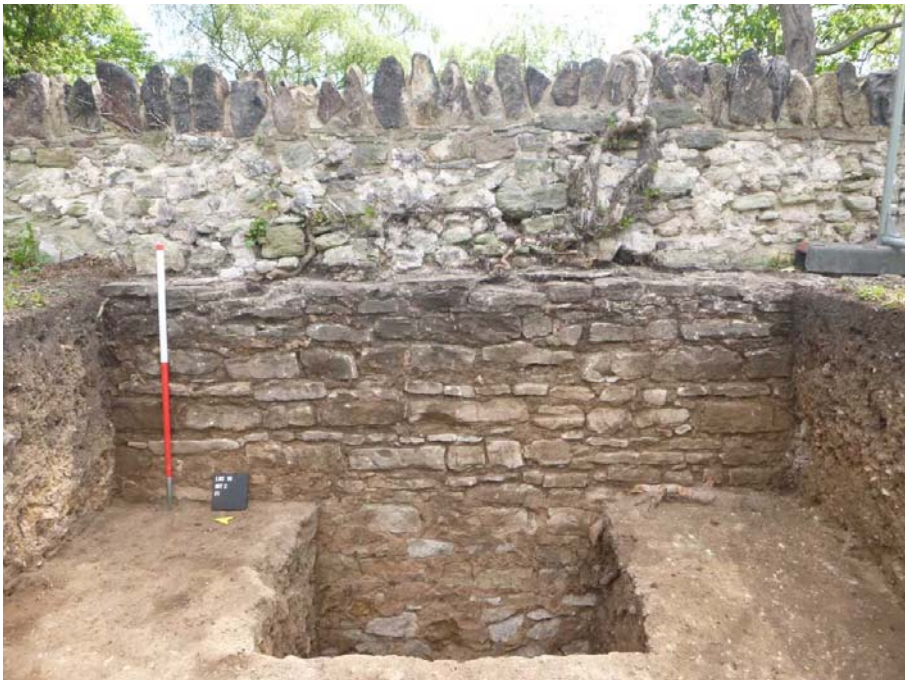
The western elevation of the precinct wall exposed for the full depth of the trench and continued beyond the depth of excavation. Here the wall was constructed with regularly coursed, roughly squared sandstone blocks, the make-up of which contrasted markedly with the less ordered, modern wall constructed over it (see Plate 15).

Plate 15 West elevation of the precinct wall (F3 C1010)

The sandstone blocks varied in dimensions from 6 x 3cm to 50 x 14cm and were bonded with a reddish-cream lime mortar with some gravel aggregate. Below c.1m BGL, the wall was found to have vestiges of wall render adhering to the elevation; the render had a more pinkish hue, and was smoother in texture, than the mortar bonding, and scored trowel marks were noted on the surface.

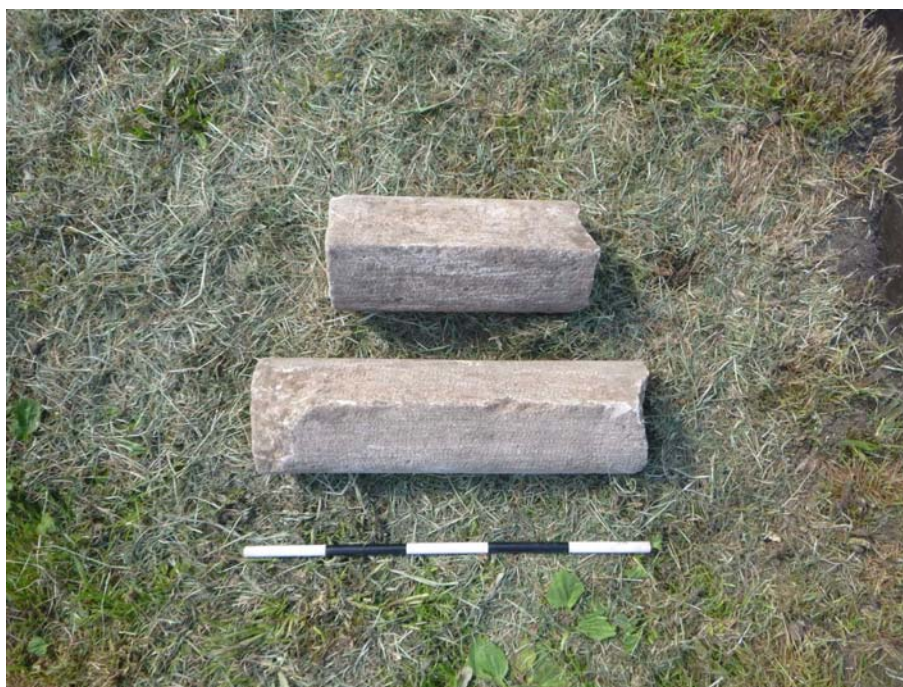
Plate 16 Fragments of architectural stone from C1008

Overlying C1011 and C1009, layer C1008 was recorded as a pack of friable stony brown silty sand, within which numerous tip lines were recorded, sloping downwards west-east towards the abbey wall (see Plate 14). This layer produced a small ceramic assemblage (three sherds), glazed floor tile fragments, a small lead scrap sheet and two pieces from a single fragment of architectural stone, interpreted tentatively as a fragment of arcading (Plate 16), all of which are likely to derive from monastic period buildings. The ceramic assemblage included sherds of Chilvers Coton C ware, of 14th to 15th-century date, and Midland Purple Ware of 14th to 15th-century date; the ceramic building material included a fragment of ridge tile and an abraded floor tile (Appendix H). However, the presence of a late-19th to early 20th-century vulcanite bottle-stop indicates the ceramic is residual and suggests a possible date for the deposition of the layer (Plate 17).

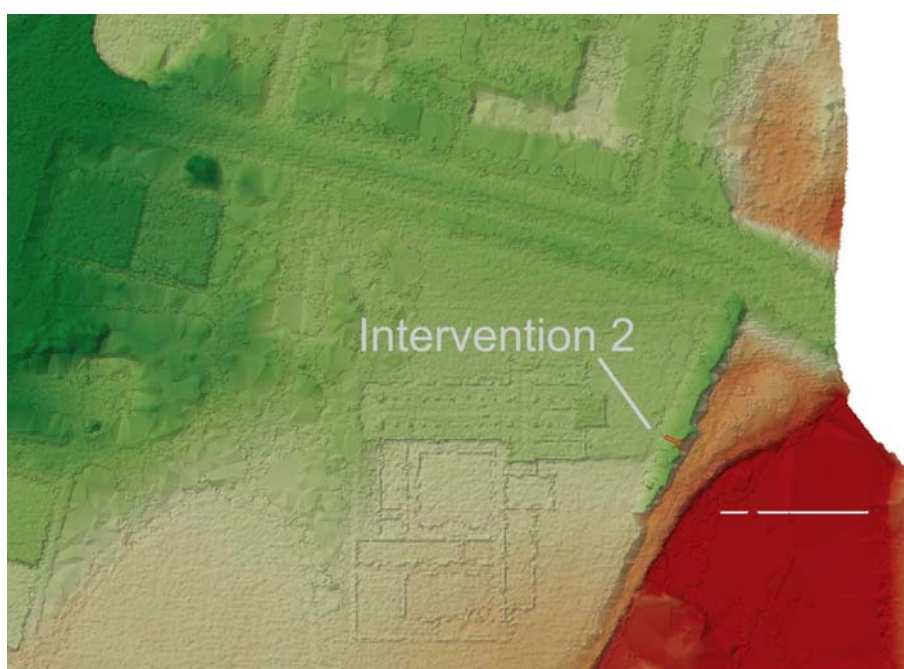
Plate 18 LiDAR DTM image of the location of the trench, showing the embankment against the east wall

Photographic evidence and the large stumps of trees would suggest that the former is most likely. Until recently, the embanked area was host to an alignment of mature trees now visible as large stumps; trees are shown in this location on maps of 1887 (Ordnance Survey) and in photographs as early as 1909 (ROLLR Henton Collection 1252; see Plate 8) suggesting the material against the east wall was in place by the end of the 19th century. Further, in discussing interpretation of a similar pack of material encountered in the evaluation trench in 2014, ULAS observed that where encountered elsewhere across the site, reworked deposits of the 1920-30s contain a larger proportion of modern rubbish (ULAS 2014).

The profile of the stratigraphy, tipping down west-east, supports the suggestion that these deposits levelled a slope and subsequently created the embankment. During test pitting in 2018, similar tipping layers were recorded in a test pit (2018 Test Pit 2), and homogenous levelling layers were observed in several of the test pits. A levelling deposit was encountered in the 2014 trench (Context 2) and extended to 1.3m BGL; this contained sandstone, roof tile and 14th-century floor tile and post-medieval ceramic.

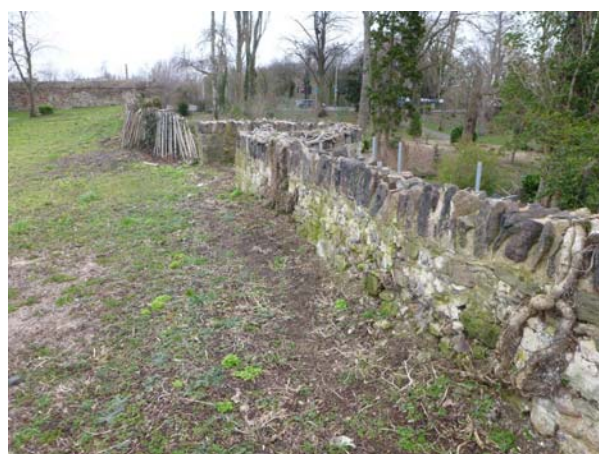
Plate 2 East precinct wall, interior, looking north

The precinct wall - Abbot Penny's Wall - is also Grade I Listed (NHLE 1361406); the designation includes the whole outer wall of the precinct, comprising both stone built elements to the north and brick elements to the south.

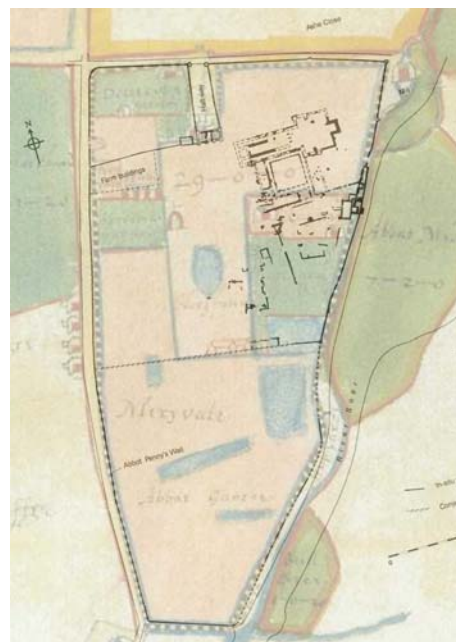
Plate 4 Detail from William Senior's map of Leicester Abbey with excavated remains overlaid © Devonshire Estates, Chatsworth. Reproduced by permission of Chatsworth Settlement Trustees

A plan of the abbey by William Senior (1613) for William Cavendish, new owner of the site shows the layout of the precinct at this time (Plate 4). The northern enclosure at this time included a dovecote garden (NW corner), a gatehouse (presumably the Hastings mansion, later Cavendish House), a 'hog yard' and stables (on the site of present farm buildings), 'apricock's garen' and 'ruynes' on the site of the church and claustral buildings. An orchard and 'horse pond' are also shown. Senior's map shows the location of the abbey mill, adjacent to the northeast corner; this was demolished in the late 18th century (Buckley 2006, 17). The course of the river is shown and appears to flow immediately adjacent to the precinct wall for most of its

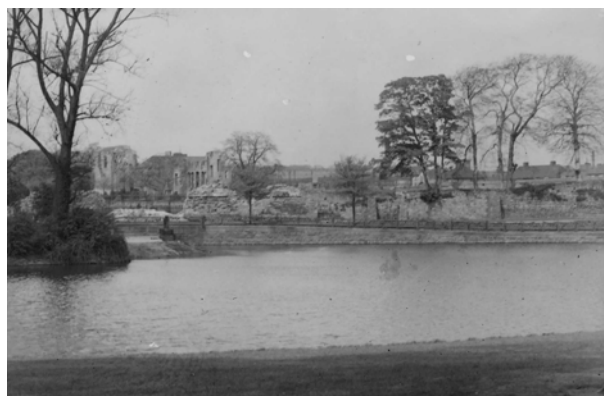
Plate 6 Historic image showing the ruinous eastern wall (Leicester Archives)

Historic images of the east wall survive, which show that by the 19th/early 20th century there had been significant collapse along this stretch. The early 20th-century rebuilding of several areas is evident in the fabric of the wall (**Error! Reference source not found.**).
