NUMBER 2 OGLEFORTH

ARCHEOLOGICAL
INVESTIGATION

ARCHAEOLOGICAL INVESTIGATION
2 OGLEFORTH
YORK

SITE CODE: YGF08
REPORT CODE: FAS2008 395 YGF349
NGR: SE 6051 5220

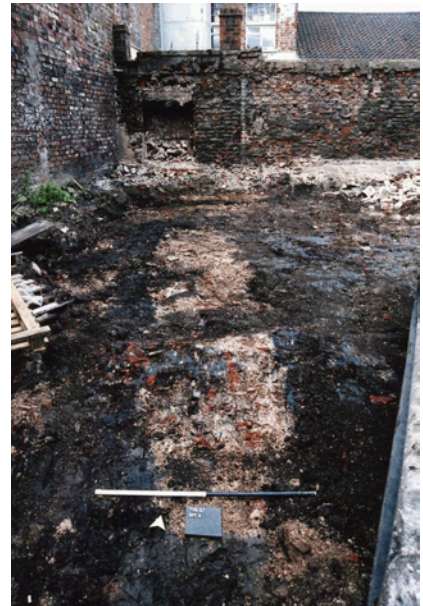
Plate 4 F58 pre-excitation

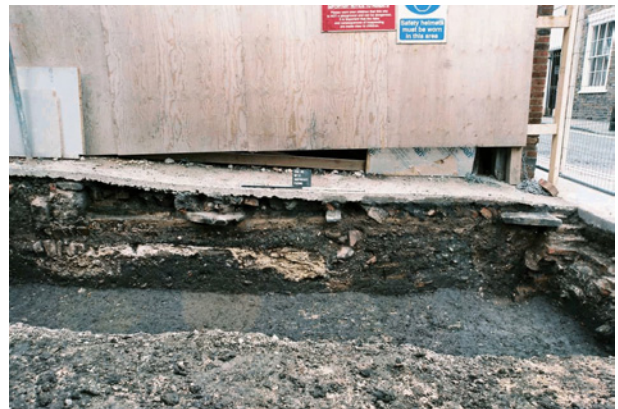
Plate 5 Intervention 6, southeast-facing section

by a thick, consistent deposit of dark greyish-brown silty clay (C1119) almost indistinguishable from C1121 (Figure 5; Plate 5). C1119 produced an assemblage of 63 sherds of glazed ceramic representing vessels of Brandsby-type ware, Beverley ware, Humber ware and York ware, suggesting a latest date of the mid-14th century for the accumulating soil (see Appendix D). Notably, C1119 produced several relatively large fragments of limestone, three of which were identified as architectural (Find nos 76 to 78). The fragments have been identified as a stone sill with central grille-hole, a fragment from a circular structure such as a small stair drum or well, and a fragment of door or window head; the bold half-roll moulding of the latter allows the fragment to be dated to the 12th-century (Dr Jonathan Clark, pers. comm.).

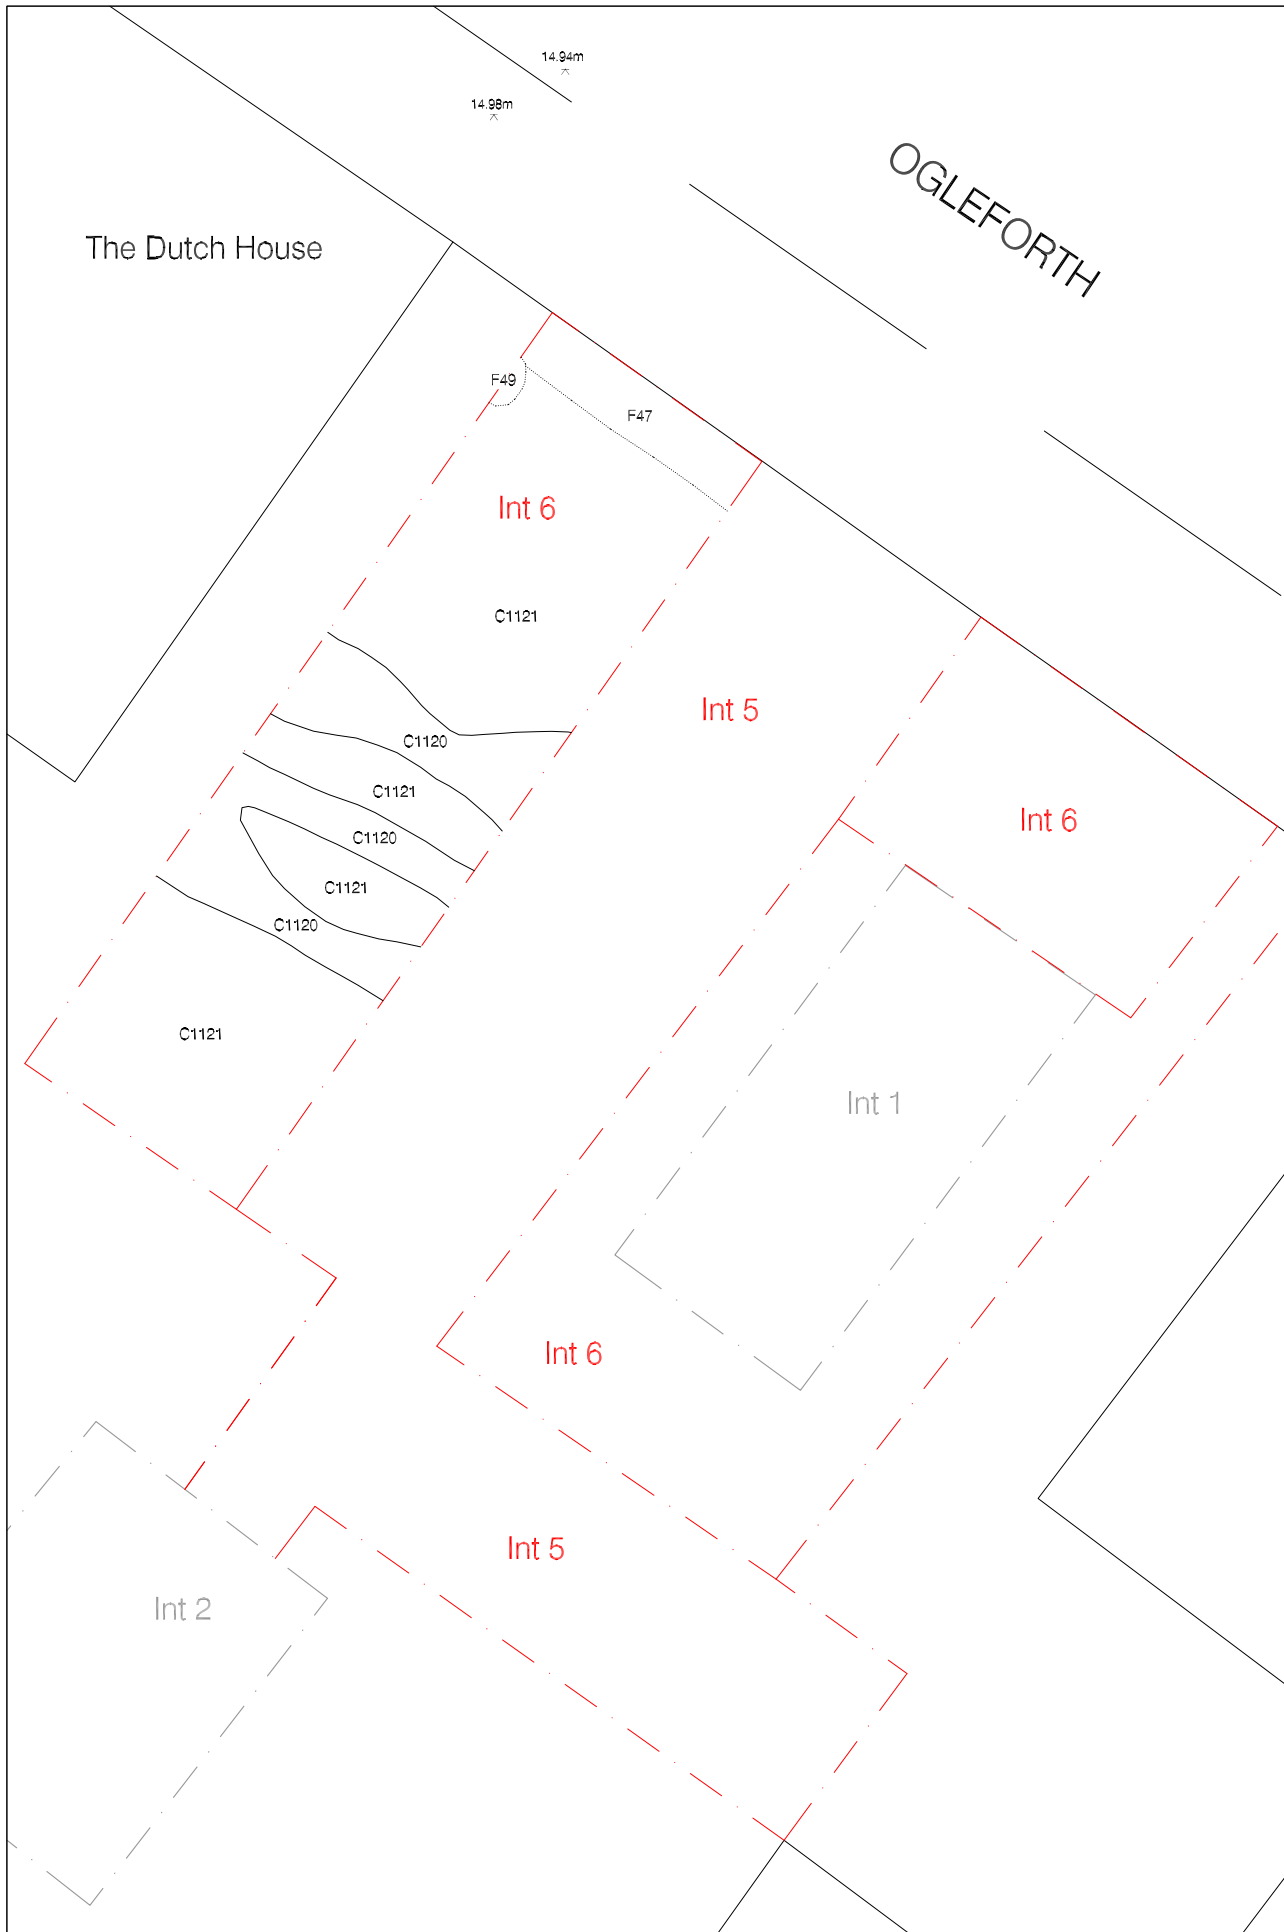
Figure 4

Intervention 6 - C1121 and C1120 pre-excavation

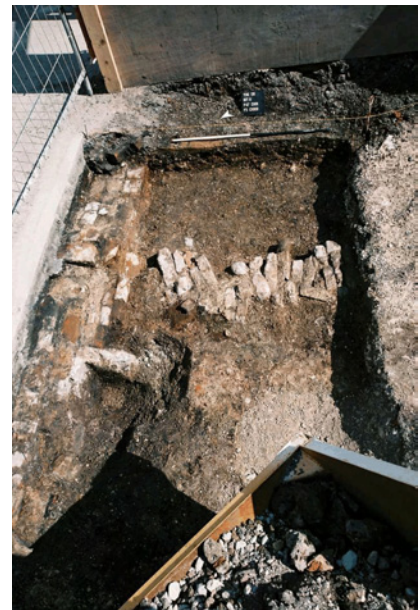
Plate 6 Wall footing F5 C1009, pre-excavation

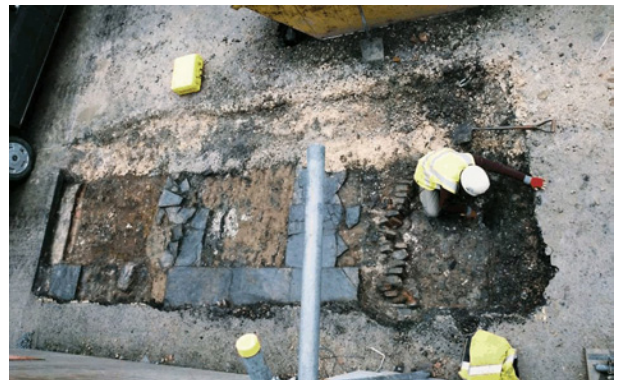
Plate 8 Structure 1 during excavation

Structure 1 was relatively well-preserved in the area of Intervention 6 with the flagstone floor largely intact, although some truncation relating to preparation for the 20th-century car park was noted. This took the form of horizontal truncation of the flagstone floor F2, particularly at the frontage, and some vertical truncation in the form of modern concreted post-settings (F48, F55 and F56). A levelling layer C1116 could be seen to fill

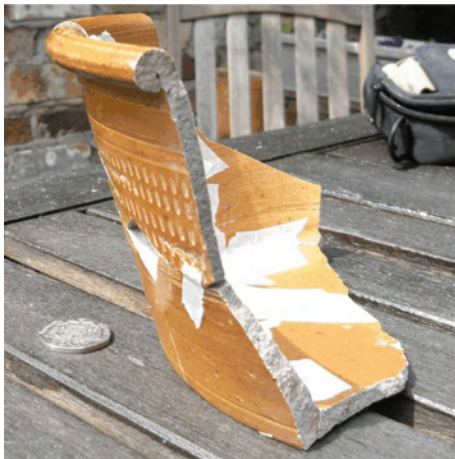
Figure 2

Eighteen sherds of pottery dating to the later 18th century or later were present. They represented two vessels. The first was a small refined redware vessel with a white slip and yellow glaze (REFR). Such vessels were produced from the mid 18th century onwards, for example as coffee pots. The second vessel was a stoneware bowl (Figs 2, 3 and 4). The bowl has a rolled-out bead rim, a turned base and was decorated with a band of roller stamping on the centre of the straight, slightly flaring, body. Production of Nottingham stoneware apparently declined in the last years of the 18th century but continued into the early 19th century, perhaps being finally eclipsed by the Derbyshire stoneware industry at Codnor Park which was founded in c.1820. The decline is documented in detail by Jewitt (Jewitt 1878, 416-7). In 1780 a list of Nottingham burgesses included 14 pot and mug makers but by 1802 the equivalent list only included four and in 1803 a list of voters in a contested election included only one and the "Old Pottery" is given as the residence of several people unconnected with pottery production. By 1815 a history of Nottingham discusses the demise of the Nottingham industry and blames the fact that clay had to be imported from a considerable distance, unlike in Staffordshire (or Derbyshire, where the stoneware clay was revealed during the cutting of the Erewash canal). From these records it seems certain that the Ogleforth bowl was made before c.1803.
