PYT HOUSE FARM BARN ASHAMPSTEAD, WEST BERKSHIRE

**PYT HOUSE FARM BARN
ASHAMPSTEAD, WEST BERKSHIRE**

Archaeological Building Recording

June 2019

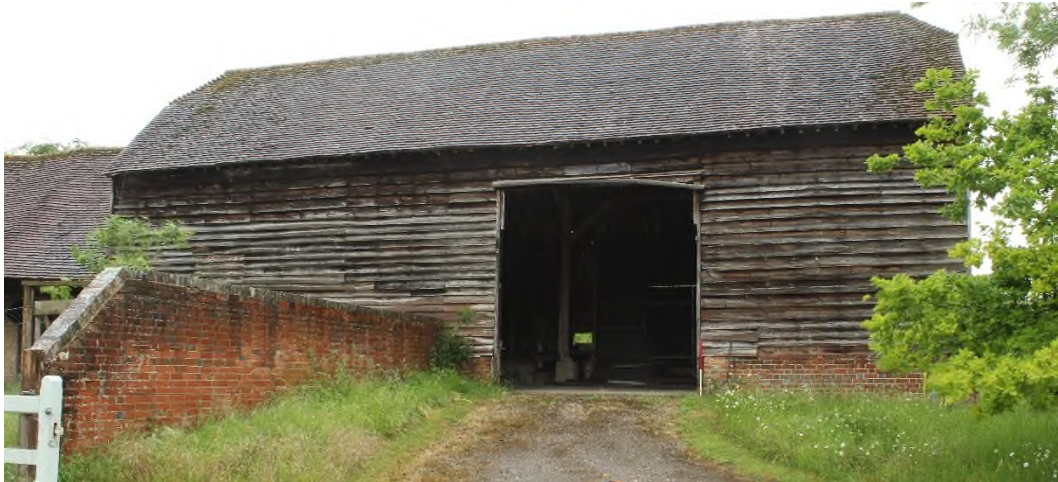
Figure 2 Barn, east elevation.

- 3.3 The barn is a four-bay timber-framed building with an aisle to the rear, west side and the threshing bay is in the second of bay from the north. The barn has weatherboarded walls above a brick plinth and half-hipped plain clay tile roof with a hipped porch to the west side of the threshing bay faced with corrugated sheet metal (Figures 2 and 3). The plinth to the north gable may have been rebuilt using cementitious mortar. Most of the weatherboarding is modern softwood with an area of older boarding at lower level on the north elevation. The timber-frame is predominantly constructed in oak, but the tie beams are of softwood and

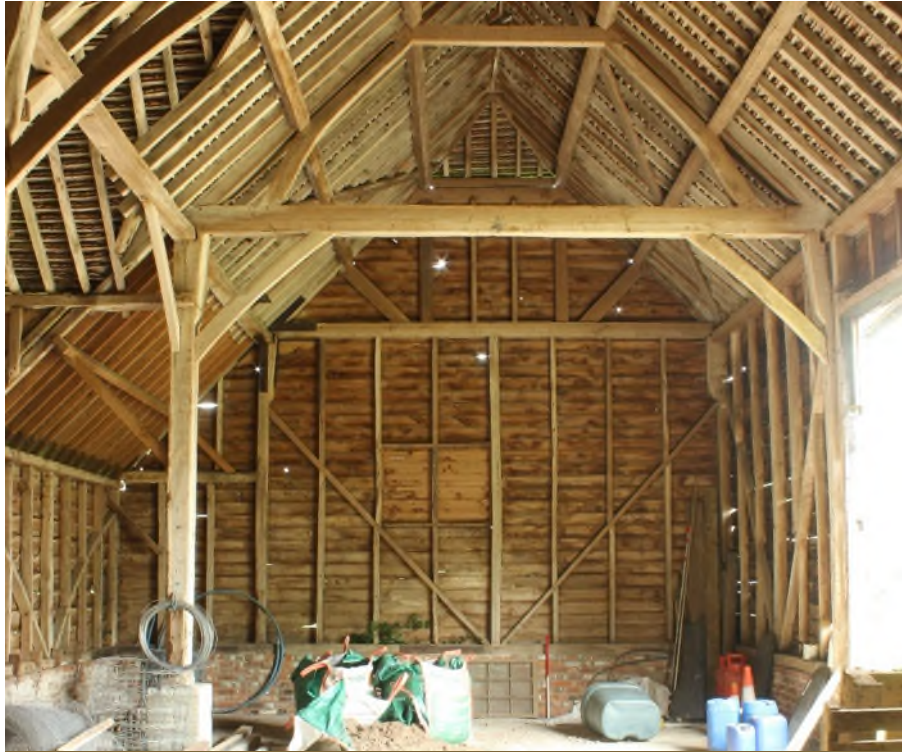
Figure 4 Barn interior facing north showing the wall framing of thin studs and long, raking shores.

The barn appears to be a building of primary timber-framing, i.e. it appears that most, if not all of the timbers used in this building are in their primary use in this building, with very little evidence for re-used timbers. The wall framing is typical late 18th/early 19th century framing consisting of tall scantling studs stretching between the soleplate and the wall plate or tie beams at the gable ends with long, raking shores between the principal posts down to the foot of the central more substantial posts to the centre of each bay and at the centre of the gable ends (Figure 4). One of the features of this building are the raking shores to the walls of the aisle; rather than being straight timbers, these shores gently curve, all but two are clearly having been cut specifically to give this effect, the other two having a less steep and slightly more irregular curve, but the overall effect is pleasing and suggests a degree of quality in the construction of this building (Figure 5).

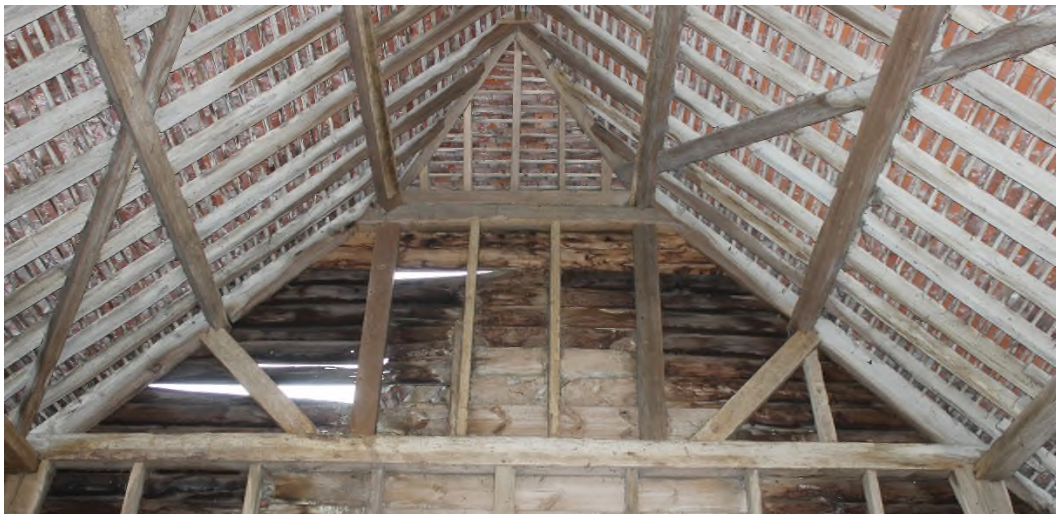
Figure 6 The roof truss of Truss I at the north end of the barn with queen and raking struts.

- 3.8 The roof trusses to the gables consist of both queen struts and raking struts, the queen struts connecting to a collar which clasps the upper set of purlins whilst the raking struts, clasp the lower purlins of the main roof (Figure 6). The three trusses defining the bays have gently curving braces between the principal posts and the tie beams, principal rafters and curved under rafters between the tie and the collar, the curve enabling the under rafters to clasp the lower purlins which are also housed into the soffit of the principal rafters (Figure 7). The principal posts are generally square in section with angle cut jowls; the only principal post that really marginally differs from this pattern is the post to the east side of Truss I at the north gable where the jowl has a gentle curve rather than angle cut but is otherwise of similar form.

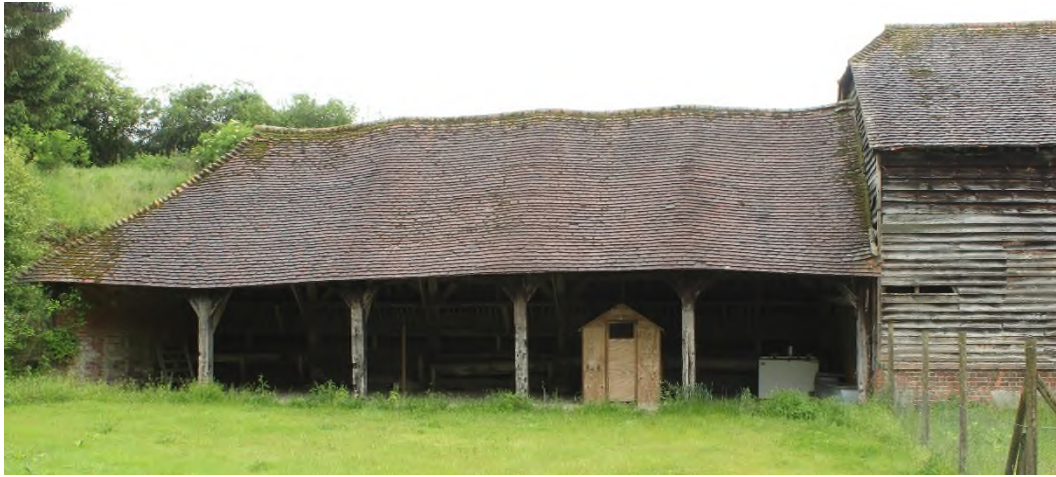
Figure 8 Shelter shed, east elevation.

- 3.11 The shelter shed is a building of five bays with brick walls to the south and west, the south wall being laid in Flemish Garden Wall bond and probably replacing a timber stud wall as there are posts to the front and on the line of the arcade plate to the rear (Figure 8). The brickwork of the wall to the rear of the aisle appears to have been rebuilt using cement mortar and the rafters over the aisle are all modern softwood timbers. The roof is of plain clay tiles and hipped to the south.
- 3.12 The shelter shed has a small aisle to the rear which appears to have served as a feeding passage; hay racks and mangers remain in-situ although the mangers are in various states of collapse with the manger in Bay 4 being almost entirely lost (Figure 9).

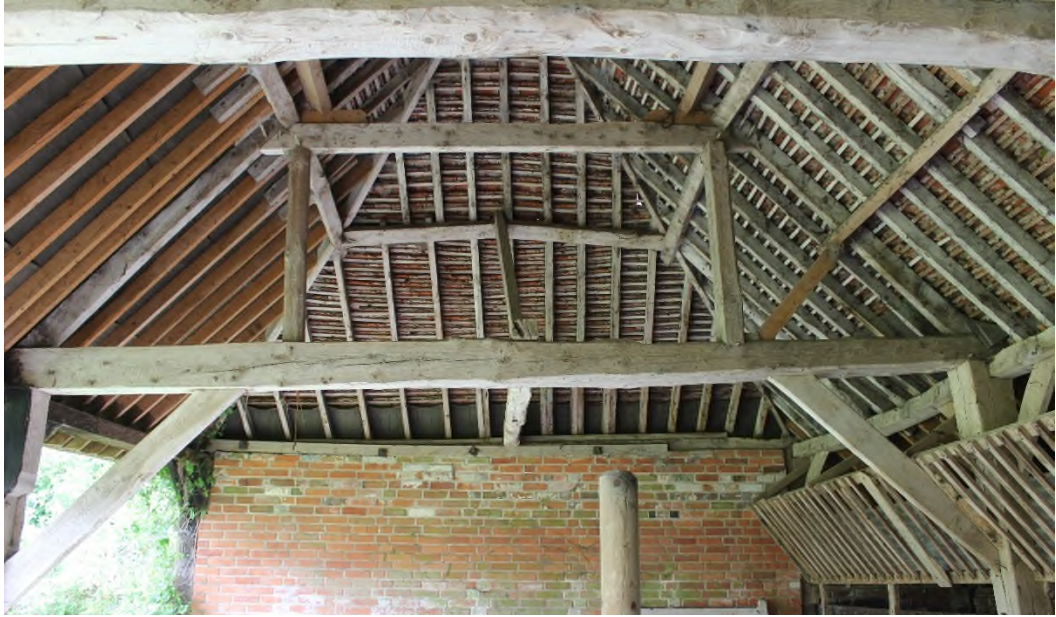
Figure 10 Truss V, north face.

The building has five roof trusses with Truss I set adjacent to the south gable wall of the barn. The trusses are all of queen-strut construction with clasped purlins and a narrow ridge board (Figure 10). The braces between the ties and posts are generally straight although some have slight or irregular curves. The posts have jowls with ogee or cyma recta mouldings (Figure 11). The tie beams of Trusses I – III are reused timbers as evidenced by void mortises in the soffits inside the triangle defined by the down braces. The tie beams of Trusses IV and V are slightly more regular softwood timbers with no evidence of reuse. To the front there are slightly curved braces and from the arcade posts to the arcade plate there are a mixture of the slightly curved and straight braces.

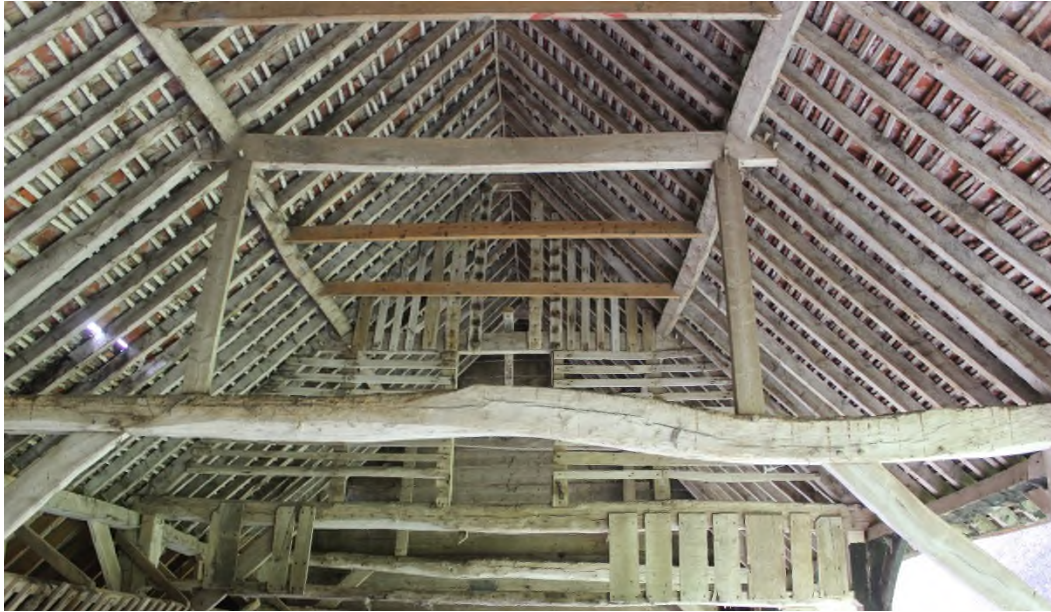
Figure 12 Roof structure looking north with the closed truss, Truss II.

Truss II has been 'closed' by horizontal battens between the queen struts and other studs, above the tie beam up to the collar, and vertical battens from collars up to the principal rafters (Figure 12). Below the tie beam there are wider, vertically set boards from the tie beam down to an inserted horizontal member set at the level of the bottom of the jowl. There is a similar horizontal timber on Truss I but no evidence for the closure of this truss. At lower level evidence for a partition is provided by a gap between the mangers in Bays 1 and 2 and marks on the inner faces of the arcade post and front principal post showing that there were timbers abutting these posts where painting/blackening of the timbers did not reach because of the presence of the timbers. There are also three sockets in the concrete floor on the
