# ARCHAEOLOGY IN SOUTH YORKSHIRE 1998/1999

*A review of archaeology in South Yorkshire*

**South Yorkshire Archaeology Service**

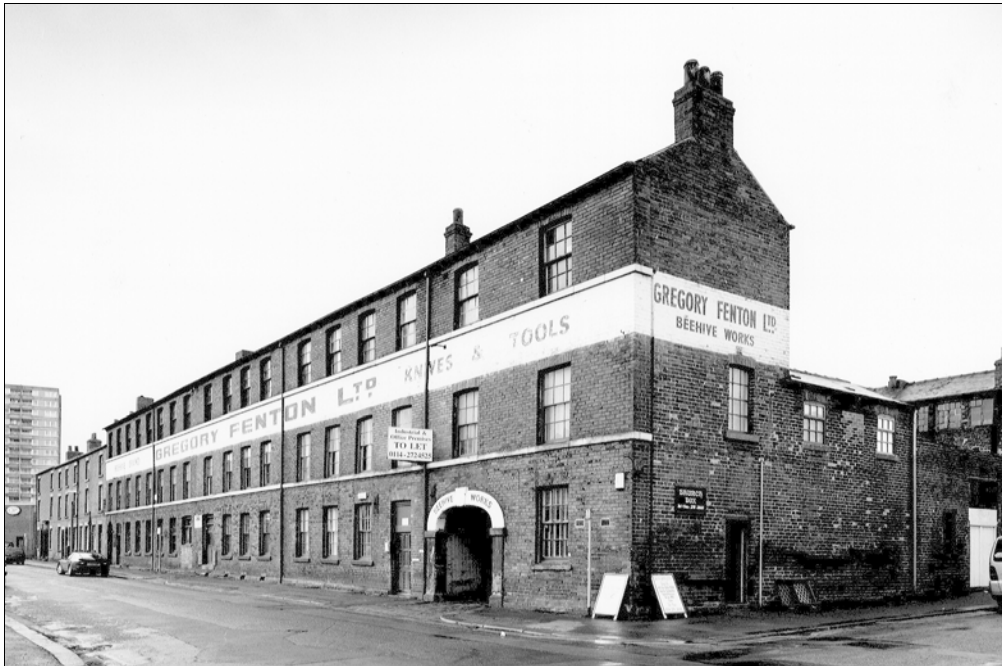
Figure 2 Beehive Works, Milton Street, Sheffield (NMR: AA98/13962). Beehive Works, originally known as Milton Works, is a large complex, arranged around two courtyards, which manufactured cutlery, silver plate and files. All the main buildings on the site were built between the 1860s and 1890. It has a front range, containing offices, showrooms and a warehouse, with workshop ranges round the courtyards, containing forges, grinding hulls and cutlers' workshops (© English Heritage)

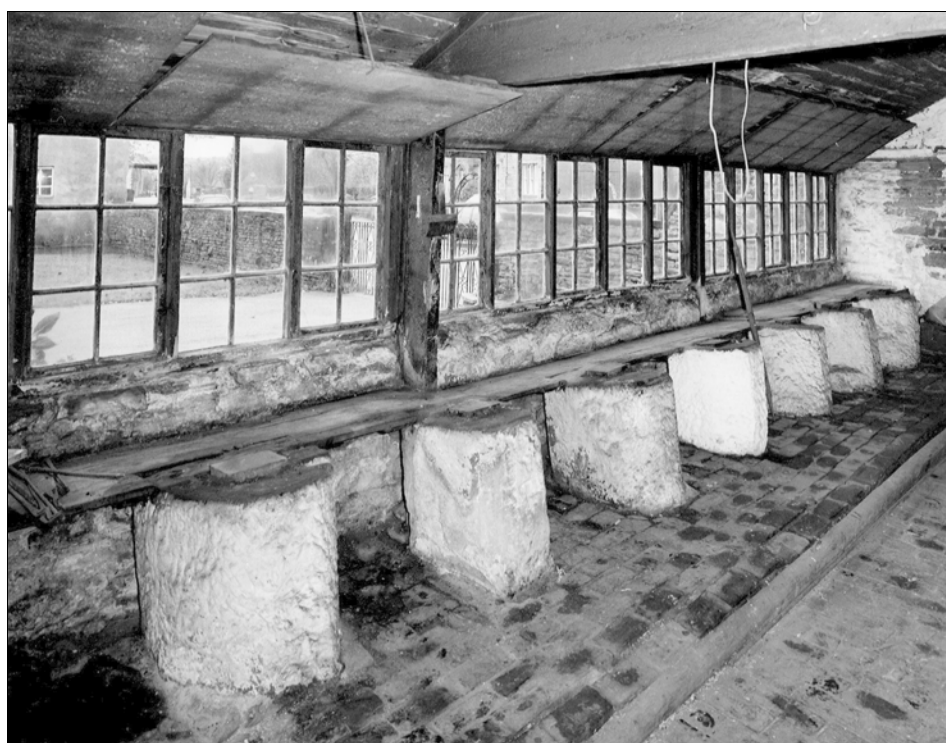
Figure 3 Interior of file cutters' workshop, Crown File Works, 11 High Street, Ecclesfield (NMR: AA98/14082). Crown File Works is a complex of sandstone buildings built around a smallholding, dating from the early 19<sup>th</sup> century. It is a good surviving example of a combined agricultural and industrial complex comprising a farmhouse, stable, file cutters' workshop, packing shop, hardening shop, tanging shop and forge, and cartshed (© English Heritage)

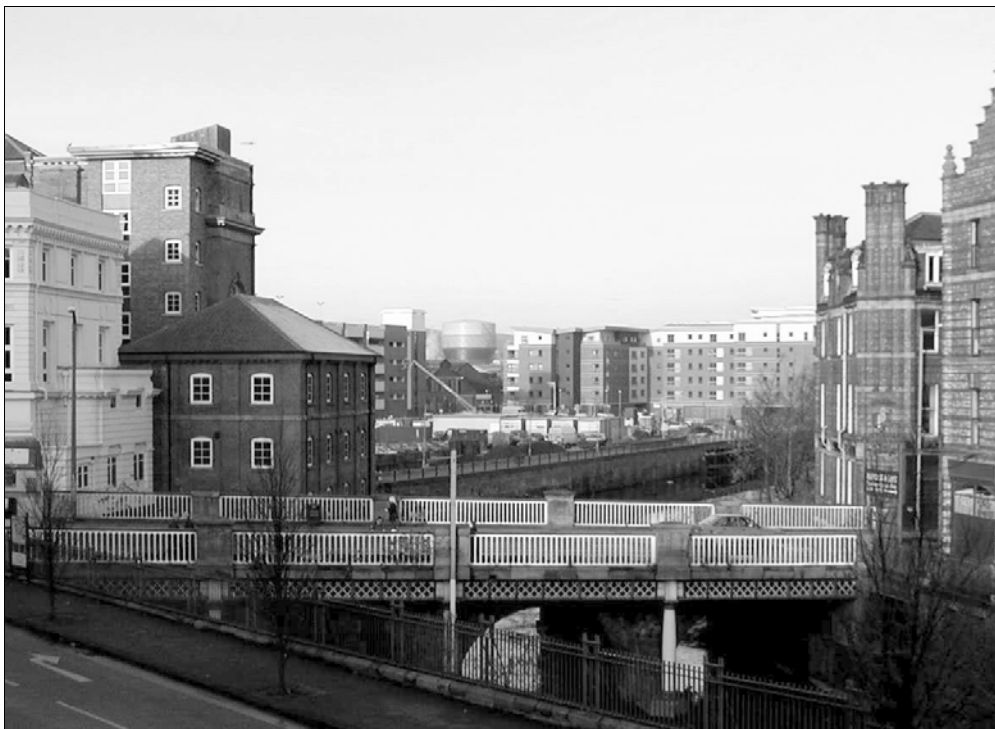
Figure 5 Lady's Bridge on the River Don (© SYAS)

The first recorded bridge on the site was constructed in the 12<sup>th</sup> century by William de Lovetot and this wooden structure was not replaced until 1486 when William Hill, a master mason, was employed by the townsmen to build a stone bridge with five arches, 14ft 6in wide (Hey 1991, 41). In 1689 it was designated as a county bridge and responsibility for its upkeep was taken over by the West Riding justices of the peace. It was subsequently widened on four occasions, and Hey has noted that some of the ribbed arches erected by Hill can still be seen from the Castlegate side. Fine (1992, 30) has published a photograph taken in 1909 which clearly shows the structural evidence for the rebuilding.

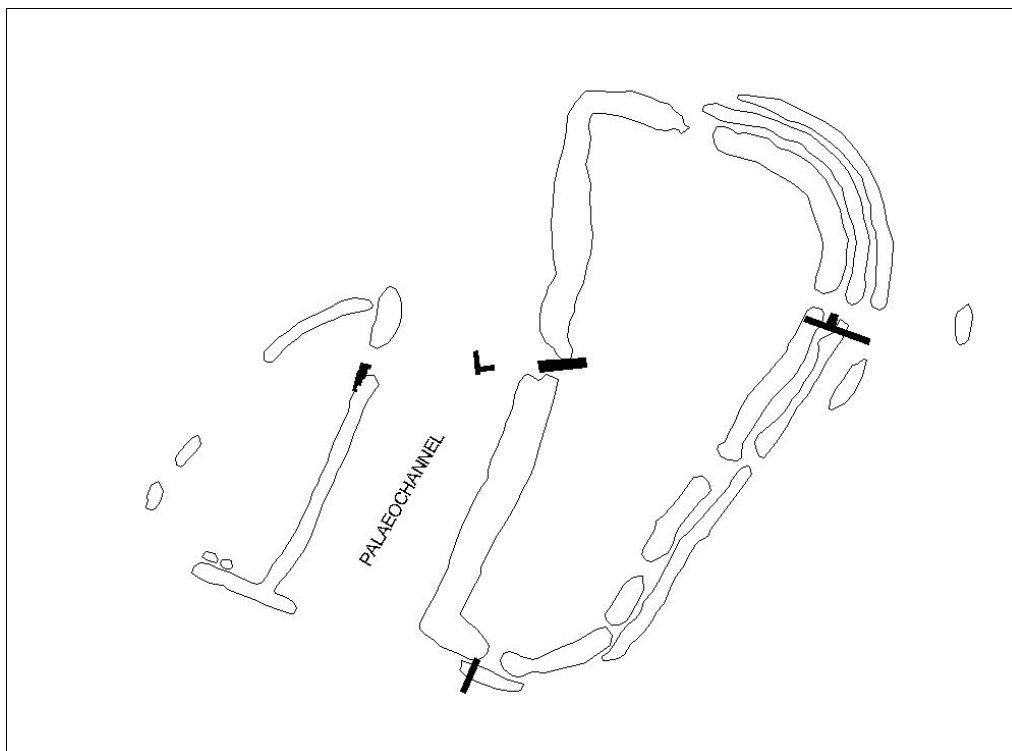
Figure 10 Outlines of the phase 2 enclosures (A and B) at Sutton Common in relation to the north-flowing palaeochannel (after Whiting 1936). The positions of the five trenches are also shown (© WEARC)

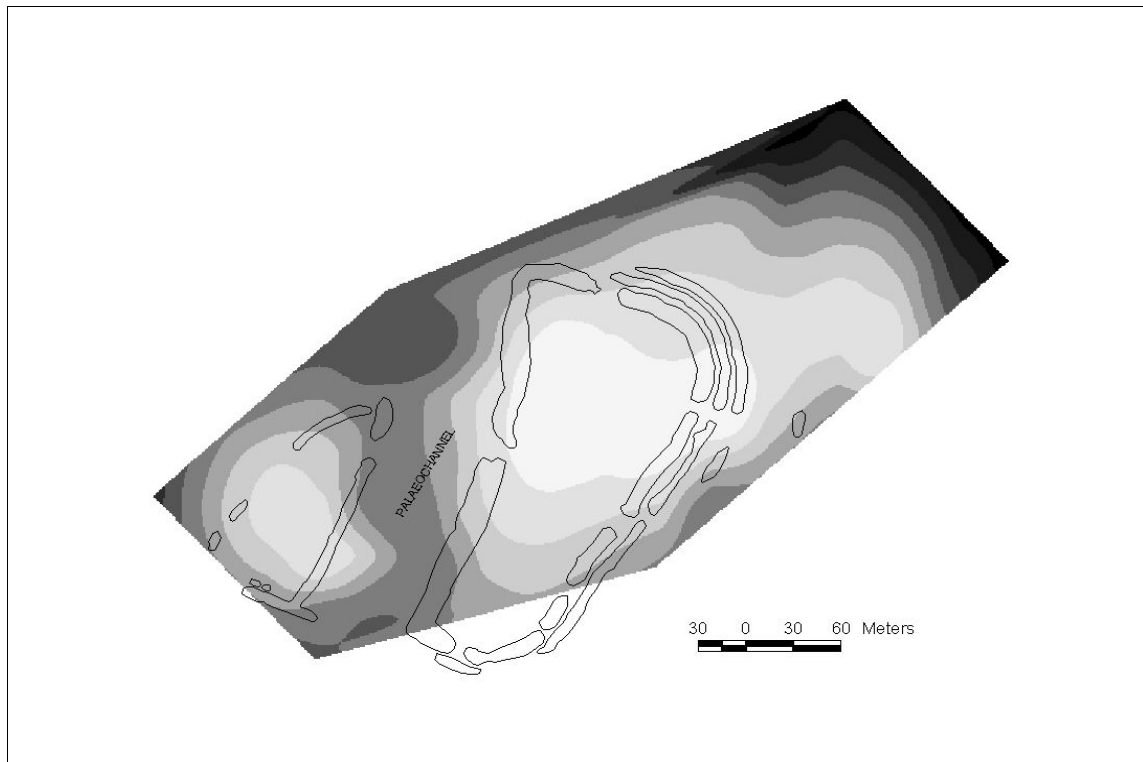
Figure 12 Results from the hydrological modelling in relation to the positions of the two enclosures (© WEARC)

from the monitoring and modelling of the water-table, which has shown that some parts of the site display consistently high water-tables relative to the land surface. Such areas are likely to sustain continued preservation. However, in other areas, despite the water-table rising beneath the enclosures, the mean water-table remains too far from the wood to enable saturation and, thereby, continued in situ preservation. Furthermore, in these areas degradation of the wood means that preservation is unlikely to be sustainable despite re-wetting.

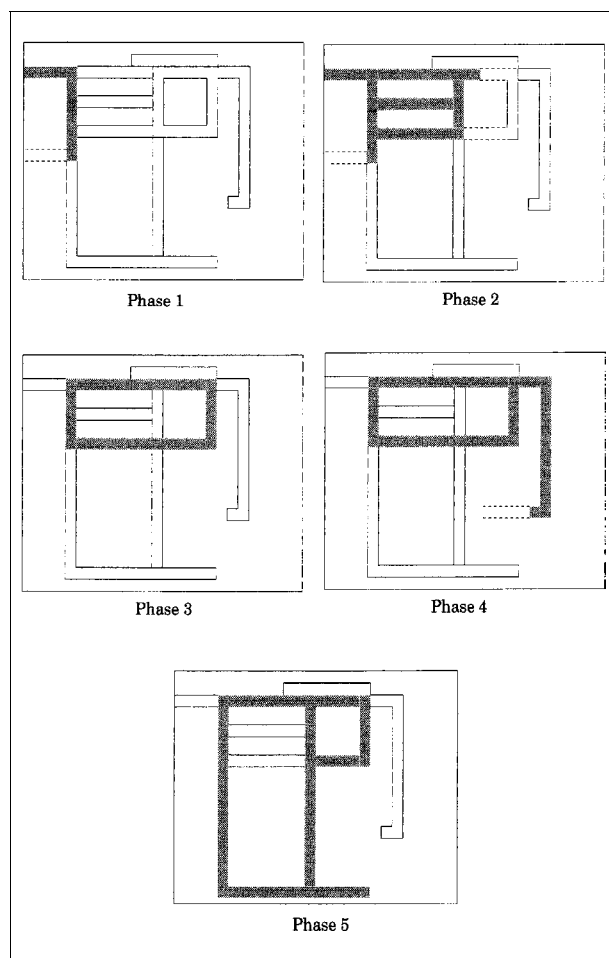
Figure 16 Diagram showing the possible building sequence at Thundercliffe Grange (© Brian Dolby)

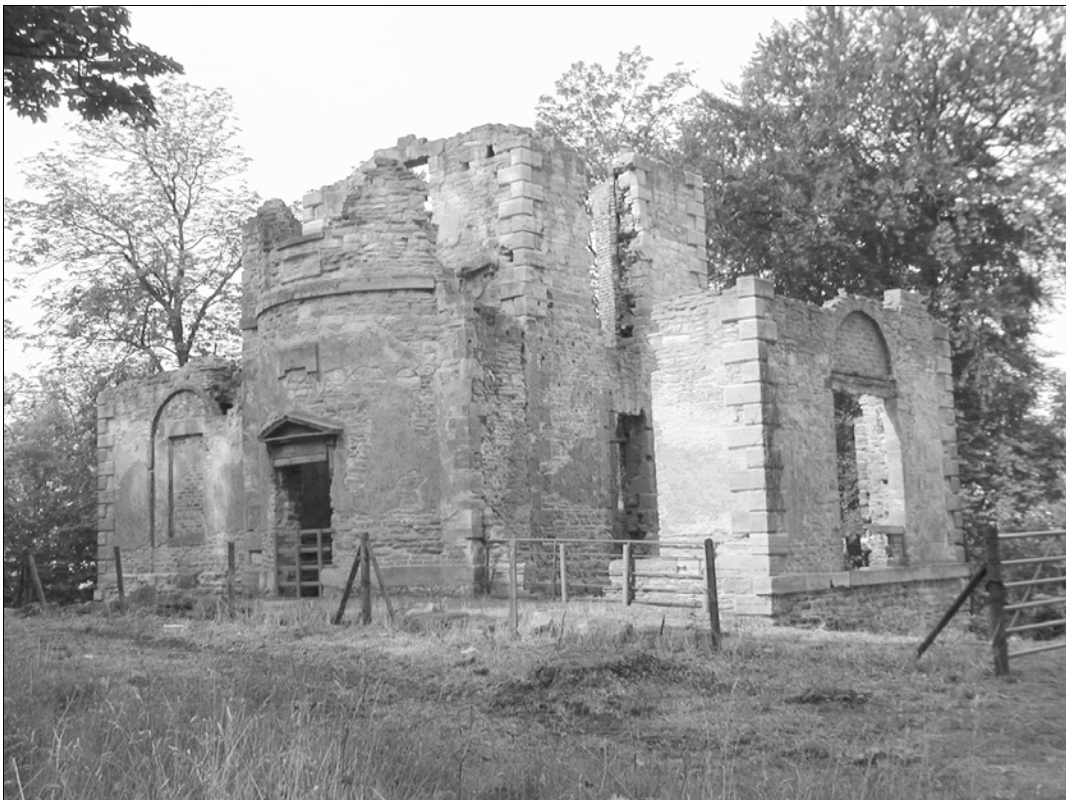
Figure 17 Bilham Belvedere as it is today (© SYAS)

apsidal extension. Masons' marks were noted, three different designs being apparent, all on bedded faces, in keeping with the date of the material. The presence of sash weights and fine 'crown glass' are commensurate with Georgian rectangular windows in the Belvedere itself (Fig 17). A moulded stone mullion and similarly styled sill may be from the west facing windows of the north wing. Rounded pilasters, several pieces of which are to be found in the exterior debris, may well have been dressing to these windows – a composite type in late 17<sup>th</sup> century style (Brunskill 1978, 131).

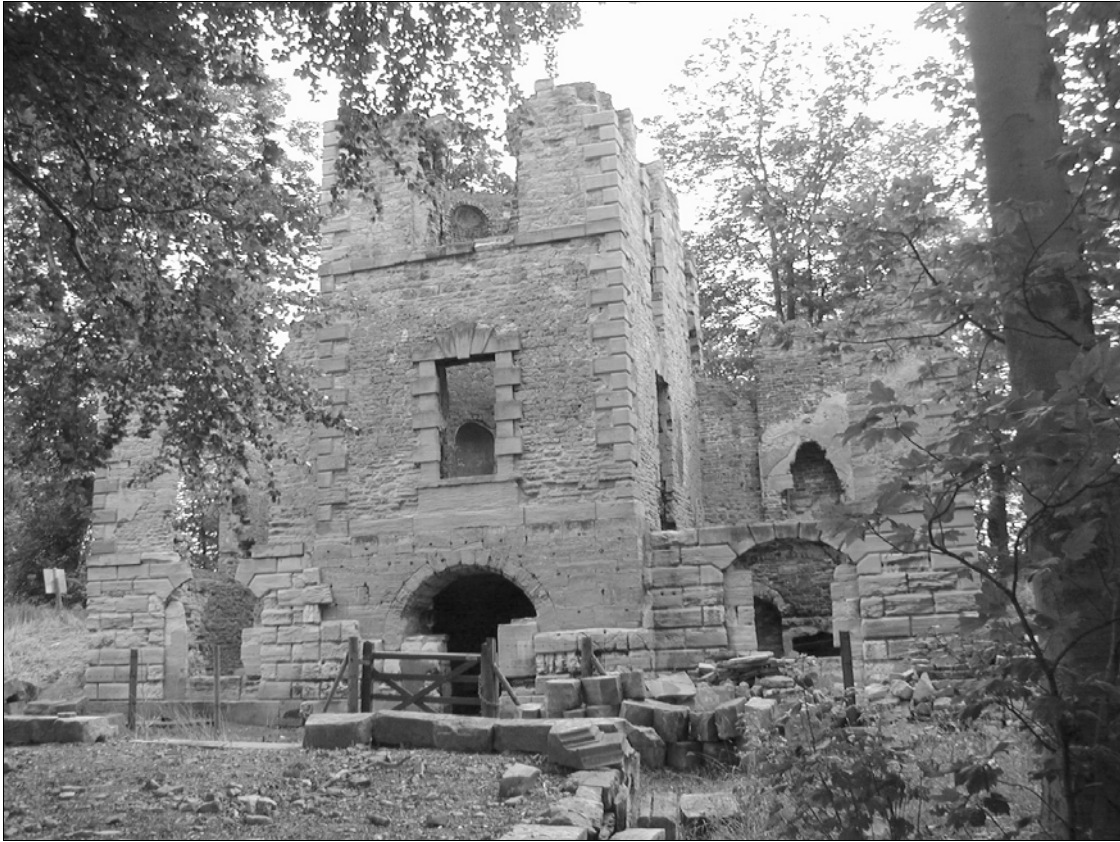
Figure 18 Bilham Belvedere, showing rectangular Georgian window (© SYAS)

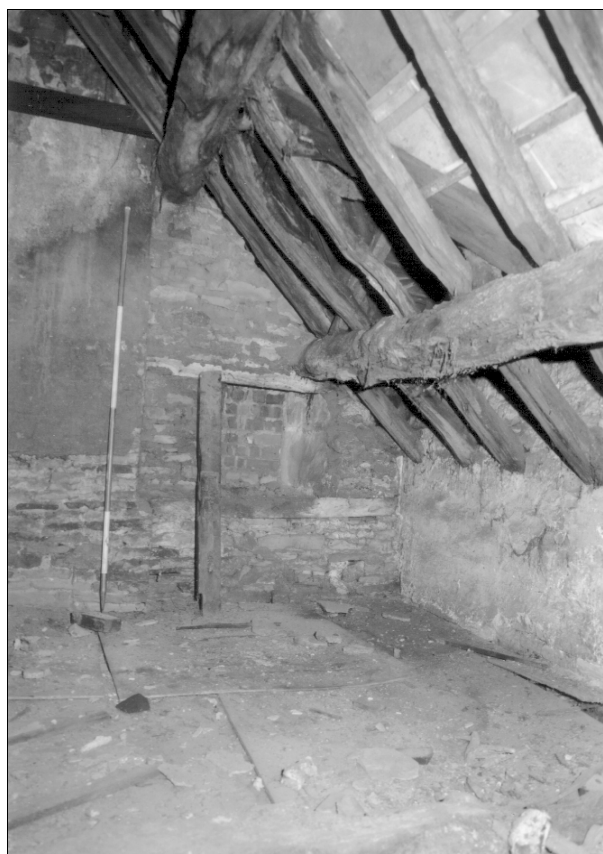
Figure 22 Barugh Lane Farm, showing blocked window in gable, and ridge of barn running into the upper purlin of the house (© Archaeological Services, WYAS)

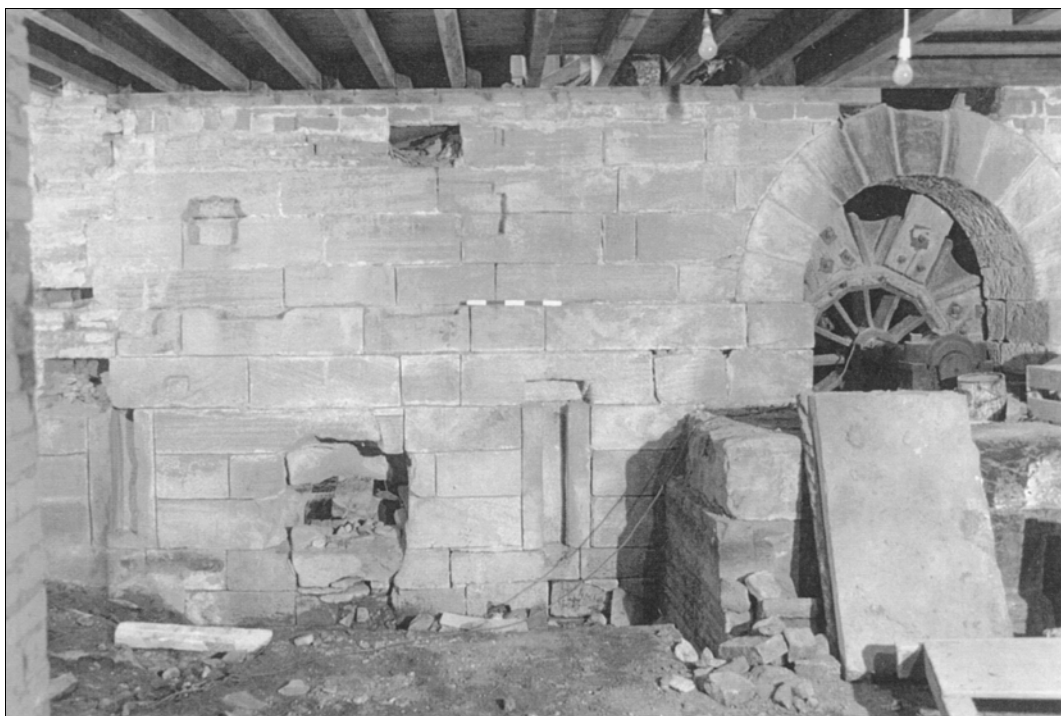
Figure 24 Gearing wall inside building 1 at the Saw Mill, showing location of phase 2 hursting (© Archaeological Services, WYAS)

suggestive of a timber-framed building. They could survive from the mill building demolished in 1705–7. The buildings erected in stone after this date seem to survive largely intact, as the basement of the present building. The functional, vernacular form of the doorways and windows at basement level conform to such a date. In addition, the gearing wall, the hursting arrangement and the earlier waterwheel housing, along with the adjacent pit-wheel pit, are all features of this rebuild.

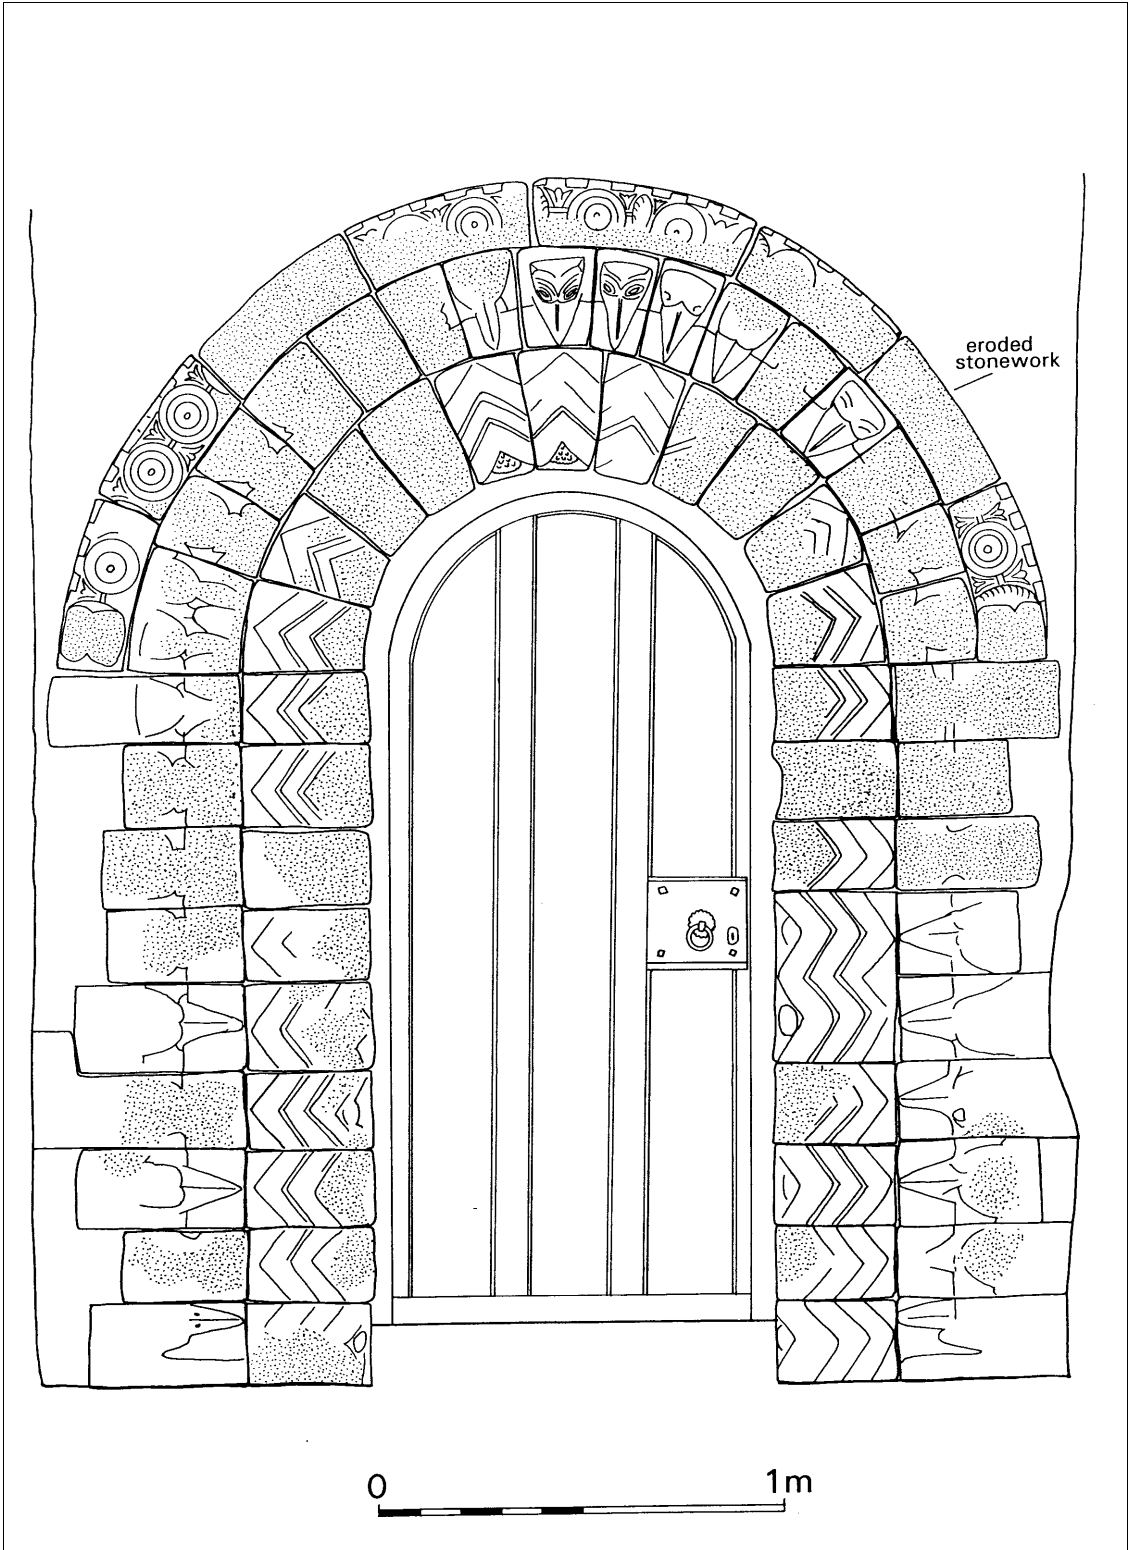
Figure 25 The south doorway of St Peter's Church, Old Edlington, (© Ed Dennison Archaeological Services)

The decoration around the doorway consists of three bands. The inner band is of chevrons with bunches of grapes set in the inner centres; only two complete examples survive, on the uppermost stones. The middle band is of beak-heads on a roll-moulding; only four examples survive to their original extent, all towards the top

east side of the doorway – it is possible that one or more of these have been replaced. The outer band, forming a hood mould, is of paired rosettes with anthemions between and a dentilled outer edge; original detail is only fully visible on one stone, on the east side.

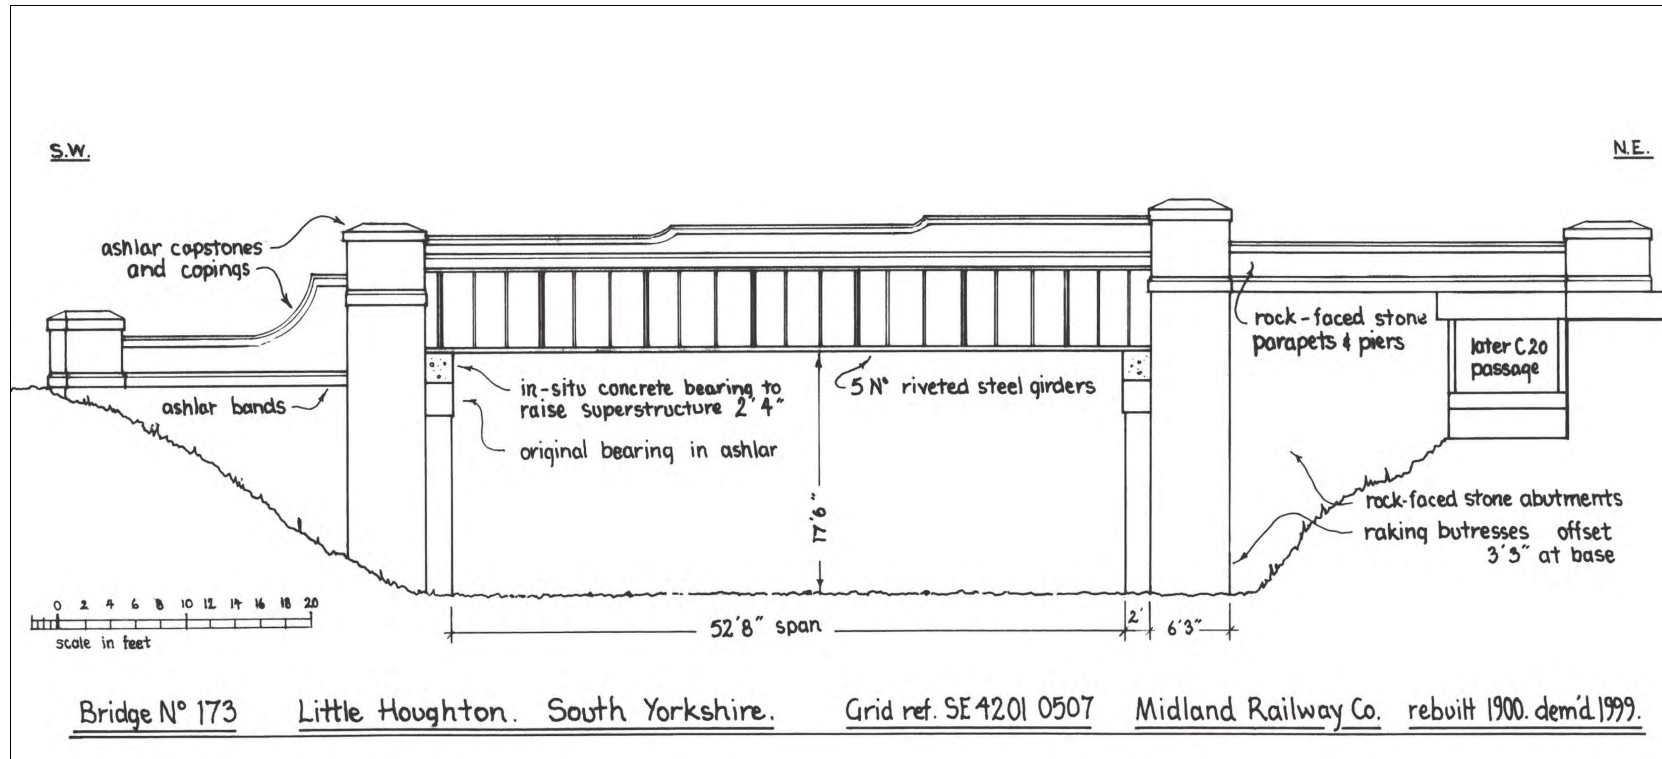
Figure 26 South facing elevation of the bridge over the former Midland Railway, Ings Lane, Little Houghton (© Adrian Siswick)

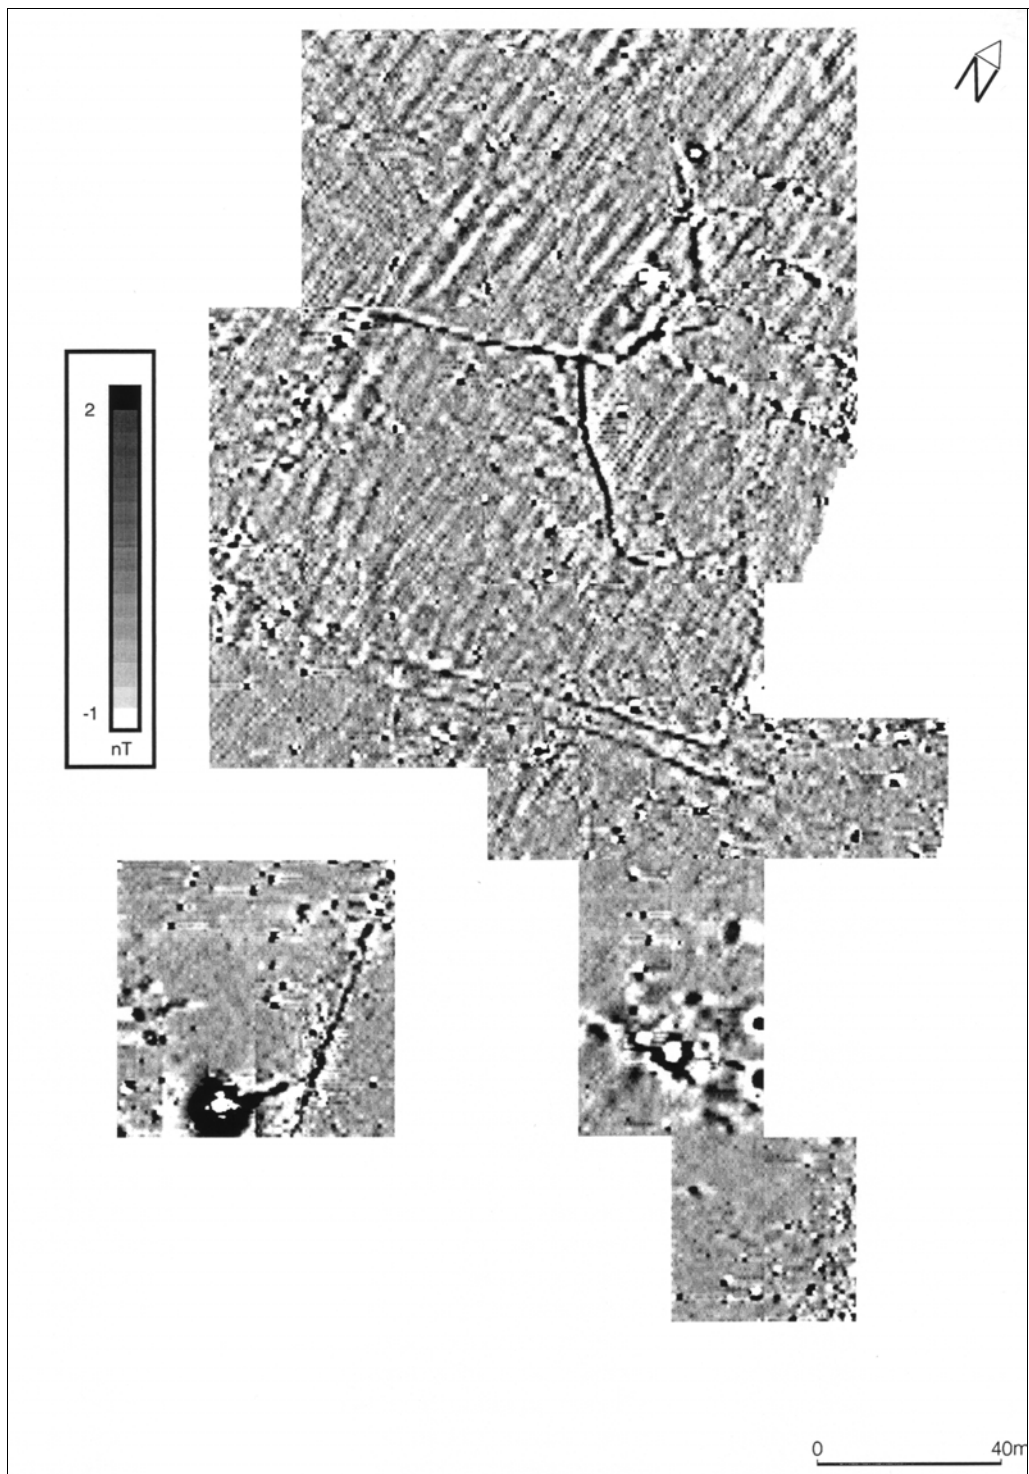
Figure 27 Gradiometer survey of land off High Street, Shafton (© Archaeological Services, WYAS)

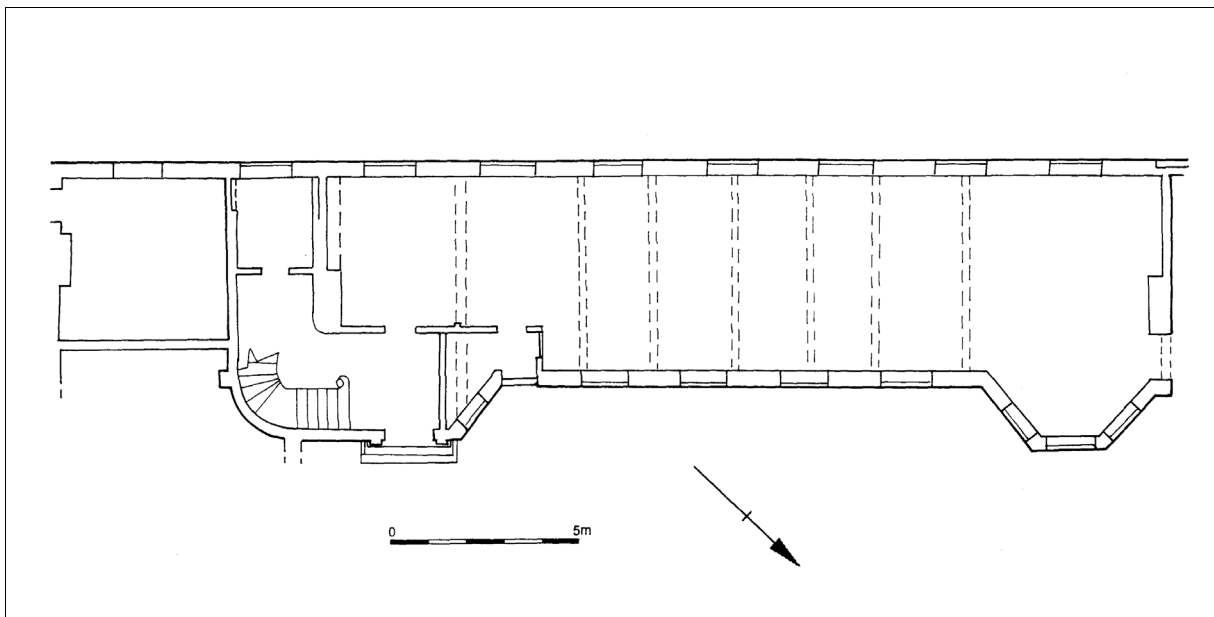
Figure 33 General ground floor plan of building 1, Cornish Place (© ARCUS)
