Land at Bury Barton, Polbury, Lapford, Devon

Results of an archaeological watching brief

Document No: ACD327/2/0

Planning ref: Mid Devon District Council 11/00427/FULL

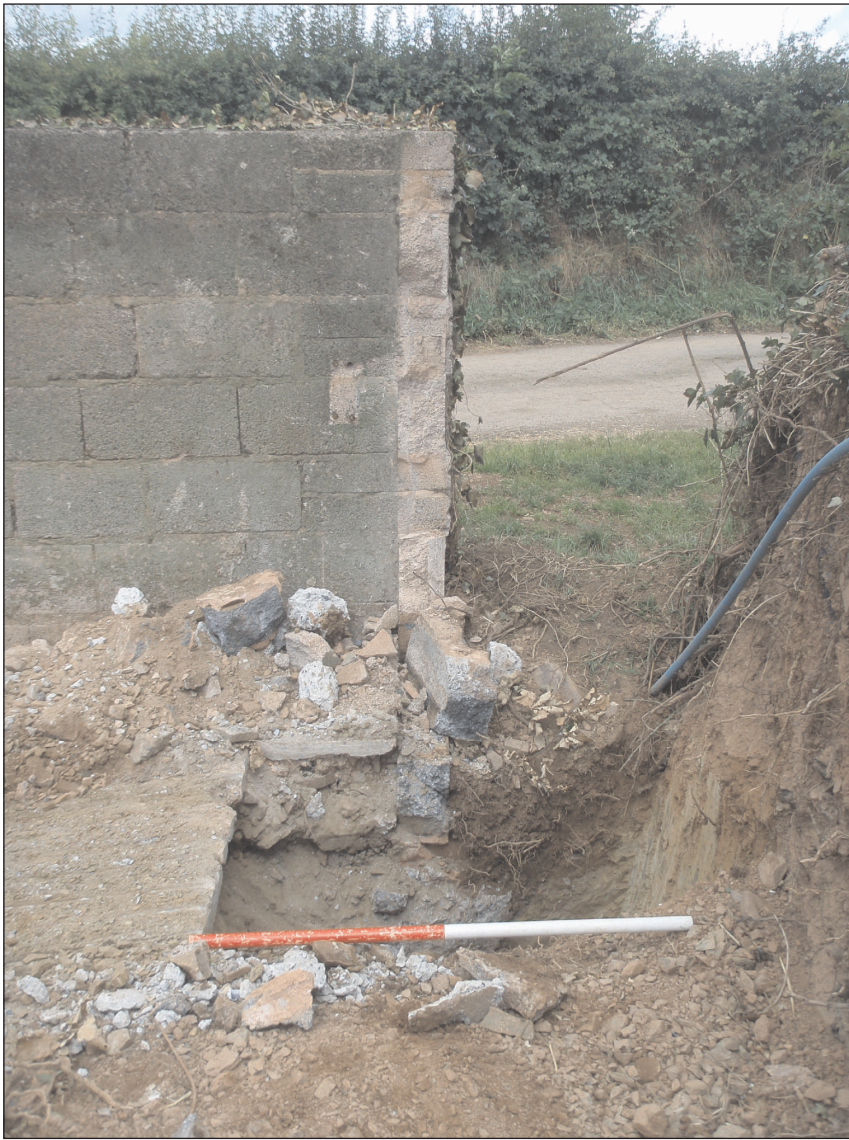
Plate 1: Test Pit 1, view to the south (Scale 1m)

- 5.2 The seven eastern pits (1-7) were excavated at the base and followed the course of an old hedgeline. These pits contained between 0.2-0.3m of mid brown topsoil exhibiting a lot of root disturbance, and 0.6-0.7m of hard, compact mottled red and yellow clay/sandstone natural subsoil. The first four stanchion pits (1-4) contained the remains of a concrete wall – the return of an existing wall built in the 1980s (Plate 1).

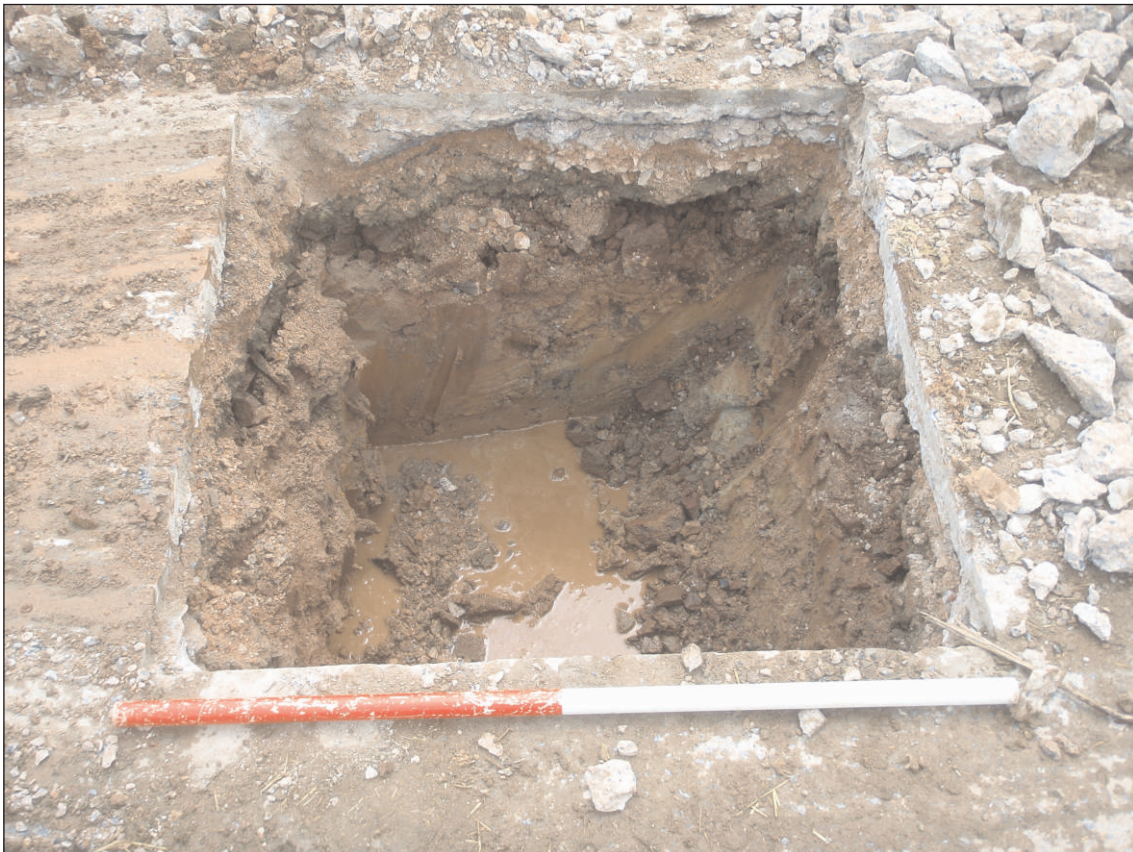
Plate 2: Test Pit 13, view to the north (Scale 1m)

- 5.3 The seven western pits (8-14) revealed a general layer sequence comprising 0.3m of dark brown silty clay topsoil, overlying 0.6m of mixed grey and yellow clay natural subsoil. The pits on this side had a very high water table and contained rotted vegetation (Plate 2).
