# LAND AT 4 BELLE VIEW, KENTON, DEVON

Results of an archaeological watching brief

Planning reference: Teignbridge District Council  
12/03136/FUL

Report No: ACD804/2/0

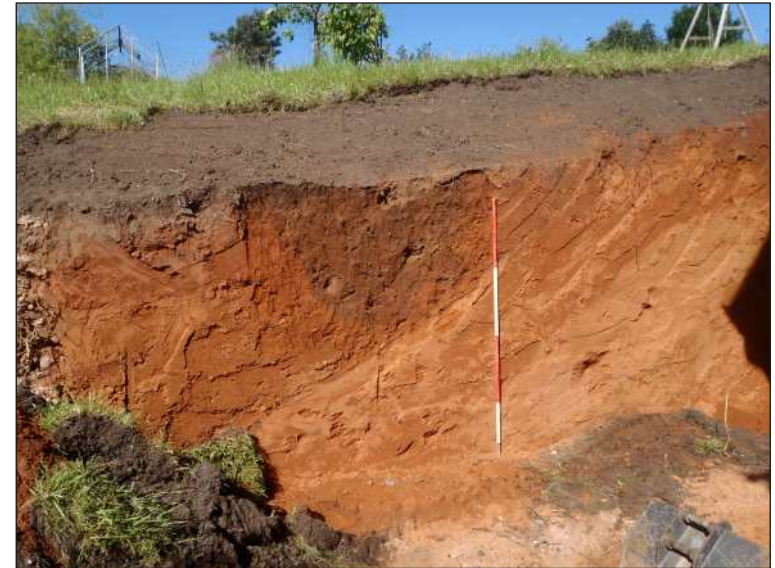
Plate 2: Probable ditch F2003, viewed from the east (scale 2m)

- 5.2 The earliest archaeological feature observed on the site was probable ditch F0023 which was revealed in section by the cutting back of the hillside to the west of the plot, following the removal of a former revetment wall (F0007), and extending the level area of the plot by approximately 1m (Plate 2). Ditch F0023 measured 1.55m wide and 1.05m deep with a U-shaped profile and cut the natural (0004) below topsoil (0025). It had a single fill (0024) consisting of mid yellowish brown sand derived from redeposited natural. It contained fragments of probable roof slate indicating a post-medieval date is likely for the fill which appears to have been a backfilled soon after its digging. As this feature was not seen in plan it is possible that it may be a pit rather than a ditch.

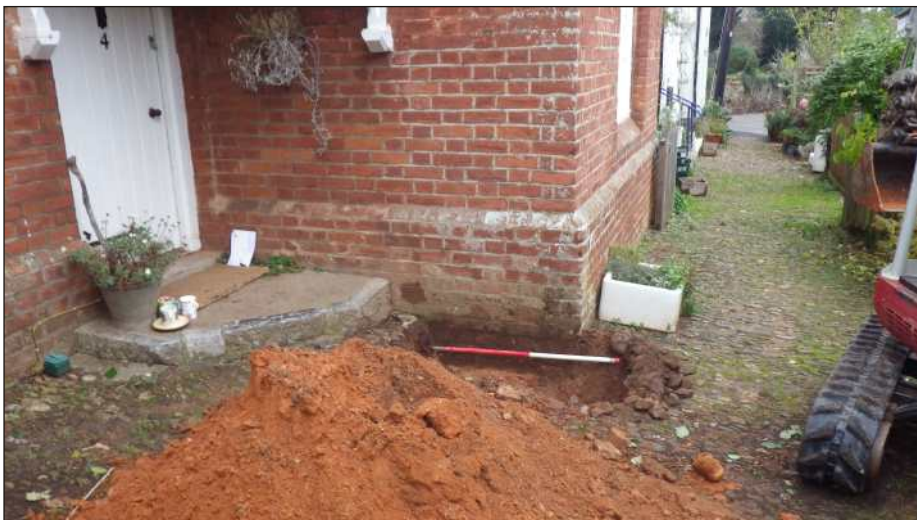
Plate 3: Geotechnical Test Pit 3, looking east (scale 1m)

- 5.3 The earliest structural feature observed on the site is wall F0018 which was partially revealed in Geotechnical Test Pit 3 located directly adjacent to the standing building (Plates 3 and 4). The wall (F0018) consisted of irregular stone blocks up to 0.5m long and bonded by light grey mortar. The wall was located in a steep-sided foundation trench (F0016) 0.1m wide and filled by a mid reddish brown silty clay with occasional mortar fragments (0017). The foundation trench cut the natural (0004). The full width of the wall was not revealed, but it was a minimum of 0.3m wide. On the east side it was clearly a different build and phase to stone footings (F0021) which support the brick wall of the current house. It also appeared to be oriented on a more northeasterly-southwesterly direction when compared with the current building. In the west section of the geotechnical test pit wall F0018 appeared to have been cut by a deposit of brick (F0020) sitting on a burnt layer (F0015) which together with loose bricks (0019) may be a demolition layer (Plate 5). A more coherent brick floor (F0028) was identified at the same depth

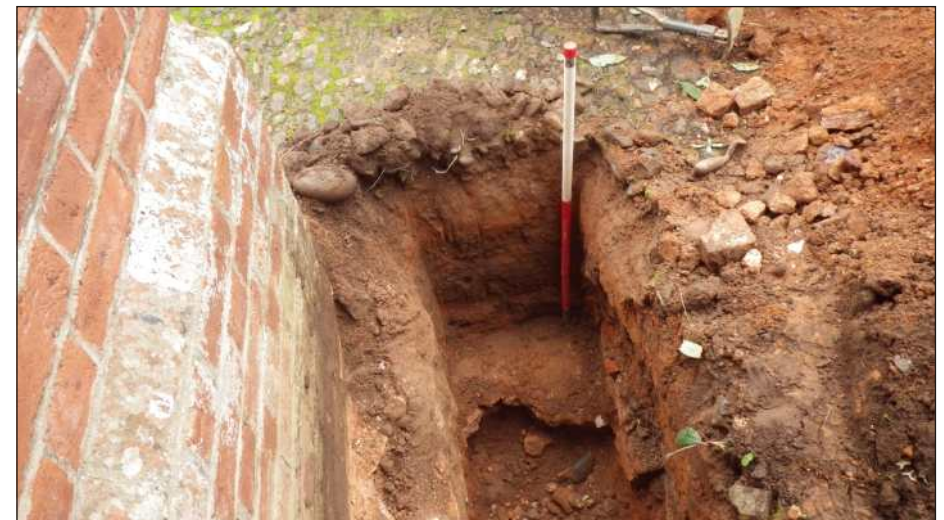
Plate 4: Geotechnical Test Pit 3, wall F0018, looking south (scale 1m)

- 7.2** Stone wall foundation F0018 was not fully revealed, but where visible it appeared to be on a slightly different northeasterly-southwesterly alignment to that of the present buildings. It is undated, but pre-dates the footings upon which the current building is built. The truncation of deposits and the lack of finds dating to earlier than the 19th century mean that this wall does not relate to the St Ann's Chapel supposedly located on the site.

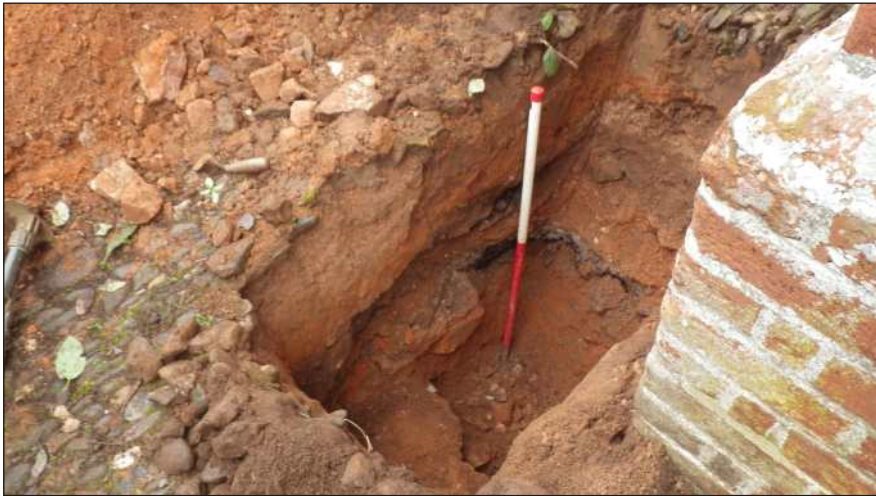
Plate 5: Geotechnical Test Pit 3, brick deposit F0018 and burnt layer (0015), looking northwest (scale 1m)

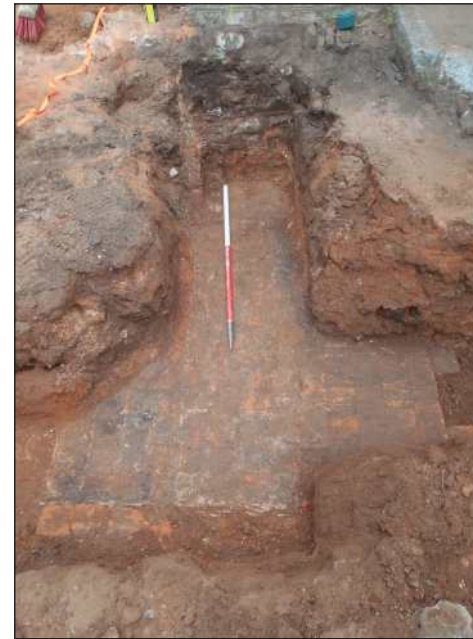
Plate 6: Footings trench, brick floor F0028, looking north (scale 1m)

below ground surface in a footings trench directly adjacent to the west. Brick floor F0028 consisted of unfrosted bricks (0.24m long x 0.12m wide x 0.06m deep) laid flat and bonded by a light grey mortar (Plate 6). Where revealed in the footings trench it was clear that the burnt layer (0015), previously observed in the disturbed section of Geotechnical Test Pit 3, sat on top of this floor, rather than below it as had originally been indicated by the disturbed deposits in Geotechnical Test Pit 3. The finds collected from layer (0015) were all modern in date. On the west side the brick floor was abutted by stone wall (F0027) consisting of irregular stone blocks up to 0.35m long and bonded by a light grey mortar. The wall F0027 and floor F0028 were located c. 0.7m below ground surface and may be the remains of a coal cellar related to the neighbouring dwelling; it is not shown on historic mapping. A similar wall foundation (F0026) compared to wall F0027 was revealed during the levelling of the garden area (Plate 7). This was at a higher level, directly beneath the cobbled yard surface (0002), and this wall is shown enclosing the garden on the 1880s 1st Edition OS map.

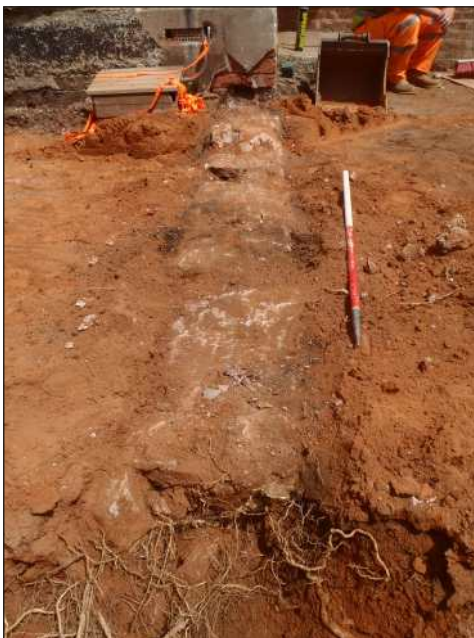
Plate 7: Site-wide levelling, garden wall foundation F0026, looking east (scale 1m)

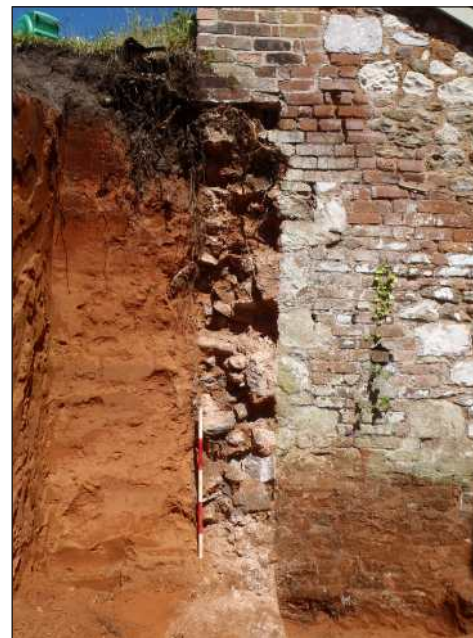
Plate 8: Site-wide levelling, demolished revetment wall (F0007) section, looking north (scale 1m)

**5.5** The whole garden area was covered by a layer (0003) of pale to mid reddish brown sandy silt containing occasional CBM fragments. This was 0.1m thick and was made ground for the construction of a metalled surface (0002) consisting of rounded stone cobbles up to 0.1m thick. This metalling extended across the site and provided a surface for the outside space. On the east side of the plot, closest to house, it formed the modern surface, whereas in the west, as shown in Geotechnical Testpits 1 and 2, the cobbles were overlain by deposit (0001), a thin band of dark grey brown silty clay 0.02m thick. This was a deliberate dump of charcoal-rich burnt material, probably from a fireplace within the house. Finally this was overlain by up to 0.32m of horticultural topsoil (0000), a dark grey brown friable silty clay forming a flowerbed. This sequence was adjacent to the revetment wall F0007 which was demolished and shown to predate the brick and stone outhouse to the rear of the property which, abutted it (see Plate 8). Natural (0004) was encountered at 0.52m below the topsoil. This had been cut by F0005, a 0.38m deep construction cut with steep straight sides and a flat base containing revetment wall F0007. Foundation trench F0005 had a single fill (0006) consisting of mid yellowish brown silty sand. The retaining wall (F0007) was 3.18m in height and constructed with irregularly shaped stone (up to approximately 0.5m long), in a pale grey mortar. This wall was constructed to retain the terrace cut (the ground level was c. 2m higher on the opposite side of the revetment).
