BARN 1, TREBOUL FARM, ST GERMAN'S, CORNWALL

Results of historic building recording

Cornwall Council planning reference PA18/11525,
condition 4

Document No: ACD2523/2/0

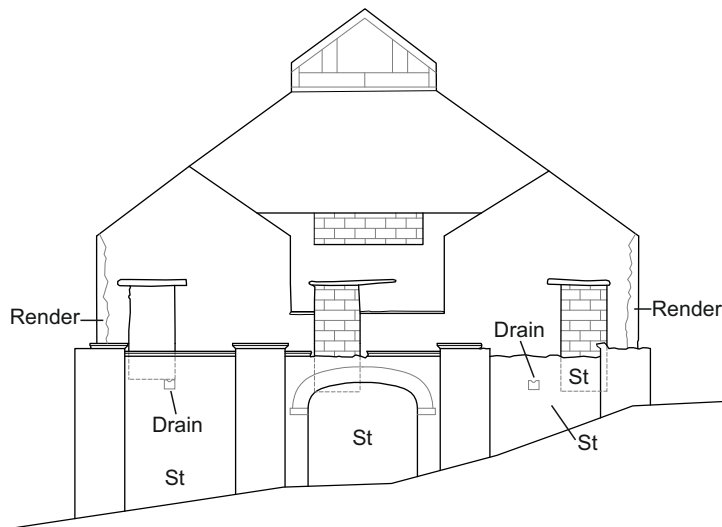
Fig. 4: Northwest and northeast elevations

Northwest elevation

Northeast elevation

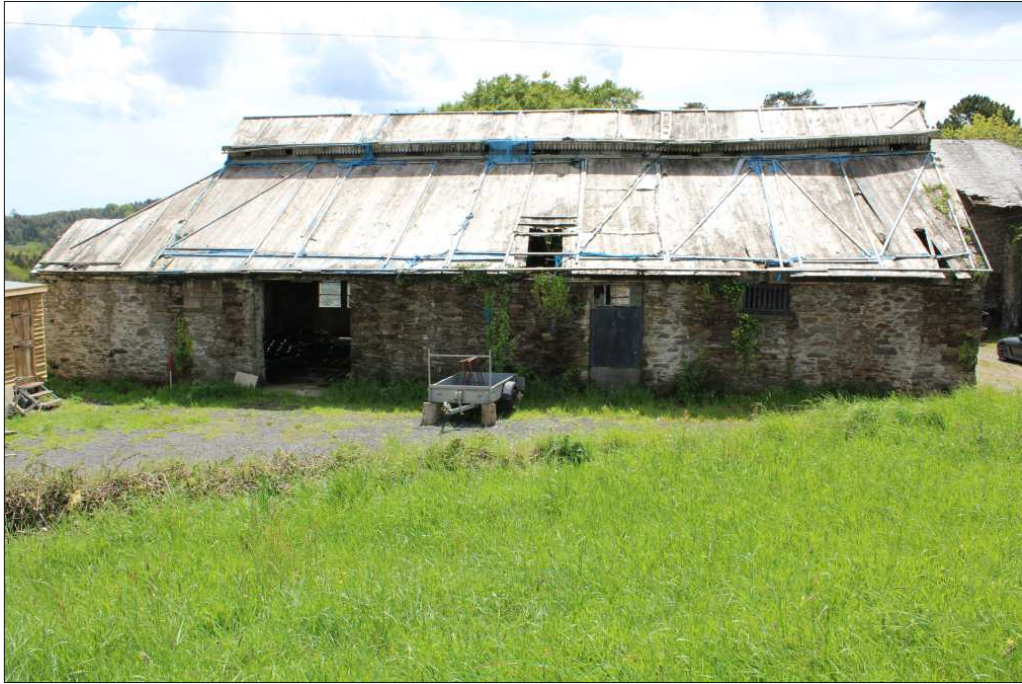
- 5.2** The northwest elevation incorporates two doorways and two window openings (Plate 1). The eastern window is a high-level opening and has a wooden sill but has been infilled with concrete blocks. To the west of this window is a large double-width opening retaining pintles for a removed door. The next opening to the west was originally a doorway but its lower portion has been infilled with the blocking material rendered. The middle portion is infilled with wooden planks set upright, and attached internally to battens. Above is a small horizontal four-pane window. The western window opening is also set at a high level (under the eaves) and has a slate sill and retains its original pegged wooden frame with a slated ventilation panel.

Plate 1: Northwest elevation, looking southeast (1m scale)

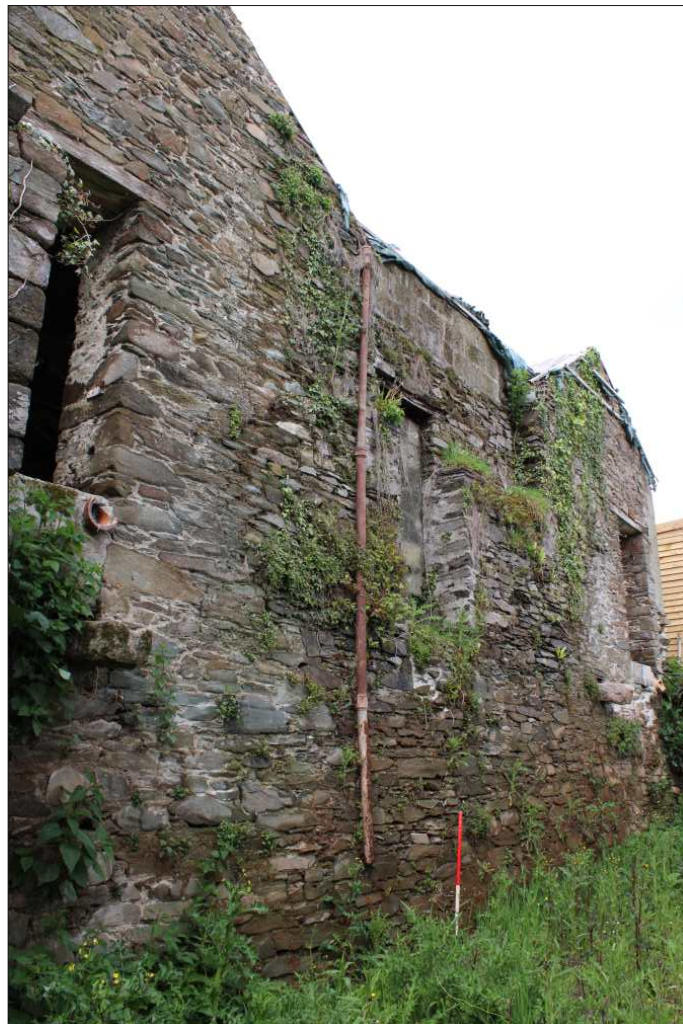
- 5.3** The northeast elevation is deeper than the others, forming the southwest side of the attached manure house. There are three doorways set at a high level reflecting the higher ground-floor level of the barn than the manure house (Plate 2). All have wooden lintels. The lower portion of the southern opening has been infilled with concrete blocks incorporating a ceramic drain and below this is an original granite drain. The central doorway is offset to the south within the central part of the wall. Its lower portion has been infilled with rubble stone and the remainder of the opening infilled with concrete blocks. The upper section of the gable steps back and is narrower than the rest of the wall. It rises above the eaves level of the adjacent gables, and here there is a low but wide opening infilled with concrete blocks. The lower portion of the northern doorway has again been infilled with rubble stone and the remainder with concrete blocks, also incorporating a ceramic drain. To the south of the opening is another original granite drain. The lower portions of all three doors were infilled when the internal floor level to the barn was raised. At the north and south corners of the elevation there are vertical strips of cement render probably applied over scars of removed masonry.

Plate 2: Northeast elevation, looking northwest (1m scale)

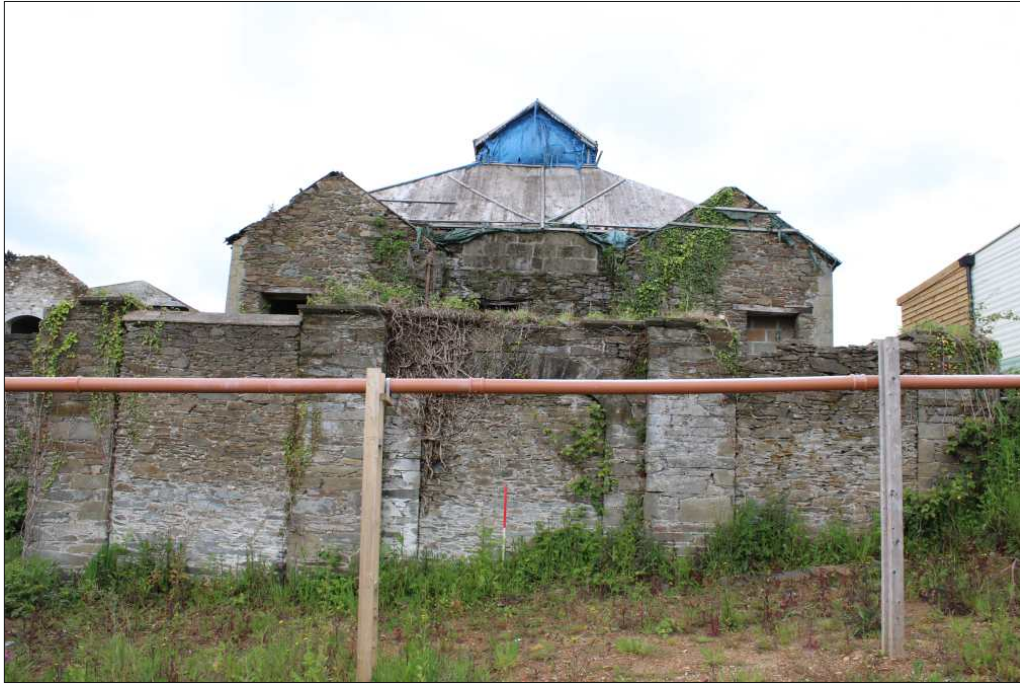
- 5.4** The manure house sits at a lower level than the barn to allow access from the road to the east (Plate 3). The main elevation is to the northeast facing the highway, and this features three openings, all infilled with rubble stonework. The central opening has a segmental arched head and dressed jambs although the stonework is of lesser quality on the inner face. The side openings also have dressed stone jambs but extend up to the tops of the walls. The northwest elevation has a central, high-level opening infilled with soil overlaid by an external tarmac surface, and the southeast elevation has a central wide, full-height opening (Plate 4). Here there is an external cobbled ramp up to the opening. Within the structure the floor was not visible due to soil and vegetation.

Plate 3: Northeast elevation of the manure house with the gables of the barn behind, looking southwest

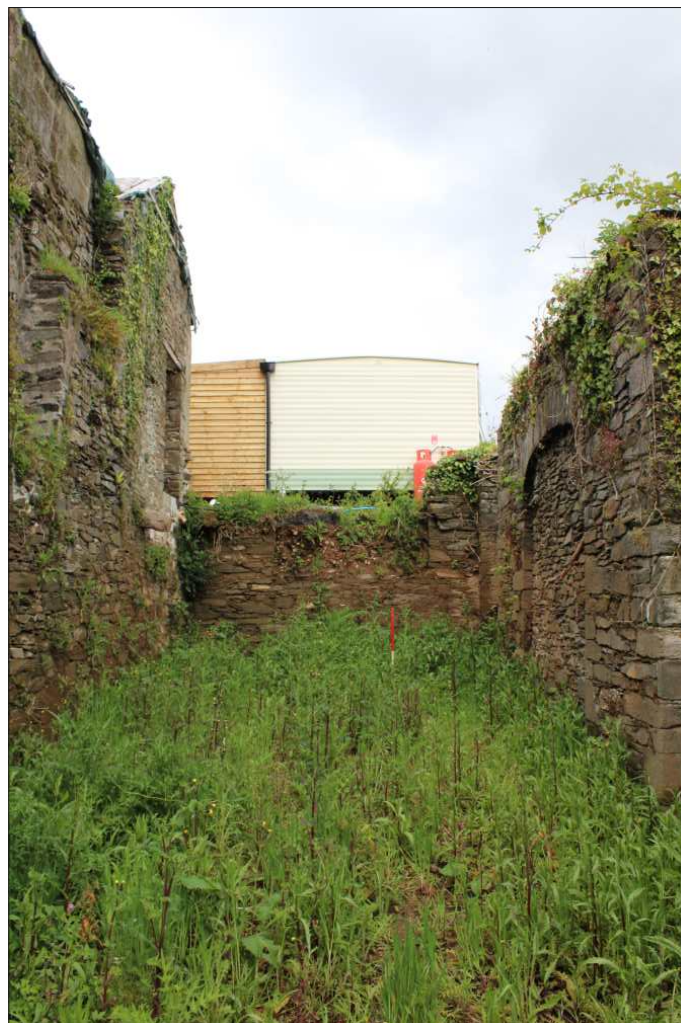
The manure house is unroofed, and there is no evidence for a roof structure (including for example joist sockets in or scars of rooflines on the gable of the barn). Some of its walls are 'capped' with horizontal slates that currently act as weatherings.

Plate 4: Internal view of the manure house, looking northwest (1m scale)

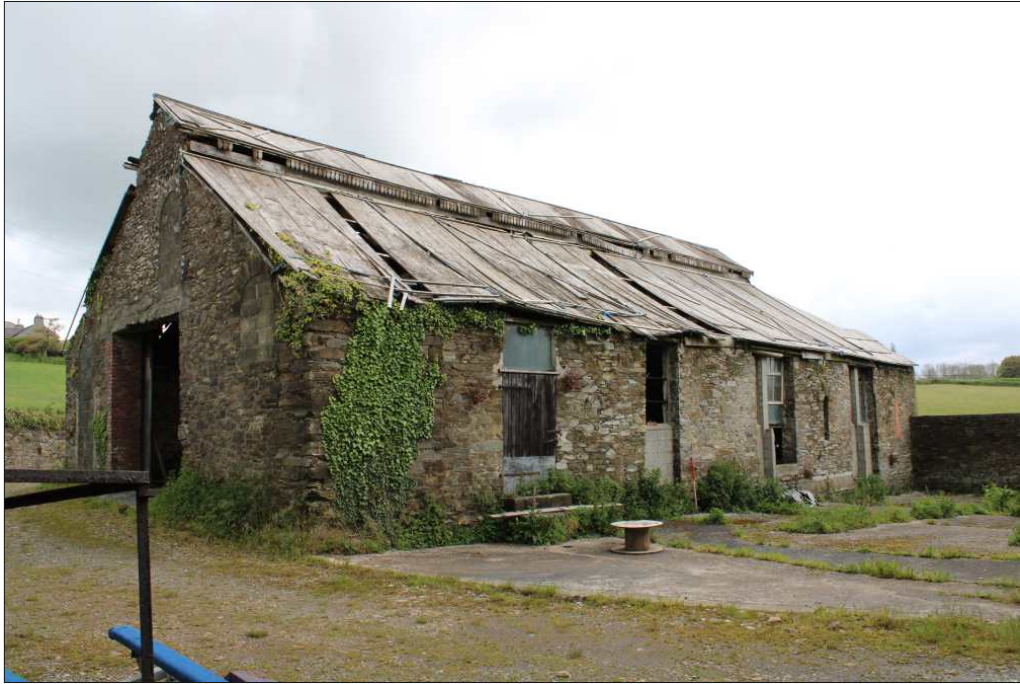
- 5.5** There are two phases of masonry in the southeast elevation of the barn with a full height vertical break close to the west end of the wall. This break is on the line of a primary opening. The secondary masonry is generally of the same style as the original building, but the jambs of openings are generally of smaller size and the size of other stonework is generally also smaller and more consistent in size. This secondary masonry incorporates four original door openings and two ventilation slits (Plate 5). The western doorway is fitted with a plank door attached with strap hinges, and has a small window above fitted with replacement safety glass. The next doorway to the east has been partially infilled with concrete blocks and has the remains of a three-pane safety glass window above. The next doorway to the east is wider than the others, and has been narrowed in the later 20th century using concrete blocks to create a pair of windows. One window again has safety glass, and the other opening now contains three stack windows, one with safety glass, and two with wooden frames and two- and three-panes each. The eastern doorway has also been converted into a pair of windows, again each with three panes of safety glass. The two ventilation slits have slightly depressed arched heads formed from three blocks of stone designed in a cross shape, and which project out slightly from the wall (Plate 6). They have plainly dressed faces and narrow slightly recessed margins. The western slit is infilled with concrete block and the eastern slit with brick. On the masonry to the west of the eastern ventilation slit is a partial scar of a roofline of a now demolished building in the yard to the south. To the east of this opening is the east wall of the yard that is lower than the wall of the barn but also extends down forming a revetment to the yard surface. Further west, there are sockets in the masonry and the barge boards associated with the demolished roof of another attached structure.

Plate 5: Southeast elevation, looking north-northeast (1m scale)

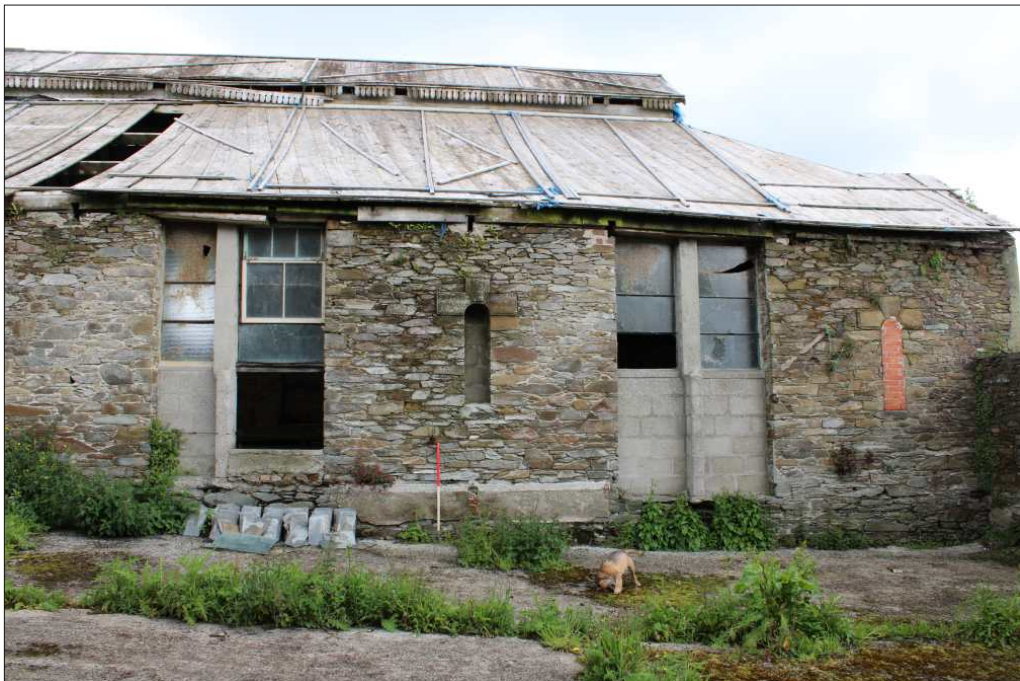
Plate 6: Openings at the east end of the southeast elevation, looking northwest (1m scale)

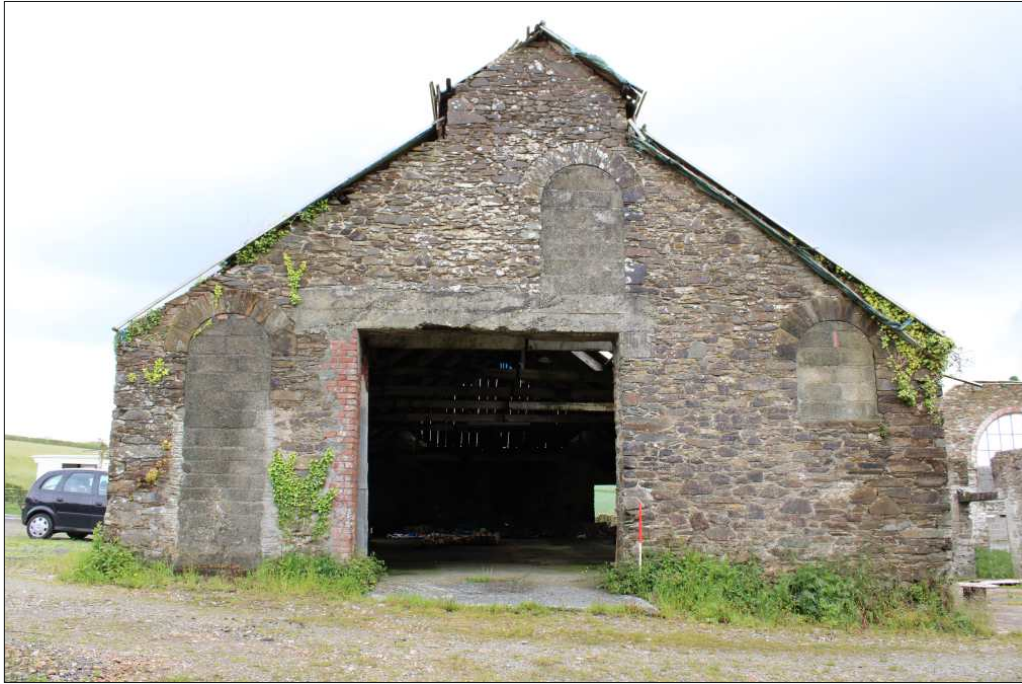
- 5.6** The southwest elevation is dominated by a large late 20th-century, slightly off-central opening under rolled steel joist lintels that are encased in concrete render (Plate 7). Its southern side appears to present one edge of a primary opening as it is slightly raised in height, whereas the north side has contemporary brick jambs. To either side of this opening are primary window openings with semi-circular arched heads formed from dressed stone voussoirs. The northern opening has been extended to ground level to form a doorway, and has subsequently been infilled with concrete blocks. The southern opening has also been infilled with concrete blocks. In the gable, offset slightly to the south, is a third primary window opening, of the same design, and also infilled with concrete blocks.

Plate 7: Southwest elevation, looking northeast (1m scale)

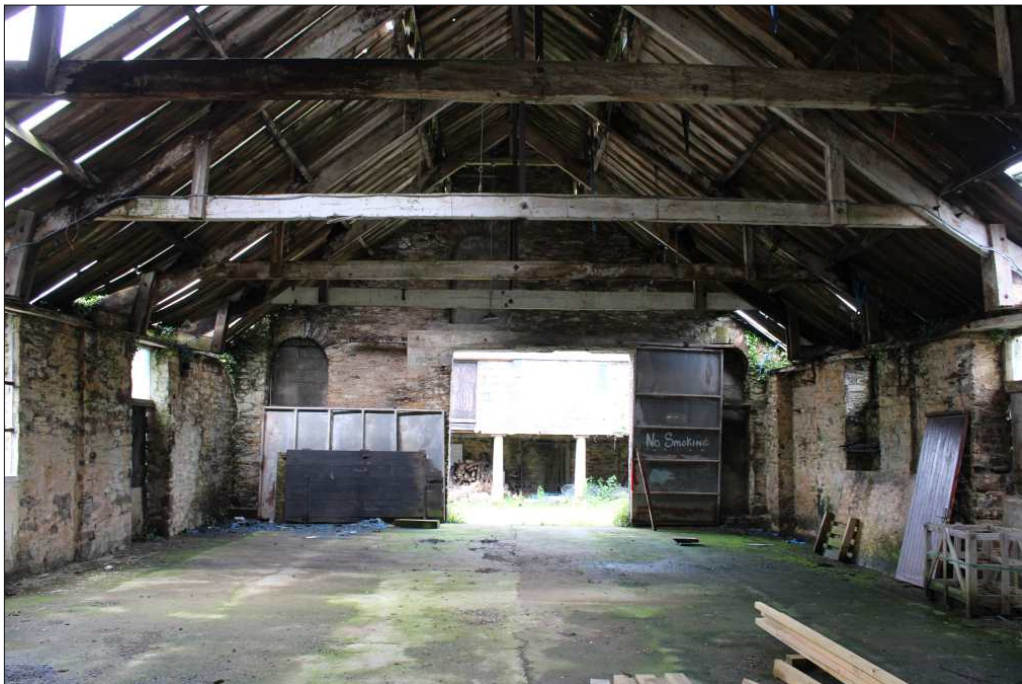
- 5.7** The floor is currently at a single level and is a concrete replacement (Plates 8-9). A test trench has been excavated through this surface at the northeast end of the building. This has exposed a cobbled surface terminating in a granite drain in the area of the former looseboxes on the north side of the building (Plate 10). The design of the north wall consists of bays (containing the openings where present) between wider integral stone piers that support the roof trusses (Plate 11). The masonry of the bays incorporate horizontal battens onto which original finishes would have been attached. None of the original finishes survive, and the walls now have a modern coating of white paint contemporary with the modern blocking of openings.

Plate 8: Internal view of the barn, looking southwest (1m scale)

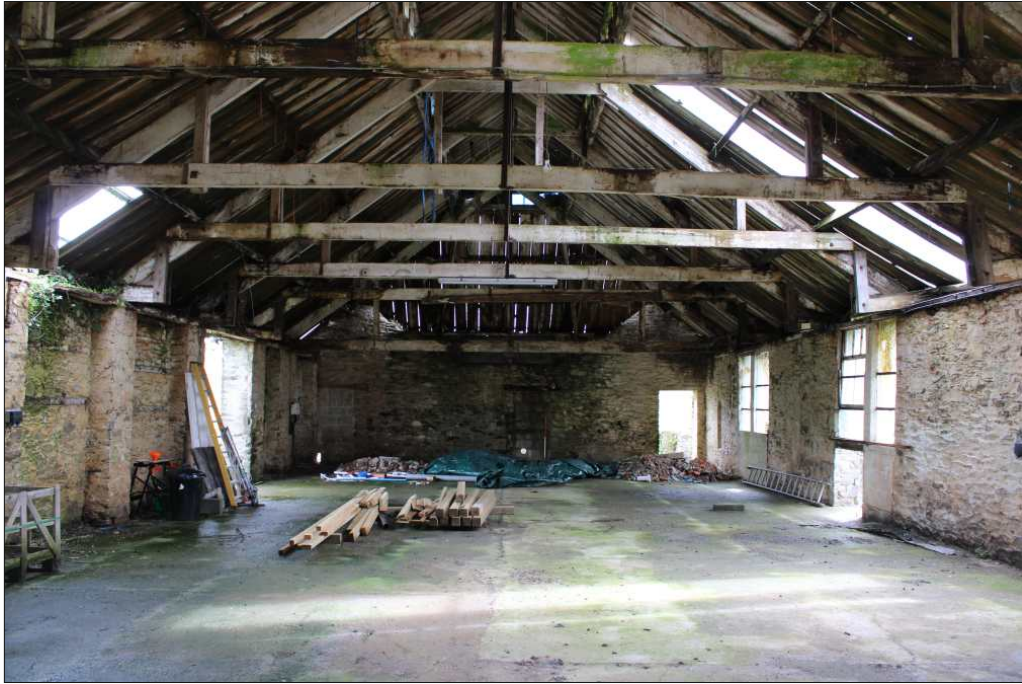
Plate 9: Internal view of the barn, looking northeast (1m scale)

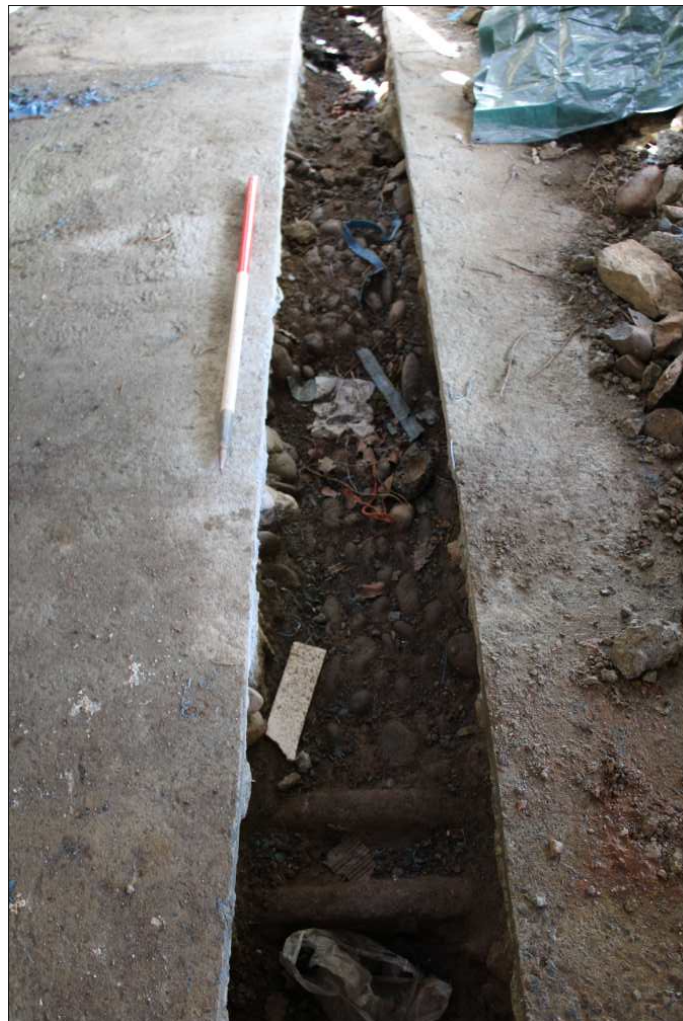
Plate 10: Test trench showing an area of cobbled floor and a drain, looking southeast (1m scale)

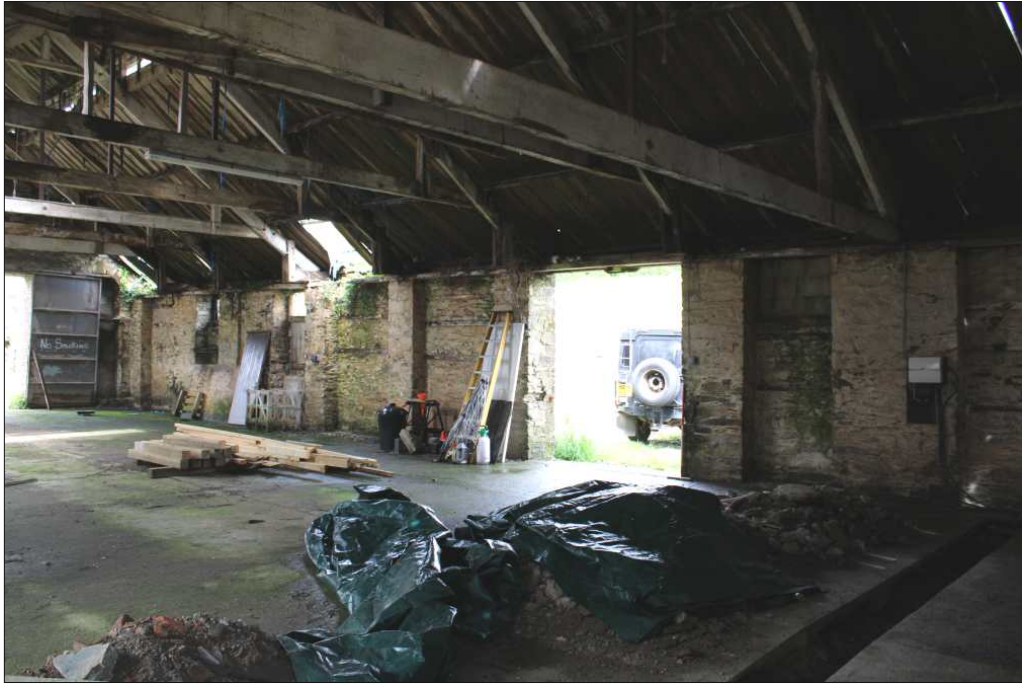
Plate 11: Internal view of northeast wall, looking northwest (1m scale)

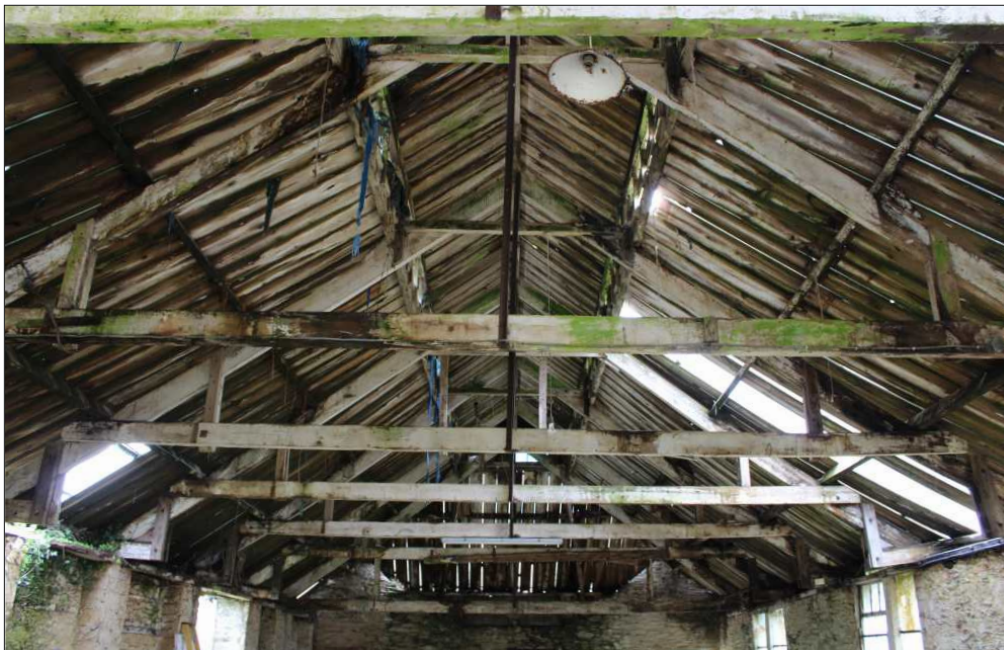
- 5.8** The roof is supported on seven trusses, which have been much altered to allow the barn to be used to store tractors and agricultural implements. They were originally of a tie beam design, with the ties resting on the piers in the northwest wall and also on the top of the masonry of the rebuilt southeast wall. The timbers were braced with slender

king posts set close to the eaves of the building. Only the eastern truss retains this arrangement, and all the others have been altered. The ties have been sawn off leaving their ends intact, and pairs of vertical struts connect the ends of the tie beams to rafters above. The removed ties have been reset higher up as applied collars. They are also connected to the truncated king posts using additional battens. The original design also incorporates halved collars set high, just below the ridge. Slender steel L-shaped braces (reusing components of shelving units) have also been added between the reset ties and the apexes of the collars (Plate 12).

Plate 12: Roof structure, looking northeast

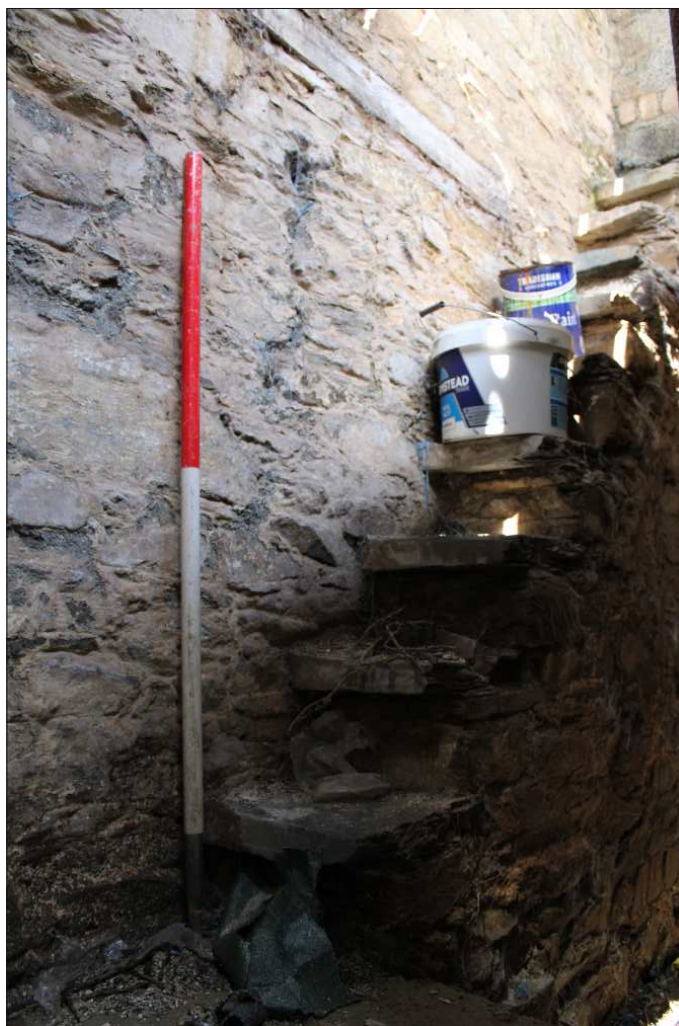
- 5.10** The roof structure displays no evidence of supporting a first floor within the barn. However, set within the south side of the northwest wall, where the masonry is narrower, are the remains of a flight of steps (Plate 13). A total of nine slate treads survive, and these project out from the masonry 'risers' below. There are no other historical fixtures or fittings surviving within the building, with the only other fittings being a modern electrical supply powering lights.

Plate 13: Stone steps on the southwest wall, looking northwest (1m scale)
