OUTBUILDING AT APPLEHAYES, CLAYHIDON, DEVON

Results of historic building recording

Mid Devon District Council planning reference
20/01848/FULL,
condition 4

Document No: ACD2690/2/0

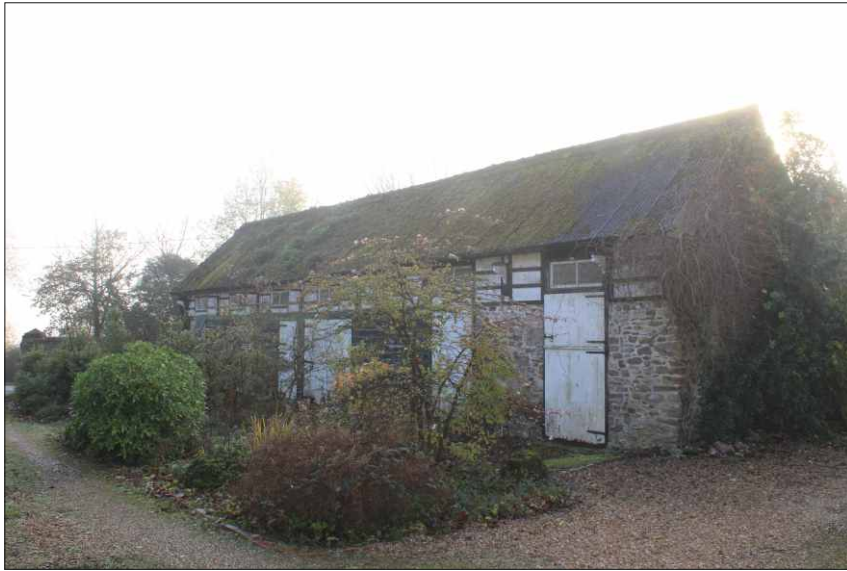
5.1 The building is constructed of rubble chert and sandstone, both local stones to the Blackdown Hills, laid in rough courses with an off-white lime mortar. It has a gabled roof finished with corrugated asbestos sheets (Plate 1).

Plate 1: General view of the outbuilding, looking southeast

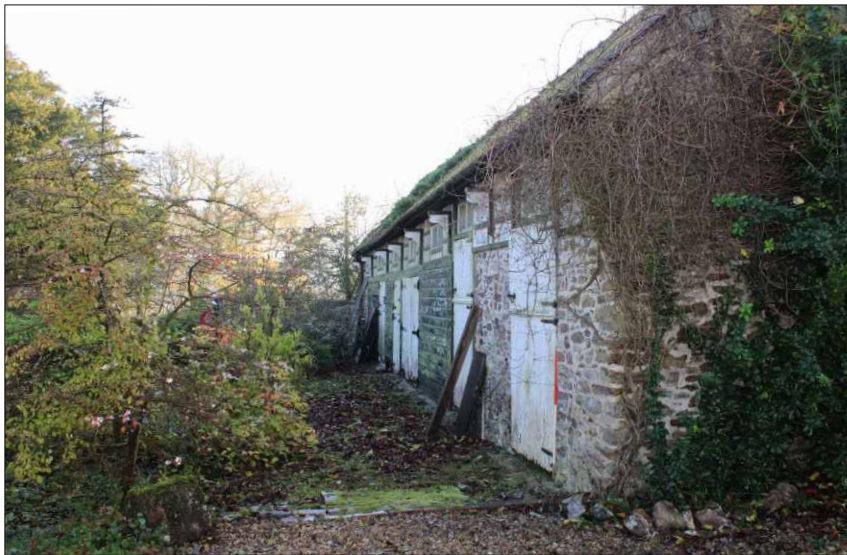
5.2 The majority of the north elevation is clad with secondary horizontal timbers, whilst the ends are lengths of primary rubble stonework extending around from the gable elevations. Above both the stonework and cladding there is further white-painted timber cladding with painted black framing around fixed casement two-pane windows. At this level are projecting timber brackets perhaps to support a former overhang to the roof; they are lower than the current eaves of the roof. There are five doorways one of which is set within the stonework at the western end of the building; four have two-part stable doors and the fifth, central opening is fitted with full-height double doors (Plate 2). The two western doors have pointed strap hinges, whilst the other doors have plain

Plate 2: North elevation, looking east (1m scale)

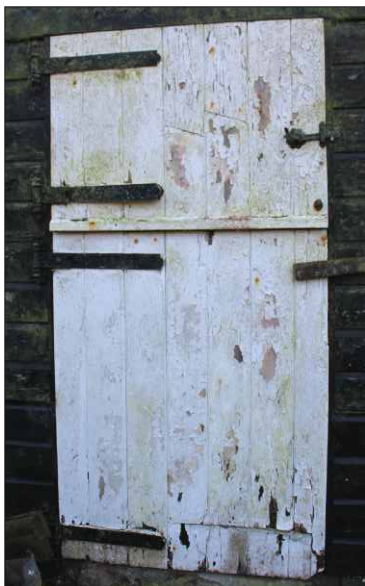
rectangular strap hinges; the latter have decorative brackets. The stable doors have lift latches with decorative ends (Plate 3). The elevation faces north on a landscaped area between the building and the entrance track to Applehayes. This incorporates a cobbled path along the front side of the building.

Plate 3: View of one of the stable doors showing the decorative fittings, looking south

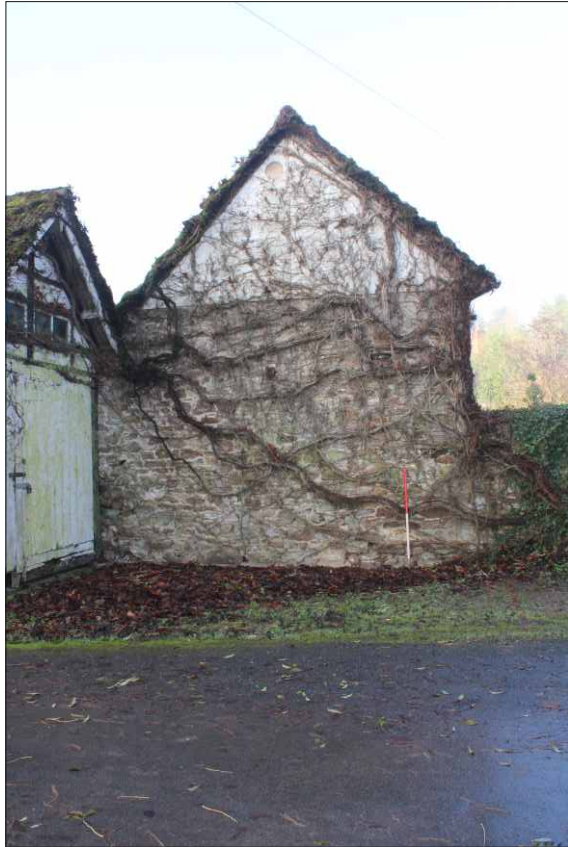
- 5.3** The east elevation is angled out from the otherwise rectangular plan of the building, which reflects the line of the adjacent highway. A short, low boundary wall extends northeast from its north corner, and an early length of boundary wall is attached to the south corner. Against this a garage has been constructed. The upper part of the gable of the outbuilding is clad in a timber board. There is a small circular, now boarded-up, opening, presumably for birds close to the apex (Plate 4). This formerly opened into an attached cage that has recently been removed. The west elevation has the same form as the east elevation (Plate 5). A blocked doorway at its south end was obscured by vegetation at the time of the survey.

Plate 4: East elevation, looking west
(1m scale)

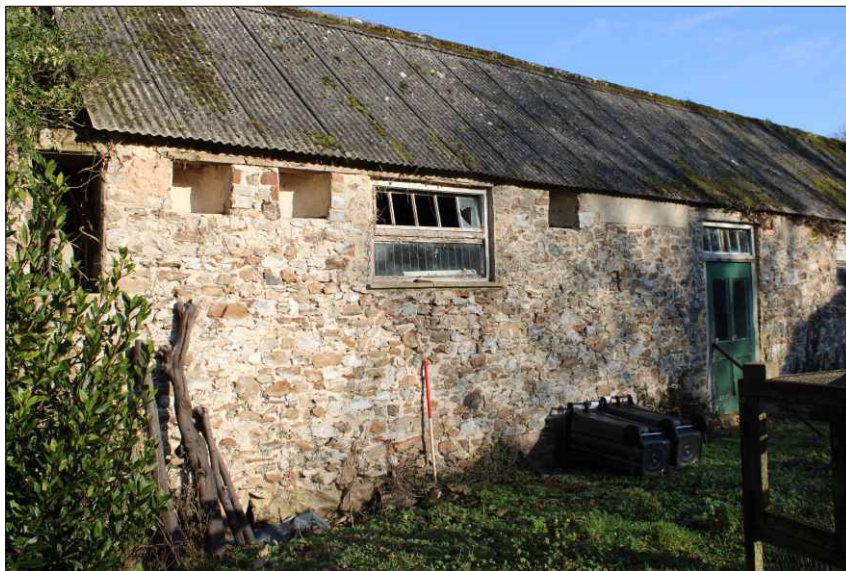
- 5.4** The south elevation has a central doorway fitted with a four-panel door, with the upper panels being glazed (Plate 6). Above the doorway is a five-pane window. To the east are two window openings; one is blocked and the other partially blocked with horizontal timbers. The later has a pegged timber frame with a single fixed pane which is a latter addition. To the west is a single window opening again with a pegged frame. This has a lower, single fixed window pane and an upper hinged window of five smaller panes. Only one glass pane now remains. The doorway and all three window openings have been inserted into the stonework, and associated new stonework is visible around parts of the openings. At the west end of the building there are three high level bee boles. The openings are rectangular with part brick jambs, internally they have a semi-circular plan reflecting the shape of the skeps. All the inside faces are rendered. There are also three patches of high-level cement render to the east. These do not line up with heights of the bee boles to the west, or with the positions of the trusses internally, and the reason for these finishes is unknown. The masonry of the south elevation continues westward from the southwest corner as a boundary wall to the adjacent garden. Adjacent to the building it incorporates a high-level blocked rectangular opening. This length of wall represents the demolished western part of the outbuilding that is recorded on old Ordnance Survey maps

Plate 6: South elevation, looking northeast (1m scale)

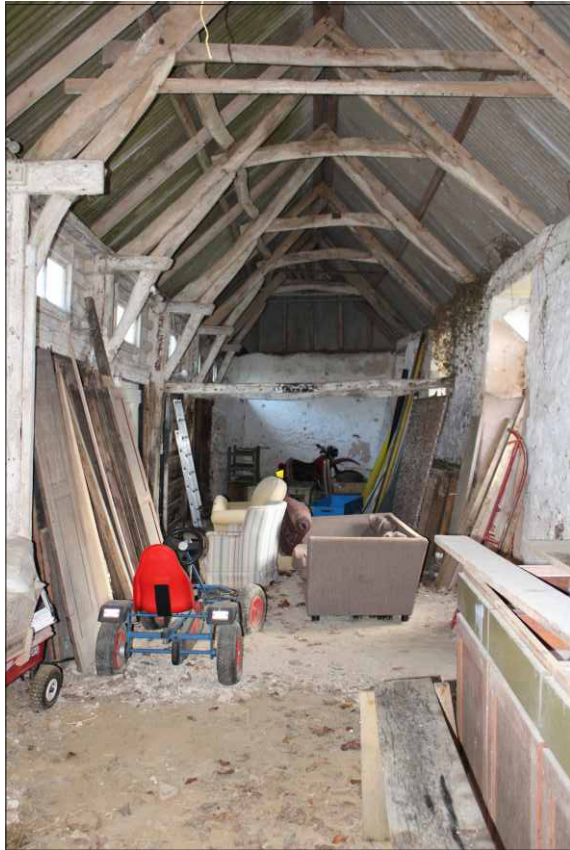
- 5.5** Internally the building currently has an earth floor (Plates 7 and 8). Along the south wall there is an integral projecting plinth that indicates, as a minimum, this the floor space adjacent to the wall was formerly a slightly higher level than present. As the ground level to the north is lower it seems likely that this higher level relates to a now-removed feature along this wall, such as troughs or a feeding passage. Its position corresponds with a wide blocked doorway in the west elevation that is infilled on the external face with rubble stone. This opening has an internal timber lintel that is supported on two vertical timbers acting as props. The upper section of the wall above the opening is narrower than masonry below. The only surviving internal fitting is a metal frame in the northeast corner to support a feeding bowl or manger.

- 5.6** The roof structure is supported on five A-frame trusses (trusses 1-6 from east to west; Plates 7 and 8). A later 20th-century frame sits above the original trusses and supports the replacement corrugated sheets.

Plate 7: General internal view, looking east

Plate 8: General internal view, looking west

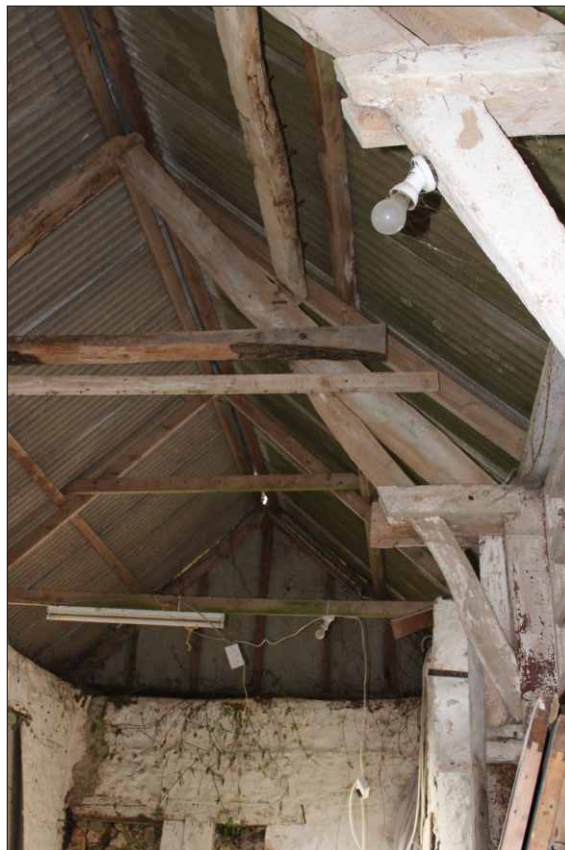
secondary curved brace added below the collar fixed with a trench joint. This is also pegged into the horizontal timber within a trenched joint and then attached at its base to the vertical post (see Plate 9 of truss 5 as an example). Below this is the end of a sawn-off floor joist. The empty socket for the other end of the joist is visible in the south wall.

- 5.11** Truss 5 is of the same form as truss 1 but the primary collar has been removed and replaced with two roughly hewn secondary collars, probably when the current roof finish was added.

Plate 9: North side of truss 5 showing how the rafters are supported on this side, looking west
