Land at Watton Gardens, Bridport, Dorset:

Results of an archaeological evaluation

Document No: ACW1036/1/0

Date: June 2017

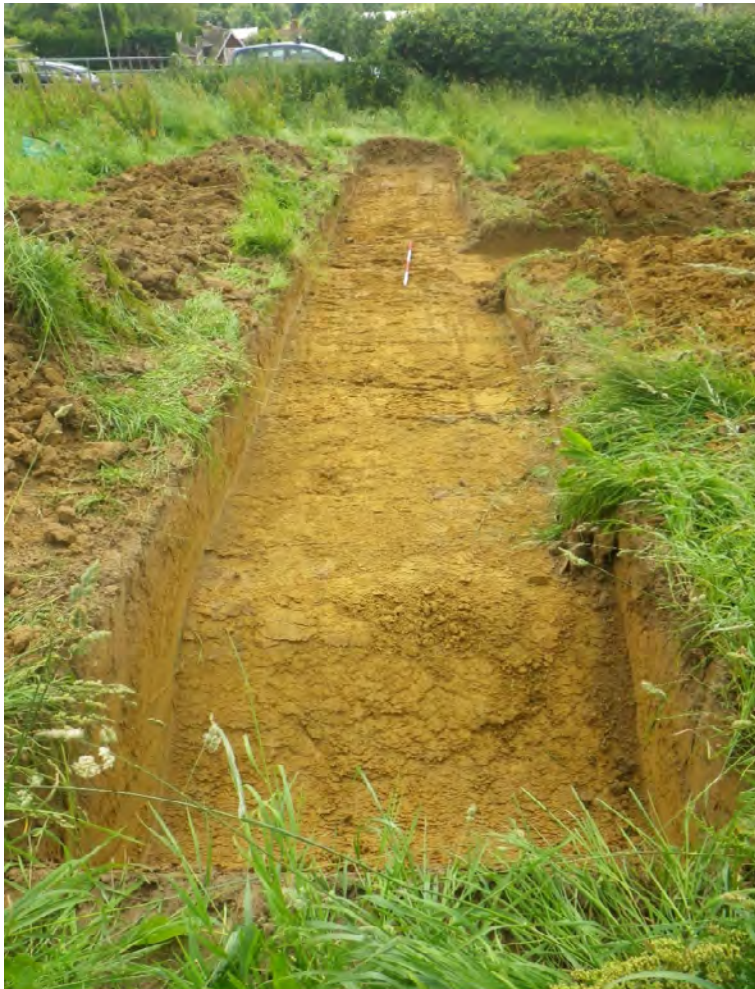
Plate 1: View of Trench 1 from the west

- 5.1 This trench measured 15m in length and was aligned approximately east to west. No evidence for archaeological activity was encountered. A maximum depth of 0.2m was excavated through topsoil (context 101). At the eastern end of the trench, a 0.8m deep sondage was excavated through the subsoils. The recorded layer sequence for this trench is summarised in Table 1.

Context	Depth b.g.s.	Description	Interpretation
100	0 – 200mm	Light brown soft sandy clay loam	Topsoil/turf
101	200 - 88mm max	Brownish yellow, soft sandy clay. Less than 1% sub-angular gravel - mudstone	Natural bedrock

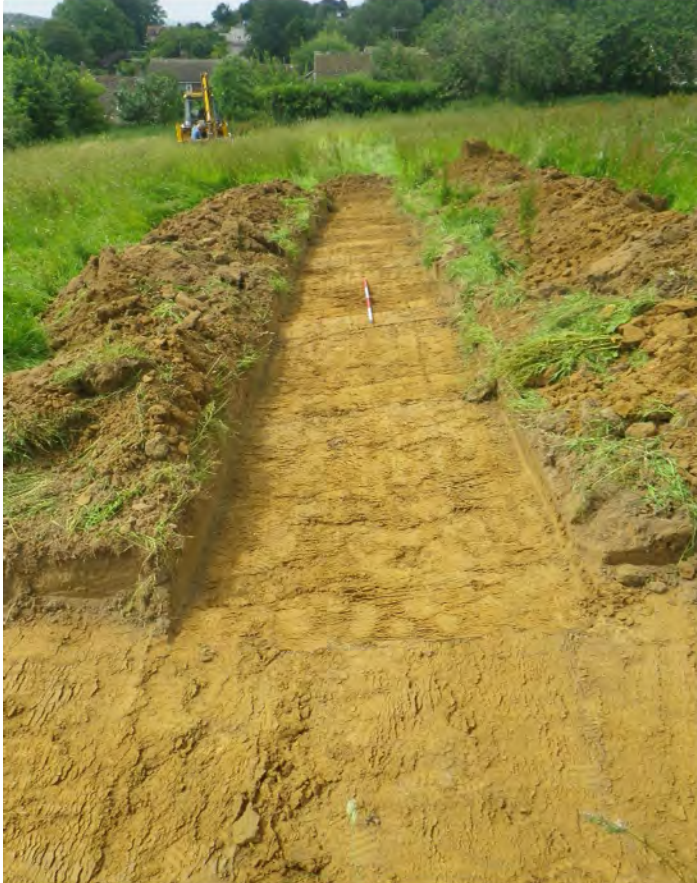
Plate 2: View of Trench 2 from the north

5.3 This trench measured 15m in length, and was aligned approximately north to south. No evidence for archaeological activity was encountered. A maximum depth of 0.2m was excavated through topsoil (context 201). At the southern end of the trench, a 0.53m deep sondage was excavated through the subsoils. The recorded layer sequence for this trench is summarised in Table 2.

Context	Depth b.g.s.	Description	Interpretation
200	0 – 200mm	Light brown soft sandy clay loam	Topsoil/turf
201	200 - 530mm max	Brownish yellow, soft sandy clay. Less than 1% sub-angular gravel – mudstone	Natural bedrock
