Church of St Michael the Archangel, Mere, Wiltshire:

Results of an archaeological watching brief

Document No: ACW1082/2/0

Date: February 2021

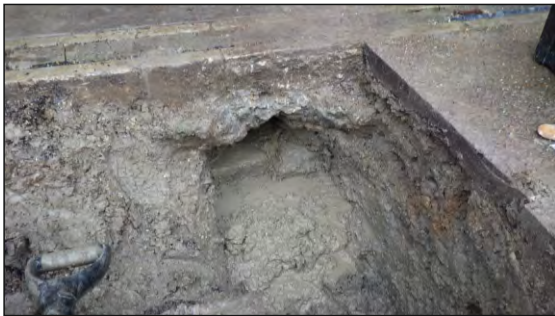
Plate 1: Stone foundation, 102

- 4.2 After the removal of the flagstones in the floor of the tower, a trench was excavated measuring 0.4m wide and dug mainly to a depth of 0.25m, but in some areas it reached a depth of 0.4m. The trench was excavated through a layer of compacted silty rubble, 0.15m thick (context 101). This appeared to represent a base layer or foundation for the overlying floor level. Below this was a deposit of compacted limestone and greensand tabular and angular slabs (context 102). These measured up to 0.3m in size and were bonded by a light brown sandy mortar. This deposit appears to represent foundation material, possibly associated with the tower walls. It appears that this foundation was also exposed slightly further to the west within pipe trench A (see Plate 1).

- 5.2** In both the west tower floor trench and the eastern extent of Trench A, stone foundations were revealed. The purpose of these foundations is unclear, but given their location, it is possible that they relate to the foundations of the west tower. The brick structure recorded in Trench B appeared to continue below the west wall foundations of the north aisle. The date of the north aisle is of mid-15th century; however the date of the brick structure is uncertain although the bricks themselves appear to be of an early date, their dimensions (approx. 0.25 x 0.1m x 0.3m) possibly suggesting a Tudor origin.
- 5.3** No dateable artefacts were present. Given the limited archaeological results it is not proposed to deposit a formal archive. A copy of this report will be submitted to the Wiltshire Historic Environment Record and uploaded to OASIS.
