# Water Main Replacement, Stowell, Sherborne, Somerset:

Results of an Archaeological Watching Brief

Document No: ACW1369/2/0

**Wessex Water Project No: B18054**

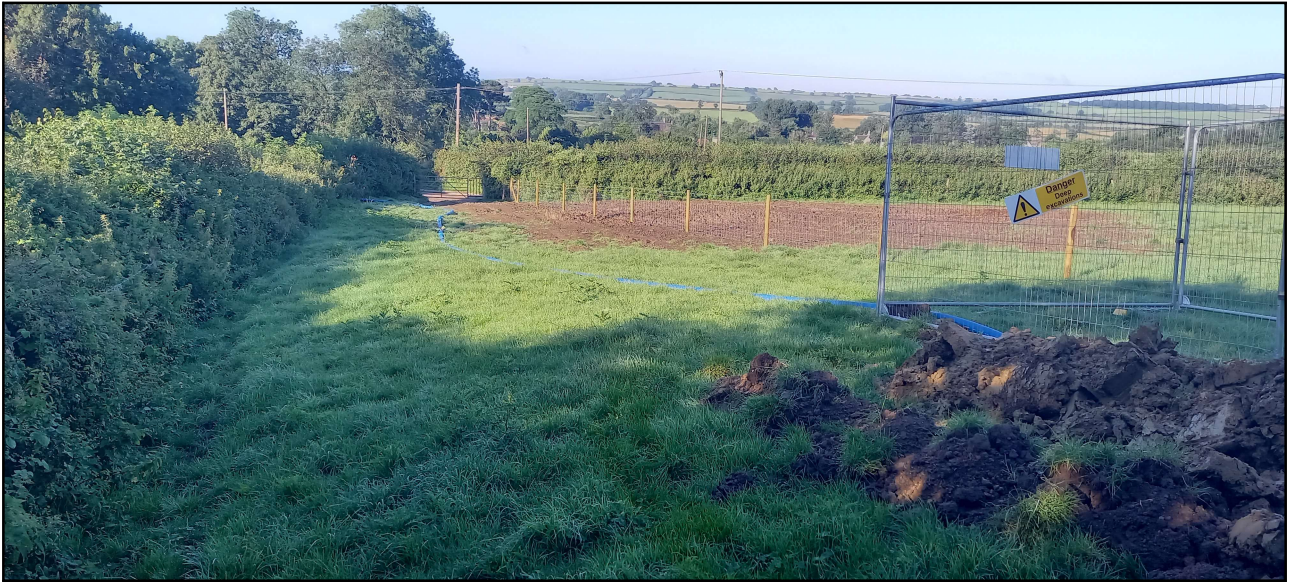
Plate 1: General view of groundworks

**5.1** The archaeological watching brief was undertaken in August 2021 and involved monitoring the length of an open-cut pipe trench measuring between 0.30m and 0.40m in width (see Plates 1-3). It was machined to a depth of up to 1.0m. The general stratigraphy consisted of a topsoil / plough-soil c. 0.20 in depth comprising a mid grey-brown clayey loam. This sealed a light grey-brown silty clay subsoil c.0.10 deep (see Plate 2). Below this was a very stiff yellow-brown clay natural.

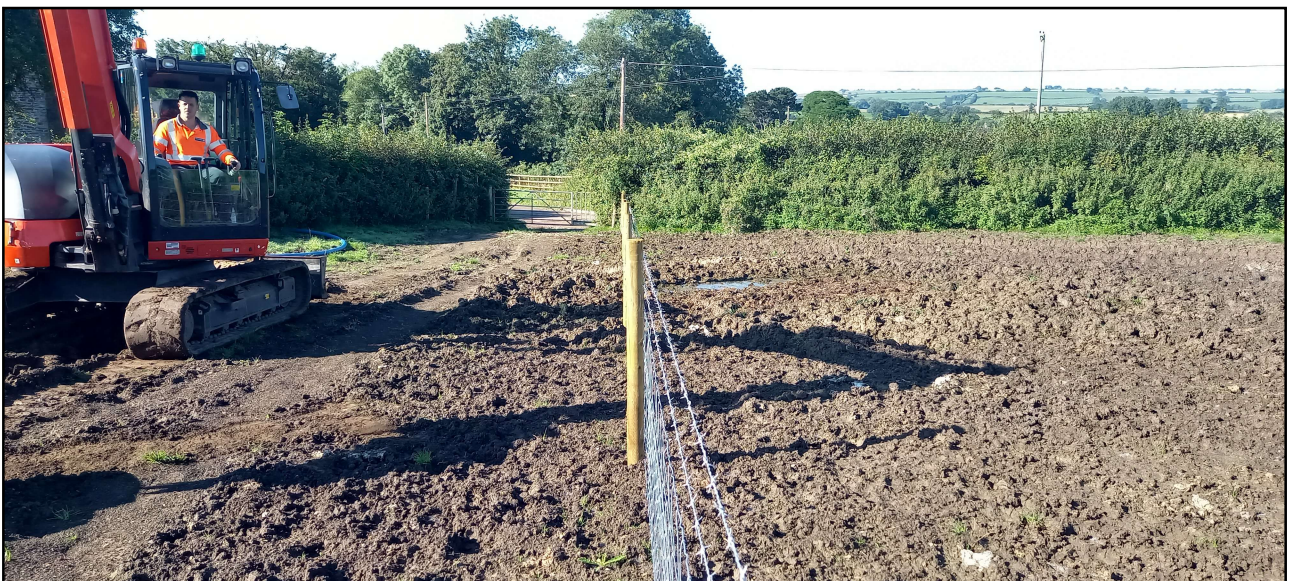
Plate 3: Disturbed ground in gateway

**5.2** No archaeological features, deposits or finds were recovered during the monitoring and the area closest to the main gate to the field was heavily disturbed by livestock and agricultural equipment. The DMV earthworks were visible in land to the south-west near Clare Farm.
