Castle view, Culmstock Road, Hemyock, Devon

Results of an archaeological trench evaluation

Planning ref. Mid Devon District Council 11/00056/FULL

Document No: ACD315/1/1

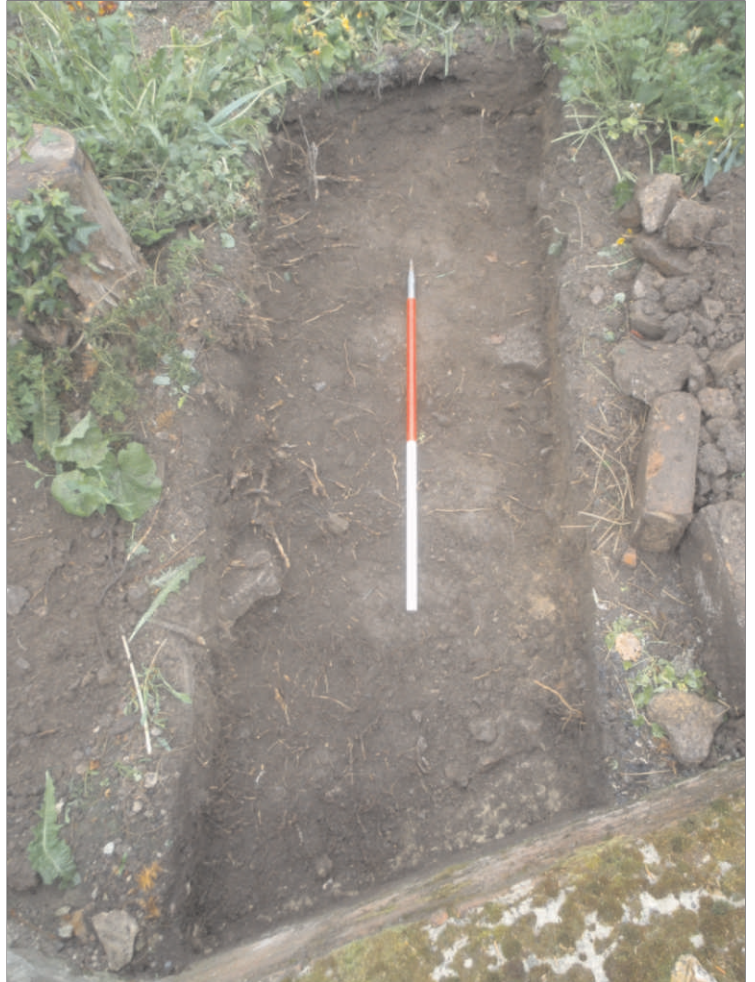
- 5.1 The results from the trench are described in detail below, with a section included as Fig. 2b and photographs as Plates 2 & 3.
- 5.2 Natural subsoil or *in situ* archaeological deposits were not exposed in the trench. There was heavy root disturbance present throughout from a nearby tree. At the northeast end of the trench a modern overburden layer of mid to light yellowish-brown friable silty clay, with frequent large sub-angular stone inclusions, was present (context 103). This was exposed at a depth of 0.10m and continued beyond the base of the trench. The layer contained modern finds such as coal, wire and plastic.

Plate 2: General view of trench, looking northwest (Scale 1m)

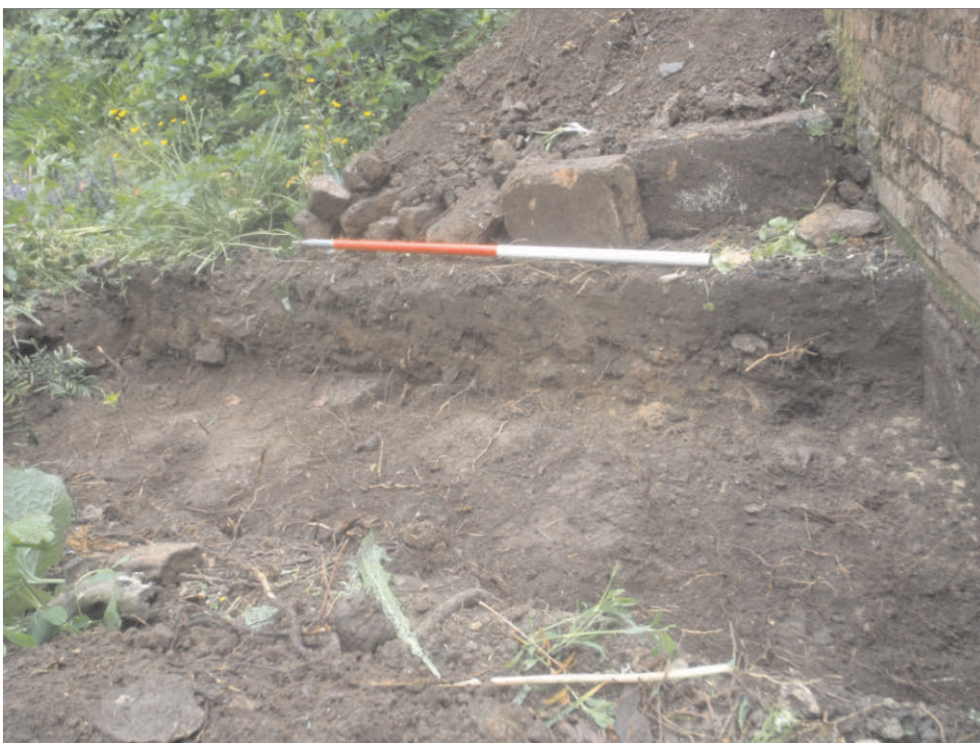
- 5.3 Layer 103 was truncated in the middle of the trench by a mixed dumped deposit (102), which consisted predominantly of yellow clay with red clay inclusions. Also within this deposit was wire, plastic, concrete blocks and ceramic field drain remnants. Deposit 102 was truncated at the southwest end of the trench by a vertical construction cut (F105) for the existing brick boundary wall (106). The wall and construction cut fill had been laid on a weak cement footing (104). The fill of the construction cut (101) was a friable mid to light brown silty clay.

- 5.4 Overlying 101, 102 and 103 was garden soil (100), which was a friable mid to dark greyish-brown silty clay with occasional quartz stone inclusions. This deposit also contained frequent modern finds such as plastic and wire.

Plate 3: northwest facing section of trench (Scale 1m)

- 6.1 With the exception of modern layers and deposits, no archaeological features were exposed and no early finds recovered. As the trench was wholly excavated within modern overburden, it is possible that archaeological features and deposits are present below the 0.30m formation depth (135.10m OD).
- 6.2 Based on the results of the work, it is considered very unlikely that the construction of the new access will have an impact on any below ground archaeological remains.
