Proposed erection of three two-storey buildings at 67 Church Road, Croydon

Results of an archaeological evaluation
Planning Application 09/01166/P

Document No: ACW358/2/0

Date: June 2011

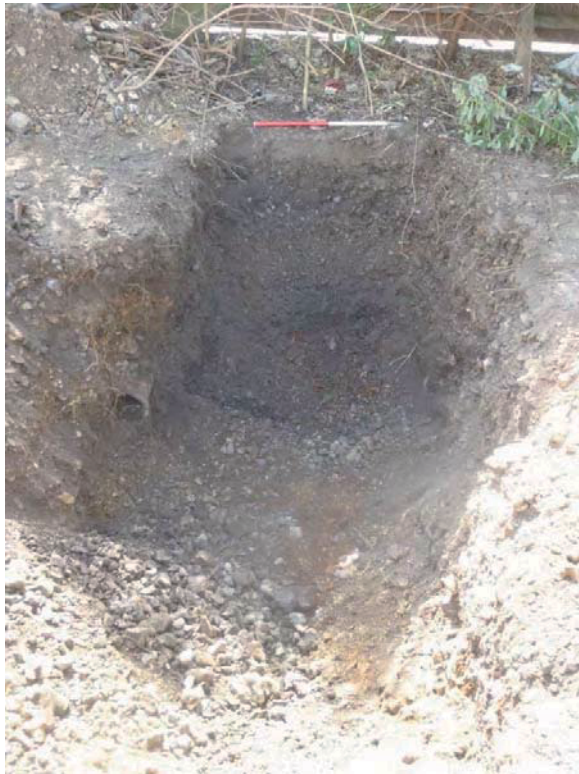
4.2 After clearance of weeds, the upper deposit of the trench comprised a greyish brown to yellow gravel in a grey-brown soil matrix (context 100) that was 200mm thick at the north-east end of the trench, but thickened to c1.40m at the south-west end. This overlay a natural yellow to brown gravel, with frequent flint nodules (context 101), that lay conformably with the upper gravel deposit.

4.3 The upper deposit, context 100, appears to have been imported into the site, presumably as make up for former yard surfaces, and was cut through by various modern ceramic drainage pipes. No artefacts were recovered from either deposit.

Plate 1: SW end of trench showing infill deposit 100 at maximum thickness

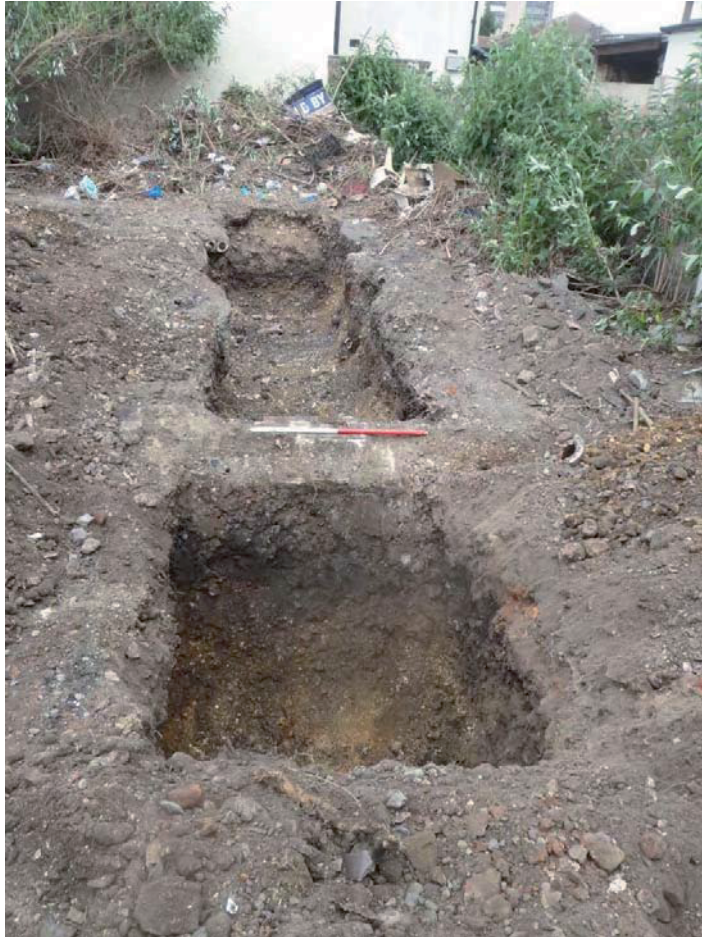
4.4 After clearance of weeds, the upper level of the trench comprised a deposit of grey-brown soil with much modern brick rubble (context 200), that was 100mm thick at the north-west end of the trench, but thickened to 200mm at the south-west end. This overlay a yellow to brown gravel, with frequent flint nodules (context 201), that was excavated to a depth of 1.4m to confirm its homogeneity. The upper 400mm of this deposit was stained dark grey/black as a result of leaching from context 200.

4.5 A baulk was left part way along the trench to avoid a drain. No artefacts were recovered from either deposit.

Plate 2: general view of Trench 2 from the SE
